Grenfell Tower Monitoring

Automated Monitoring System

Annual Monitoring Report – From 1st January to 31st December 2020.

PC Monitoring have been instructed to monitor any movements of the structure of the Grenfell Tower undertaken during the propping and remedial works of the tower.

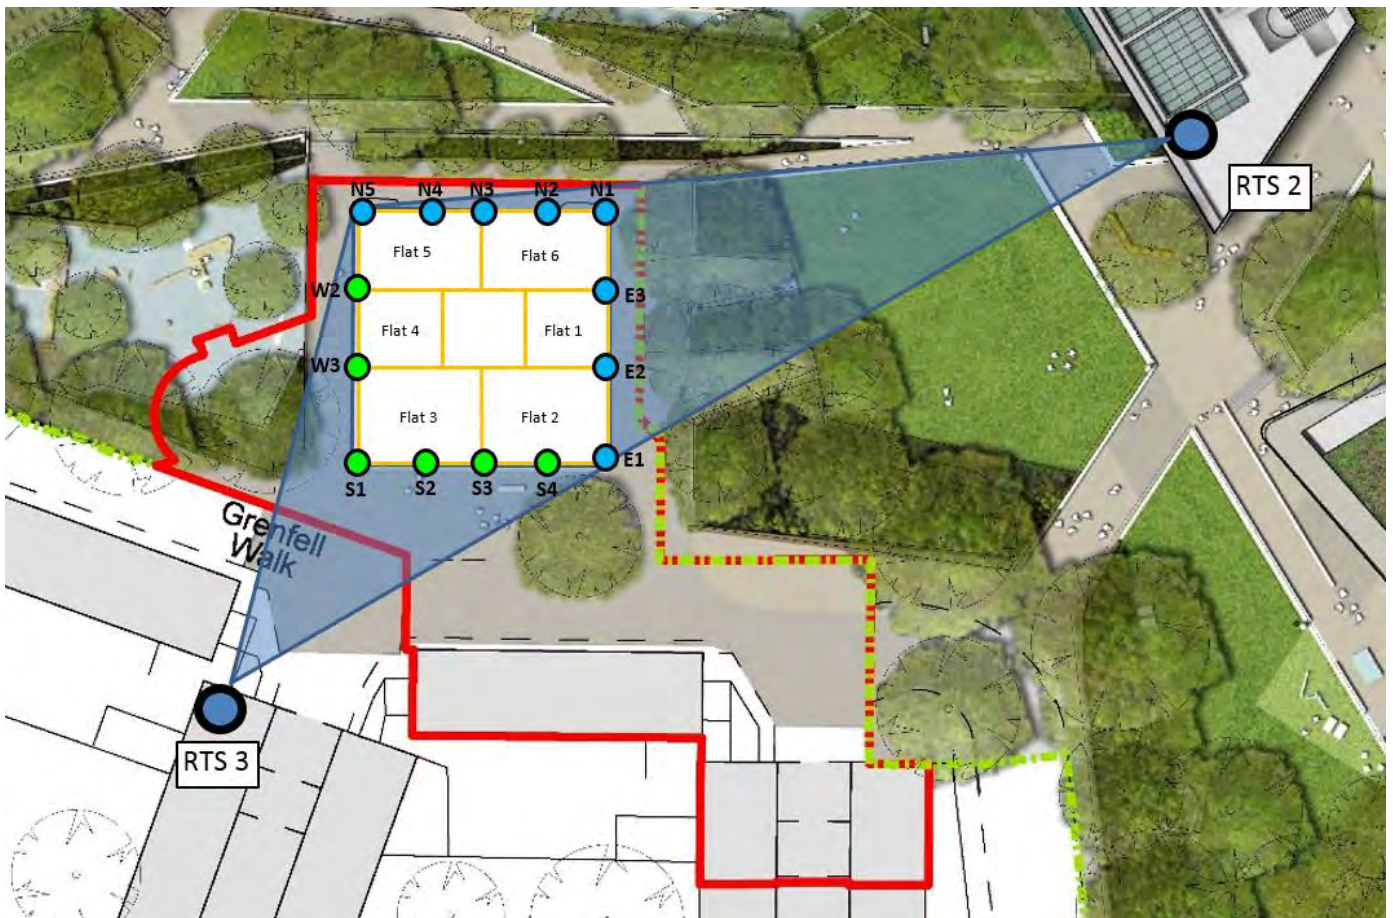
Figure 1 - Location of the monitoring arrays and automated total stations.

The location of the infrastructure that requires monitoring can be seen below in Fig 1.

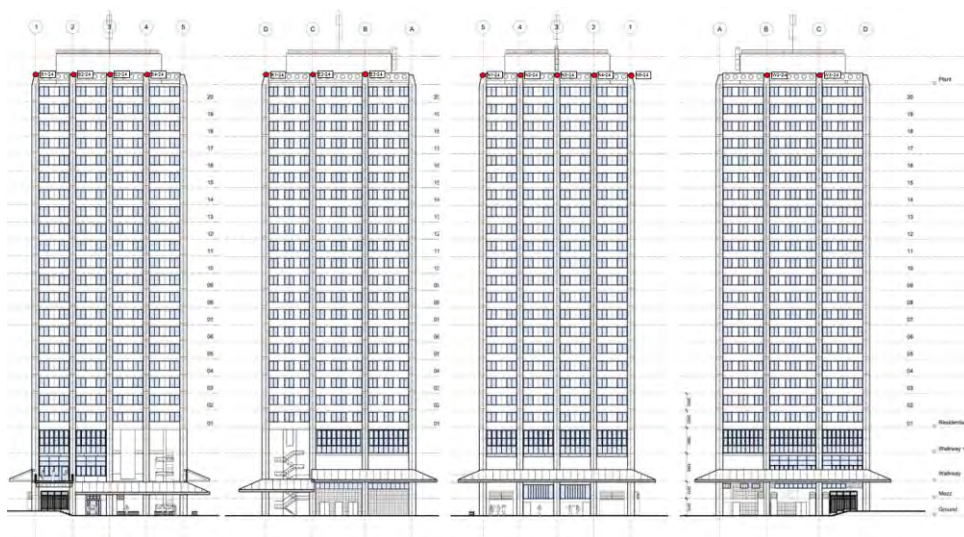
FIGURE 2 – GRENPELL TOWER MONITORING PRISMS ON FACADES

- 14 No. monitoring prisms have been installed within the Grenfell Tower Building Façades. The 14 prisms are located on the façades of Level 24 which are monitored by 2 No. Automated Total Stations (ATS) Systems.

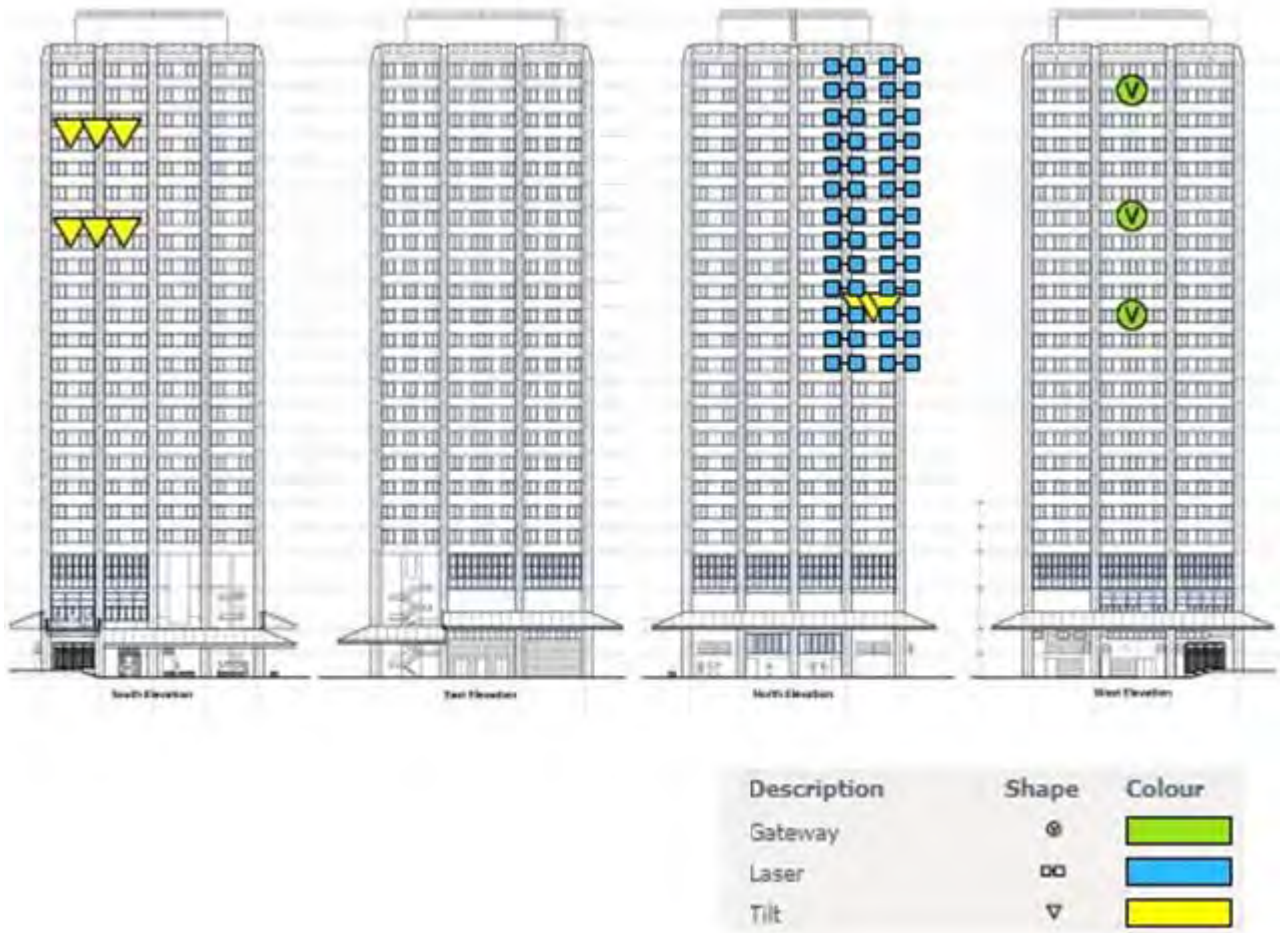
Figure 3 - Grenfell Tower Internal Sensors

- 26 No. Distometer Nodes are located on Columns N4 & N5 on Levels 11-23, 9 No. Tiltmeters are located on Levels 13, 16 and 20. and 3 No. Gateways.
- 1 No. Weather station is location on top of the of the structure
- 26 No. Temperature and humidity sensors

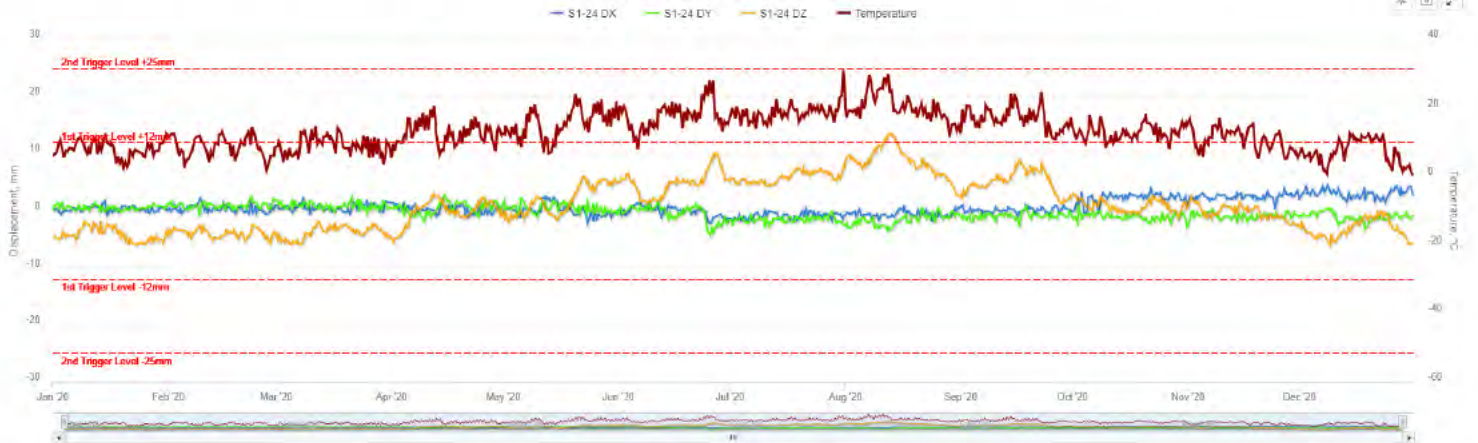
L24 S1 - Displacement vs Temperature

An analysis of measured displacement of monitoring prisms at Grenfell Tower indicates a close correlation to measured atmospheric conditions. The recorded data from the project has been collated and used to quantify a temperature related displacement coefficient. An offset has been applied to minimise the effect of temperature variations on the monitoring data. See table 1 below for offsets applied to some Level 24 monitoring prisms.

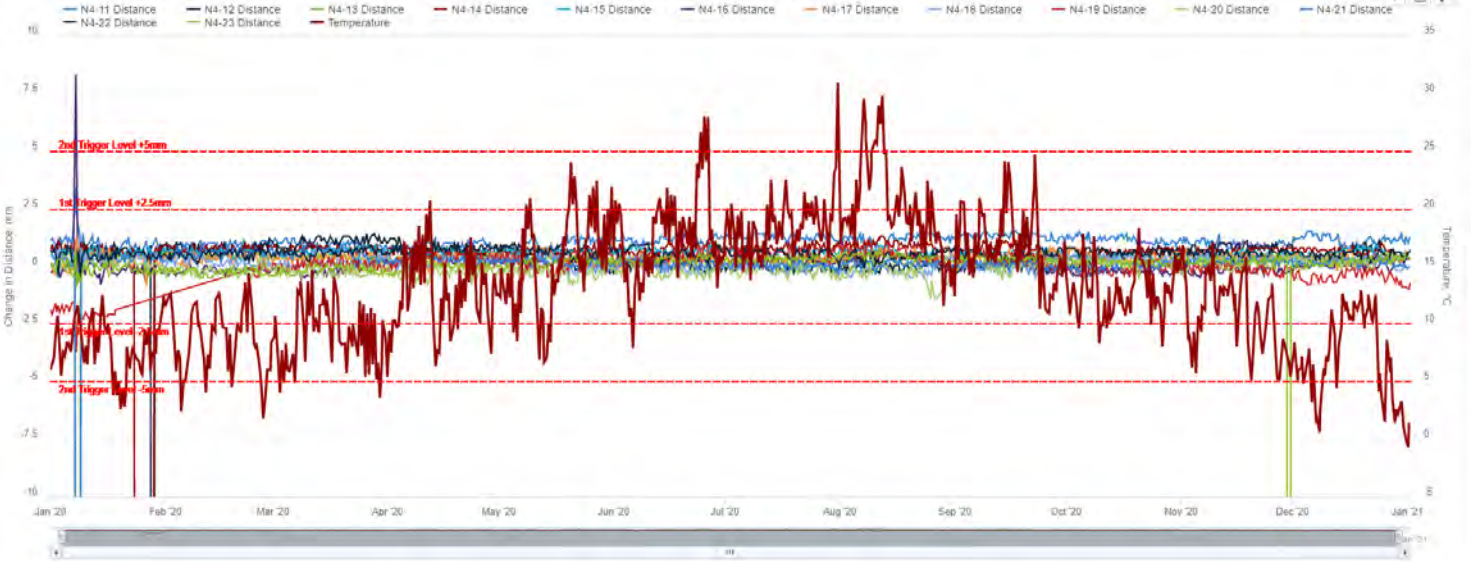
N4 Laser Distometers vs Temperature - Last Year

Point ID	Date	Time	Trigger Level Exceeded	Cause
N4_21_D	07/01/2020	06:06	Amber 2.5mm	Maintenance
N4_20_D	07/01/2020	11:36	Amber 2.5mm	Maintenance
N4_16_D	07/01/2020	12:06	Amber 2.5mm	Condensation
N5_11_D	07/01/2020	12:06	Amber 2.5mm	Condensation
N5_21_D	07/01/2020	14:36	Amber 2.5mm	Condensation
N4_14_D	23/01/2020	16:00	Amber 2.5mm	Maintenance
N4_14_D	28/01/2020	13:00	Amber 2.5mm	Maintenance
N4_12_D	28/01/2020	13:00	Amber 2.5mm	Maintenance
N4_23_D	30/11/2020	10:00-11:00	Red 5mm	Knocked
