Construction noise and vibration Monthly Report – April 2021

London Borough of Camden

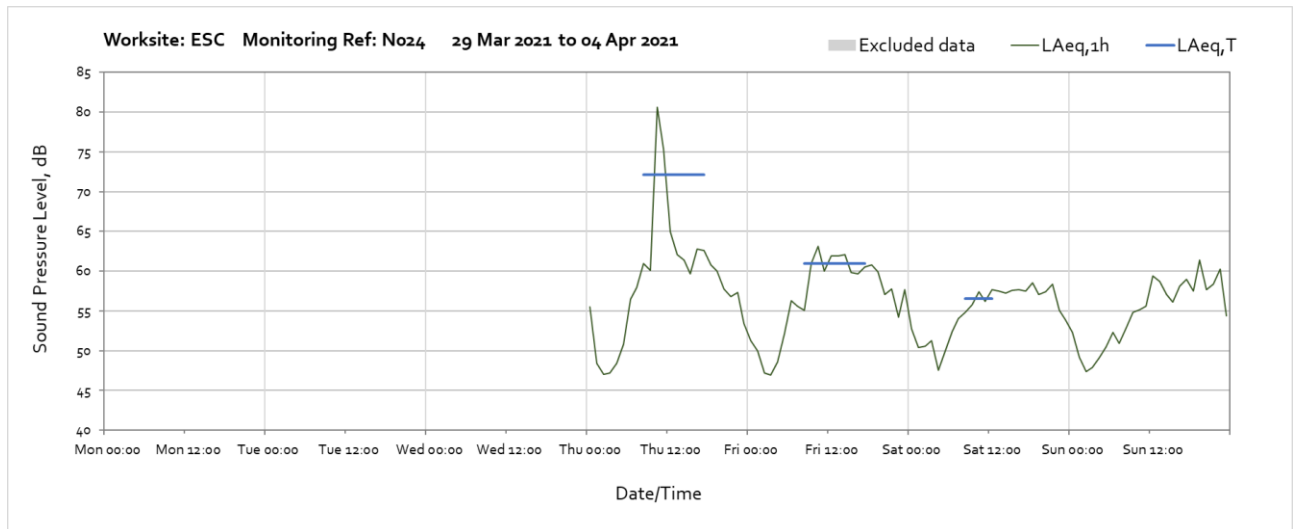
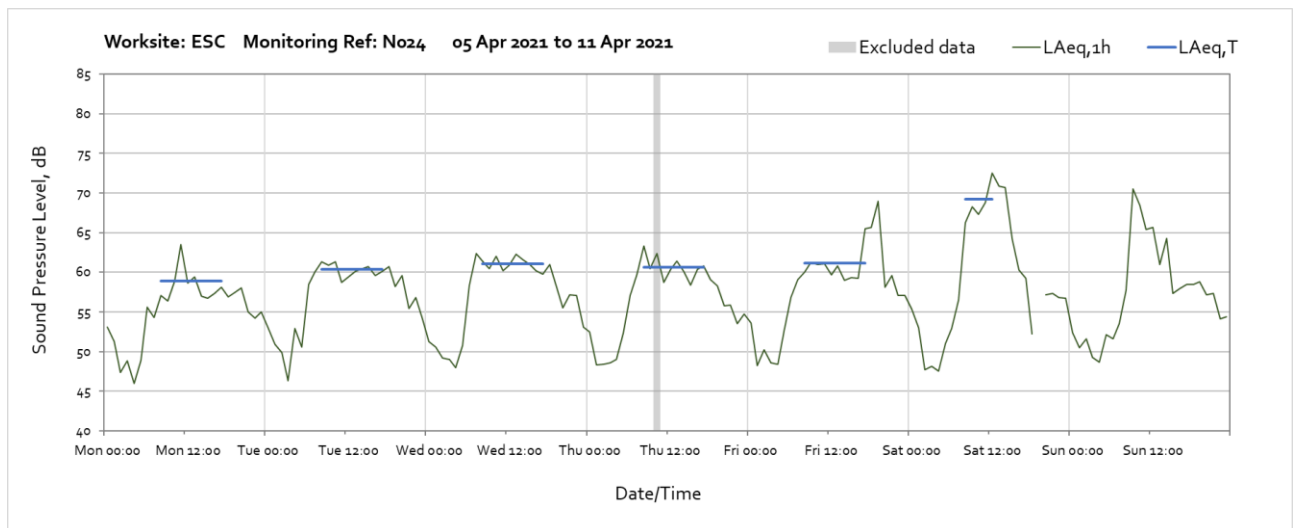
Worksite: ESC – Monitoring Ref: N024

Note: Missing data between 19:00-20:00 on Saturday 10th April was due to a memory card fault.

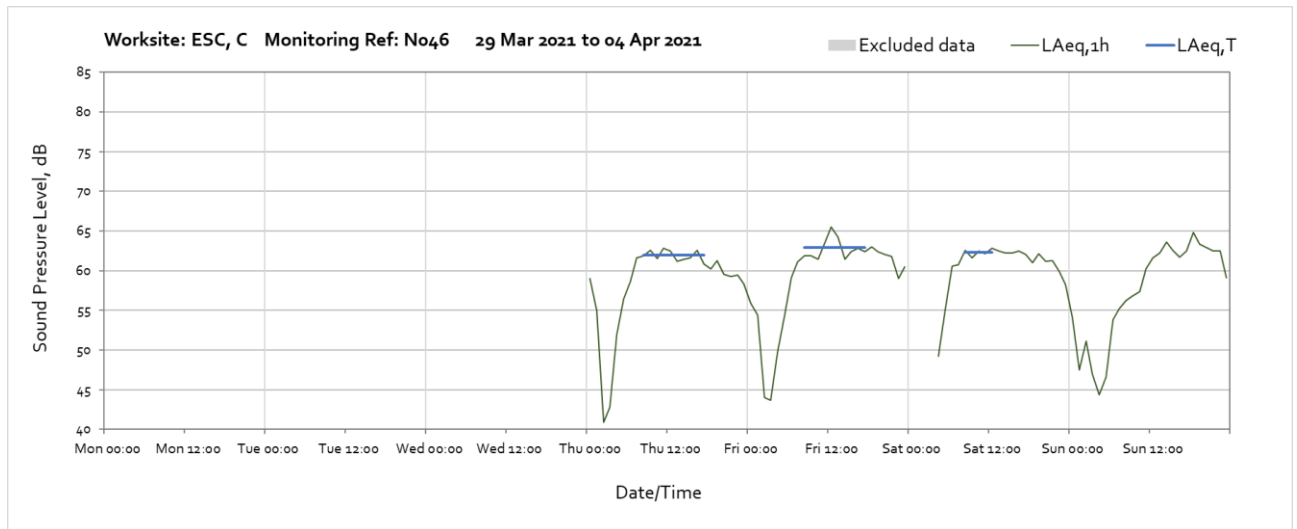
Worksite: ESC, C – Monitoring Ref: N046

Note: Missing data between 00:00-04:00 on Saturday 3rd April was due to a memory card fault.

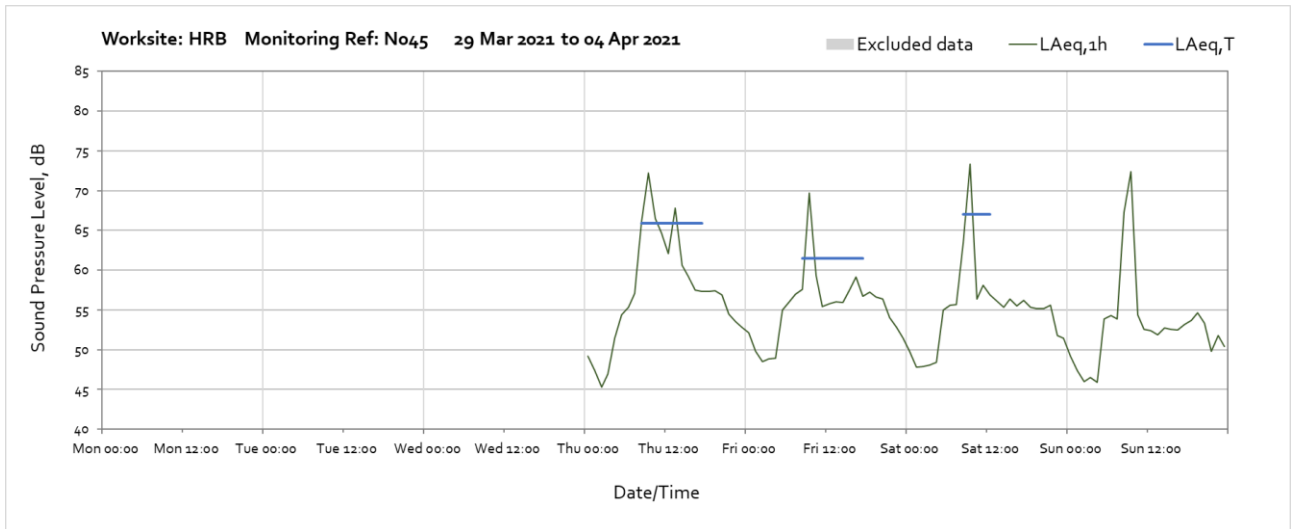
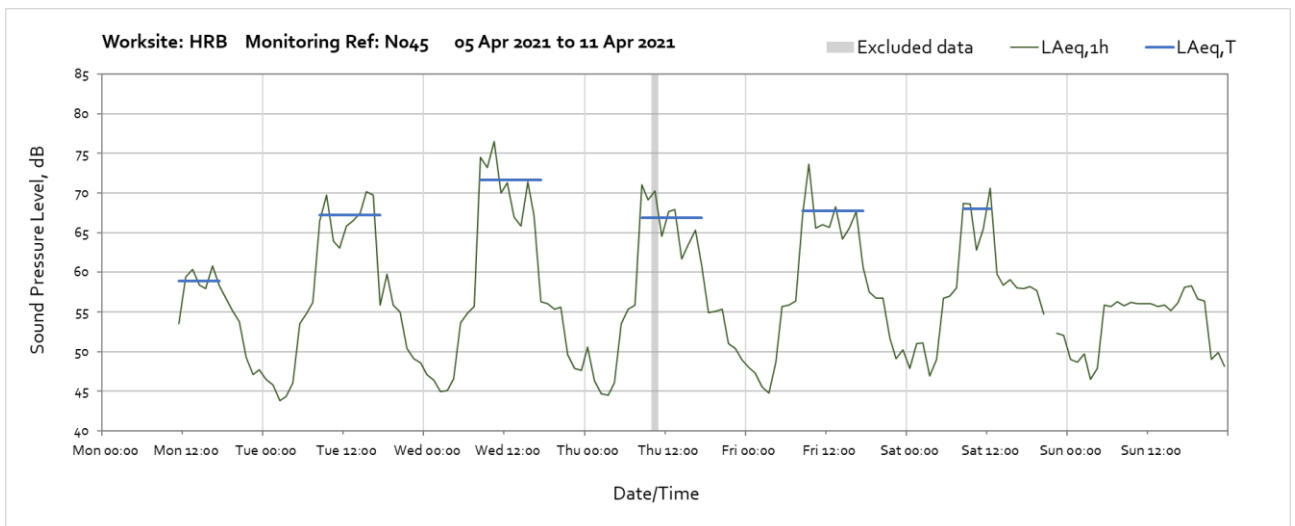
Worksite: HRB – Monitoring Ref: N045

Note: Missing data between 00:00 and 11:00 on Monday 5th April and between 21:00 and 22:00 on Saturday 10th April was due to a memory card fault.

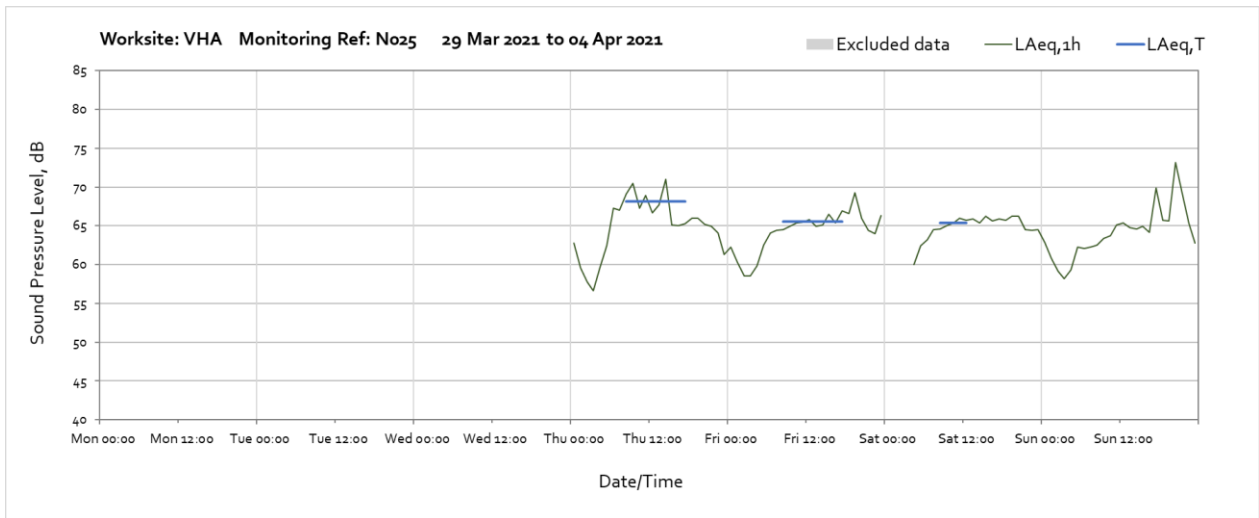
Vehicle Holding Area (VHA) – Monitoring Ref: N025

Note: Missing data between 00:00 and 04:00 was due to a memory card fault.

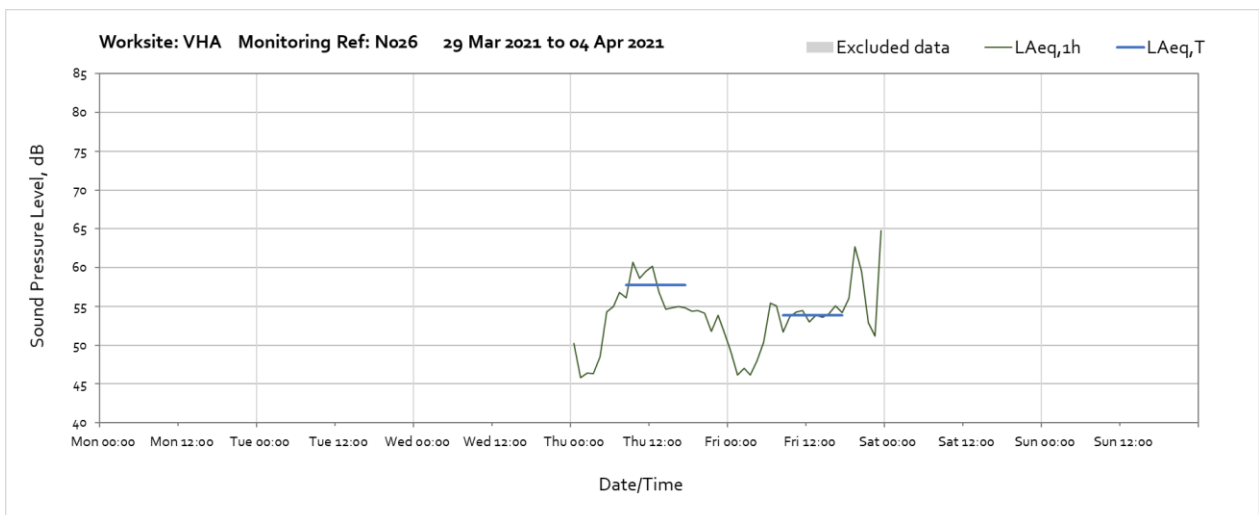
Vehicle Holding Area (VHA) – Monitoring Ref: N026

Note: Missing data between 00:00 on Saturday 3rd April and 09:00 on Tuesday 6th April was due to a loss of site power.

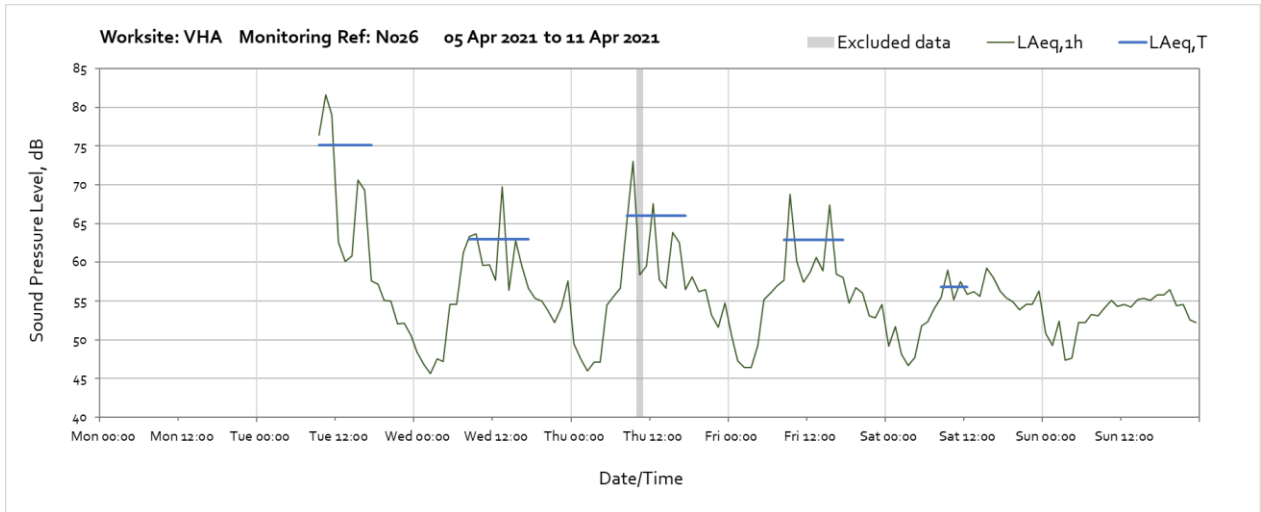
Note: Missing data between 00:00 on Saturday 3rd April and 09:00 on Tuesday 6th April was due to a loss of site power.

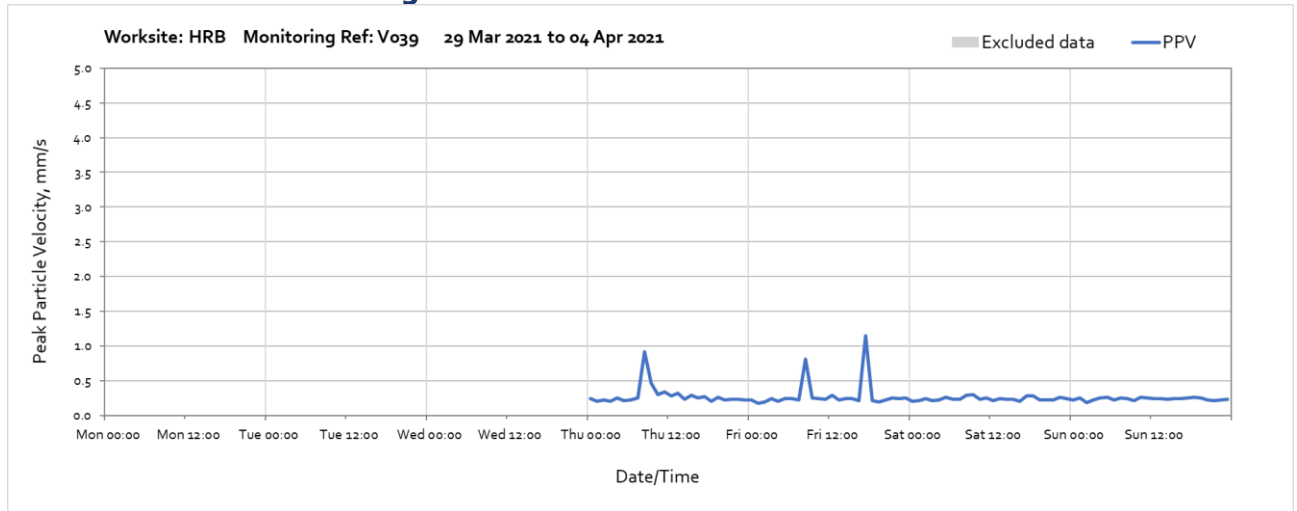
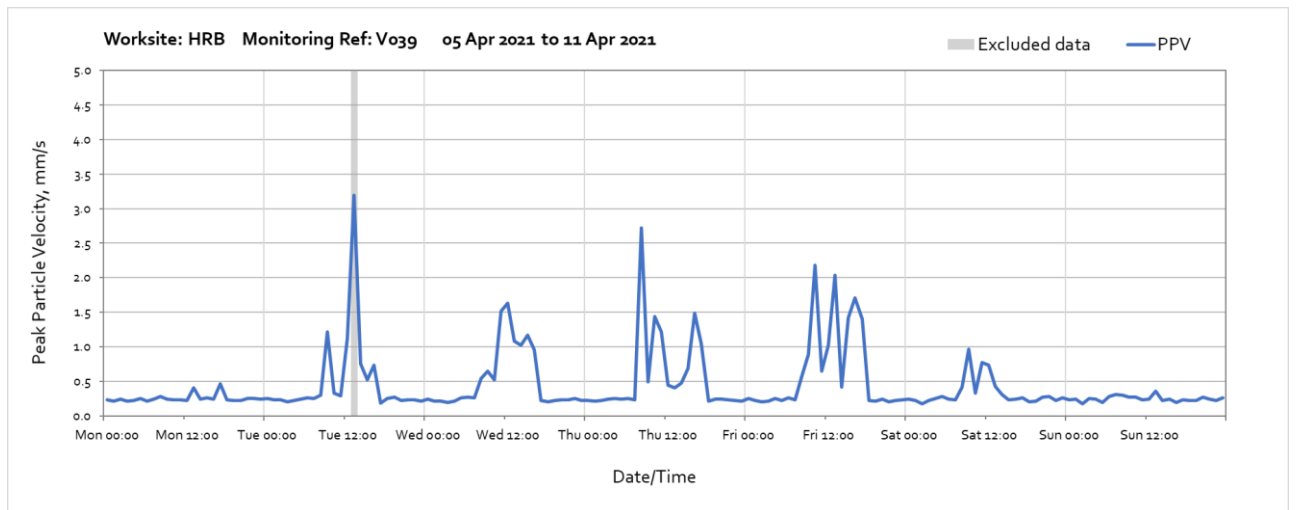
Worksite: HRB – Monitoring Ref: V039

Note: High vibration levels measured between 13:00 – 14:00 on Tuesday 6th April were due to local interference of the monitor and are not representative of HS2 vibration levels.

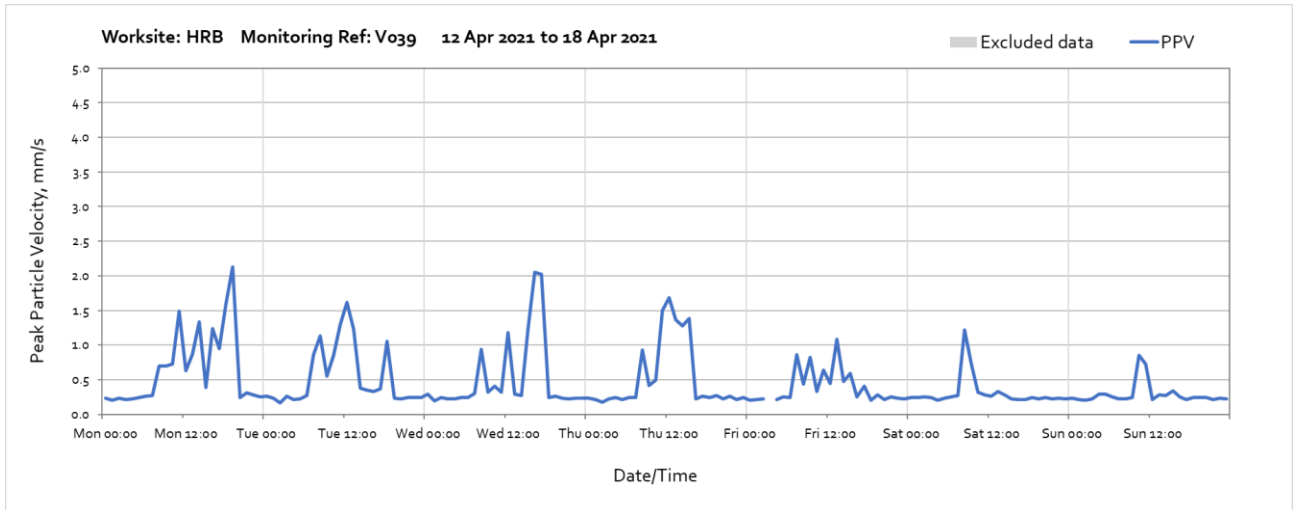
Note: Missing data between 03:00 - 04:00 on Friday 16th April was due to a server connection dropout at the monitoring station. Investigation into the use of dual SIM cards is being undertaken with view of minimising further loss of data.

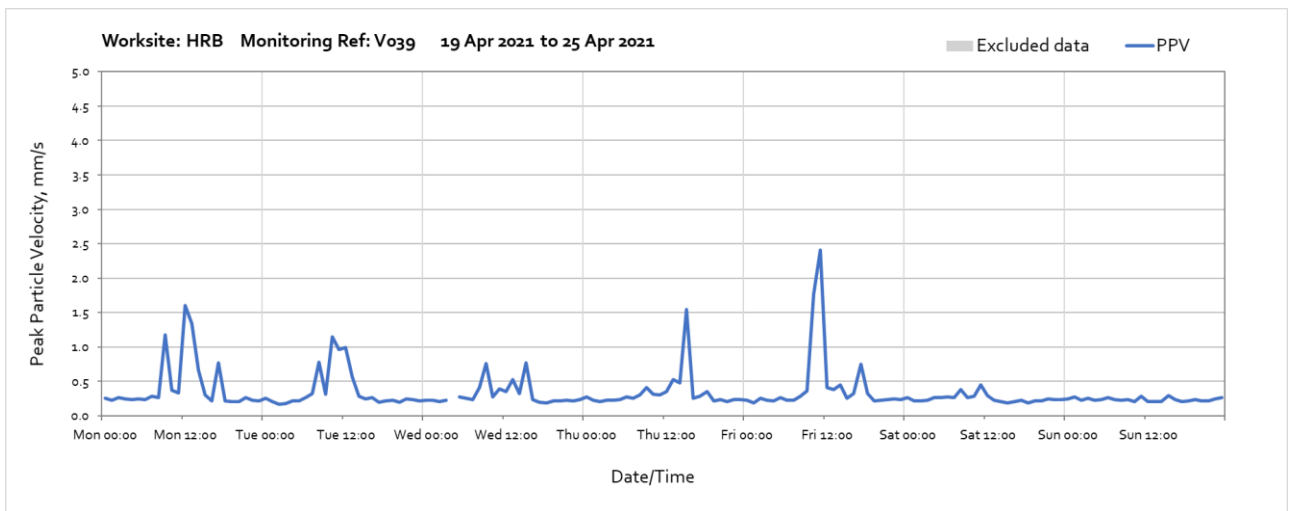
Note: Missing data between 04:00 - 05:00 on Wednesday 21st April was due to a server connection dropout at the monitoring station. Investigation into the use of dual SIM cards is being undertaken with view of minimising further loss of data.

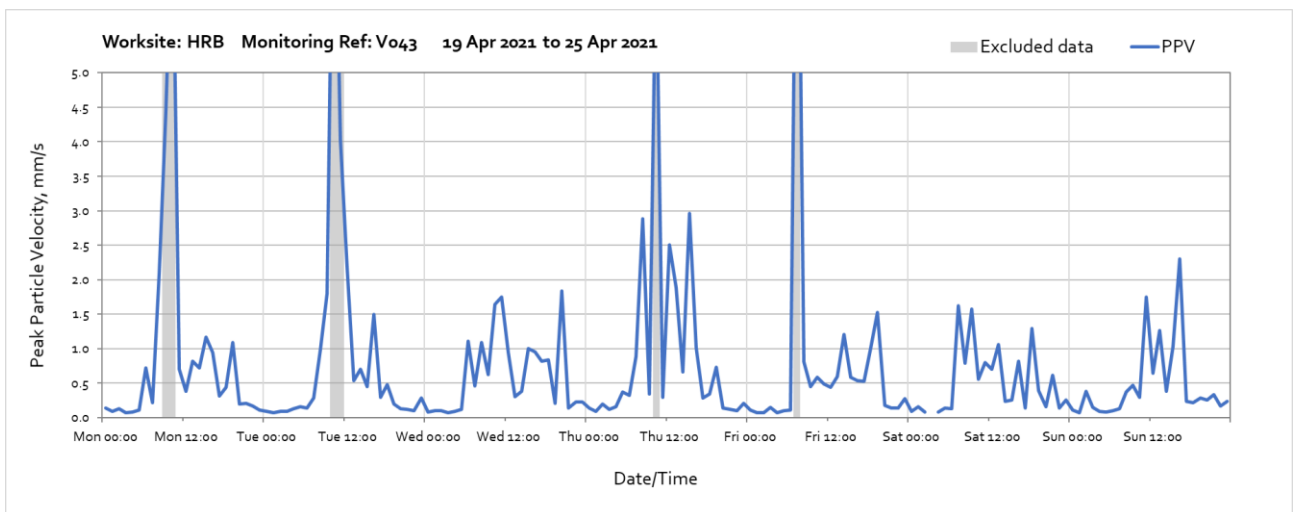
Note: High vibration levels measured throughout the week were due to the use of the nearby residential bin store and local interference of the monitor and are not representative of HS2 vibration levels. Missing data between 03:00 – 04:00 on Saturday 24th April was due to a server connection dropout at the monitoring station. Investigation into the use of dual SIM cards is being undertaken with view of minimising further loss of data.

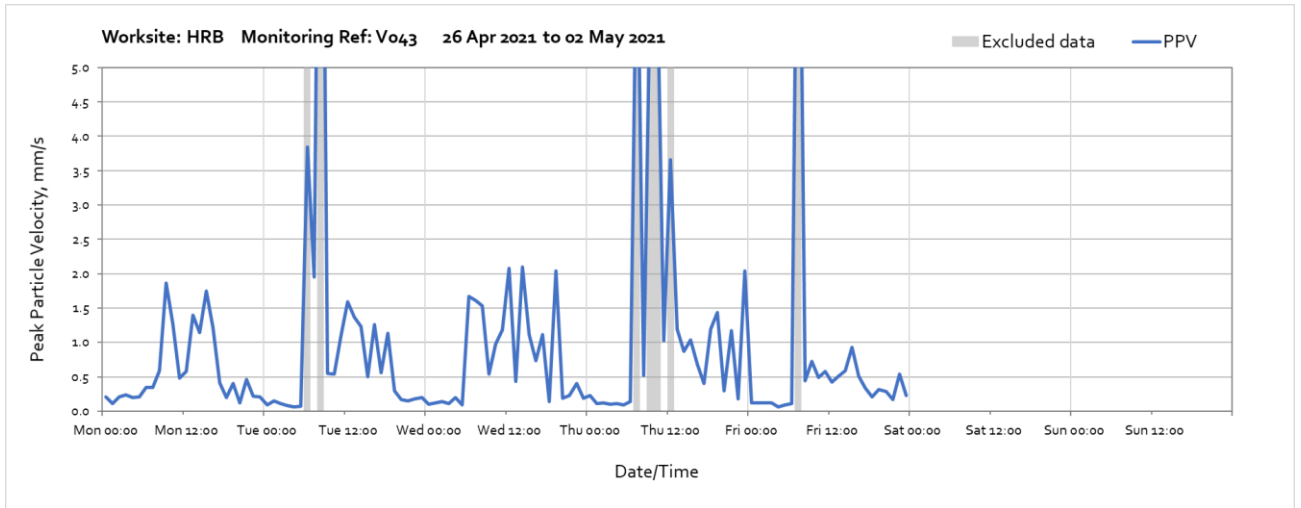
Note: High vibration levels measured throughout the week were due to the use of the nearby residential bin store and local interference of the monitor and are not representative of HS2 vibration levels.

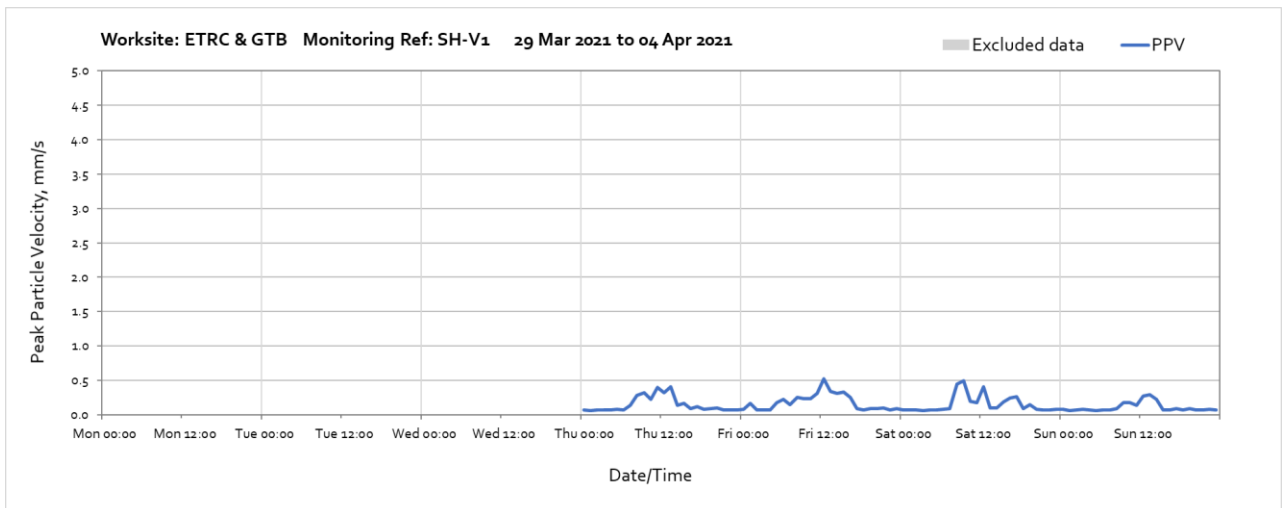
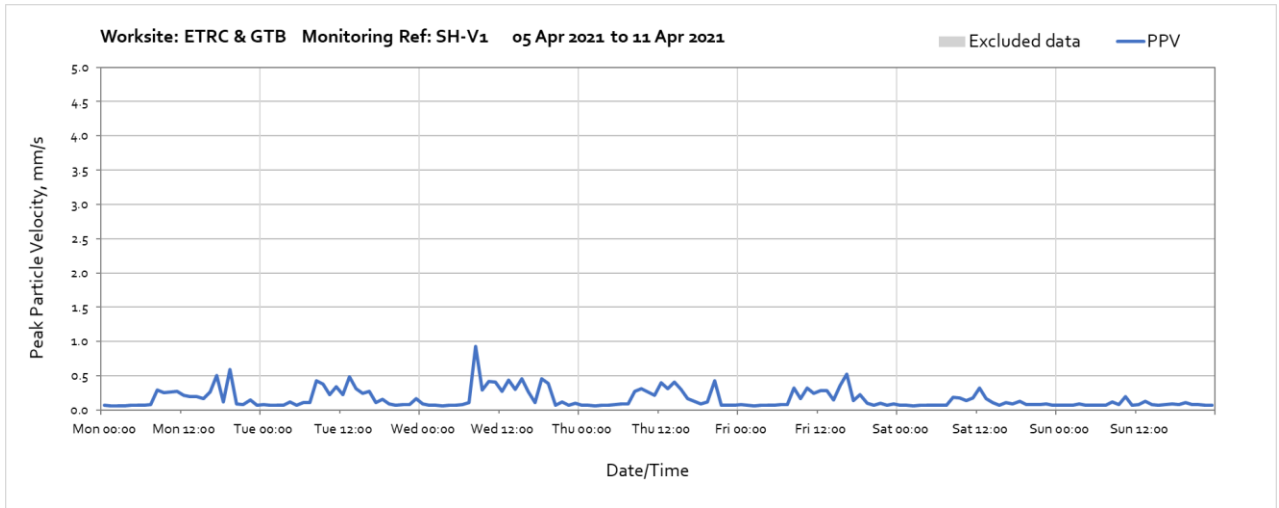
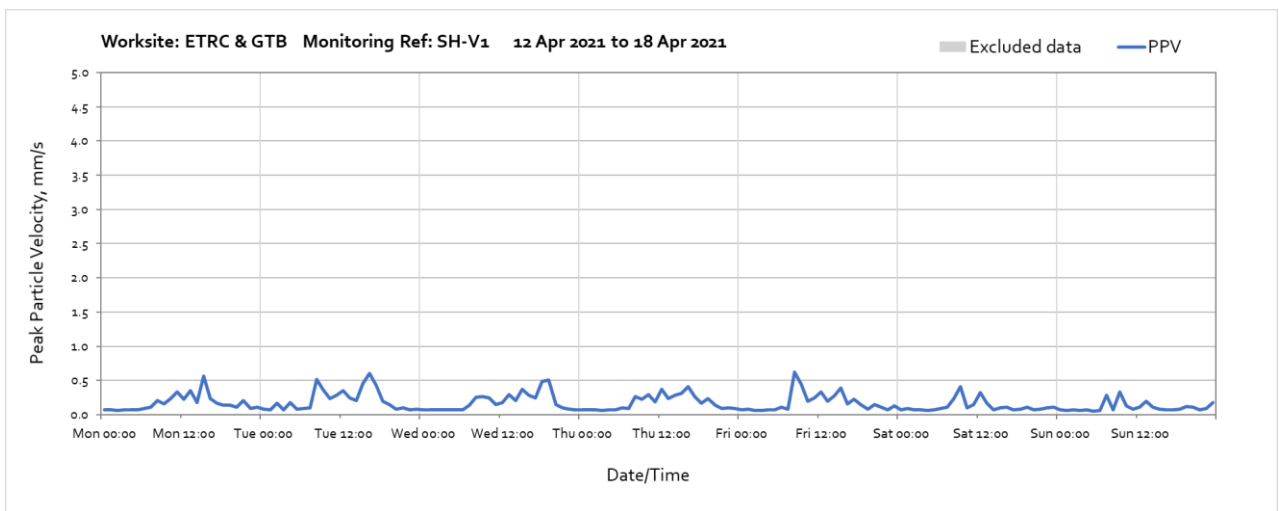
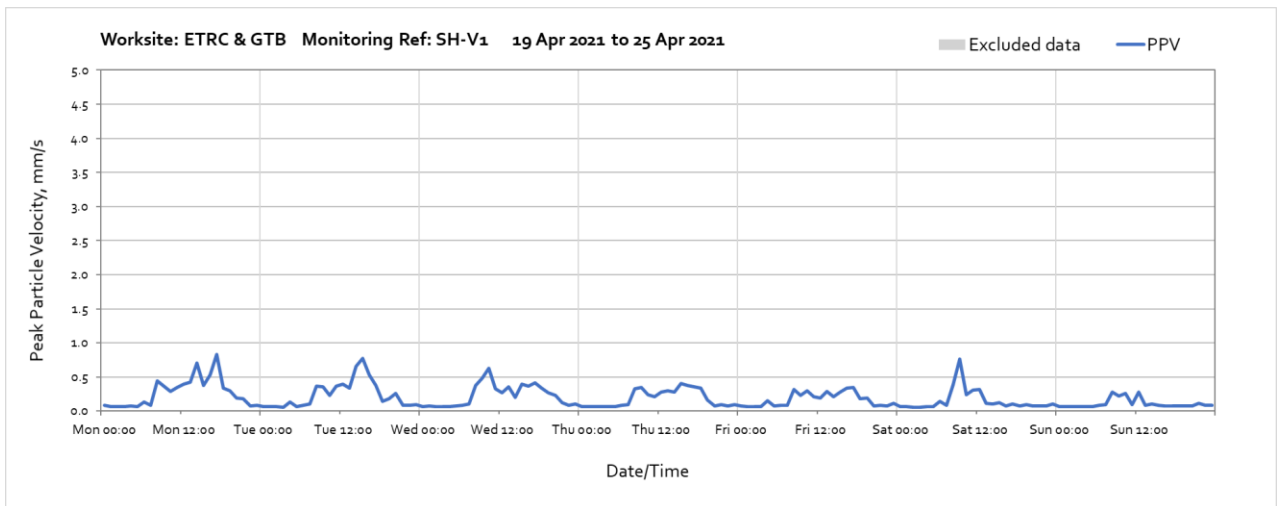
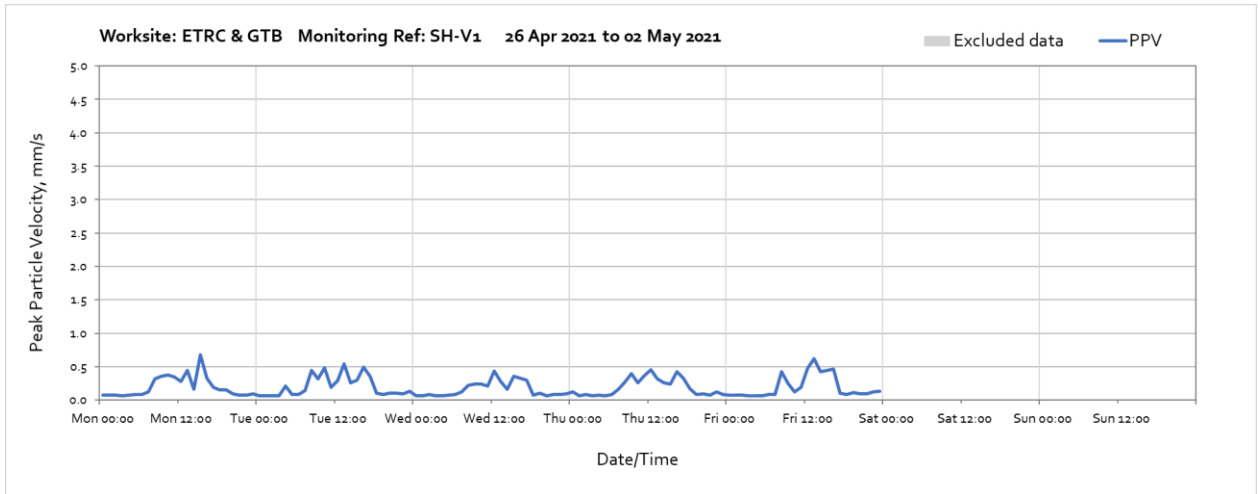
Worksite: ETRC & GTB – Monitoring Ref: SH-V1

The following graphs show the hourly measured peak particle velocity PPV recorded during the monitoring period. The graphs show the resultant PPV due to vibration components on three orthogonal axis x, y and z. Where high values of PPV were caused by local interference with the vibration monitor, which are not representative of HS2 construction works, these values have been greyed out in the following charts and have been excluded to calculate values in Table 4 of the main report.
