Construction noise and vibration Monthly Report – April 2021

Buckinghamshire

Non-Technical Summary

This Noise and Vibration Monitoring Report fulfils HS2 Limited's commitment detailed in the Environmental Minimum Requirements (EMRs), Annex 1, Code of Construction Practice, to present the results of noise monitoring carried out within Buckinghamshire (BS) during the month of April 2021.

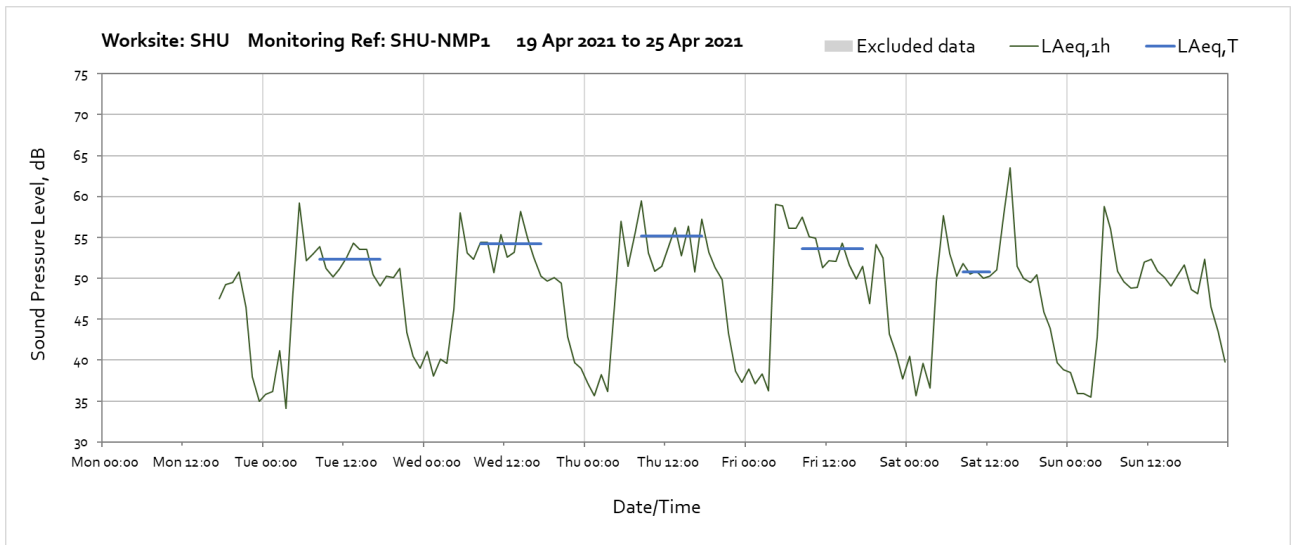
Worksite: SHU – Monitoring Ref: SHU-NMP1

Note: The monitor was installed at 17:00 on Monday 19th April.

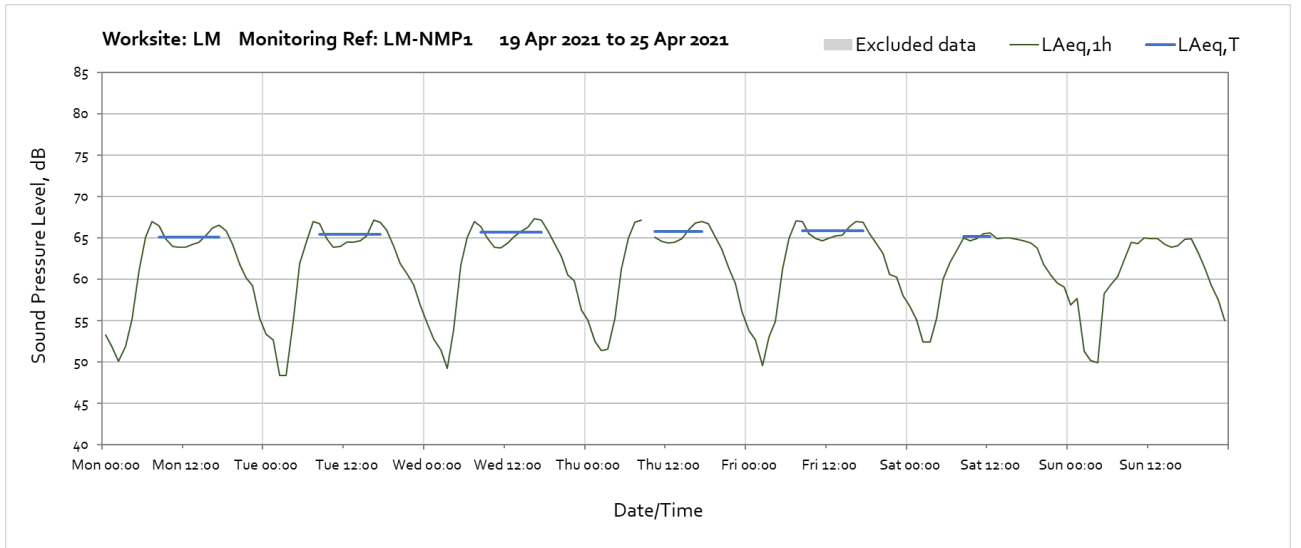
Note: Missing data between 09:00 and 10:00 on Thursday 22nd April was due to maintenance being undertaken to check calibration of the monitor.

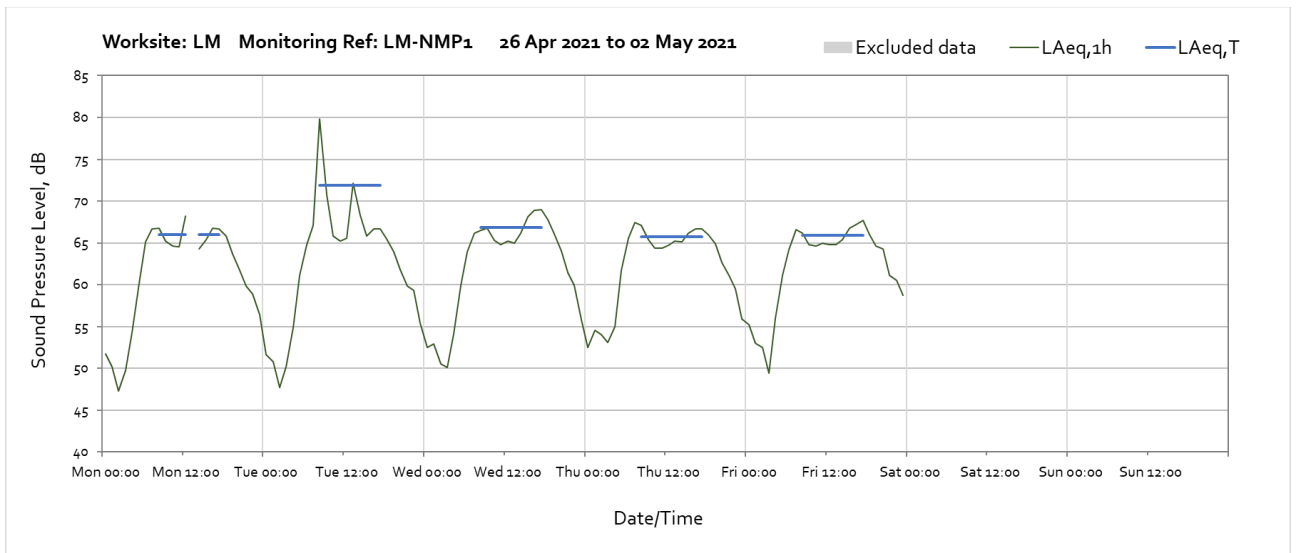
Note: Missing data between 13:00 and 14:00 on Monday 26th April was due to maintenance being undertaken to the monitor to setup audio alarm.

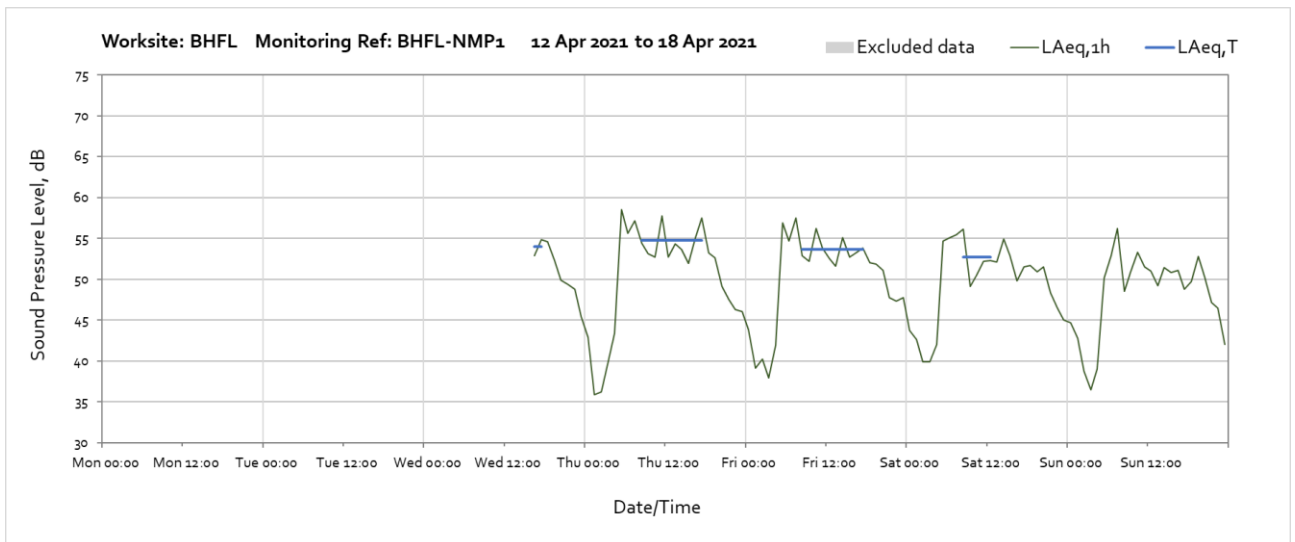
Worksite: BHFL – Monitoring Ref: BHFL-NMP1

Note: Missing data until 16:00 on Wednesday 14th April was due to interruption of main power supply to the monitor.

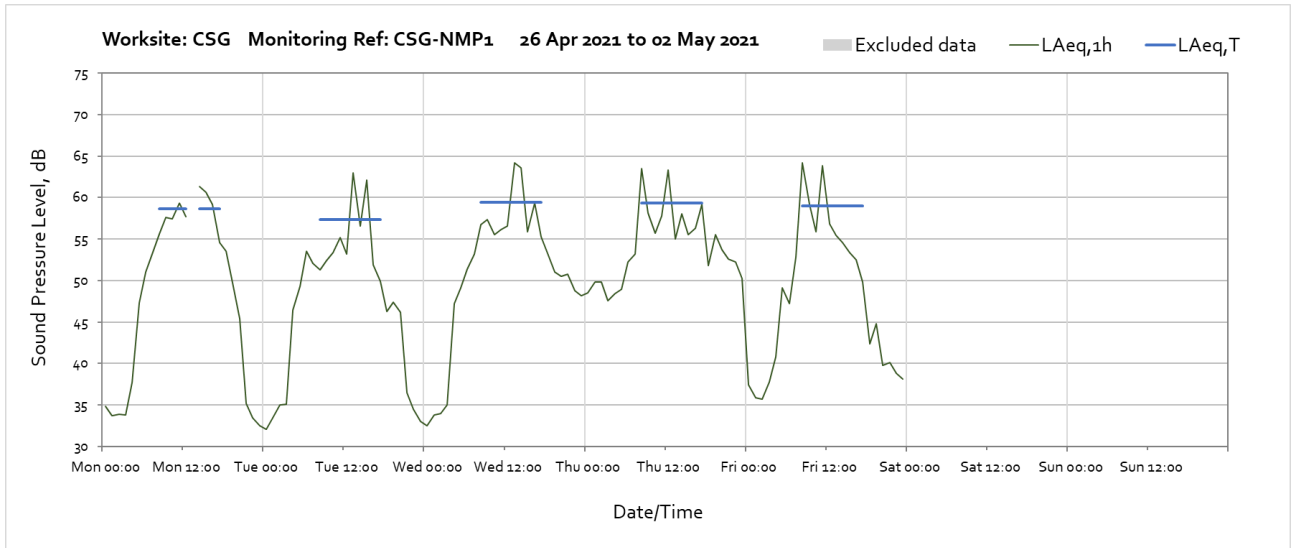
Note: Missing data between 13:00 and 14:00 on Monday 26th April was due to maintenance being undertaken to the monitor to setup audio alarm.

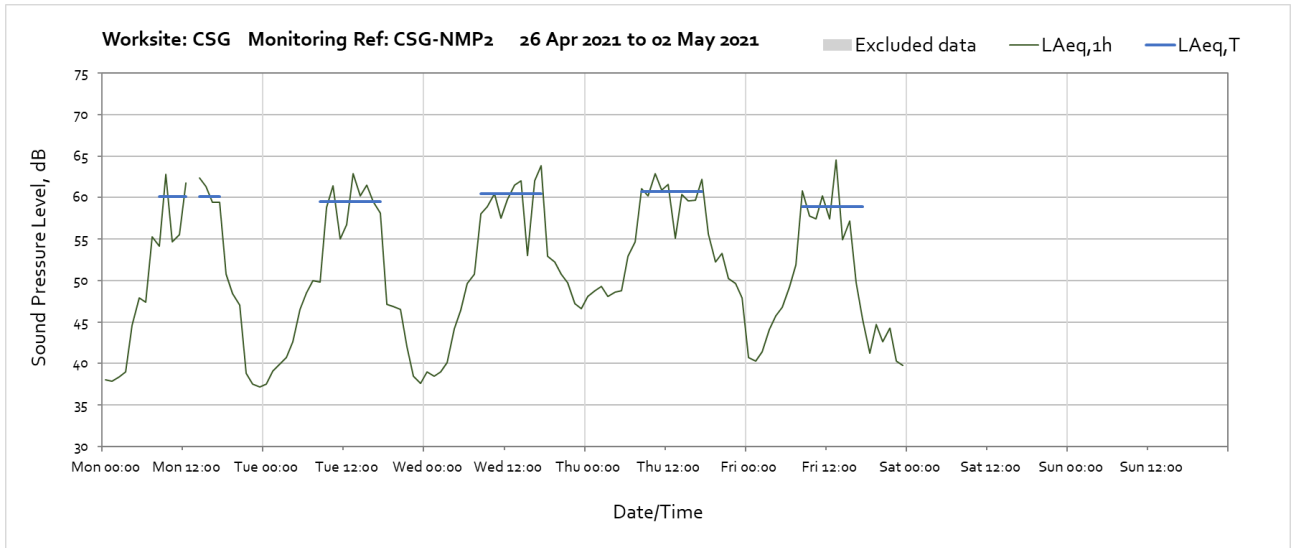
Note: Missing data between 13:00 and 14:00 on Monday 26th April was due to maintenance being undertaken to the monitor to setup audio alarm.

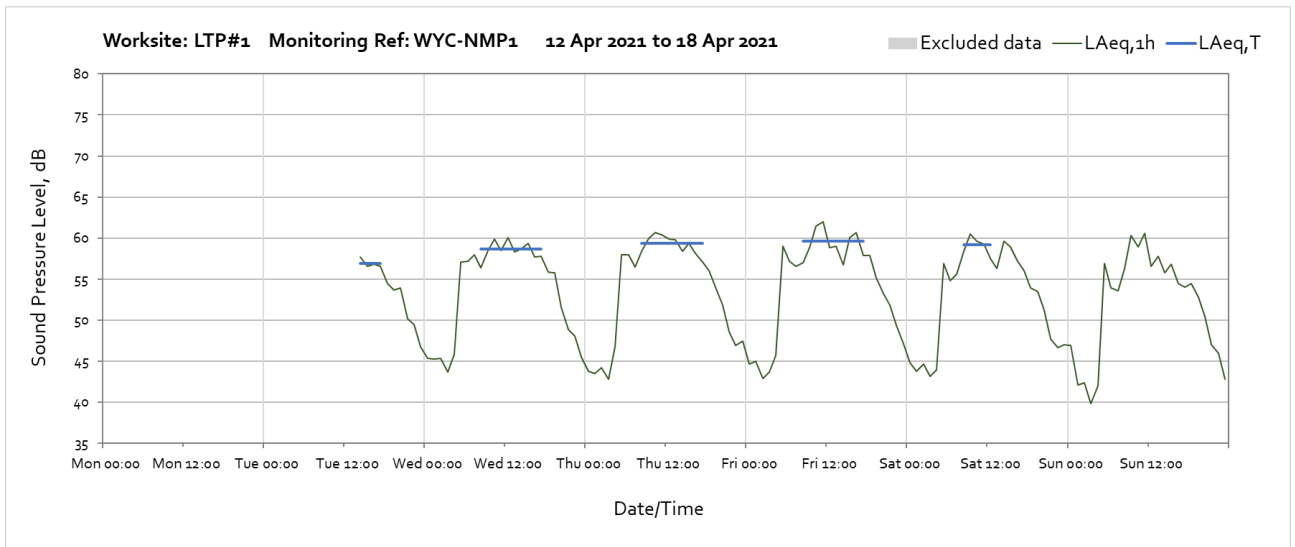
Worksite: LPT#1 – Monitoring Ref: WYC-NMP1

Note: The noise monitor was installed at 12:00 on Tuesday 13th April 2021.

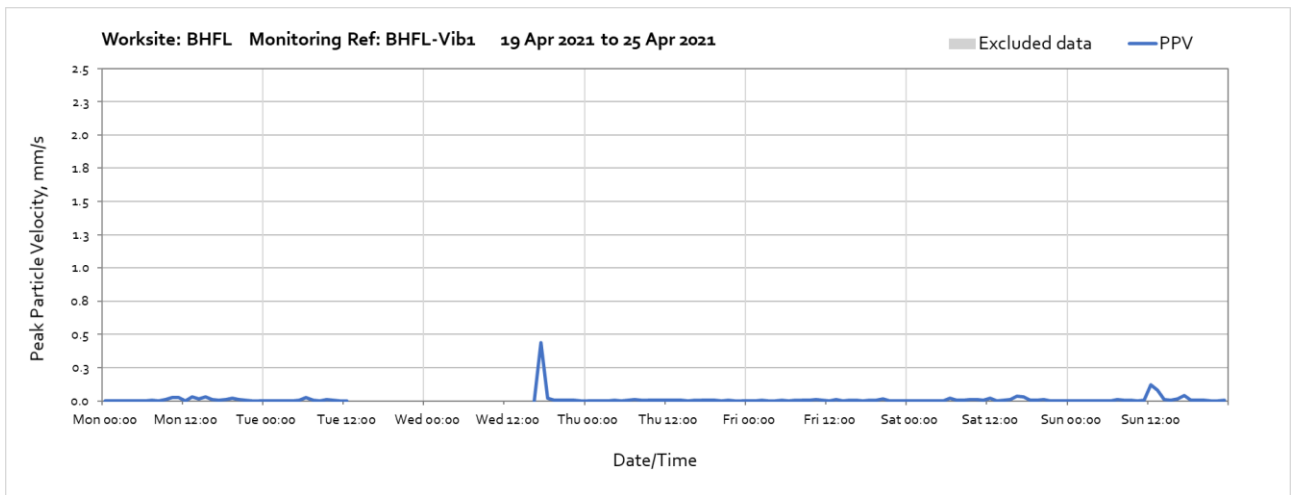
Note: Missing data between 13:00 on Tuesday 20th April and 16:00 on Wednesday 21st April was due to interruption of power to the monitor.
