NHS Breast Screening Programme Equipment Report

Practical evaluation of 'GE Healthcare
Senographe Pristina' 2D digital
mammography system

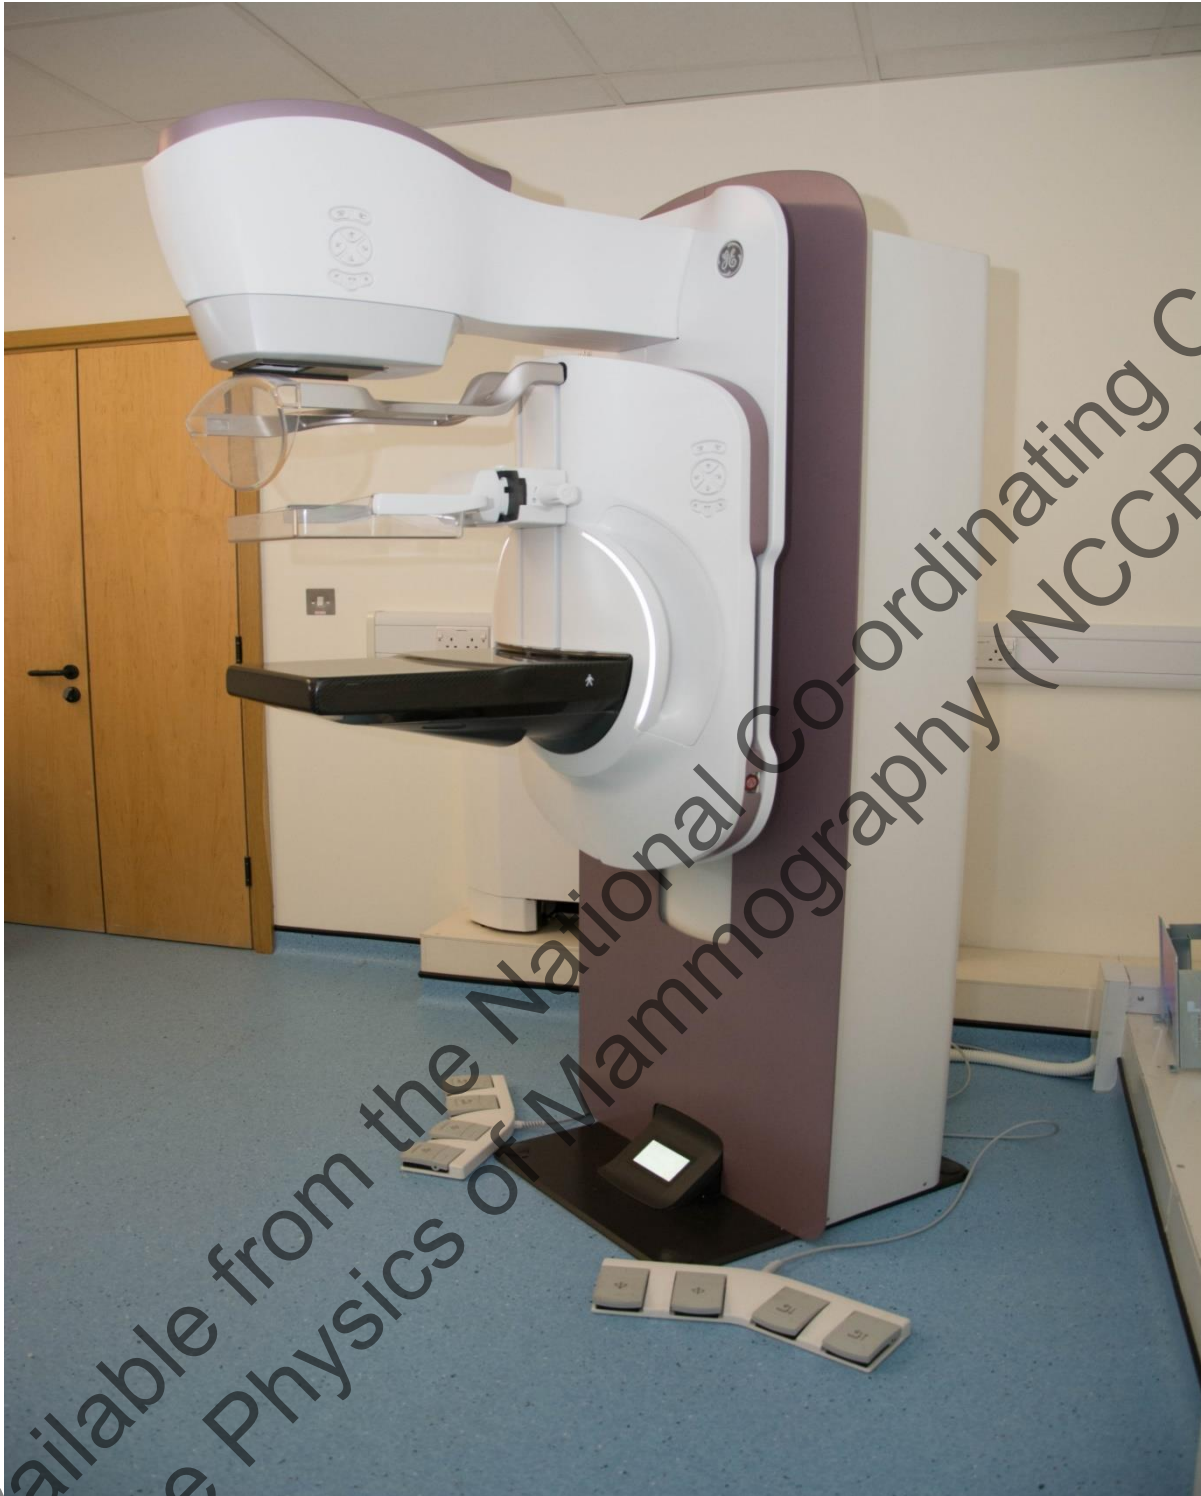
Figure 1- Photo - Gantry

The Senographe Pristina is a full-field digital mammography unit with both 2-D and tomosynthesis capabilities. The gantry comprises of a gantry arm assembly, tube head, image receptor and breast support table. The gantry offers 3 types of movement:

At the foot of the gantry is a LCD display which shows the rotation angle and mode of operation (that is, 2-D or tomosynthesis). On application of a compression force it automatically indicates the compressed breast thickness in mm, the compression force in daN and the angulation position.

The Senographe Pristina is powered by a high frequency single phase generator which is integrated into the gantry. It uses a 24cm x 29cm caesium iodide detector with 100 micron resolution. It uses Molybdenum (Mo) and Rhodium (Rh) anode tracks with Molybdenum and Silver (Ag) filters. There are 2 options that can be selected by the system according to the compressed breast thickness: 26kV Mo/Mo or 34kV Rh/Ag. A universal grid compatible with both 2-D and tomosynthesis imaging is also used.

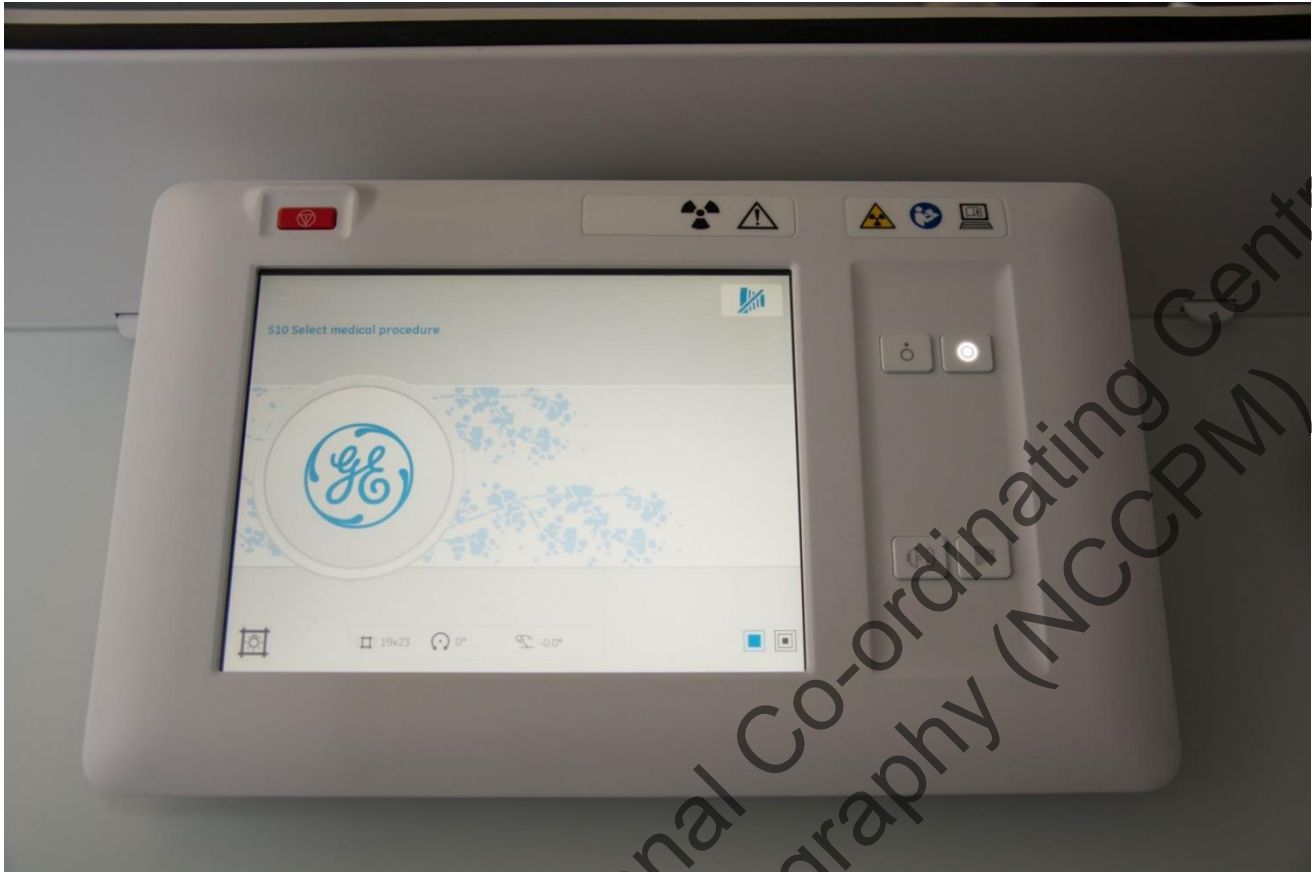
Figure 2 - Photo - Console

The unit uses a touch screen console with additional buttons for power, preparation and x-ray exposure and emergency stop. There is no emergency compression release button on the console. The protective lead shield was integrated within the console unit. The acquisition monitor is available in both 1MP LCD and 3MP options for immediate image display. In contrast to the console it uses the traditional keyboard and mouse configuration. The 3MP monitor was used for this evaluation and was mounted on a swing arm.

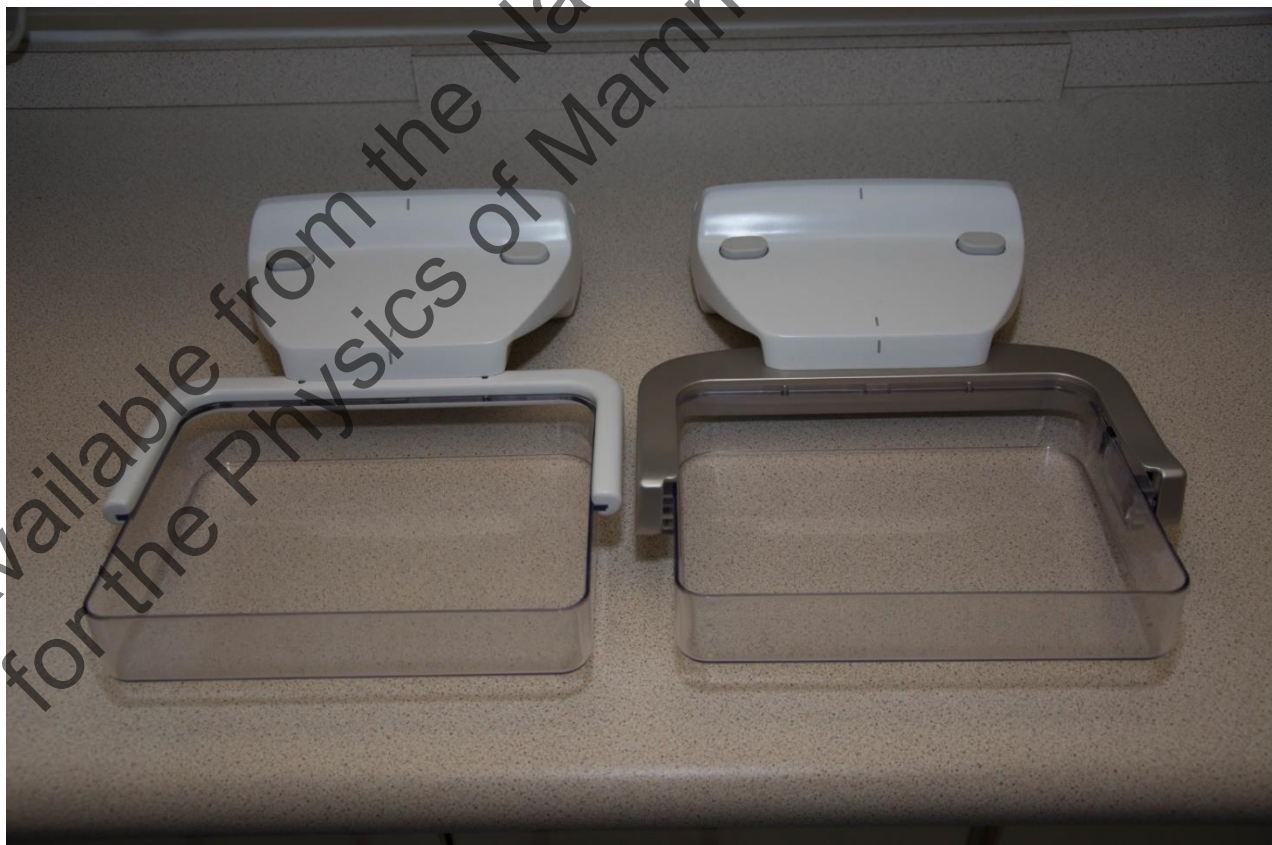
Figure 3 - Photo - Paddles

Standard and flexible paddles were available in both 24cm x 29cm and 19cm x 23cm sizes. The smaller paddle can be offset against the centre of the breast support plate to optimise positioning. The pre-exposure sensing area is automatically reduced to the field-of-view (FOV) in use as selected by compression paddle size. In contrast to the standard paddle which is intended to remain parallel to the image receptor the flexible paddle offers a more uniform compression. It compresses in both the medial-lateral and superior-inferior plane by tilting in respect to the breast support plate.

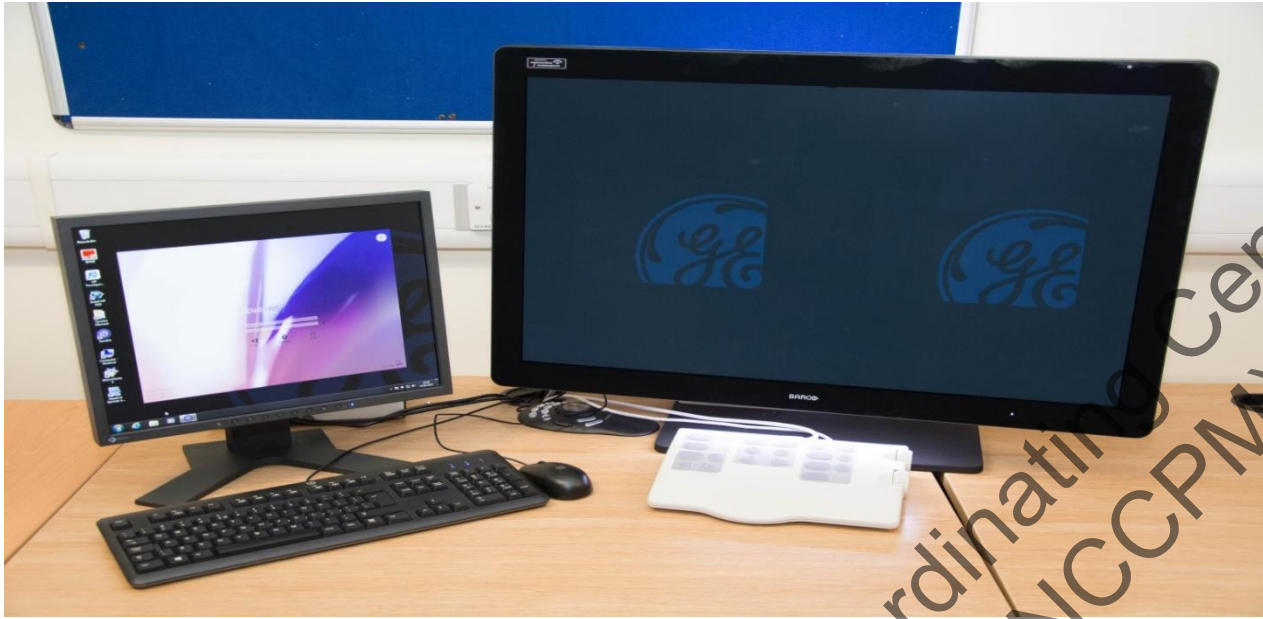
Figure 4 - Photo - Workstation

The dual monitors were exchanged for a 10MP single display monitor during the evaluation.

The system uses a Windows 7 professional operating system and a 4 core central processing unit (CPU).

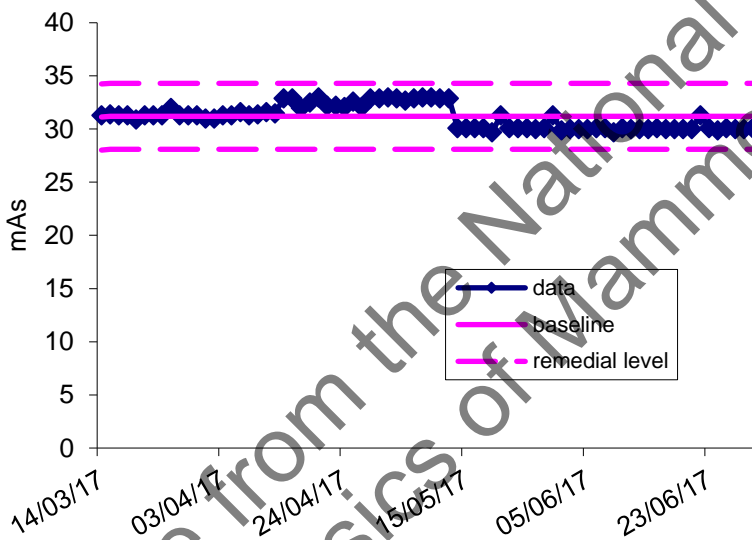
A 4.5cm thick block of Perspex was imaged using the Standard setting daily. The mAs and SNR (signal-to-noise ratio) were recorded and shown in figures 5 and 6. All the recorded values lie within the recommended limits.

Figure 5 mAs recorded daily for 45mm of Perspex

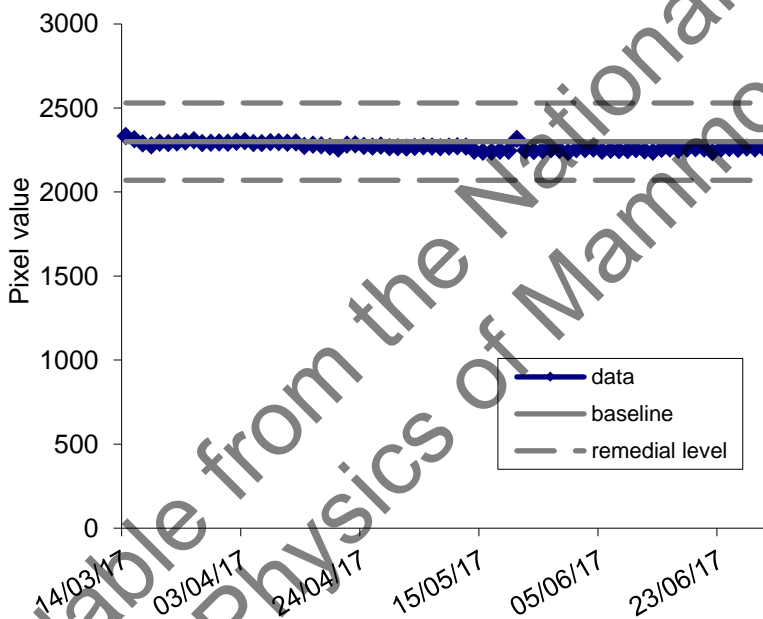
All the values remained within the recommended limits as demonstrated in figures 5 to 7.

Figure 7 Mean pixel value recorded daily for 45mm of Perspex

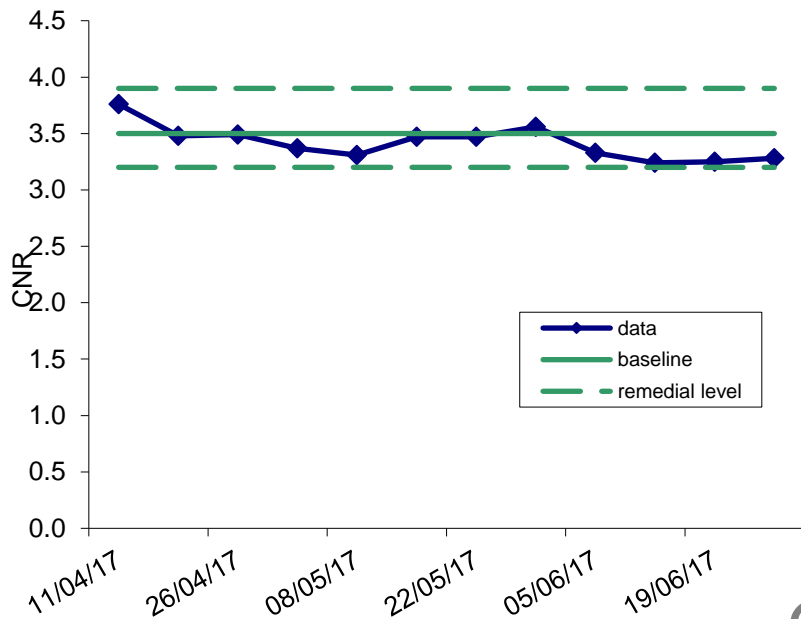
Weekly CNR (contrast to noise ratio) testing was completed and the results can be seen in figure 8. All the results were within the recommended limits.

Figure 8 Weekly CNR measurements for 45mm Perspex

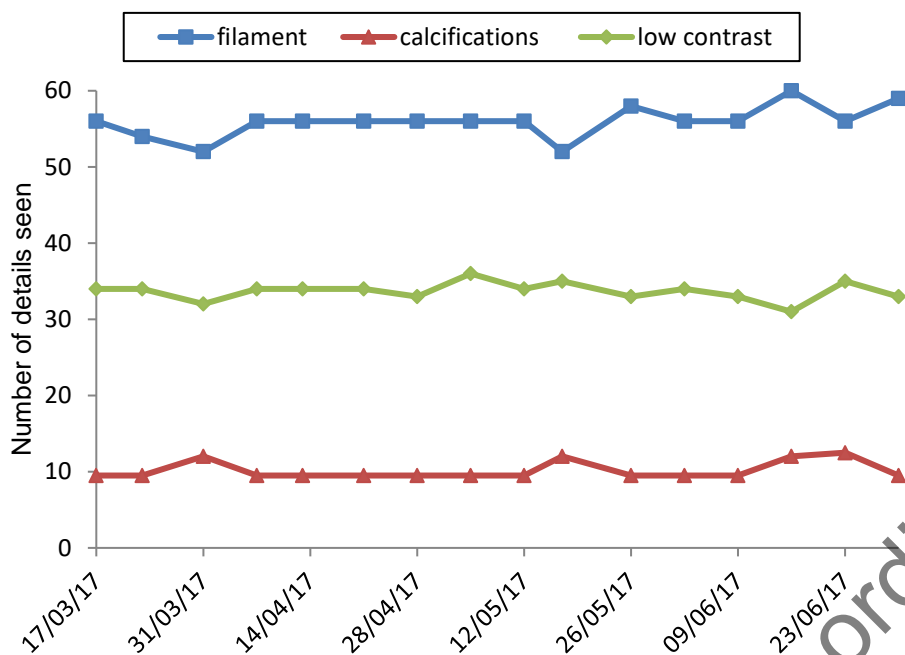
Figure 10 shows the results from the weekly image quality assessment measured with the TOMAM which was interpreted by 2 experienced Quality Assurance radiographers. The variation in the scoring is most likely to be due to reader subjectivity but all results were acceptable.

Figure 9 Weekly tests of image quality measured with TORMAM test object

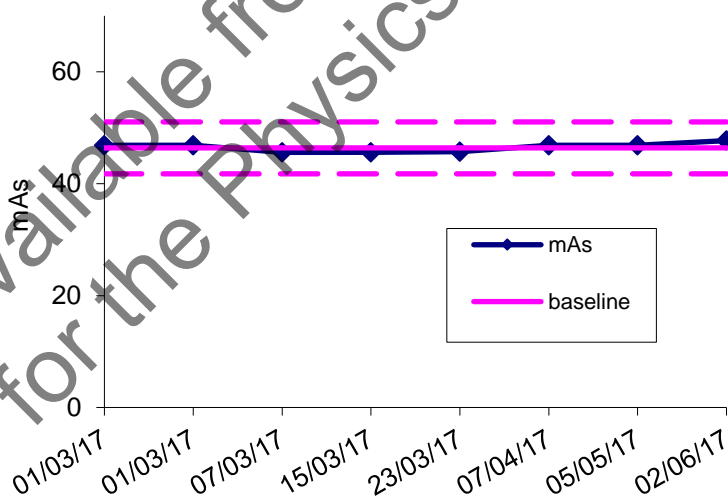
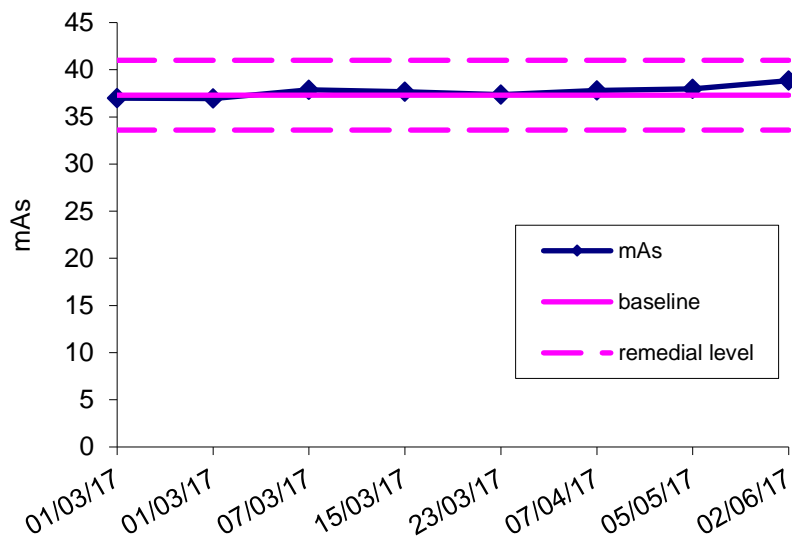
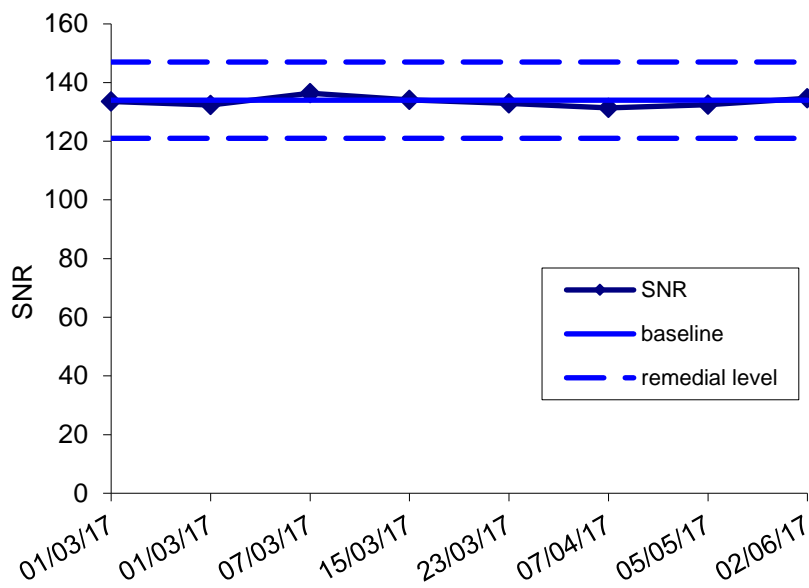
The GE QC routine was followed for the monthly test. The test now only comprises of 2 thicknesses' of 20mm and 50mm which covers the range of beam qualities used by the machine clinically.

The results can be seen in figures 10 to 13. All results remained consistent throughout the evaluation and are all within the recommended limits.

Figure 10 mAs recorded monthly for 30mm Perspex

Figure 11 mAs recorded monthly for 50mm Perspex

Figure 12 Monthly SNR measurements for 30mm Perspex

Figure 13 Monthly SNR measurements for 50mm Perspex

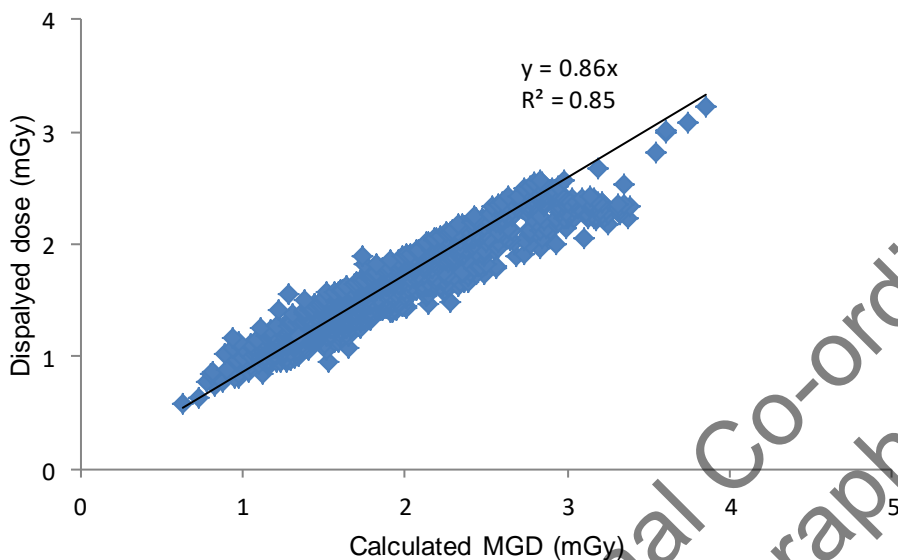
The calculated MGDs were compared with the doses displayed on the acquisition workstation. Displayed AGD was plotted against calculated MGD in figure 14. Trend lines were plotted and indicated a gradient of 0.86. Although this is within both the GE specification and IPEM guidance this was not as expected for a newly installed system.

After further investigation it became apparent that there was a discrepancy between the half value thickness measurement and the value stored on the system. An additional visit was made to site by GE and medical physics to repeat measures and investigate the discrepancy. It was concluded that the change of the filter system to remedy the artefact provided an explanation for the discrepancy. Once a calibration had been done there was much closer agreement between calculated and displayed doses.

Figure 14 Displayed AGD vs Calculated MGD

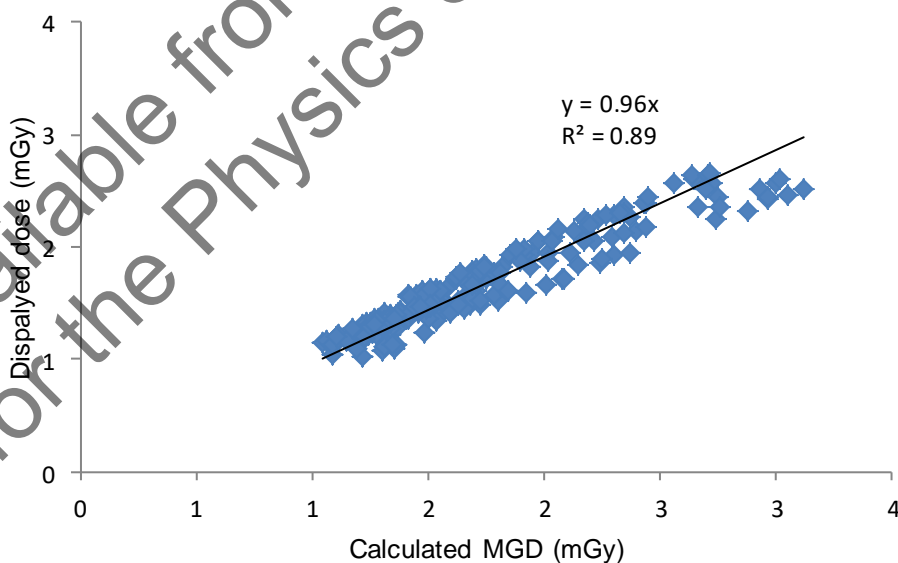
A second smaller dose audit was performed to confirm this. On this smaller sample the average dose to 50 to 60 mm MLO was found to be 1.37, but there was much better agreement between the AGD and the MGD. Trend lines were plotted with a gradient of 0.96, Figure 15.

Figure 15 Displayed AGD vs Calculated MGD after recalibration

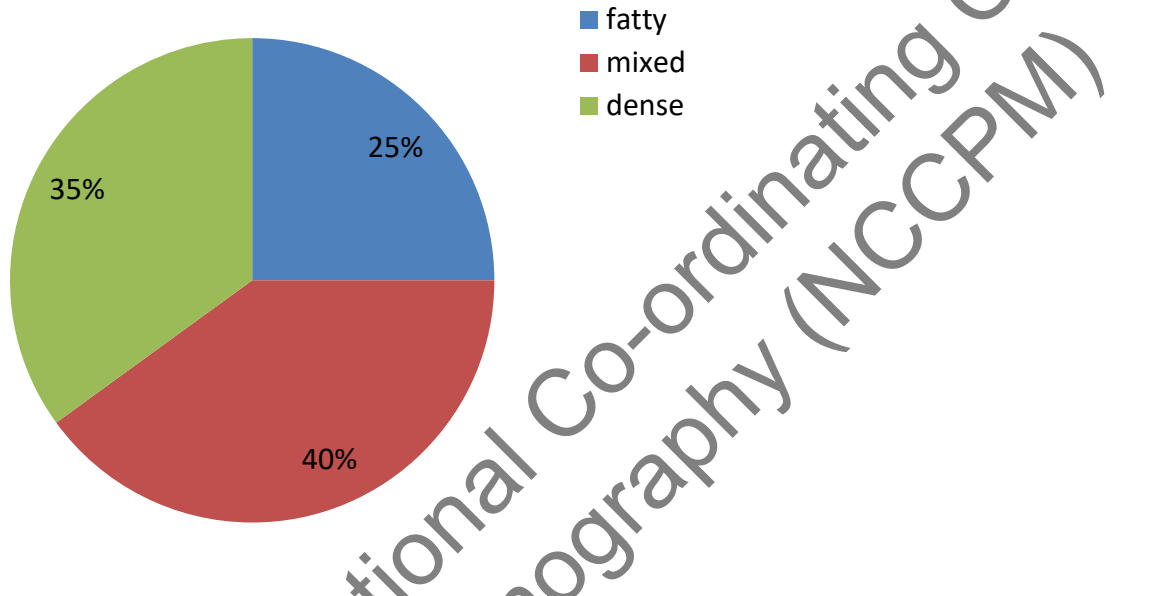
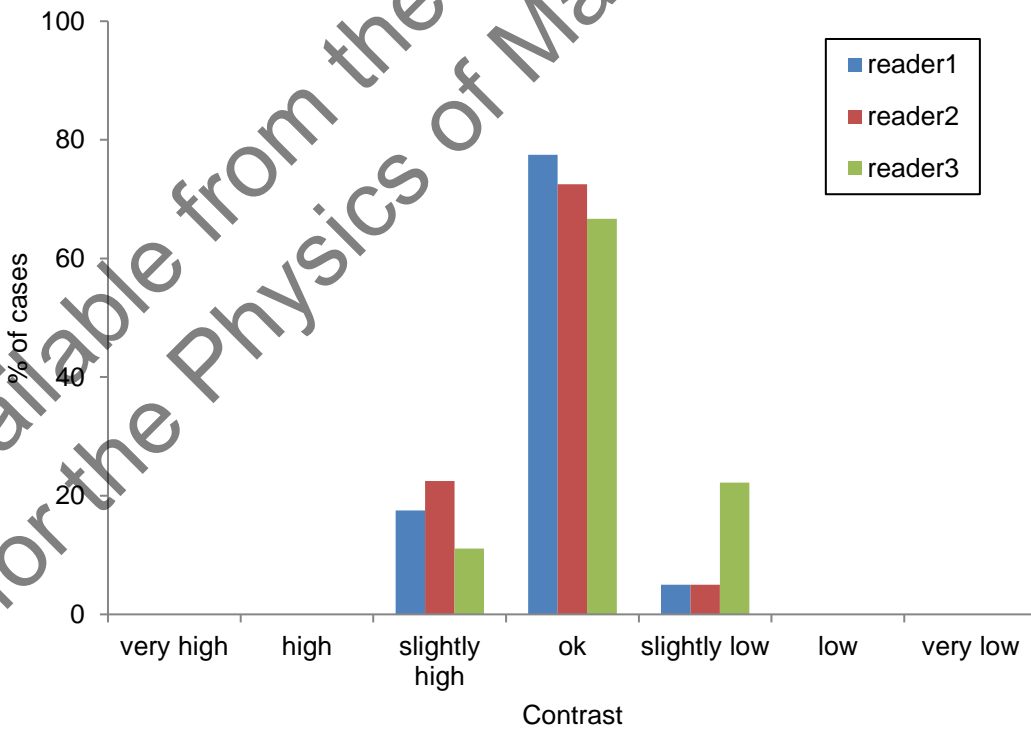
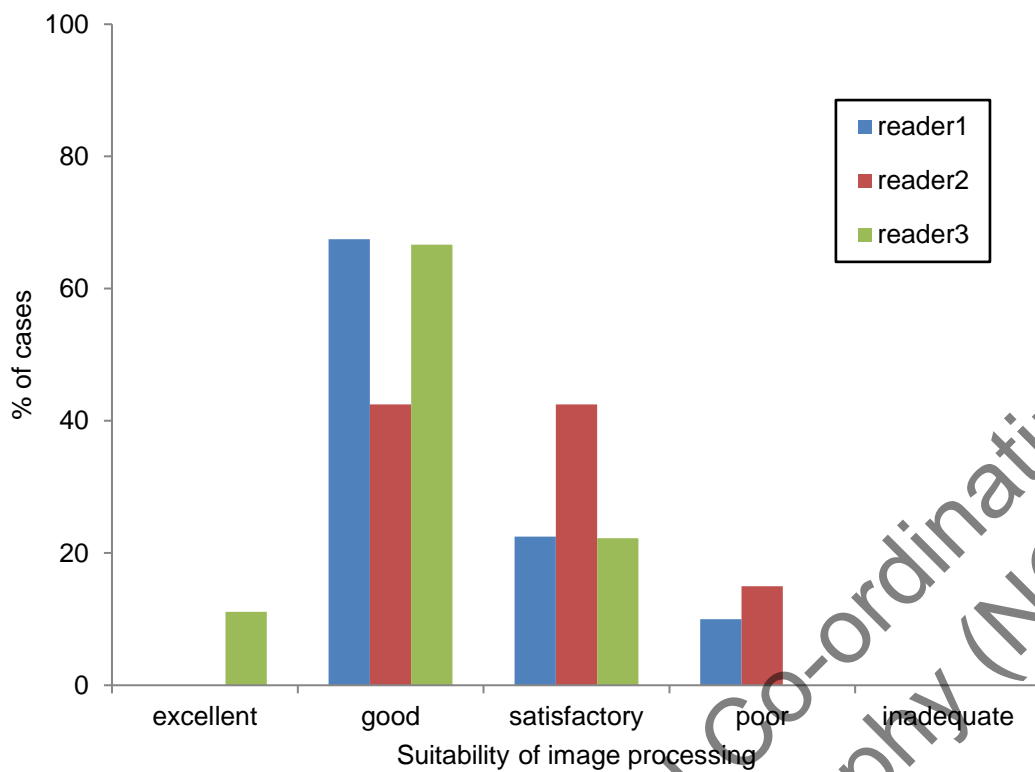
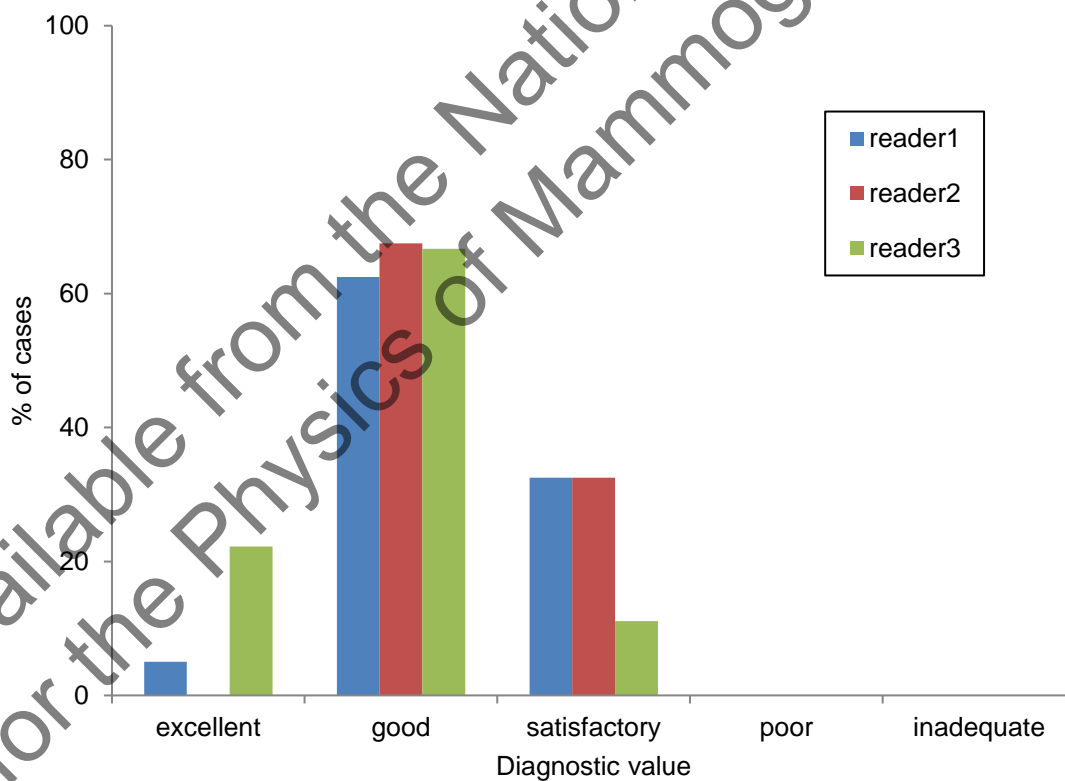
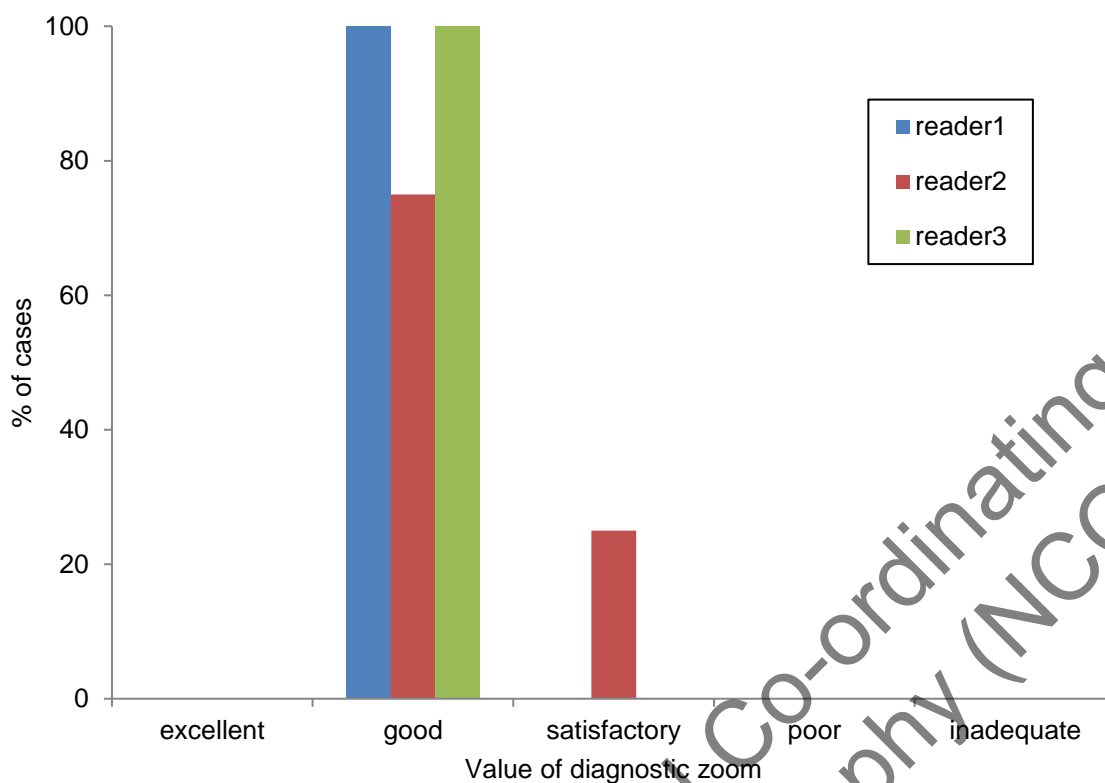
The results of these assessments can be found in figures 17 to 20. All 20 sets of images were considered to have acceptable image sharpness and noise levels.

Figure 16 Readers' estimates of breast density

Figure 17 Readers' assessment of contrast

Figure 18 Readers' assessment of suitability of image processing

Figure 19 Readers' assessment of overall diagnostic value

Figure 20 Readers' assessment of diagnostic zoom

Image quality for a set of 20 randomly selected was reviewed by a team of film readers. The image quality was assessed as being satisfactory for all images with the diagnostic value for 92% of the cases being excellent. No images were considered to be poor or inadequate demonstrating that the Senographe Pristina performs well for all breast compositions.

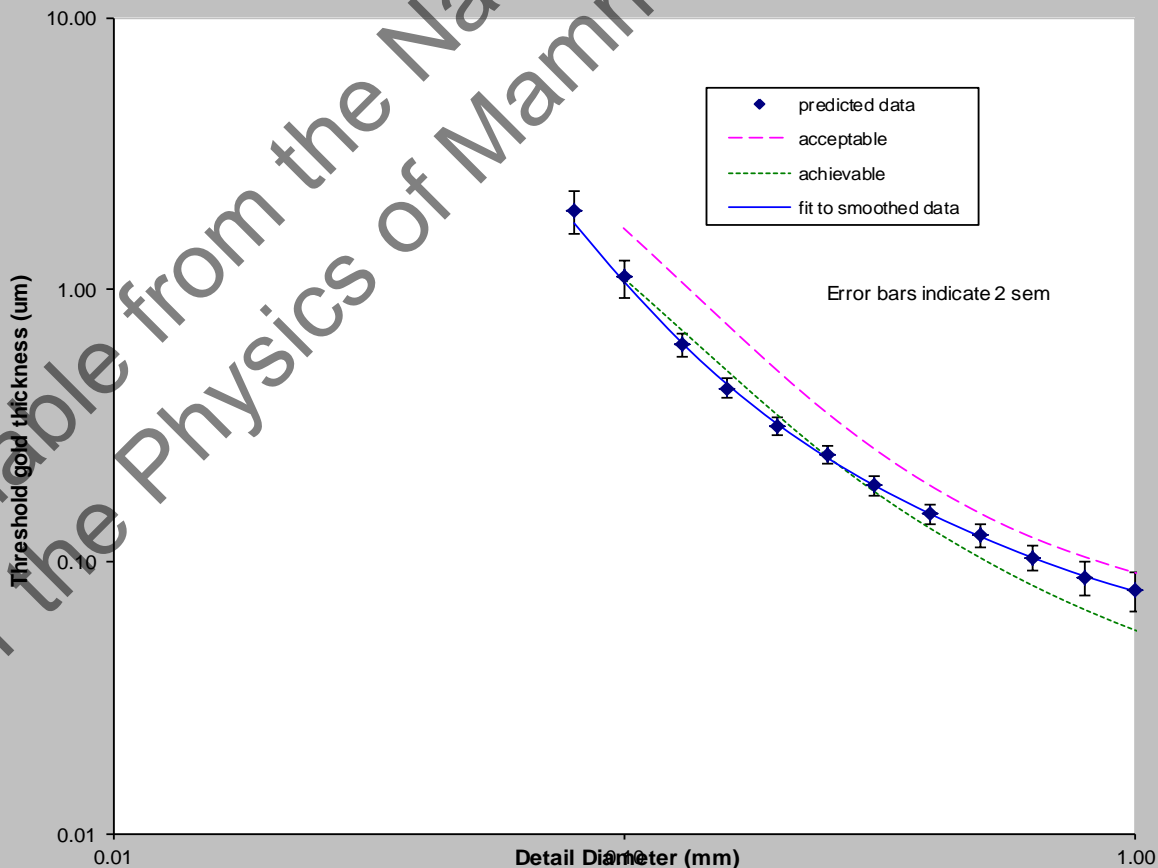
Summary of Results of Automatic CDMAM reading

Predicted threshold contrast measurements

physics ID	NGPE	unprocessed	
Local ID / location	0	added px	4 cm
Centre	Nottingham	spacer	0 cm
Digital make	GE	mode	STD+
Digital model	Pristina	kV	34
Date	03 March 2017	target	Rh
manufacturer of X-ray set		filter	Ag
model of X-ray set		mAs	58.0
model of CR plate		MGD	2.34 mGy
Comments	s/n 1074

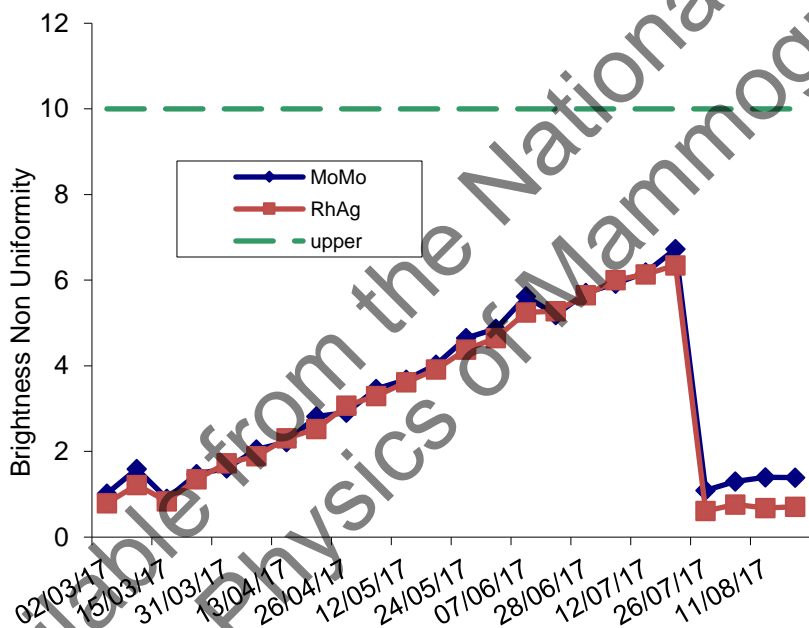
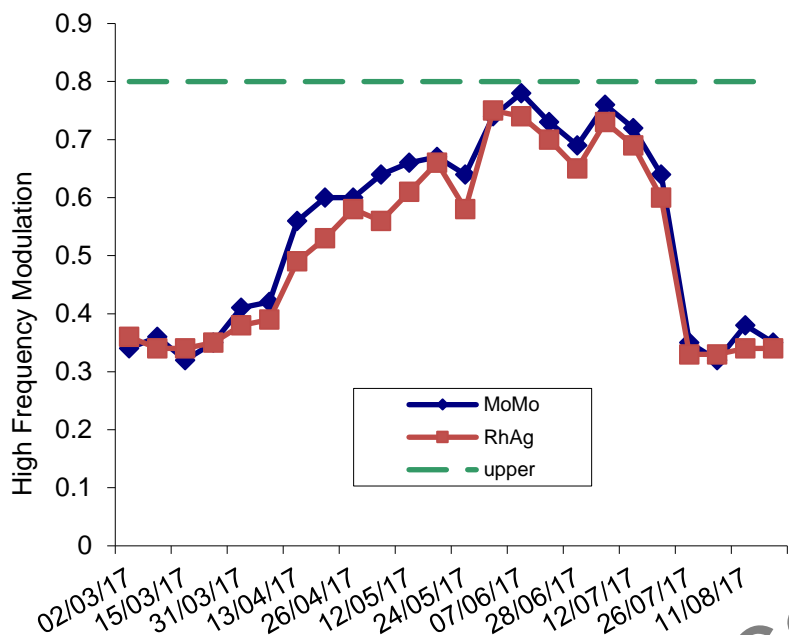
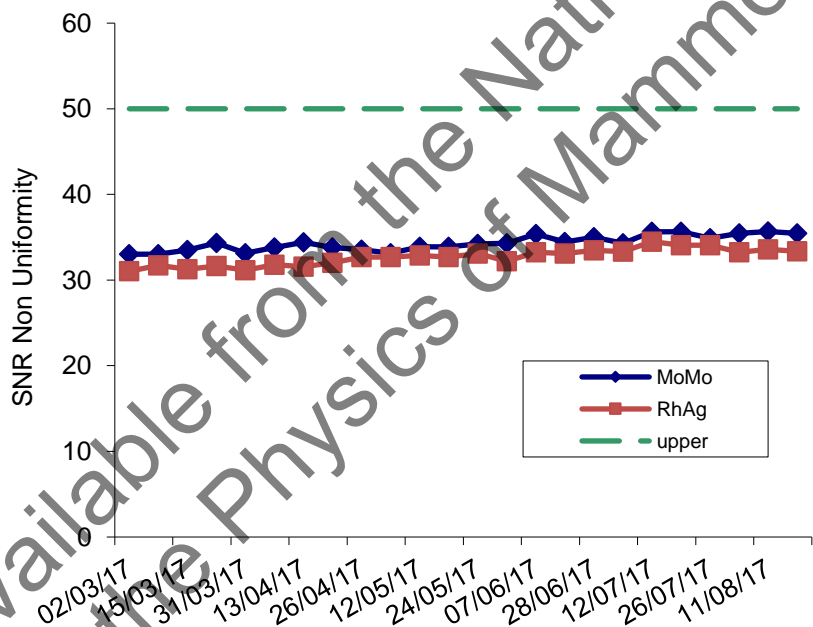
The purpose of this test is to check the uniformity of signal and noise over the entire image receptor and also to check for the presence of uncorrected defective detector elements.

The 24x29cm phantom used was supplied by GE and the test was performed in the following configurations: 2D contact Mo/Mo (grid) and 2D contact Rh/Ag (grid). Results for Brightness Non-Uniformity, SNR Non-Uniformity and High-Frequency Modulation are shown below and include the period after the evaluation. The results were all within GE limits. The decrease in BUU and HFM corresponded to software update in July 2017, it then remains stable.

Results for Bad Pixel and Bad ROI are also shown and are within limits.

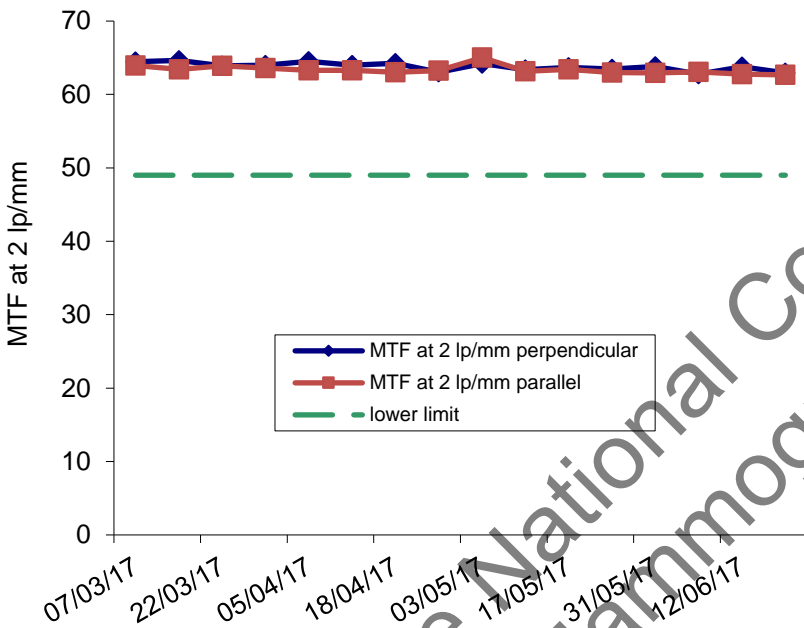
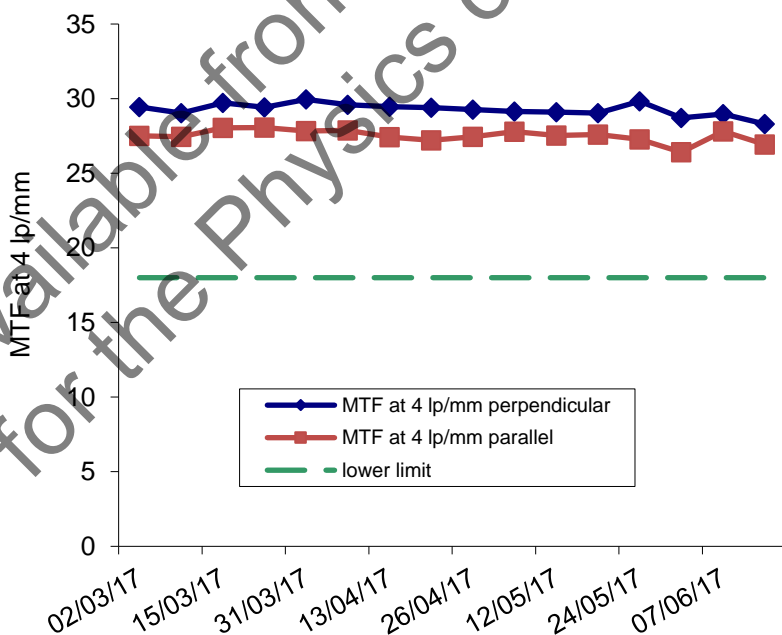
A3.2 GE IQST test

This test is designed to check that the MTF (Modulation Transfer Function) values at 2 lp/mm and 4 lp/mm and the resolution uniformity over the entire image receptor conforms to GE specifications.

The IQST phantom is supplied by GE. The test is performed weekly and results are all within limits and shown below.
