**Specialist Professional and Technical
Services (SPATS) Framework
Lot 1**

**Task 696
Roadside Vehicle Noise Measurement**

Phase 2 Final Report

February 2020

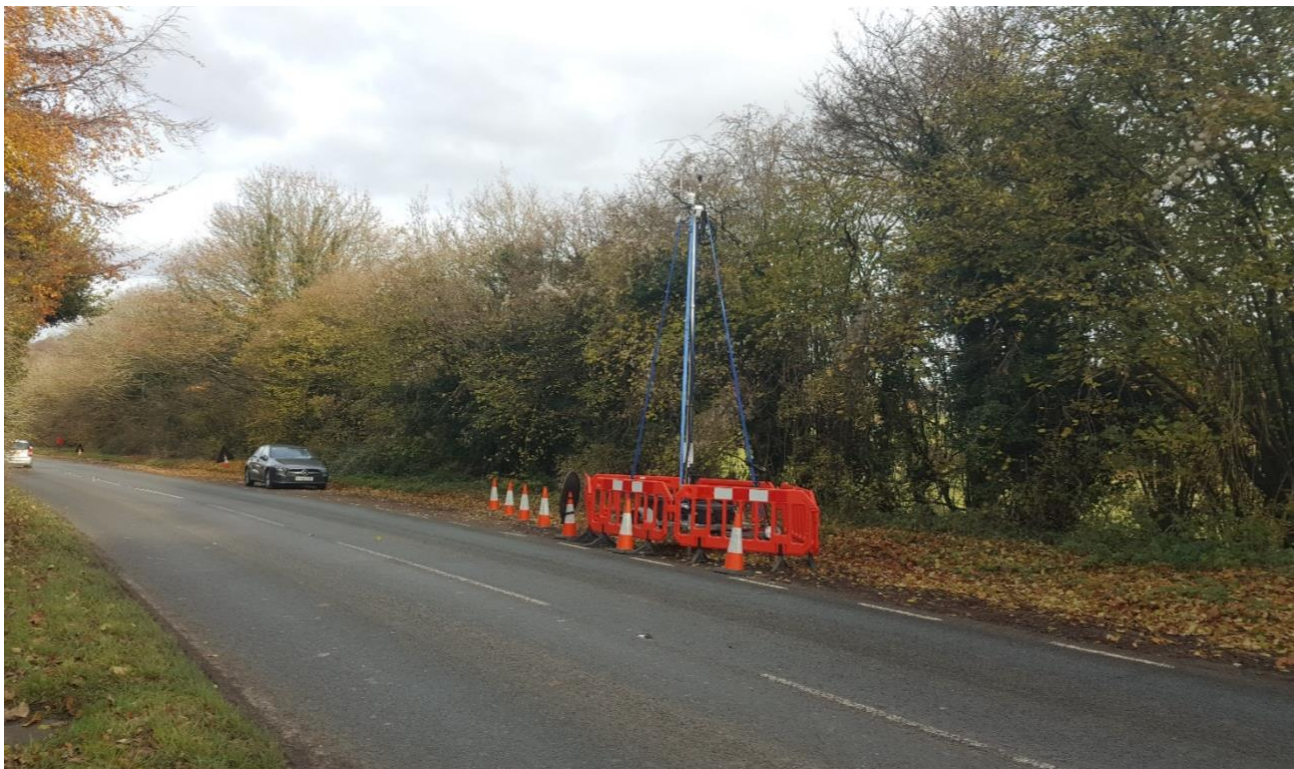
The noise camera was installed on the southernmost end of the A32 layby across from Hut Cottage, south of Loomies Moto Café, a distance of 1.8m from the nearside carriageway edge and at 6m height. The noise camera was deployed from Saturday 16th November to Thursday 28th November 2019. It was sectioned off with a barrier, cones, and signage. A photograph of the site set-up is provided in Figure 4.2 below.

Figure 4.2. Noise camera installed on the A32 north of West Meon

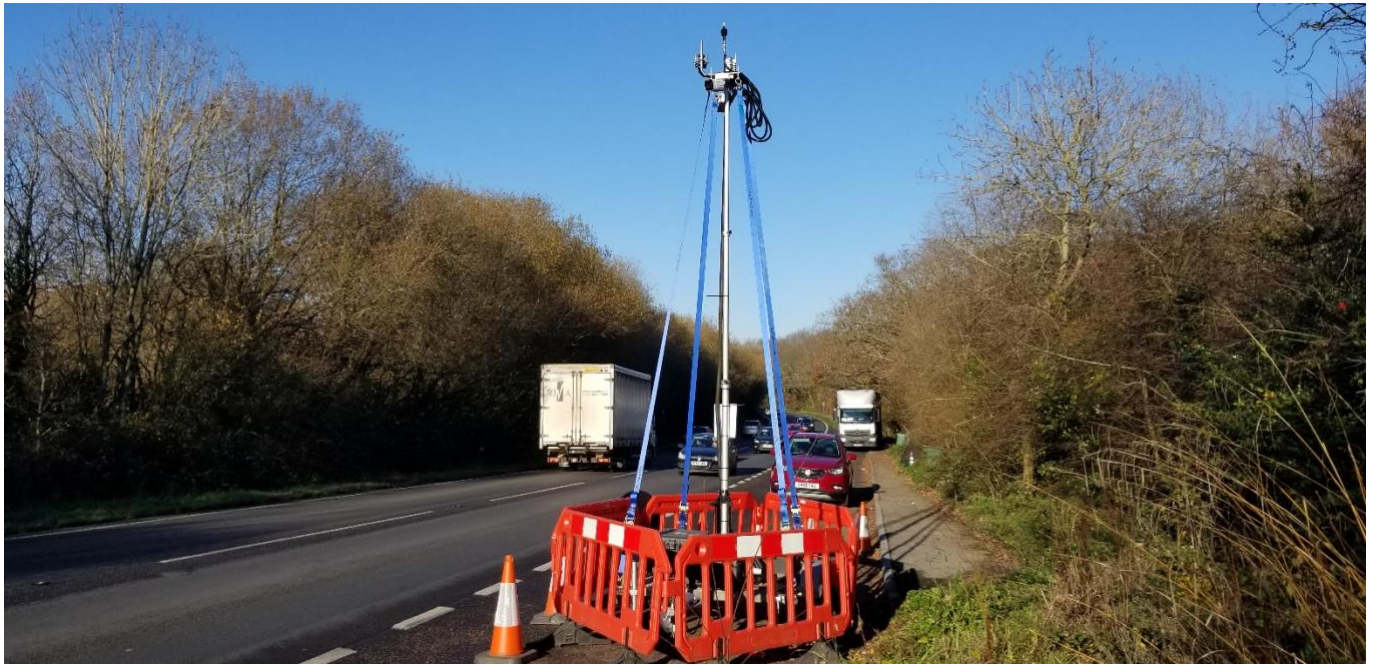
28th November to Monday 9th December 2019. It was sectioned off with a barrier, cones, and signage. A photograph of the noise camera at Site 2 is provided in Figure 4.4.

Figure 4.4. Noise camera installed on the A326 Marchwood Bypass

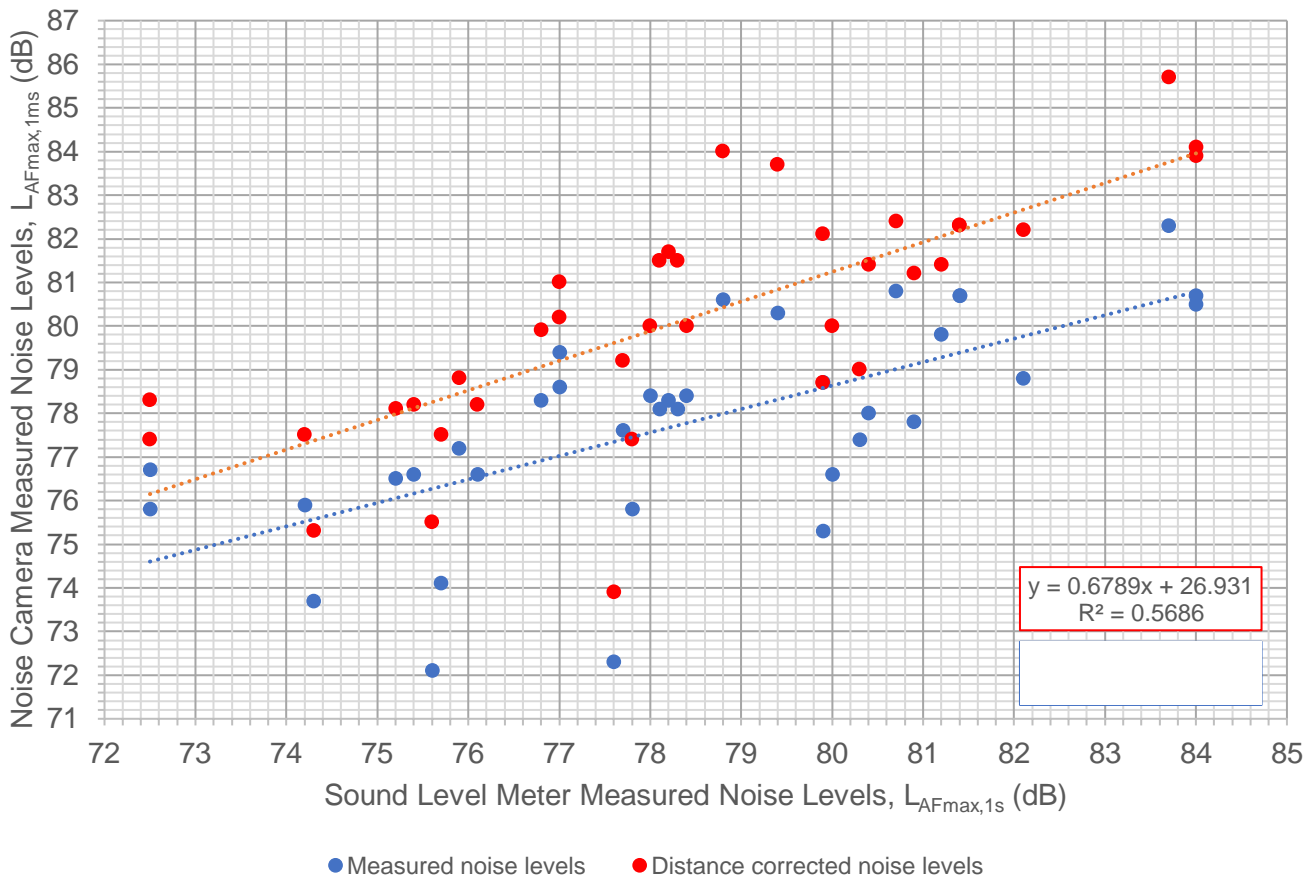
Figure 5.1 shows the linear regression analysis between the noise levels measured by the sound level meter and the noise camera.

Figure 5.1. Regression analysis of simultaneous noise camera and attended noise measurements at the Marchwood Bypass for the northbound carriageway

Figure 5.1 shows that for the measured noise data the coefficient of multiple correlation, R_2 , of the measured noise data, was 44.5% which indicates weak to no correlation between the two measurement types (blue data in figure). However, when distance corrections were applied to the measured noise levels (red data in figure) the correlation improved and R_2 was increased to 56.9%.

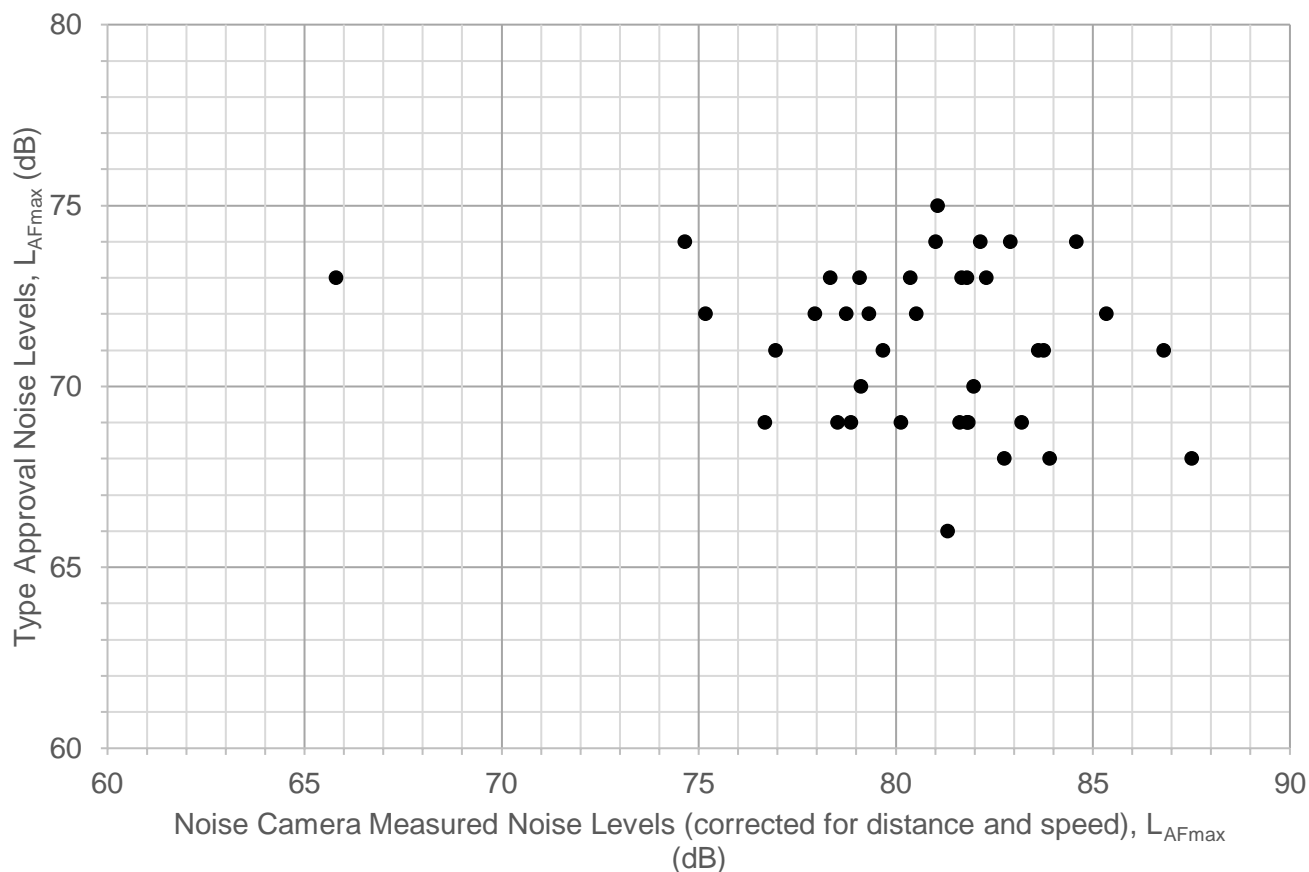
To confirm whether measured roadside noise levels could be robustly appraised against type approval noise levels for enforcement, measurement results from the trials have been corrected for distance and speed in order to enable a comparison with type approval noise levels for a number of vehicles. The analysis was undertaken for Marchwood Bypass, where the site and traffic conditions better match those stated in ISO 362 [4] [5] and ISO 11819 [7]. Distance and speed corrections were calculated as described in Appendix C. This comparison is shown in Figure 6.1, where noise levels measured at the noise camera (horizontal axis) are plotted against the relevant type approval noise level (vertical axis).

Figure 6.1. Comparison of type approval sound levels with noise camera measurements at the Marchwood Bypass.

The corrected noise levels were found to be generally significantly higher (on average +9 dB) than type approval noise levels for the vehicle, with maximum drifts up to 19.5 dB. Therefore other variables need to be considered, which might include road surface and directivity of the noise source, as well as potential contributions from other noise sources and differences in driving style during type approval tests compared to live carriageways. It should be noted that the majority of vehicles included in this analysis were travelling on the nearside carriageway, as more information on speed was available for these vehicles.

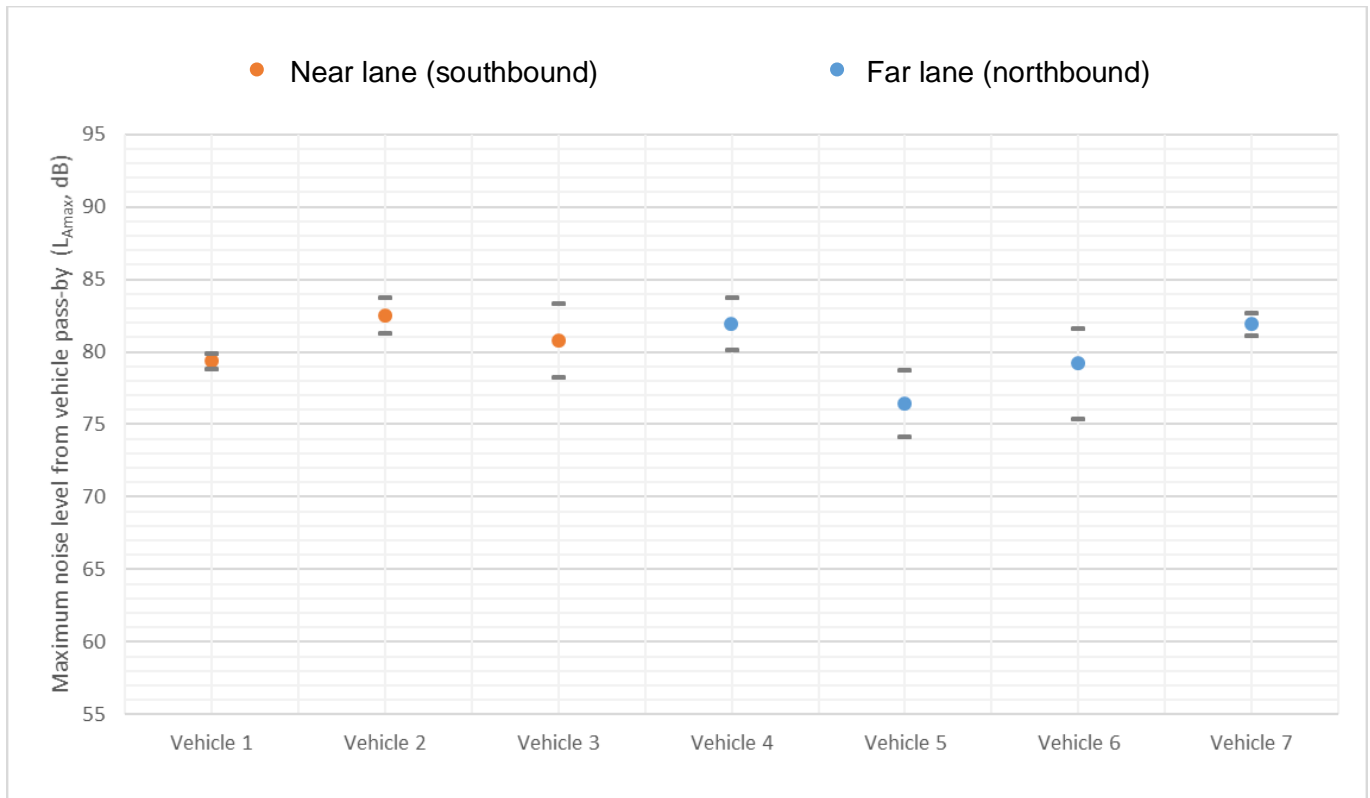
Figure 7.4 presents the maximum noise levels measured for seven vehicles that had passed the noise camera at least twice on the same carriageway at West Meon so that the distance between the noise camera and the passing vehicle would be approximately the same. The average of the maximum noise levels measured during each pass-by is plotted together with the minimum and maximum values registered within each dataset.

Figure 7.4. Average of maximum noise levels L_{Amax} measured for vehicles that passed at least twice during the monitoring period. Results are grouped for travelling direction

Figure 7.4 shows that for the repeatedly measured vehicles, similar noise levels were measured for vehicles travelling on the carriageway closest to the noise camera where there was less distance attenuation. This correlates with trial-wide data presented in Table 7.1.

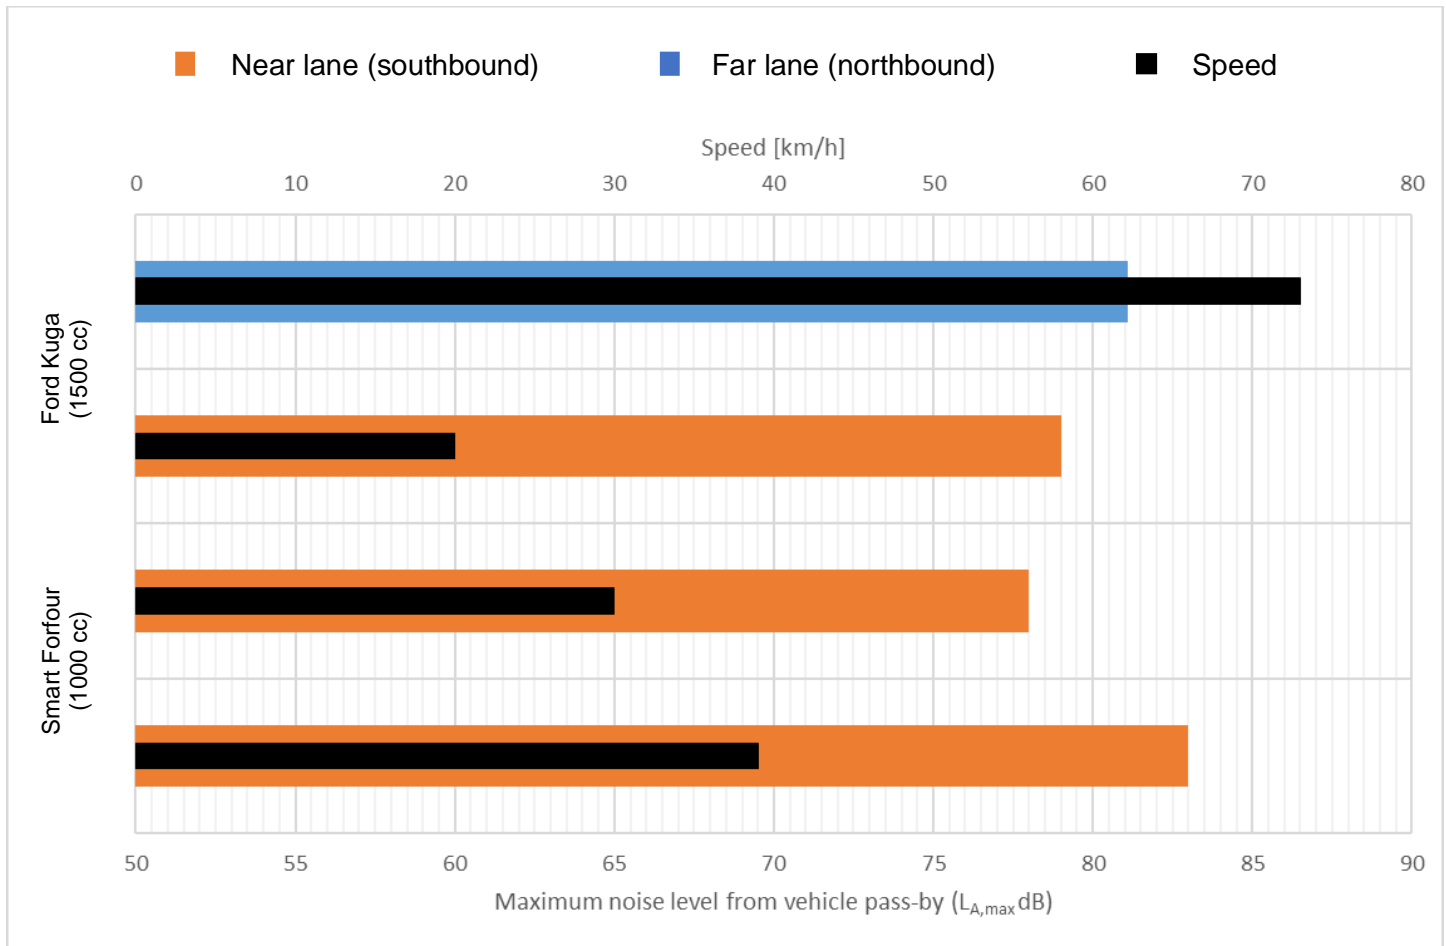
The results for the Smart Forfour shown in Figure 7.5 indicate that travelling 9 km/h faster in the nearside carriageway (to 39 km/h) corresponded to a 4.5 dB increase in the measured pass-by noise level (to 83 dB).

Figure 7.5. Comparison between average of maximum noise levels L_{Amax} and speed data measured for vehicles that passed at least twice during the monitoring period. Results are grouped for travelling direction.

The difference between the measured vehicle speeds on the nearside carriageway (20-39 km/h) and the far side carriageway (73 km/h) may be due to the status of the traffic lights at the junction north of the trial site. The presence of the noise camera may have had an effect vehicular behaviour as drivers may decrease the speed of their vehicles at sight of the noise camera on the nearside carriageway. The noise camera was partly hidden behind vegetation when approaching the crossroads from the northbound direction, so drivers may have travelled at faster speeds when passing the noise camera from this direction.

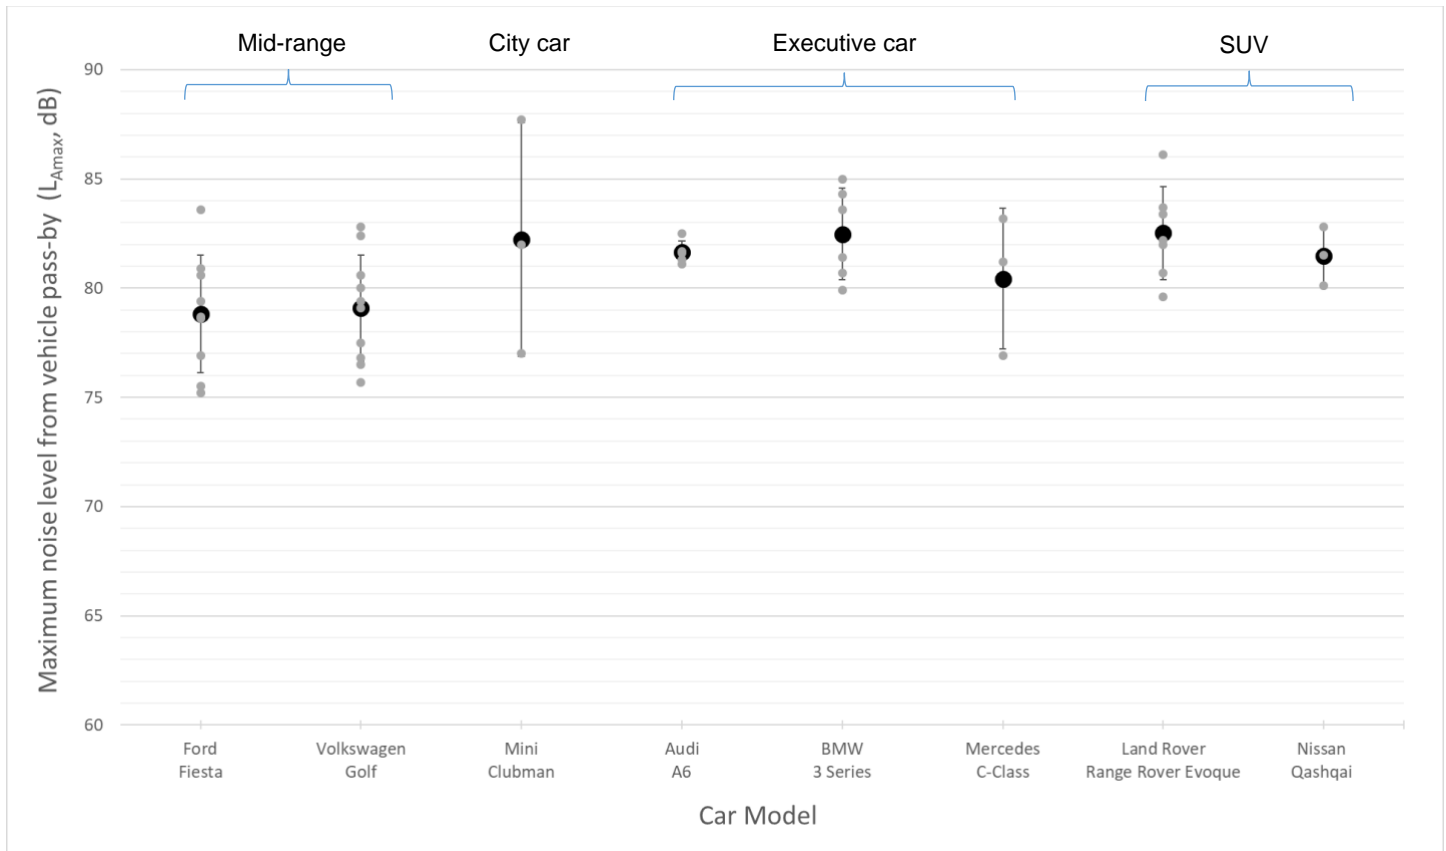
Further analysis has been undertaken to widen the dataset to consider maximum noise levels associated with the pass-by noise levels of vehicles of the same make and model rather than individual vehicles. Several vehicles of the same make and model that were found to travel more frequently through the trial sites were analysed, including samples of vehicles from different categories (city car, executive car and SUV). Figure 7.6 and Figure 7.7 present the maximum noise level measured from individual vehicle pass-bys grouped by vehicle type, together with the average (large black dot) and the standard deviation. The results reported in Figure 7.6 and Figure 7.7 are related to West Meon trial site only. Not enough data have been recorded for the Marchwood site to allow a similar comparison of pass-by noise levels to be undertaken.

Figure 7.6. Maximum noise levels L_{Amax} measured for pass-by of similar vehicles on A32 West Meon southbound carriageway (closest to the noise camera)

Figure 7.6 and Figure 7.7 show that there is no clear trend on whether the mean noise levels for difference vehicle types are higher on the northbound or southbound carriageway, and the standard deviation for the same vehicle type is inconsistent between carriageways. For example, the measured maximum noise levels for the Mini have less variation in the northbound carriageway whereas the converse is shown for the Nissan and BMW. In other cases, similar levels of variation are shown (Volkswagen and Ford).

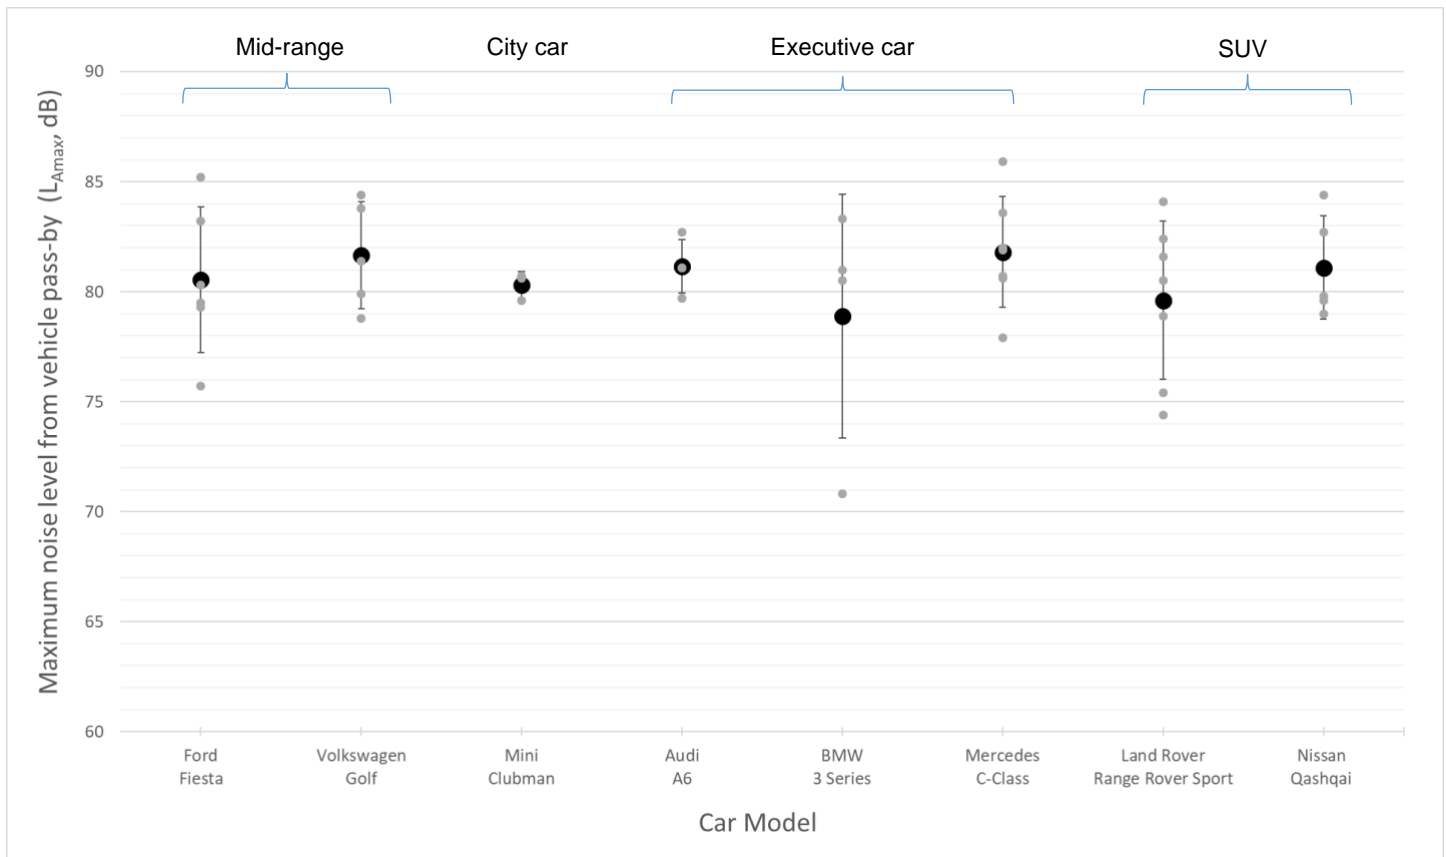
Figure 7.7. Maximum noise levels L_{Amax} measured for similar vehicles on the A32 West Meon northbound carriageway (furthest from the noise camera)

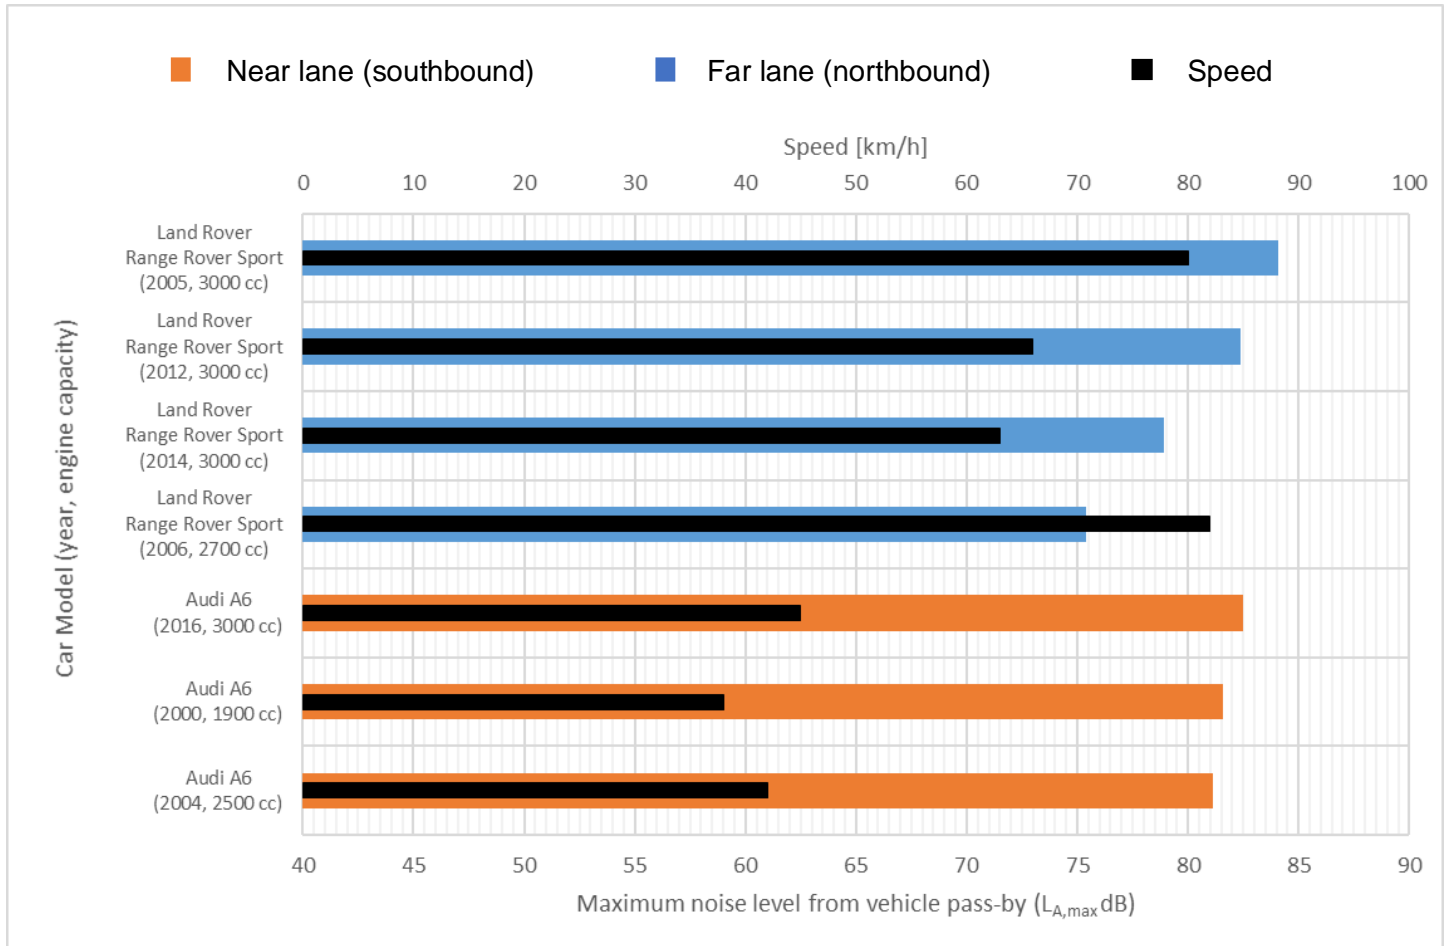
The results show that the measured noise levels are linked to speed, year of manufacture and engine capacity, but not enough data are available to conclude which of these factors is most influential on noise levels for the same vehicle type. For example, the measured noise level for the Range Rover (2006, 2700 cc) is the lowest value in its category and this could be explained in terms of engine capacity as it has the smaller capacity, even though the speed and the year of manufacture may suggest different expected result. Higher noise levels could be connected to the vehicle's age, as shown by the Audi data in Figure 7.8. The Audi A6 (2000, 1900 cc) travelled at a slower speed past the noise camera and has smaller engine capacity than the other Audis shown on Figure 7.6. However, the noise camera measured higher noise levels for the Audi A6 registered in 2000 than a newer, more powerful model travelling faster Audi A6 (2004, 2500 cc).

Figure 7.8. Comparison between average of maximum noise levels $L_{A,max}$ and speed data measured for two different car model, year of manufacture and engine capacity, that passed during the monitoring period. Results are grouped for travelling direction.

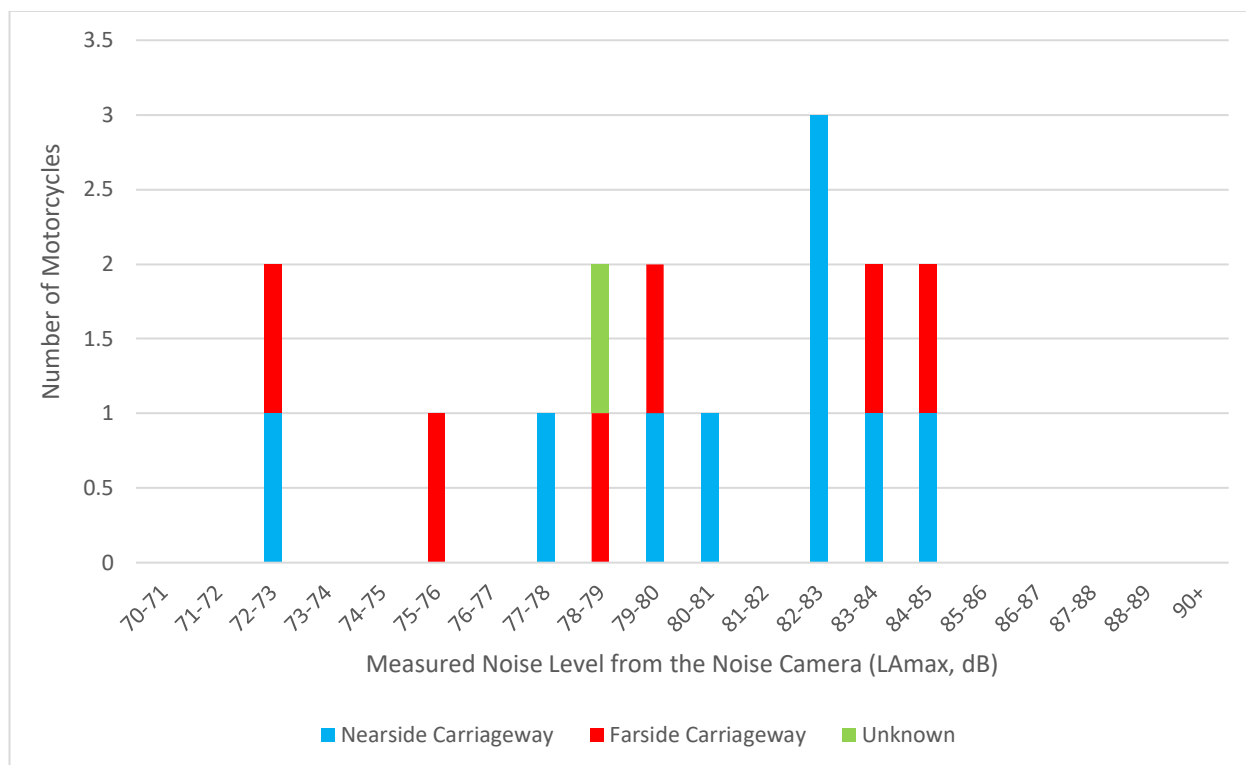
As the prototype noise camera identified only four motorcycle pass-bys during the trials, an analysis of video footage was undertaken for the West Meon site for the evening period of 27th November 2019. A best fit strategy was adopted to match the measured noise levels to each motorcycle pass-by due to the time lag between the vehicle appearing on the ANPR camera's field of view and the corresponding maximum noise levels recorded by the noise camera's microphone. The range of matched motorcycle noise levels is shown in Figure 8.1.

Figure 8.1. Measured noise levels for motorcycles identified by the prototype noise camera and from cross-referencing video footage

Figure 8.1 shows that the limited dataset of measured maximum noise levels for motorcycles were not particularly higher than those shown in Figure 7.1 and Figure 7.3. One continuous traffic event of seven motorcycles passing the noise camera within a 14 second time window resulted in the highest maximum noise levels between 84 and 85 dB L_{Amax}.

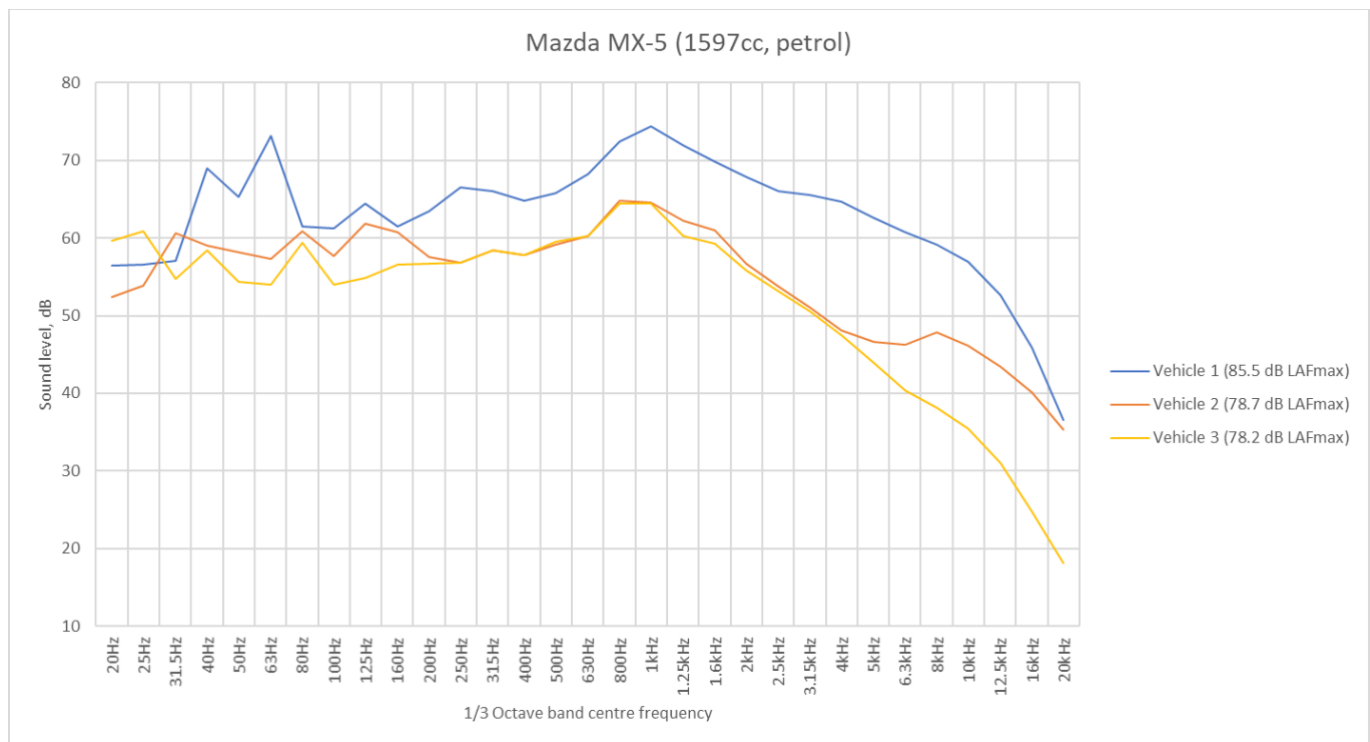
Figure 9.1 to Figure 9.3 show the third-octave band frequency content associated with pass-bys of different types of vehicles. Vehicles included in each graph were of the same make and model, engine capacity and type of fuel. Vehicle 1 is always the noisiest of the group, with Vehicle 2 to Vehicle 7 being progressively quieter.

Figure 9.3. Measured maximum noise levels L_{Amax} in third-octave bands for Mazda MX-5s

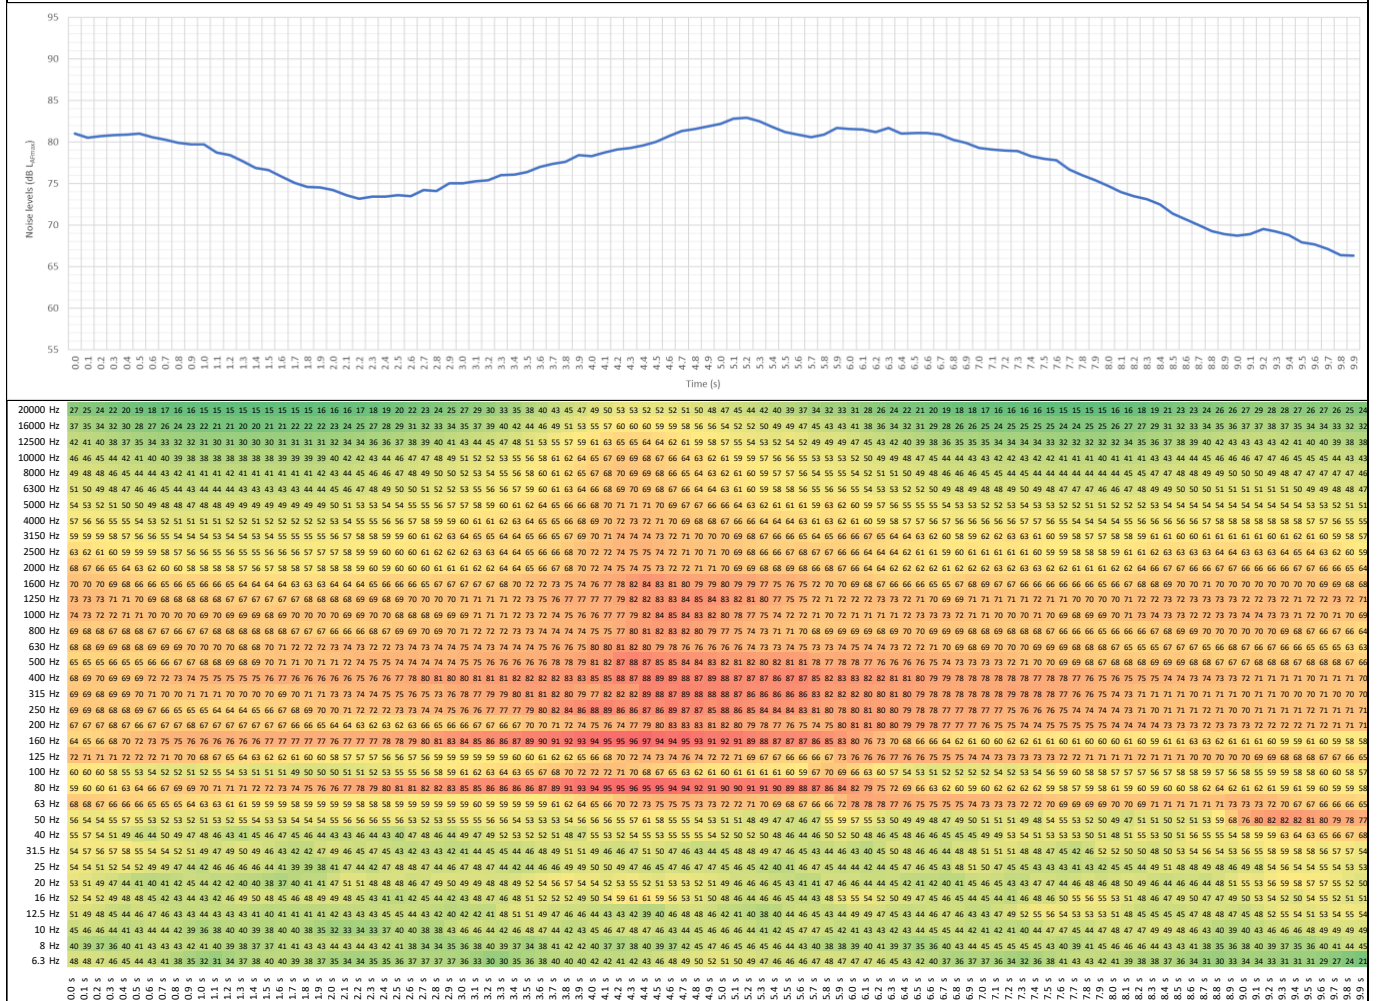
Vehicle information: Toyota Yaris (2003), 1299cc, petrol, type approval drive-by sound level not available.
Pass-by information: Site 1 (West Meon), far side carriageway, speed 68 km/h, maximum noise 92.8 dB L_{max}.

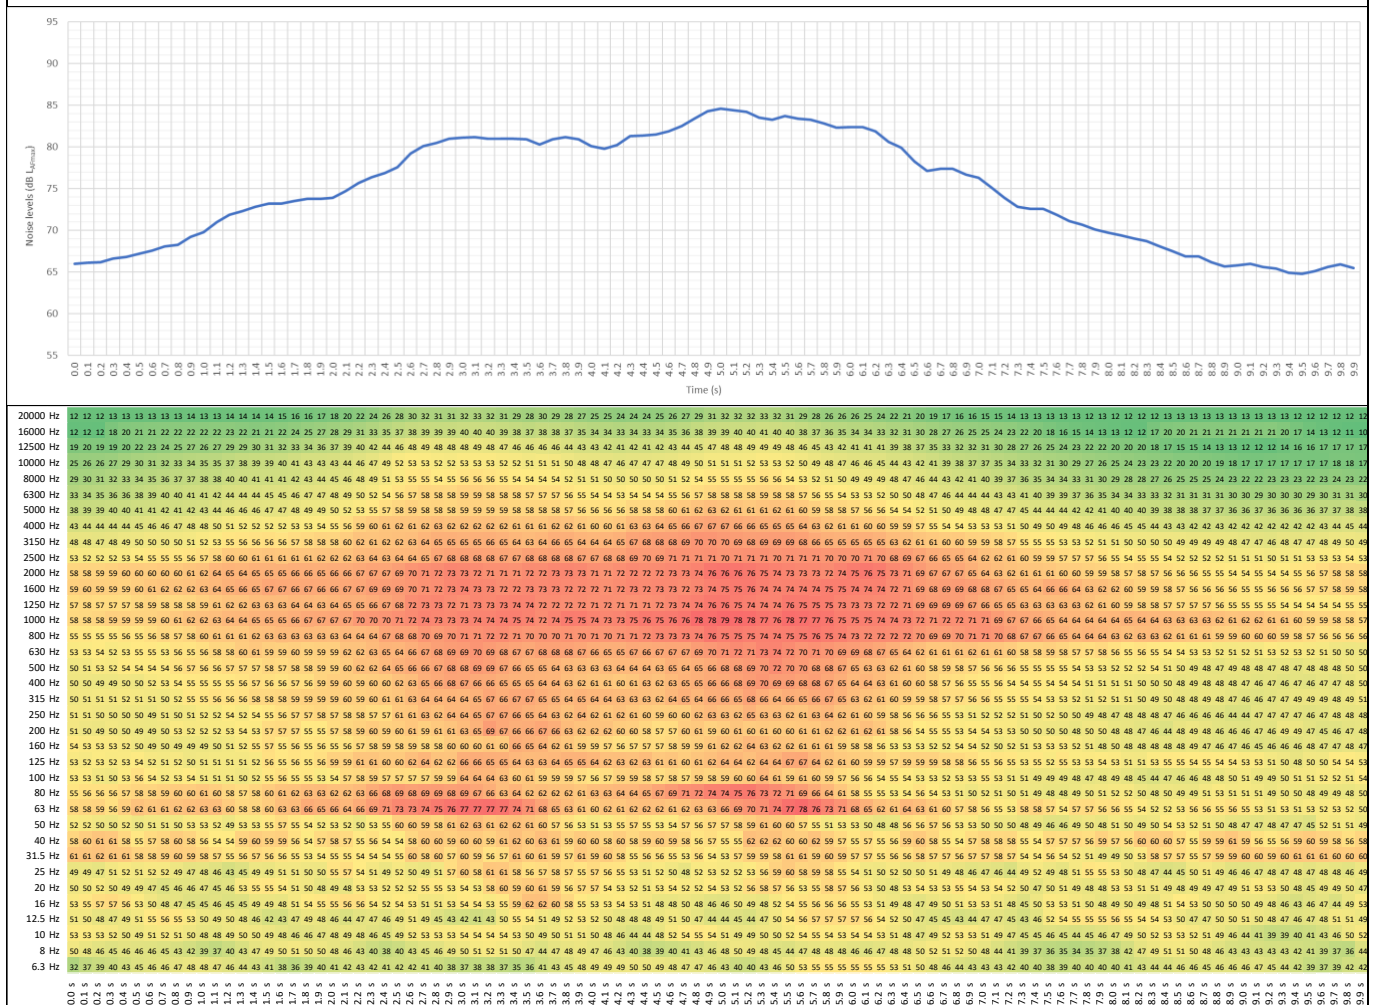
Vehicle information: Honda Jazz (2004), 1339cc, petrol, type approval drive-by sound level 71 dB L_{Amaz}.

Pass-by information: Site 2 (Marchwood bypass), far side carriageway, speed n/a, maximum noise 84.6 dB L_{Amaz}.

Figure 9.5. Measured maximum noise levels L_{max} in third-octave bands as a function of time for a Honda Jazz - 1

The spectrum presented in Figure 9.5 presents two marked regions of higher emissions separated by a few seconds 63-80 Hz and in the frequency range between 1000 Hz and 2500 Hz. This may indicate that the vehicle was revving the engine during the pass-by.
