Air Quality and Dust Monitoring Monthly Report – June 2021

Buckinghamshire Council

Monthly Summary

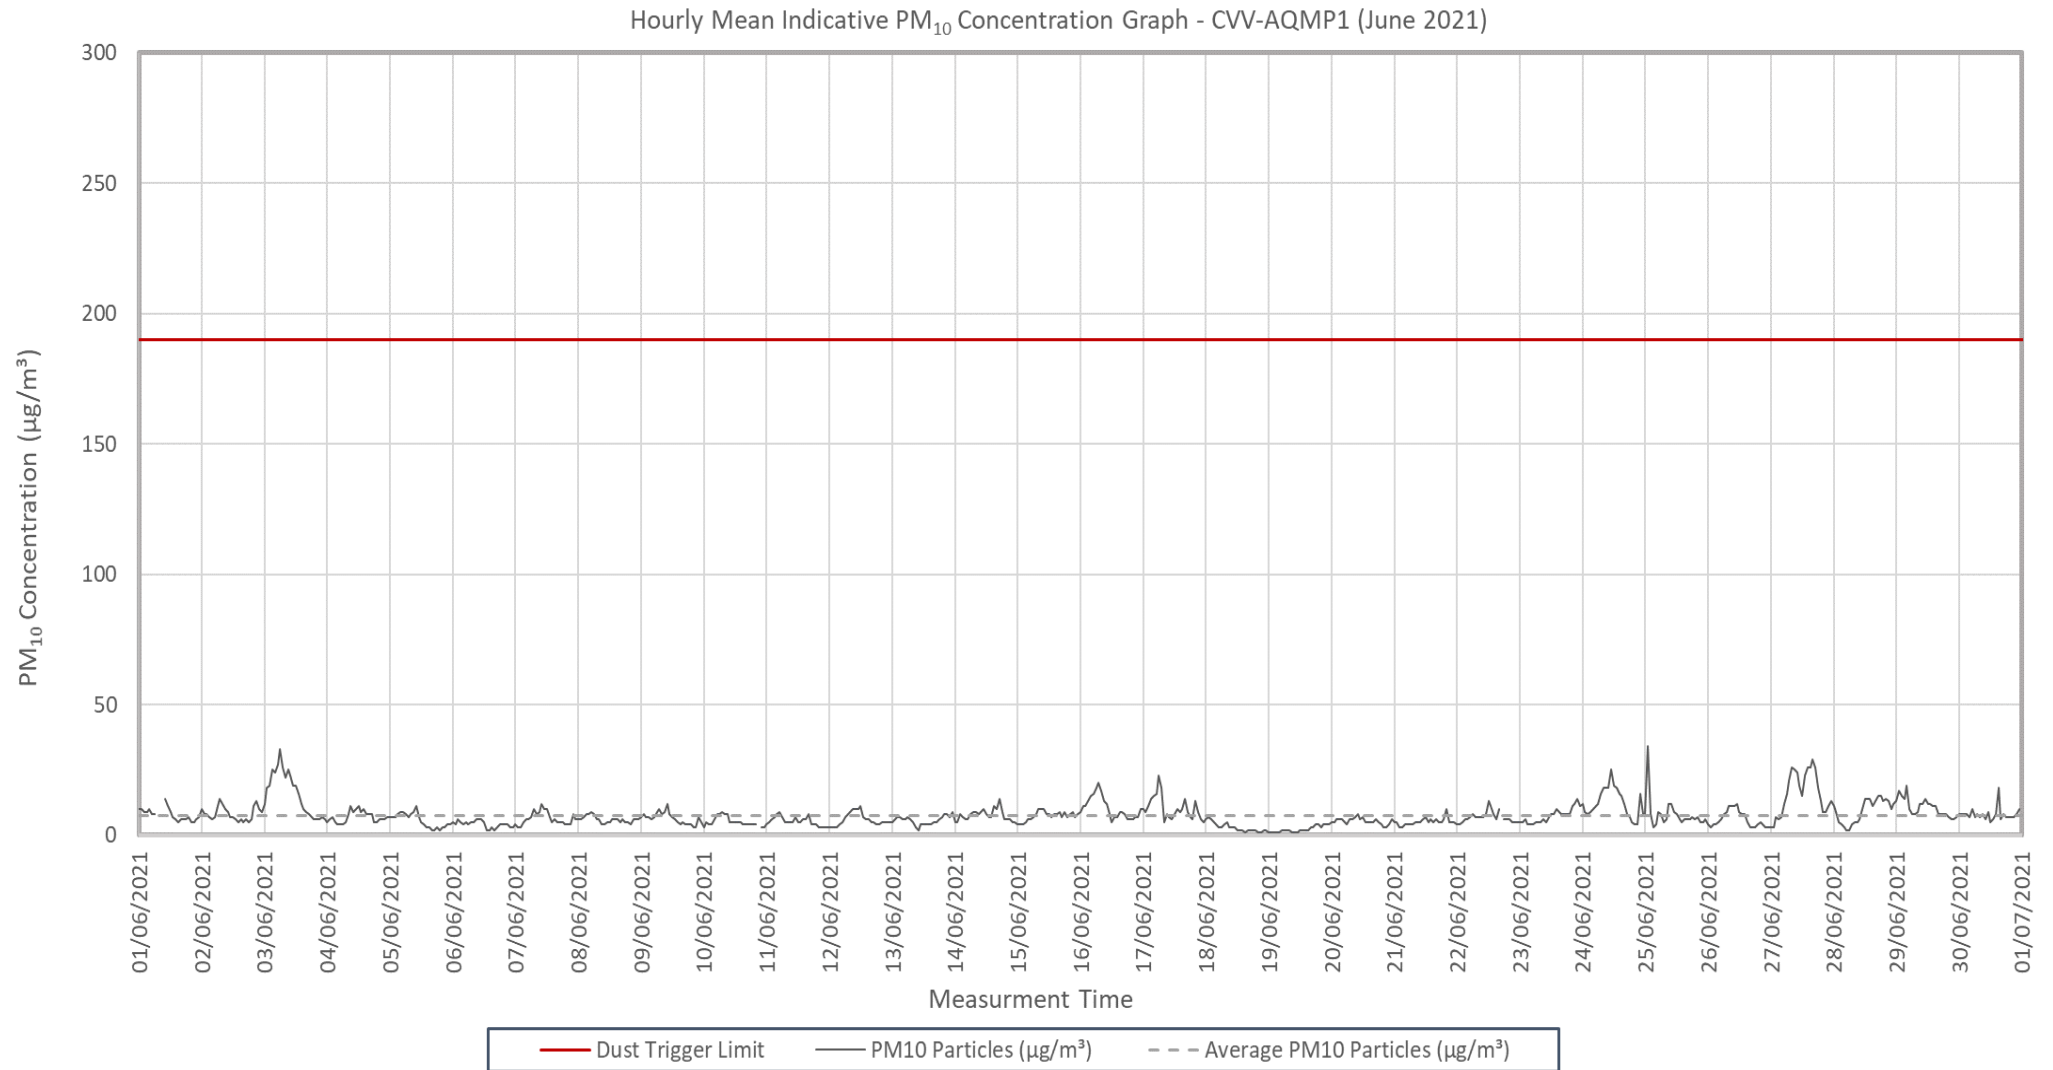
| Monitoring site ID | Coordinates (X,Y) | Location description | Dust risk rating for site | Monitoring site active during period | Change to site since previous period report | Mean 1-hour PM ₁₀ concentration (µg/m ³) | Minimum 1-hour PM ₁₀ concentration (µg/m ³) | Maximum 1-hour PM ₁₀ concentration (µg/m ³) | Number of 1-hour periods exceeding trigger level of 190 µg/m ³ | Data capture (%) |
|---|---|---|---|---|---|---|--|--|---|---|
| CVV-AQMP1 | 503612, 189846 | On the north boundary of LTP1 | M | Yes | Yes | 7.5 | 1.0 | 34.0 | 0 | 99 |

Figure 8: Continuous dust 1-hour mean indicative PM₁₀ concentration for CVV-AQMP1 for June 2021

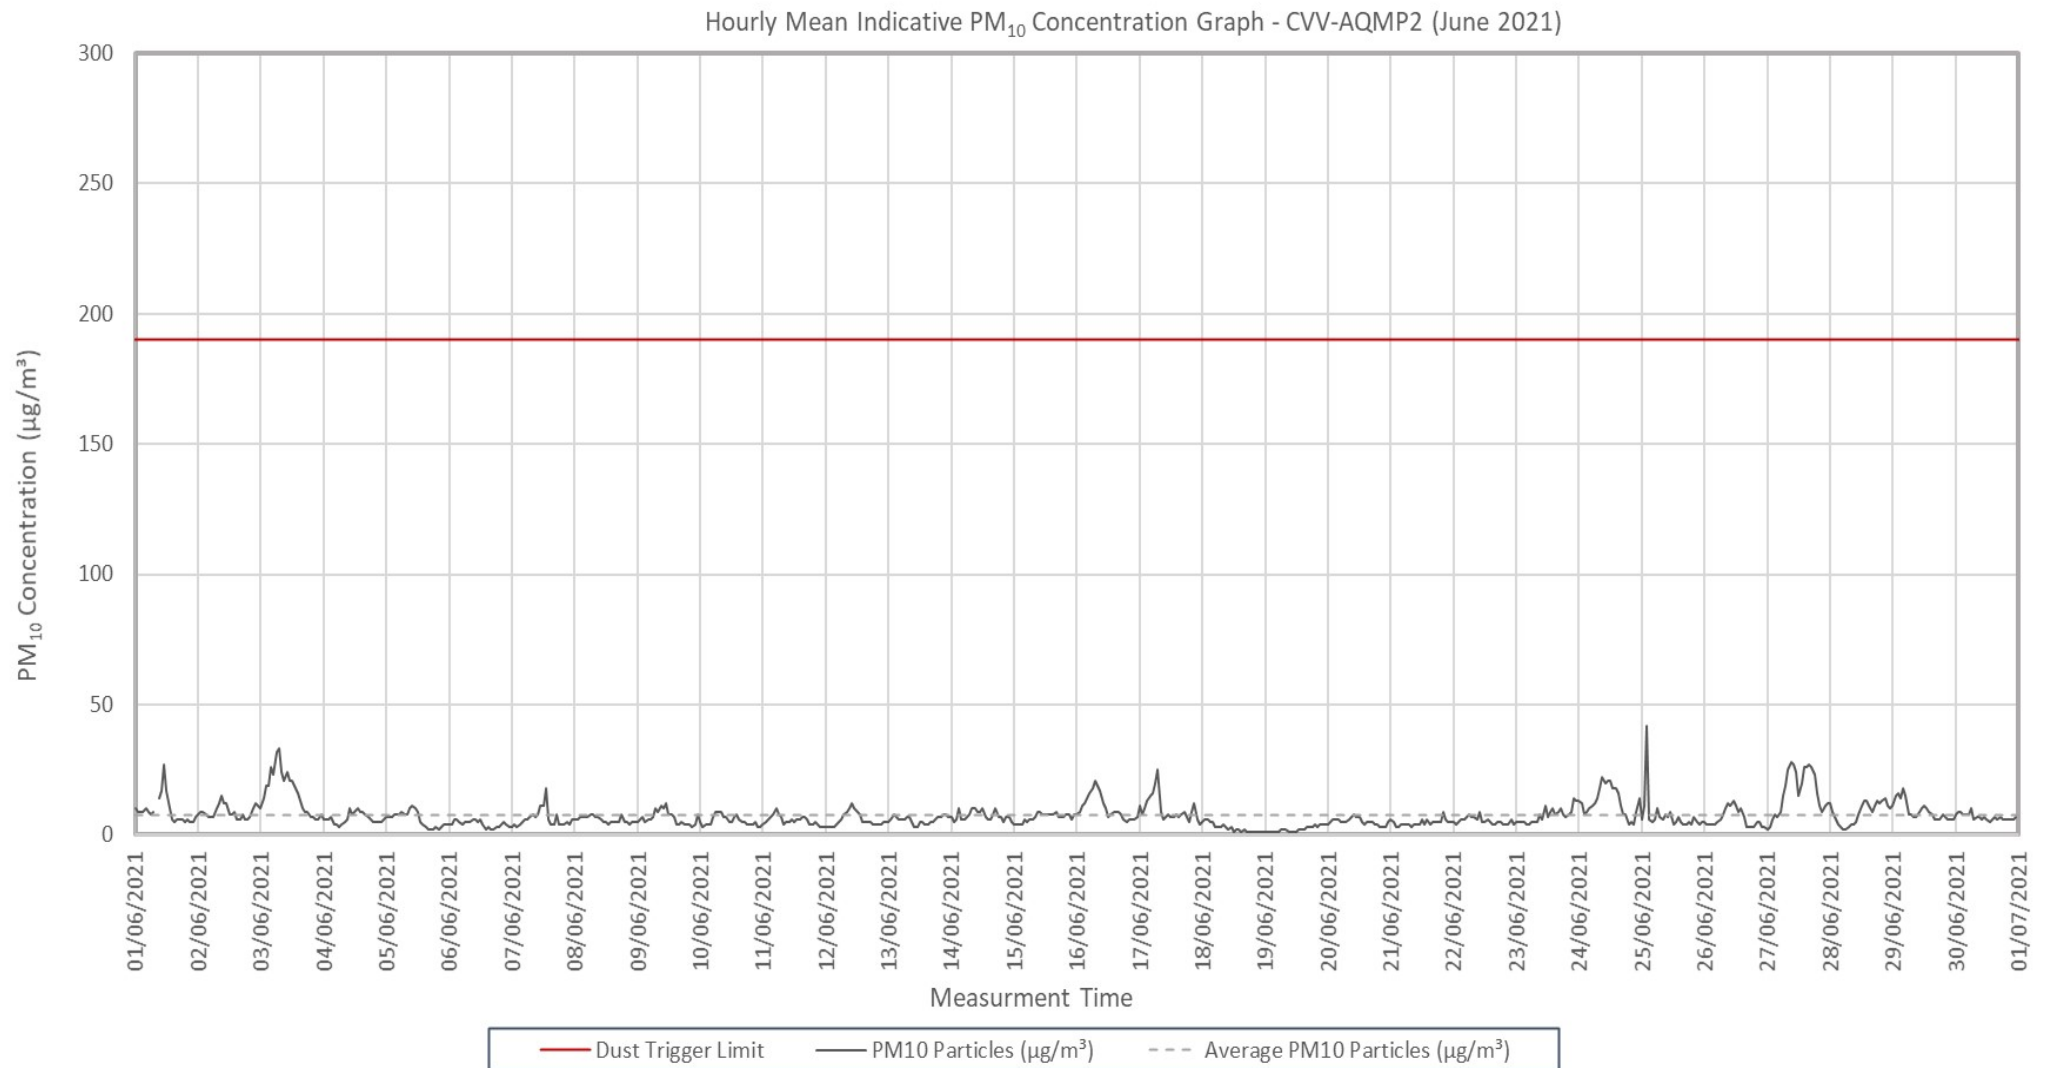
| Monitoring site ID | Coordinates (X,Y) | Location description | Dust risk rating for site | Monitoring site active during period | Change to site since previous period report | Mean 1-hour PM ₁₀ concentration (µg/m ³) | Minimum 1-hour PM ₁₀ concentration (µg/m ³) | Maximum 1-hour PM ₁₀ concentration (µg/m ³) | Number of 1-hour periods exceeding trigger level of 190 µg/m ³ | Data capture (%) |
|---|---|---|---|---|---|---|--|--|---|---|
| CVV-AQMP2 | 503662, 189775 | On the south boundary of LTP1 | M | Yes | Yes | 7.4 | 42.0 | 1.0 | 0 | 100 |

Figure 9: Continuous dust 1-hour mean indicative PM₁₀ concentration for CVV-AQMP2 for June 2021

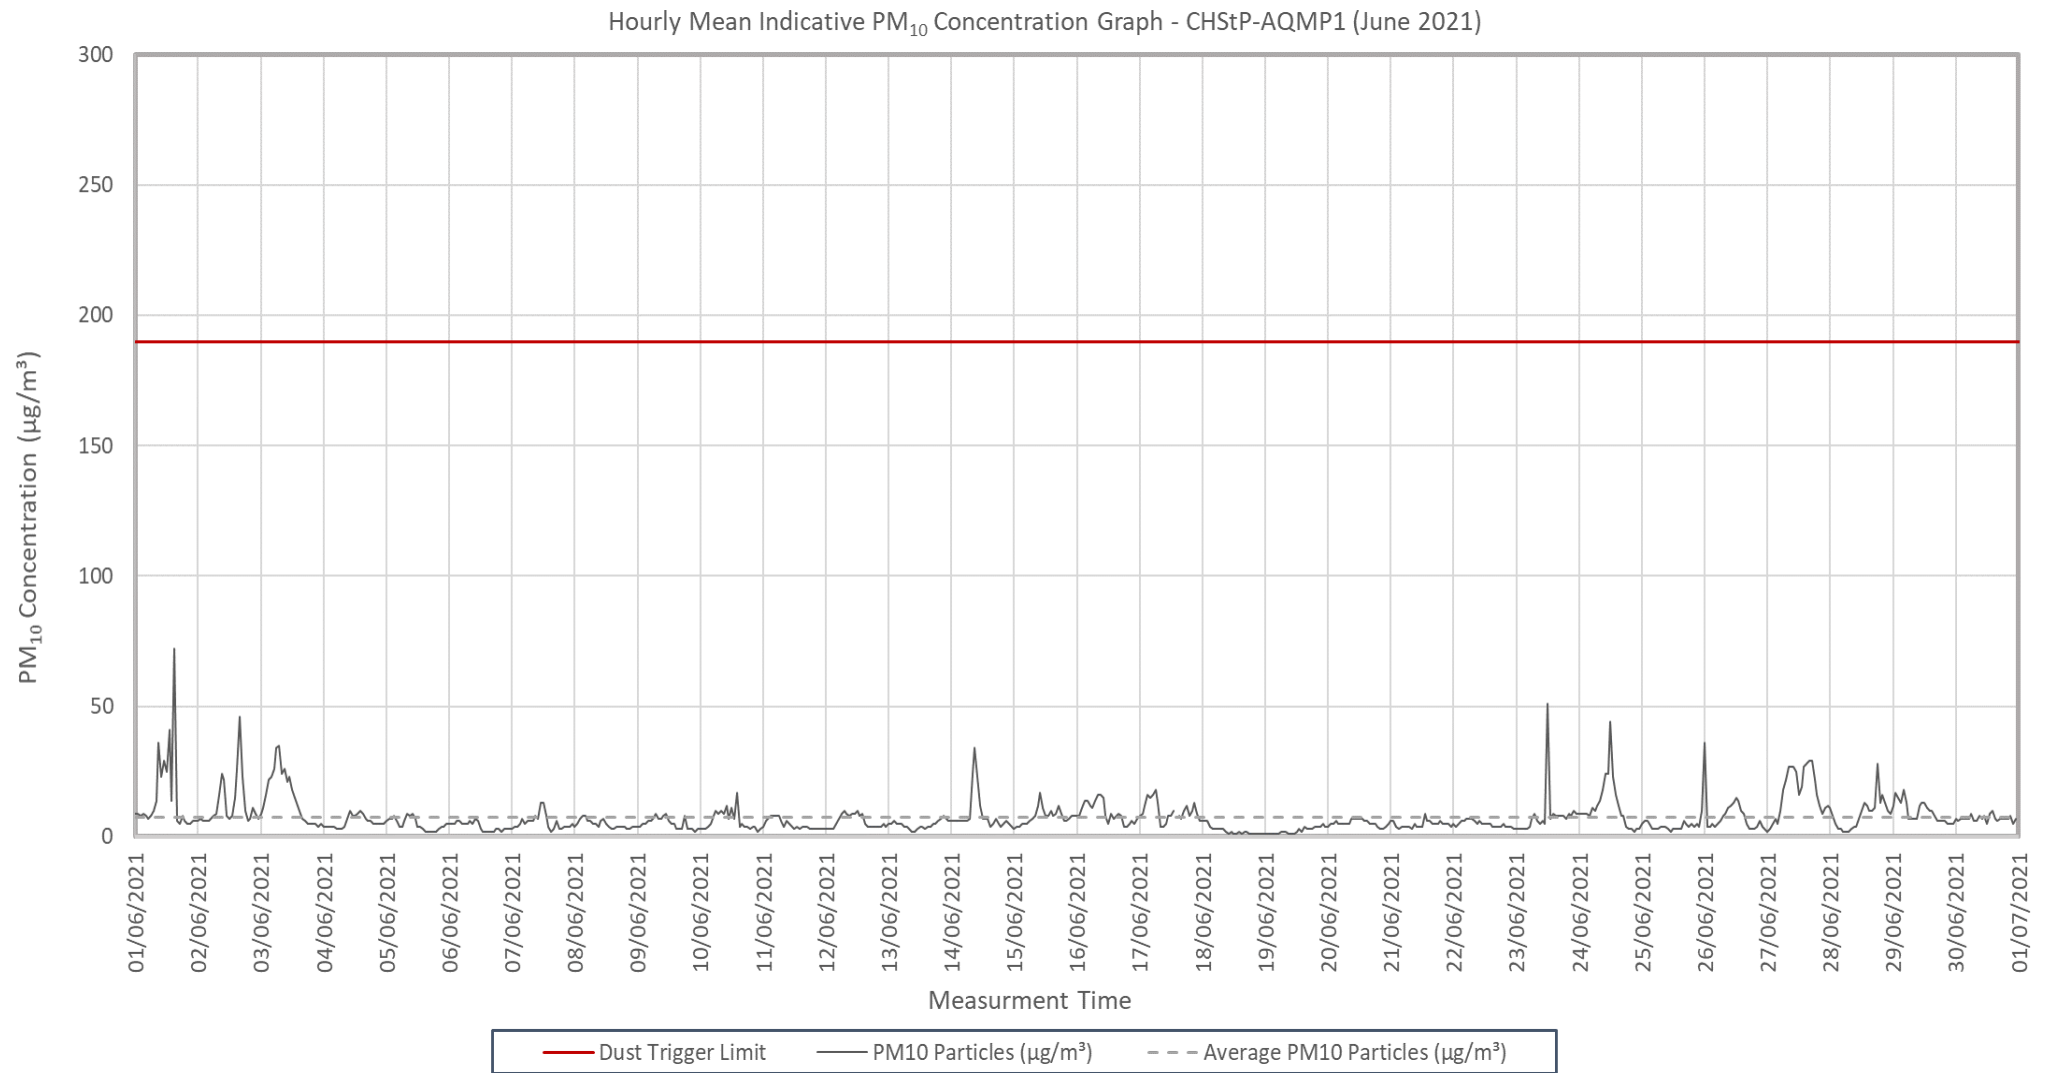
| Monitoring site ID | Coordinates (X,Y) | Location description | Dust risk rating for site | Monitoring site active during period | Change to site since previous period report | Mean 1-hour PM ₁₀ concentration (µg/m ³) | Minimum 1-hour PM ₁₀ concentration (µg/m ³) | Maximum 1-hour PM ₁₀ concentration (µg/m ³) | Number of 1-hour periods exceeding trigger level of 190 µg/m ³ | Data capture (%) |
|---|---|---|---|---|---|---|--|--|---|---|
| CHStP-AQMP1 | 500118, 193105 | On the eastern boundary of the site with Chesham Lane | M | Yes | Yes | 7.5 | 72.0 | 1.0 | 0 | 100 |

Figure 10: Continuous dust 1-hour mean indicative PM₁₀ concentration for CHStP-AQMP1 for June 2021

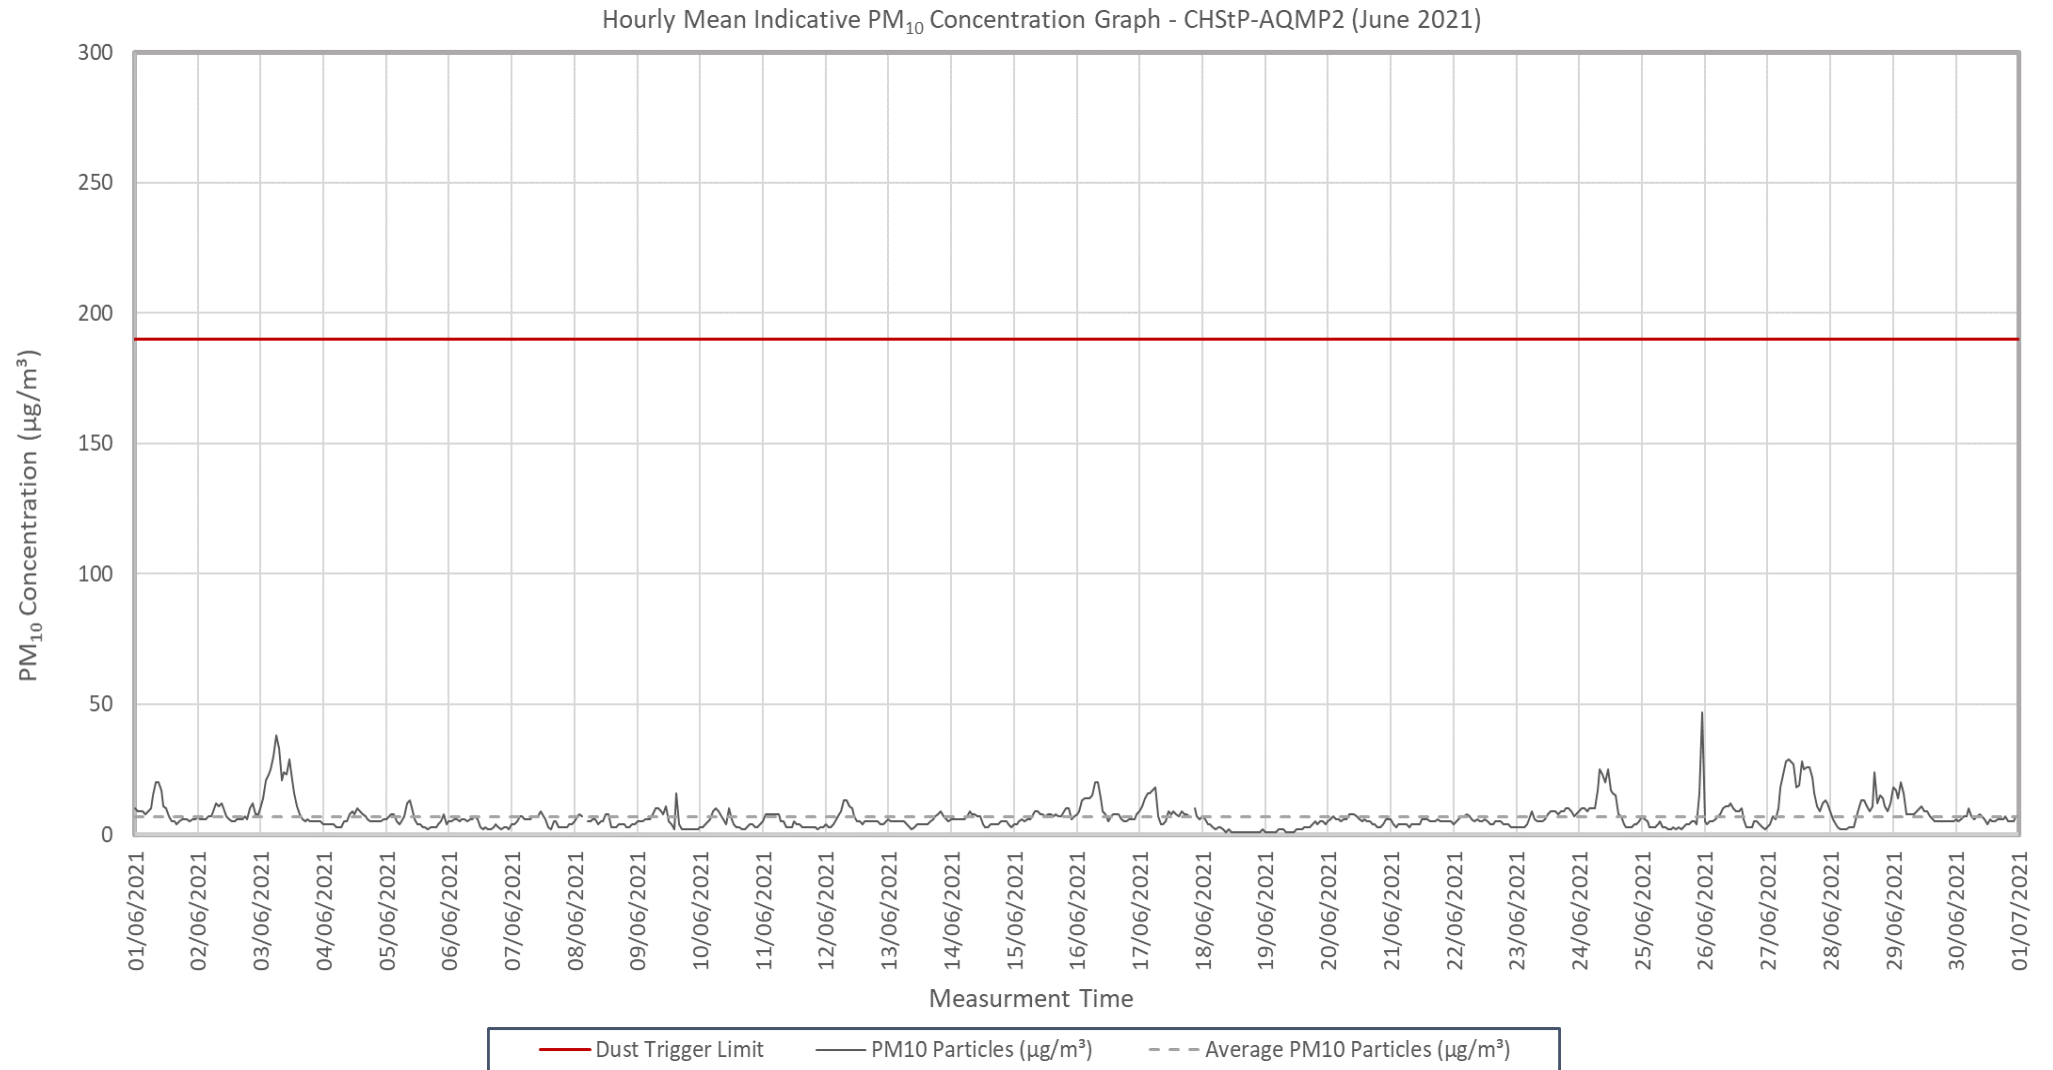
| Monitoring site ID | Coordinates (X,Y) | Location description | Dust risk rating for site | Monitoring site active during period | Change to site since previous period report | Mean 1-hour PM ₁₀ concentration (µg/m ³) | Minimum 1-hour PM ₁₀ concentration (µg/m ³) | Maximum 1-hour PM ₁₀ concentration (µg/m ³) | Number of 1-hour periods exceeding trigger level of 190 µg/m ³ | Data capture (%) |
|---|---|---|---|---|---|---|--|--|---|---|
| CHStP-AQMP2 | 499951, 193282 | On the western boundary of the site | M | Yes | Yes | 6.9 | 47.0 | 1.0 | 0 | 100 |

Figure 11: Continuous dust 1-hour mean indicative PM₁₀ concentration for CHStP-AQMP2 for June 2021

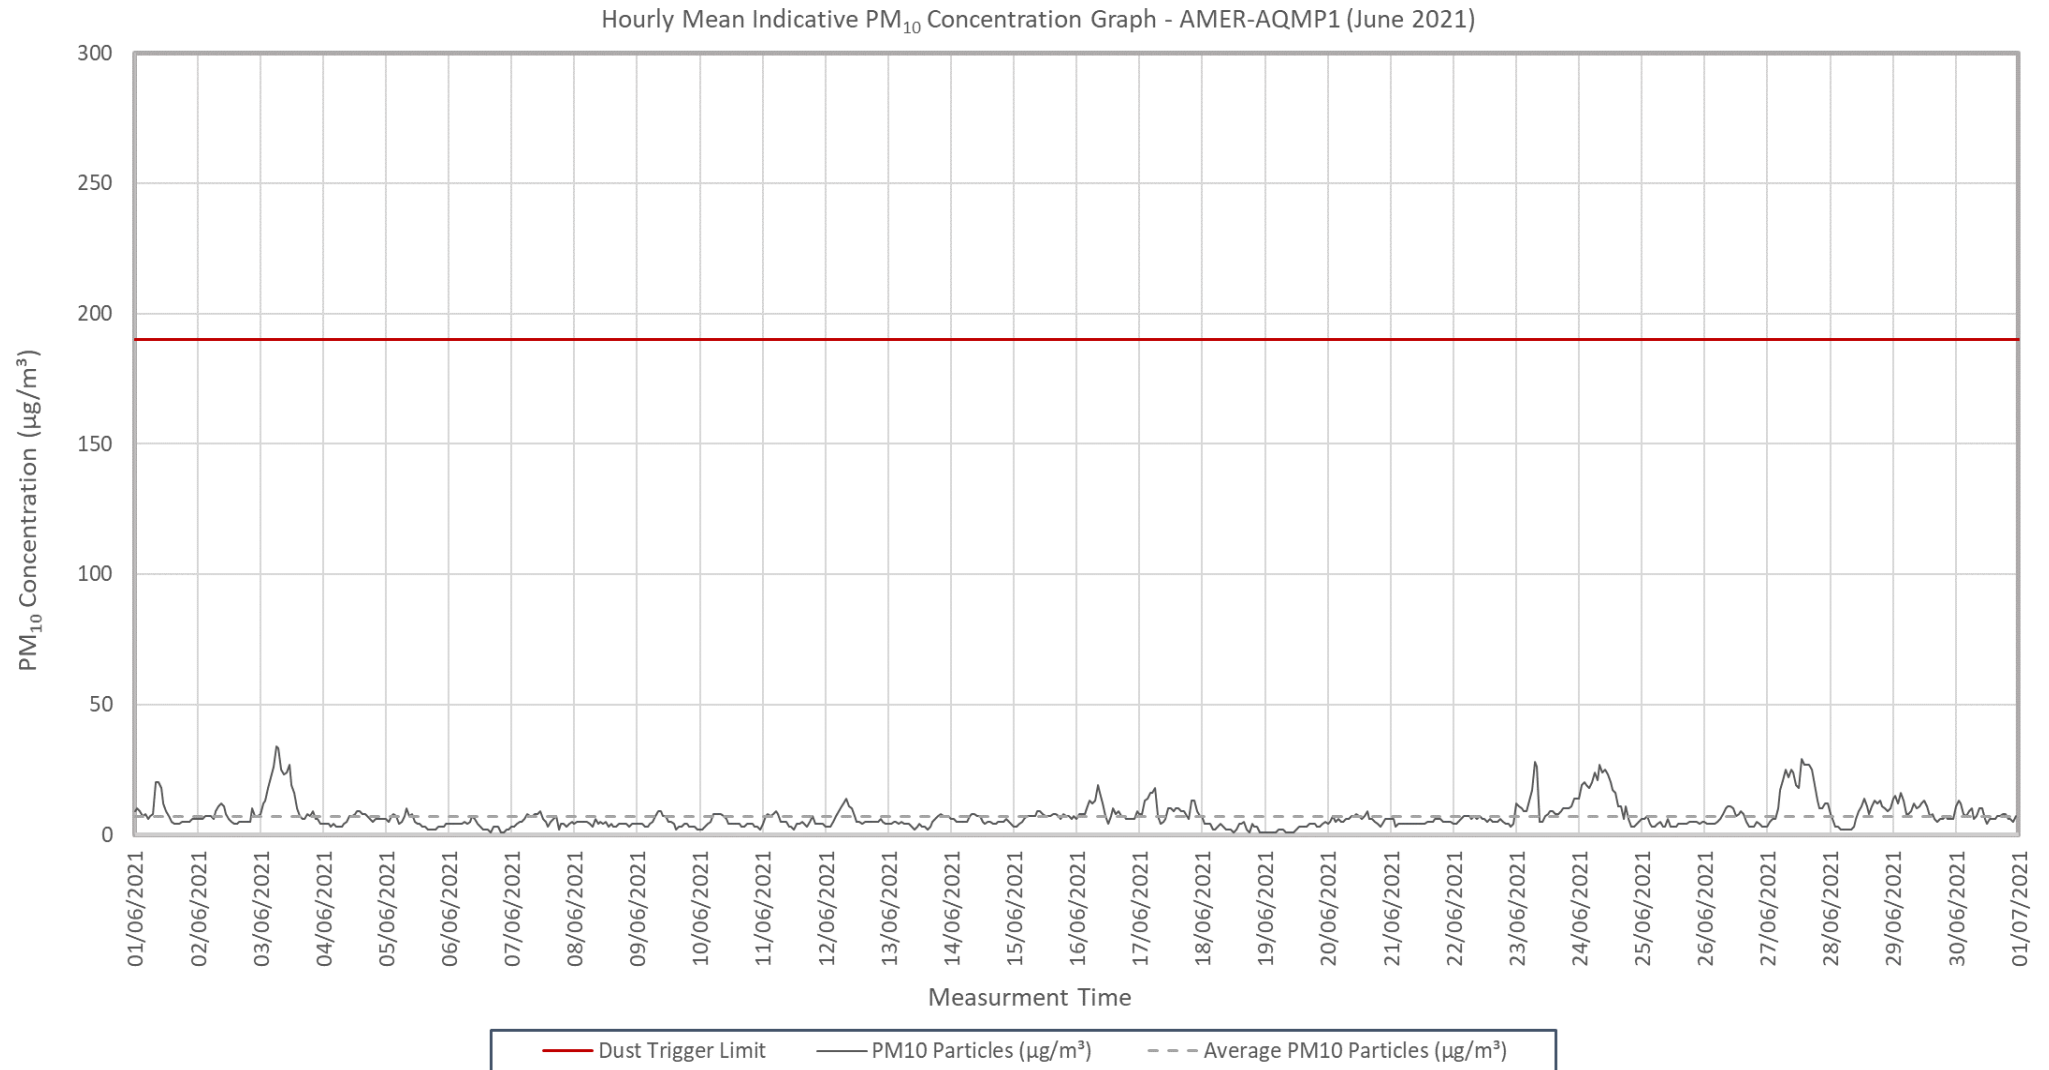
| Monitoring site ID | Coordinates (X,Y) | Location description | Dust risk rating for site | Monitoring site active during period | Change to site since previous period report | Mean 1-hour PM ₁₀ concentration (µg/m ³) | Minimum 1-hour PM ₁₀ concentration (µg/m ³) | Maximum 1-hour PM ₁₀ concentration (µg/m ³) | Number of 1-hour periods exceeding trigger level of 190 µg/m ³ | Data capture (%) |
|---|---|---|---|---|---|---|--|--|---|---|
| AMER-AQMP1 | 495418, 196737 | On the north-eastern boundary of Amersham | M | Yes | Yes | 7.0 | 34.0 | 1.0 | 0 | 100 |

Figure 12: Continuous dust 1-hour mean indicative PM₁₀ concentration for AMER-AQMP1 for June 2021

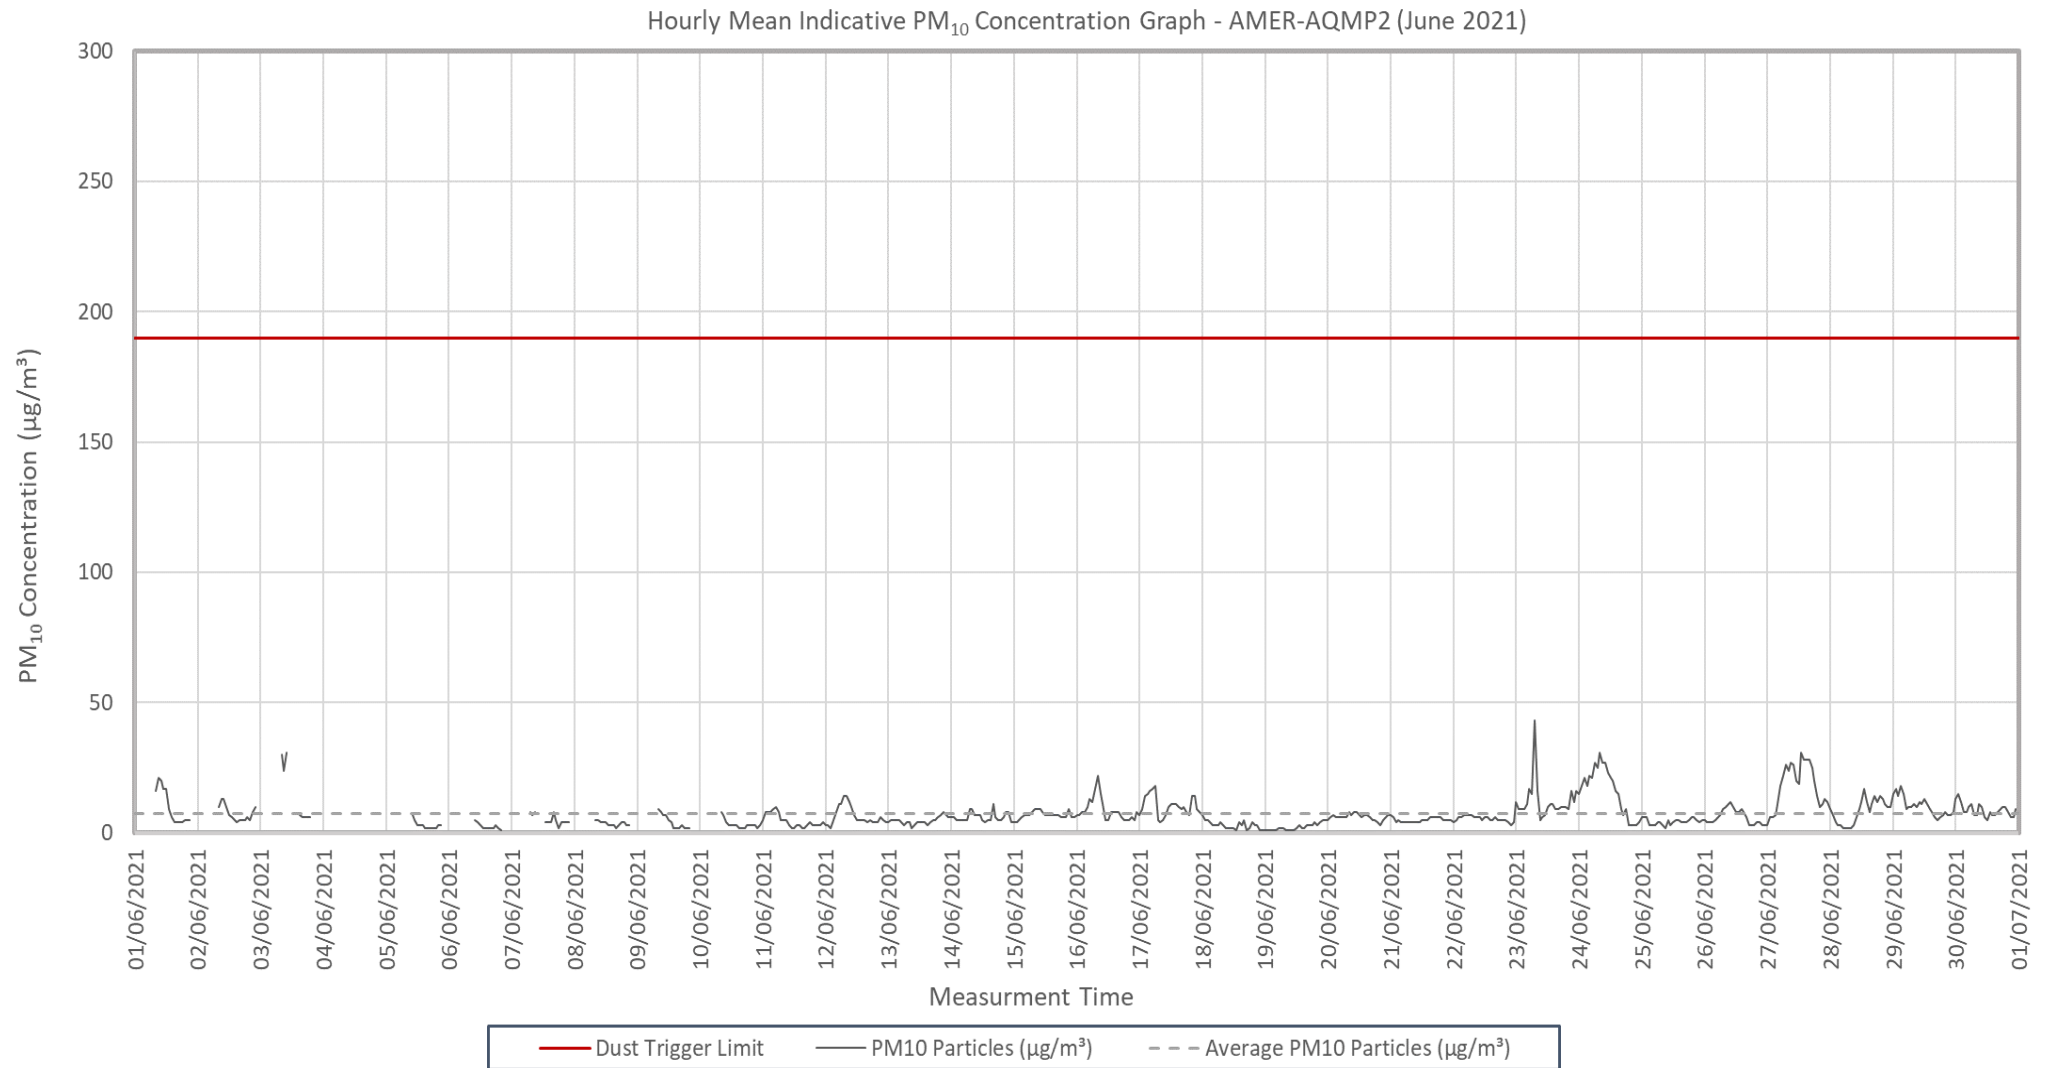
| Monitoring site ID | Coordinates (X,Y) | Location description | Dust risk rating for site | Monitoring site active during period | Change to site since previous period report | Mean 1-hour PM ₁₀ concentration (µg/m ³) | Minimum 1-hour PM ₁₀ concentration (µg/m ³) | Maximum 1-hour PM ₁₀ concentration (µg/m ³) | Number of 1-hour periods exceeding trigger level of 190 µg/m ³ | Data capture (%) |
|---|---|---|---|---|---|---|--|--|---|---|
| AMER-AQMP2 | 495324, 196556 | On the south-western boundary of Amersham | M | Yes | Yes | 7.3 | 43.0 | 1.0 | 0 | 83 |

Figure 13: Continuous dust 1-hour mean indicative PM₁₀ concentration for AMER-AQMP2 for June 2021

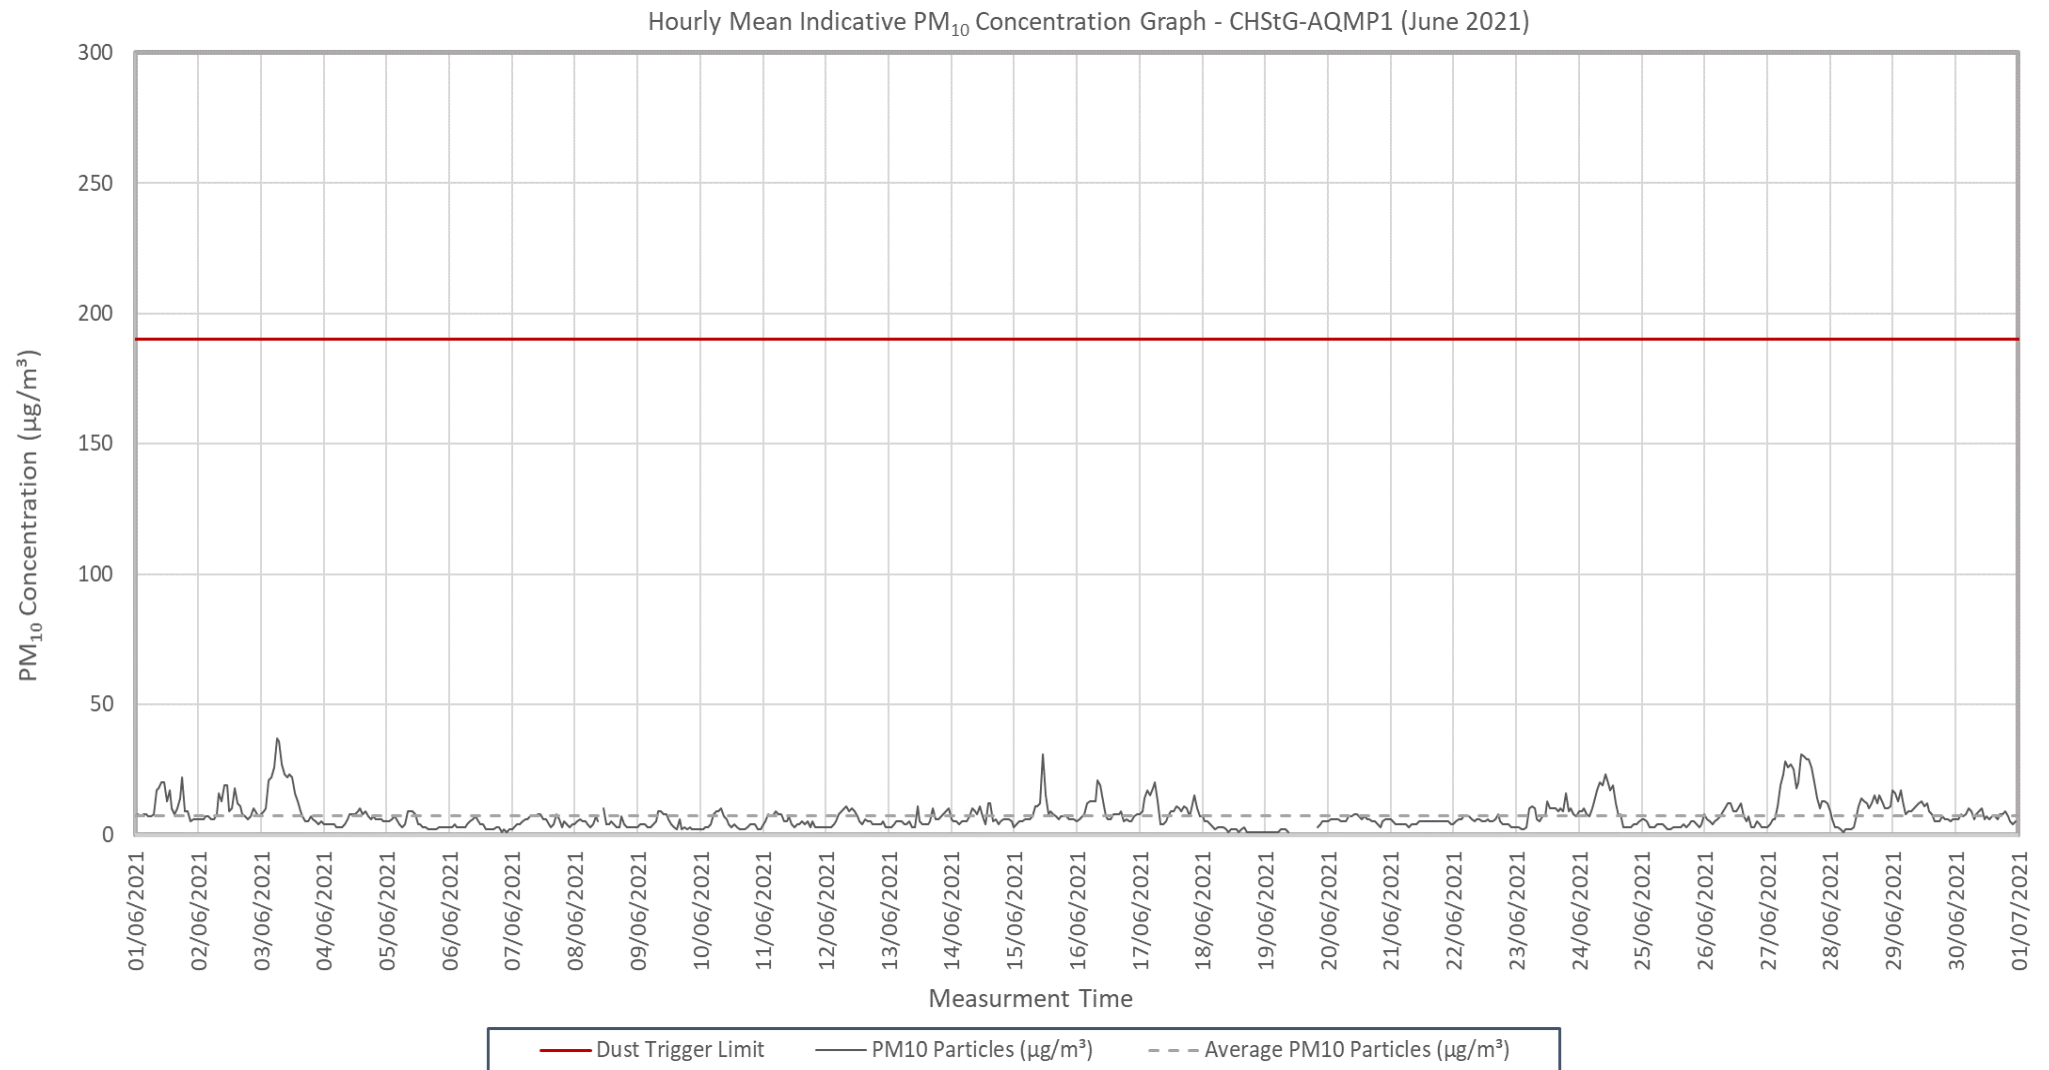
| Monitoring site ID | Coordinates (X,Y) | Location description | Dust risk rating for site | Monitoring site active during period | Change to site since previous period report | Mean 1-hour PM ₁₀ concentration (µg/m ³) | Minimum 1-hour PM ₁₀ concentration (µg/m ³) | Maximum 1-hour PM ₁₀ concentration (µg/m ³) | Number of 1-hour periods exceeding trigger level of 190 µg/m ³ | Data capture (%) |
|---|---|---|---|---|---|---|--|--|---|---|
| CHStG-AQMP1 | 497170, 194752 | On the southern boundary close to Hobbs Hole Cottage | M | Yes | Yes | 7.1 | 37.0 | 1.0 | 0 | 98 |

Figure 14: Continuous dust 1-hour mean indicative PM₁₀ concentration for CHStG-AQMP1 for June 2021

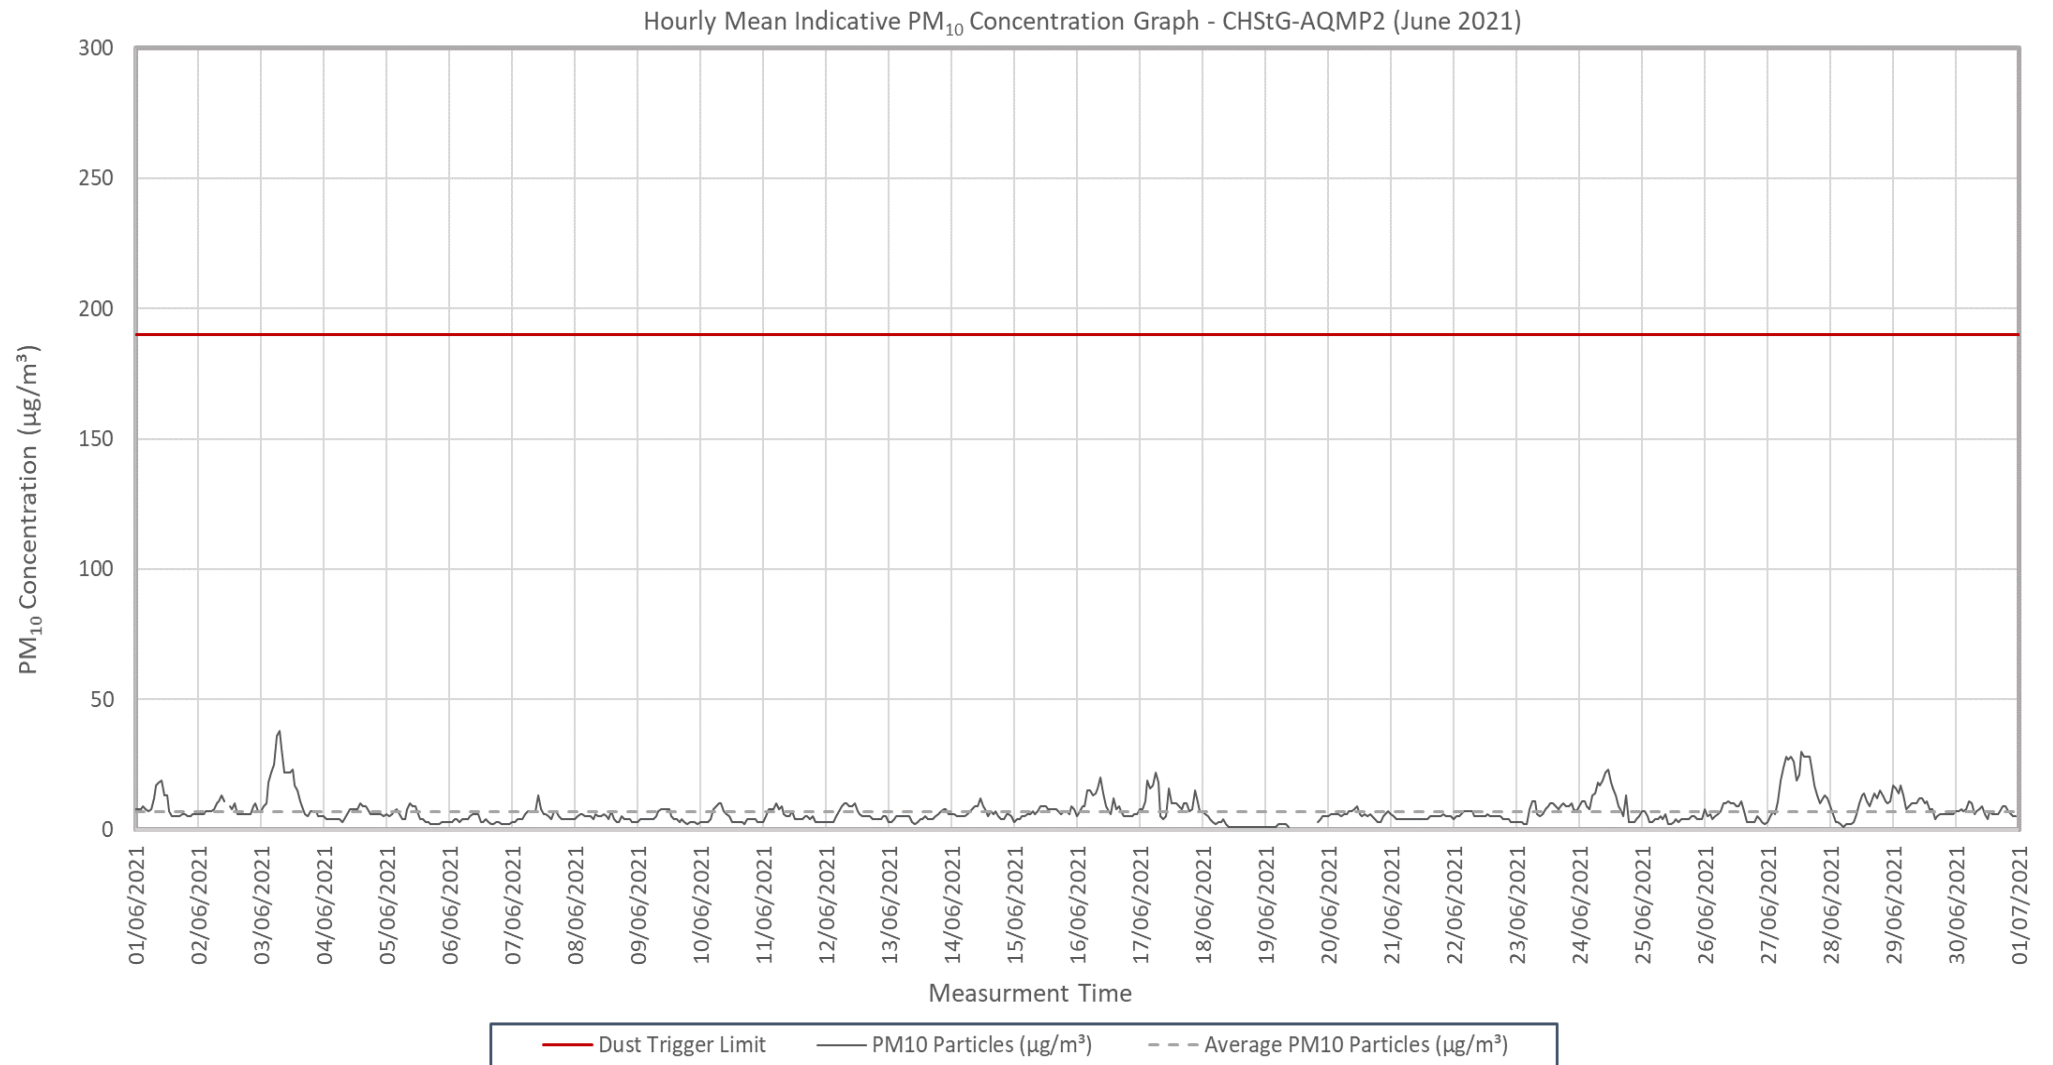
| Monitoring site ID | Coordinates (X,Y) | Location description | Dust risk rating for site | Monitoring site active during period | Change to site since previous period report | Mean 1-hour PM ₁₀ concentration (µg/m ³) | Minimum 1-hour PM ₁₀ concentration (µg/m ³) | Maximum 1-hour PM ₁₀ concentration (µg/m ³) | Number of 1-hour periods exceeding trigger level of 190 µg/m ³ | Data capture (%) |
|---|---|---|---|---|---|---|--|--|---|---|
| CHStG-AQMP2 | 497320, 194770 | On southern boundary next to carpark | M | Yes | Yes | 7.0 | 38.0 | 1.0 | 0 | 98 |

Figure 15: Continuous dust 1-hour mean indicative PM₁₀ concentration for CHStG-AQMP2 for June 2021

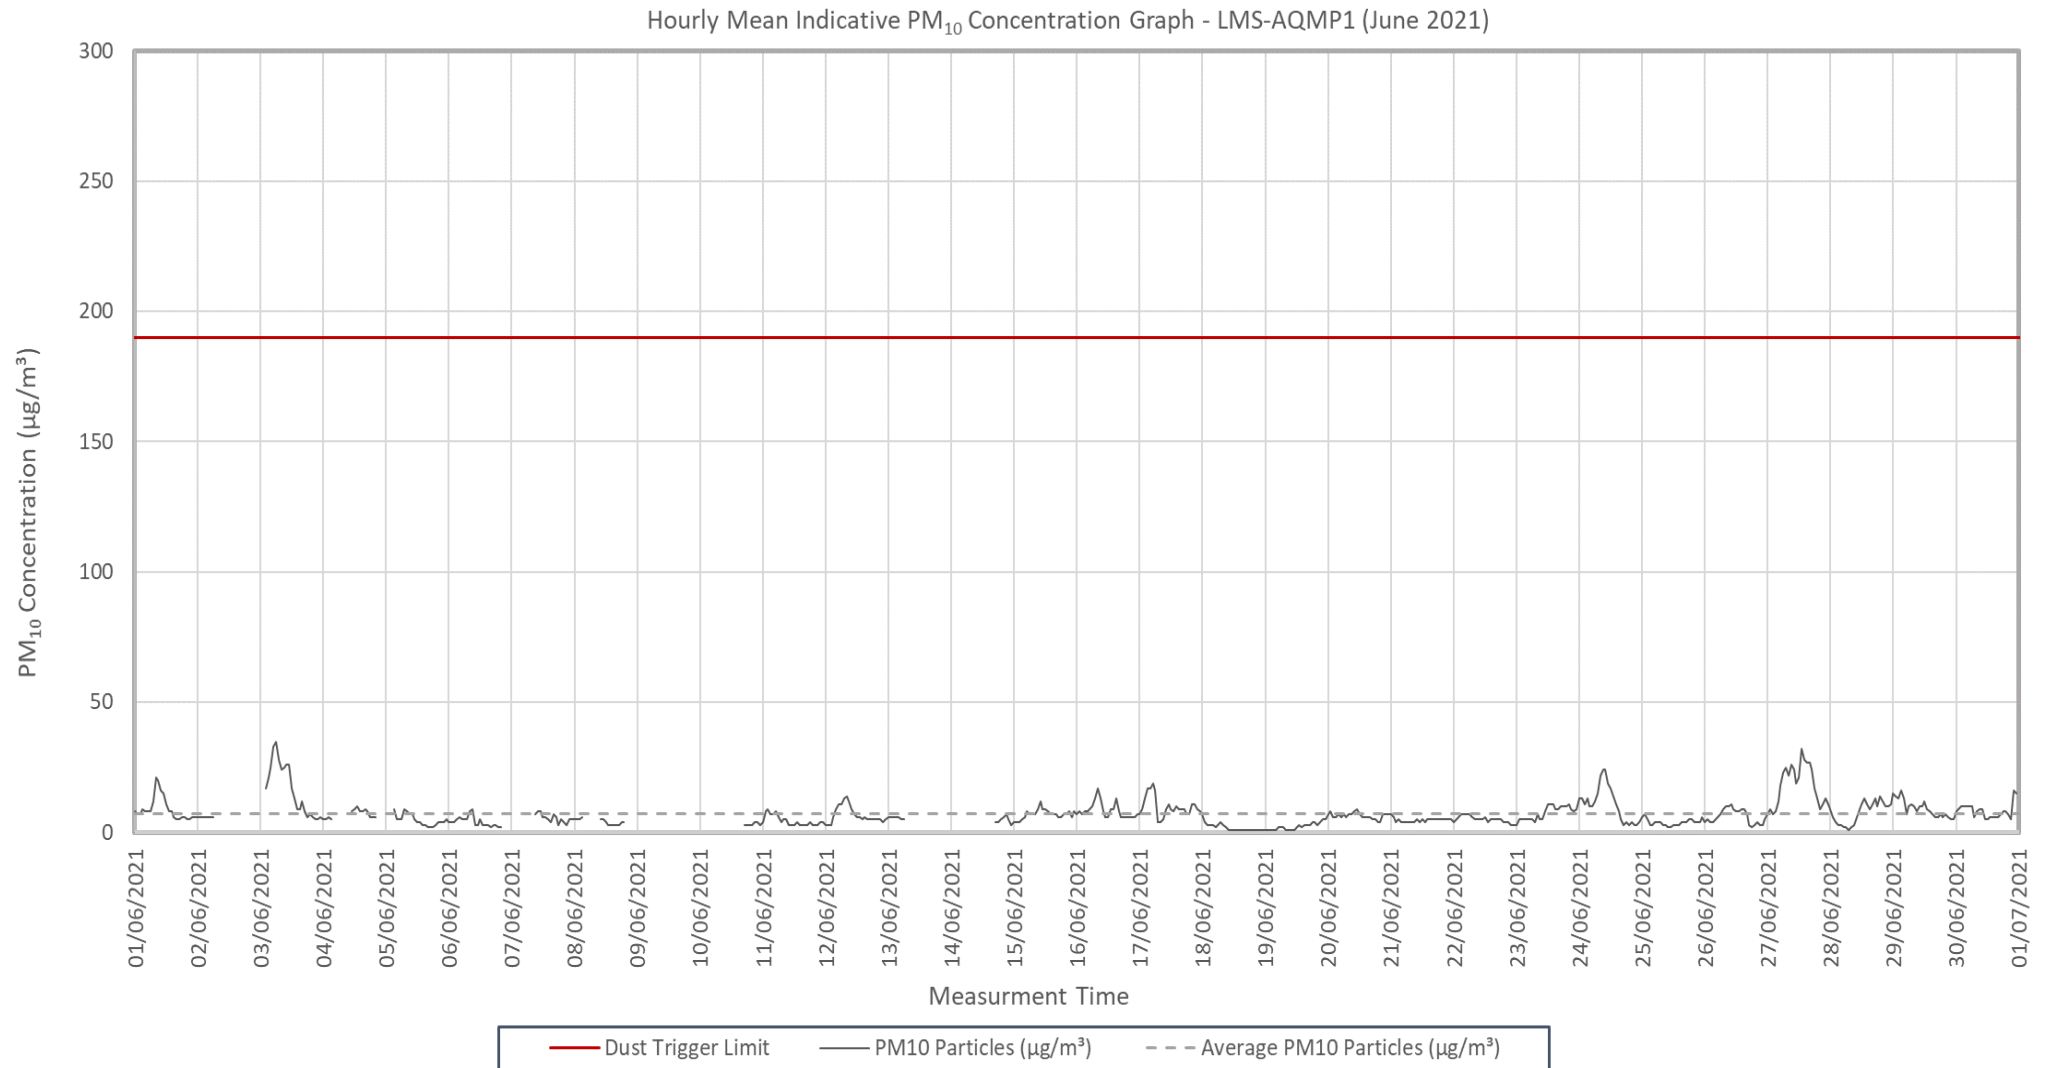
| Monitoring site ID | Coordinates (X,Y) | Location description | Dust risk rating for site | Monitoring site active during period | Change to site since previous period report | Mean 1-hour PM ₁₀ concentration (µg/m ³) | Minimum 1-hour PM ₁₀ concentration (µg/m ³) | Maximum 1-hour PM ₁₀ concentration (µg/m ³) | Number of 1-hour periods exceeding trigger level of 190 µg/m ³ | Data capture (%) |
|---|---|---|---|---|---|---|--|--|---|---|
| LMS-AQMP1 | 493190, 198848 | On the south-west of the site | M | Yes | Yes | 7.2 | 35.0 | 1.0 | 0 | 82 |

Figure 16: Continuous dust 1-hour mean indicative PM₁₀ concentration for LMS-AQMP1 for June 2021
