Air Quality and Dust Monitoring Monthly Report – June 2021

Buckinghamshire Council

Monthly Summary

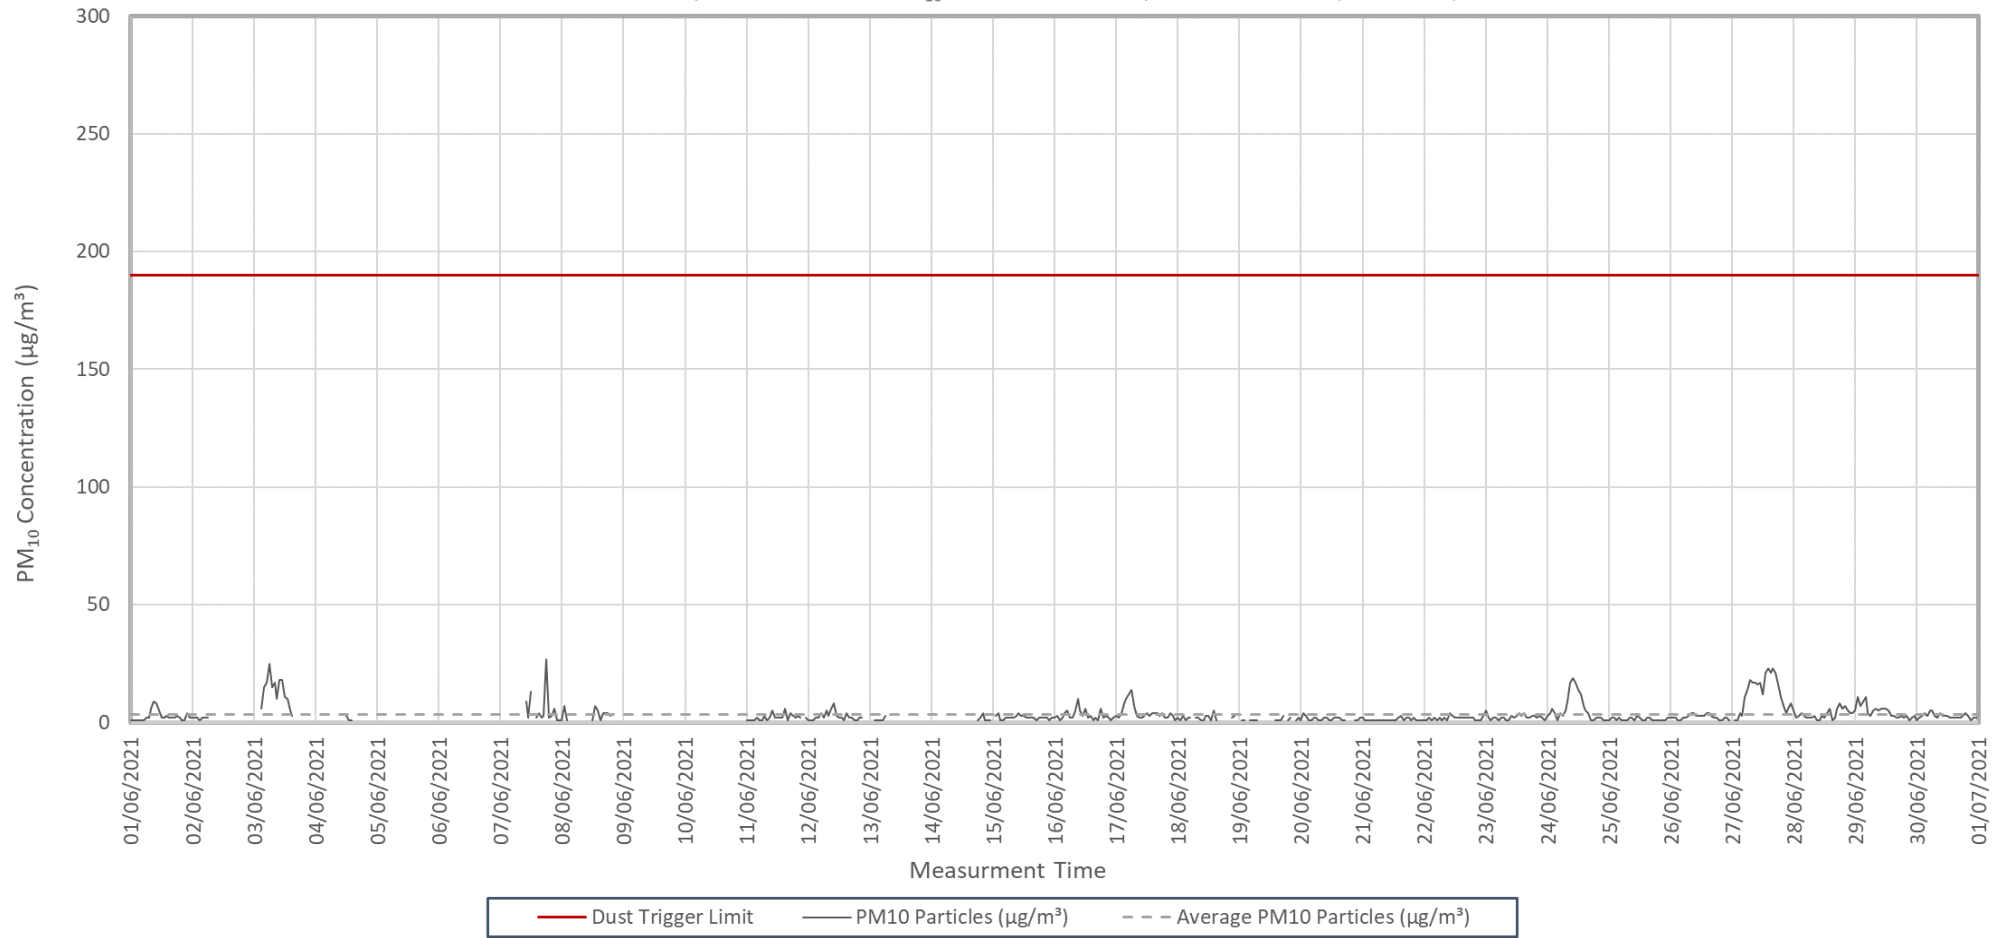
| Monitoring site ID | Coordinates (X,Y) | Location description | Dust risk rating for site | Monitoring site active during period | Change to site since previous period report | Mean 1-hour PM ₁₀ concentration (µg/m ³) | Minimum 1-hour PM ₁₀ concentration (µg/m ³) | Maximum 1-hour PM ₁₀ concentration (µg/m ³) | Number of 1-hour periods exceeding trigger level of 190 µg/m ³ | Data capture (%) |
|---|---|---|---|---|---|---|--|--|---|---|
| LMS-AQMP2 | 493407, 198731 | On the south-east of the site | M | Yes | Yes | 3.5 | 27.0 | 1.0 | 0 | 68 |

Figure 17: Continuous dust 1-hour mean indicative PM₁₀ concentration for LMS-AQMP2 for June 2021

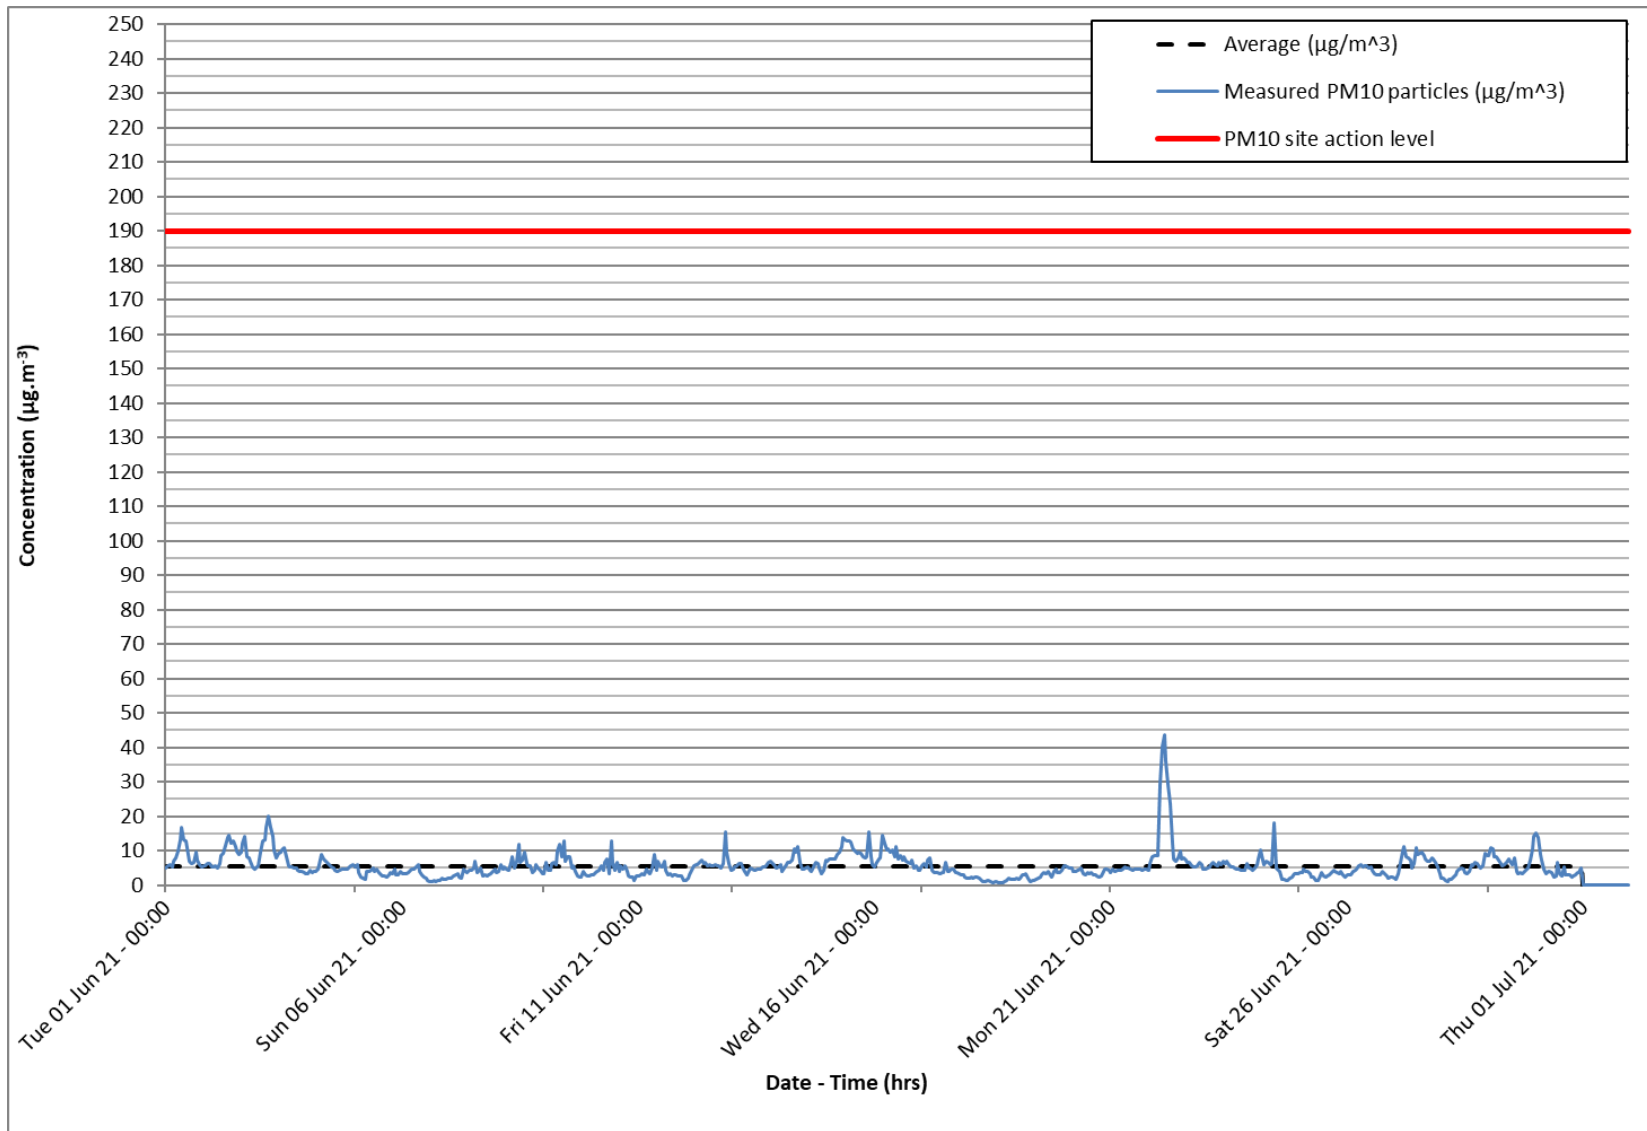
| Monitoring site ID | Coordinates (X,Y) | Location description | Dust risk rating for site | Monitoring site active during period | Change to site since previous period report | Mean 1-hour PM ₁₀ concentration (µg/m ³) | Minimum 1-hour PM ₁₀ concentration (µg/m ³) | Maximum 1-hour PM ₁₀ concentration (µg/m ³) | Number of 1-hour periods exceeding trigger level of 190 µg/m ³ | Data capture (%) |
|---|---|---|---|---|---|---|--|--|---|---|
| 3252Dust3 | 498100, 195145 | On the site boundary opposite Lower Bottom House Farm | M | Yes | No | 5.6 | 0.7 | 43.7 | 0 | 100.0 |

Figure 18: Continuous dust 1-hour mean indicative PM₁₀ concentration for 3252Dust3 for June 2021

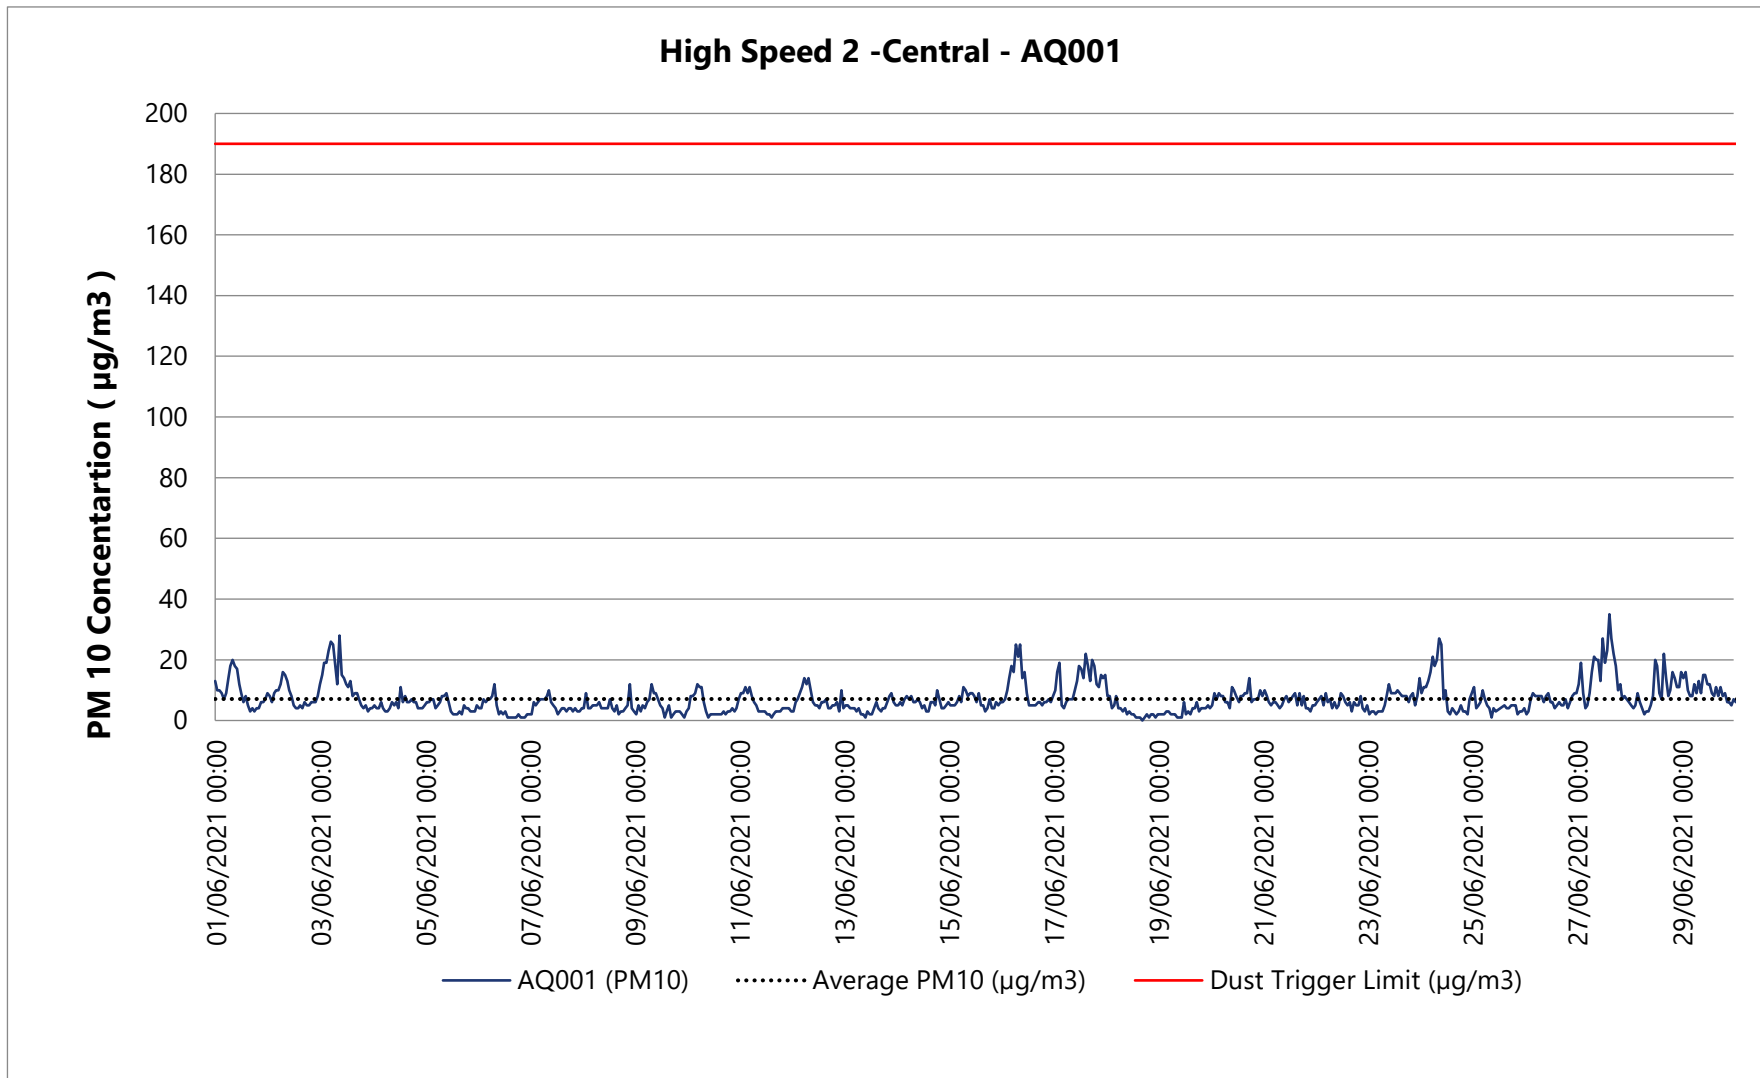
| Monitoring site ID | Coordinates (X,Y) | Location description | Dust risk rating for site | Monitoring site active during period | Change to site since previous period report | Mean 1-hour PM ₁₀ concentration (µg/m ³) | Minimum 1-hour PM ₁₀ concentration (µg/m ³) | Maximum 1-hour PM ₁₀ concentration (µg/m ³) | Number of 1-hour periods exceeding trigger level of 190 µg/m ³ | Data capture (%) |
|---|---|---|---|---|---|---|--|--|---|---|
| AQ001 | 471424, 221337 | Woodlands Farm | M | Yes | No | 7.1 | 1 | 35 | 0 | 99.4 |

Figure 19: Continuous dust 1-hour mean indicative PM₁₀ concentration for AQ001 for June 2021

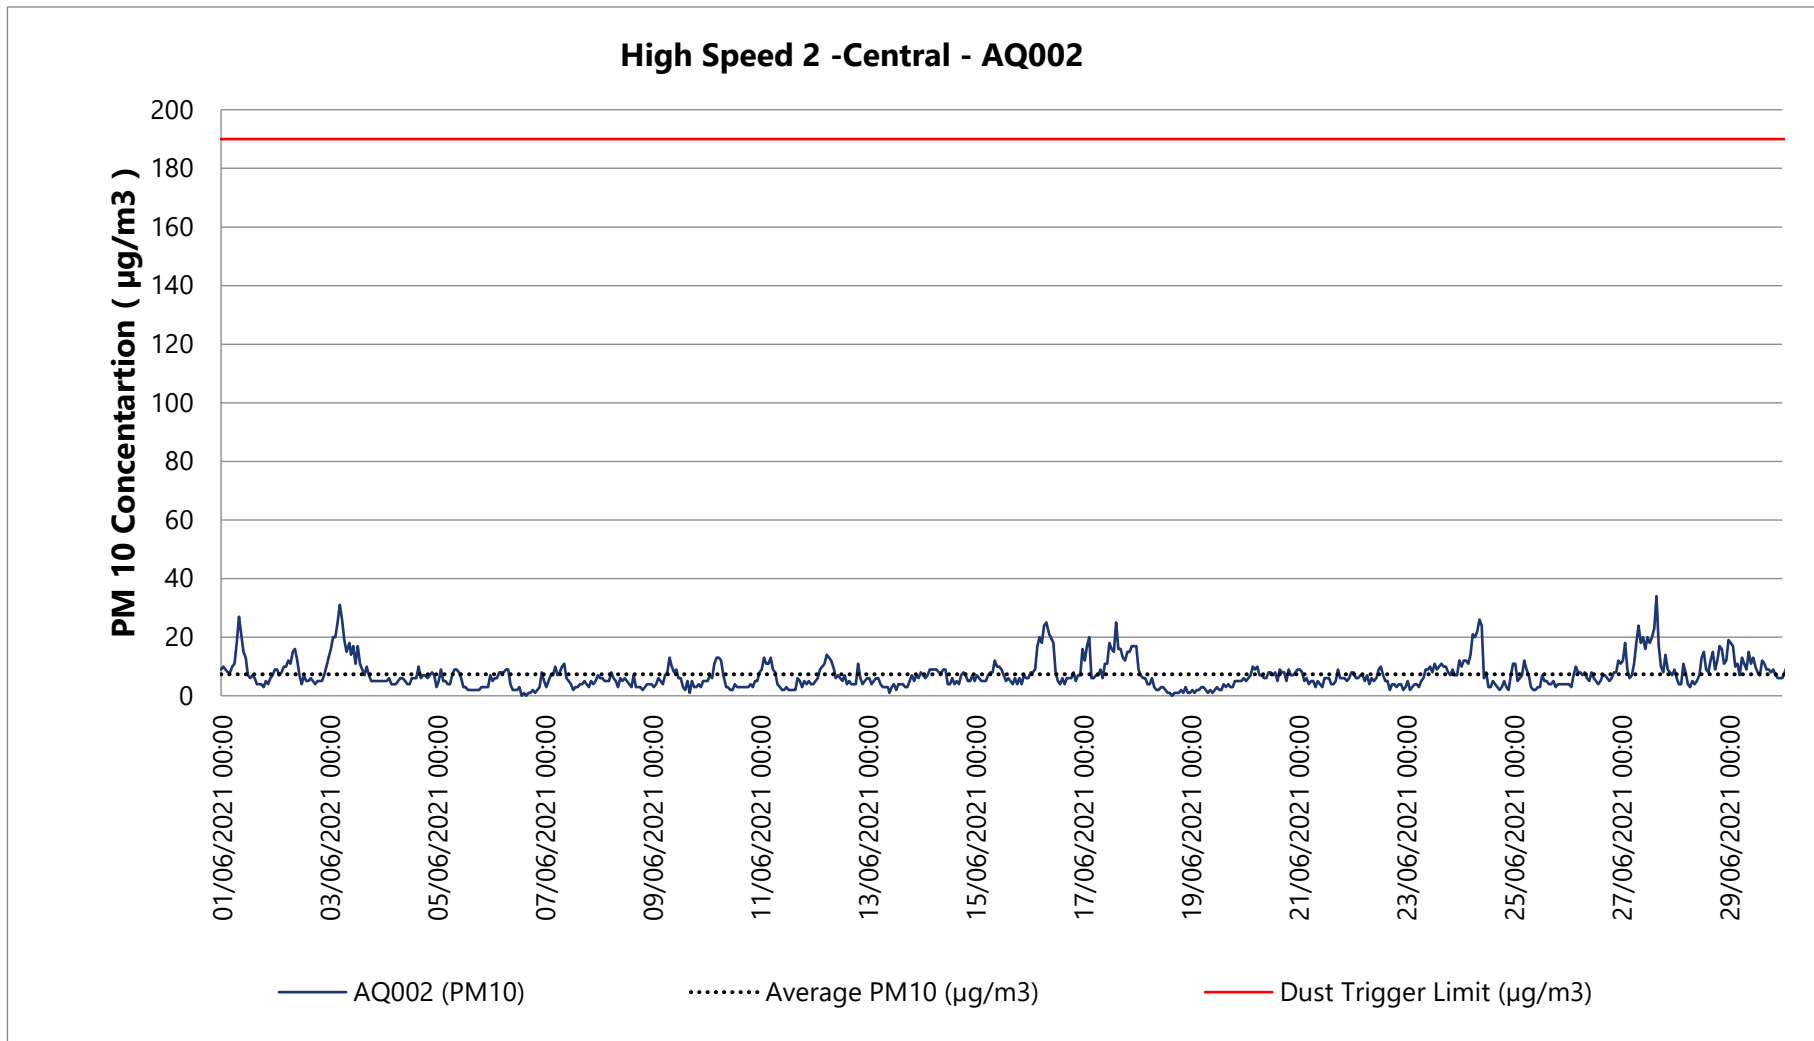
| Monitoring site ID | Coordinates (X,Y) | Location description | Dust risk rating for site | Monitoring site active during period | Change to site since previous period report | Mean 1-hour PM ₁₀ concentration (µg/m ³) | Minimum 1-hour PM ₁₀ concentration (µg/m ³) | Maximum 1-hour PM ₁₀ concentration (µg/m ³) | Number of 1-hour periods exceeding trigger level of 190 µg/m ³ | Data capture (%) |
|---|---|---|---|---|---|---|--|--|---|---|
| AQ002 | 471654, 221030 | Woodlands Cottage | M | Yes | No | 7.3 | 1 | 34 | 0 | 100.0 |

Figure 20: Continuous dust 1-hour mean indicative PM₁₀ concentration for AQ002 for June 2021

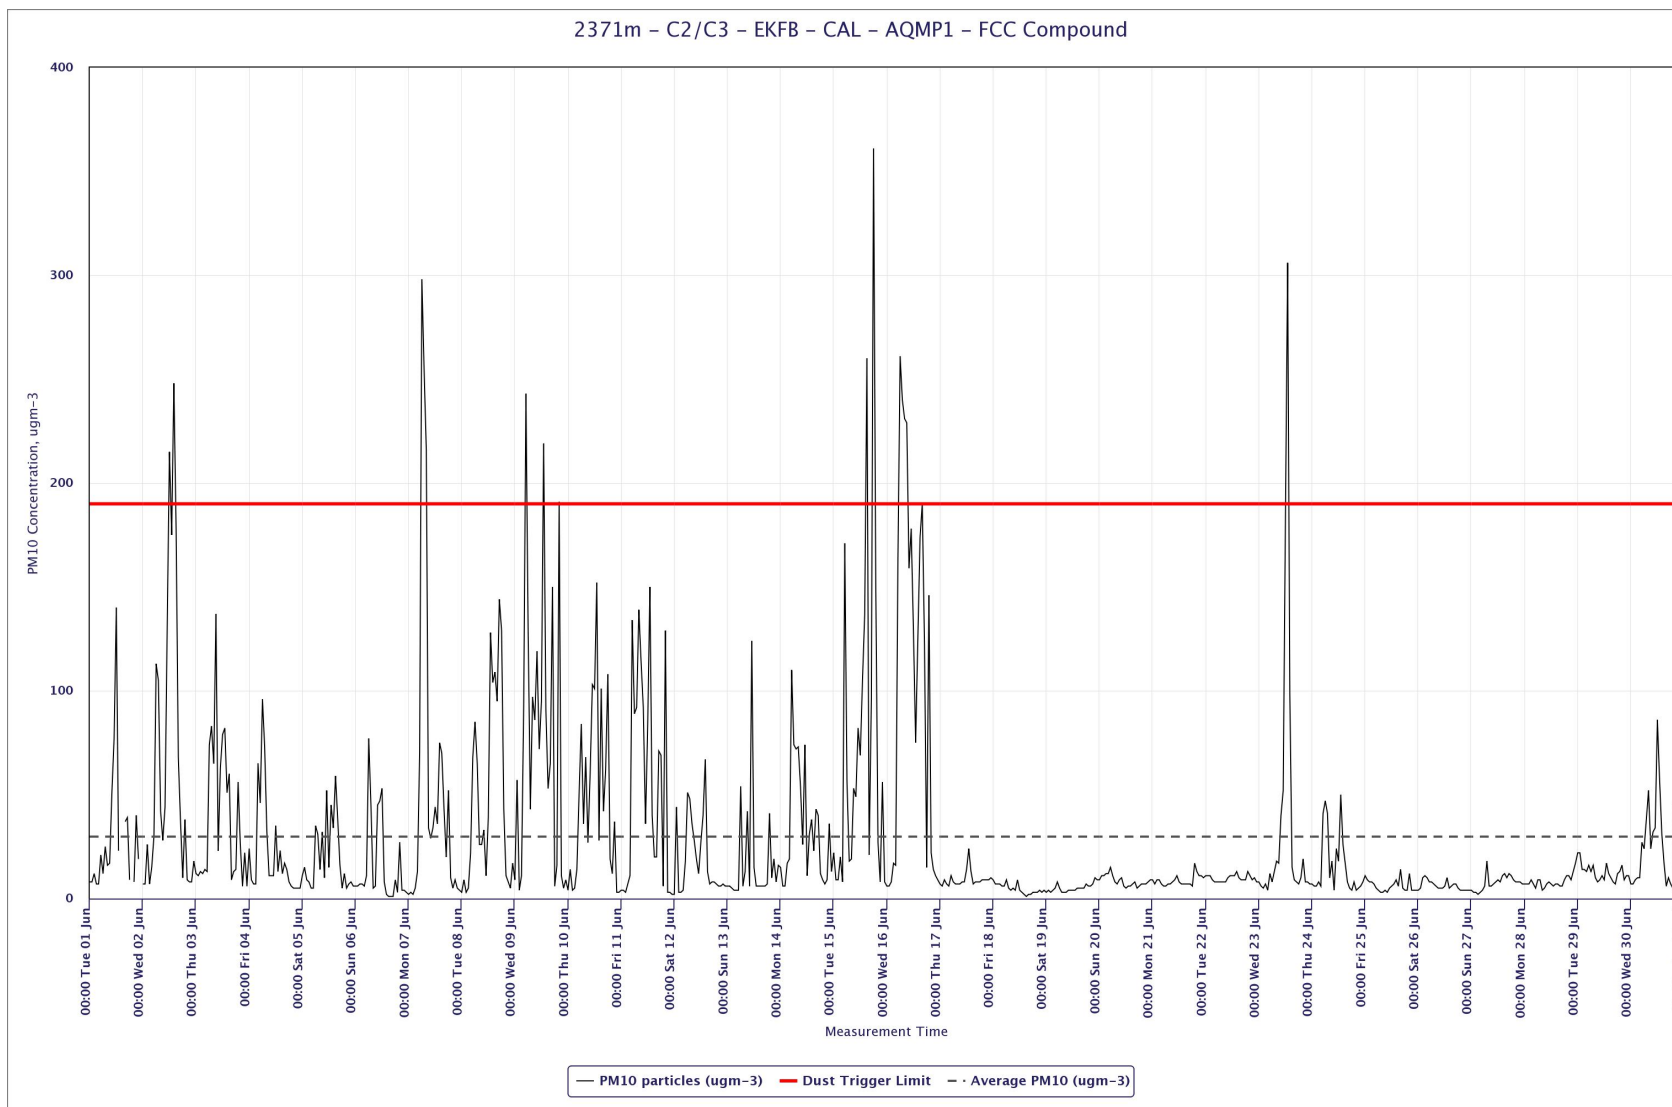
| Monitoring site ID | Coordinates (X,Y) | Location description | Dust risk rating for site | Monitoring site active during period | Change to site since previous period report | Mean 1-hour PM ₁₀ concentration (µg/m ³) | Minimum 1-hour PM ₁₀ concentration (µg/m ³) | Maximum 1-hour PM ₁₀ concentration (µg/m ³) | Number of 1-hour periods exceeding trigger level of 190 µg/m ³ | Data capture (%) |
|---|---|---|---|---|---|---|--|--|---|---|
| CAL-AQMP1 | 469040, 224261 | Adjacent Red Kite View, Calvert | M | Yes | Yes | 29.8 | 1.0 | 360.8 | 16 | 99.3 |

| Monitoring site ID | Period exceeding trigger alert and concentration recorded | Investigation | Outcomes / Resolution / Remedial measures implemented |
|---|--|--|---|
| CAL-AQMP1 | 02/06/2021 12:00 – 13:00; 215.0 µg/m ³ 14:00 – 15:00; 248.0 µg/m ³ | At the time of the triggers, there were no dust generating activities being undertaken by EKFB. | N/A |
| CAL-AQMP1 | 07/06/2021 07:00 – 08:00; 254.7 µg/m ³ 08:00 – 09:00; 216.0 µg/m ³ | At the time of the triggers, there were no dust generating activities being undertaken by EKFB. | N/A |

| Monitoring site ID | Period exceeding trigger alert and concentration recorded | Investigation | Outcomes / Resolution / Remedial measures implemented |
|---|--|---|---|
| CAL-AQMP1 | 15/06/2021 15:00 – 16:00; 260.0 µg/m ³ | At the time of the triggers, there were no dust generating activities being undertaken by EKFB. | N/A |
| CAL-AQMP1 | 16/06/2021 07:00 – 08:00; 240.2 µg/m ³ 08:00 – 09:00; 231.5 µg/m ³ 09:00 – 10:00; 228.6 µg/m ³ 16:00 – 17:00; 190.4 µg/m ³ 13:00 – 14:00; 306.0 µg/m ³ | At the time of the triggers, there were no dust generating activities being undertaken by EKFB. | N/A |

Figure 21: Continuous dust 1-hour mean indicative PM₁₀ concentration for CAL-AQMP1 for June 2021

| Monitoring site ID | Period exceeding trigger alert and concentration recorded | Investigation | Outcomes / Resolution / Remedial measures implemented |
|---|--|--|---|
| CAL-AQMP1 | 07/06/2021 06:00 – 07:00; 298.0 µg/m ³ | Outside of site working hours | Good housekeeping practices continue to be implemented across the site. |
| CAL-AQMP1 | 09/06/2021 05:00 – 06:00; 243.3 µg/m ³ 20:00 – 21:00; 190.8 µg/m ³ | Outside of site working hours | Good housekeeping practices continue to be implemented across the site. |

| Monitoring site ID | Period exceeding trigger alert and concentration recorded | Investigation | Outcomes / Resolution / Remedial measures implemented |
|---|--|---|---|
| CAL-AQMP1 | 15/06/2021 18:00 – 19:00; 360.8 µg/m ³ 06:00 – 07:00; 260.9 µg/m ³ | Outside of site working hours | Good housekeeping practices continue to be implemented across the site. |

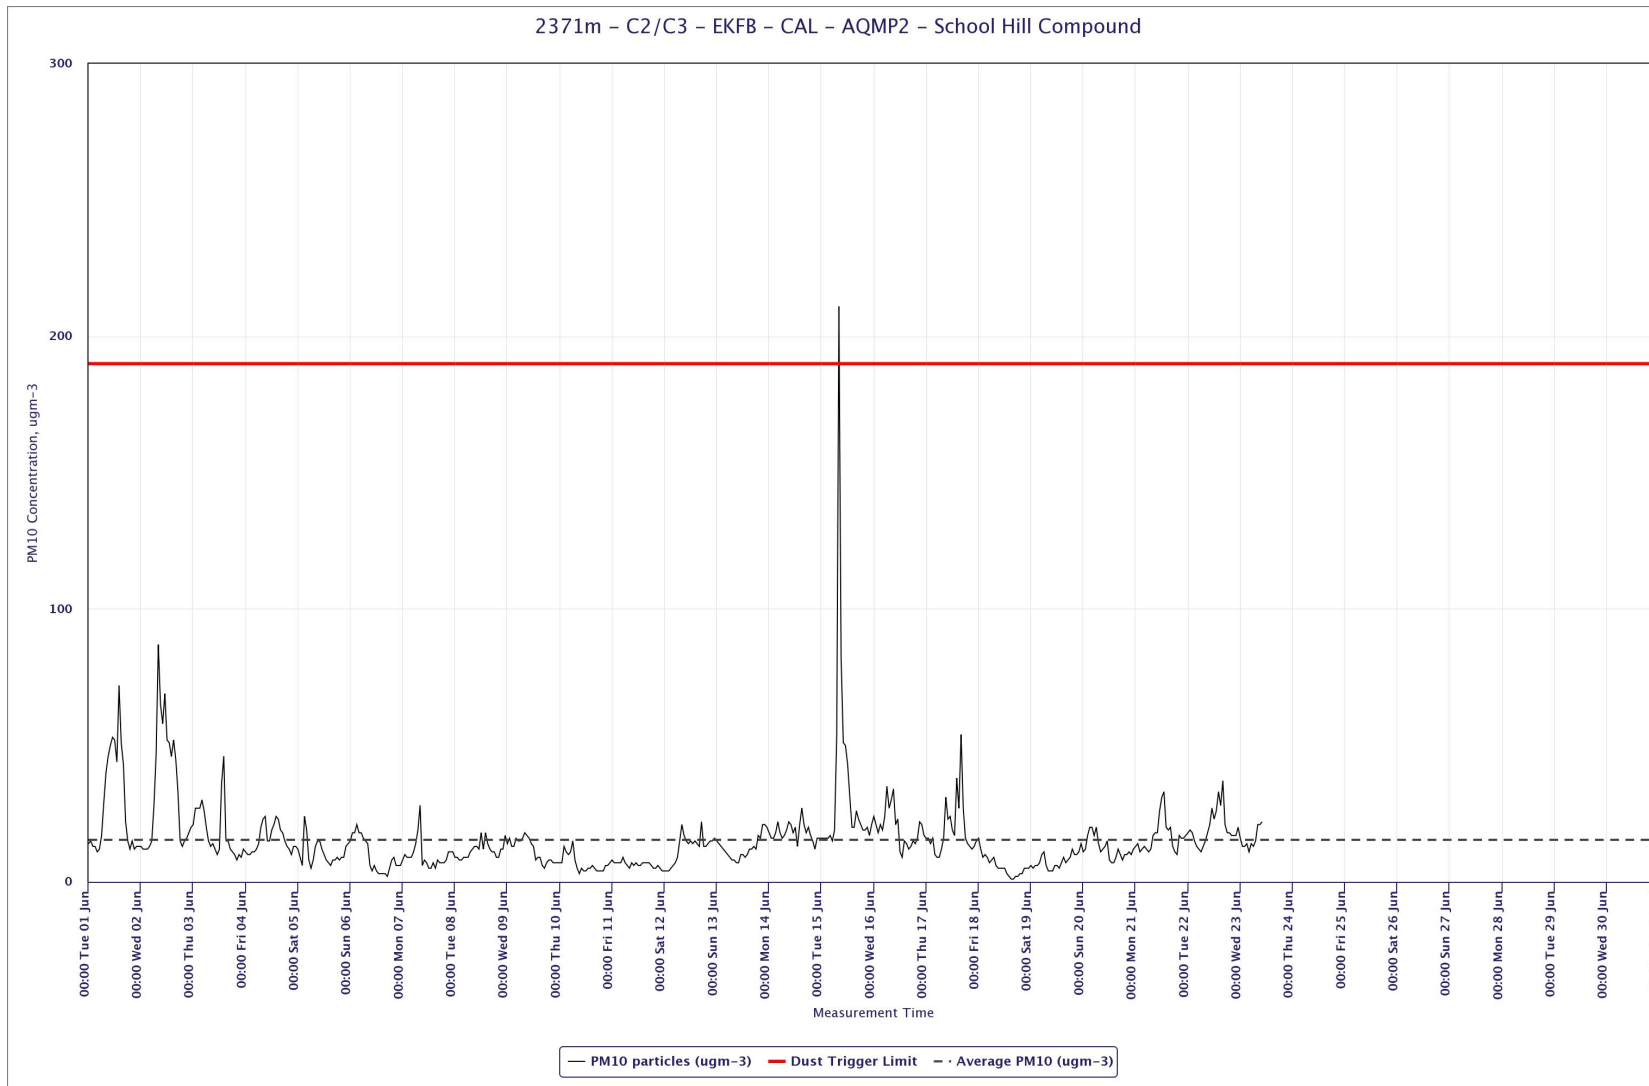
1.1.9 Data capture for various monitors was below 90% for the month of June 2021. The data losses are due to ongoing power interruptions, including loss of solar and battery power caused by a lack of sunlight, and loss of mains power supply, which have since been resolved. Missing data for monitor CAL-AQMP2 was due to a fault with the monitor that is under investigation.

| Monitoring site ID | Coordinates (X,Y) | Location description | Dust risk rating for site | Monitoring site active during period | Change to site since previous period report | Mean 1-hour PM ₁₀ concentration (µg/m ³) | Minimum 1-hour PM ₁₀ concentration (µg/m ³) | Maximum 1-hour PM ₁₀ concentration (µg/m ³) | Number of 1-hour periods exceeding trigger level of 190 µg/m ³ | Data capture (%) |
|---|---|---|---|---|---|---|--|--|---|---|
| CAL-AQMP2 | 469003, 224740 | School Hill Compound | M | Yes | Yes | 15.4 | 1.2 | 210.6 | 1 | 74.9 |

| Monitoring site ID | Period exceeding trigger alert and concentration recorded | Investigation | Outcomes / Resolution / Remedial measures implemented |
|---|--|---|---|
| CAL-AQMP2 | 15/06/2021 08:00 – 09:00 210.6 µg/m ³ | The monitor location is currently positioned behind the welfare cabins on the compound perimeter. At the time of the trigger alert, there were no dust generating activities being undertaken by EKFB. | Mitigation measures set out in the CoCP continue to be implemented across the site. |

Figure 22: Continuous dust 1-hour mean indicative PM₁₀ concentration for CAL-AQMP2 for June 2021

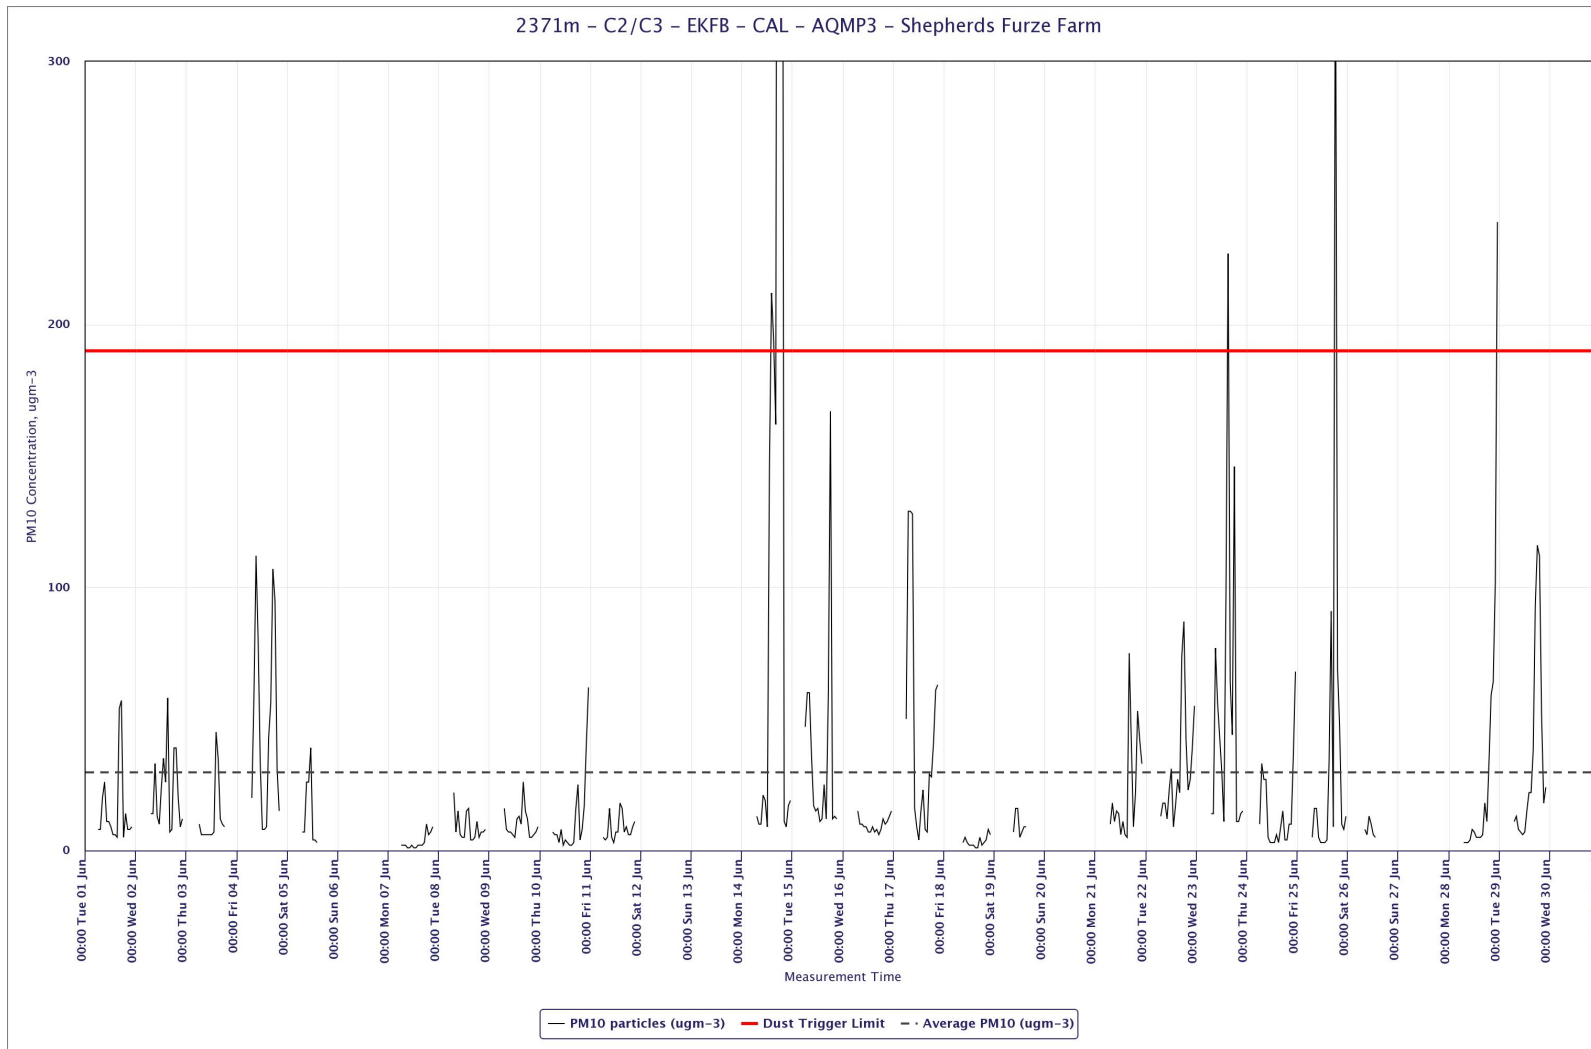
| Monitoring site ID | Coordinates (X,Y) | Location description | Dust risk rating for site | Monitoring site active during period | Change to site since previous period report | Mean 1-hour PM ₁₀ concentration (µg/m ³) | Minimum 1-hour PM ₁₀ concentration (µg/m ³) | Maximum 1-hour PM ₁₀ concentration (µg/m ³) | Number of 1-hour periods exceeding trigger level of 190 µg/m ³ | Data capture (%) |
|---|---|---|---|---|---|---|--|--|---|---|
| CAL-AQMP3 | 468478, 225351 | Shepherds Furze Farm | M | Yes | Yes | 29.7 | 0.7 | 814.2 | 8 | 50.4 |

| Monitoring site ID | Period exceeding trigger alert and concentration recorded | Investigation | Outcomes / Resolution / Remedial measures implemented |
|---|--|--|---|
| CAL-AQMP3 | 14/06/2021 14:00 – 15:00; 211.7 µg/m ³ 15:00 – 16:00; 193 µg/m ³ | At the time of the trigger alert, an aggregate train was offloading material in close proximity to the monitoring location. An inspection was undertaken to determine if dust mitigation measures were effective or whether additional mitigation was required. During the inspection, it was noted that the site team were employing several dust mitigation controls including dampening down aggregate before offloading with water cannons, dampening down of stockpiles with water cannons and s tractor-bowser, discharging aggregate from reduced heights and slowing down the rate of discharge (in line with the CoCP). | Site teams continue to be vigilant in ensuring that dust mitigation measures are deployed across the site, in line with the CoCP. |
| CAL-AQMP3 | 14/06/2021 17:00 – 18:00; 676.3 µg/m ³ 18:00 – 19:00; 814.2 µg/m ³ 19:00 – 20:00; 555.8 µg/m ³ | Outside of site working hours. | Good housekeeping practices continue to be implemented across the site. |

| Monitoring site ID | Period exceeding trigger alert and concentration recorded | Investigation | Outcomes / Resolution / Remedial measures implemented |
|---|--|---|---|
| CAL-AQMP3 | 23/06/2021 15:00 – 16:00; 227.0 µg/m ³ | As per the trigger alert received on the 14/06/2021, at the time of the trigger alert, an aggregate train was offloading material in close proximity to the monitoring location. An inspection was undertaken to determine if dust mitigation measures were effective or whether additional mitigation was required. During the inspection, it was noted that the site team were employing several dust mitigation controls including dampening down aggregate before offloading with water cannons, dampening down of stockpiles with water cannons and a tractor-bowser, discharging aggregate from reduced heights and slowing down the rate of discharge (in line with the CoCP). | Site teams continue to be vigilant in ensuring that dust mitigation measures are deployed across the site, in line with the CoCP. |

Figure 23: Continuous dust 1-hour mean indicative PM₁₀ concentration for CAL-AQMP3 for June 2021

| Monitoring site ID | Period exceeding trigger alert and concentration recorded | Investigation | Outcomes / Resolution / Remedial measures implemented |
|---|--|---|---|
| CAL-AQMP3 | 25/06/2021 18:00 – 19:00; 362.6 µg/m ³ 23:00 – 00:00; 238.5 µg/m ³ | Outside of site working hours | Good housekeeping practices continue to be implemented across the site. |
