Construction noise and vibration Monthly Report – June 2021

Buckinghamshire

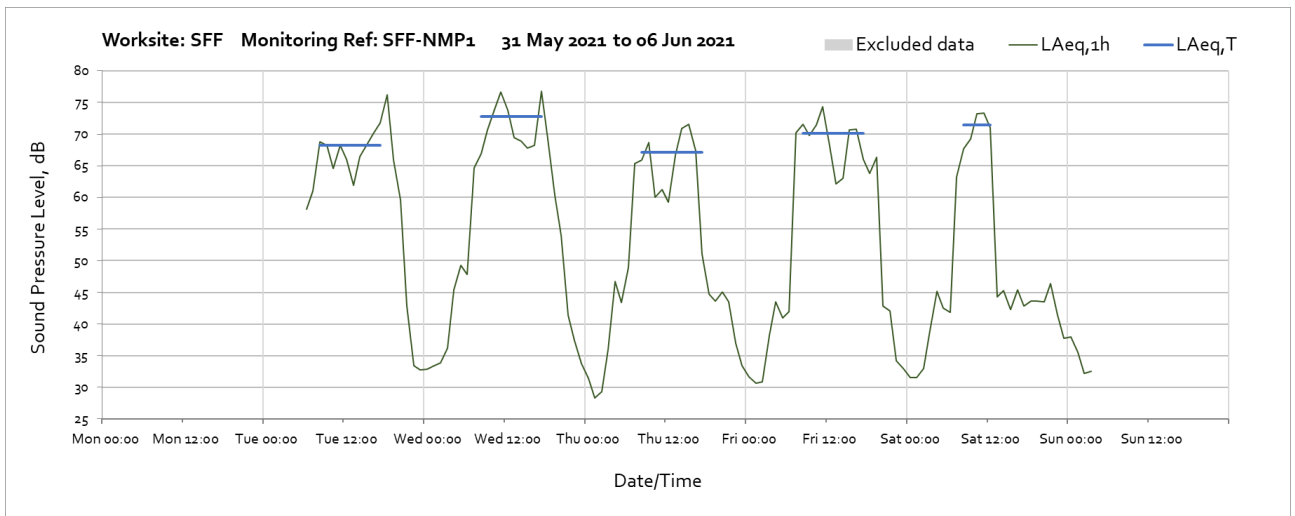
Worksite: SFF – Monitoring Ref: SFF-NMP1

Note: Missing data between 00:00 and 06:00 on Tuesday 1st of June and between 04:00 on Sunday 6th June of June and 07:00 on Monday 7th June was due to loss of continuous site power to the equipment.

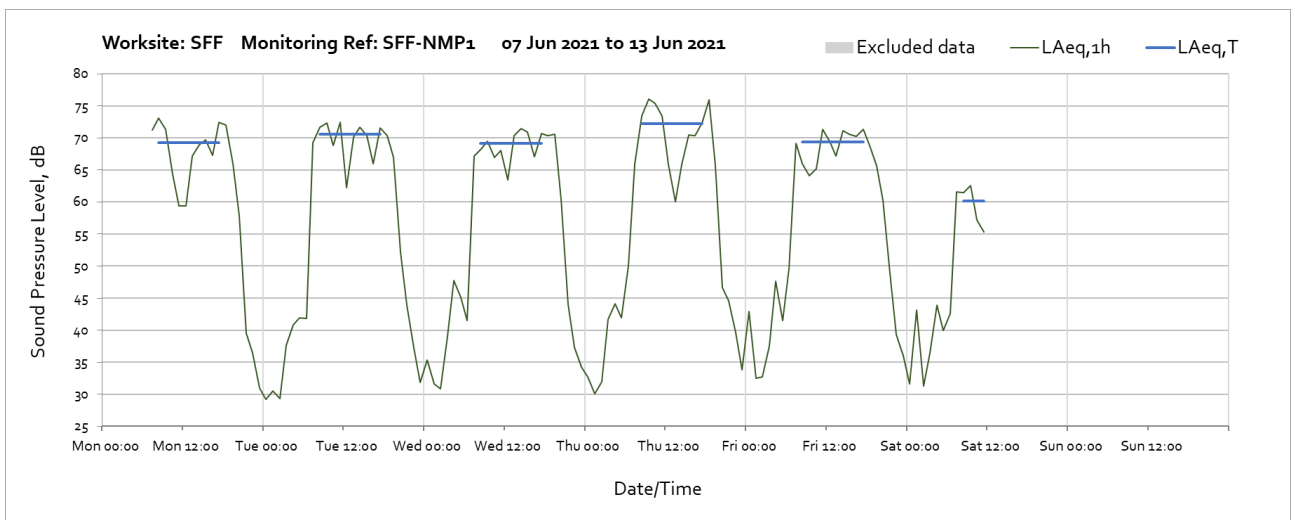
Note: Missing data between 04:00 on Sunday 6th June of June and 07:00 on Monday 7th June and between 12:00 on Saturday 12th of June and 07:00 on Monday 14th of June was due to loss of continuous site power to the equipment.

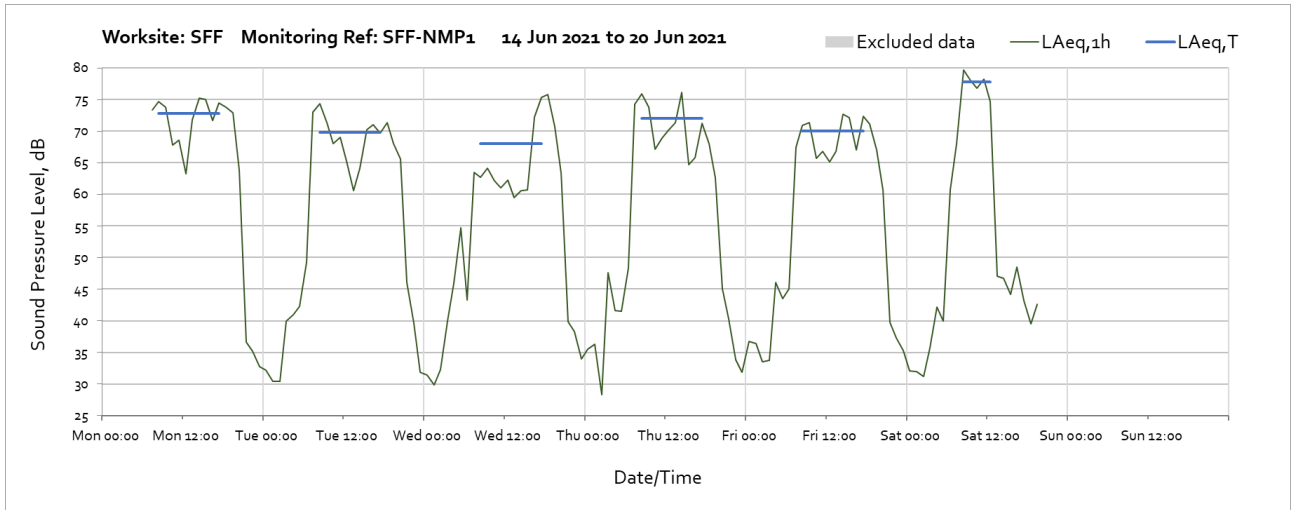
Note: Missing data between 12:00 on Saturday 12th of June and 07:00 on Monday 14th of June and between 20:00 on Saturday 19th of June and 07:00 on Monday 21st of June was due to loss of continuous site power to the equipment.

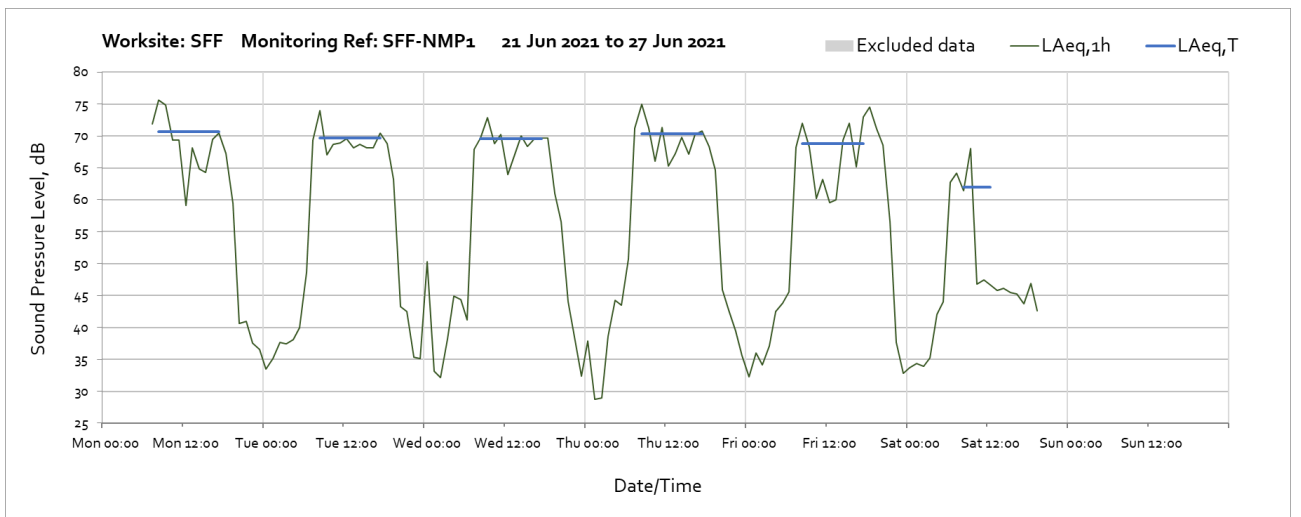
Note: Missing data between 20:00 on Saturday 19th of June and 07:00 on Monday 21st of June and between 20:00 on Saturday 26th of June and 07:00 on Monday 28th of June was due to loss of continuous site power to the equipment.

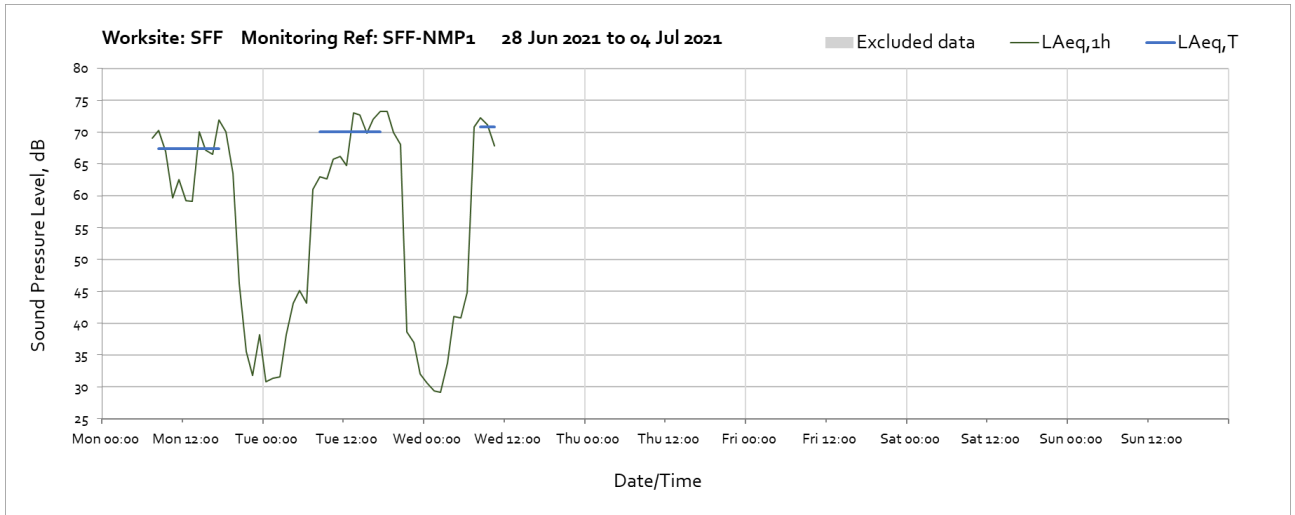
Note: Missing data between 20:00 on Saturday 26th of June and 07:00 on Monday 28th of June and between 11:00 on Wednesday 30th of June and 00:00 on Thursday 1st of July was due to loss of continuous site power to the equipment.

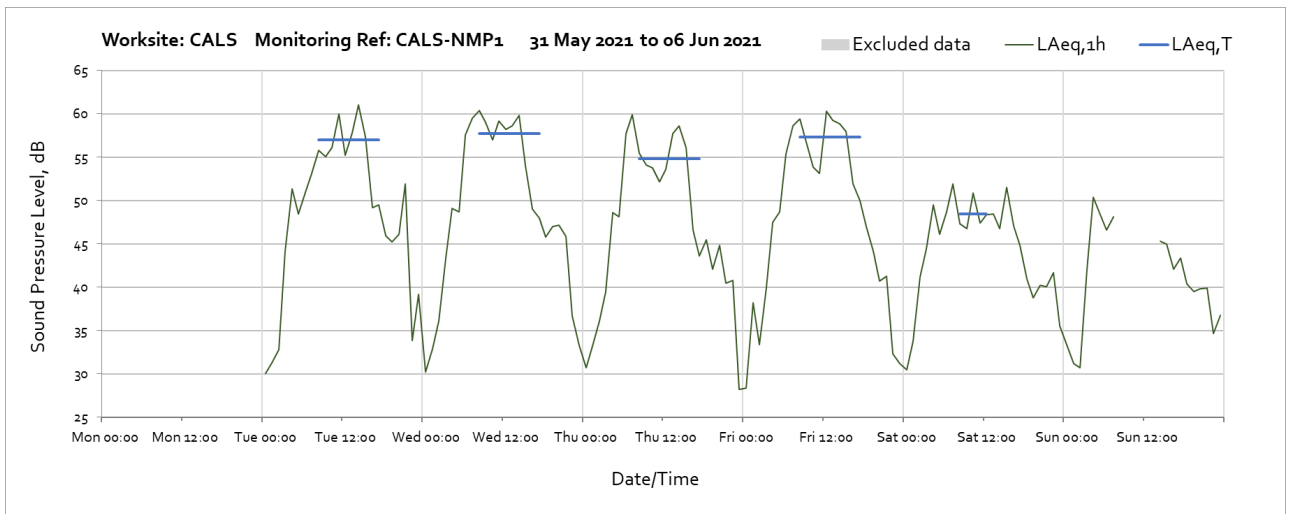
Worksite: CALS – Monitoring Ref: CALS-NMP1

Note: Missing data between 08:00 and 14:00 on Sunday 6th June was due to loss of remote connection to the equipment.

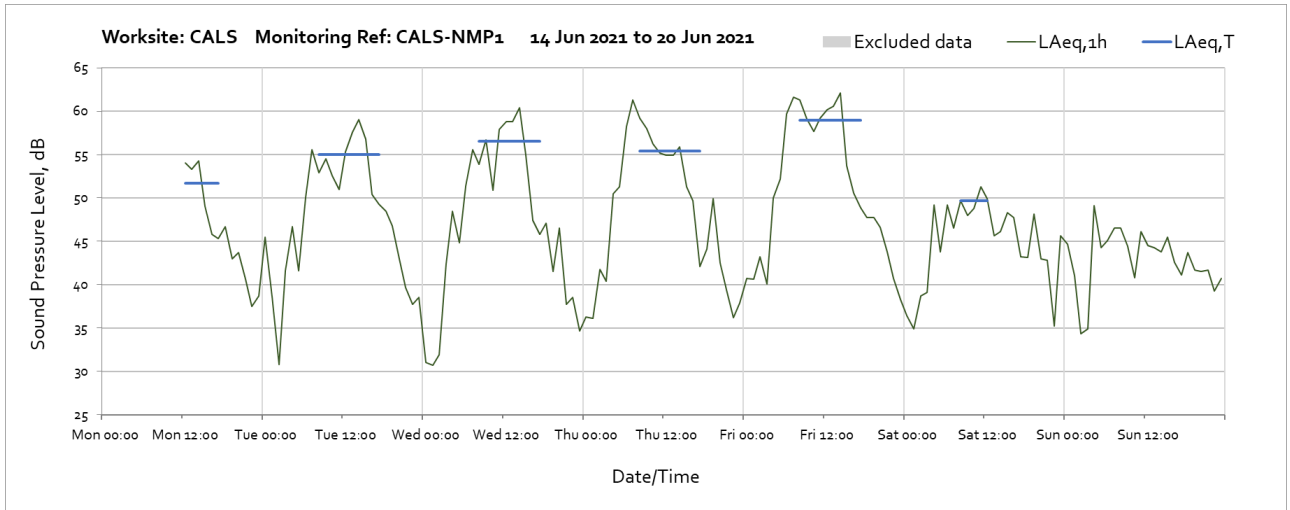
Note: Missing data between 00:00 and 12:00 on Monday 14th June was due to loss of remote connection to the equipment.

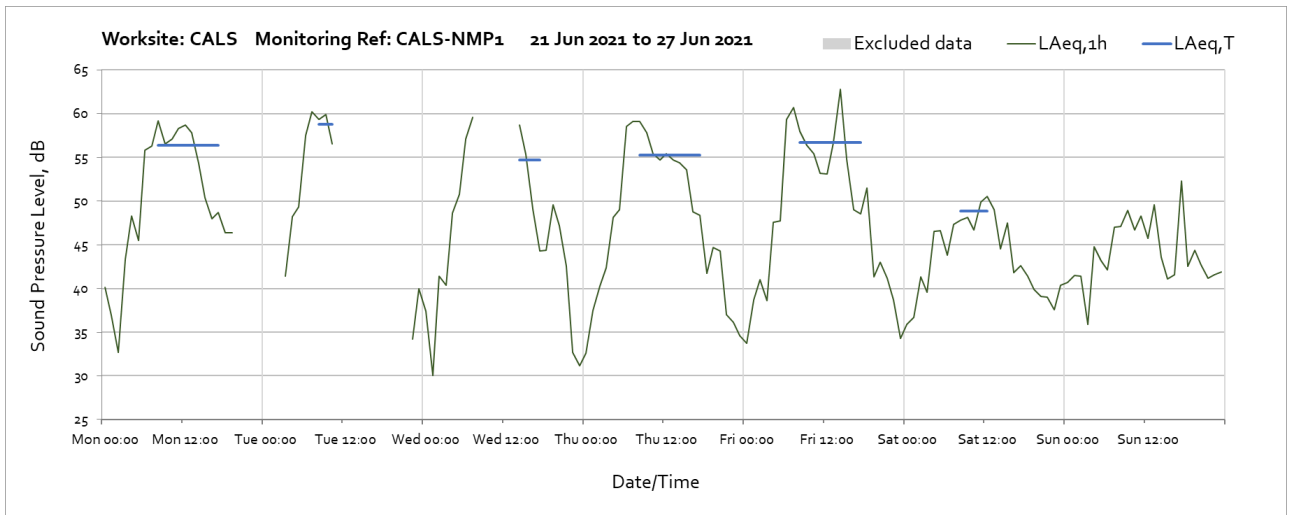
Note: Missing data between 20:00 on Monday 21st June and 03:00 on Tuesday 22nd June, between 11:00 and 20:00 on Tuesday 22nd June, and between 08:00 and 14:00 on Wednesday 23rd June was due to loss of remote connection to the equipment.

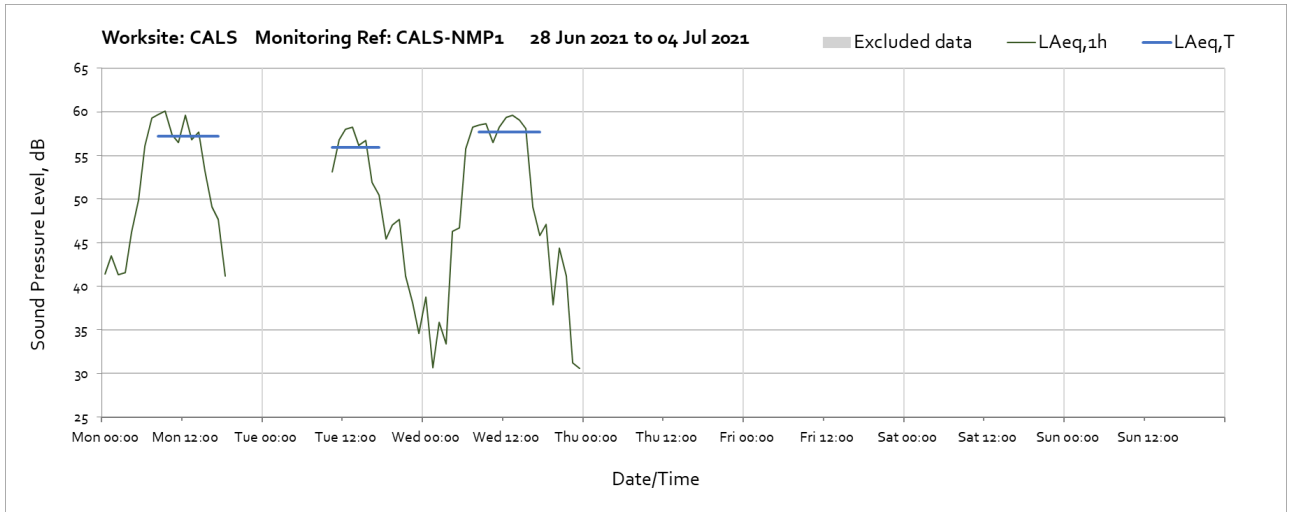
Note: Missing data between 19:00 on Monday 28th June and 10:00 on Tuesday 29th June was due to loss of remote connection to the equipment.

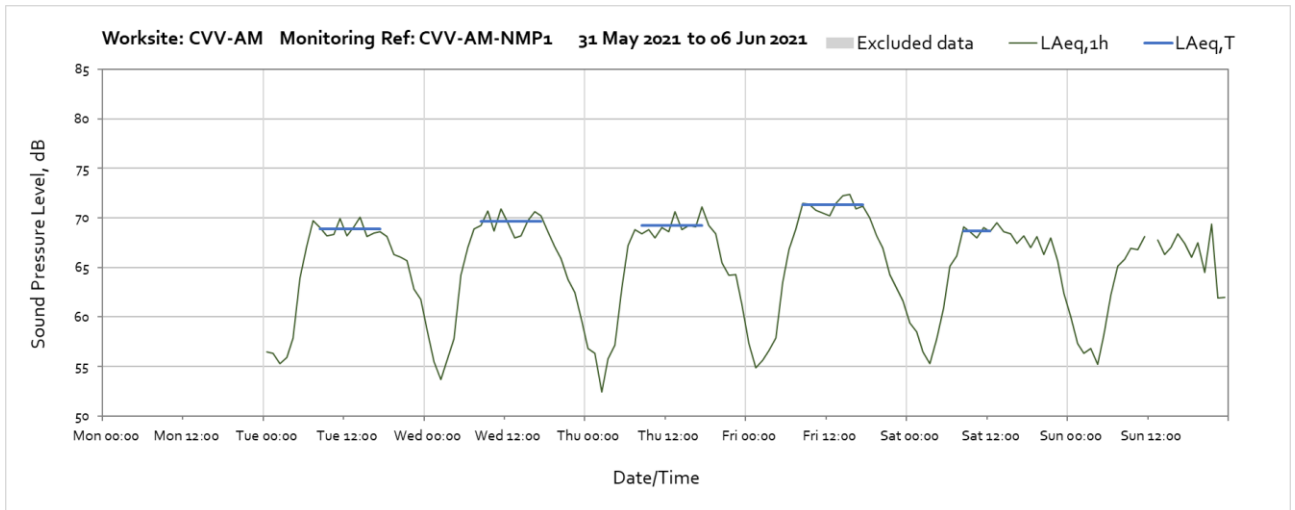
Worksite: AM - Monitoring Ref: AM-NMP1

Note: Missing data between 12:00 and 13:00 on Sunday 6th June is due to monitor connection issues

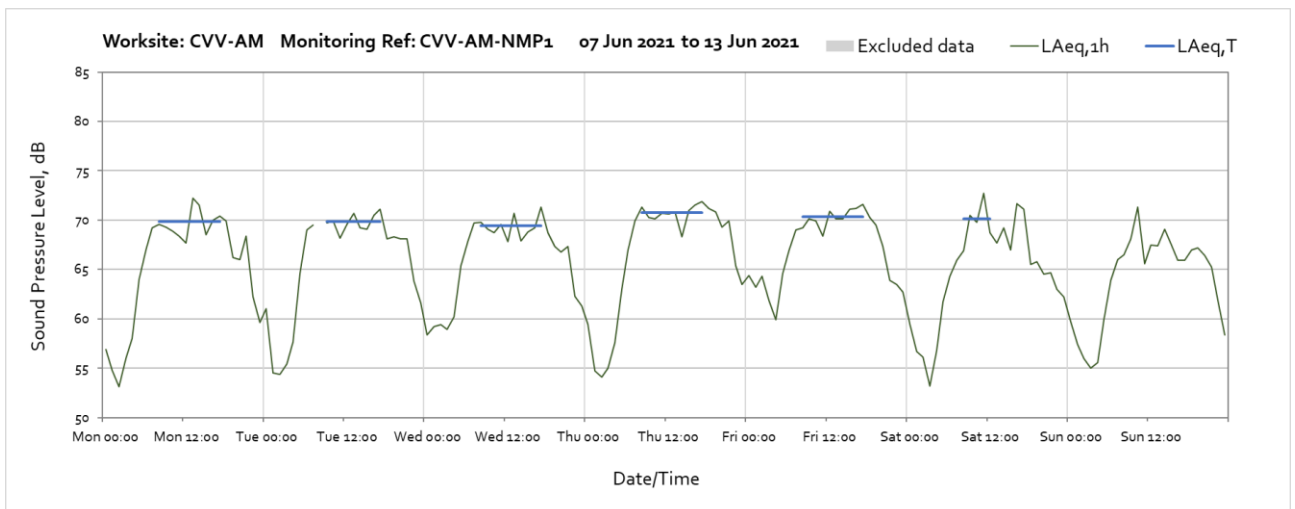
Note: Missing data between 08:00 and 09:00 on Tuesday 8th June is due to the monitoring being paused for setting updates.

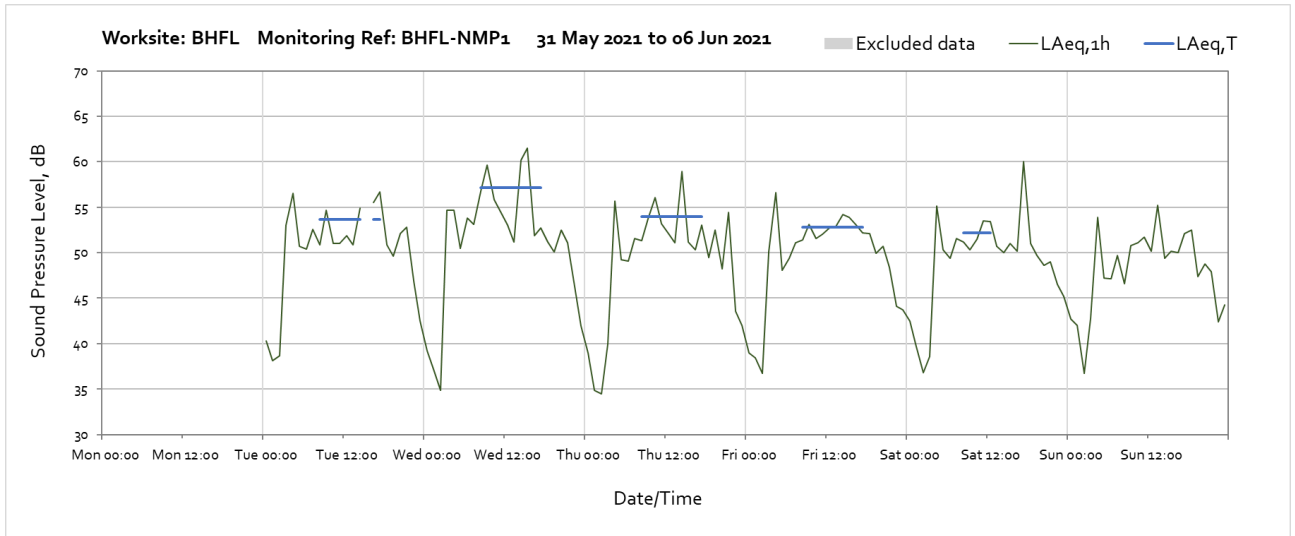
Worksite: BHFL – Monitoring Ref: BHFL-NMP1

Note: Missing data between 15:00 and 16:00 on Tuesday 1st June is due to monitoring equipment changeover.

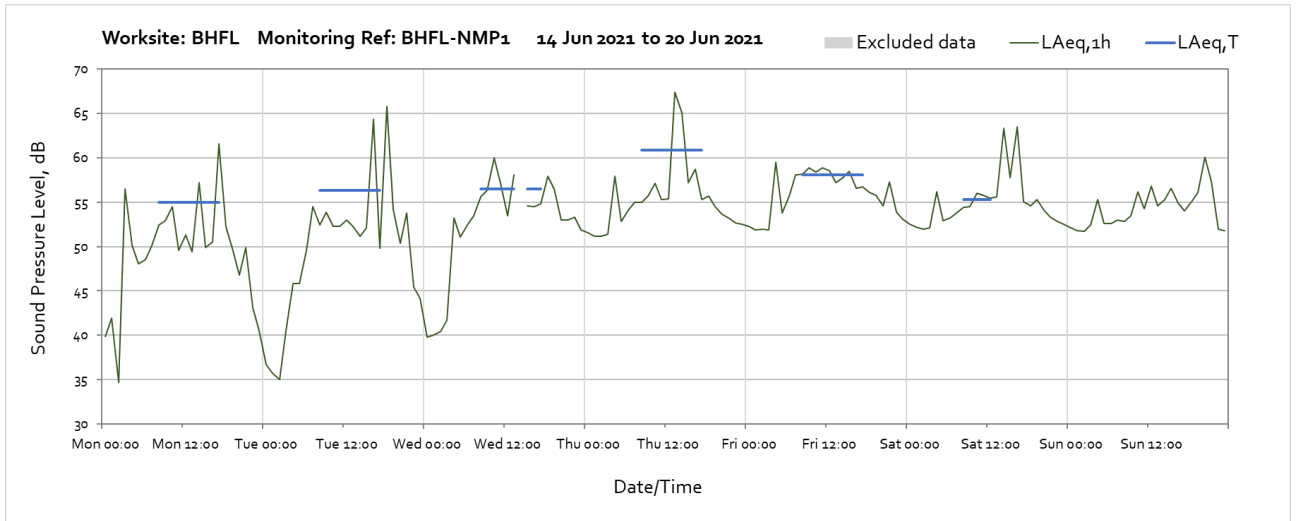
Note: Missing data between 14:00 and 15:00 on Wednesday 16th June is due to monitoring equipment changeover.

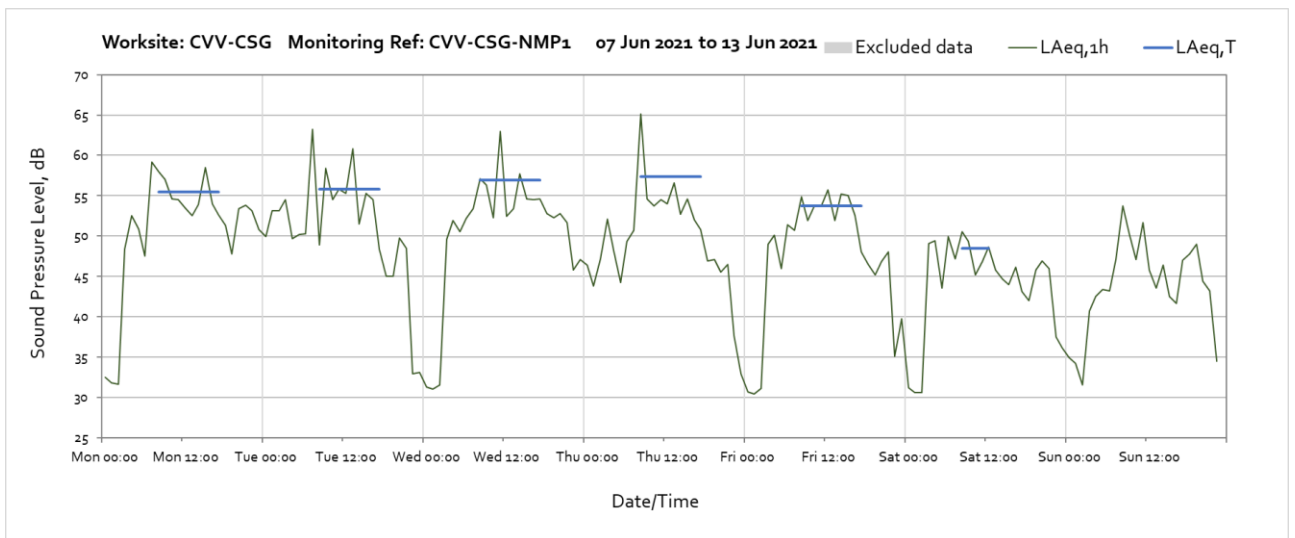
Note: Missing data between 23:00 on Sunday 13th June and 00:00 on Monday 14th June was due to issues with monitor connection.

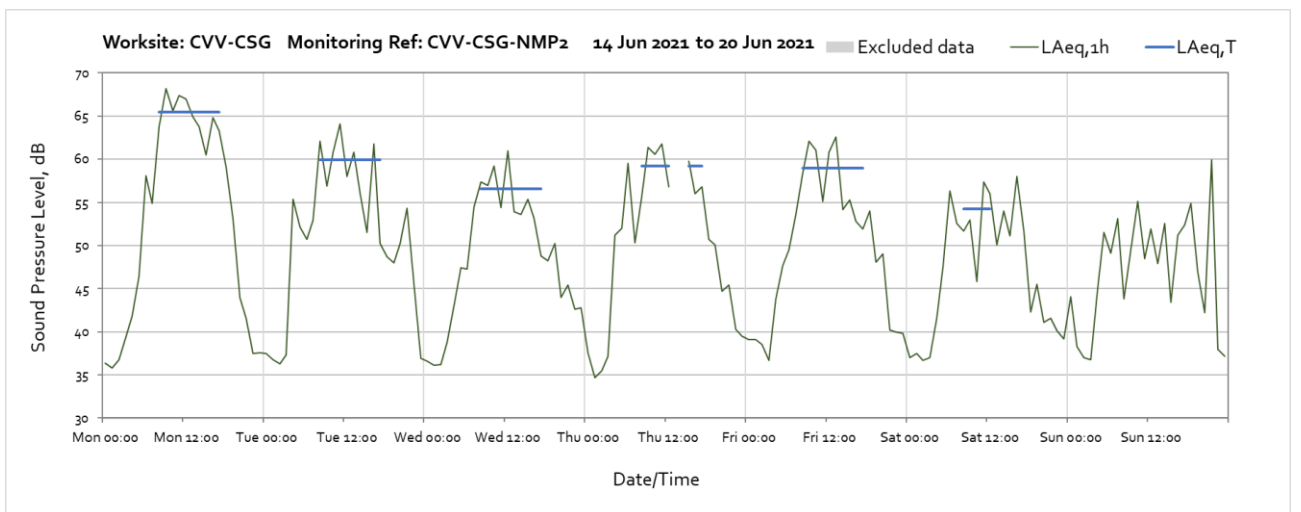
Note: Missing data between 13:00 and 15:00 on Thursday 17th June was due to equipment being paused for setting updates.

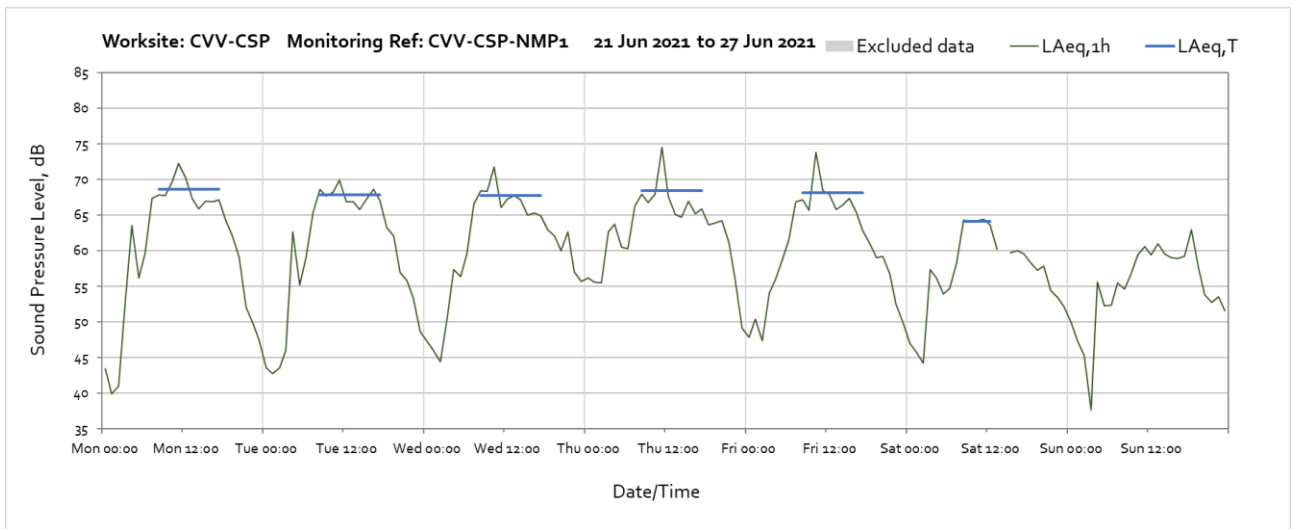
Note: Missing data between 14:00 and 15:00 on Saturday 26th June was due to issues with monitor connection.

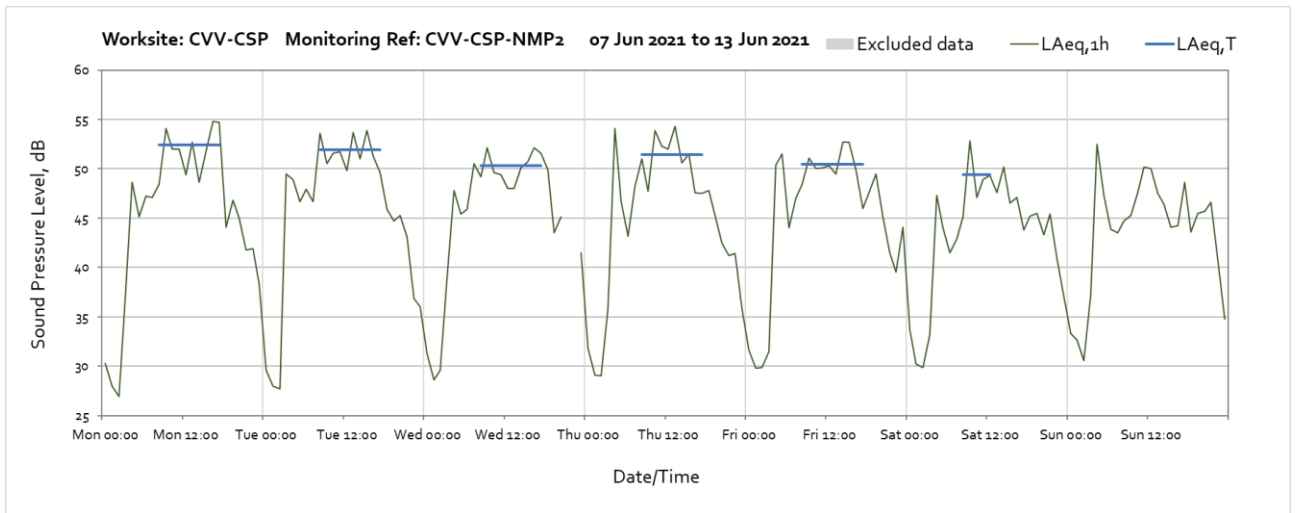
Note: Missing data between 21:00 and 23:00 on Wednesday 9th June was due to issues with monitor connection.

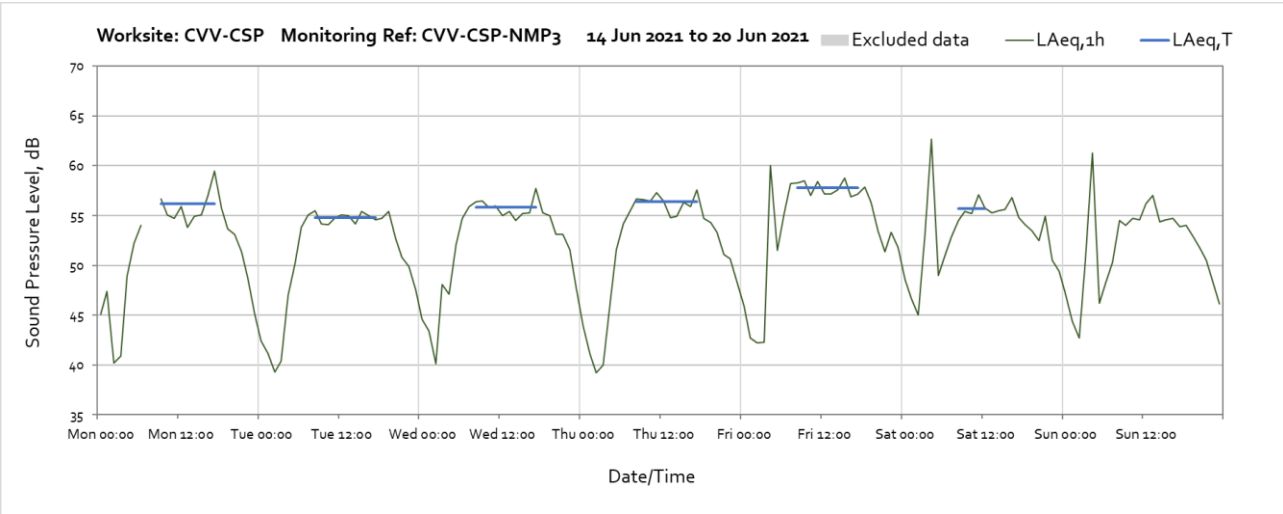
Note: Missing data between 07:00 and 09:00 on Monday 14th June was due to monitor being paused for setting updates.

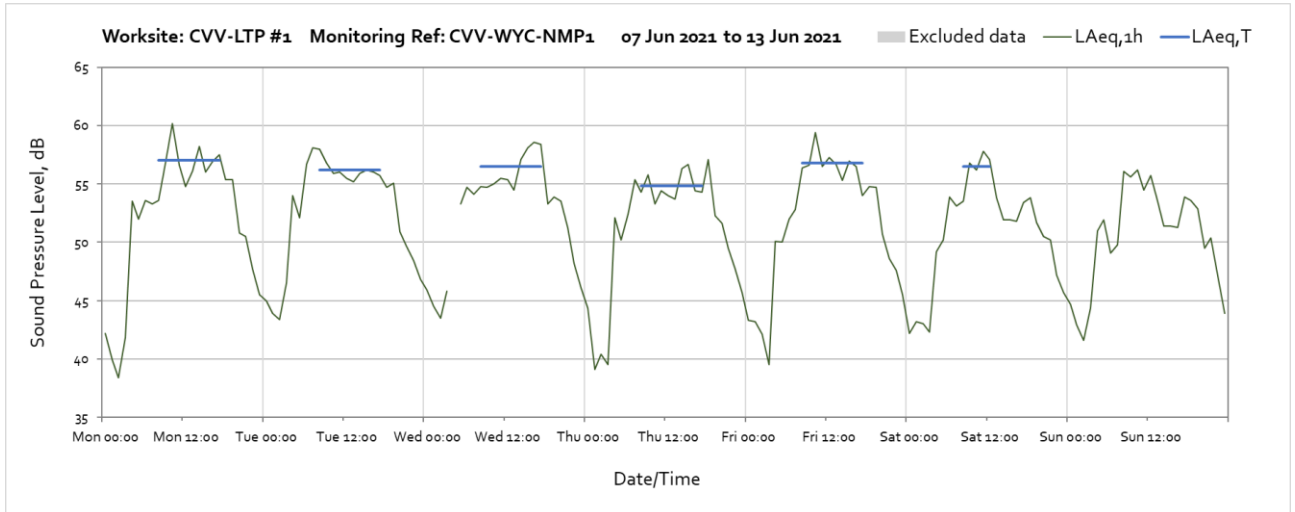
Note: Missing data between 04:00 and 05:00 on Wednesday 9th June was due to issues with monitor connection.

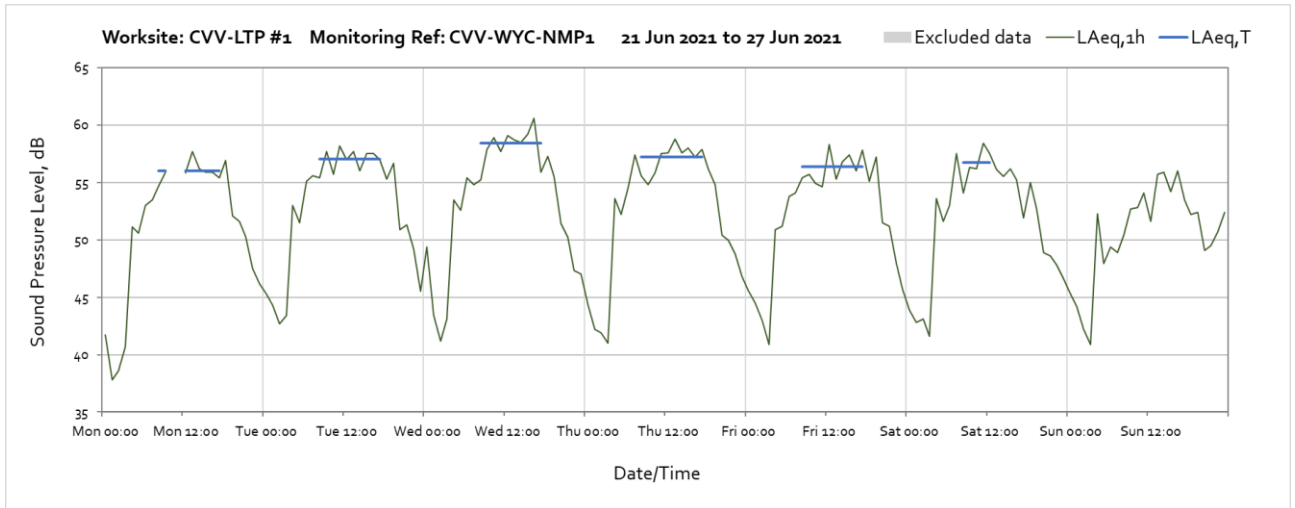
Note: Missing data between 10:00 and 12:00 on Monday 21st June was due to monitor being paused for field calibration.

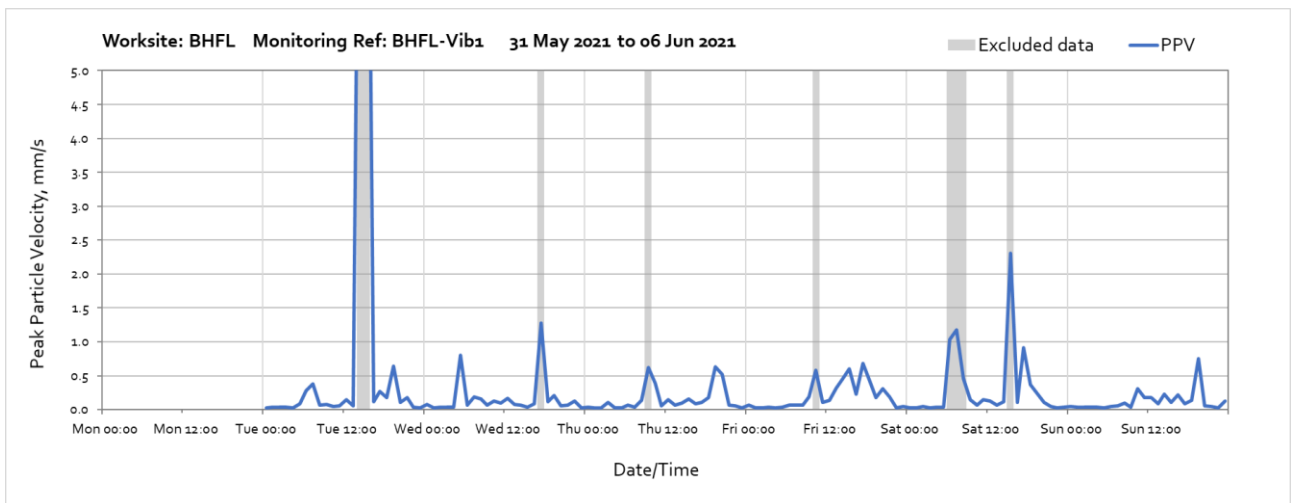
Worksite: BHFL – Monitoring Ref: BHFL-Vib 1

The following graphs show the hourly measured peak particle velocity PPV recorded during the monitoring period. The graphs show the highest PPV of the three orthogonal axes x, y and z. Where high values of PPV were caused by local interference with the vibration monitor, which are not representative of HS2 construction works, these values have been greyed out in the following charts and have been excluded to calculate values in Table 4 of the main report.

Note: High levels of vibration measured between 14:00 and 16:00 on Tuesday 1st June was due to physical disturbance to the monitor during maintenance. High levels of vibration measured throughout the week were due to local disturbance of the monitor and are not representative of HS2 construction vibration levels.
