# Construction noise and vibration Monthly Report – June 2021

**London Borough of Camden**

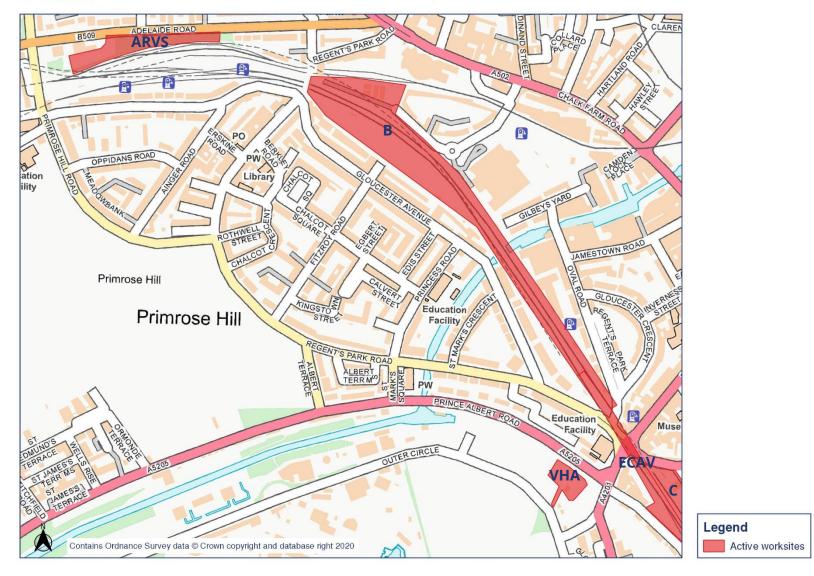
### Worksite identification plan - 1

- ground floor and basement slab demolition.
- Vehicle Holding Area worksite ref.: VHA (see plan 1 in Appendix A), where work activities included:
  - steel fixing of concrete slabs;

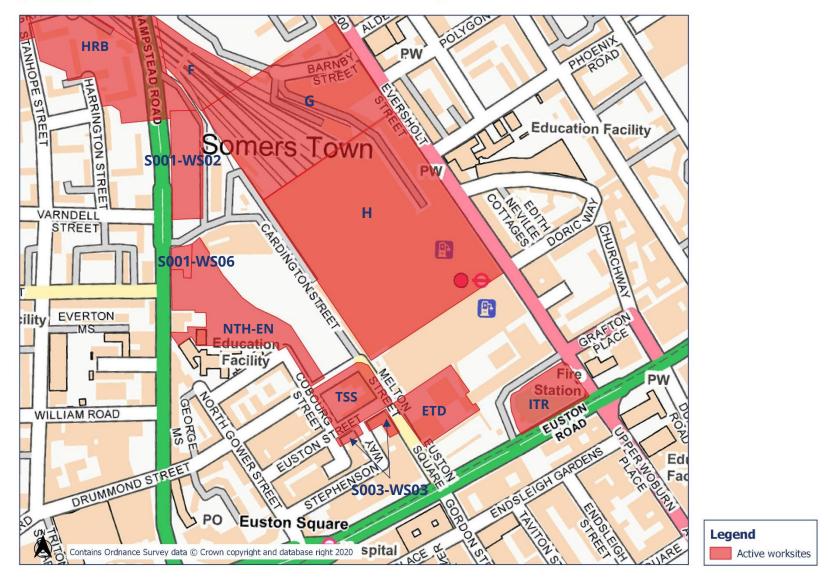
## **Worksite identification plan - 3**

- haul road roadworks
- Hampstead Road Bridge worksite ref.: HRB (see plan 3 in Appendix A), where work activities included:
  - vegetation clearance;
  - wall construction;

- welfare unit fitout works; and
- haul road modification works.
- Euston Cavern worksite ref.: ECAV (see plan 3 in Appendix A), where work activities included:

- On-Network worksites ref.: B, C, D, E, F, G and H (see plan 3 in Appendix A), where work activities included:
  - excavation of trial holes (worksite E);

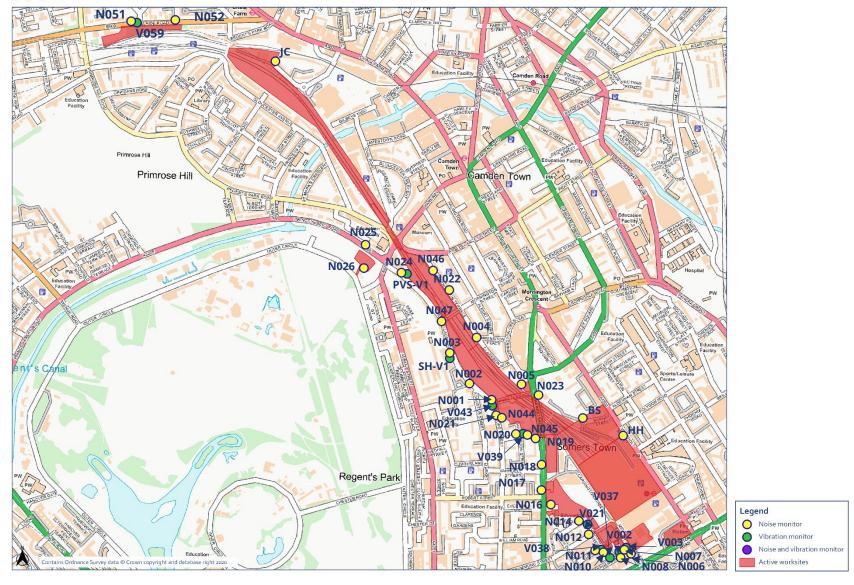
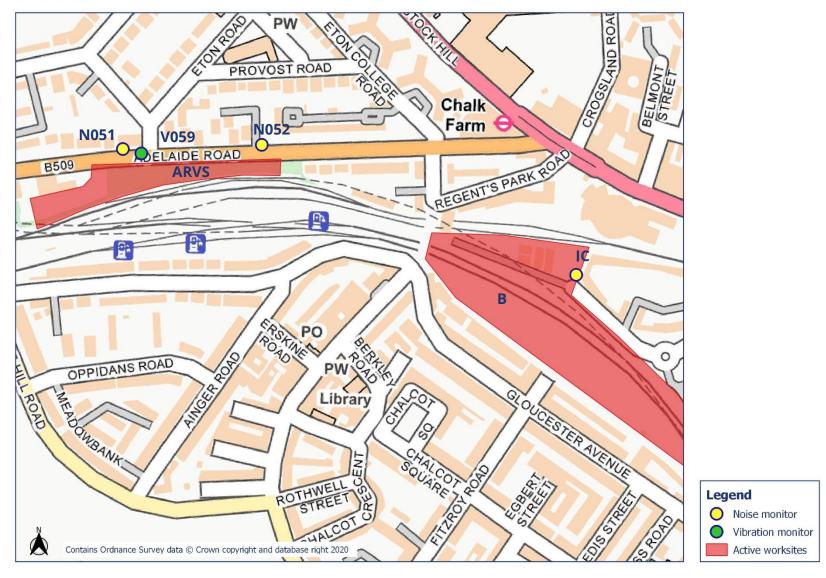
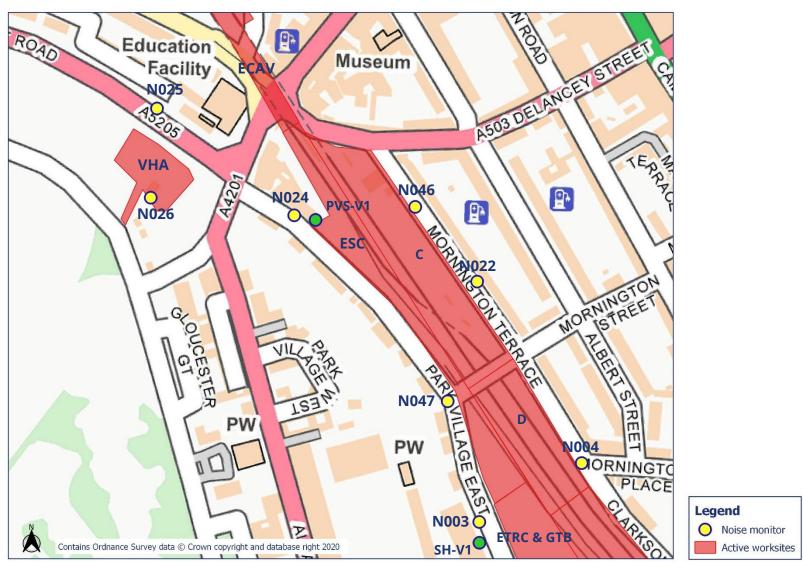
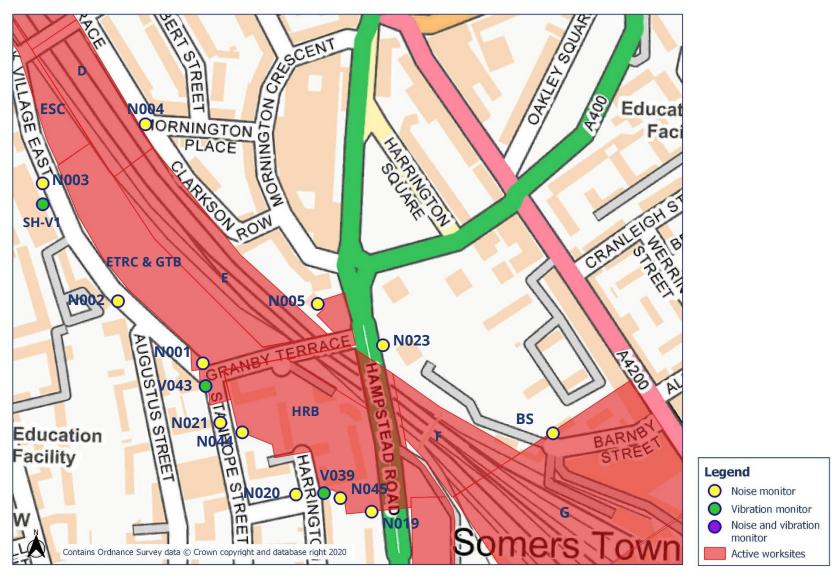
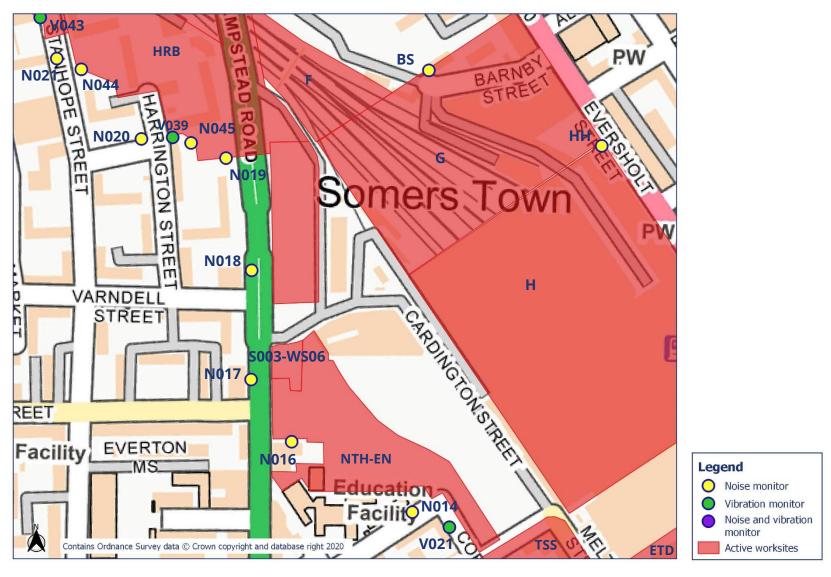
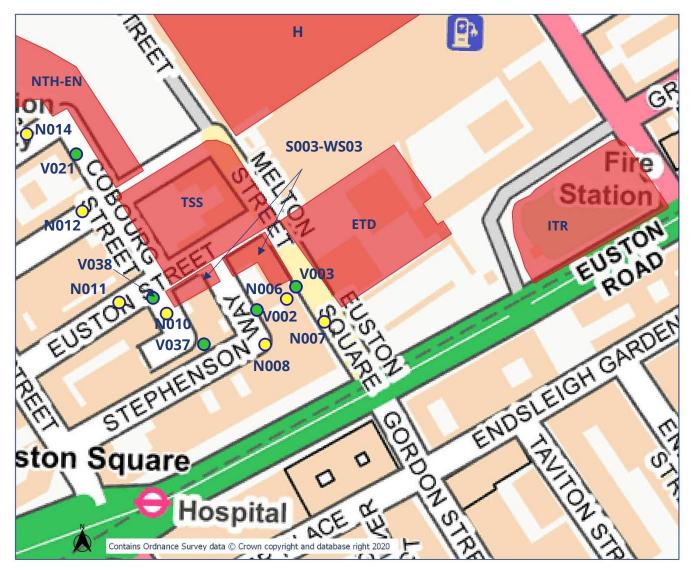
#### Noise and vibration monitoring plan - Overview

- 1.2.1 Thirty-two (32) noise and ten (10) vibration monitoring installations were active across fifteen (15) worksites in June in the LBC area. Table 2 summarises the position of noise and vibration monitoring installations within the LBC area in June 2021.
- 1.2.2 Maps showing the position of noise and vibration monitoring installations are presented in Appendix B.

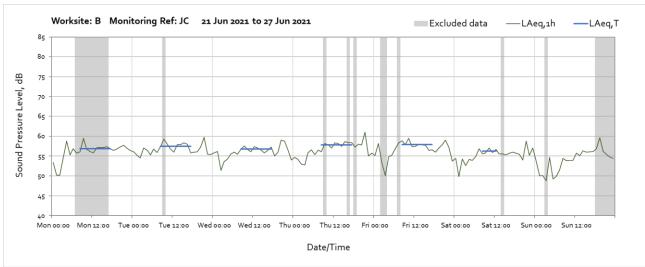
Note: Missing data from 00:00 until 03:00 on Saturday  $5^{th}$  June was due to a monitoring station network connection error.

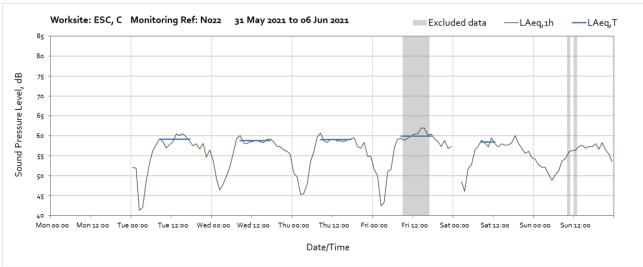
## **Worksite: ESC, C - Monitoring Ref: N022**

Note: Missing data from 00:00 until 02:00 on Saturday 5<sup>th</sup> June a monitoring station network connection error.

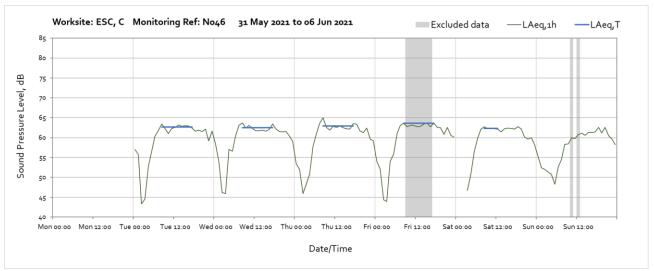
### **Worksite: ESC, C - Monitoring Ref: N046**

Note: Missing data from 00:00 until 03:00 on Saturday  $5^{th}$  June a monitoring station network connection error.

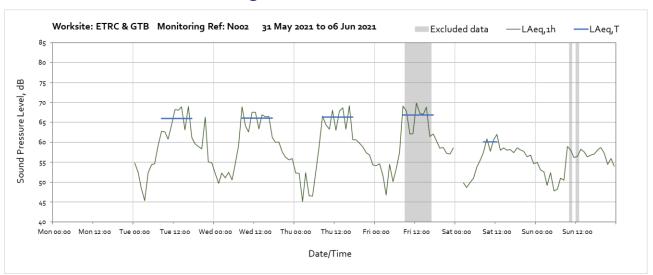
#### Worksite: ETRC & GTB - Monitoring Ref: N002

Note: Missing data from 00:00 until 02:00 on Saturday 5<sup>th</sup> June a monitoring station network connection error.

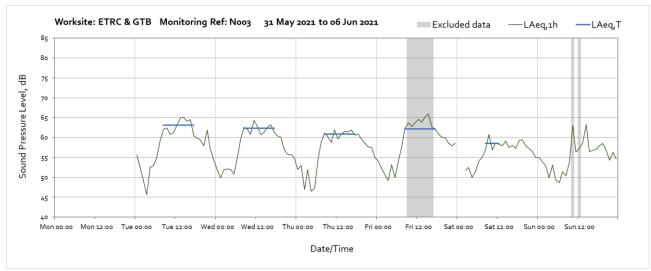
#### **Worksite: ETRC & GTB - Monitoring Ref: N003**

Note: Missing data from 00:00 until 02:00 on Saturday  $5^{th}$  June a monitoring station network connection error.

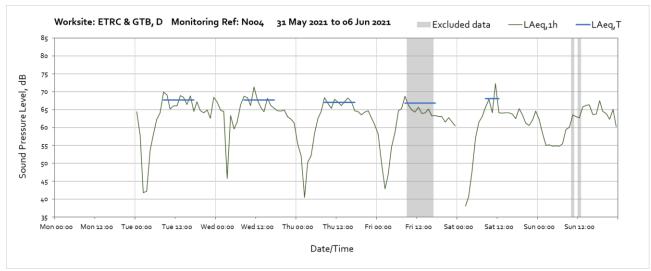
#### Worksite: ETRC & GTB, D - Monitoring Ref: N004

Note: Missing data from 00:00 until 02:00 on Saturday  $5^{th}$  June was due to a monitoring station network connection error.

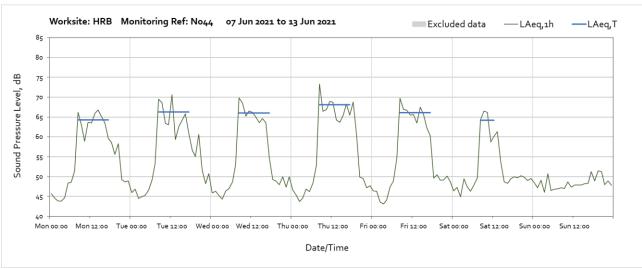
Note: Continuous noise levels from 18:00 on Friday 18<sup>th</sup> June until 07:00 on Monday 21th June were not caused by HS2 construction plant equipment.

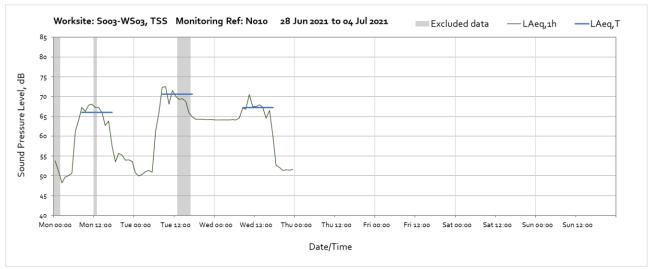
Note: Continuous noise levels measured outside of core construction hours were due to refridgeration plant equipment associated with a nearby hotel and is not associated with HS2 contruction.

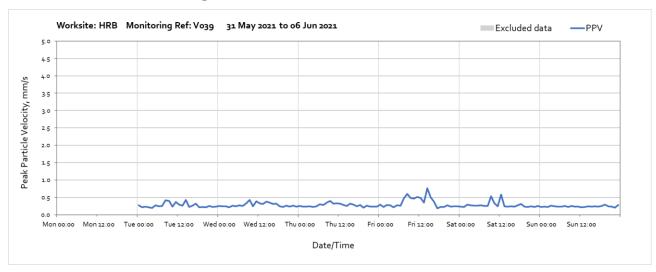
#### **Worksite: HRB - Monitoring Ref: V039**

The following graphs show the hourly measured peak particle velocity PPV recorded during the monitoring period. The graphs show the resultant PPV due to vibration components on three orthogonal axes x, y and z. Where resultant PPV data is not available (monitors V039 and V043), the highest vibration component in either of the three axes is presented for each 1hr measurement period respectively. Where high values of PPV were caused by local interference with the vibration monitor, which are not representative of HS2 construction works, these values have been greyed out in the following charts and have been excluded to calculate values in Table 4 of the main report.

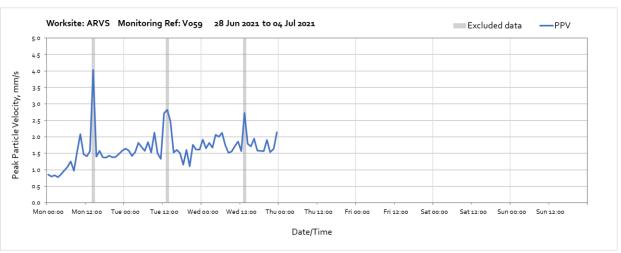
Note: High vibration levels measured throughout the week were due to local intereference of the monitor and are not representative of HS2 vibration levels.
