Markham ST-1 Decommissioning Close Out Report

Document ID:		SPT-DCM-SNS0025-REP-0012	
Document Classification:		PUBLIC	
Document Ownership:		Decommissioning	
Date of Document:	02/08/19	Signature	Date
Prepared by:	S. Axon	DocuSigned by: <i>Simon Axon</i> 60E4ED34127B454...	19/06/21
Reviewed by:	S. Mackenzie	DocuSigned by: <i>Susan Mackenzie</i> C224C94659854FC...	28/6/2021
Approved by:	M. Fotheringham	DocuSigned by: <i>Mark Fotheringham</i> 53863A46368D4A5...	28/6/2021

EXECUTIVE SUMMARY

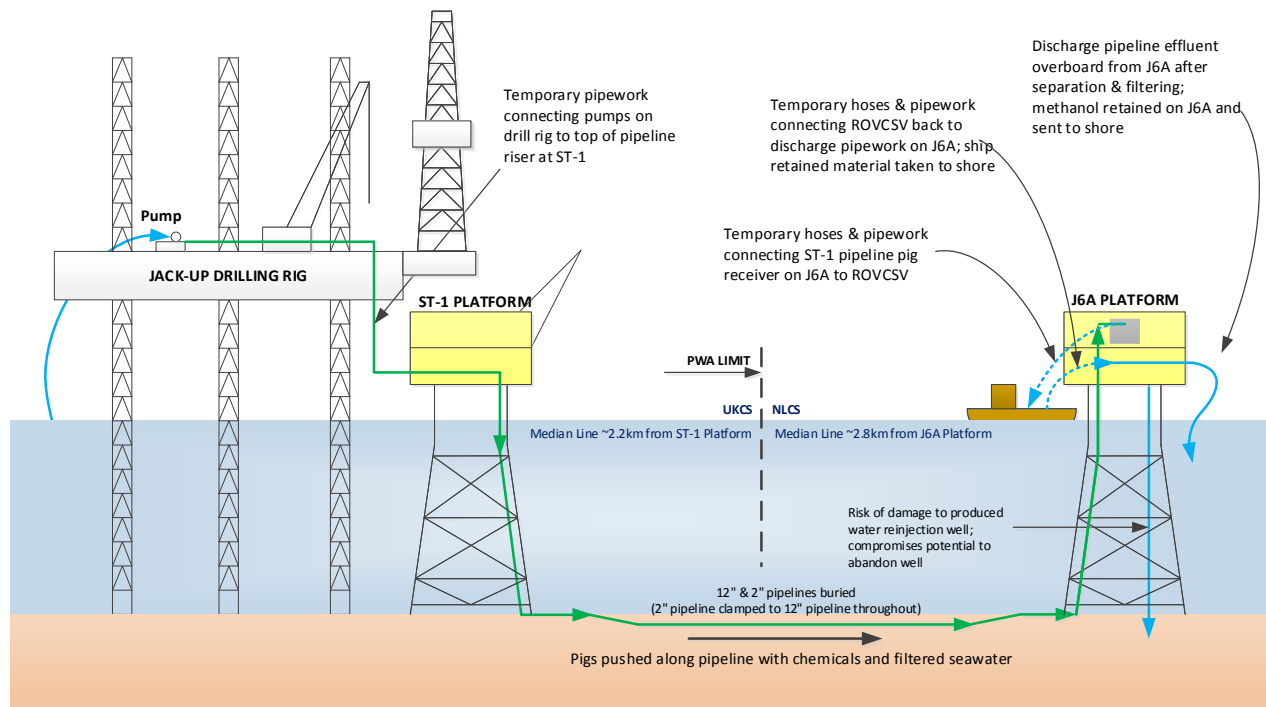
Figure 4.2.1: ST-1 to J6A pipeline flushing arrangement

The filtration spread on the ROVSV was provided by Cetco Energy Services working with Altus Intervention and used several vessels and equipment, including 12x 20m³ tote tanks², filtration units, hydrocarbon coalesce and absorption media, pumps, laboratory, air dryer, and nitrogen gas quads.

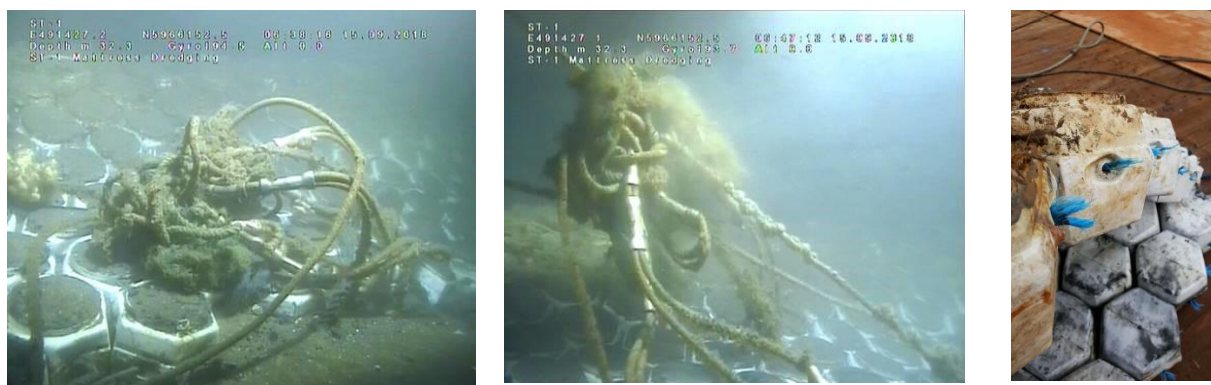
Figure 4.2.3: Concrete mattresses & rigging, failed polypropylene rope

Prior to the removal of the mattresses a survey was carried out using an ROV to confirm the condition and number of mattresses to be removed and their burial status. From this, the mattresses were thought to be in good condition.

Although they were thought to be in good condition, their design was such that the 3.5m long polypropylene lifting loops that had originally been used to install the mattresses disintegrated when being lifted. The polypropylene rope used to bind the concrete blocks in the mattress also disintegrated. Therefore, a contingency measure was used. This involved using a hydraulic grab to recover the mattresses into a basket while any smaller pieces left behind were recovered by ROV to baskets temporarily placed on the seabed. The baskets were recovered to the deck of the ROVSV. Some whole mattresses were successfully placed into the basket, but this was by exception rather than the rule.

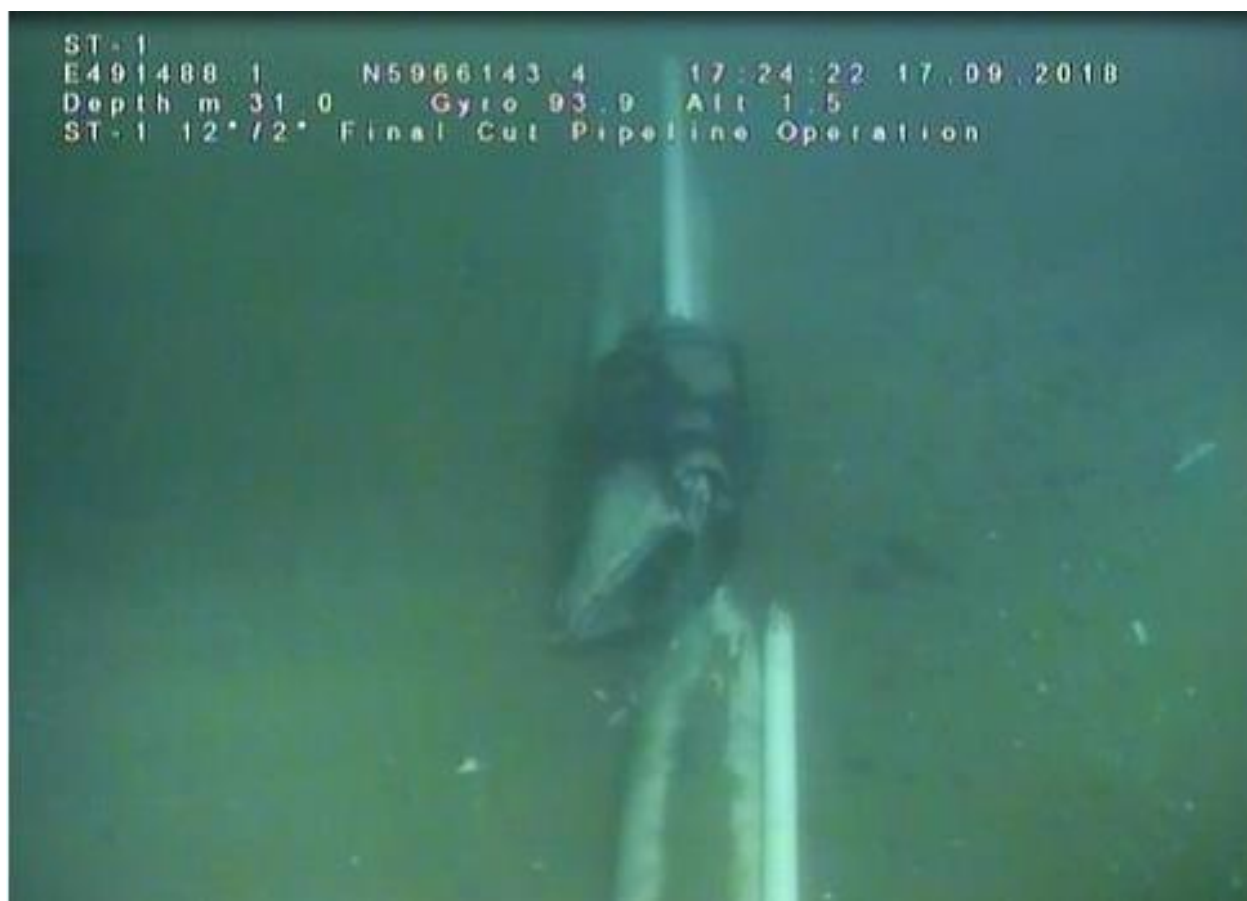
Figure 4.2.4: PL992 & PL993 both severed

Product	Cut Location (UTM)	Cut Location WGS84 Decimal	WGS84 Decimal Minute
PL992 12" pipeline	491490.28 E 5966142.63 N	53.84372695° E 2.870662697° N	53°50.6236' E 2°52.2398' N
PL993 2" Pipeline	491490.28 E 5966142.63 N	53.84372695°E 2.870662697°N	53°50.6236' E 2°52.2398' N

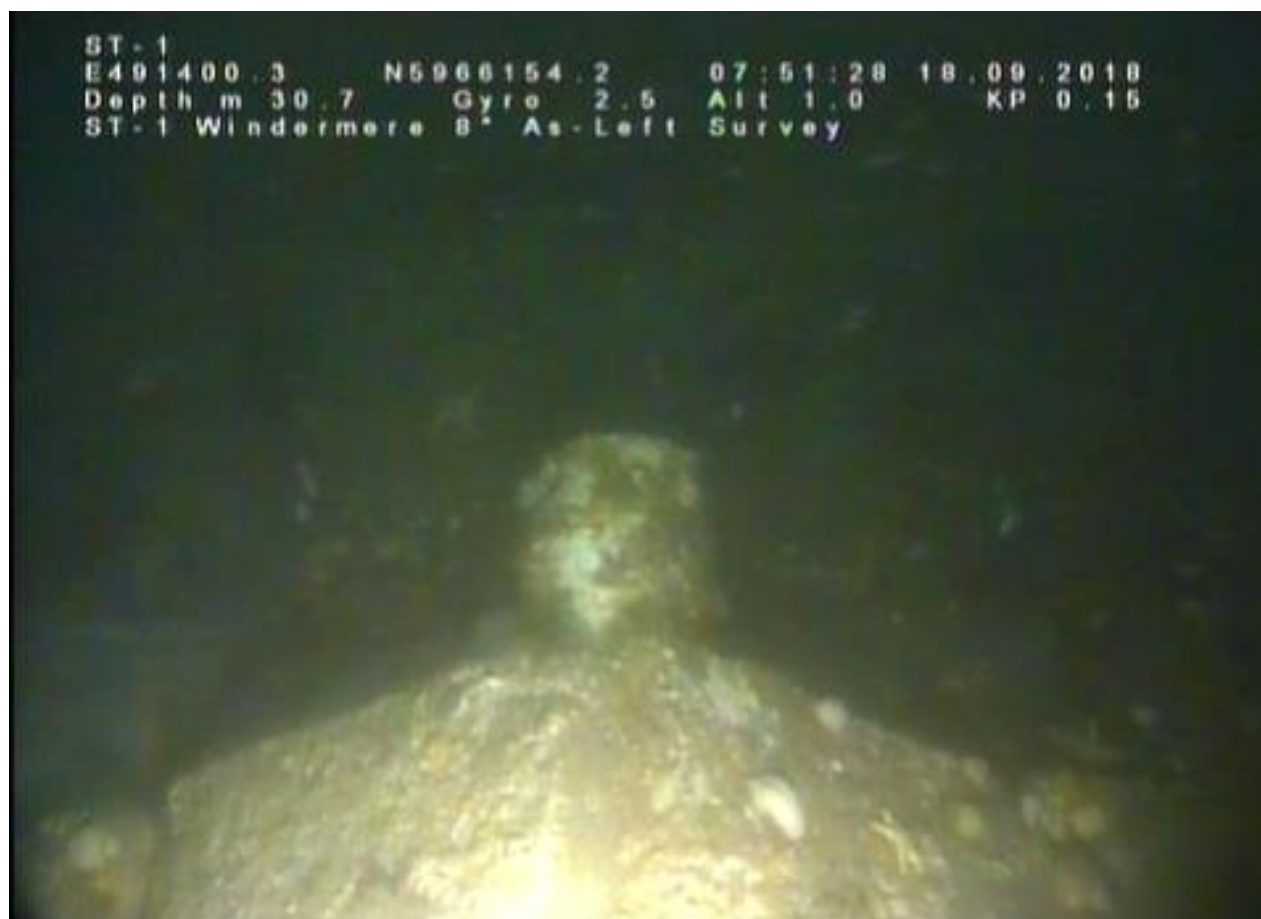
Figure 4.2.5: Windermere pipeline PL1273 severed (mattress in foreground)

For the ST-1 jacket to be removed the Windermere pipelines also had to be severed.

Product	Cut Location (UTM)	Cut Location WGS84 Decimal	WGS84 Decimal Minute
PL1273.1-3 Windermere Umbilical	491369.00 E 5966168.80 N	53.84396017° E 2.86881866° N	53°50.63761022' E 2°52.12911958' N
PL1273 Windermere 8" Pipeline (near 1 st mat)	491398.80 E 5966154.80 N	53.84383483° E 2.869271976° N	53°50.63008984' E 2°52.15631858' N

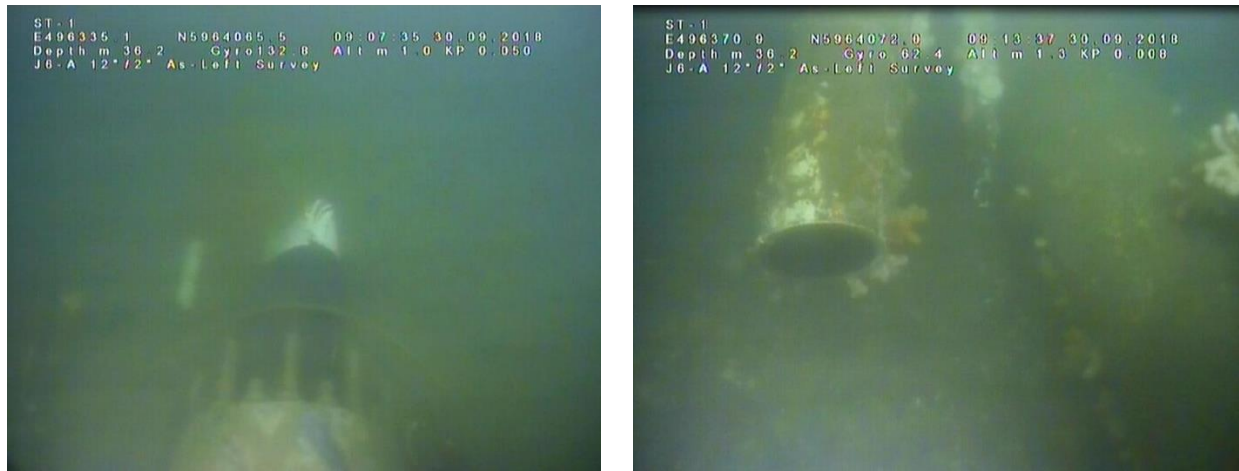
Figure 4.2.6: PL992 & PL993 severed at J6A @mattresses and riser)

Product	Cut Location (UTM)	Cut Location WGS84 Decimal	WGS84 Decimal Minute
PL992 12" pipeline at riser	496371.2 E 5964072.4 N	53.82517642° E 2.94487107° N	53°49.51058499' E 2°56.69226423' N
PL992 12" near pipeline flange	496355.9 E 5964065.0 N	53.8251098° E 2.94463872° N	53°49.50658782' E 2°56.67832319' N
PL993 2" pipeline at riser	496371.4 E 5964072.1 N	53.82517372° E 2.944874112° N	53°49.51042329' E 2°56.69244674' N
PL993 2" near pipeline flange	496336.3 E 5964065.4 N	53.82511325° E 2.944340951° N	53°49.50679527' E 2°56.66045708' N
