**A Condition Survey of the Archaeological Sites of Merrivale  
Range, Dartmoor Training Area**

| Surveyed: | Aug-Oct 2010 |
| Client: | Landmarc/Defence Estates |

# A CONDITION SURVEY OF THE ARCHAEOLOGICAL SITES OF MERRIVALE RANGE, DARTMOOR TRAINING AREA, DEVON

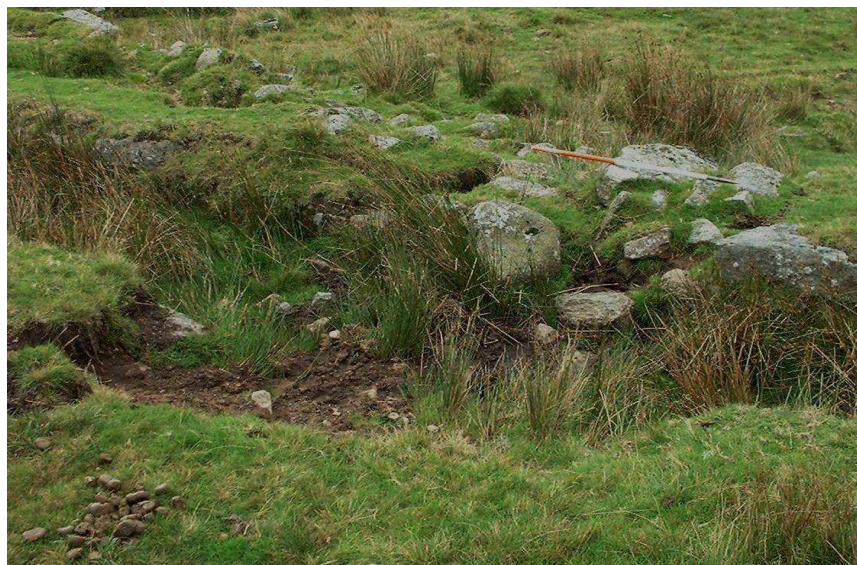
The only monument in this category, the former Prison Leat 1065830 (Fig. 3), is suffering from a lack of maintenance since its relatively recent abandonment. In several places the banks of the now dry channel have been eroded by livestock and walkers to create new crossing points in this often substantial feature. Several sections of the revetments lining the channel have also started to collapse.

**Fig. 3**  
Prison  
Leat,  
1065830.  
Livestock  
poaching  
north of  
the Lych  
Way  
crossing.

Given that this feature is nearly 6km long and redundant a program of monitoring and restoration is impractical. It is anticipated that the rate of decline will gradually slow and a state of stability will be achieved in the fullness of time.

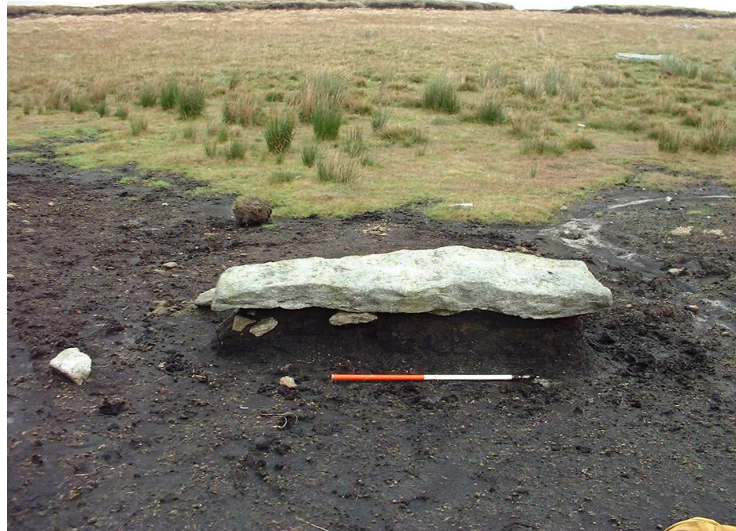
The majority of the stones of the former Cut Hill stone row are in a stable condition but the westernmost lies on an eroding pillar of peat in an area of bare ground (Fig. 4). A restorative action for this stone is difficult to prescribe and its gradual decline is probably the only feasible result.

**Fig. 4** Cut Hill stone row (1405946). The westernmost of the exposed stones lies on a pedestal of peat.

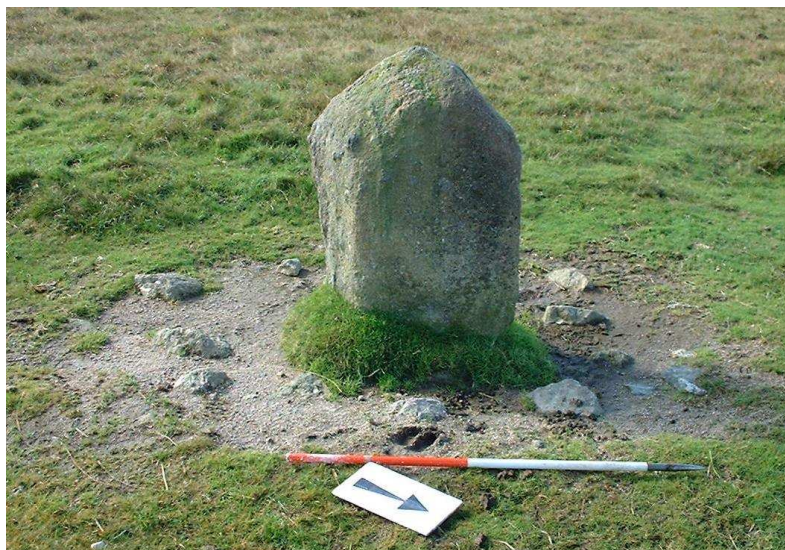
Despite an overall decline in the amount of livestock on the moor in general the stocking levels on Peter Tavy Great Common appear unchanged. Upright stones such as those of the Langstone Moor stone circle and the Longstone itself are attractive to livestock as rubbing posts.

**Fig. 5**  
Langstone  
Moor stone  
circle, 439606.  
Stone used as  
rubbing post by  
livestock  
inhibiting  
regrowth of  
vegetation.  
Cattle hoof print  
above red  
section of scale  
bar.

The resulting damage varies from bare patches around the stones (Fig. 5) to sizeable holes such as that around boundary stone 1403757 (Fig. 6).

At present all the affected stones remain stable but monitoring should continue with a view to remedial action in the medium term. Human intervention is not suspected to be a contributing factor in the gradual decline of these particular features.

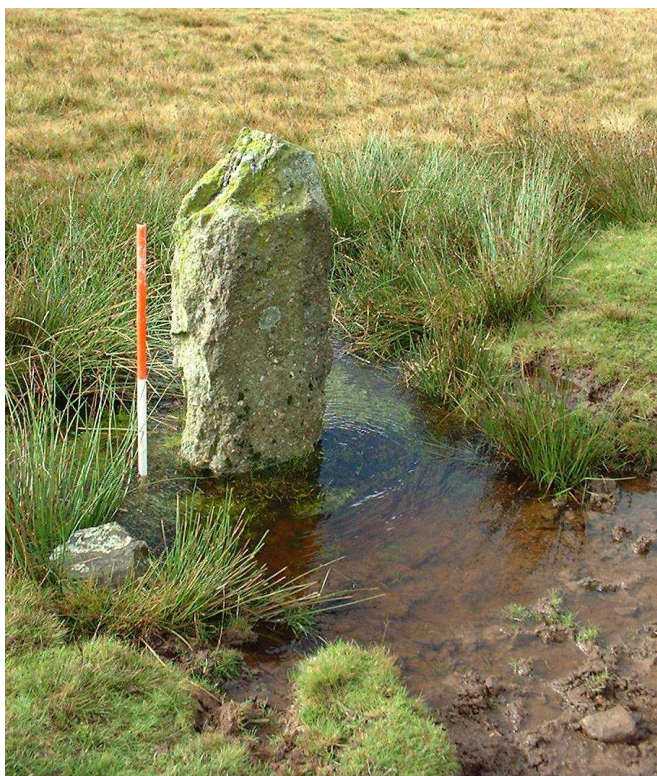
**Fig. 6** Boundary stone  
1403757. Despite the  
large water-filled hollow  
at the foot of this stone it  
remains secure in its  
socket.

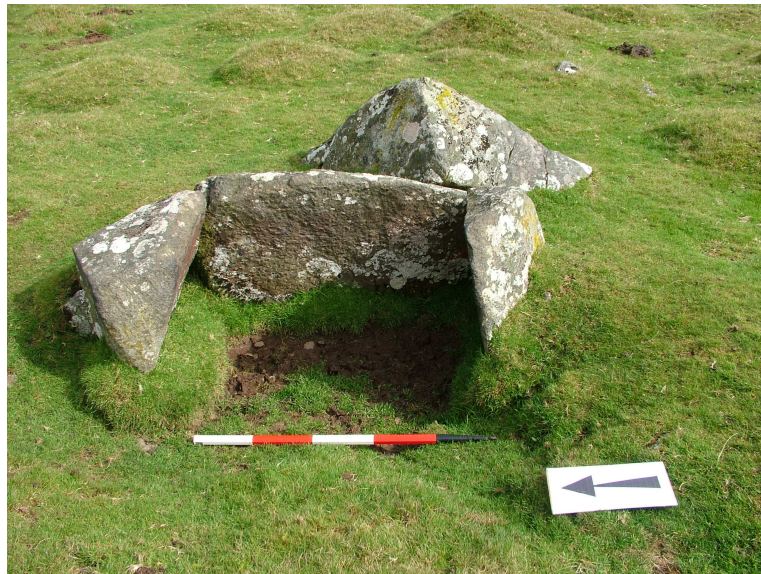
Smaller areas of livestock poaching occur on several monuments, in particular the remains of the small cist (439738) on the eastern flank of Whittor (Fig. 7) and on the northern fringe of White Barrow. These examples appear to result from sheep seeking shelter and are probably transitory.

**Fig. 7**  
Cist 439738.  
Minor livestock  
damage to former  
burial chamber

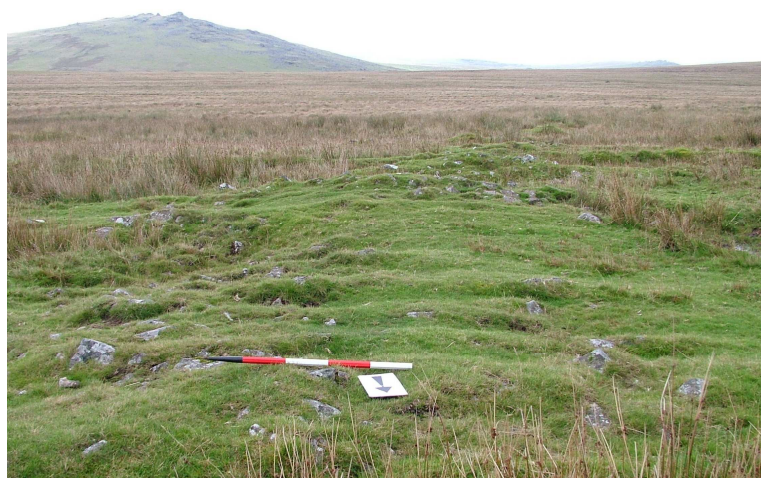
As stated above the use of the larger off-road vehicles has apparently ceased on Merrivale Range. Historic trouble spots such as where vehicles have crossed the reave (439794), east of Whittor on a broad front, have regenerated fully (Fig. 8)

**Fig. 8** Reave  
439794.  
The reave,  
running top to  
bottom, remains  
heavily rutted by  
old vehicle tracks  
but the turf has  
regrown since  
traffic was  
diverted.

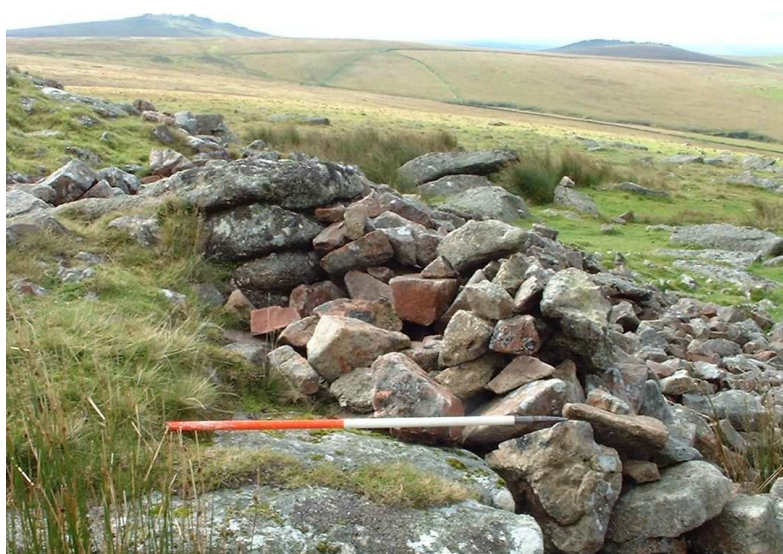
Lynch Tor occupies a striking location with panoramic views to the south and west. As such it acts as a magnet to visitors. The stony matrix of the large prehistoric cairn, Limsboro, (440633) built around the tor has been rearranged to form a number of shelters (Fig. 10) and smaller, secondary cairns.

**Fig. 10** Limsboro. 440633. The fresh faces on the exposed stonework above the scale bar indicate the recent creation of a small shelter in the west side of the cairn.

Whatever the scale of activity, it is in contravention of the Ancient Monuments and Archaeological Areas Act of 1979. New features should be identified and dismantled with the assistance of the Dartmoor National Park Authority and English Heritage.

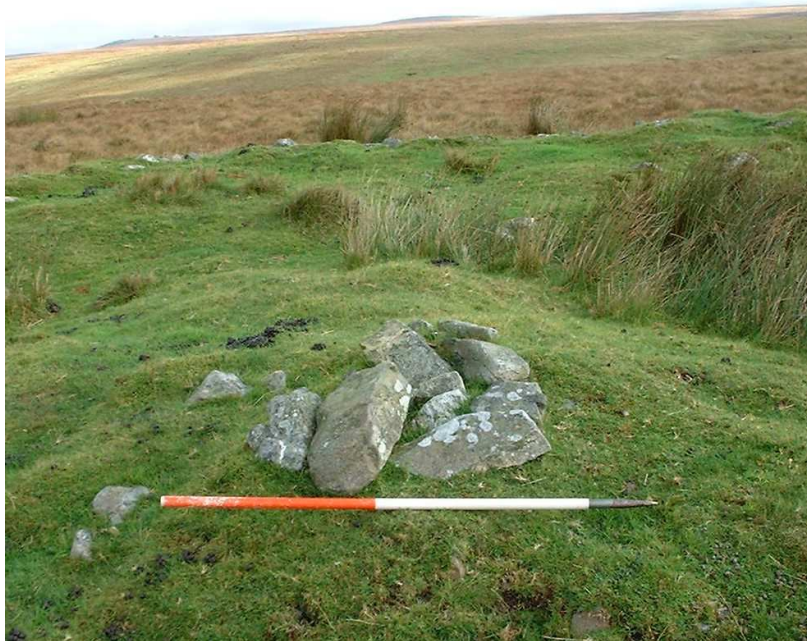
While this is the most obvious example of vandalism most of the other stony monuments in this area have also suffered disturbance with loose stones being rearranged to form new features. Fortunately most of this activity is on a very small scale (Fig. 11).

**Fig. 11** Cairn 439603. Loose stones have been assembled to create a new feature on this Bronze Age monument. Fortunately this site lies away from the main tracks and damage is unlikely to escalate.

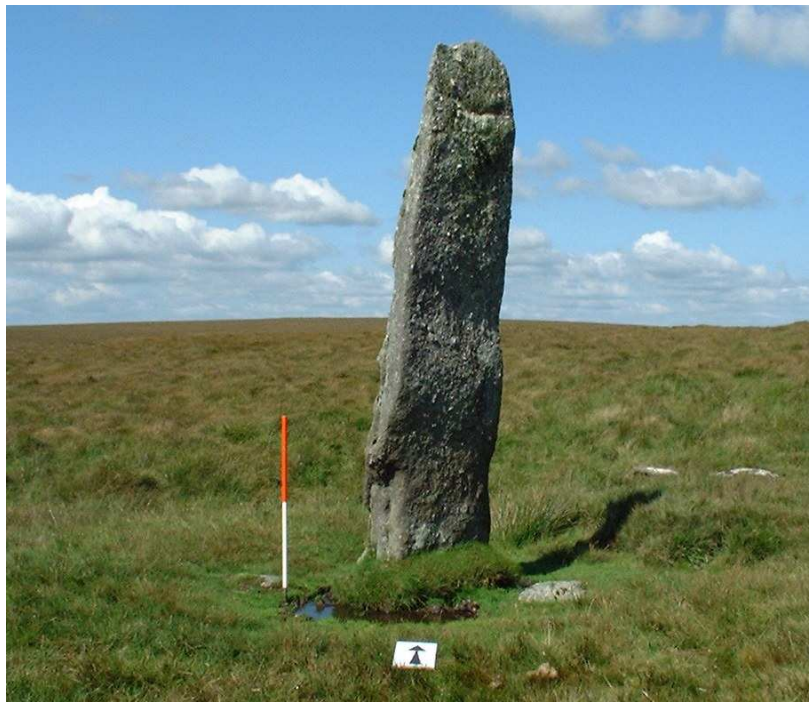
The appearance of two monuments in this classification is an indirect result of the reduction in the numbers of livestock on the higher moor. Both sites previously exhibited distinct poaching scars, Beardown Man 439571 (Fig.12), still possesses a small, water-filled erosion hollow at its base but the vegetation in the larger hollow around the stone is regenerating.

**Fig. 12**  
Beardown  
Man 439571.  
Regeneration  
of previously  
extensive  
erosion  
hollow.

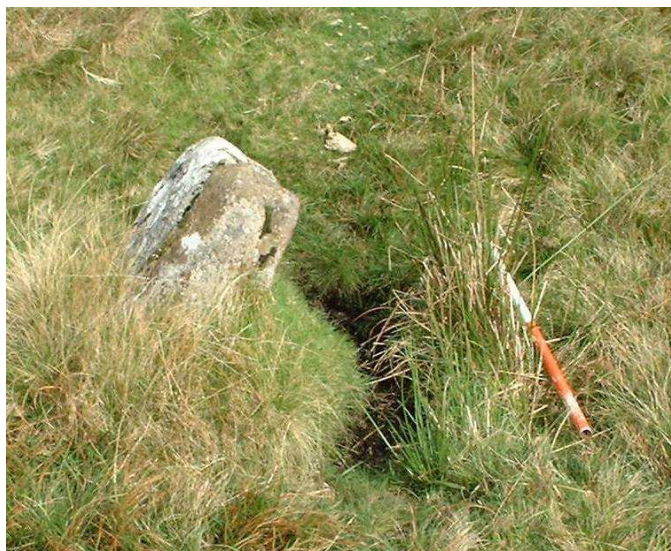
It is anticipated that if stocking levels remain low several more sites may be included in this category in subsequent assessments. In particular, the Conies Down Stone Row 439578 (Fig.13), suffers from a low degree of stock damage that may cease or regenerate in the short term.

**Fig. 13** Conies Down  
Stone Row 439578.  
Erosion hollow at the  
base of one of the few  
remaining upright stones.
