**A Condition Survey of the Archaeological Sites of the Ringmoor Training  
Area, Dartmoor**

County:	Devon
District:	West Devon
Parish:	Sheepstor
NGR (Centre):	SX 571663
Surveyed:	Nov-Dec 2010
Contractor:	S Probert
Client:	Landmarc/Defence Estates

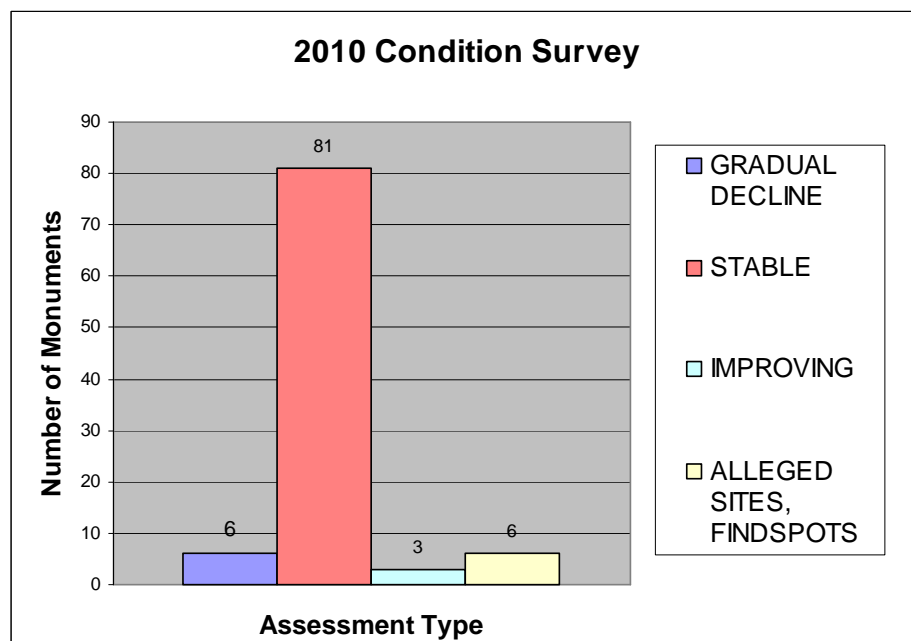
The findings of the 2010 survey are summarised in Fig. 1 (actual numbers of monuments) and Fig. 2 (percentages). The number of stable monuments forms

**Fig. 1** Actual findings of the 2010 condition survey

the bulk (81 monuments 84%) of the sample while those in gradual decline constitute only 6 or 6%. Monuments whose condition is considered to be improving form 3% of the dataset.

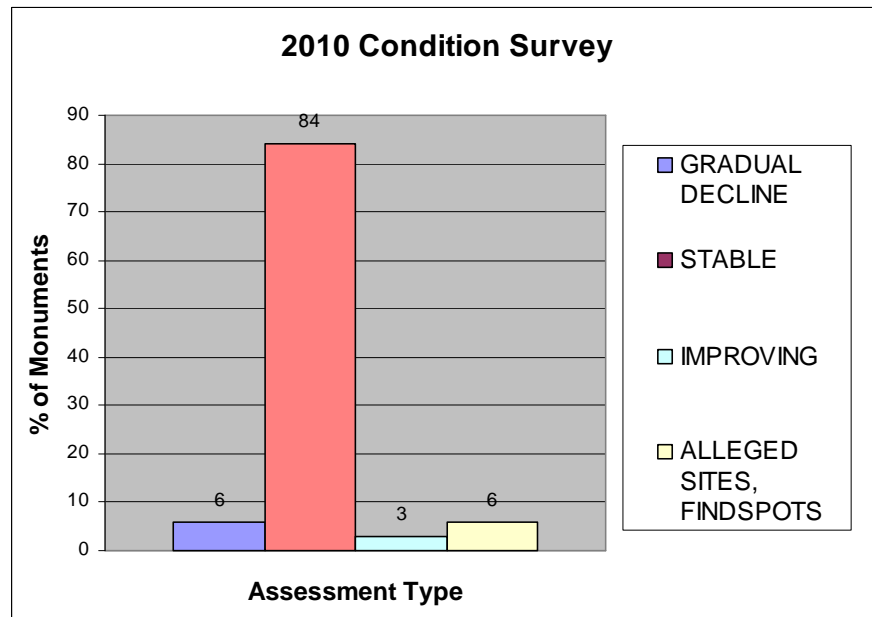
**Fig. 2** Percentage findings of the 2010 condition survey

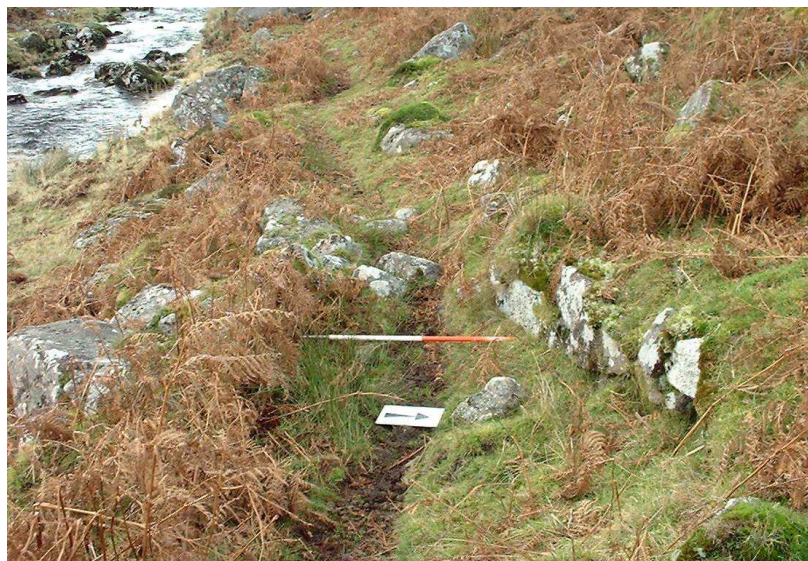
A vermin trap, 1409610, (Fig. 3), lies on a small ledge above the right bank of the River Plym that is also occupied by a relatively well-used footpath. The continued use of this path, which has already scarred the site of the former trap and its approaches, may lead, in the medium or longer term, to further disruption to this feature.

**Fig. 3**  
Vermin trap 1409610. Footpath erosion. The path runs through the former trap, the funnel walls are visible either side of the scale bar.

During the course of this assessment and the baseline survey in 2005 it was noticed that the track was used almost exclusively by the military as a route between Legis Tor and a crossing point on the river. Were the descent to the river to be made downstream, west, of this feature the erosion would be considerably lessened if not terminated.

The condition of two of the smaller monuments, the vermin traps 1311114 and 1409610, would be enhanced if the paths that bisect them were to be diverted.

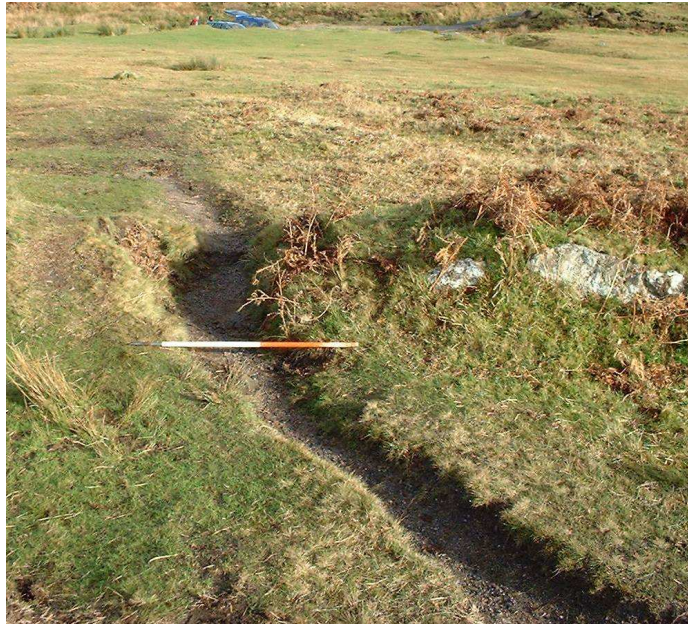
**Fig. 4**  
Medieval enclosure 1313030. Footpath erosion through outer bank.

The other three instances of footpath disruption affect medieval field boundaries. The small sub-circular enclosure 1313030 adjacent to the car park at the end of the public road to the Scout Hut is traversed by a number of footpaths. Several erosion scars have been created on this feature by foot traffic from the car park to the open moor (Fig. 4). Other than the closure of the car park, which is both useful to the military and popular with the public, there is no viable remedy to this erosion. Consequently, as long as the footpaths retain their current routes the relatively mild and slow deterioration of this monument should be tolerated.

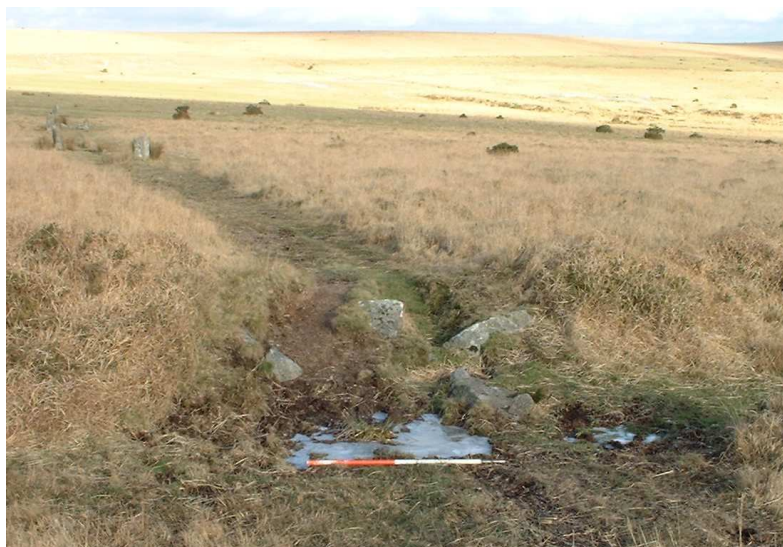
**Fig. 5**  
Field system 1409366. The medieval enclosure bank running left to right in the foreground is pierced by a footpath following the stone row.

In the same vein the now redundant boundaries of the extensive medieval field systems 438858 and 1409366 covering the Ringmoor plateau and Lynch Common are pierced by a number of footpaths (Fig. 5). While the diversion of the paths is a possible action, their courses are relatively fixed and restricting the damage to the present alignments would be the preferred option.

On a much larger scale, the remains of the medieval field systems, 438858 and 1409366, which occupy 230ha of Lynch Common and the Ringmoor plateau are traversed by a number of footpaths. Erosion of these remains is an issue at several of the bottlenecks where paths cross banks. This damage is best tolerated providing that future monitoring does not show the problem to be escalating or the paths wandering to create further breaches.

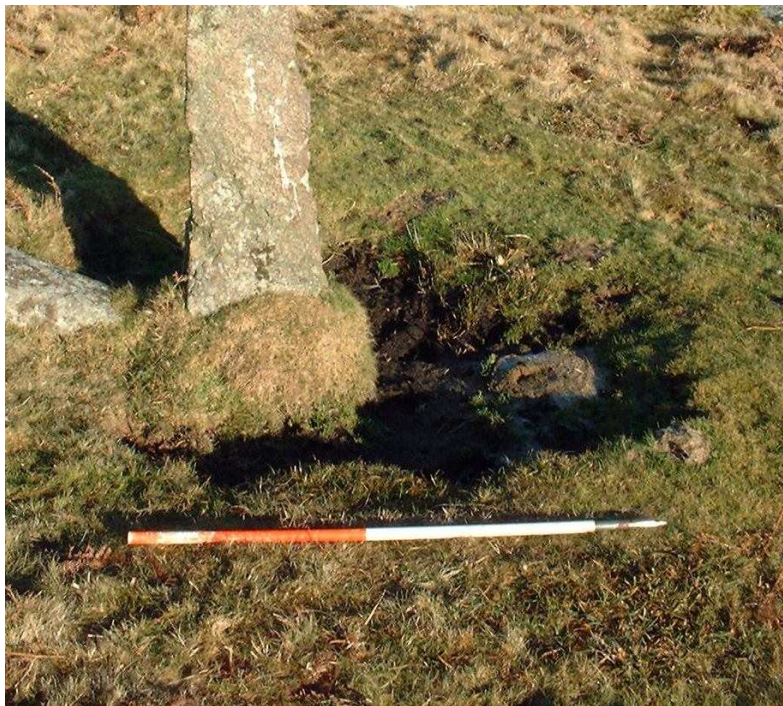
The reduction in stock numbers has reversed much of the damage noticed in the 2005 survey. However, a collection of upright stones, 1260494, on the open moor north of Dittsworthy House continue to serve as rubbing posts for ponies and cattle in particular. This activity has created bare erosion hollows around the bases of these stones (Fig. 6). All stones remain stable in their sockets but comparison with the 2005 survey shows a slight deterioration in the surrounding hollows. Given that these features are relatively recent erections monitoring at the next condition assessment in five years should suffice and remedial action can be taken then, if necessary.

**Fig. 6** One of the stones of monument 1260494. Despite the erosion hollow the stone remains stable in its socket.

Poaching by livestock has reduced markedly with the decrease in stocking levels. The vegetation on most previously affected sites has either regenerated or is in the process of regeneration. An exception lies on the unenclosed part of the training area around Eastern Tor where the relatively good grazing is supplemented by a supply of rubbing posts, site 1260494.

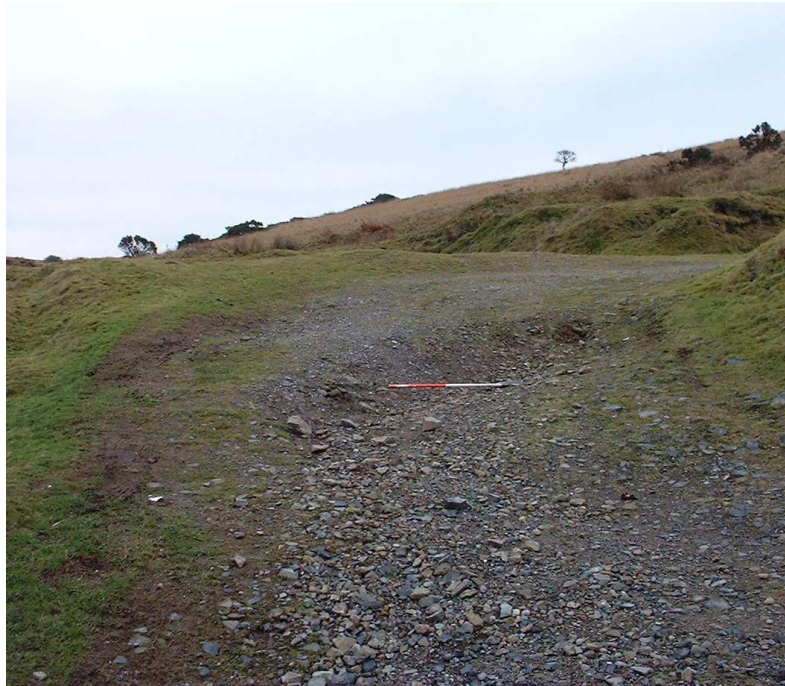
The small car park at the junction of the Sheepstor and Eylesbarrow roads occupies the site of the former processing area of a small tin mine, 1408397. The approach to the car park is already heavily rutted (Fig. 7) which may be affecting any sub-surface remains. Its continued use threatens the medium to long-term integrity of this site.

**Fig. 7** Entrance to car park containing mine 1408397. Vehicle damage spreading to avoid deep rut in approach track.

Vehicular damage is limited to the car park on the site of the former mine, 1408397, at the junction of the Sheepstor and Eylesbarrow roads. The approach track is already severely rutted and the erosion of any sub surface remains is likely. It is recommended that this car park is closed.

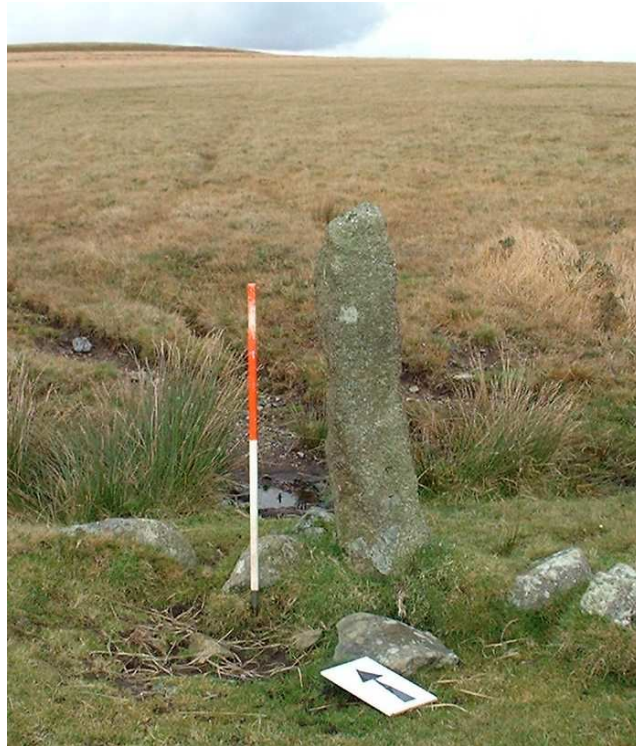
The stable category contains several monuments that were classified as in gradual decline in the 2005 Baseline Survey. The erosion scars and vegetation on the possible cairn at Legis Tor, 1408396, previously at risk from military activity, have regenerated while the erosion hollows around the boundary stones in the enclosed land on the Ringmoor plateau have stabilised due to the reduction in the amount of livestock, Fig. 8.

**Fig. 8** Boundary stone 1409370. The vegetation in the erosion hollow at the base of this stone has regenerated sufficiently for this monument to be considered stable. Active footpath erosion is visible in the background.

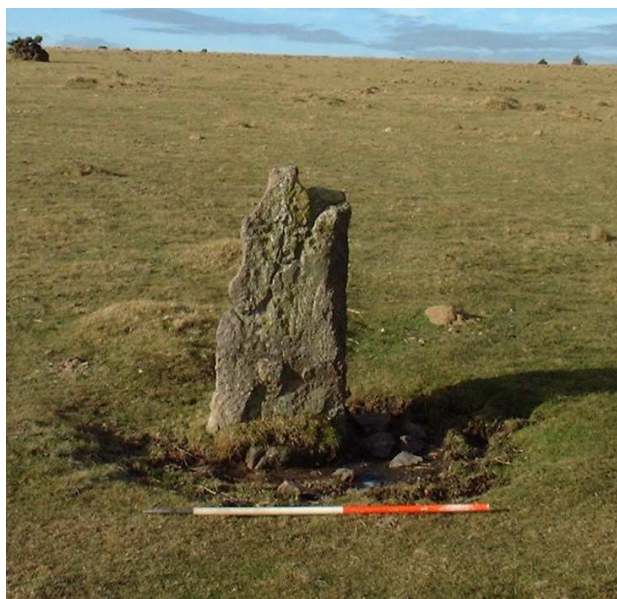
**Fig. 9** Ringmoor Down Stone Row, 438671. Regeneration of erosion hollow.

The erosion hollows and vegetation around the stone row and cairn circle, 438671, are regenerating as is the footpath running up the row. The former, once bare hollows, are largely grassed over, only those around the larger stones exhibiting exposed peat (Fig. 9). This improvement is probably due to the livestock reduction as these stones formerly served as rubbing posts. The footpath remains as a slight hollow though now it is also largely grassed over suggesting a diminution in the number of visitors.

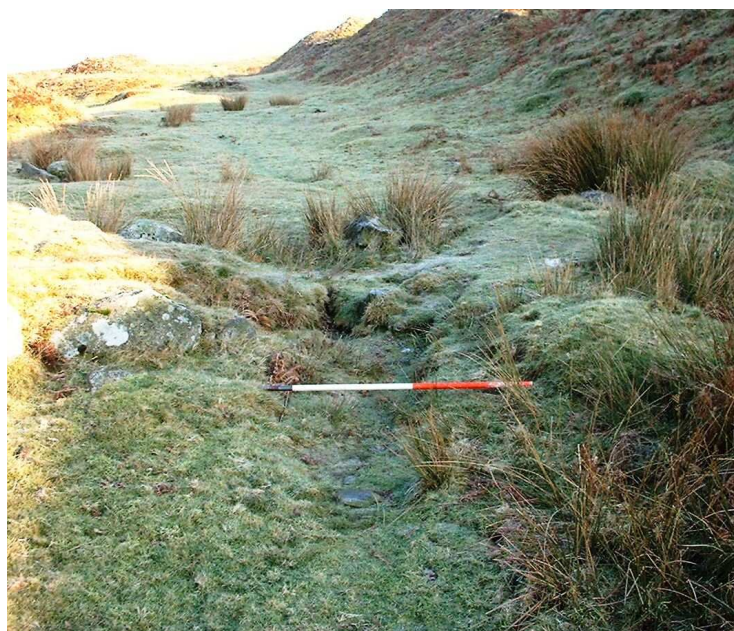
**Fig. 10** Vermin trap 1311114.

A footpath runs left to right across the monument above the scale bar. In 2005 the path was marked by a band of bare ground.

The footpath between Gutter Tor and Dittsworth House continues to bisect the vermin trap 1311114, though the condition of the monument has improved since the 2005 survey. The paths that approach the site remain deeply eroded but the monument itself is now largely vegetation covered with little bare ground visible, Fig. 10, in contrast with 2005. It remains desirable that the footpath be diverted to maintain this improvement.

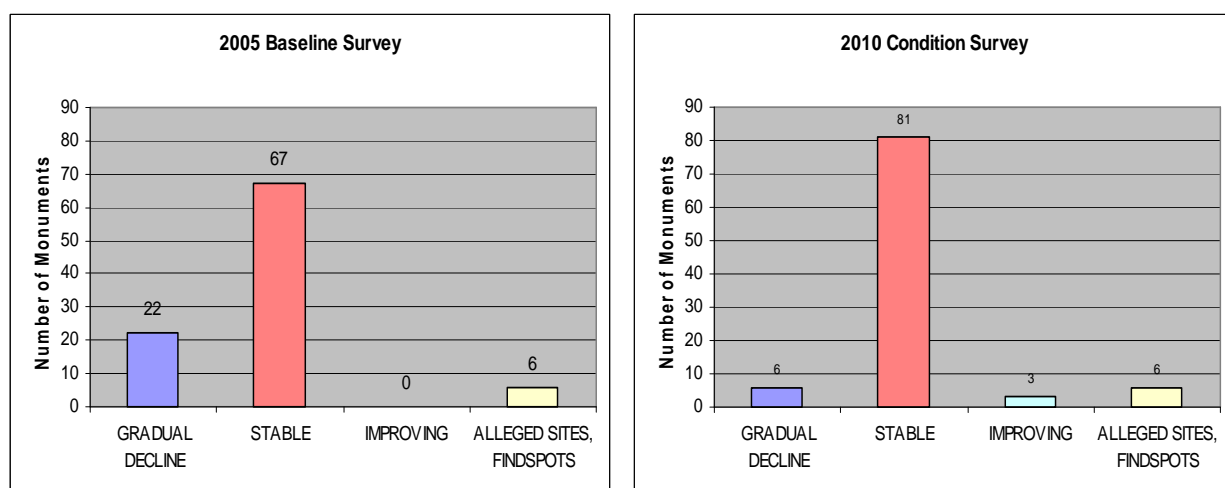
The numbers and relative quantities of each condition type in the 2005 and 2010 surveys can be seen in Figs. 11 and 12 respectively.

**Fig. 11** Actual results of the 2005 Baseline survey and 2010 resurvey.

The monuments represent a relatively fluid dataset with a number of condition assessments changing between the 2005 and 2010 surveys.

There is a degree of what is best described as ‘bedding in’ of the data, the 2010 survey confirming or negating assessments that could only be speculation in the 2005 reference set. The 2010 assessment suggests that the number of sites suspected of being in Gradual Decline in 2005 was overstated, the size of this category being reduced from 23 to 6. Most of these reclassifications have occurred because there has been no discernible change in the appearance of these monuments. Other sites, as described above, have benefitted from changes in livestock levels and visitor numbers and progressed through Improving to become Stable. Of particular note, an apparent change in military activity has reversed the decline of the possible cairn at Legis Tor, 1408396, which now presents as a stable feature.

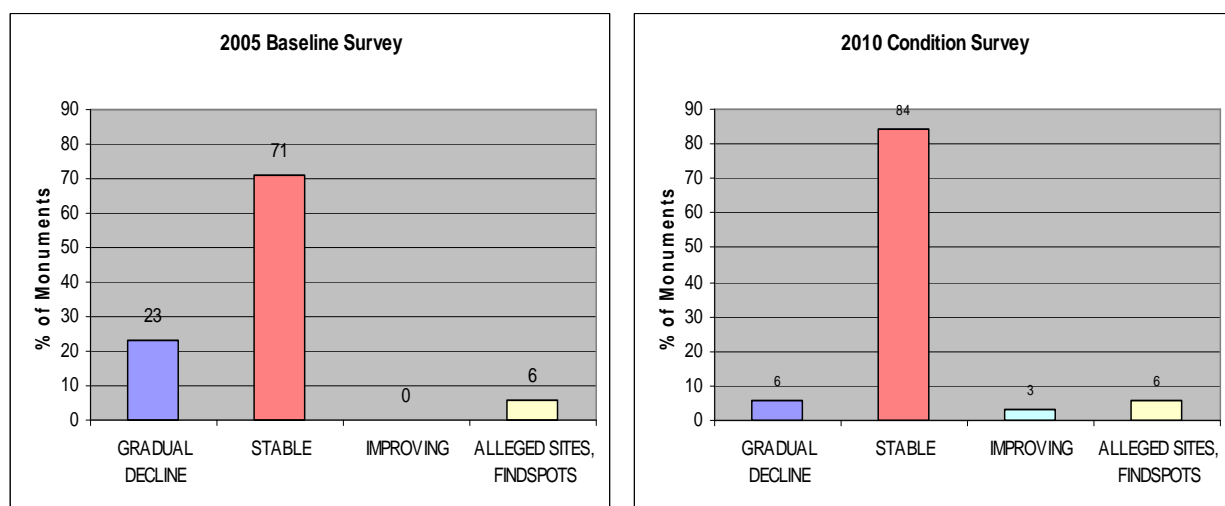
**Fig. 12** Relative results of the 2005 Baseline survey and 2010 resurvey.

The ability to compare the site photography has facilitated the creation of a more objective dataset which itself has enabled the population of the Improving category containing three monuments previously deemed in gradual decline.

In broad terms both surveys present a solid core of Stable sites. The major difference being a movement of monuments across the x-axis from Gradual Decline in 2005 to Stable and Improving in 2010.
