# Archaeological Sites within Okehampton Training Area, Dartmoor National Park, Devon: A condition survey on behalf of Defence Infrastructure Organisation January 2014

Report prepared on behalf of WYG by  
Dr Phil Newman of South-West Landscape Investigations

Project: Okehampton Range Monument Condition Survey

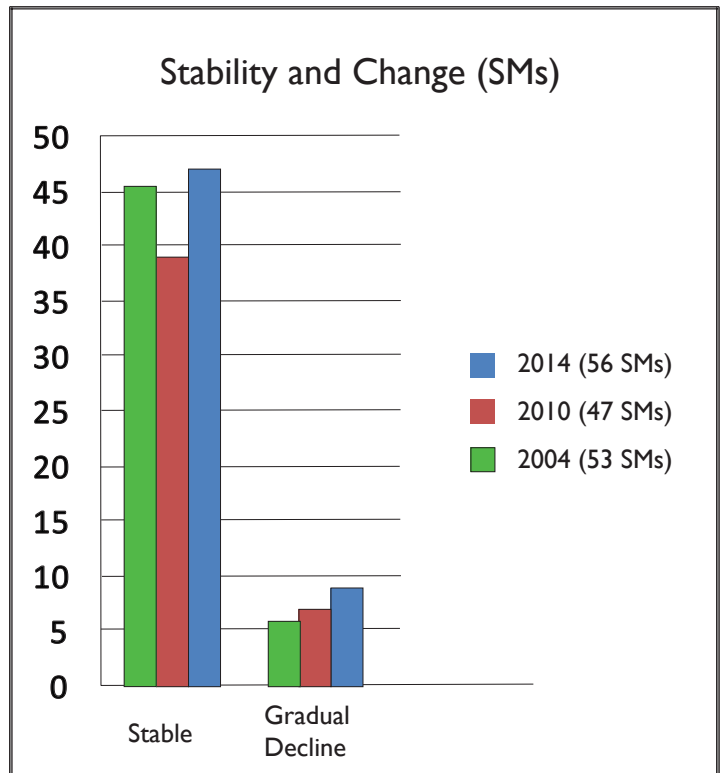
Under the more objective measure of *Stability and Change*, 47 (84% - up 1.5% on 2010) remain in a stable condition and, while nine (16% - up 1% on 2010) are reported as in gradual decline (Fig 3), in most cases this is due to very insignificant patches of erosion. Only four SMs have suffered any notable damage and in only one case has this been deliberate or recent (443946 see below). One other example has been subject to controlled archaeological intervention (443720 see below). Statistically, the number of SMs in stable condition has increased slightly since the baseline survey of 2004.

Table I Graph showing statistics for stability and change in sheduled monuments.

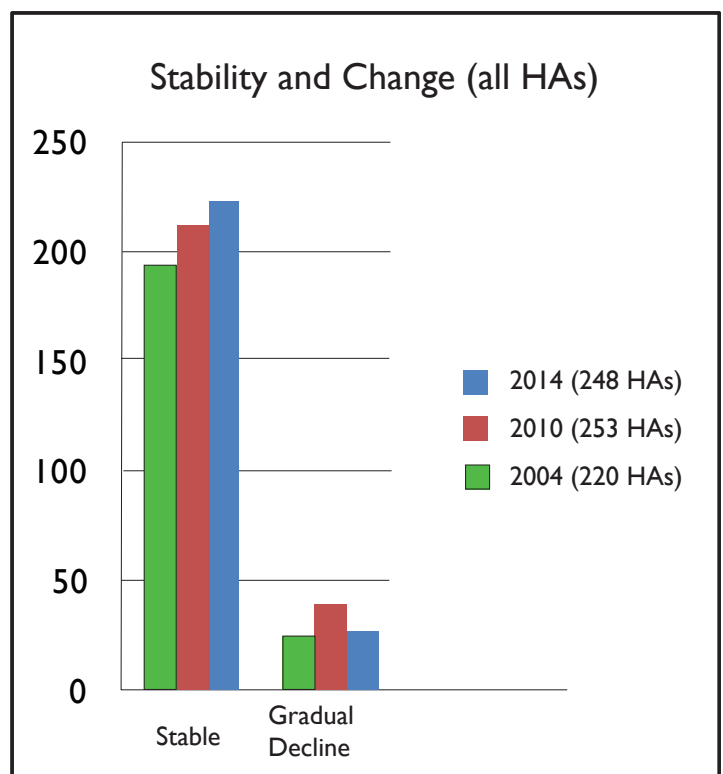
<b>2014 survey of <u>248</u> heritage assets assessed</b>	No.	% of total
Stable	221	89.5
Gradual Decline	26	10.5
Rapid Decline	1	0
Improving	0	0
<b>2010 survey of <u>253</u> heritage assets assessed</b>		
Stable	211	83.5
Gradual Decline	38	15
Rapid Decline	1	0.4
Improving	1	0.4
<b>2004 survey of <u>220</u> heritage assets assessed</b>		
Stable	193	87.5
Gradual Decline	25	11.5
Rapid decline	0	0
Improving	0	0
Other	2	1

Table I Graph showing statistics for stability and change in heritage assets.

These figures represent an increase of 6% in the total number of heritage assets reported to be in a stable condition, while those considered to be in gradual decline has fallen by 4.5%, representing a healthy reduction in the number of sites with current or potential management concerns.

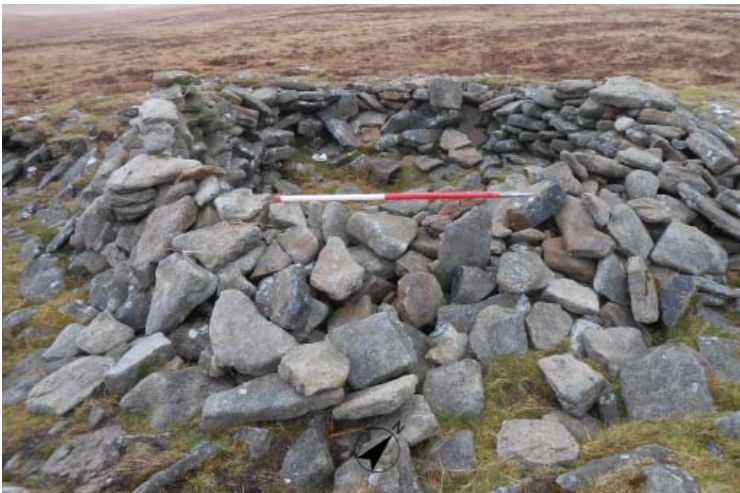
**Description:** The remains of a large, stony, prehistoric cairn located on the southern tip of Whitehorse Hill. Stone, originally part of the monument's fabric, has been removed and used to construct a circular

shelter on top of the mound by persons unknown. The removal of this stone has already disturbed the integrity of the cairn and if this continues, additional stone currently making up the original mound, will also become removed, risking further damage and exposure of archaeological layers beneath.

Fig 4 View of the upper surface of the Quintin's Man cairn (443946), showing the circular structure constructed from cairn fabric.

It is suggested that this additional circular structure should be recorded, then carefully removed, and the stone used to remodel the cairn. This process has previously been achieved successfully on Dartmoor via the English Heritage Historic Environment Field Advisor (HEFA), based at Dartmoor National Park HQ, with manpower provided by volunteers. It is strongly recommended that liaison between the MoD, DNPA and EH could bring a positive outcome to the management of this heritage asset.

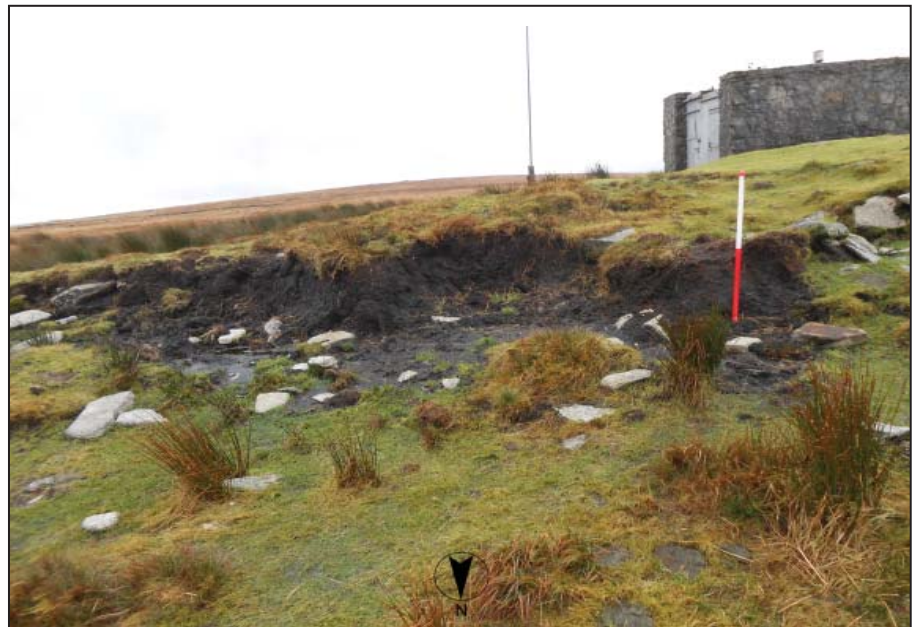
**Description:** A large stony round cairn of over 1m in height on the northern summit of Hangingsstone Hill. Legacy damage to the site comes in form of a stone-built military structure imposed on the southern arc of the cairn. However, the northern side of the cairn is actively declining due to a probable combination of livestock erosion and wet weather. This has caused a scarp to develop along the peat and turf covering, exposing it to depth of approximately 0.5m. To prevent further exposure, the scarp needs to be covered, either by loose stone or turf or a combination of both.

Fig 5 View of Hangingstone Hill summit cairn (443723), showing erosion on the north side.

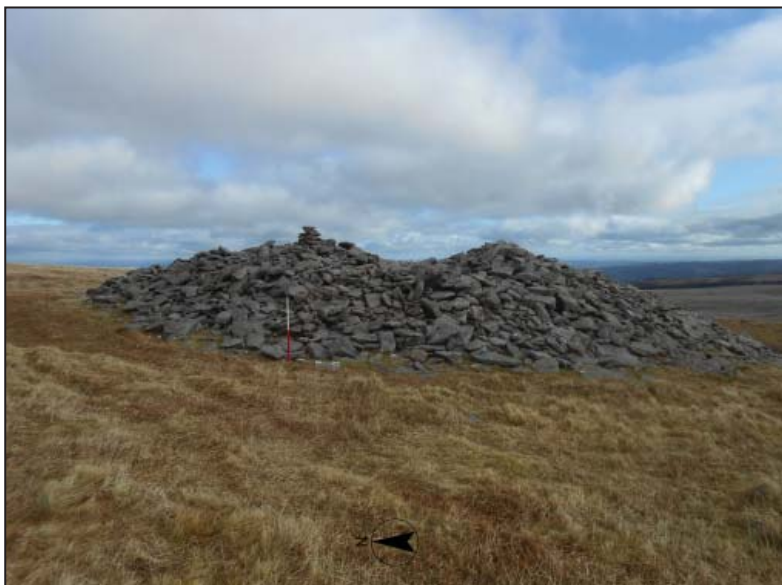
**Description:** A prehistoric round cairn on the ridge to the south of Watern Tor. This stony cairn is among the largest of its type within OTA, and although suffering interference to the loose stone of its interior, much of this is legacy damage, which has created a hollowed appearance to the profile of the cairn. Interference continues, however, with the building of small cairns from the fabric of the main pile. This is difficult to combat but removal of existing stone piles may discourage further stacking of the stone. This feature needs to be discussed with the EH HEFA and a joint decision taken as to whether or not to act.

Fig 6 View of the cairn on Watn Tor Ridge (443720), showing interference on the upper surface.

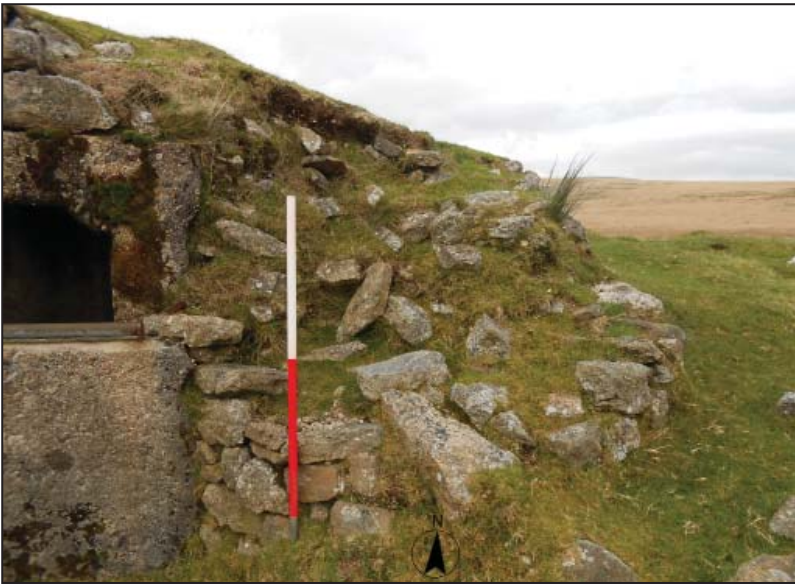
There is little to report in the way of specific damage or erosion at individual non-scheduled sites in OTA. However, a decline in the condition of some of the military structures and earthworks is notable, particularly the OP's, where soil erosion is causing patches of the soil and stone parts of the splinter-proof coverings to slump.

Fig 7 Erosion and slumping on one of the military observation post (967377).

Decline is notable in the condition of three artillery observation posts. Soil and stone which make up the splinter-proof coverings has weathered and begun to slump. This is not a recent problem, nor is it serious, but it is ongoing and will worsen as time goes on. These are significant and nationally rare structures to be surviving in the modern National Park and certainly worth conserving. Works to remediate this decline are probably not necessary yet, but it is advised that a policy on whether or how these structures will be managed in the future should be formulated soon.

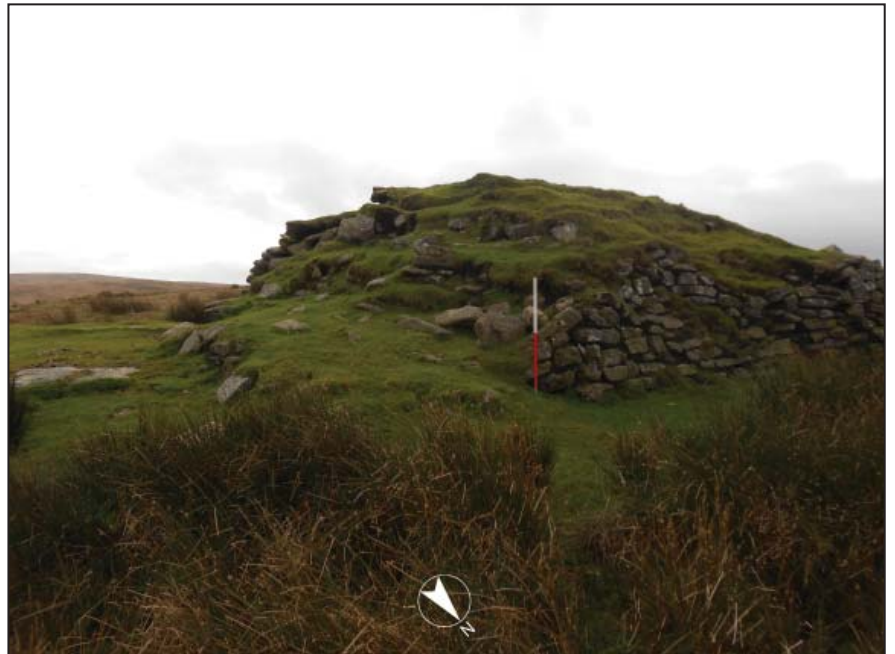
Fig 8 Erosion and slumping on one of the military observation post (967699).

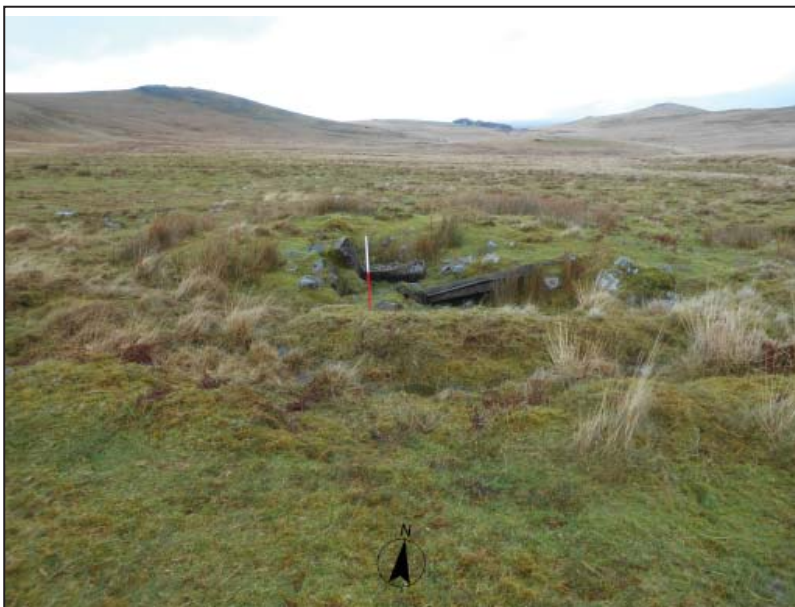
Many observation posts (OPs) once existed within OTA. The structures were robustly built from concrete and stone (or in some cases timber), and reinforced with turf to protect them from blast damage. Only seven OPs survive upstanding, although the condition of some is declining, suffering erosion of both the turf and the stone reinforcement (Figs 7-8). Eleven other OPs have been demolished, leaving scant evidence (Fig 9) and in one case at Dinger Tor (1063939), no trace at all.

Fig 9 An example of a demolished military observation post (967100).
