Archaeological Sites within Willsworthy Training Area,  
Dartmoor National Park, Devon: A condition survey on behalf  
of Defence Infrastructure Organisation

February 2019

Dr Phil Newman MCI(A), FSA  
Southwest Landscape Investigations

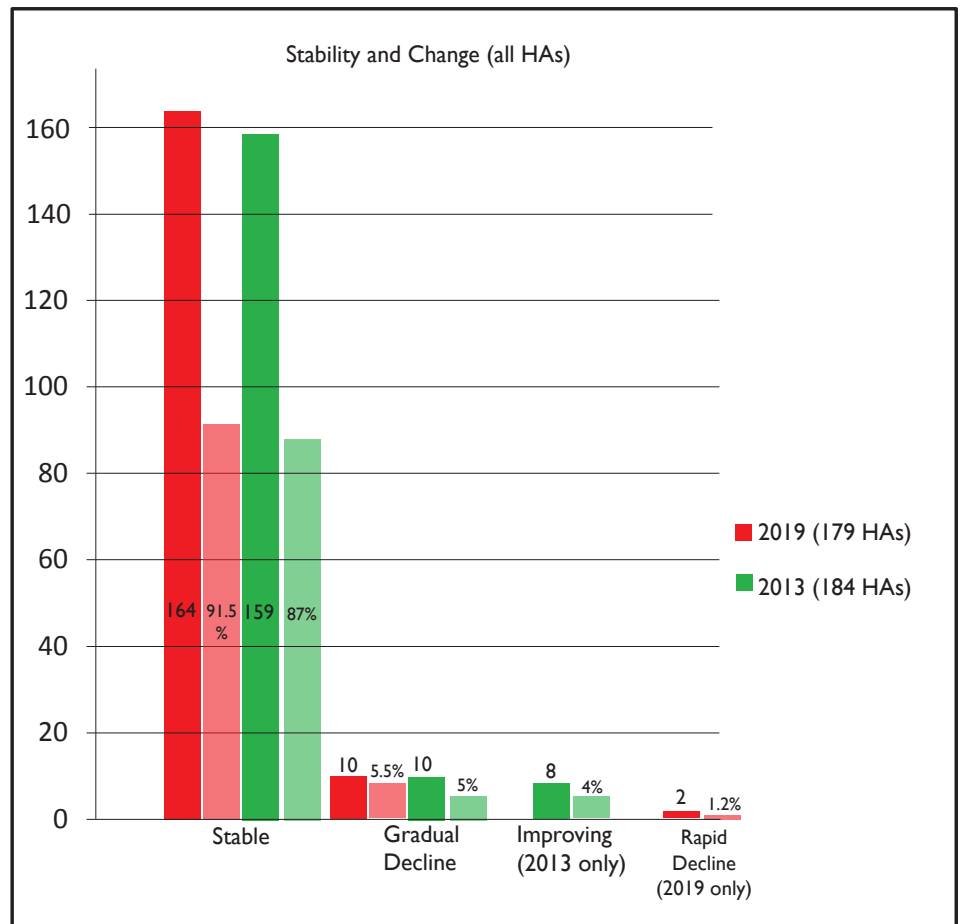
Fig. 2 Graph presenting the statistics and percentages for stability and change for all heritage assets (HA) recorded in Willsworthy TA 2013 and 2019.

In 2019, 164 (90%) of the total sample (179) remain in a stable condition, while 10 (5.5%) are reported as in gradual decline, in most cases this is due to very insignificant patches of erosion or minor threats. Zero assets may be seen to be improving, as no measures have been in place, but two have been moved to the rapid decline category (see below).

The figures are summarized in Table 2 and Fig. 2, which includes the statistics from previous surveys for comparison and represent an increase of 4.5% in the total number of heritage assets reported to be in a stable condition, while those considered to be in gradual decline has reached equilibrium, which indicates a generally positive direction of travel for the aggregate statistics within this TA.

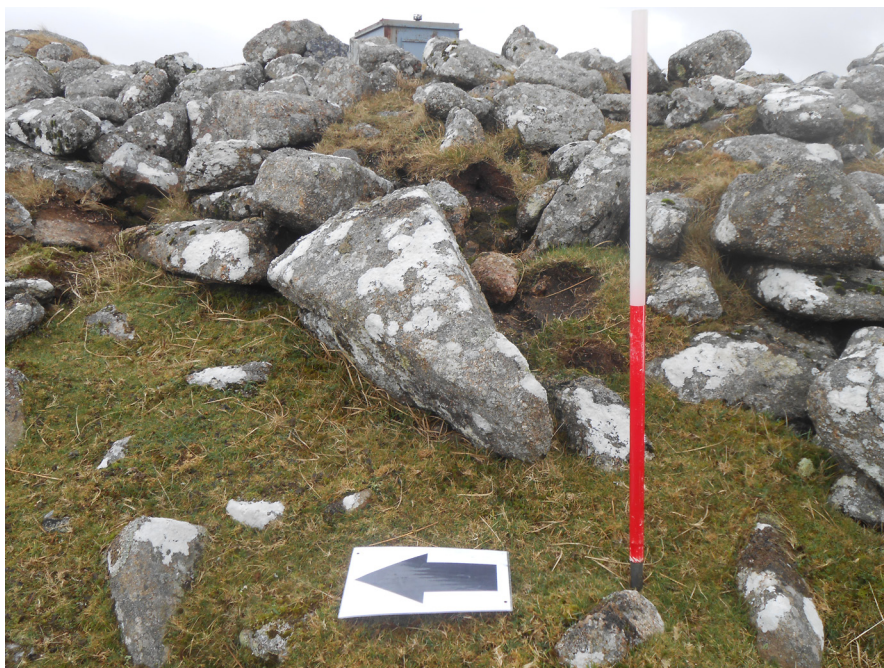
All but one SM in Willsworthy TA is in a stable state. The exception is the large tor cairn on Standon Hill (**440627**; SM No. 1016253), which has very recently been disturbed by persons unknown, removing stones from the cairn to construct a wall beneath a nearby overhanging rock, to build a shelter. Demolition of the shelter could be followed by returning the stones to the hollows from where they were removed to restore this damage, which although not severe, the presence of the shelter could encourage others to augment its walls and escalate the problem.

*Fig 3. 440627. The tor cairn on Standon Hill showing details of stone removed from the fabric of the cairn.*

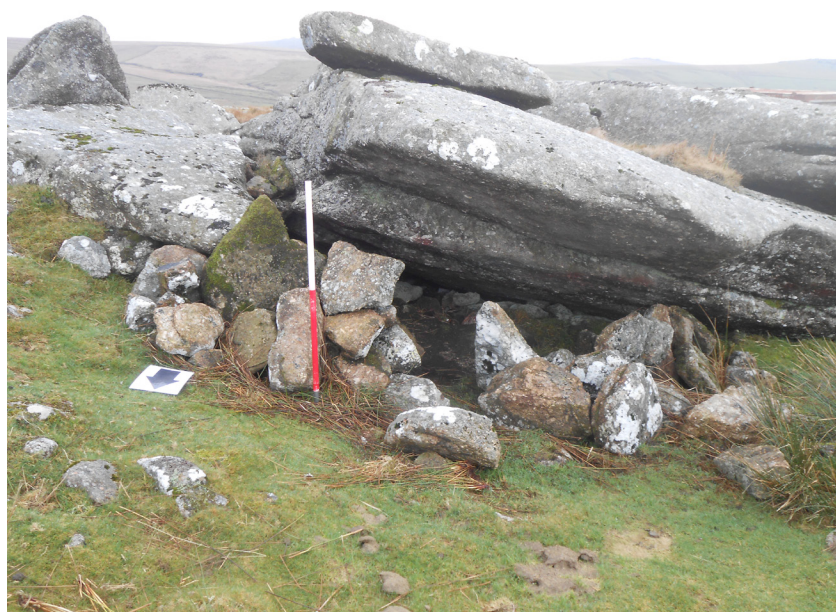
*Fig 4. 440627 The tor cairn on Standon Hill showing details of a recent shelter built nearby from material robbed from the cairn.*

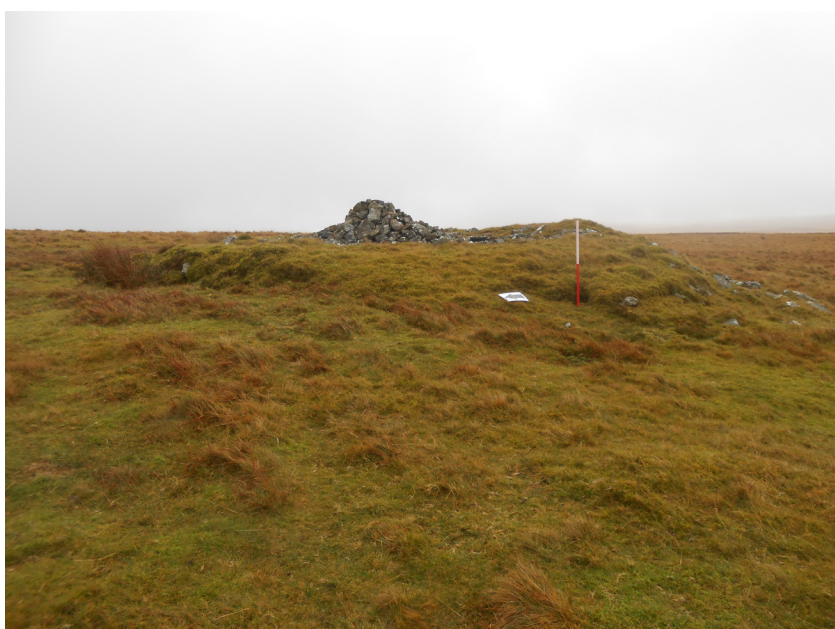
A large cairn to the west of Hare Tor (**440579**) has been reported in previous condition reports as having suffered interference, whereby a secondary stony cairn has been constructed within the main turf-covered cairn. Despite remedial action following the 2007 survey, the interference continued and the stony cairn had reappeared by 2013 and has remained stable since then. A further intervention could restore the cairn but would not prevent the continued interference. It may be more practical to leave the illegitimate cairn in place and re-assess the condition at the next survey cycle rather than continuously moving the stone about.

*Fig 5. 440579 A small cairn to the north of Hare Tor, with un-authorised modifications.*

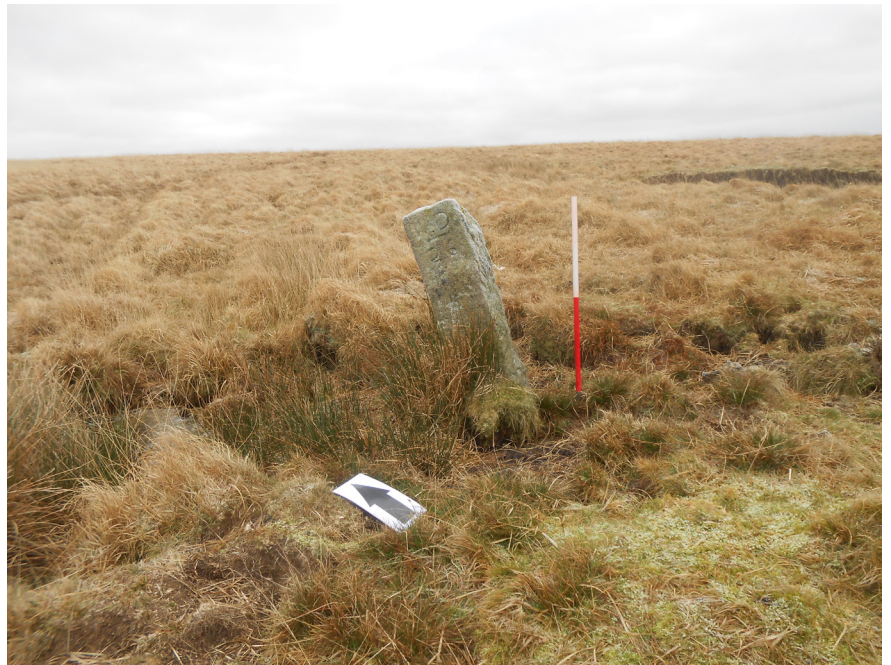
Animal poaching around the base of boundary stones is an ongoing issue, highlighted in previous reports but most seem to be surviving well at present, with only two stones having excessive erosion (**1146705**; **1146695**). This may cause them to topple eventually. Only one stone is currently threatening to do this (**1157552**), which is currently leaning, hence its 'rapid decline' status.

*Fig 7. 1157552 A leaning War Department boundary stone near the head of Baggator Brook.*

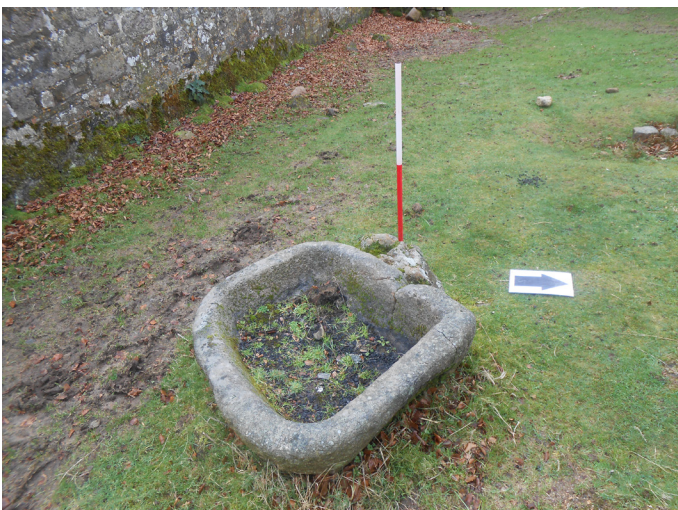
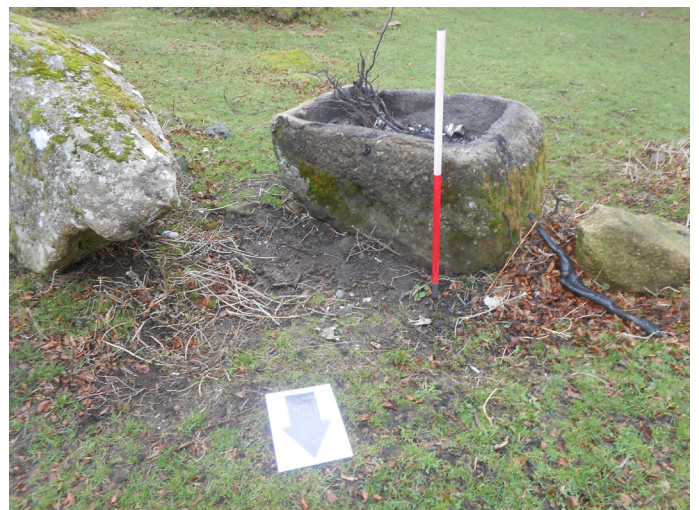
Two stone troughs (**1149362**; **1135491**) in the yard of Standon Farm are still being used as barbecue pits which is causing heat damage and fresh cracks are visible. This was reported in 2013 but continues. The culprits may be members of the public, but perhaps more likely military personnel using the accommodation at the farm, in which case measures should be taken to stop this activity, perhaps by provision of an information sheet inside the accommodation.

*Figs 8 and 9. Granite troughs (1149362; 1135491) in courtyard of Standon Farm, showing evidence for use as barbecue pits. Both now have fresh hairline fractures as a result.*
