Archaeological Sites within Willsworthy Training
Area, Dartmoor National Park, Devon:
A condition survey on behalf of Defence
Infrastructure Organisation

February 2019

(SX 5440 8333)

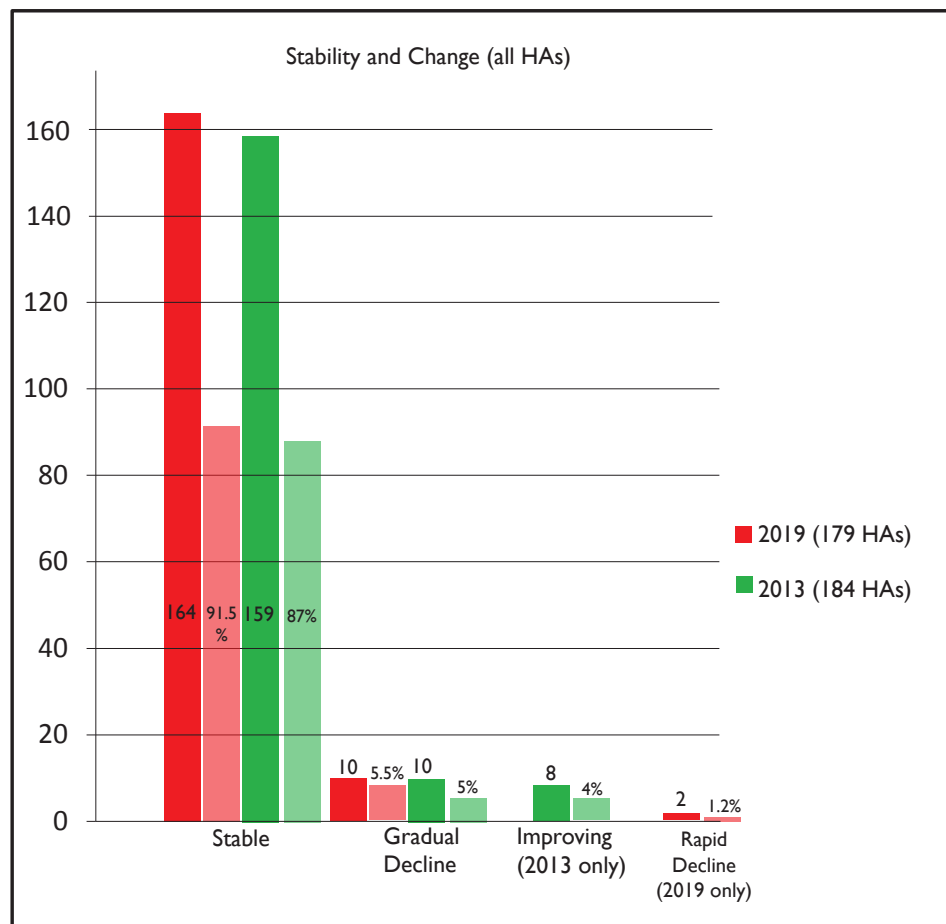
Fig. 2 Graph presenting the statistics and percentages for stability and change for all heritage assets (HA) recorded in Willsworthy TA 2013 and 2019.

In 2019, 164 (90%) of the total sample (179) remain in a stable condition, while 10 (5.5%) are reported as in gradual decline, in most cases this is due to very insignificant patches of erosion or minor threats. Zero assets may be seen to be improving, as no measures have been in place, but two have been moved to the rapid decline category (see below).

The figures are summarized in Table 2 and Fig. 2, which includes the statistics from previous surveys for comparison and represent an increase of 4.5% in the total number of heritage assets reported to be in a stable condition, while those considered to be in gradual decline has reached equilibrium, which indicates a generally positive direction of travel for the aggregate statistics within this TA.

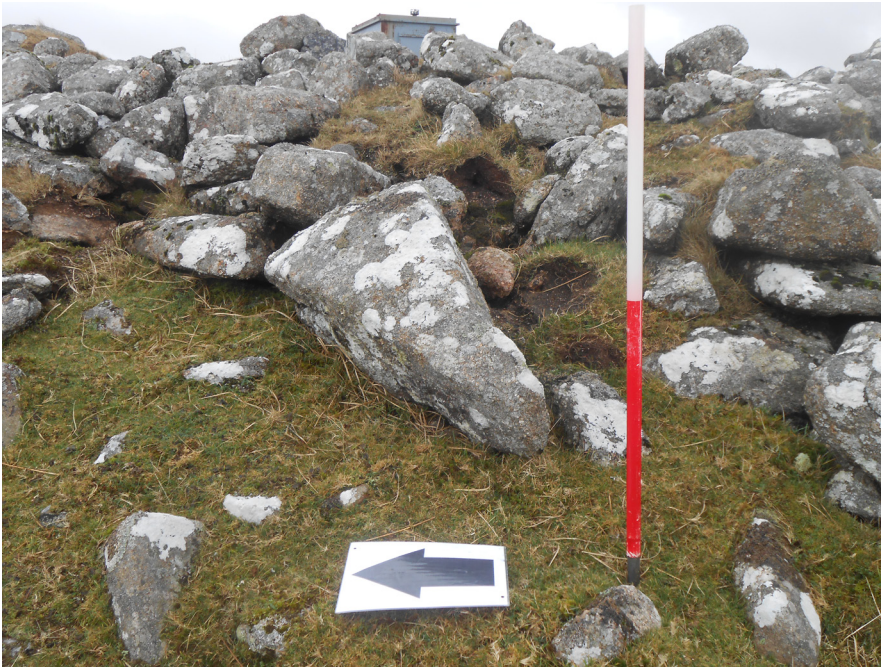
Fig 3. 440627. The tor cairn on Standon Hill showing details of stone removed from the fabric of the cairn.

All but one SM in Willsworthy TA is in a stable state. The exception is the large tor cairn on Standon Hill (**440627**; SM No. 1016253), which has very recently been disturbed by persons unknown, removing stones from the cairn to construct a wall beneath a nearby overhanging rock, to build a shelter. Demolition of the shelter could be followed by returning the stones to the hollows from where they were removed to restore this damage, which although not severe, the presence of the shelter could encourage others to augment its walls and escalate the problem.

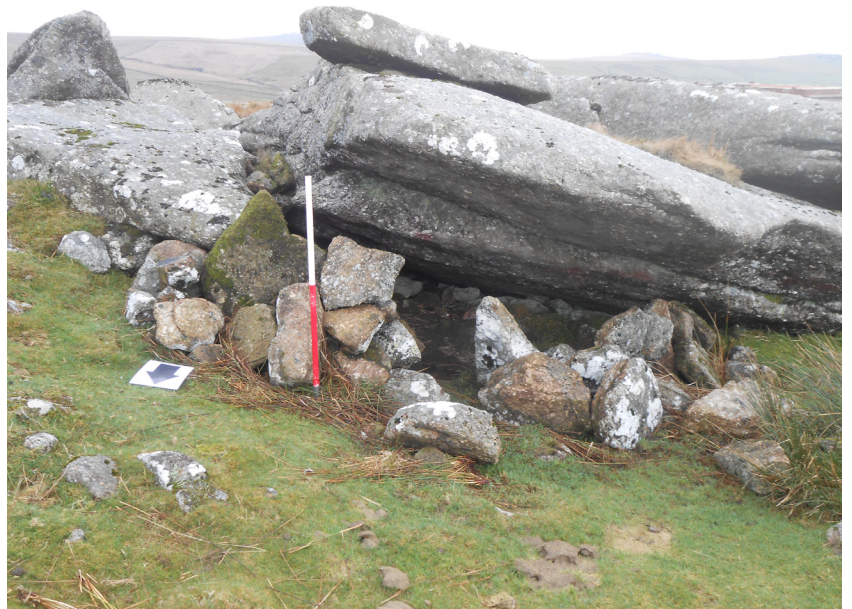
Fig 4. 440627 The tor cairn on Standon Hill showing details of a recent shelter built nearby from material robbed from the cairn.

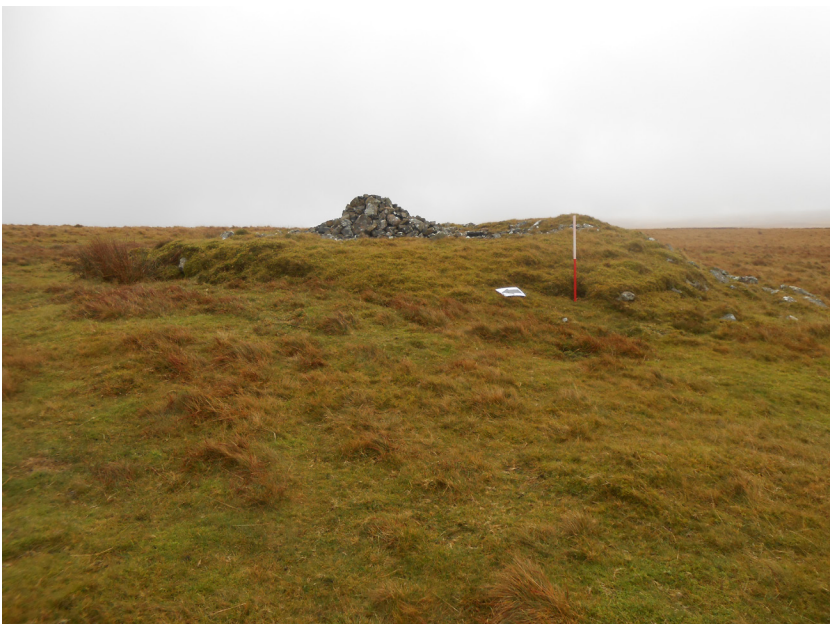
Fig 5. 440579 A small cairn to the north of Hare Tor, with un-authorised modifications.

A large cairn to the west of Hare Tor (**440579**) has been reported in previous condition reports as having suffered interference, whereby a secondary stony cairn has been constructed within the main turf-covered cairn. Despite remedial action following the 2007 survey, the interference continued and the stony cairn had reappeared by 2013 and has remained stable since then. A further intervention could restore the cairn but would not prevent the continued interference. It may be more practical to leave the illegitimate cairn in place and re-assess the condition at the next survey cycle rather than continuously moving the stone about.

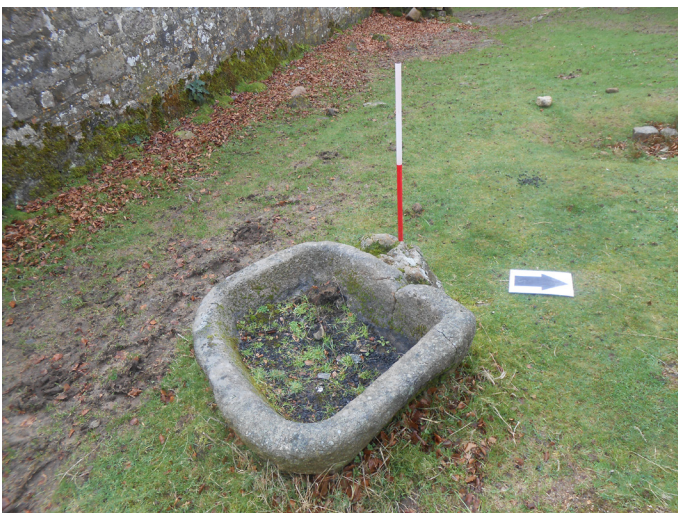
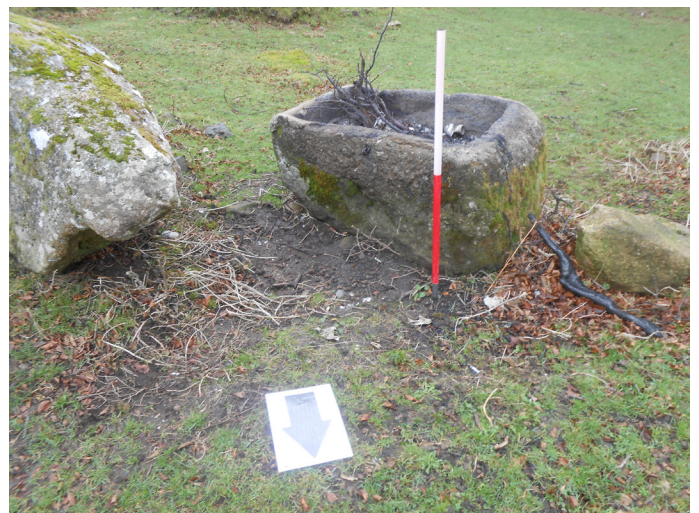
Figs 8 and 9. Granite troughs (1149362; 1135491) in courtyard of Standon Farm, showing evidence for use as barbecue pits. Both now have fresh hairline fractures as a result.

Two stone troughs (**1149362**; **1135491**) in the yard of Standon Farm are still being used as barbecue pits which is causing heat damage and fresh cracks are visible. This was reported in 2013 but continues. The culprits may be members of the public, but perhaps more likely military personnel using the accommodation at the farm, in which case measures should be taken to stop this activity, perhaps by provision of an information sheet inside the accommodation.
