Archaeological Sites within Okehampton Training
Area, Dartmoor National Park, Devon:
A condition survey on behalf of Defence
Infrastructure Organisation

February 2020

Survey and report by

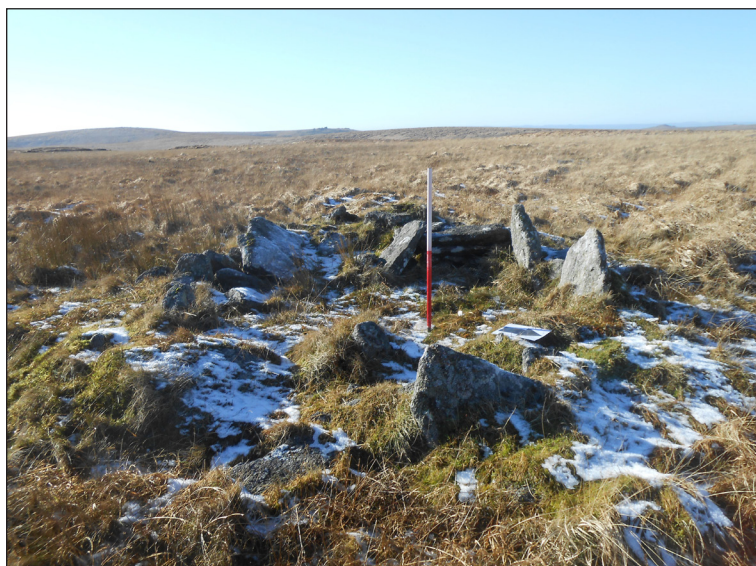
*Frontispiece: A possible hut circle on Whitehorse Hill
Cover picture: A prehistoric cairn on Fordsland Ledge*

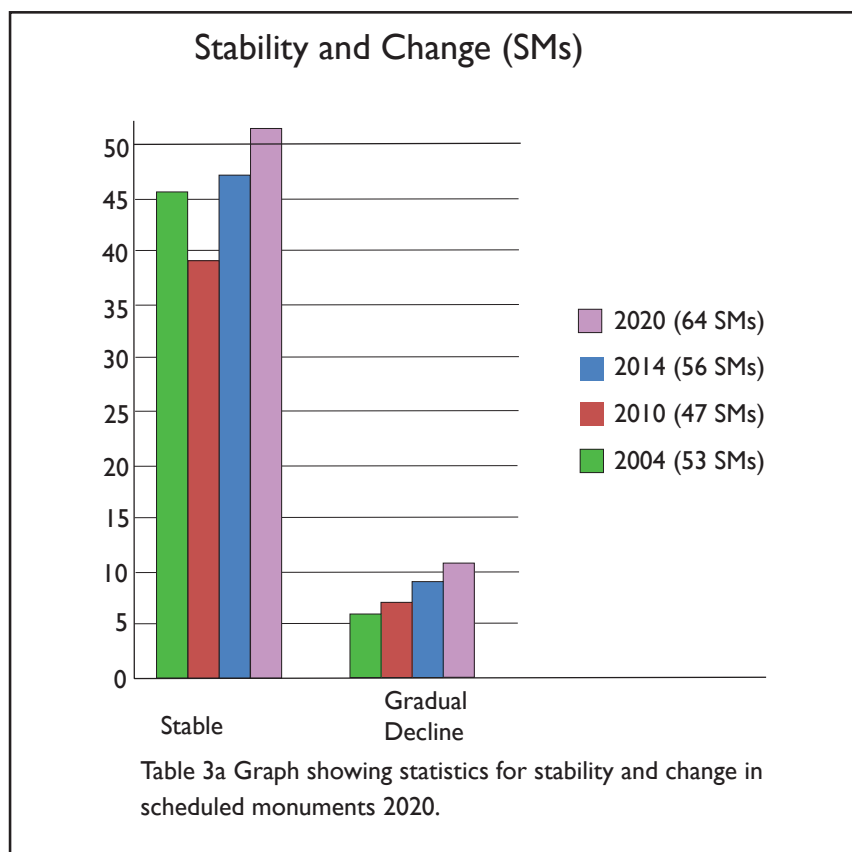
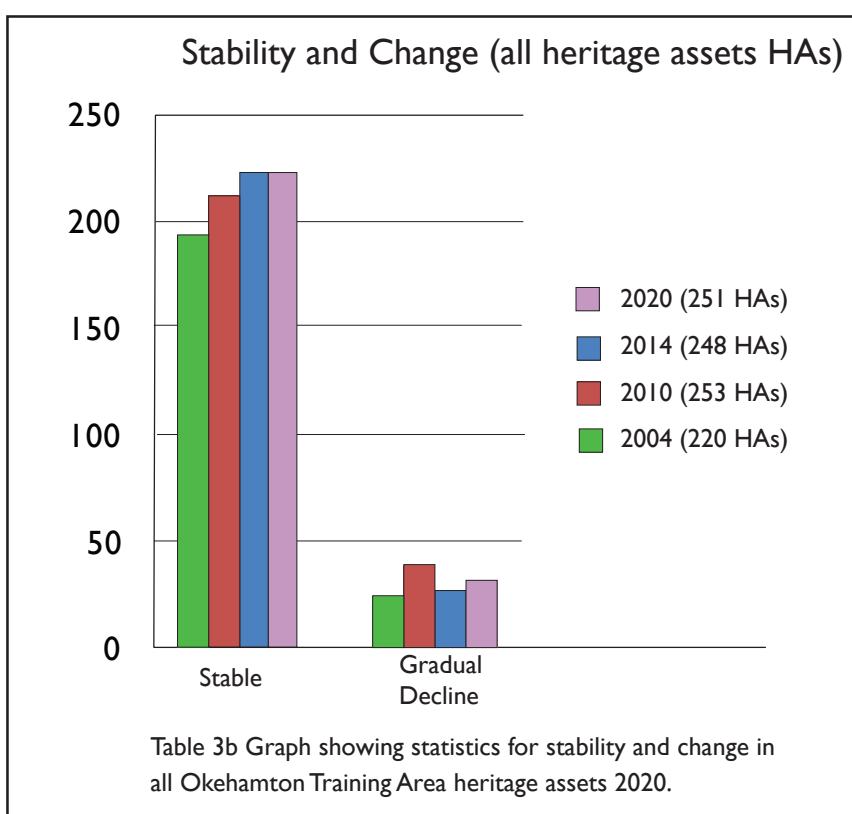
This varies only very slightly from the 2014 record. The number rated as 'Poor' is falsely high due to eleven military observation posts in the list which were demolished some decades ago. Discounting these would reduce the total somewhat. For all assets rated as Poor, this can be regarded as a legacy condition and in no instance as a result of recent disturbance.

Since the last survey of 2014, a boundary stone (SWLI030) has been removed, presumed stolen, by persons unknown. The DNPA HR team are aware of this problem.

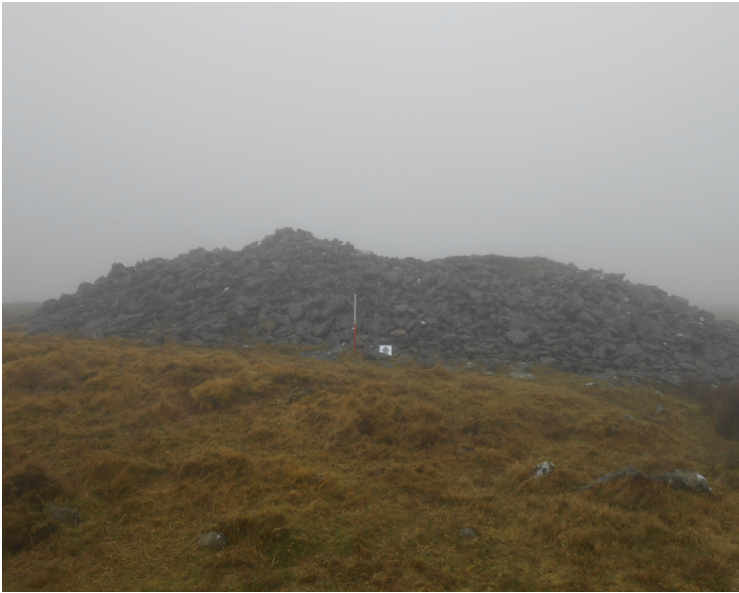
Description: A prehistoric round cairn on the ridge to the south of Watern Tor. This stony cairn is among the largest of its type within OTA, and although suffering interference to the loose stone of its upper surface, much of this is legacy damage, which has created a hollowed appearance to the profile of the cairn. Interference continues, however, with the building of small cairns from the fabric of the main pile. This is difficult to combat but removal of existing stone piles may discourage further stacking of the stone. This feature needs to be discussed with the EH HEFA and a joint decision taken as to whether or not to act.

Fig 3 A large cairn on Watern Tor Ridge (43720) viewed from the south showing the artificially altered profile caused by unauthorised cairn building.

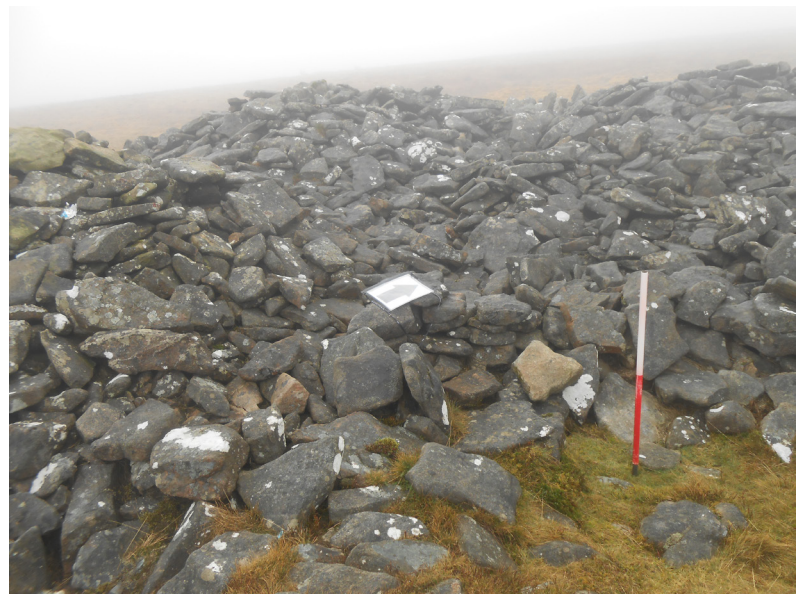
Fig 4 The interior of the above cairn showing shelter walling and mounding.

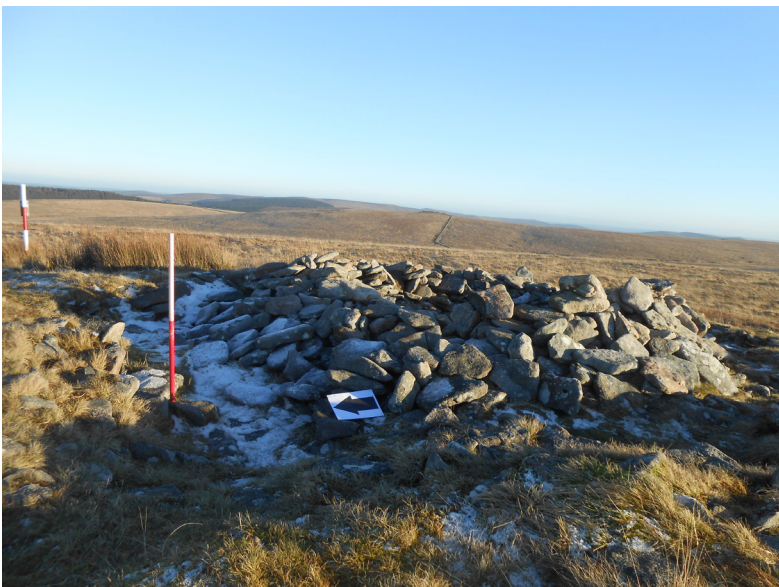
Description: The remains of a large, stony, prehistoric cairn located on the southern tip of Whitehorse Hill. Stone, originally part of the monument's fabric, has been removed and used to construct a circular shelter on top of the mound by persons unknown. The removal of this stone has already disturbed the integrity of the cairn and if this continues, additional stone currently making up the original mound, will also become removed, risking further damage and exposure of archaeological layers beneath.

Fig 5 The cairn at Quintin's Man, showing a substantial circular structure built onto the upper surface of the mound.

It is suggested that this additional circular structure should be recorded, then carefully removed, and the stone used to remodel the cairn. This process has previously been achieved successfully on Dartmoor via the English Heritage Historic Environment Field Advisor (HEFA), based at Dartmoor National Park HQ, with manpower provided by volunteers. It is strongly recommended that liaison between the MoD, DNPA and EH could bring a positive outcome to the management of this heritage asset. NB: this problem and suggested course of remedial action was also reported on the condition survey of 2014.
