## **Construction noise and vibration Monthly Report – July 2021**

### **Buckinghamshire**

# Non-Technical Summary

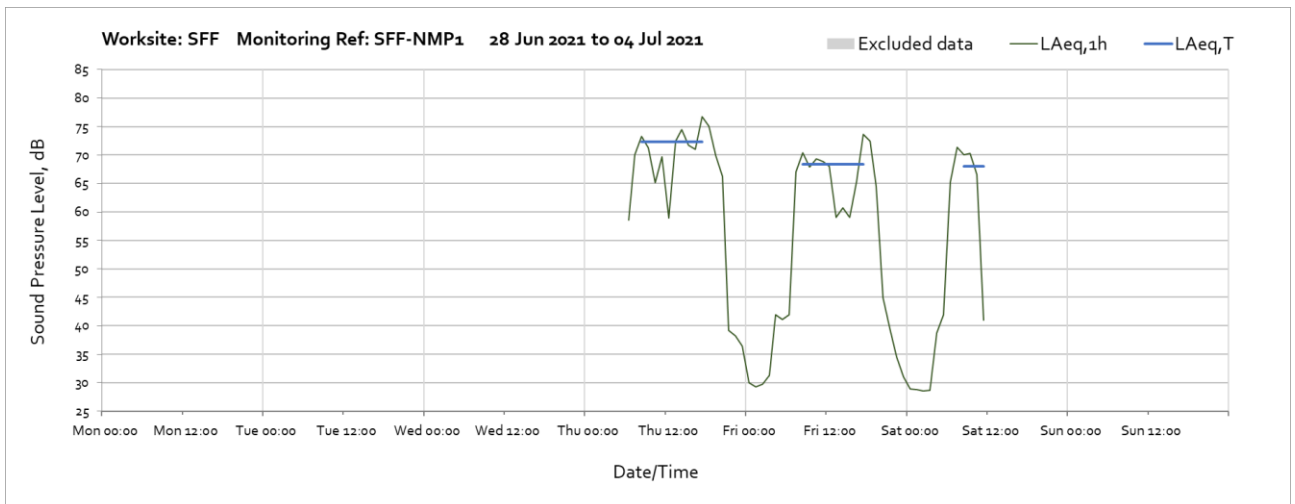
**Worksite: SFF – Monitoring Ref: SFF-NMP1**

Note: Missing data between 00:00 and 06:00 on Thursday 1<sup>st</sup> of July and between 12:00 on Saturday 3<sup>rd</sup> July and 07:00 on Monday 5<sup>th</sup> July was due to loss of continuous site power to the equipment.

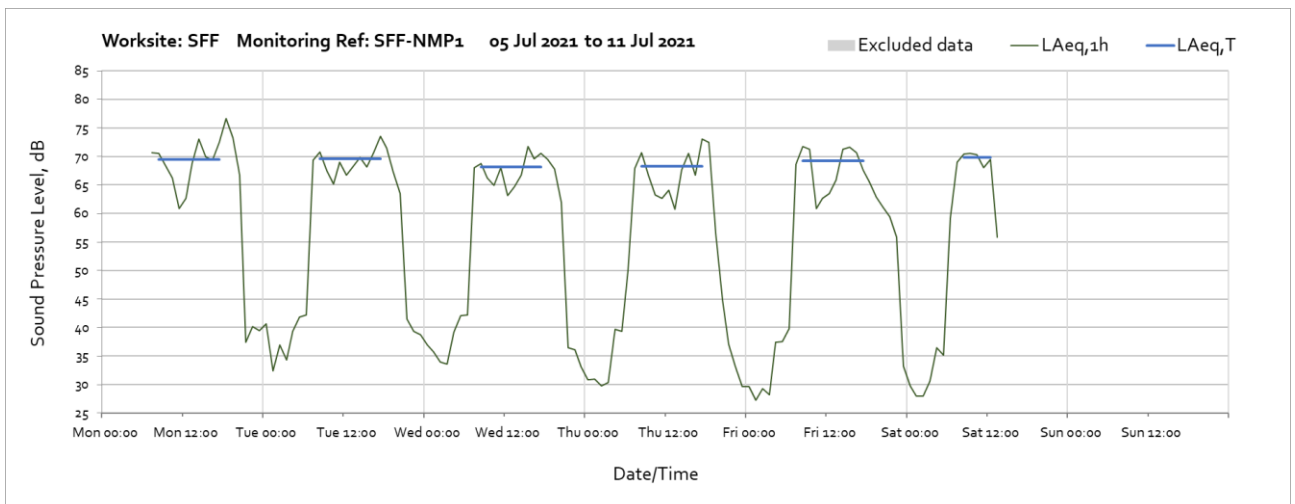
Note: Missing data between 14:00 on Saturday 10<sup>th</sup> July and 07:00 on Monday 12<sup>th</sup> July was due to loss of continuous site power to the equipment.

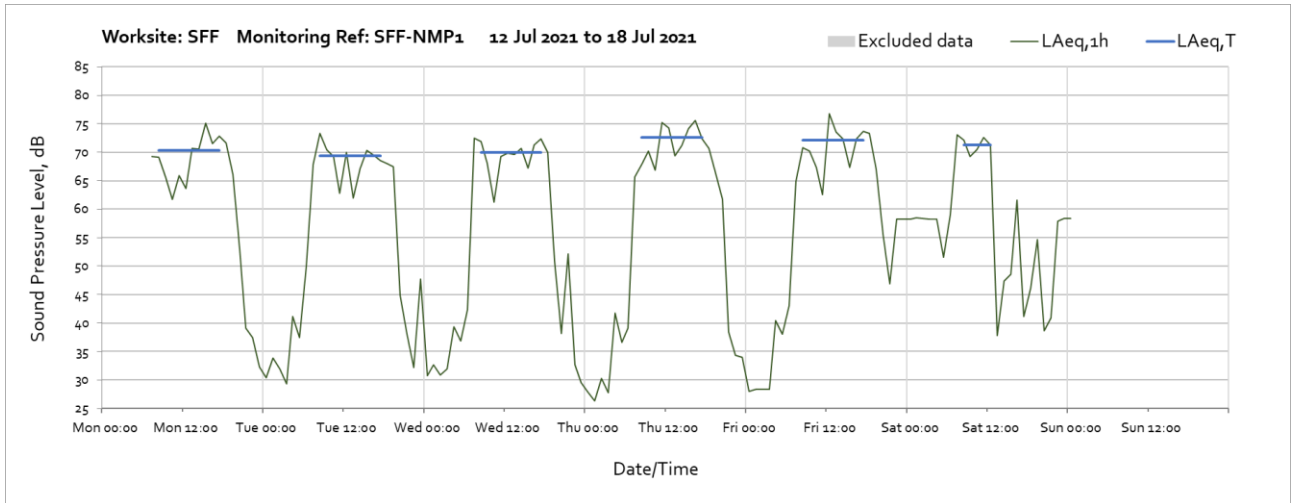
Note: Missing data between 01:00 on Sunday 18<sup>th</sup> July and 07:00 on Monday 19<sup>th</sup> July was due to loss of continuous site power to the equipment.

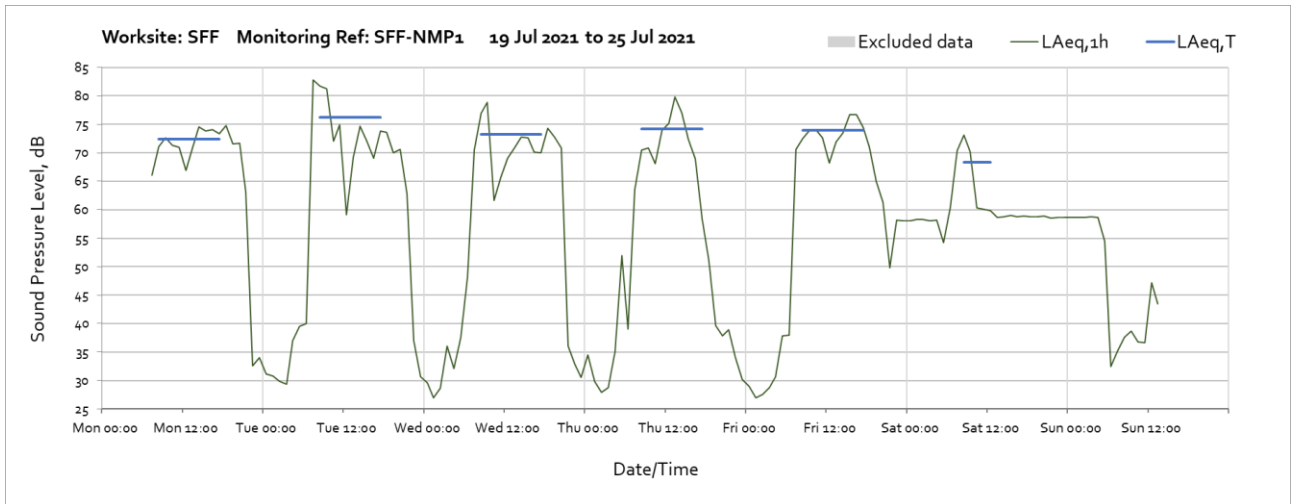
Note: Missing data between 14:00 on Sunday 25<sup>th</sup> July till the end of the month was due to loss of continuous site power to the equipment.

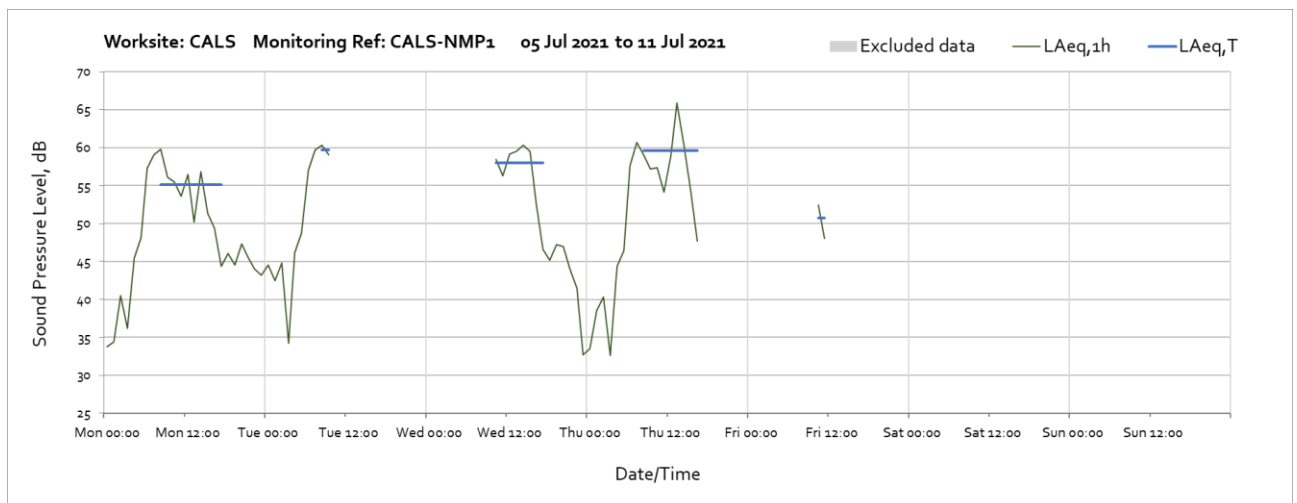
## Worksite: CALS – Monitoring Ref: CALS-NMP1

Note: Missing data between 10:00 on Tuesday 6<sup>th</sup> July and 12:00 on Tuesday 27<sup>th</sup> July was due to insect infestation causing equipment error.

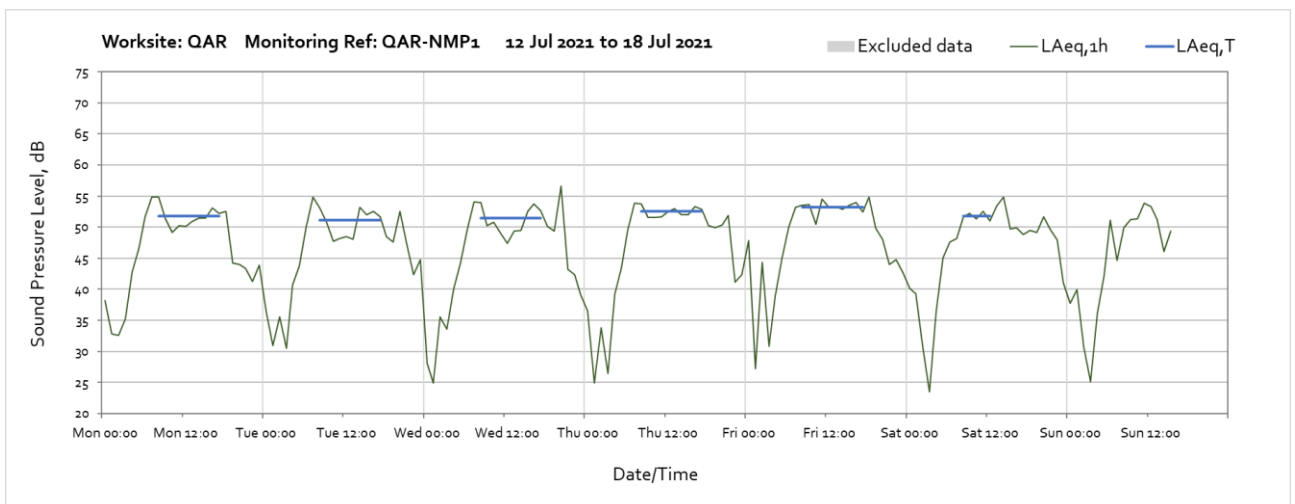
## Worksite: QAR – Monitoring Ref: QAR-NMP1

Note: Missing data between 16:00 on Sunday 18<sup>th</sup> July and 00:00 on Monday 19<sup>th</sup> July was due to loss of power to the monitor.

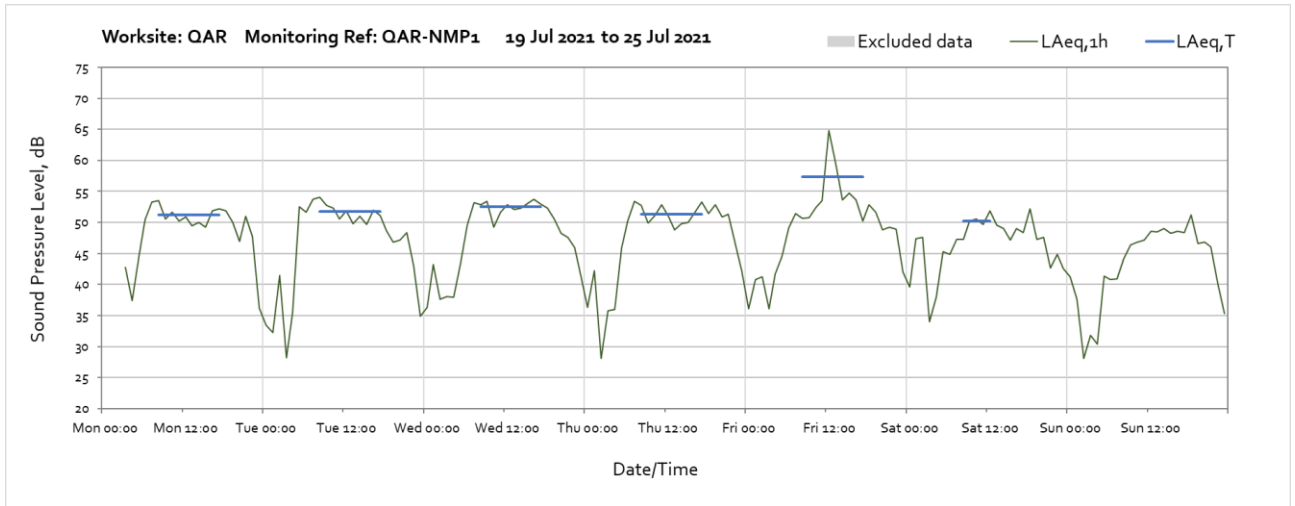
Note: Missing data between 00:00 and 03:00 on Monday 19<sup>th</sup> July was due to loss of power to the monitor.

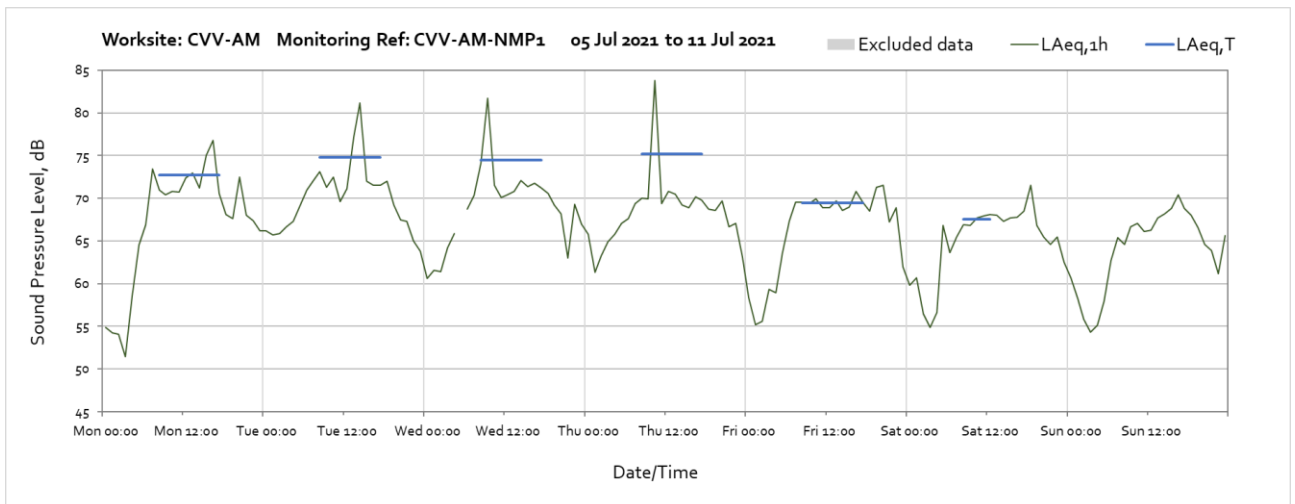
## Worksite: AM – Monitoring Ref: AM-NMP1

Note: Missing data between 05:00 and 06:00 on Wednesday 7<sup>th</sup> July is due to loss of connection to the monitor.

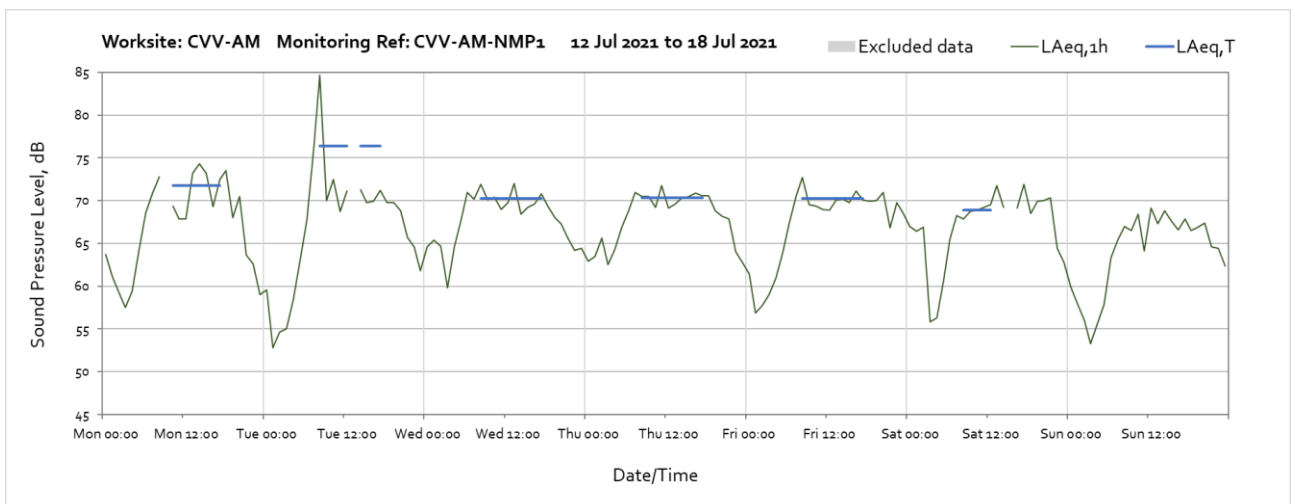
Note: Missing data between 09:00 and 10:00 on Monday 12<sup>th</sup> July, between 13:00 and 14:00 on Tuesday 13<sup>th</sup> July and between 15:00 and 16:00 on Saturday 17<sup>th</sup> July are due to loss of connection to the monitor.

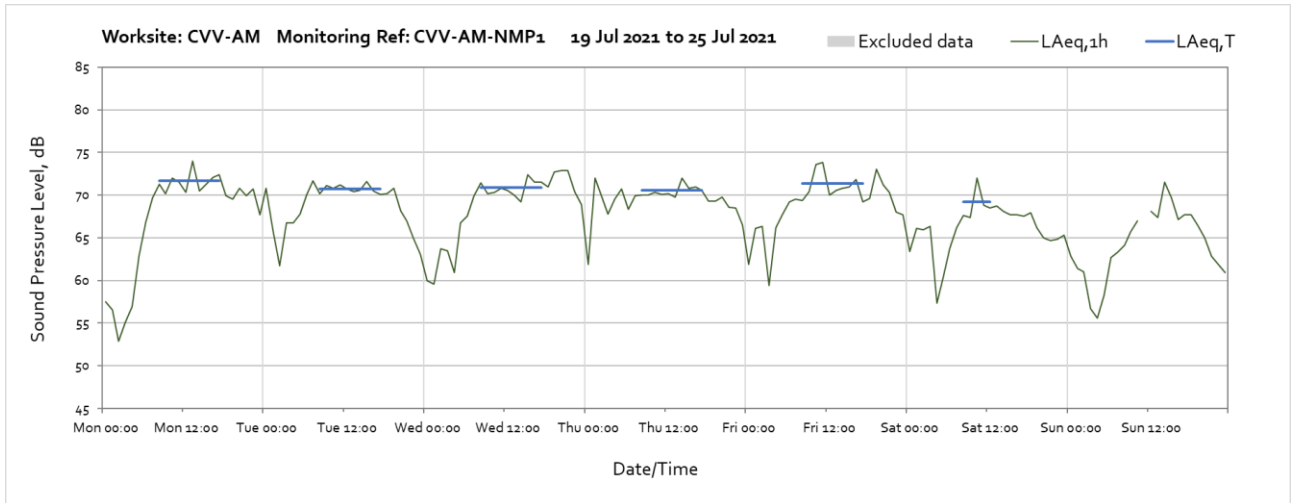
Note: Missing data between 11:00 and 12:00 on Sunday 25<sup>th</sup> July is due to loss of connection to the monitor.

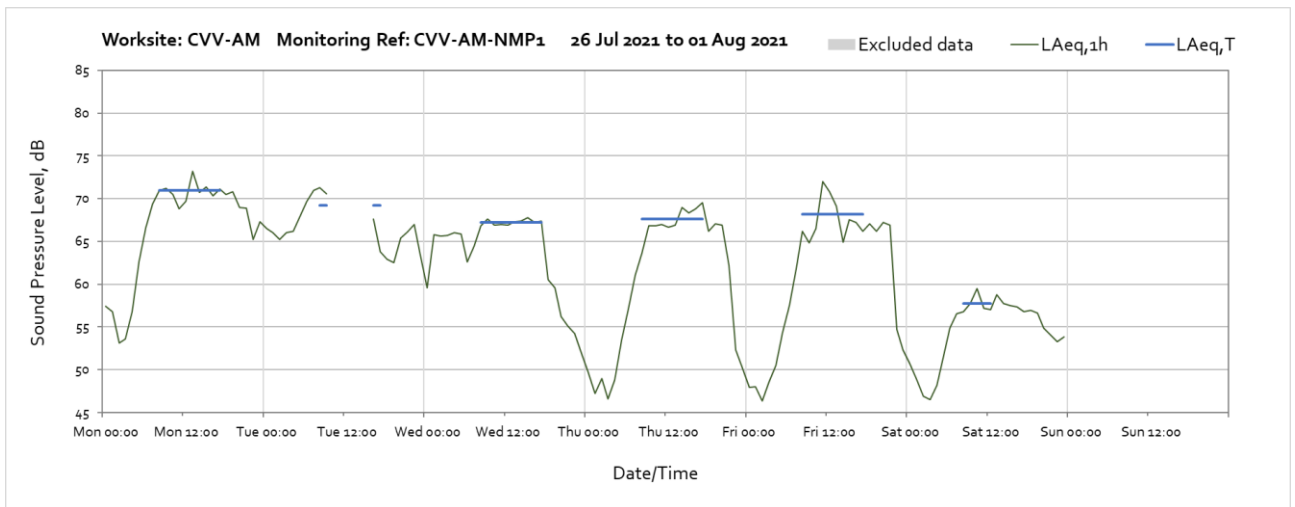
Note: Missing data between 10:00 and 16:00 on Sunday 27<sup>th</sup> July is due to monitor being paused for relocation.

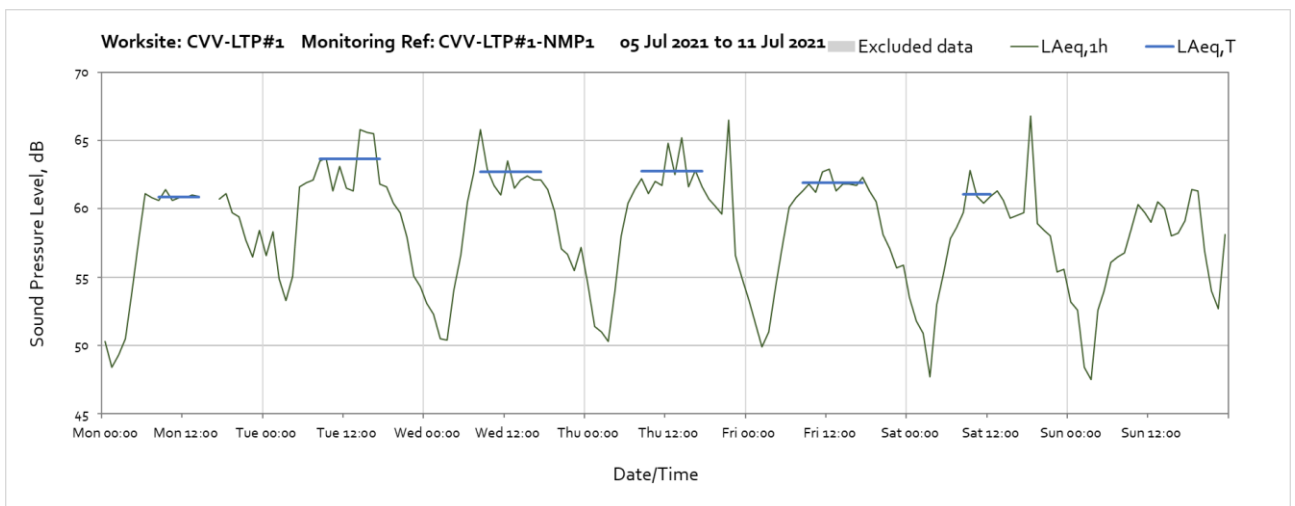
## Worksite: CVV-LPT#1 – Monitoring Ref: CVV-LPT#1-NMP1

Note: Missing data between 15:00 and 17:00 on Monday 5<sup>th</sup> July is due to monitor being paused for setting updates.

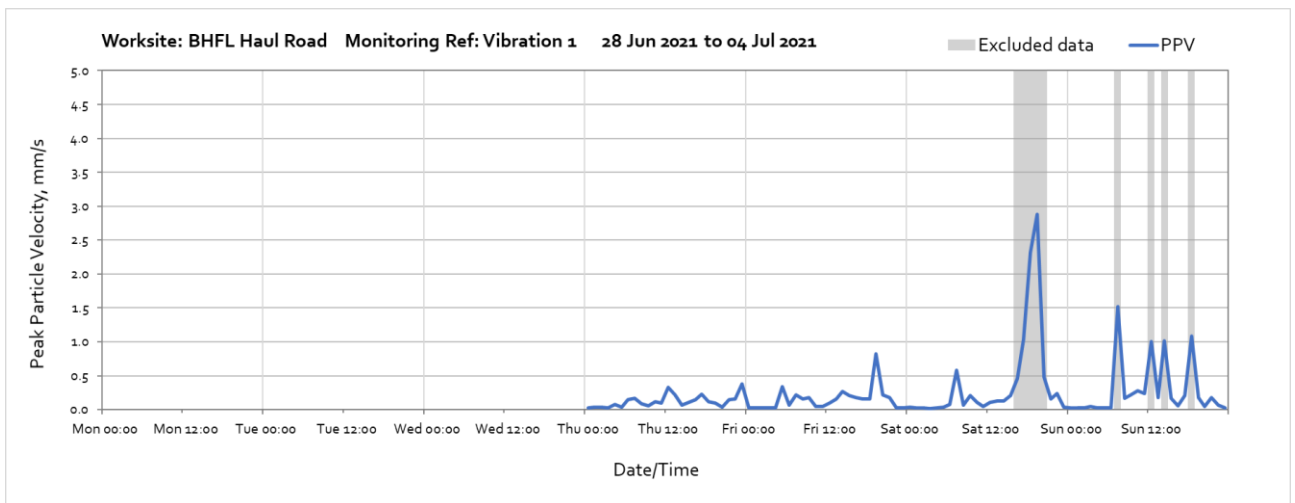
## Worksite: BHFL – Monitoring Ref: BHFL-Vib 1

The following graphs show the hourly measured peak particle velocity PPV recorded during the monitoring period. The graphs show the highest PPV of the three orthogonal axes x, y and z. Where high values of PPV were caused by local interference with the vibration monitor, which are not representative of HS2 construction works, these values have been greyed out in the following charts and have been excluded to calculate values in Table 4 of the main report.

Note: High levels of vibration measured throughout the week were due to local disturbance of the monitor and are not representative of HS2 construction vibration levels.

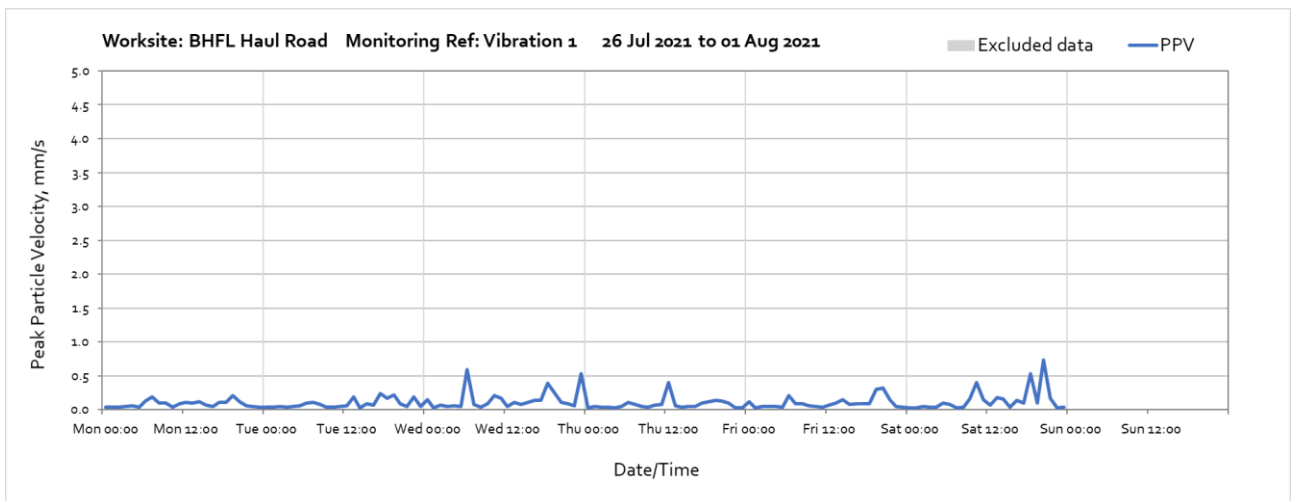
Note: High levels of vibration measured throughout the week were due to local disturbance of the monitor and are not representative of HS2 construction vibration levels.
