Construction noise and vibration Monthly Report – July 2021

London Borough of Camden

Non-Technical Summary

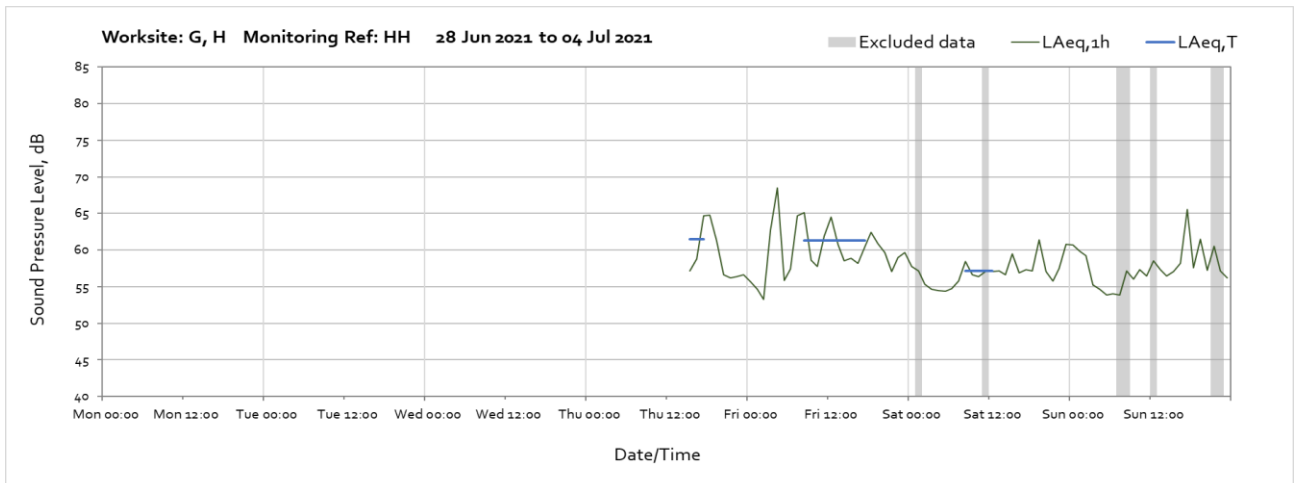
Worksite: G - Monitoring Ref: HH

Note: Missing data from the start of the month until 15:00 on Thursday 1st July was due to a monitoring station software error. The monitor will be exchanged for another unit as soon as is reasonably practical with view of minimising loss of data in the future.

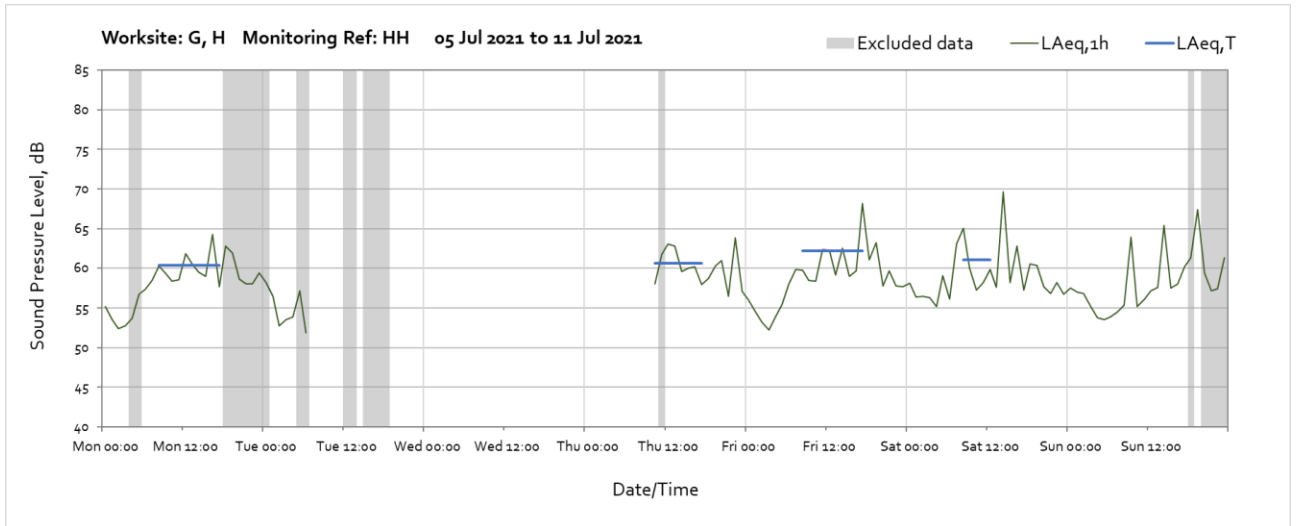
Note: Missing data from 07:00 on Tuesday 6th July until 10:00 on Thursday 8th July was due to a monitoring station software error. The monitor will be exchanged for another unit as soon as is reasonably practical with view of minimising loss of data in the future.

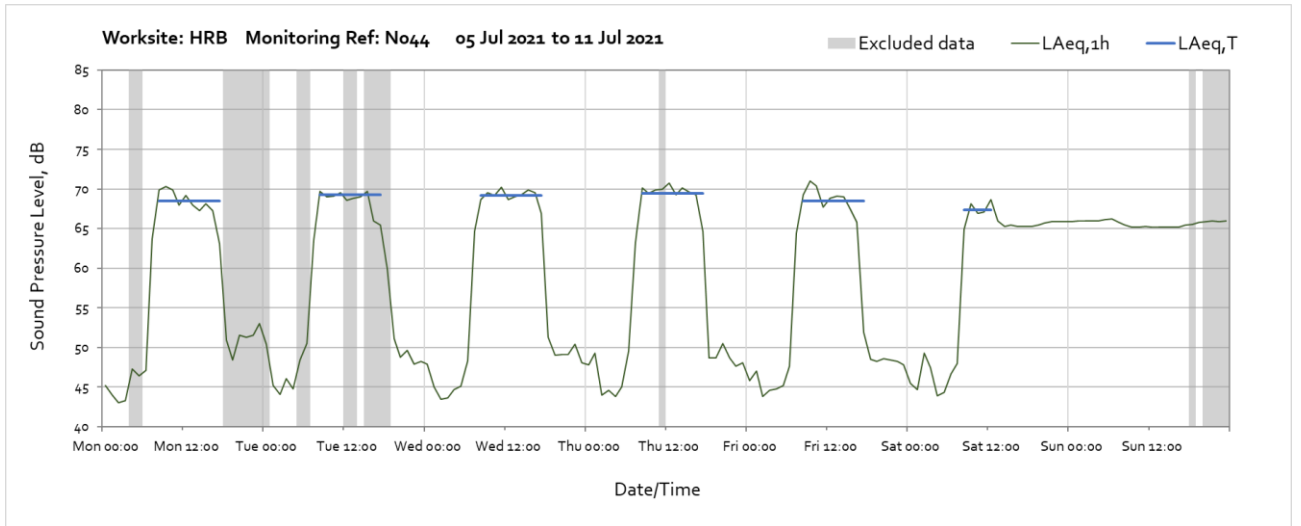
Worksite: HRB - Monitoring Ref: N044

Note: Continuous noise levels from 14:00 on Saturday 10th July until 02:00 on Monday 12th July were not caused by HS2 construction plant equipment.

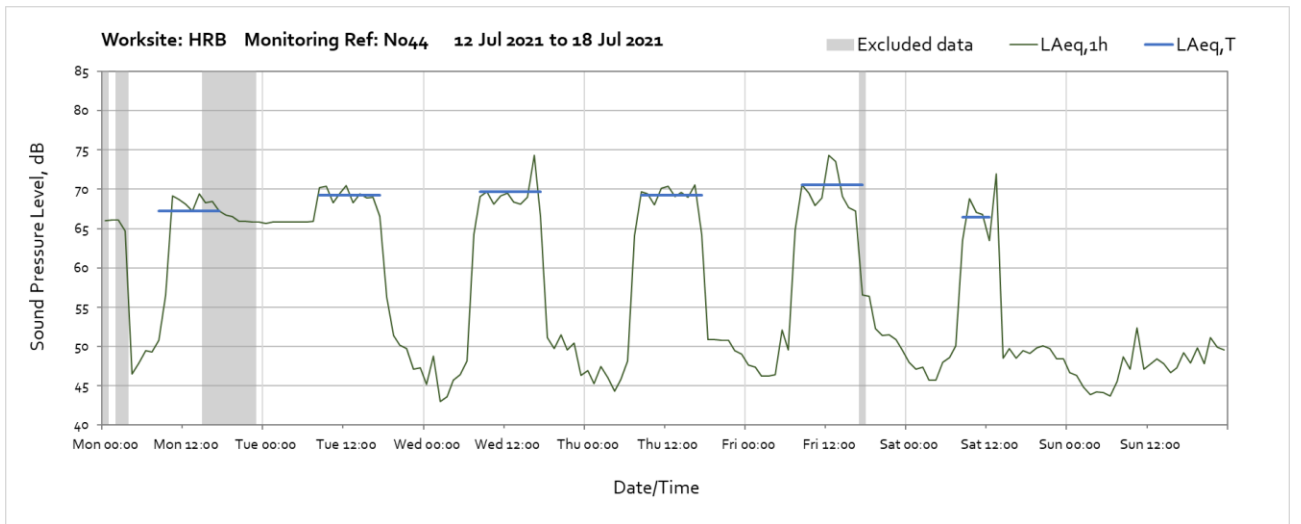
Note: Continuous noise levels from 14:00 on Saturday 10th July until 02:00 on Monday 12th July were not caused by HS2 construction plant equipment.

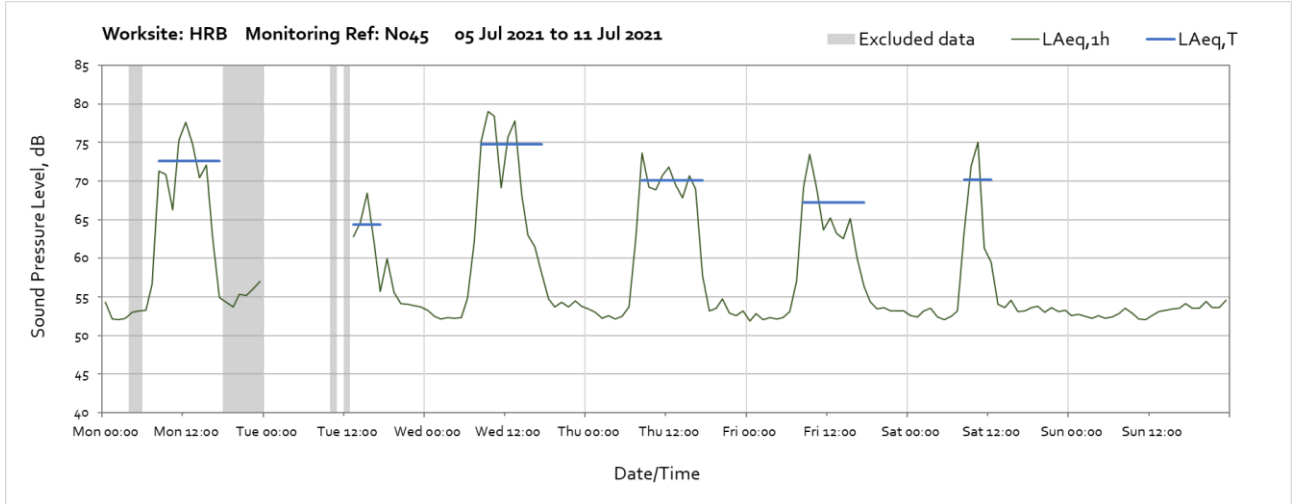
Worksite: HRB – Monitoring Ref: N045

Note: Missing data from 00:00 until 13:00 on Tuesday 6th July was due to a fault with the monitoring station whereby the monitor stopped measuring data and did not restart. The memory card was reformatted with view of minimising future data loss.

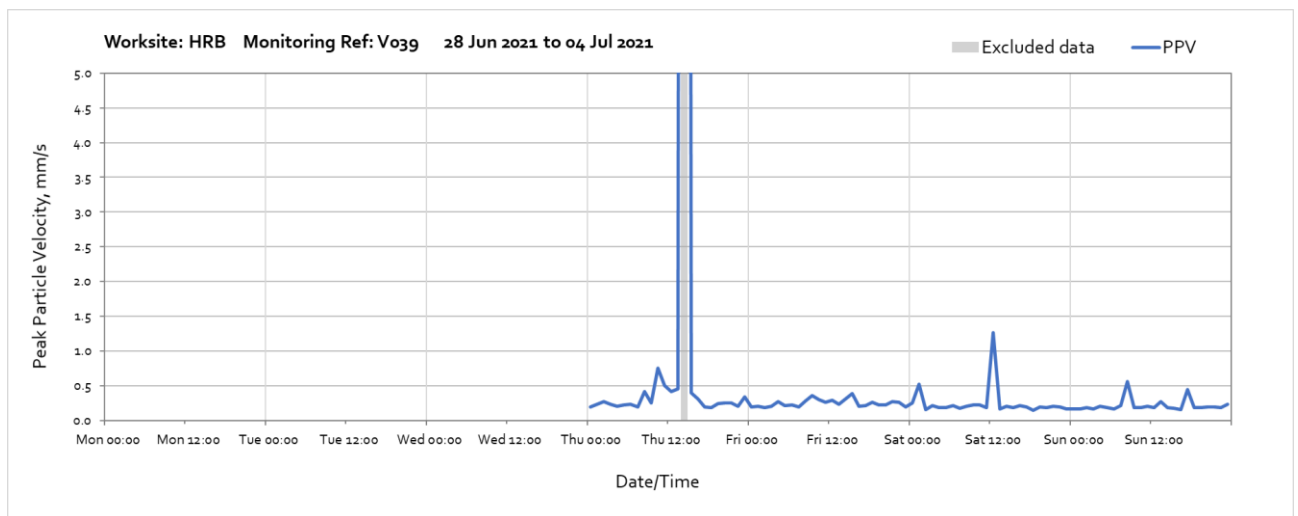
Worksite: HRB – Monitoring Ref: V039

Note: High vibraton levels measured from 14:00 until 15:00 on Thursday 1st July were due local intereference of the monitor and are not representative of HS2 vibration levels at the receptor.

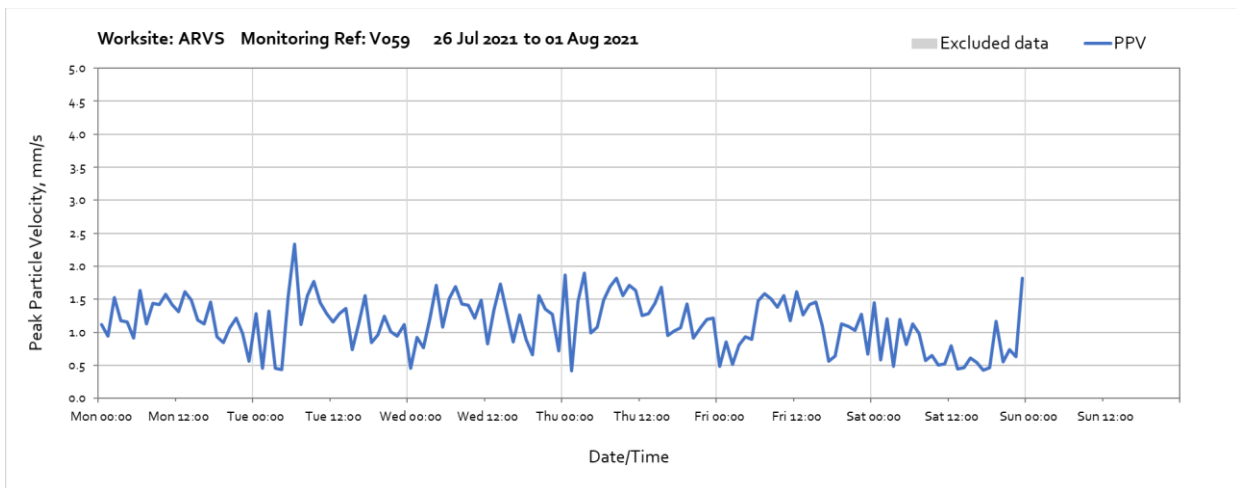
Note: High vibration levels measured throughout the week were due to local interference of the monitor and are not representative of HS2 vibration levels at the receptor.
