Decommissioning Close out Report

HEWETT INSTALLATION 48/29B

VENT STACK REMOVAL AND PREPARATION WORKS

June 2021

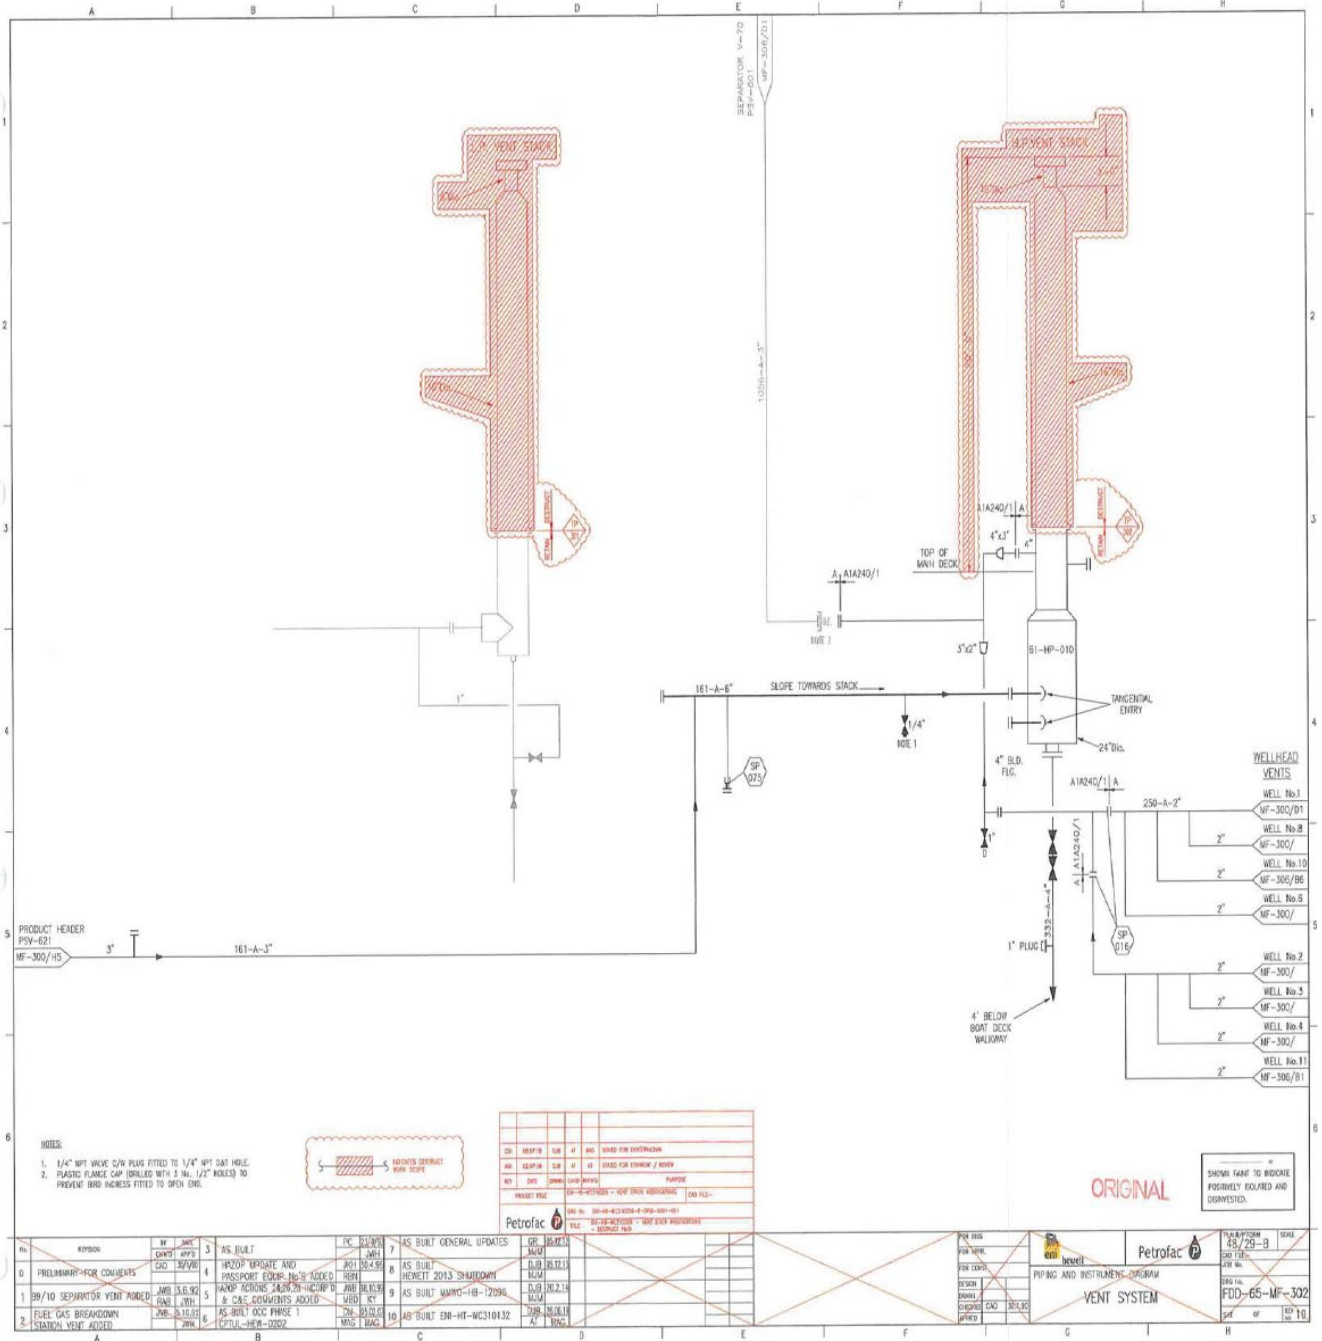
1.4 Schematic of Installation Being Decommissioned

The decommissioned element of the vent stack is shown marked up in Red.

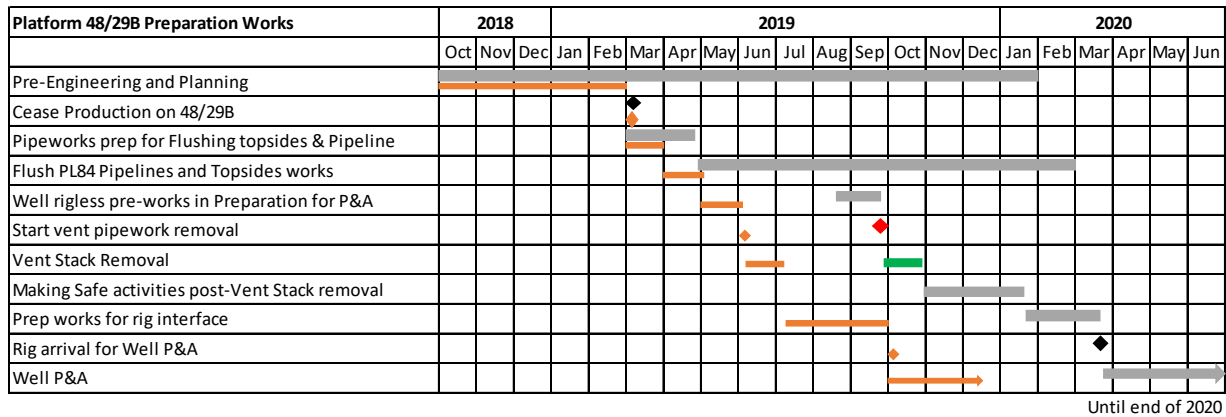
1.5 Gantt chart / Actual completion dates against approved schedule

The above schedule shows estimated activity and actual completion dates of work outlined in the approved DP schedule.

COP on 48/29B was achieved on 1st March 2019 after which the preparation works for topsides and pipeline flushing could commence. PL84 was flushed and the topsides were flushed, purged and air-gapped to remove hydrocarbons. Redundant equipment was engineered down and preparation works were carried out on the wells prior to P&A.

There was a minor delay in the removal of the vent stacks against the plan due to lack of readiness (detailed engineering) which led to the postponement of the start of activity to September 2019 to be executed during the annual planned shutdown. However during the shutdown, critical activities (integrity related) took priority and resources were required to address those criticalities deferring this work to October 2019.

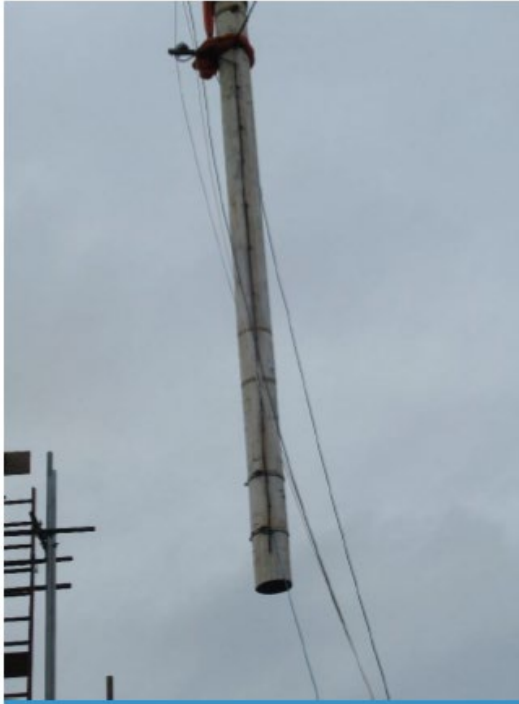
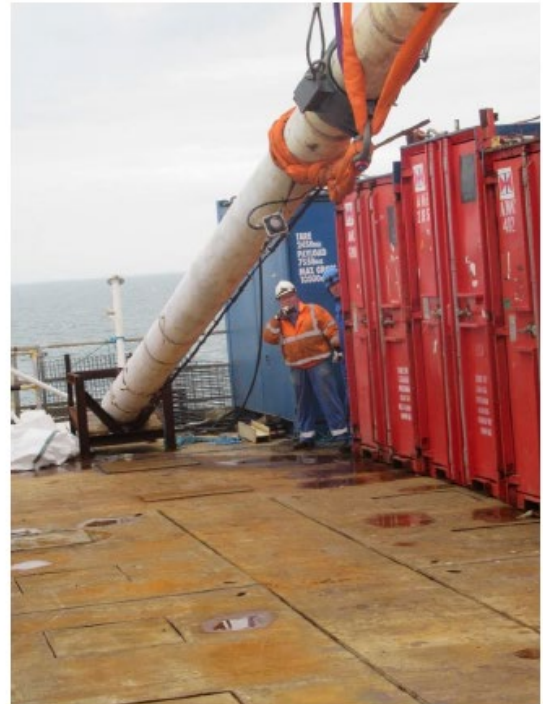
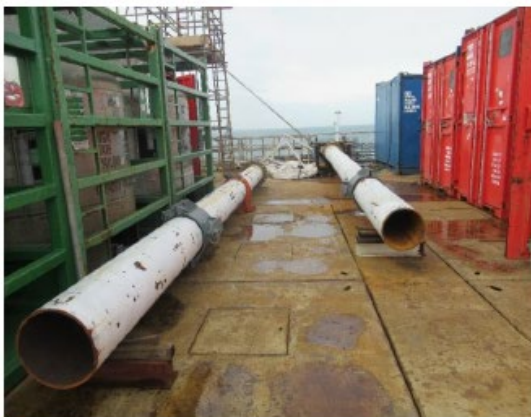
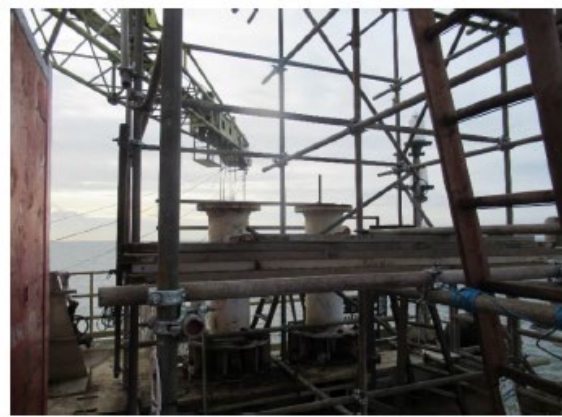
Figure 1 - Vent Stack during removal, lifting, laydown and post-removal

* The original DP had an estimate of removed weight of 8.4 tonnes as the full weight of the vent stacks from the platform weight reports. However the bottom pieces of the vent stacks below the flanges were left in place to avoid the need for cutting and welding around the deck plate. Hence the actual removed weight was 6.7 tonnes.

Table 1.3: Completed Decommissioning Activity against proposed decommissioning solution	
Removal for Recycling	<p>Vent Stack Removal Activities:</p> <ul style="list-style-type: none"> • Pre-rigging each vent pipe prior to cutting around 12m from the top of the stack; a single circular cut carried out [18-31 October 2019] • Top section removed by platform crane to lay-down area and cradles. [18-31 October 2019] • Remaining section split at the bottom flange and removed by crane to laydown area. [18-31 October 2019] • The operation was repeated for the remaining stack. [18-31 October 2019] <p>The cut sections back loaded onto a supply vessel for transport to shore and recycling via the normal operations waste management channels through ASCO : CBDU151798 [02 November 2019]</p>
