Air Quality and Dust Monitoring Monthly Report – August 2021

Buckinghamshire Council

A report prepared by EWCs and MWCCs on behalf of HS2 Ltd.

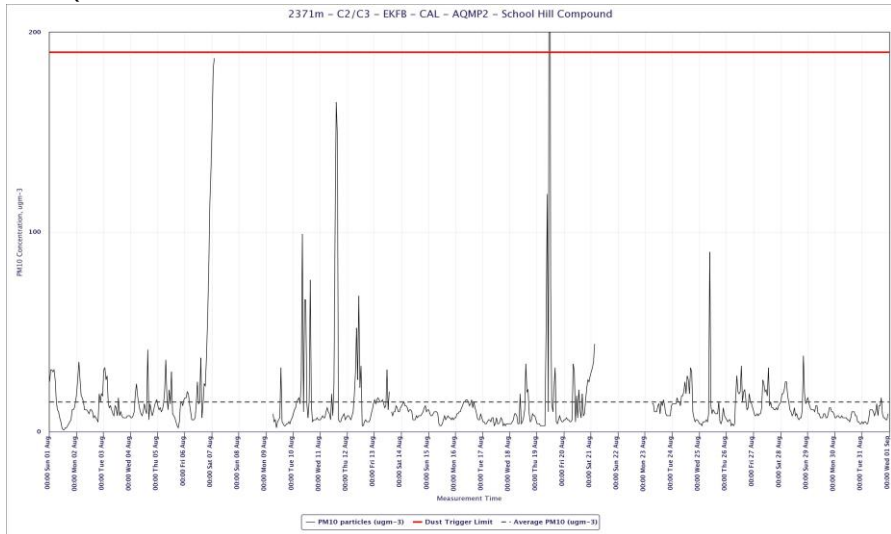
CAL-AQMP2	469003, 224740	School Hill Compound	M	Yes	Yes	14.9	1.2	445.4	1	86.3
School End – Dust	463666, 230049	School End, Chetwode	M	Yes	Yes	5.7	1.0	82.0	0	66.1
Chetwode/Hermitage – Dust	463936, 229521	Hermitage, Chetwode	M	Yes	Yes	4.7	1.0	27.0	0	100.0
Rosehill Farm – Dust	464368, 228939	Old Stable Cottage, Rosehill Farm, Chetwode	M	Yes	Yes	9.0	1.5	108.2	0	96.05
South Heath – Dust	490534, 202014	Bury Farm, South Heath	M	Yes	Yes	4.4	1.0	11.0	0	99.5

- 1.1.8 Data capture for multiple monitors was below 90% for the month of August 2021. The data loss at Elm Tree Cottage is due to ongoing power interruption. Missing data at CAL-AQMP2 was due to the monitor being turned off on weekends, while site was not active. Missing data at Grimms Ditch, NCA station 5 and NCA station 6 is due to it being installed on 23rd August 2021. The FCC Sidings monitor's low data capture was due to issues with tree cover over the solar panel, which is now backed up with batteries. The monitor at the School End worksite had low data because of power supply issues. All concerned issues have been or are in the process of being resolved.
