Construction noise and vibration Monthly Report – August 2021

Buckinghamshire

Non-Technical Summary

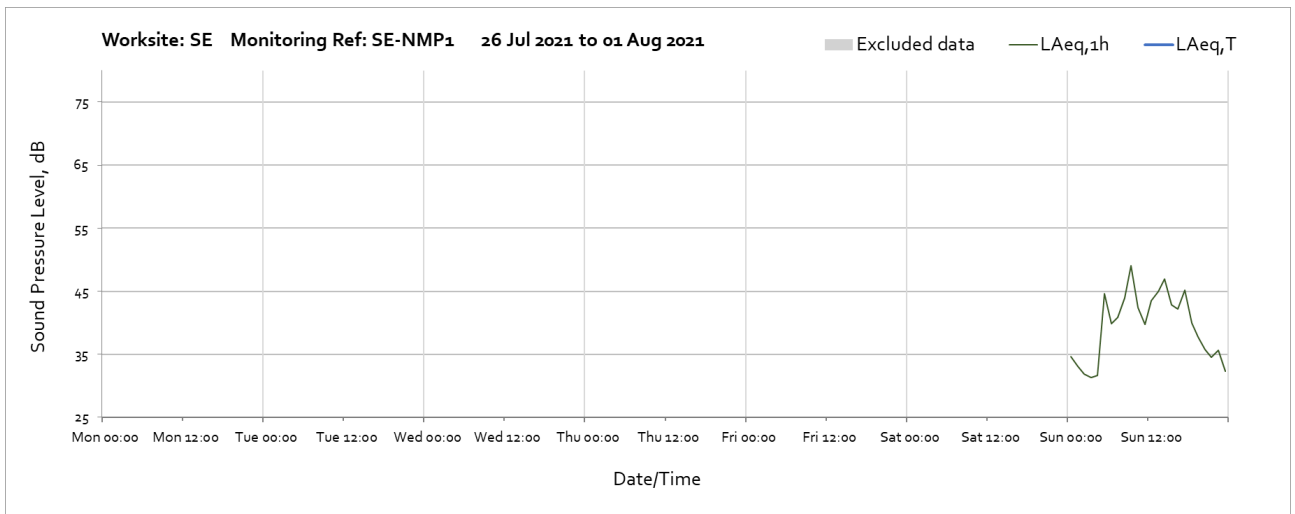
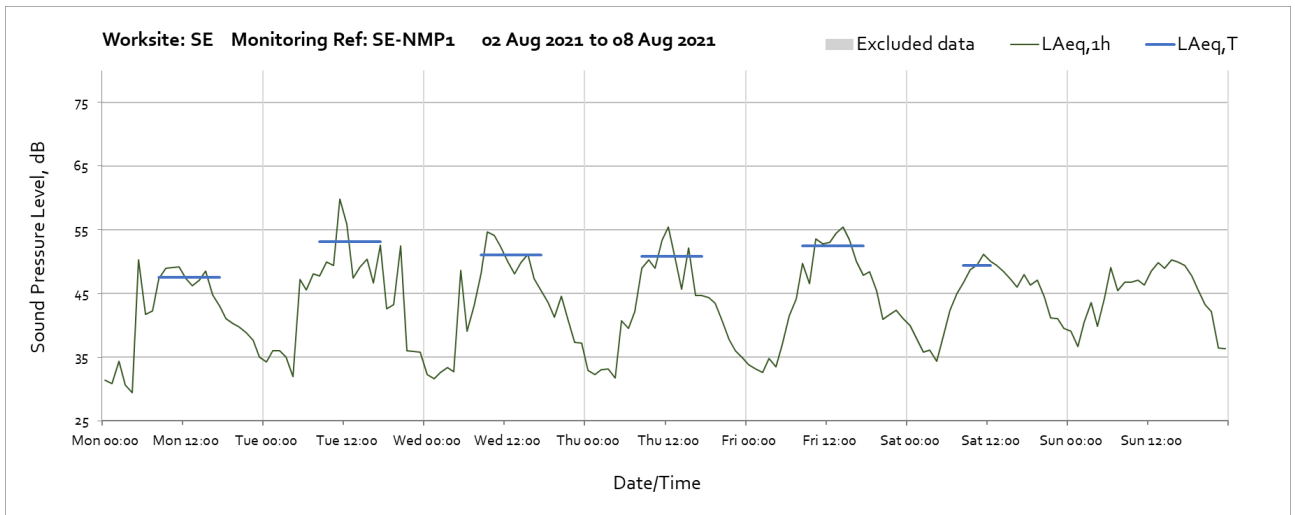
Worksite: SE – Monitoring Ref: SE-NMP1

The following graphs show the hourly measured ambient noise level $L_{Aeq,1h}$ and, where relevant, the averaged noise level $L_{Aeq,T}$ values, where the time period T is as specified in Table 1 of HS2 Information Paper E23. Periods with adversely weather affected noise levels are greyed out and have been excluded from the calculation of the $L_{Aeq,T}$ values in **Error! Reference source not found.** of the main report.

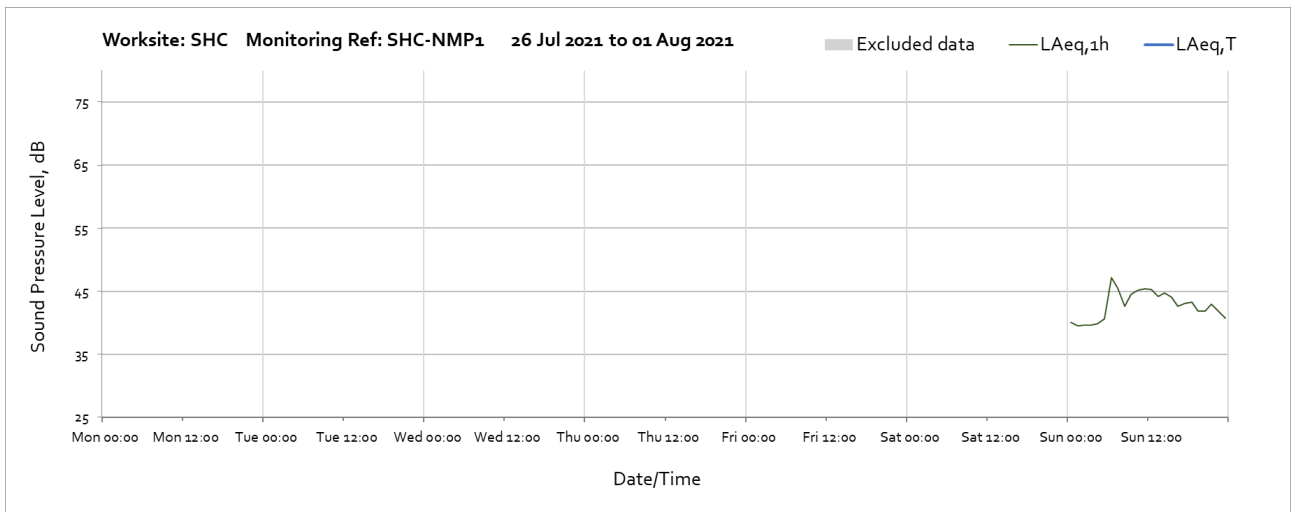
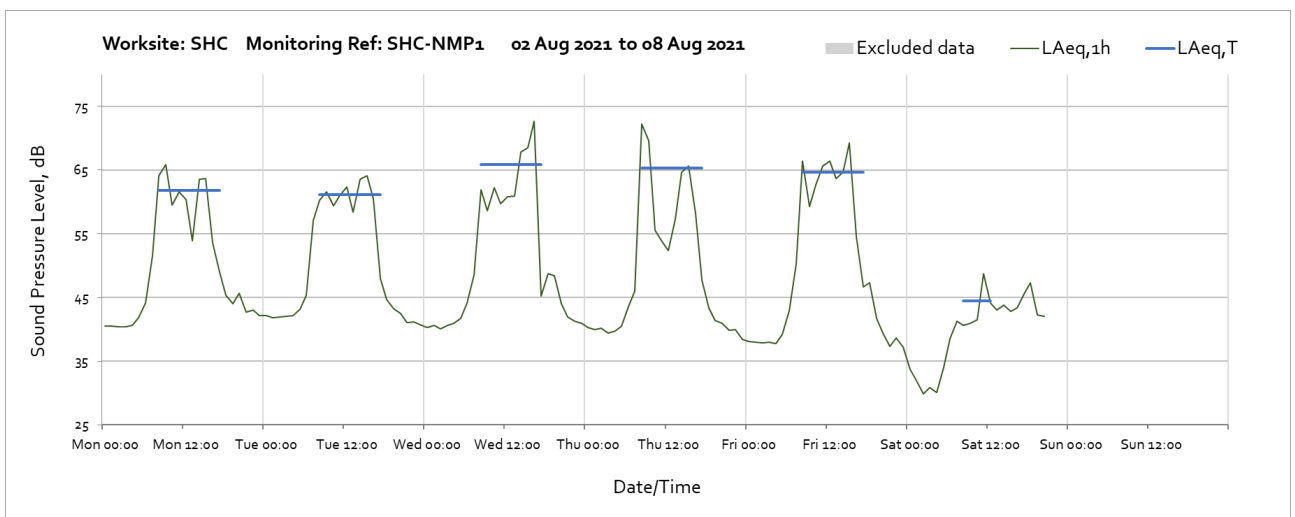
Worksite: SHC - Monitoring Ref: SHC-NMP1

Note: Missing data between 21:00 on Saturday 7th August and 05:00 on Monday 09th August was due to loss of continuous site port to the monitor.

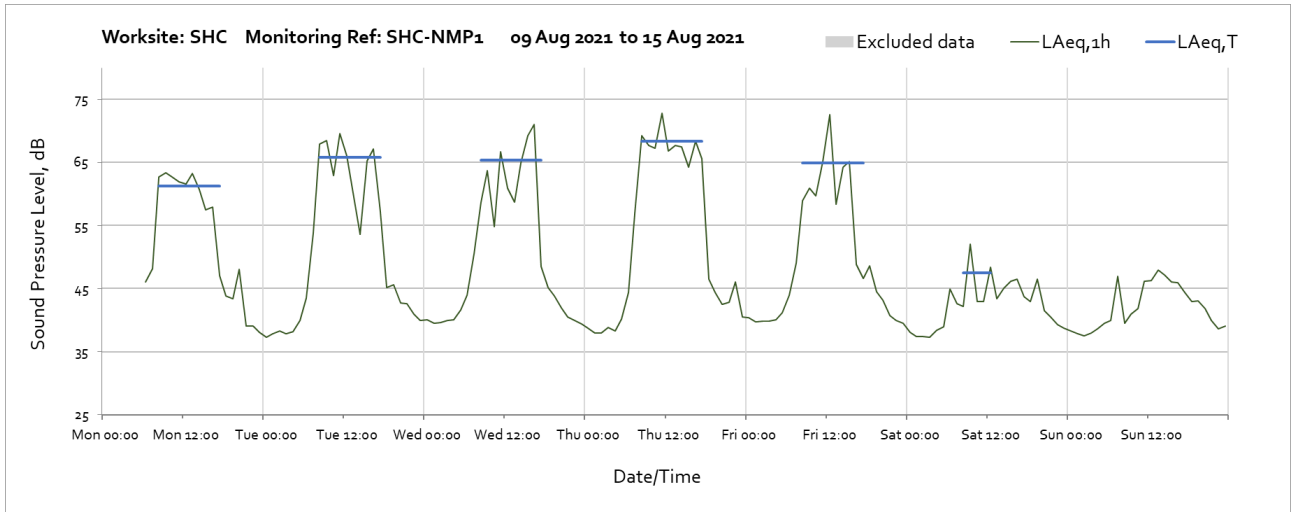
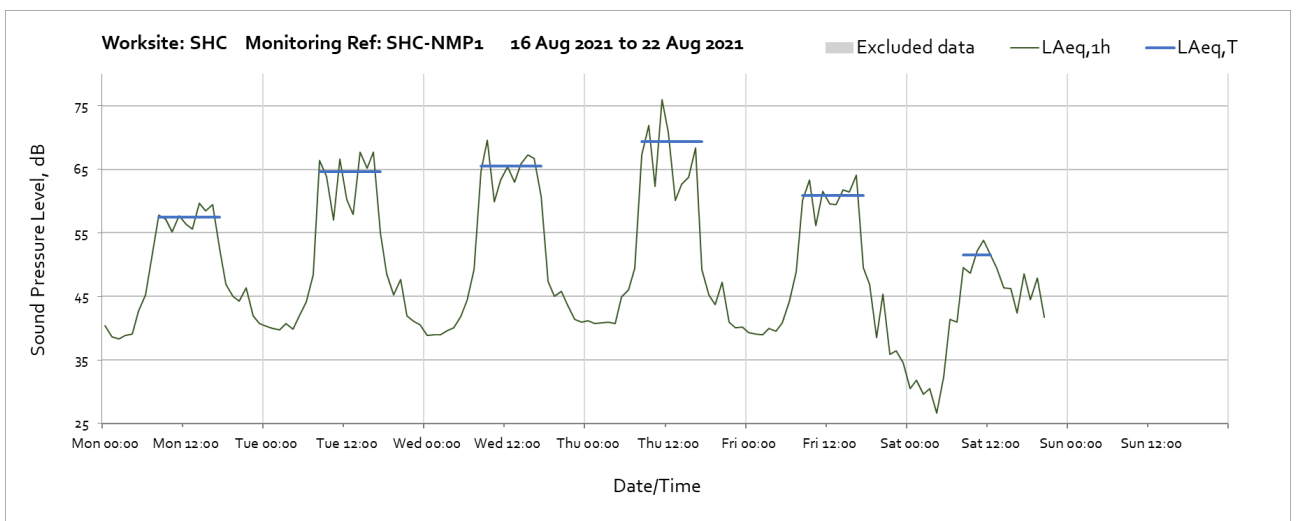
Note: Missing data between 21:00 on Saturday 21st August and 05:00 on Monday 23rd August was due to loss of continuous site power to the monitor.

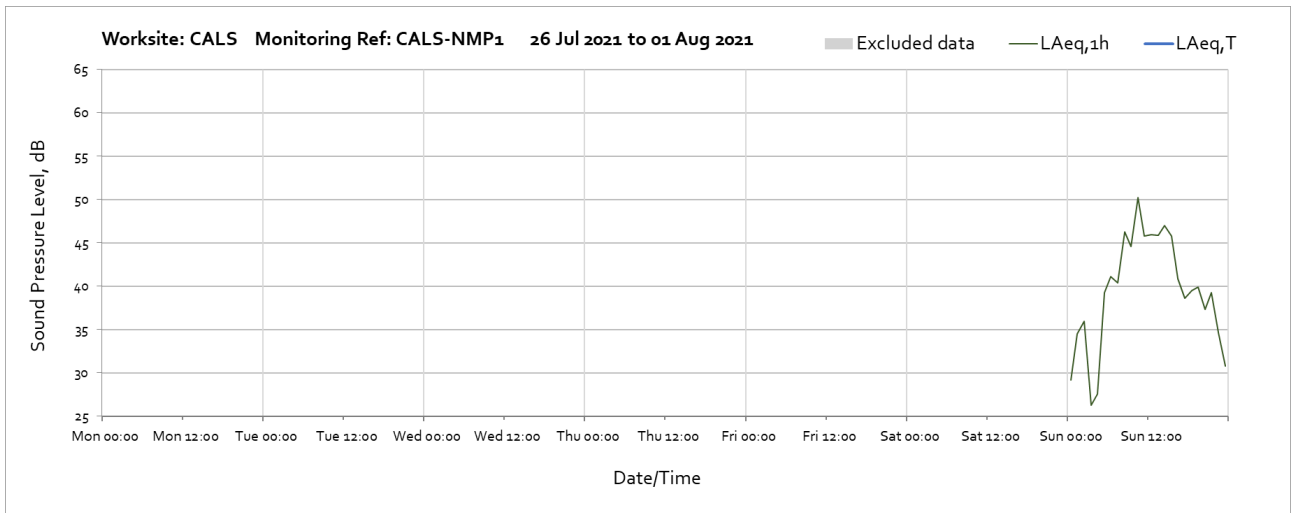
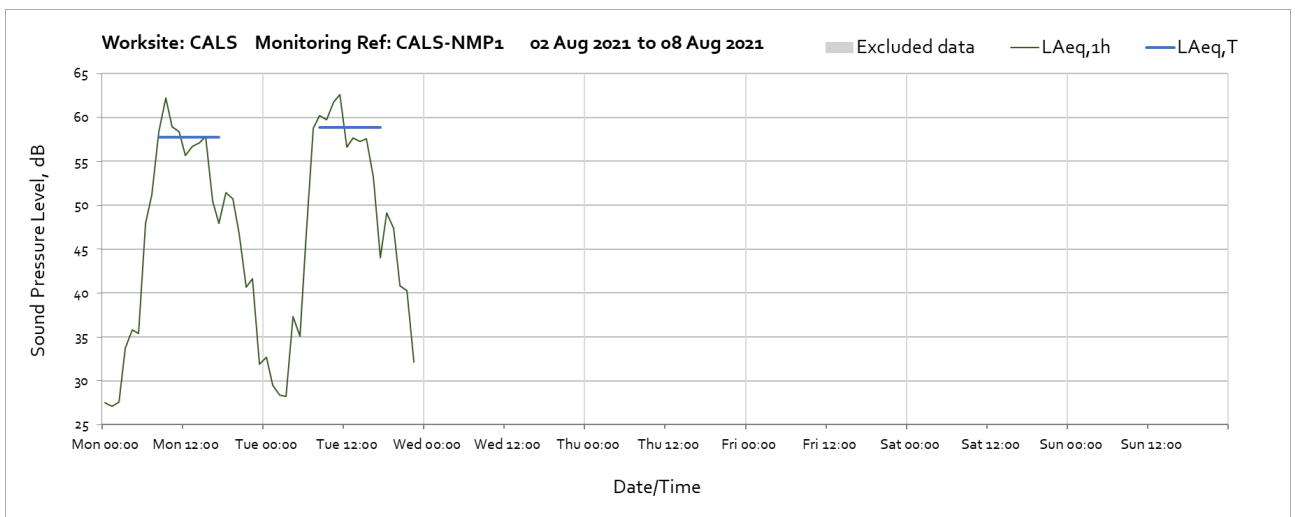
Worksite: CALS – Monitoring Ref: CALS-NMP1

Note: Missing data between 23:00 on Tuesday 3rd August and 00:00 on Monday 9th August was due to loss of power supply to the monitor. As a remedial measure, additional back-up batteries are being installed and frequent online monitoring is undertaken.

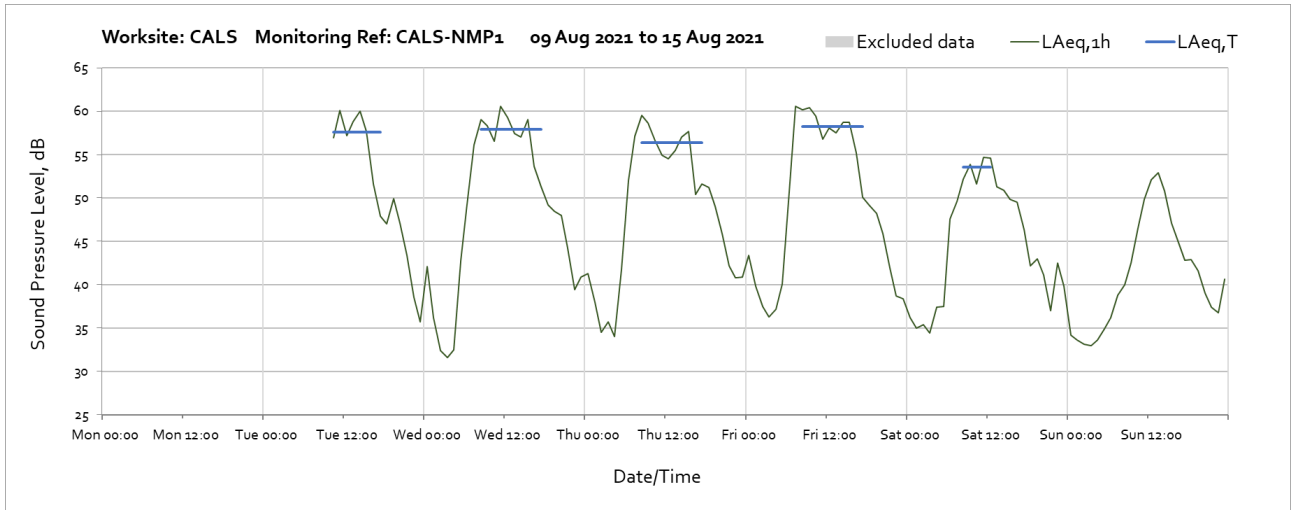
Note: Missing data between 00:00 on Monday 9th August and 10:00 on Tuesday 9th August was due to loss of power supply to the monitor. As a remedial measure, additional back-up batteries are being installed and frequent online monitoring is undertaken.

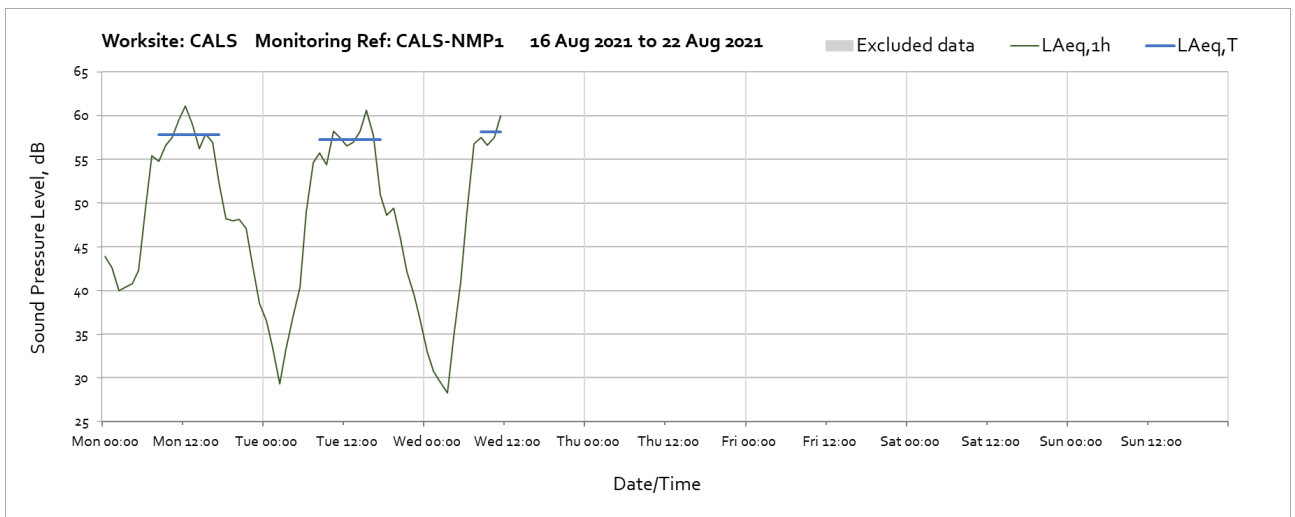
Note: Missing data between 12:00 on Wednesday 18th August and the end of the month was due to loss of power supply to the monitor. As a remedial measure, additional back-up batteries are being installed and frequent online monitoring is undertaken.

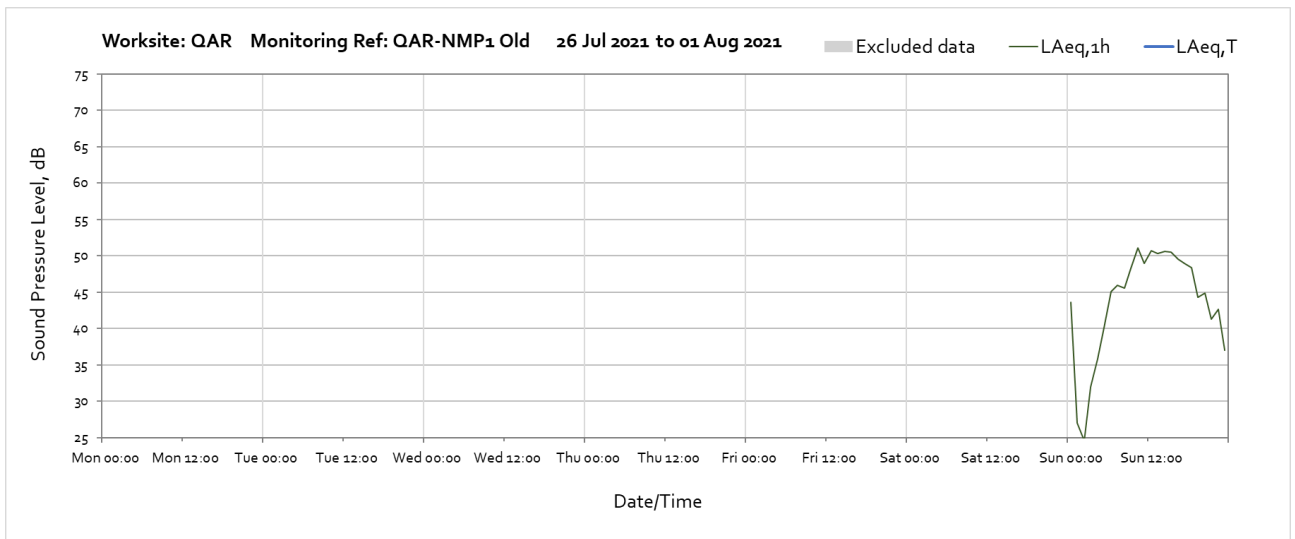
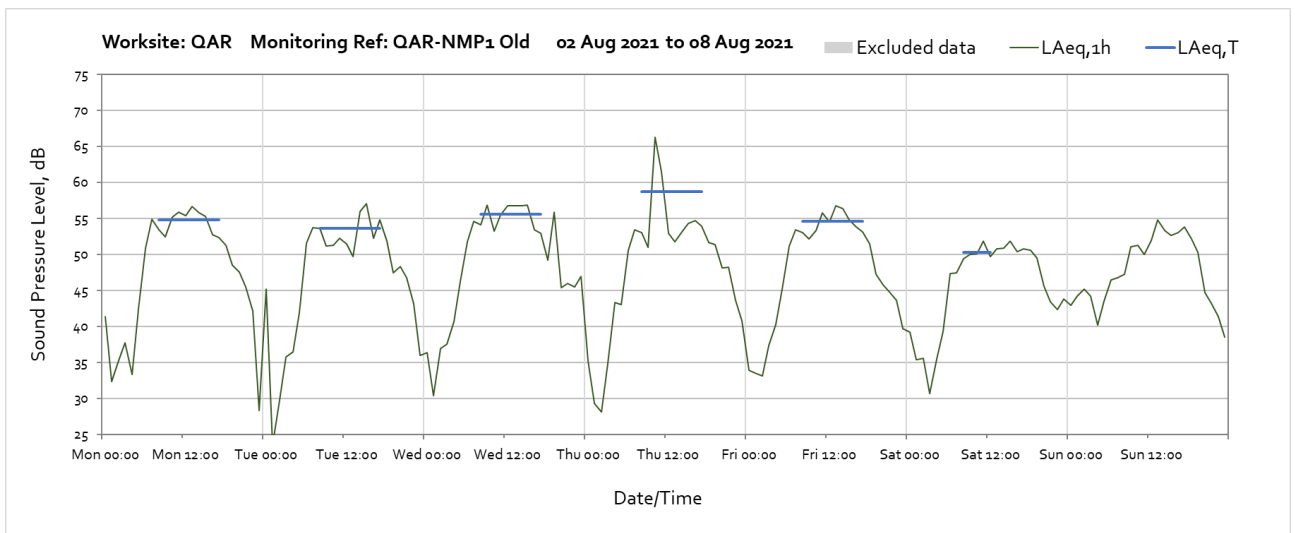
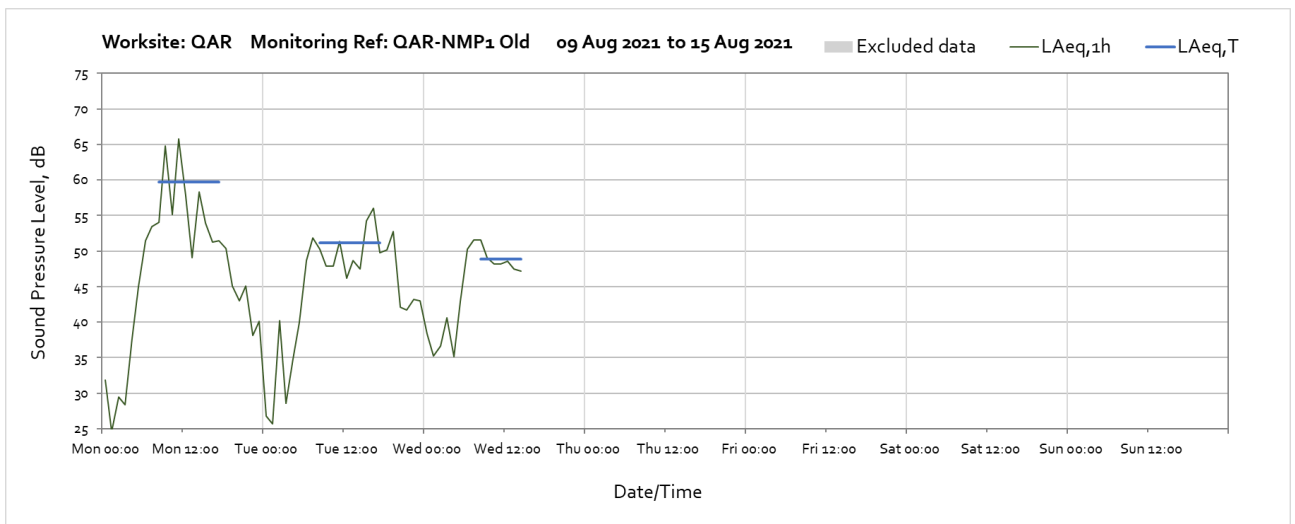
Worksite: QAR – Monitoring Ref: QAR-NMP1 Old

Note: The noise monitor was relocated to a new location on 11th August 2021.

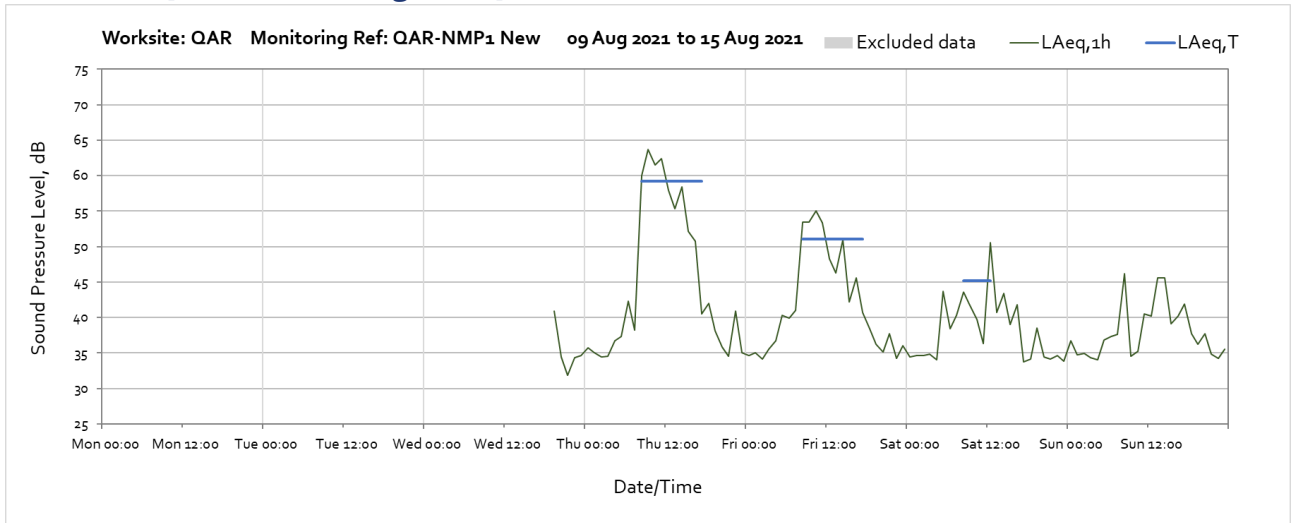
Worksite: QAR – Monitoring Ref: QAR-NMP1 New

Note: The noise monitor was installed at the new location on 11th August 2021.

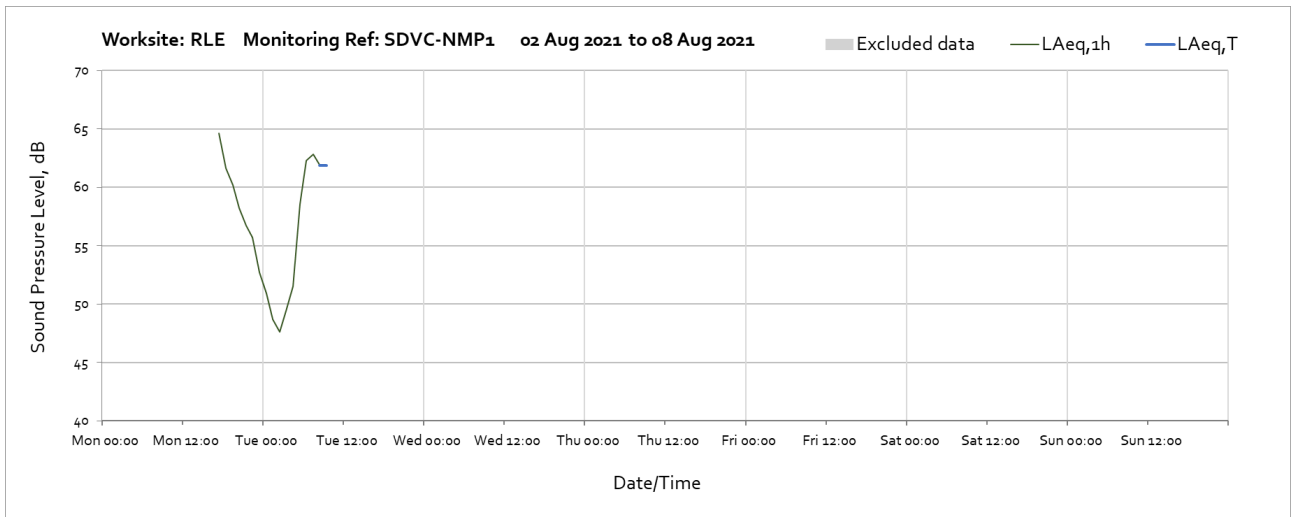
Worksite: RLE - Monitoring Ref: SDVC-NMP1

Note: The noise monitor was installed on 2nd August 2021. Missing data between 10:00 on Tuesday 3rd August and 16:00 on Tuesday 10th August was due to a fault in the noise monitor.

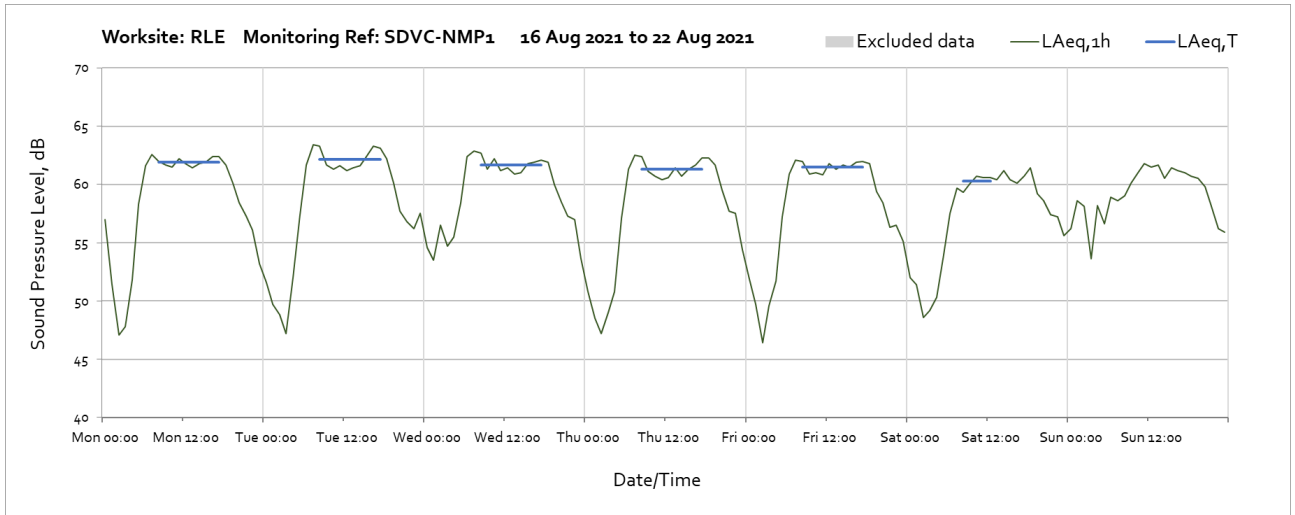
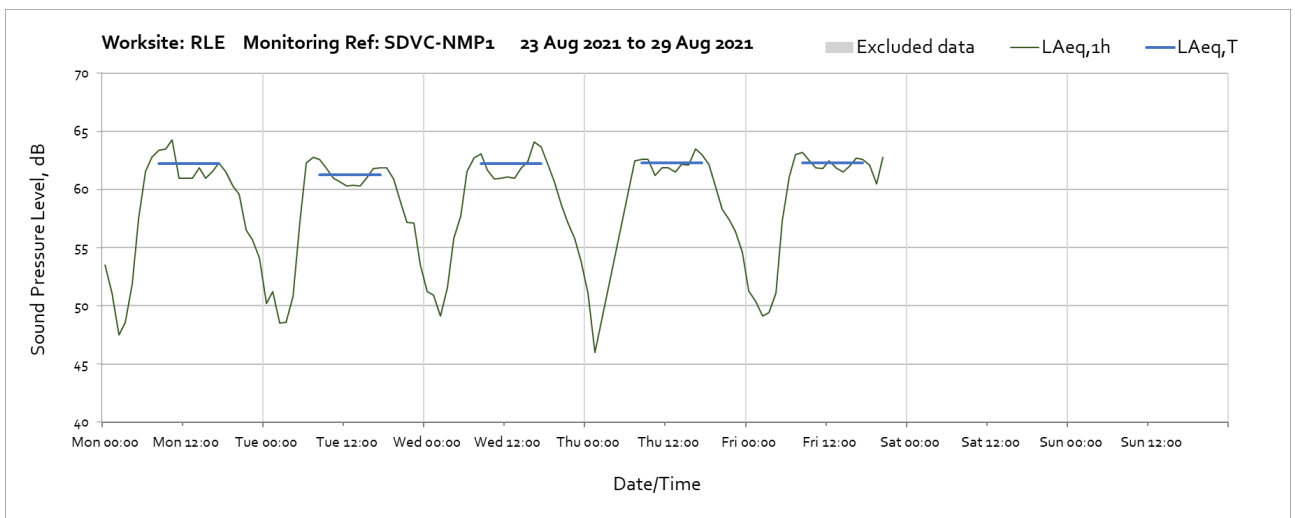
Note: Missing data between 21:00 on Friday 27th August and the end of the month was due to a fault in the noise monitor.

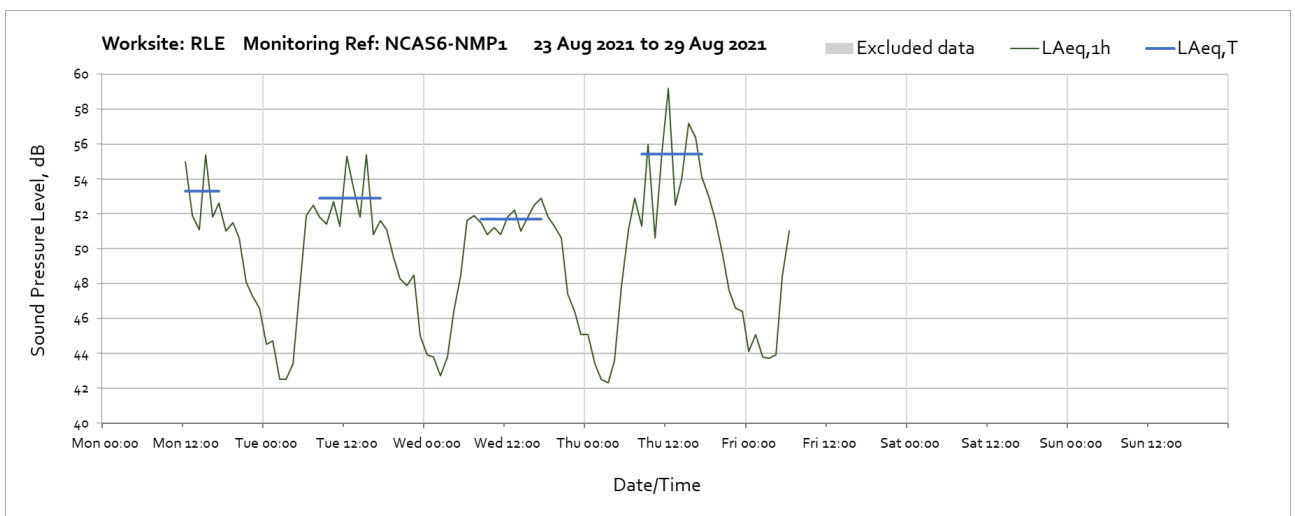
Worksite: RLE – Monitoring Ref: NCAS6-NMP1

Note: The noise monitor was installed on 23rd August 2021. Missing data between 07:00 on Friday 27th August and the end of the month was due to insufficient memory in the monitor.

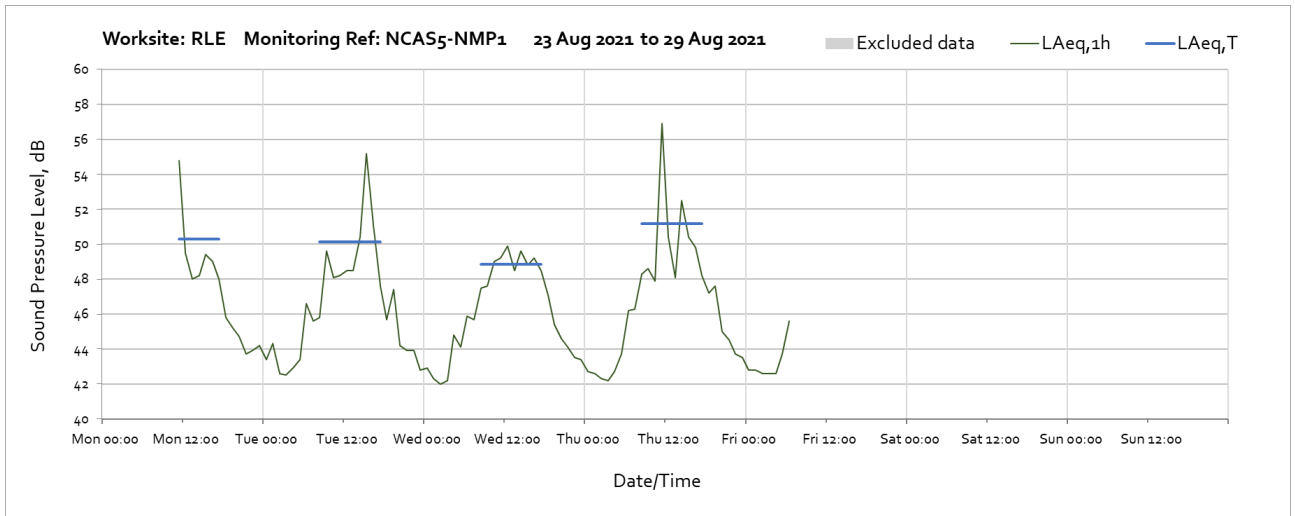
Worksite: RLE – Monitoring Ref: NCAS5-NMP1

Note: The noise monitor was installed on 23rd August 2021. Missing data between 07:00 on Friday 27th August and the end of the month was due to insufficient memory in the monitor.

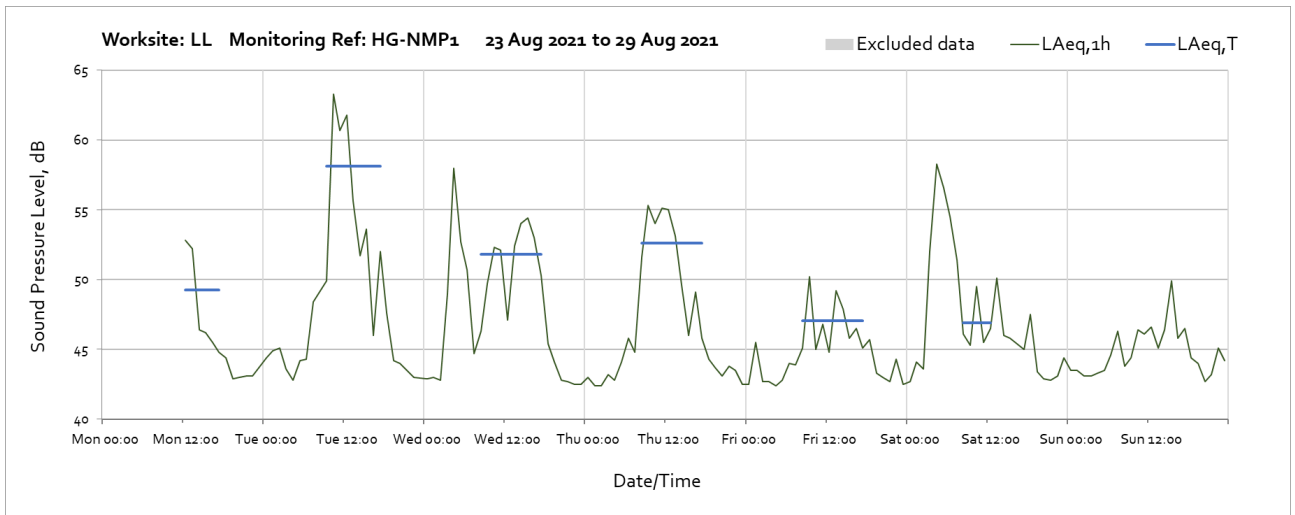
Worksite: LL – Monitoring Ref: HG -NMP1

Note: The noise monitor was installed on 23rd August 2021.

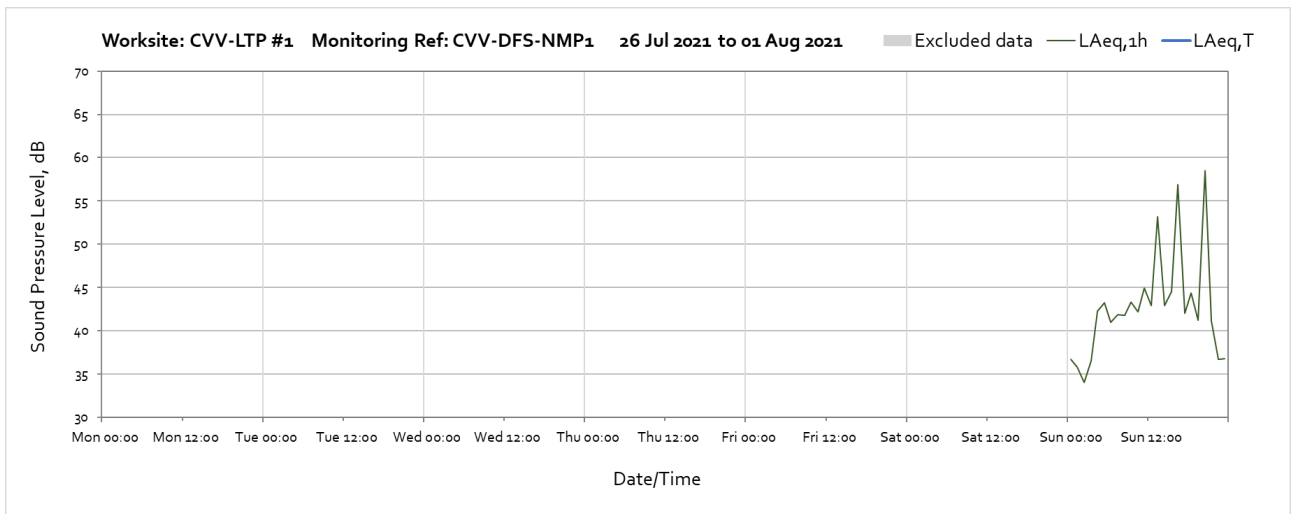
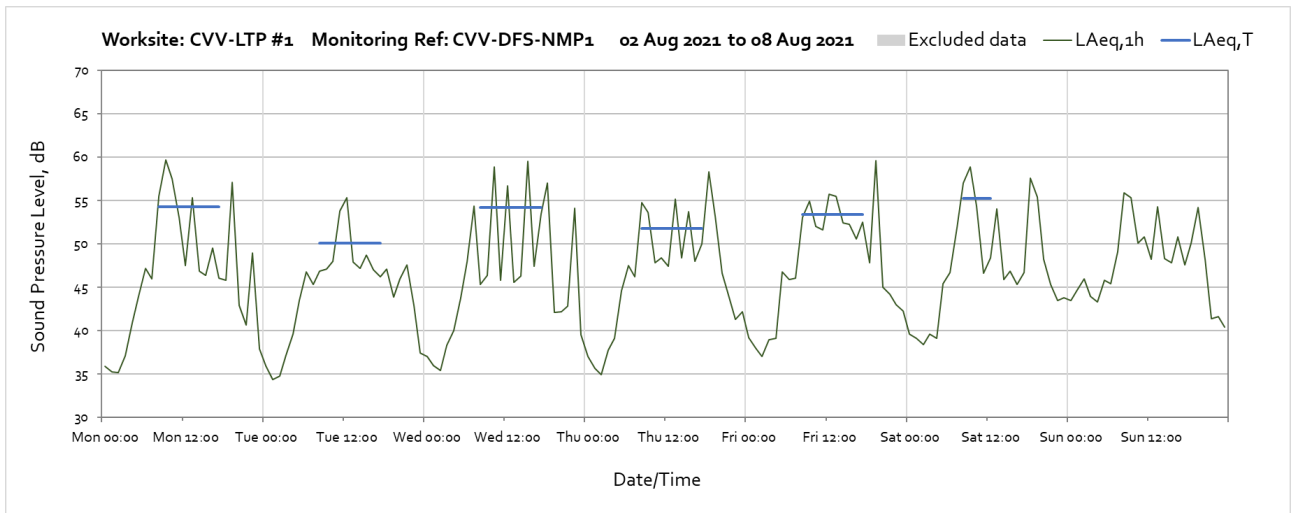
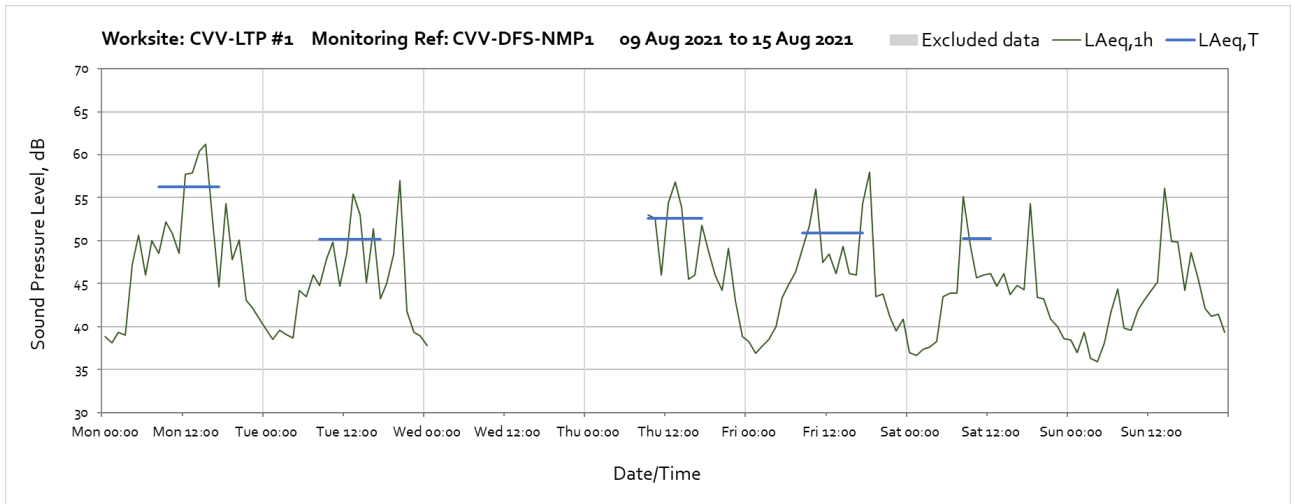
Worksite: CVV-LTP#1 – Monitoring Ref: CVV-DFS-NMP1

Note: Missing data between 01:00 on Wednesday 11th August and 09:00 on Thursday 12th August was due to a loss of battery power to the monitor.

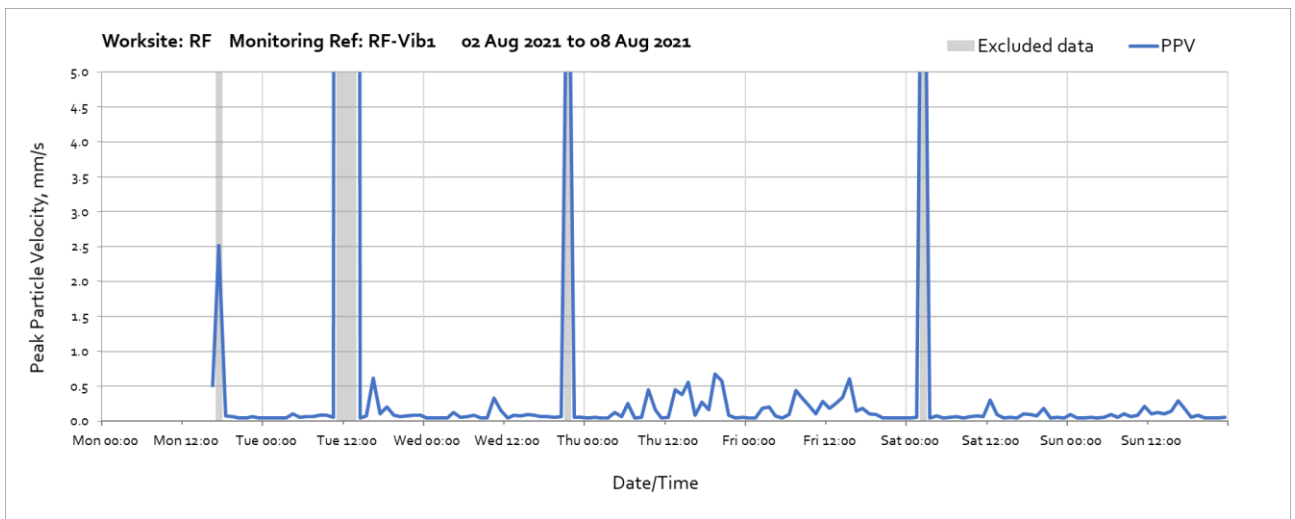
Worksite: RF – Monitoring Ref: RF-Vib 1

The following graphs show the hourly measured peak particle velocity PPV recorded during the monitoring period. The graphs show the highest PPV of the three orthogonal axes x, y and z. Where high values of PPV were caused by local interference with the vibration monitor, which are not representative of HS2 construction works, these values have been greyed out in the following charts and have been excluded to calculate values in Table 4 of the main report.

Note: High levels of vibration measured throughout the week were due to local disturbance of the monitor and are not representative of HS2 construction vibration levels.

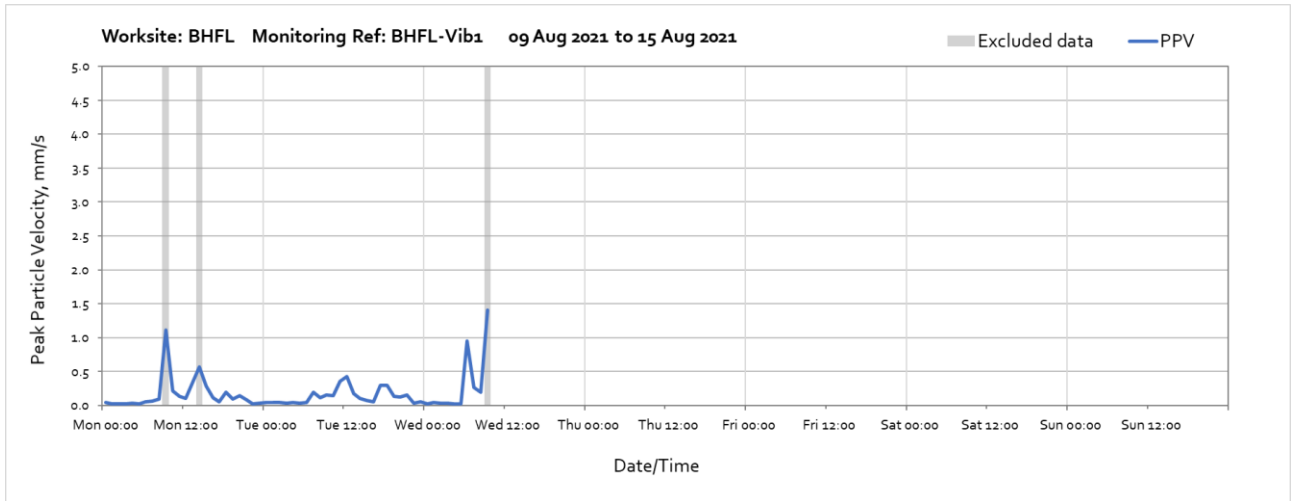
Note: High levels of vibration measured throughout the week were due to local disturbance of the monitor and are not representative of HS2 construction vibration levels. The vibration monitor was uninstalled on 11th August 2021.
