Construction noise and vibration Monthly Report – September 2021

London Borough of Brent

Noise and vibration monitoring were undertaken in the vicinity of the Canterbury Road Vent Shaft worksite (ref: CRVS), where the following activities were underway:

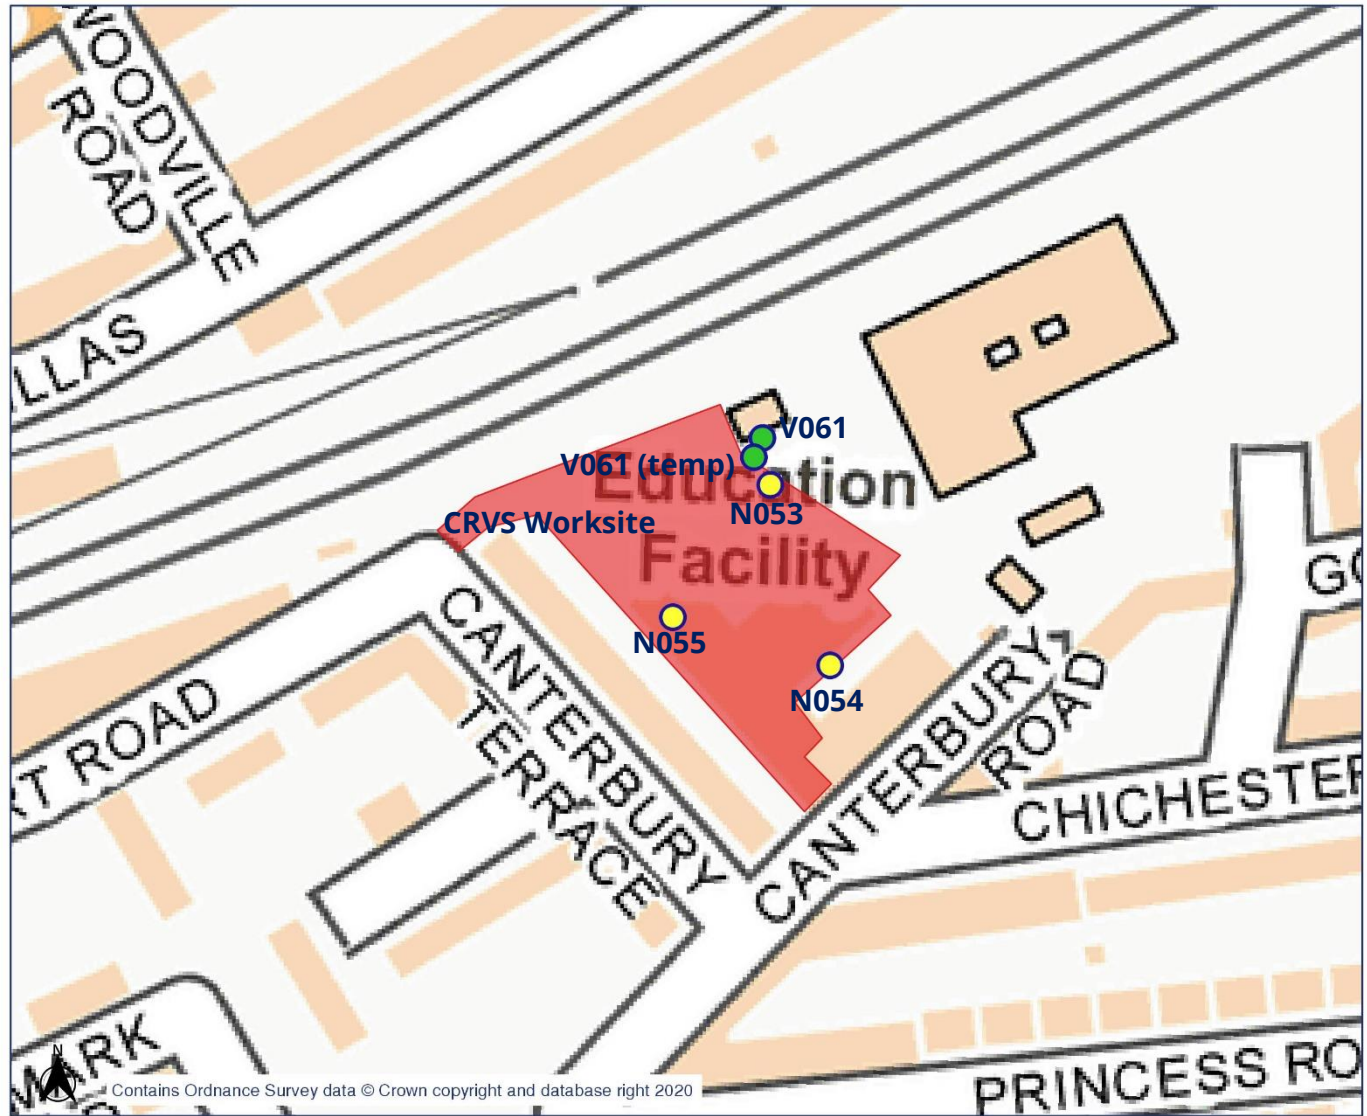
Appendix B Monitoring Locations

1.2.3 A map showing the positions of the noise monitoring installations is presented in Appendix B.

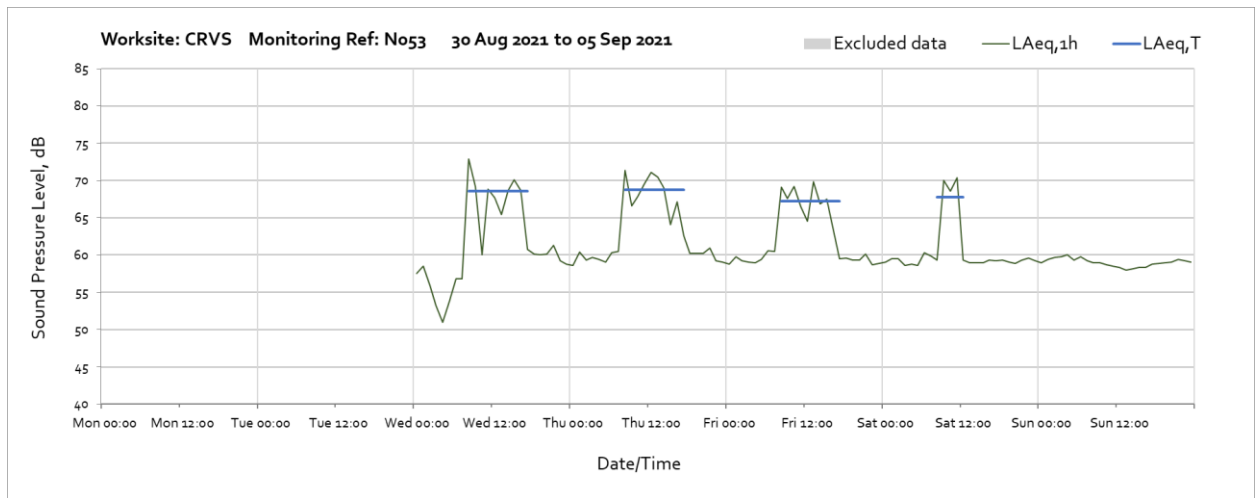
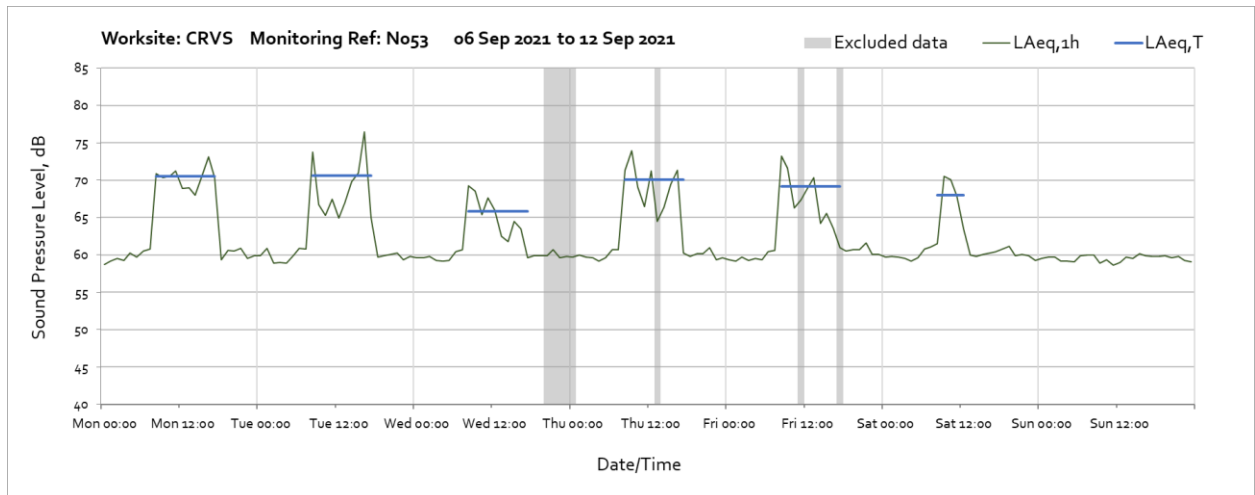
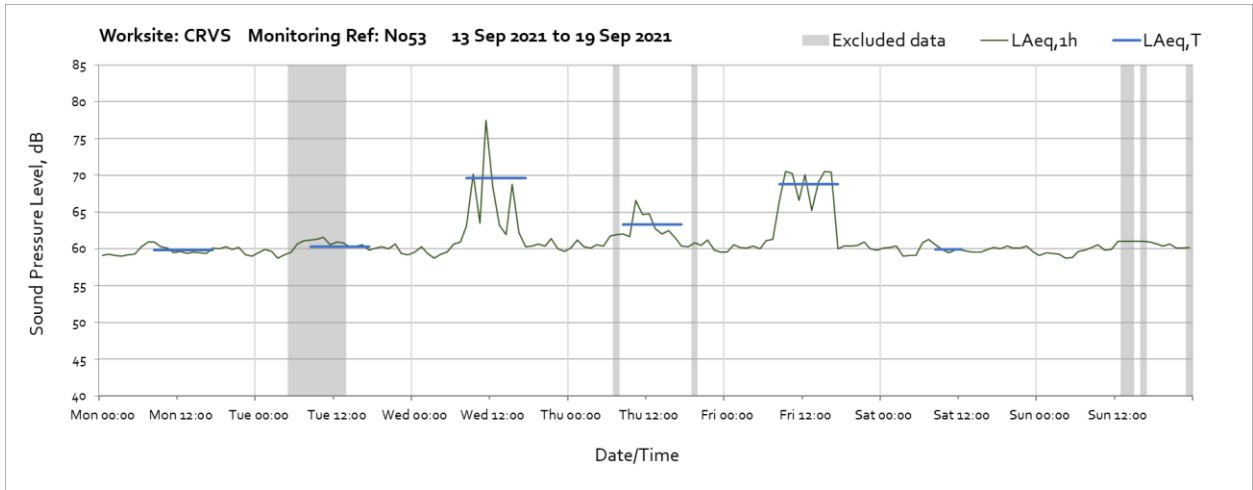
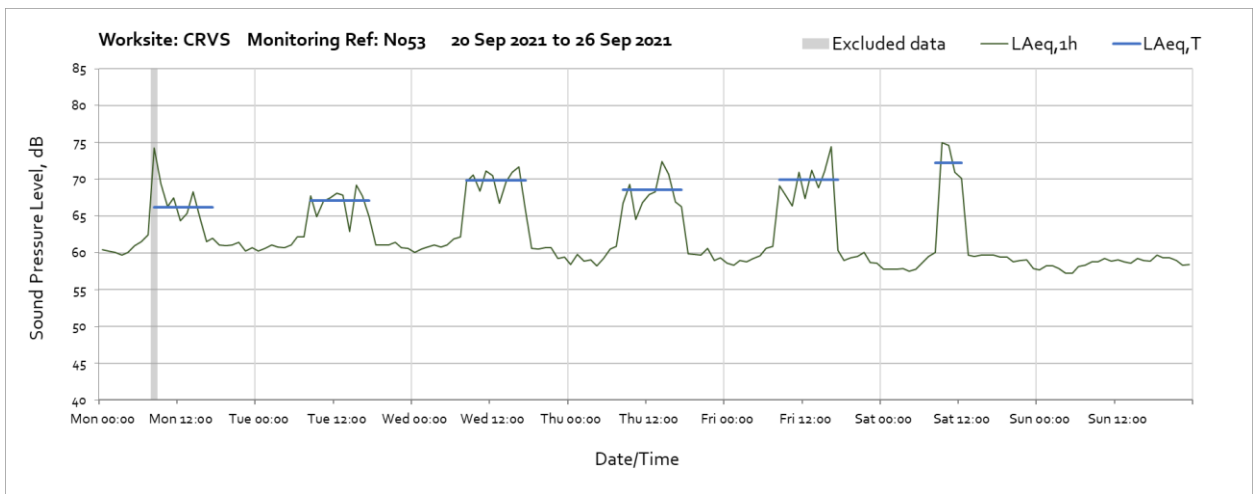
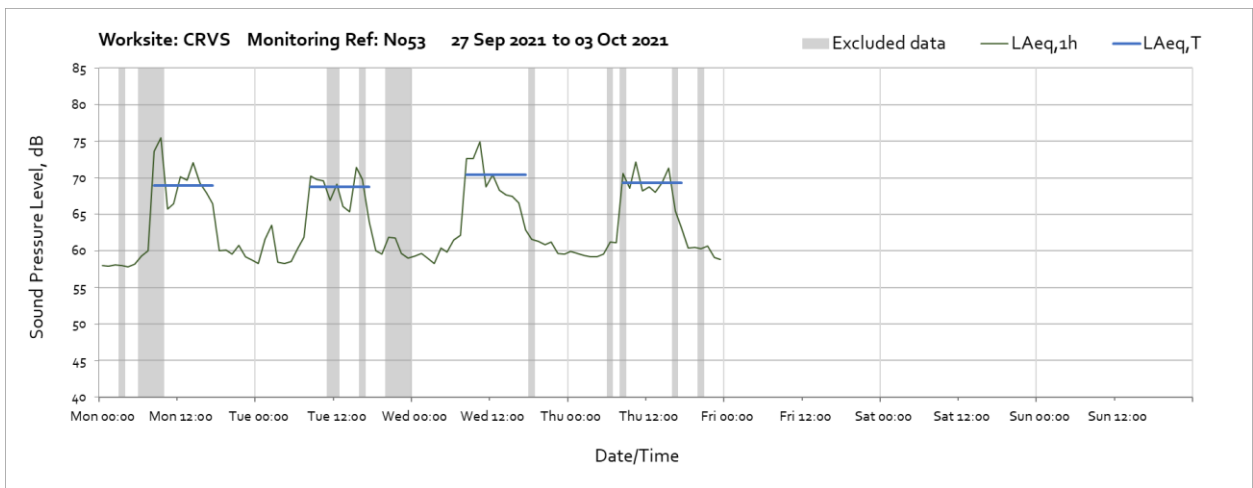
Worksite: CRVS – Monitoring Ref: N053

The following graphs show the hourly measured ambient noise level $L_{Aeq,1h}$ and, where relevant, the averaged noise level $L_{Aeq,T}$ values, where the time period T is as specified in Table 1 of HS2 Information Paper E23. Periods with adversely weather affected noise levels are greyed out and have been excluded from the calculation of the $L_{Aeq,T}$ values in Table 3 of the main report.

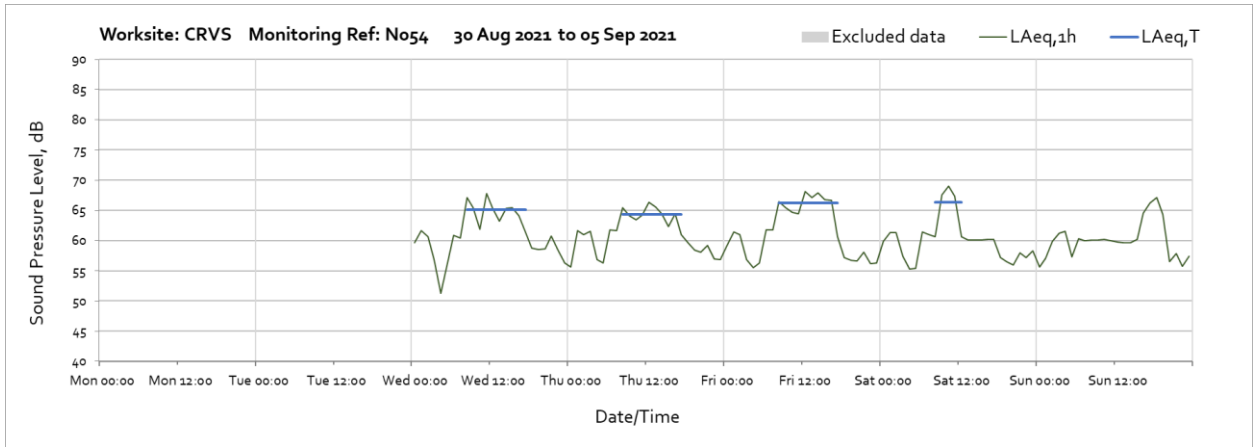
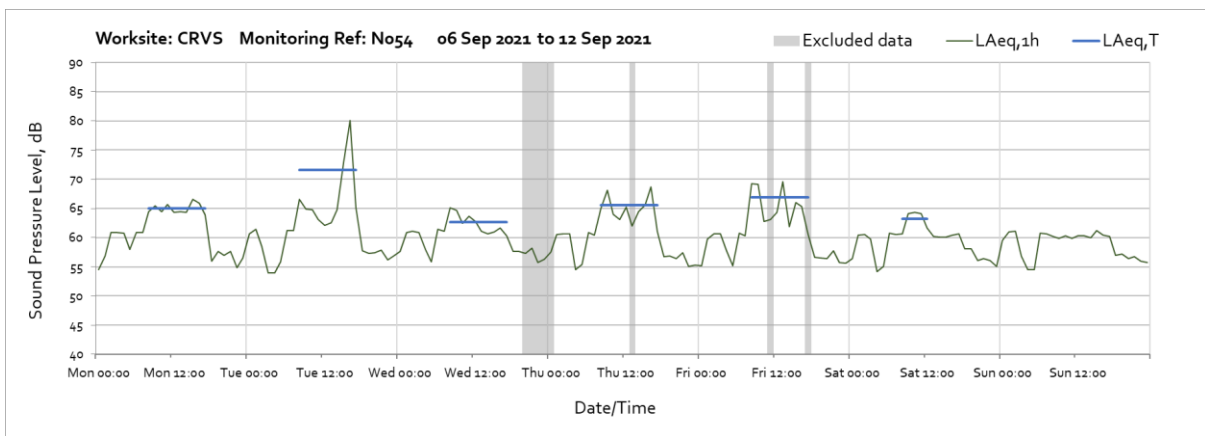
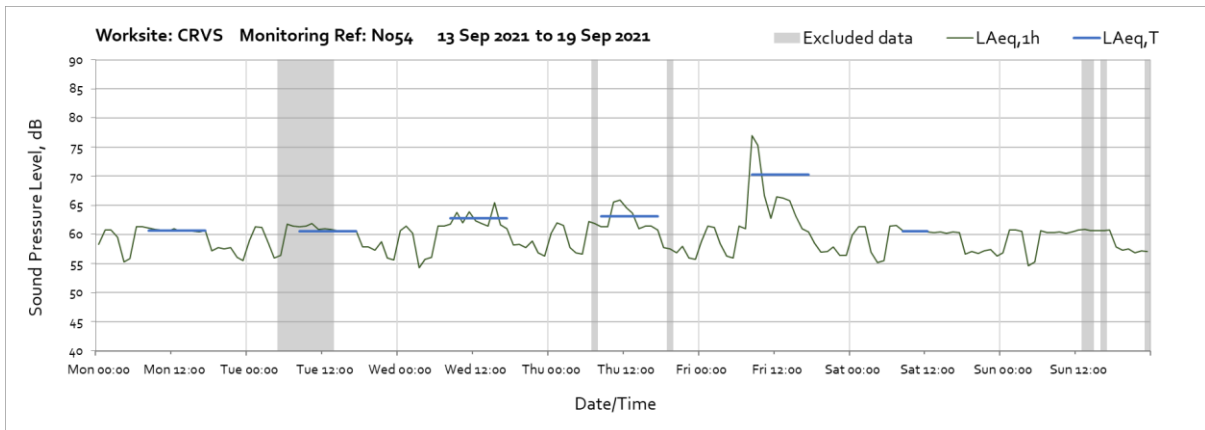
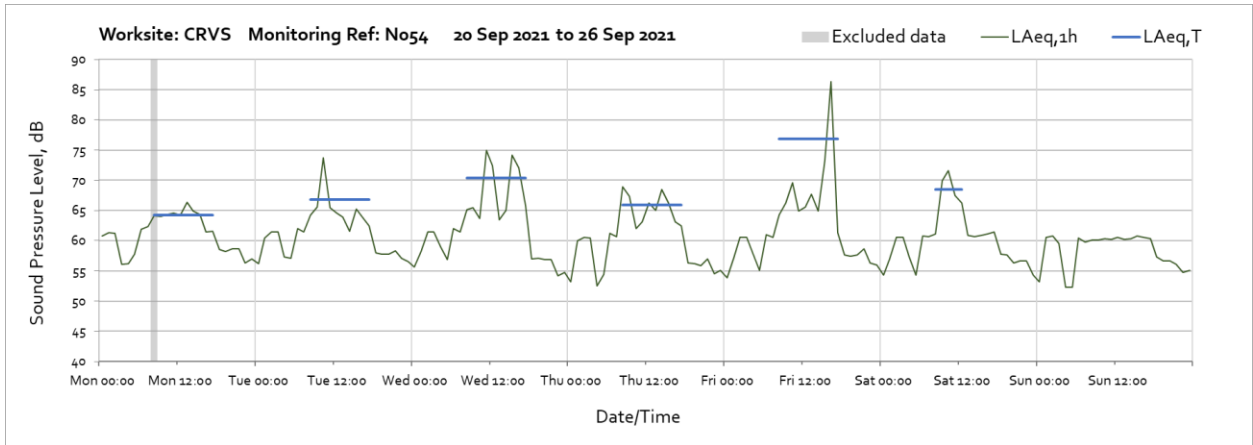
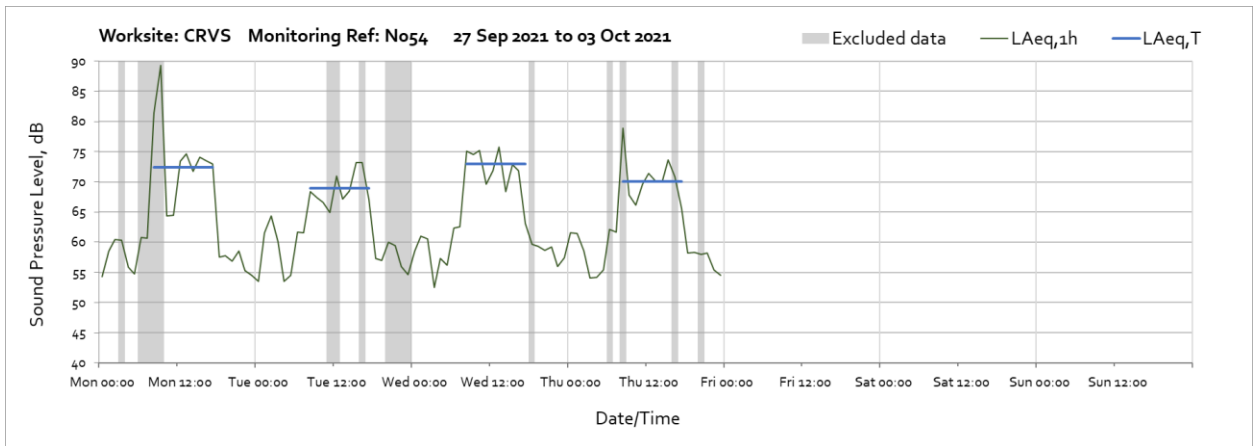
Worksite: CRVS – Monitoring Ref: N054

2.2.6 1 exceedances of the SOAEL were recorded due to HS2 construction works during September 2021 due to use of a 15t excavator with breaker attachment breaking out a concrete slab next to Canterbury House.

Complaint Reference Number (if applicable)	Worksite Reference	Date and Time Period	Identified Source	Results of Investigation (including noise monitoring results)	Actions Taken
N/A	CRVS	24/09/2021 Weekday	Concrete breaking	A 15t excavator with breaker attachment was breaking out a concrete slab next to Canterbury House. The highest noise level due to the concrete breaking works predicted at the monitor within the Section 61 assessment was 74 dB LAeq,10hr. 76.8 dB LAeq,10hr measured at the time of trigger alert.	Works stopped for further best practicable means (BPM) check / review.

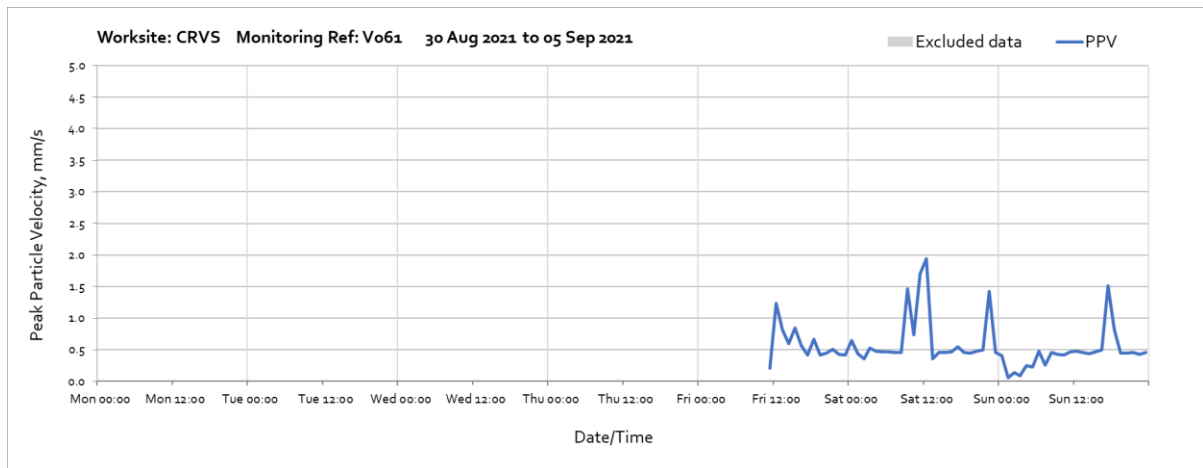
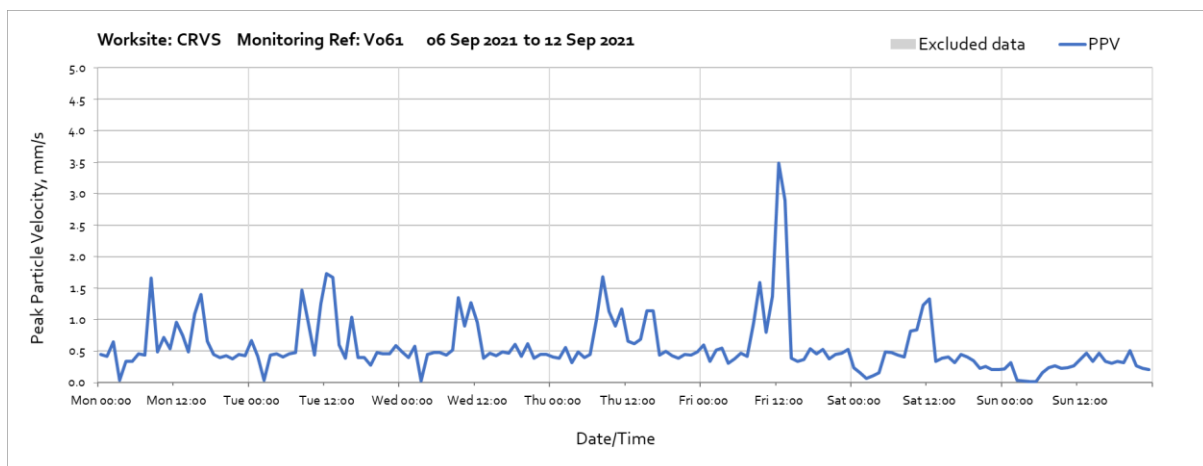
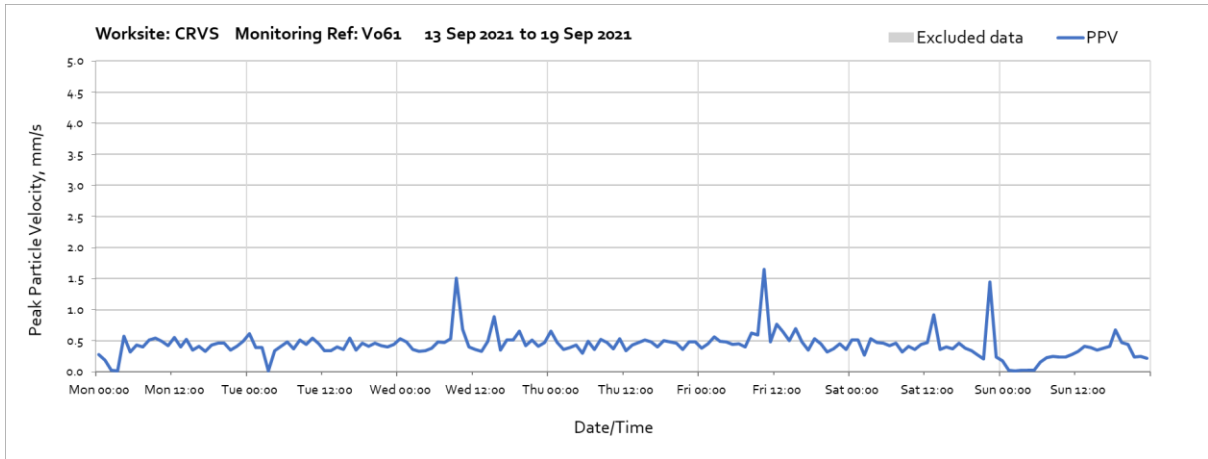
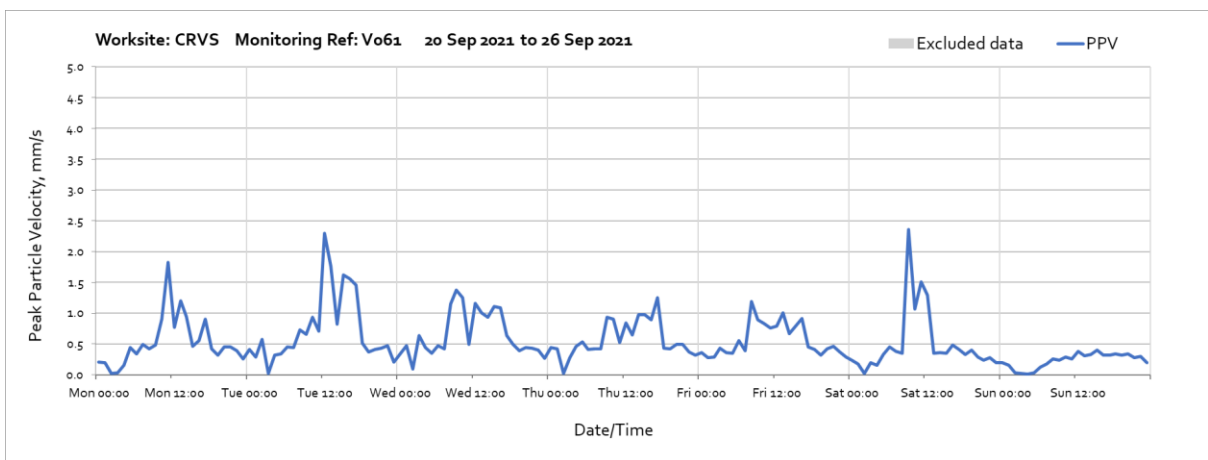
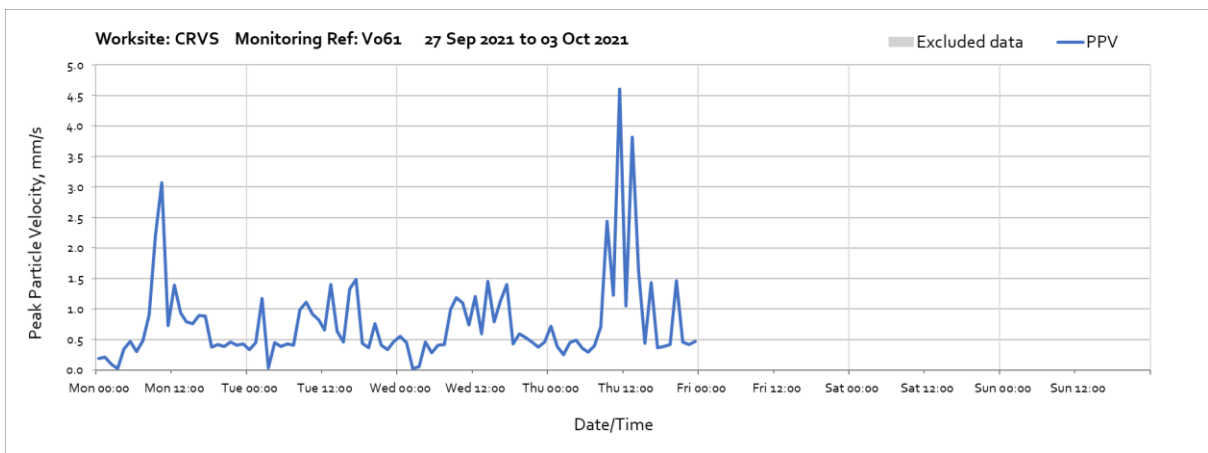
Worksite: CRVS – Monitoring Ref: V061

The following graphs show the hourly measured peak particle velocity PPV recorded during the monitoring period. The graphs show the highest PPV of the three orthogonal axis x, y and z. Where high values of PPV were caused by local interference with the vibration monitor, which are not representative of HS2 construction works, these values have been greyed out in the following charts and have been excluded to calculate values in Table 4 of the main report.

Note: Missing data from 00:00 on Wednesday 30th August until 12:00 on Friday 3rd September was due to depleted batteries and difficulty in obtaining access to change the batteries due to the school holidays. A temporary additional vibration monitor V061 (temp) was installed within CRVS worksite 4 metres from vibration monitor V061 on Tuesday 10th August to provide cover for vibration monitor V061. The unit was replaced to prevent further loss of data.

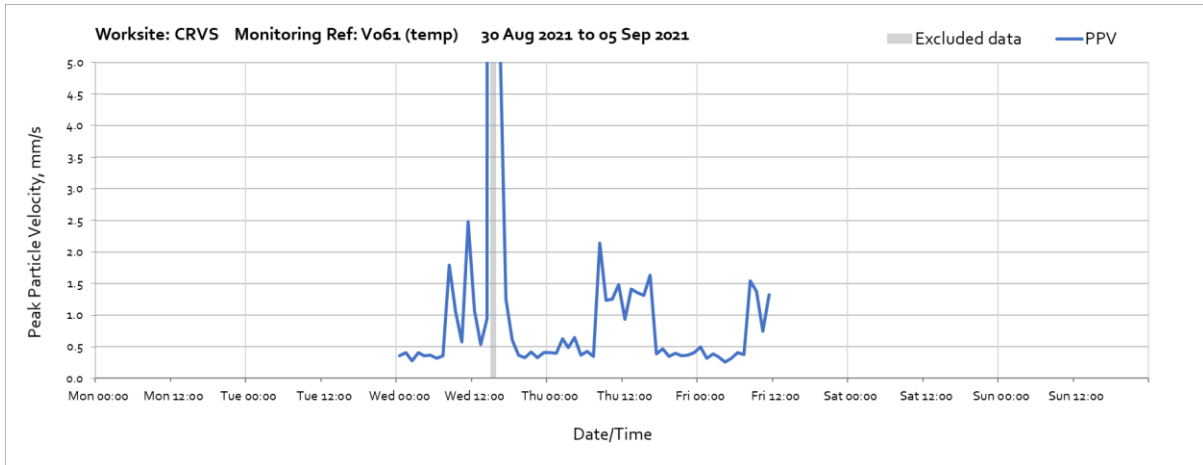
Worksite: CRVS – Monitoring Ref: V061 (temp)

Note: A temporary additional vibration monitor V061 (temp) was installed within CRVS worksite 4 metres from vibration monitor V061 on Tuesday 10th August. It was installed to provide cover for vibration monitor V061. The batteries for V061 were successfully replaced on Friday 3rd September, therefore, V061 (temp) was retrieved from the site.
