Rail Accident Investigation Branch

# Track workers struck by a train at Margam

## The accident and its causes

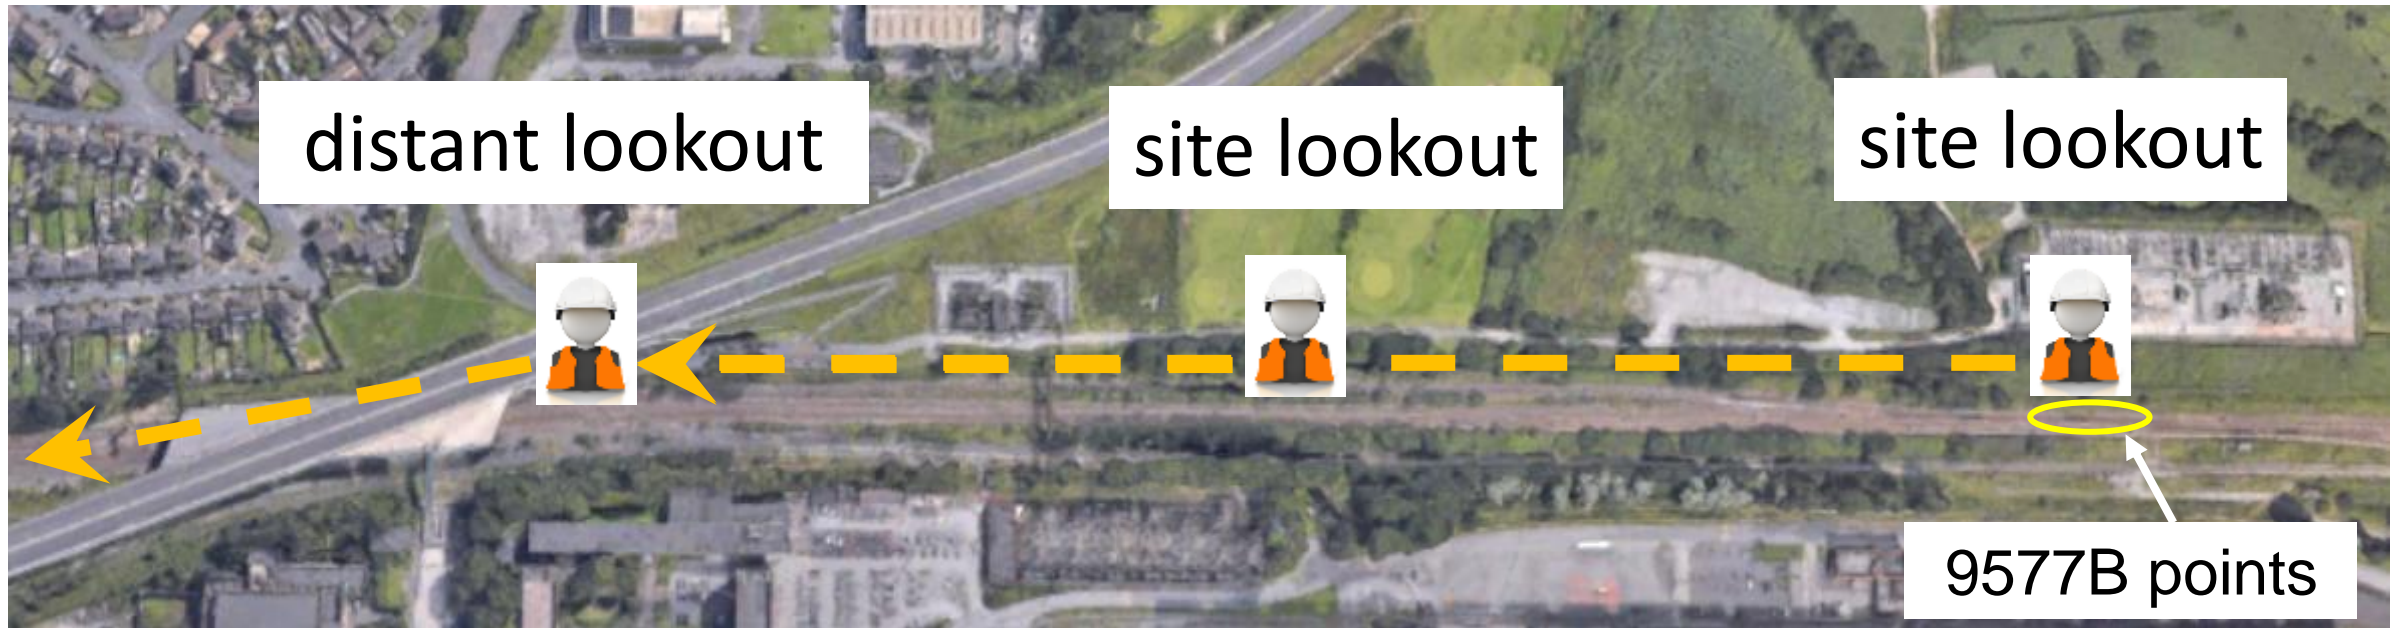
# 08:00 to 08:50 hrs – Margam East Junction

- The COSS planned to protect them from moving trains on the up main line
- A decision was later made, and accepted by all, not to use a distant lookout

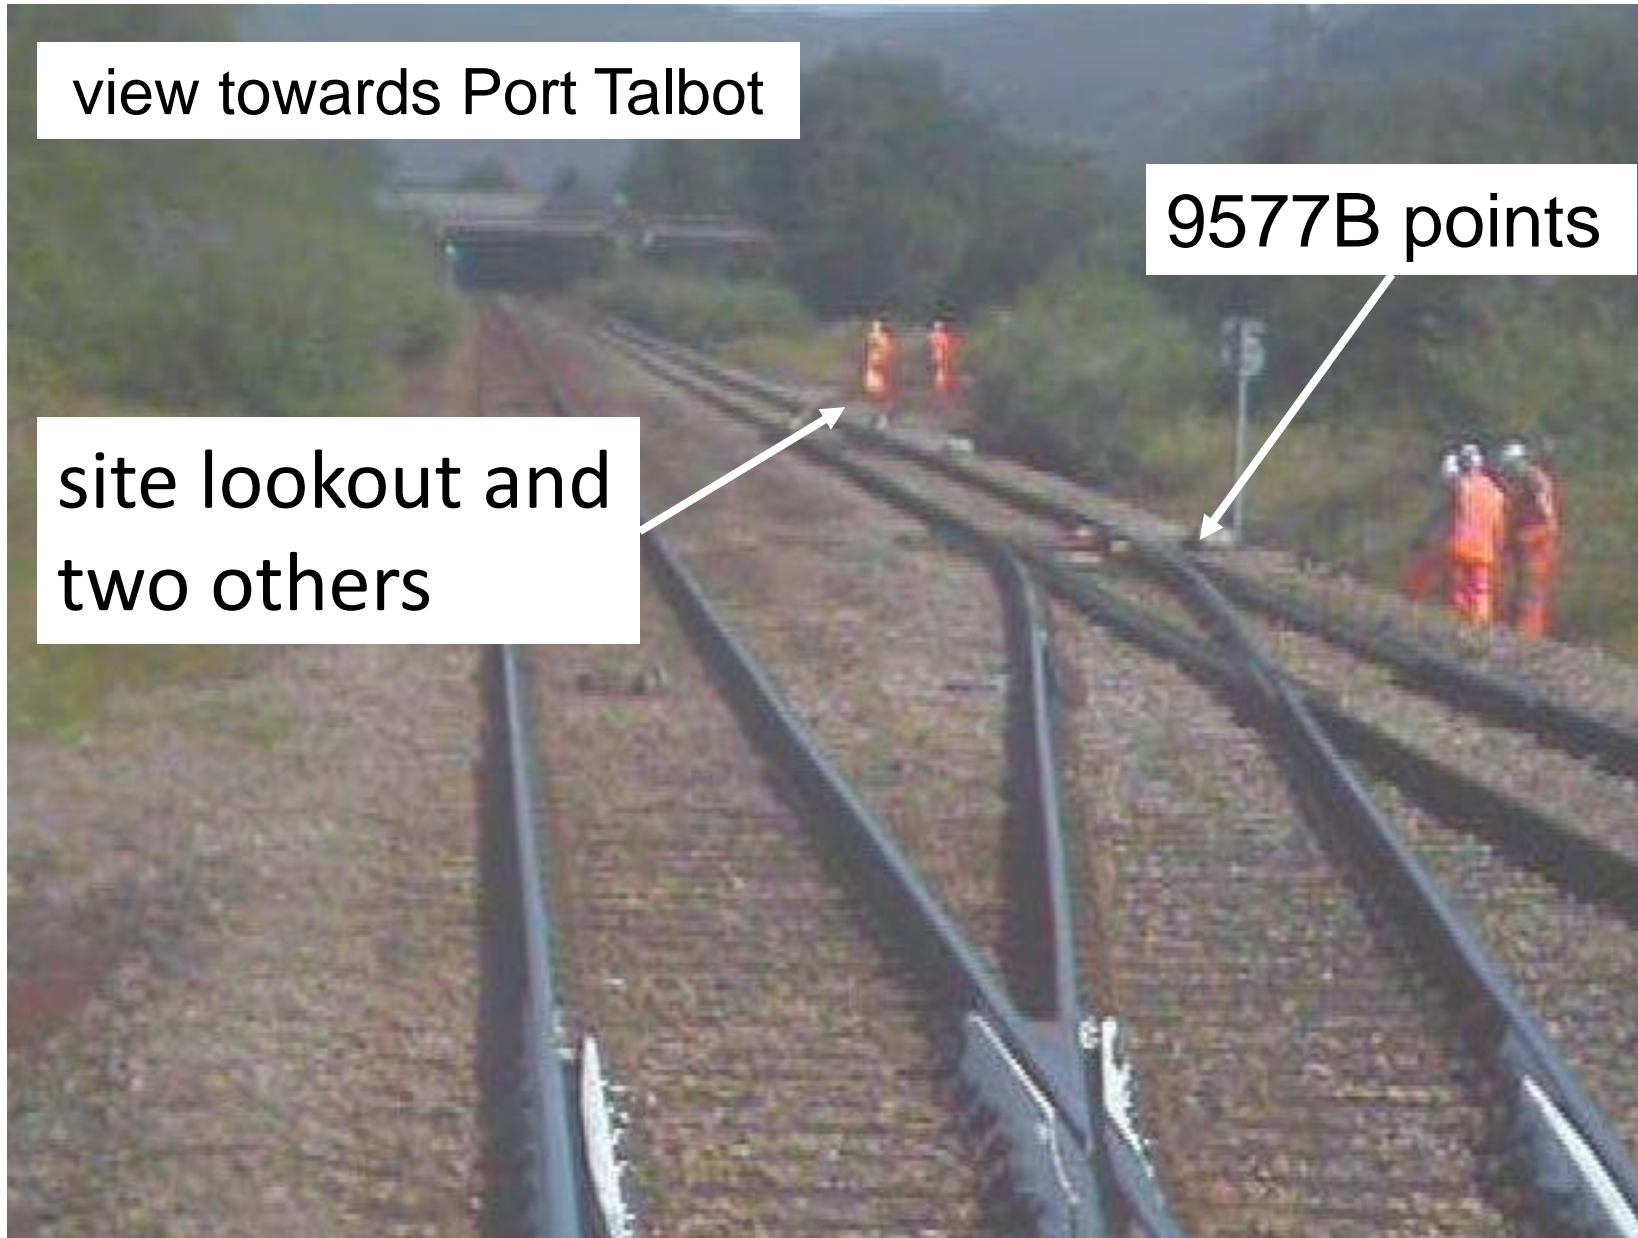
09:45 hrs – the group met up and then split again

view towards Port Talbot

9577B points

site lookout and  
two others

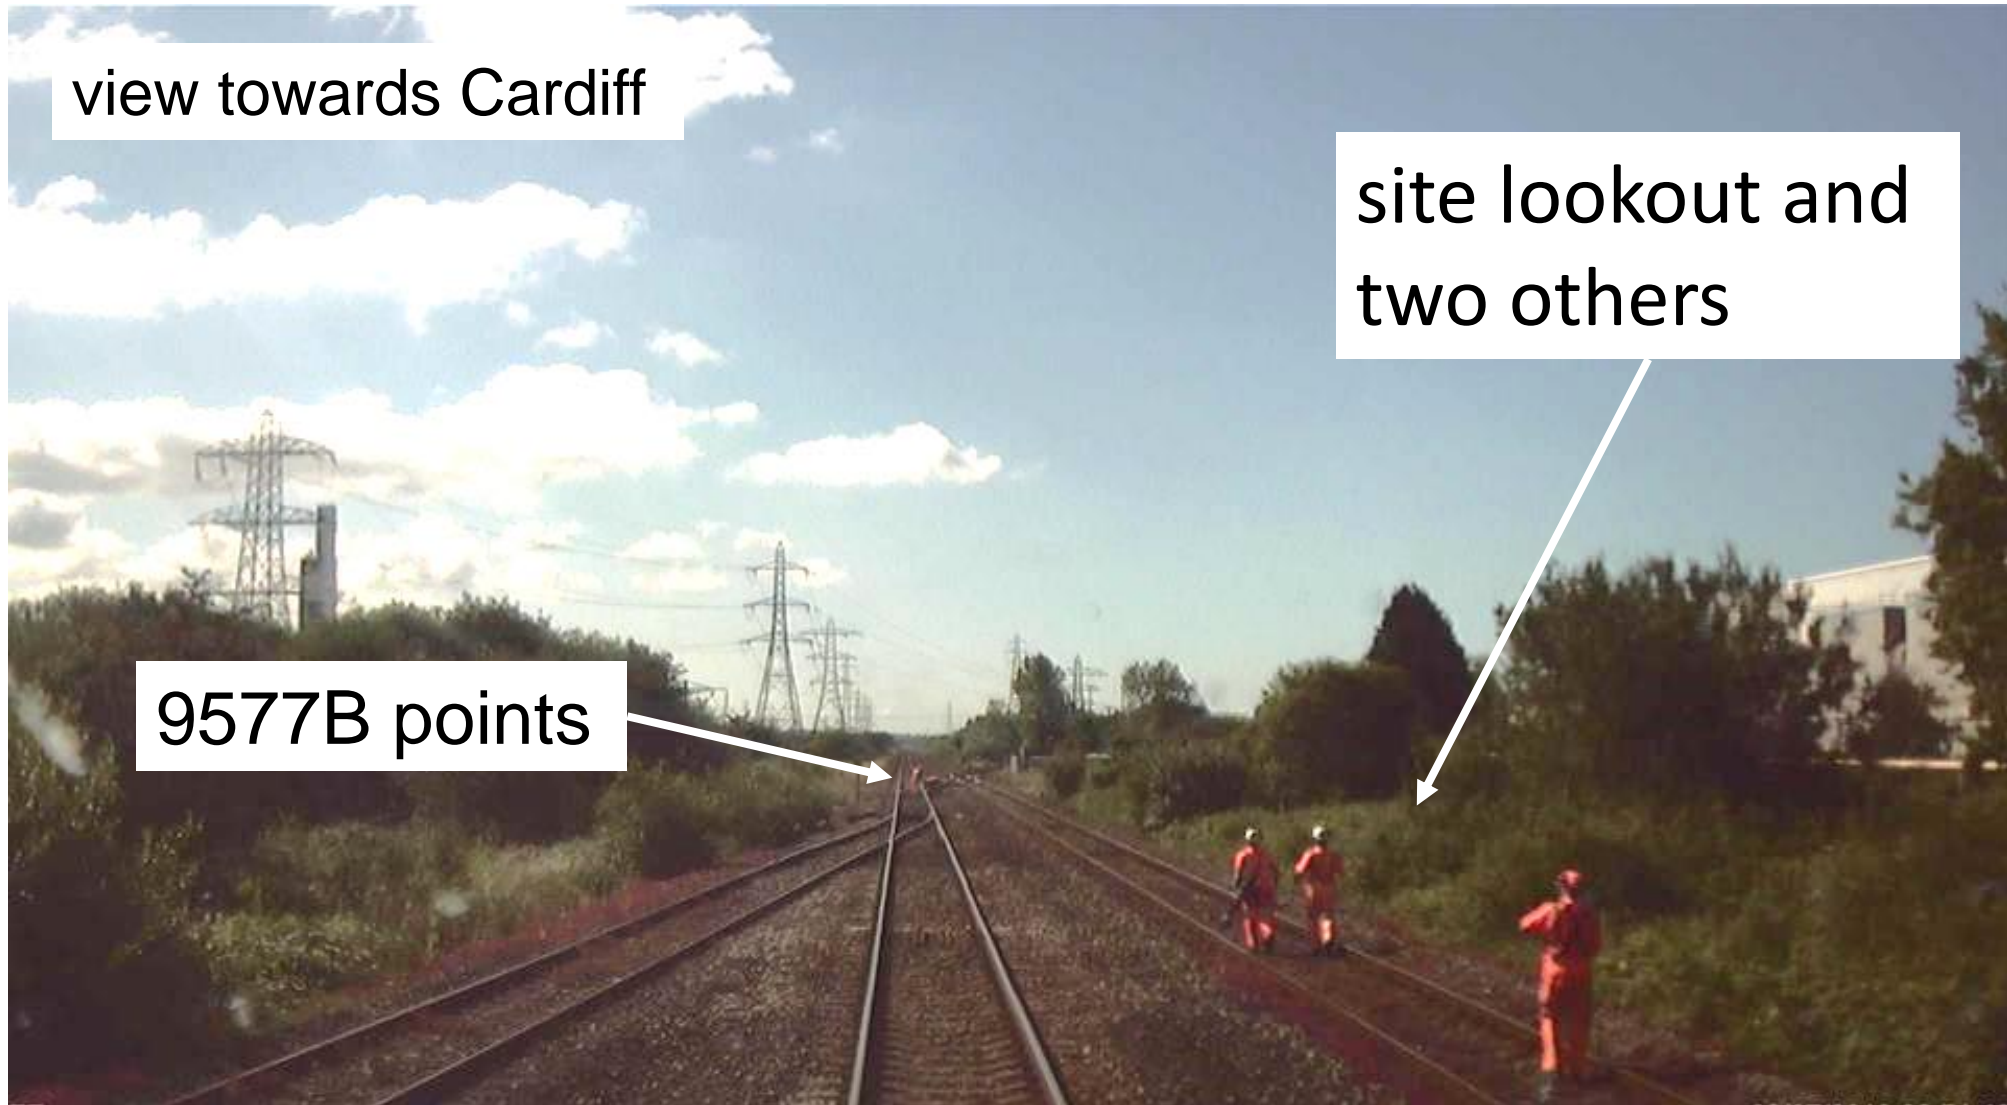
# 09:52 hrs – the approach of the train

view towards Cardiff

site lookout and  
two others

9577B points

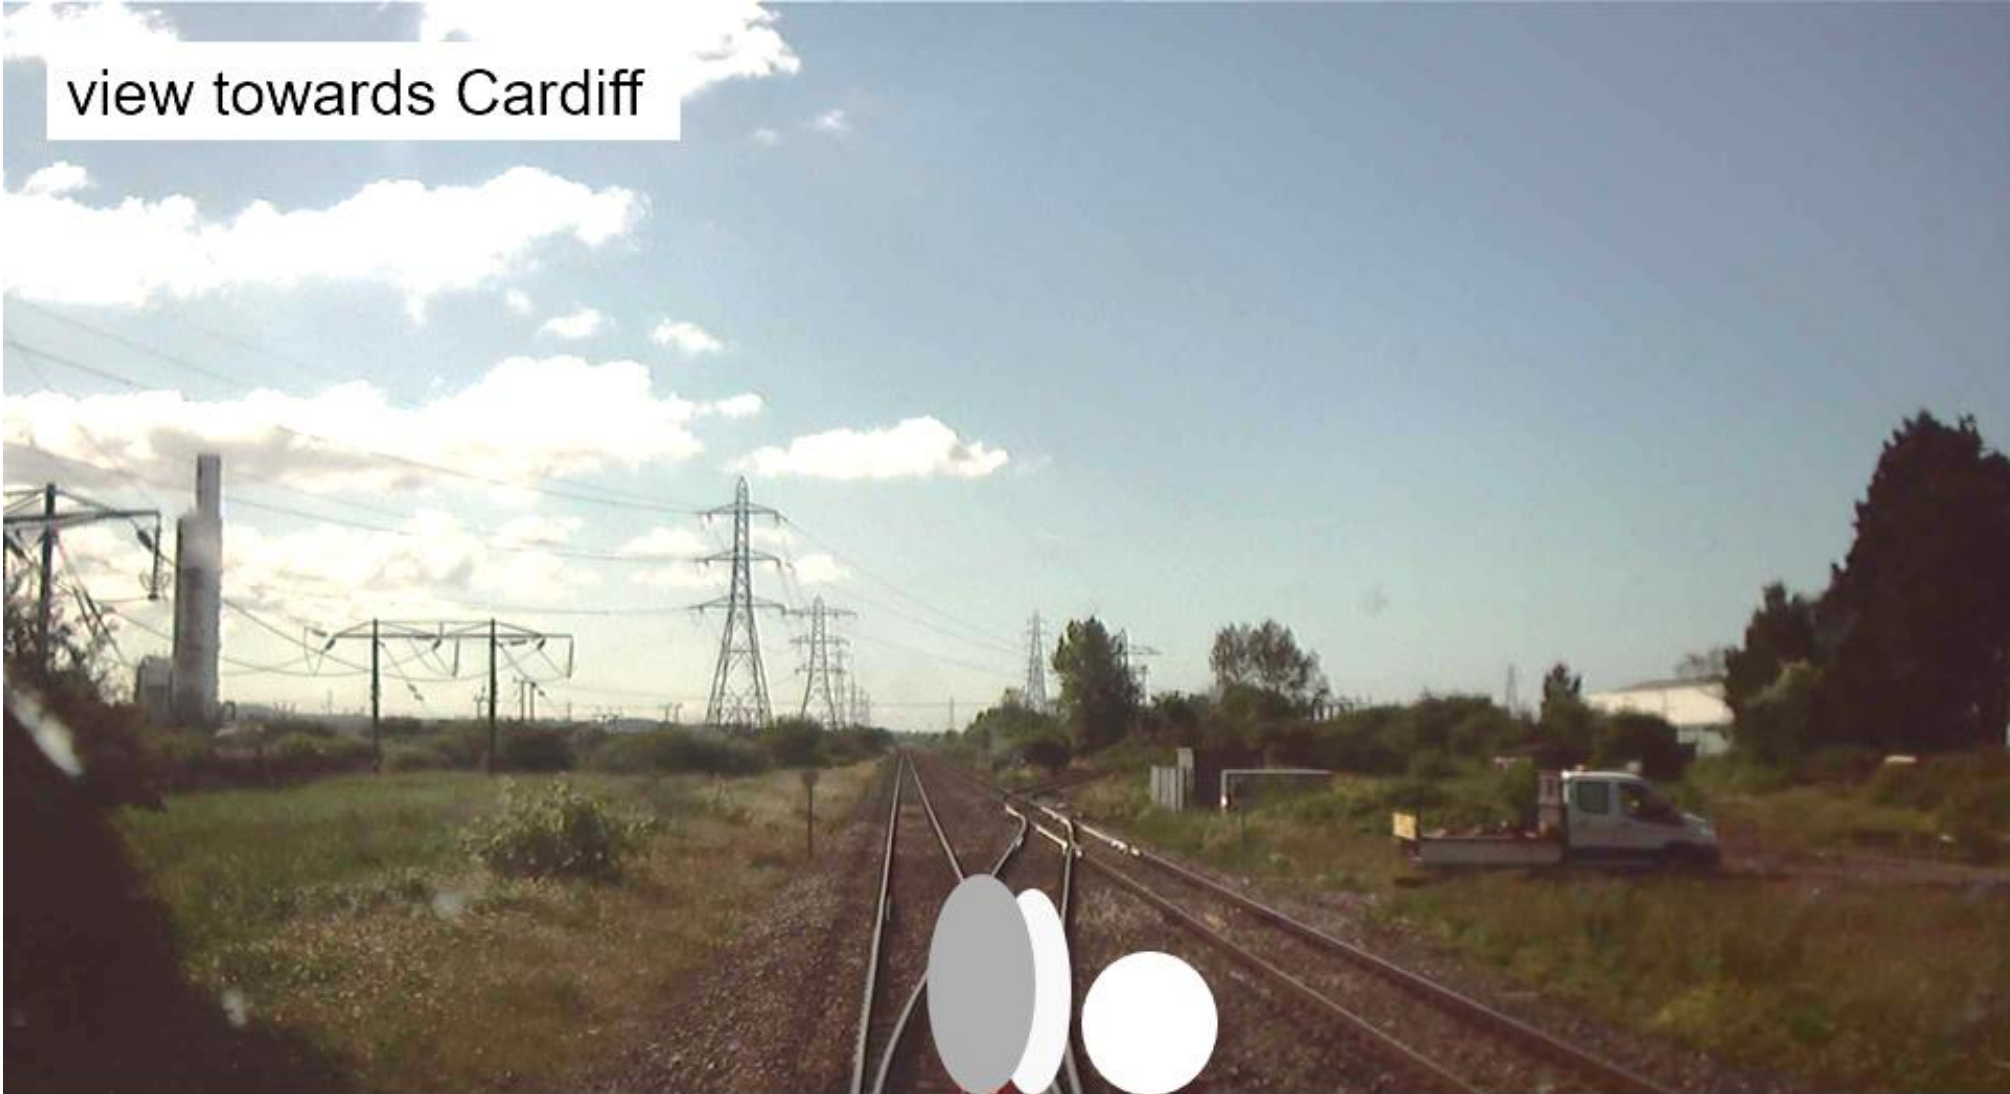
# 09:52 hrs – the arrival of the train

view towards Cardiff

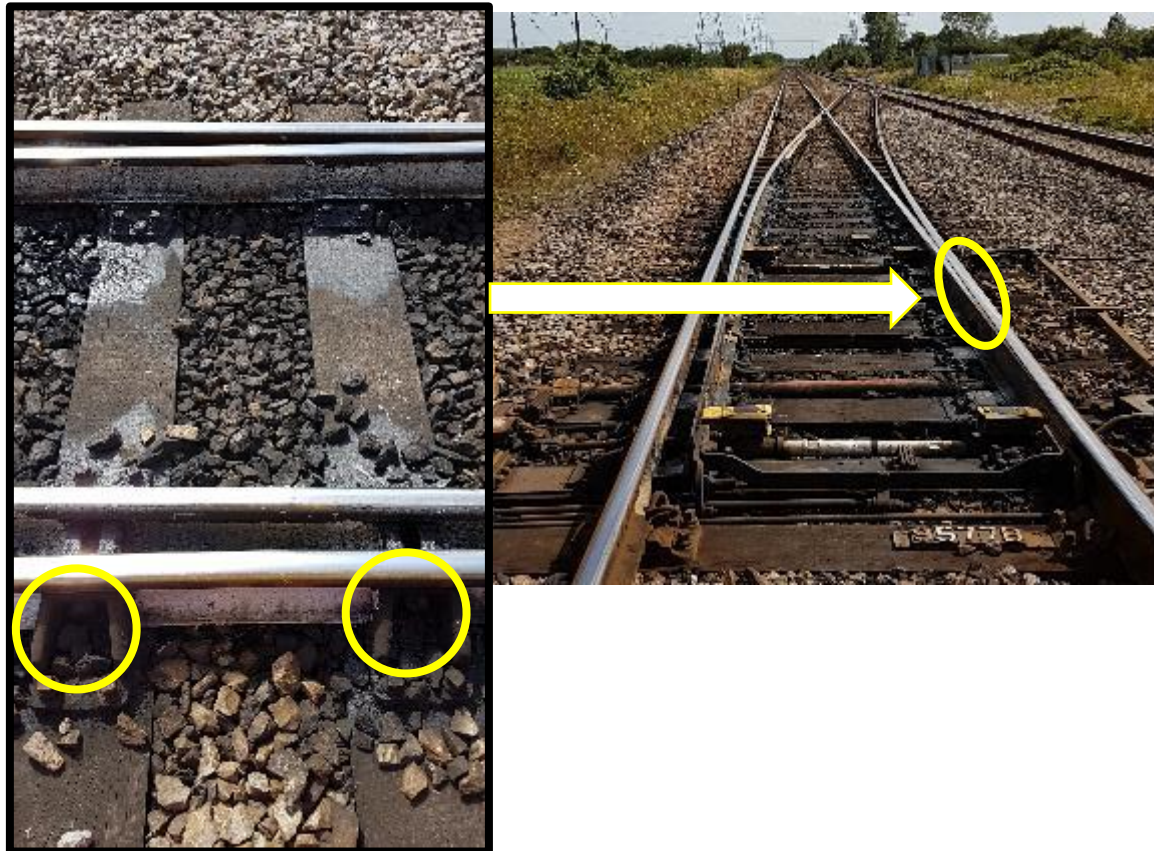
1.1 The work being undertaken at the time of the accident.

‘unnecessary’

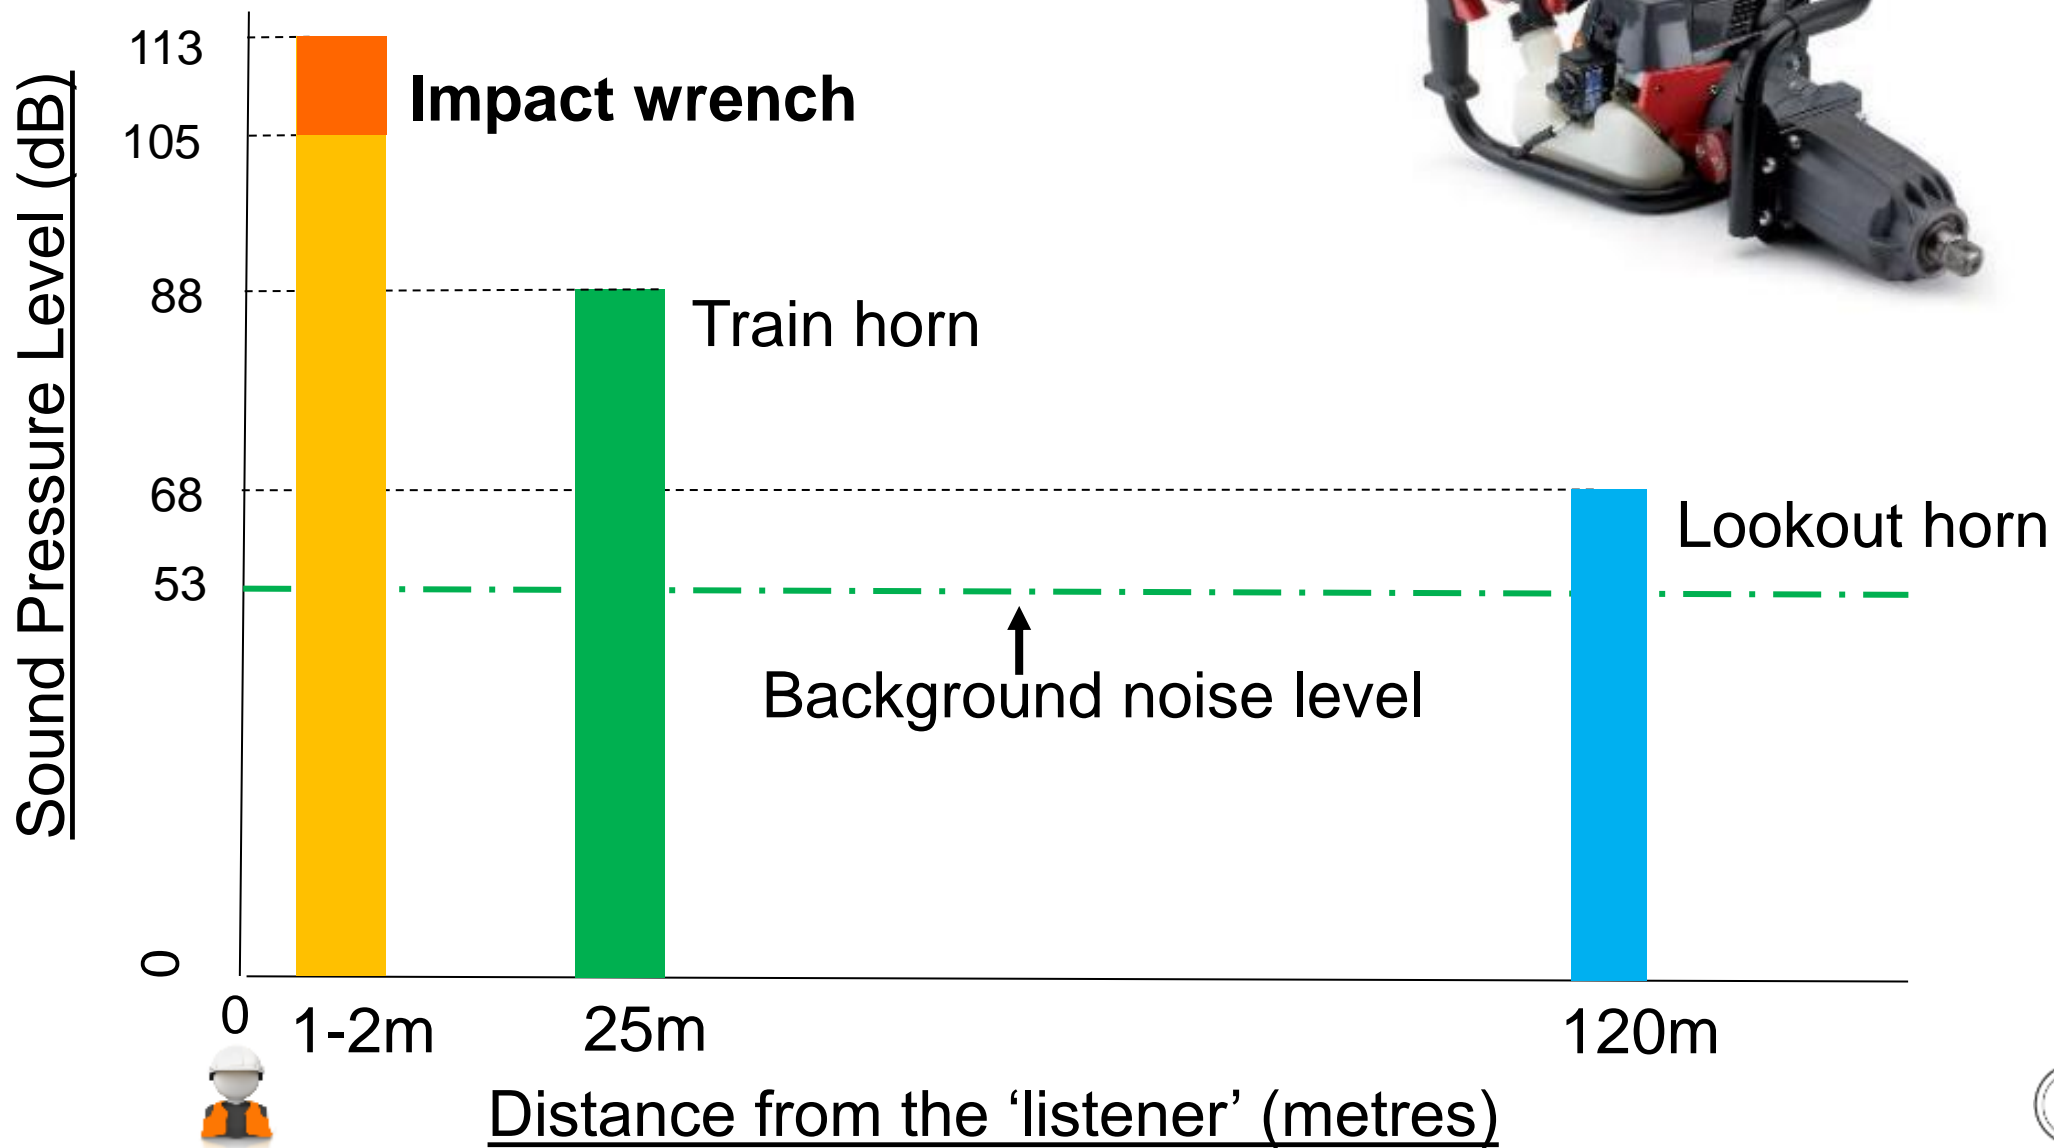
# Audibility

**The group of three track workers did not hear any warning of, or see, the train's approach.**
