Proposed Redevelopment
Jerrings Hall Farm
Tanworth Lane
Shirley
Solihull
West Midlands
B90 4DX

GEOTECHNICAL REPORT

REPORT NO. 19106, February 2020

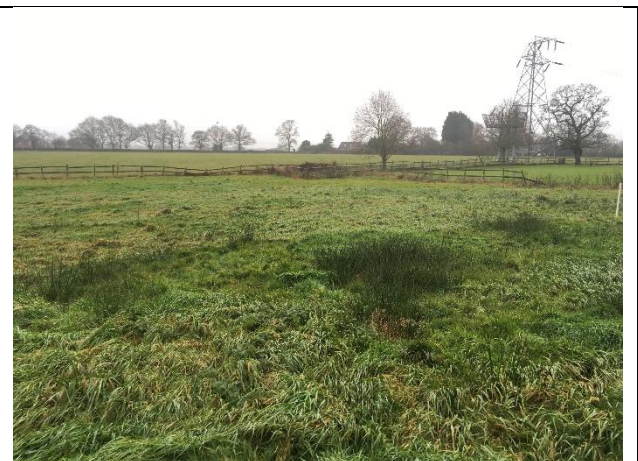
Plate 6 – Hydrophilic vegetation locally within the W of the southern paddock, looking SW towards former pond location.

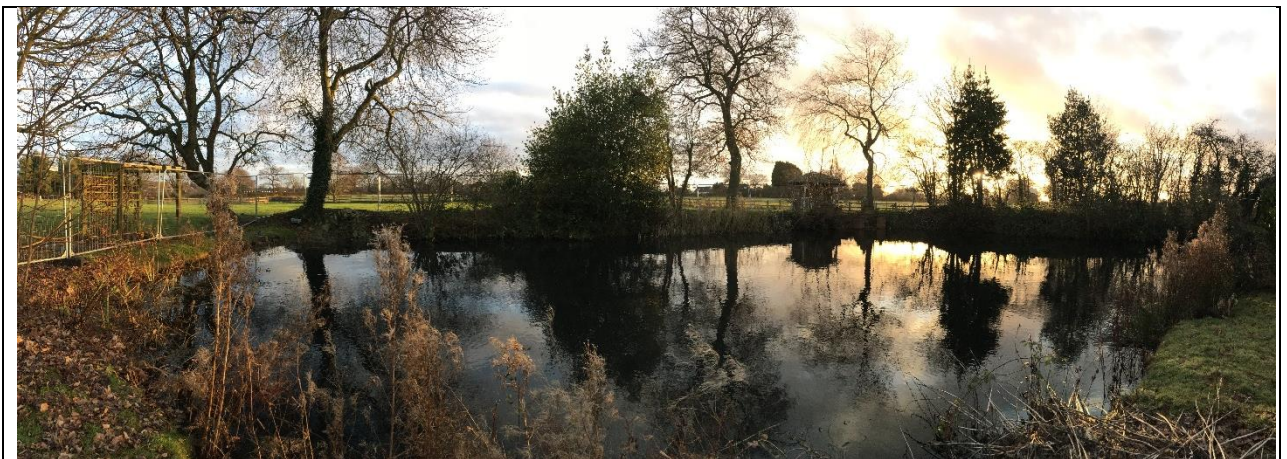
Plates 9 & 10 – The pond in the SW quadrant of the site, looking SW.

Drainage:	It is unclear where the pond drains to as no drainage features have been noted along the WSW or SSE boundaries of the site. Additionally, no culvert outflows or similar were noted along the ENE boundary adjacent to Tanworth Lane, where the former stream crossed onto adjacent land. Hydrophilic vegetation was noted within the paddock area in the SE quadrant, inferred to be on the line of the former stream.
Other evidence of Services:	Buried propane tank between barn and cottage. Septic tanks buried in various locations around the site. Manholes adjacent to the NNW boundary within the garden.
Vehicle maintenance:	N/A
Waste:	N/A
Sub-stations:	None within or adjacent to the site boundary.
Ecological features of note:	On-site pond.
Any seepages on or adjacent to site:	None.
Watercourses, water levels:	No surface watercourses present within or adjacent to the site boundary. The water level in the pond was c.0.3m below the top of the E bank.

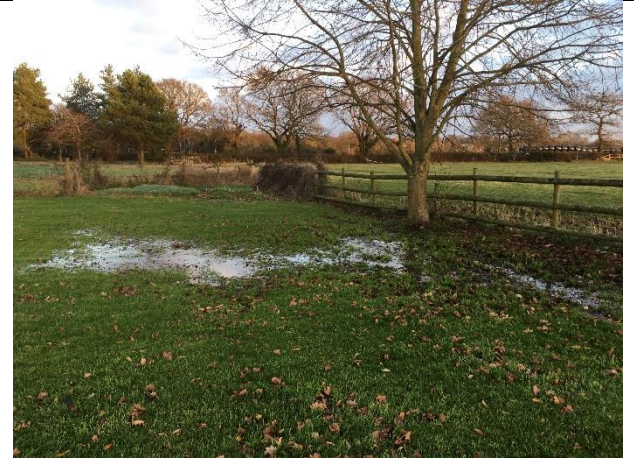
Plate 20 – The ground was saturated throughout the investigation with standing water noted adjacent to the S boundary.

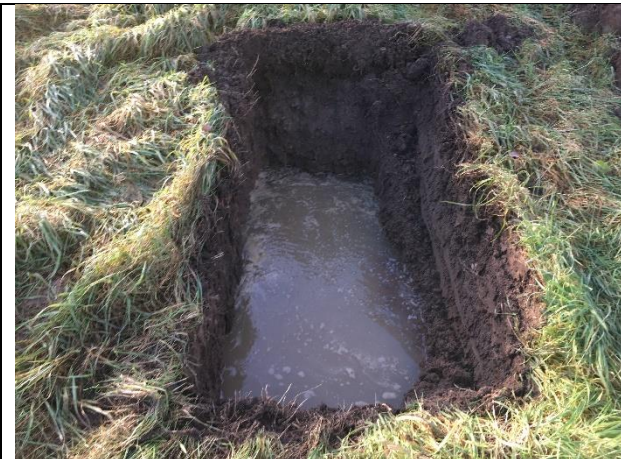
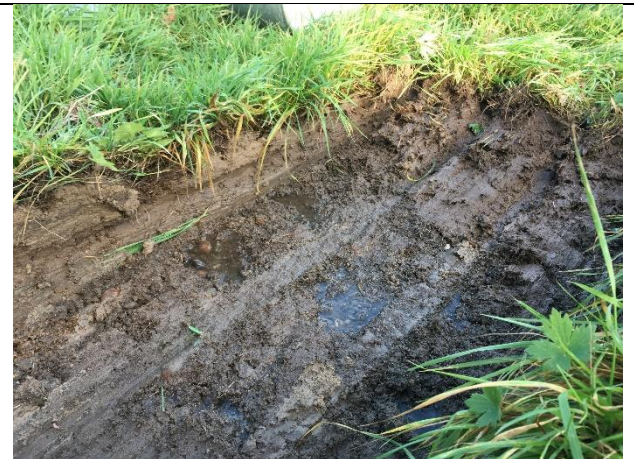
Plate 21 – Perched water flowed into shallow excavations from the glacial soils, as evidenced at VP2 (left) and DR2 (right) in the southern paddock.

Infiltration testing within the clayey topsoil was undertaken in 3 No. locations following stripping of the overlying grass and root invaded soils. The dual rings were filled by hand from a container and the drop in water level was recorded over time with the results provided in Appendix F. Within approximately 30-40 minutes the water level had only dropped by 5-18mm, suggesting an infiltration rate between 2.78×10^{-6} m/s and 7.50×10^{-6} m/s, although three tests could not be completed at each position. No discernible drop in water level was noted at DR1 and subsequently was deemed to be practically impermeable. Very shallow perched water ingress was noted at DR2 when the topsoil had been stripped back to 0.05m depth.

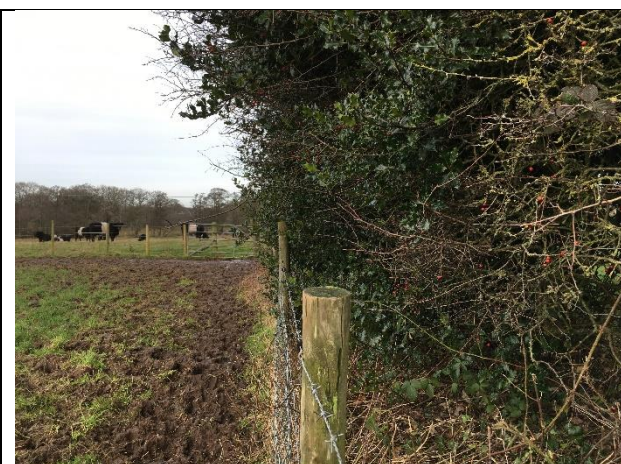
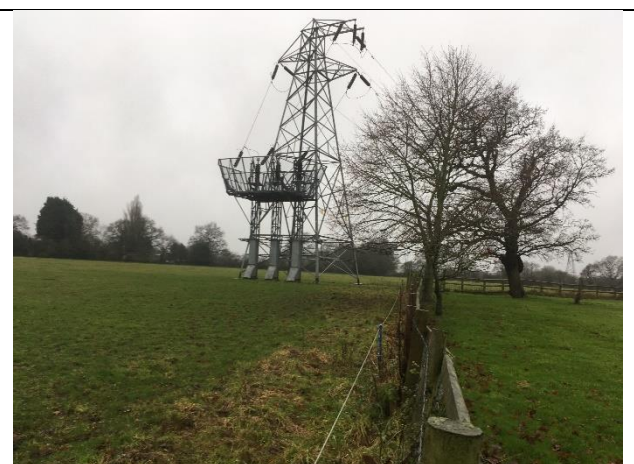
Plates 23 & 24 – The W (left) & S (right) boundaries were checked for evidence of drainage ditches or similar, no such features were noted.

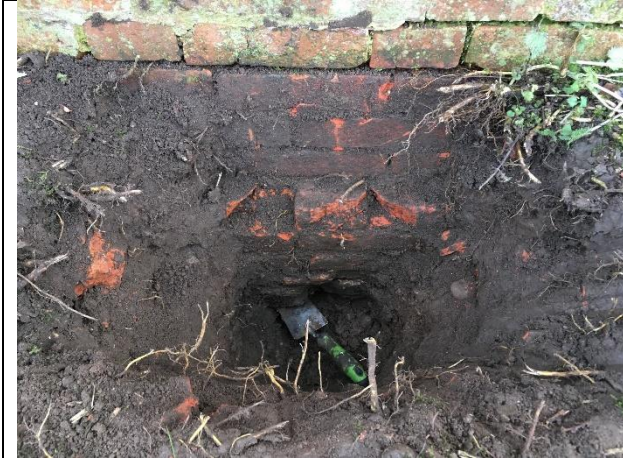
Plate 25 – The foundation of the stable block/outbuildings' N elevation.

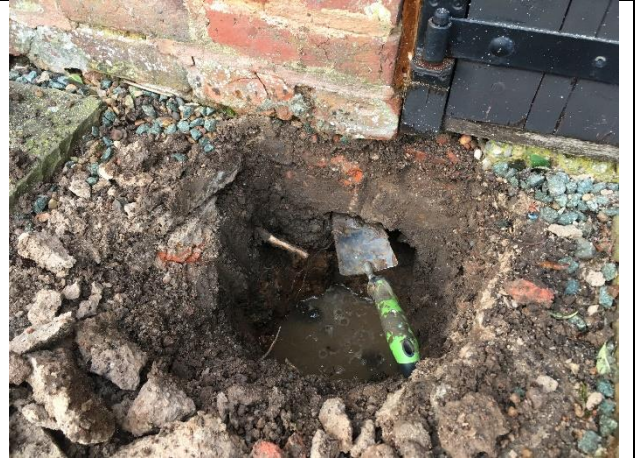
Plate 26 – The foundation of the stable block/outbuildings' S elevation.

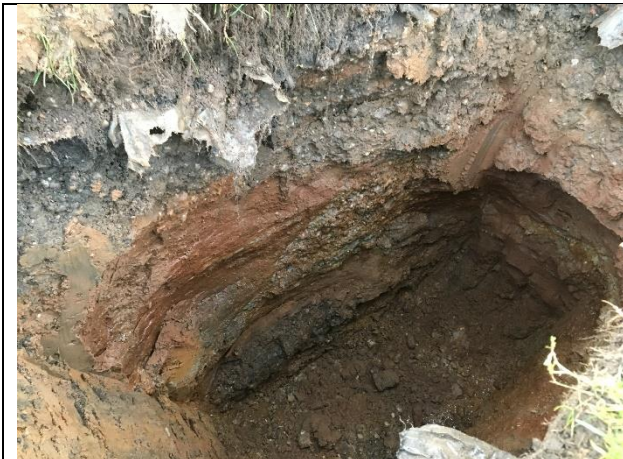
Plate 27 – The glacial soils were variable in composition, noted in TP1 with very clayey Sand interspersed with very sandy Gravel.

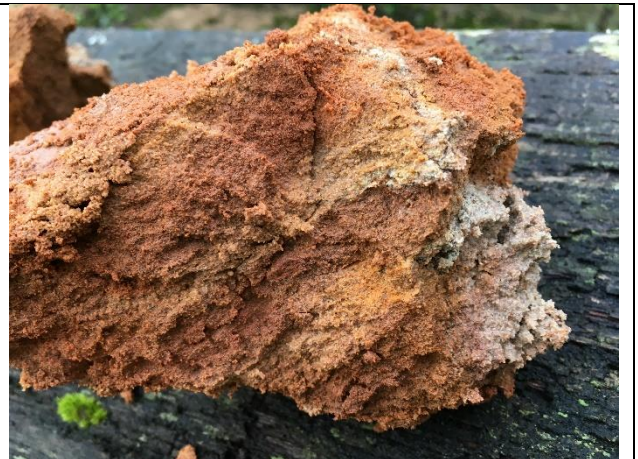
Plate 28 – Red-brown very clayey Sand recovered from TP1, at c. 0.75m, S of site Centre.

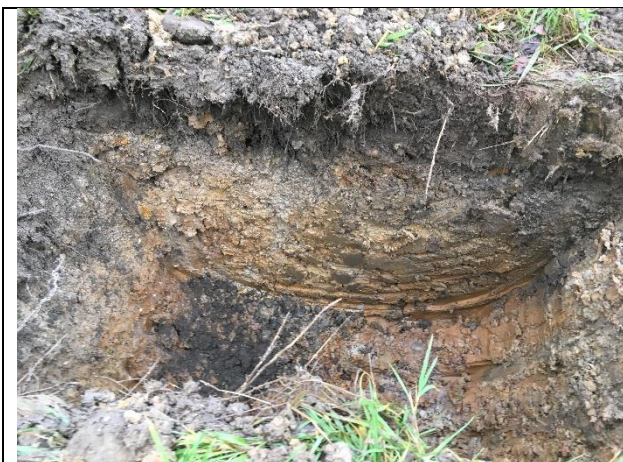
Plate 29 – Slightly sandy slightly gravelly Clay, exposed in SA4 in the E of the site.

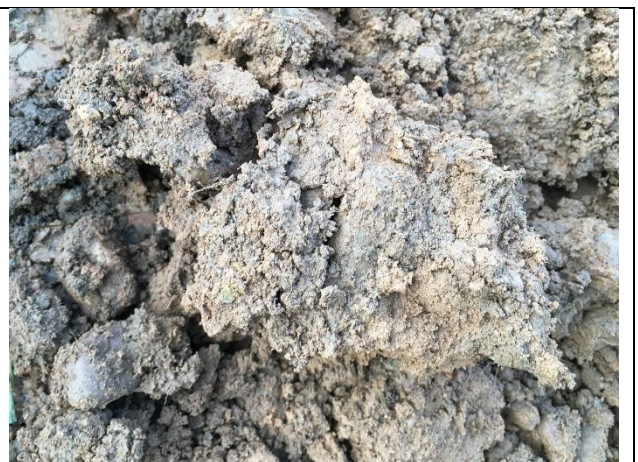
Plate 30 – Soft grey-brown slightly sandy slightly gravelly Clay, recovered from SA4 at c.0.5m.
