Jerrings Hall Farm

**Archaeological
Assessment**

May 2020
Report Reference
edp5137_r001c

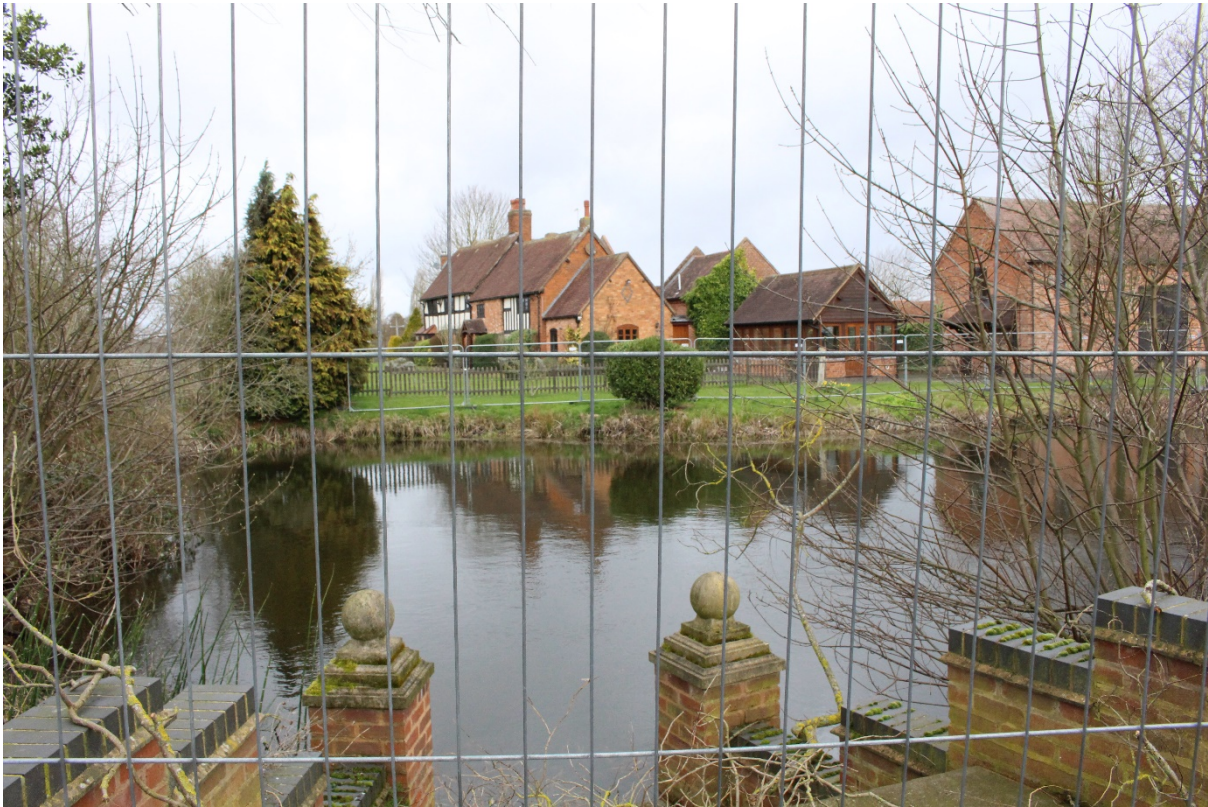
Image EDP 1 View of the pond and Jerrings Hall, taken from the southern banks of the pond, facing north. The pond is separated somewhat from the buildings.

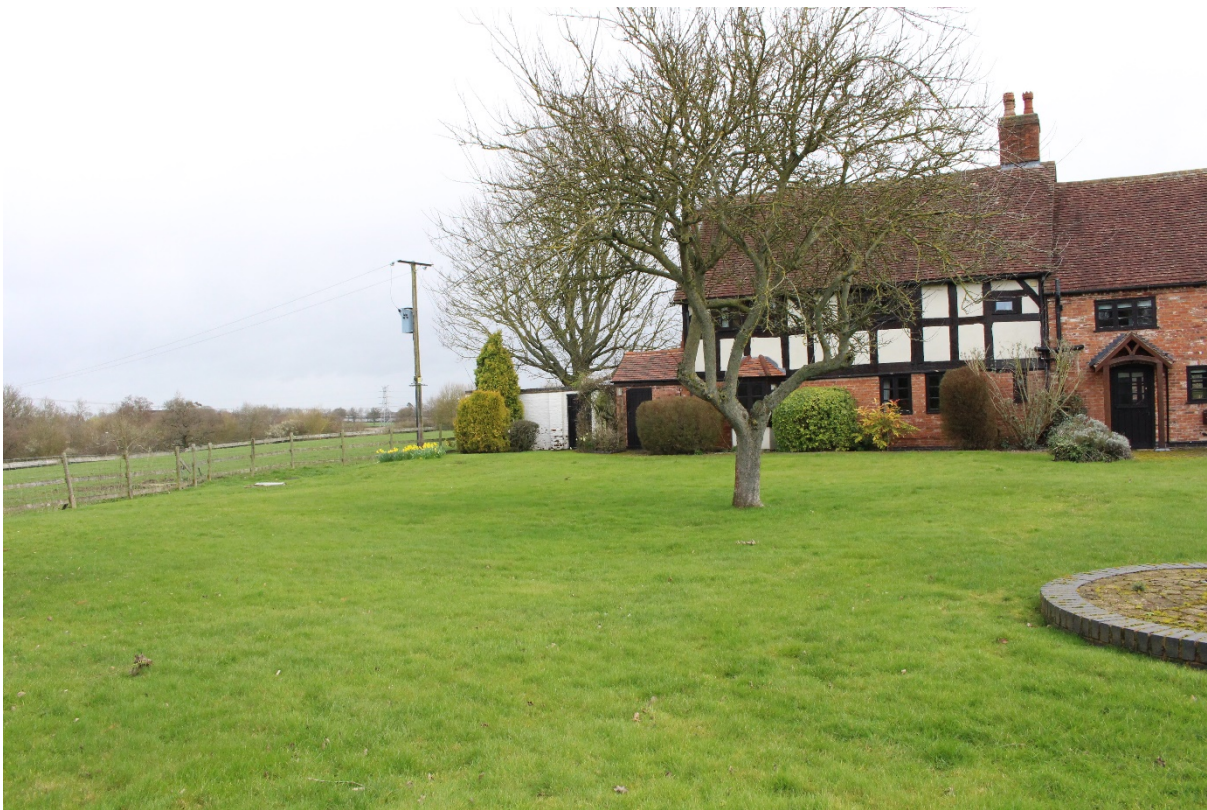
Image EDP 2 View of area to the north of the pond, illustrating the lack of above-ground features suggestive of moat earthworks.

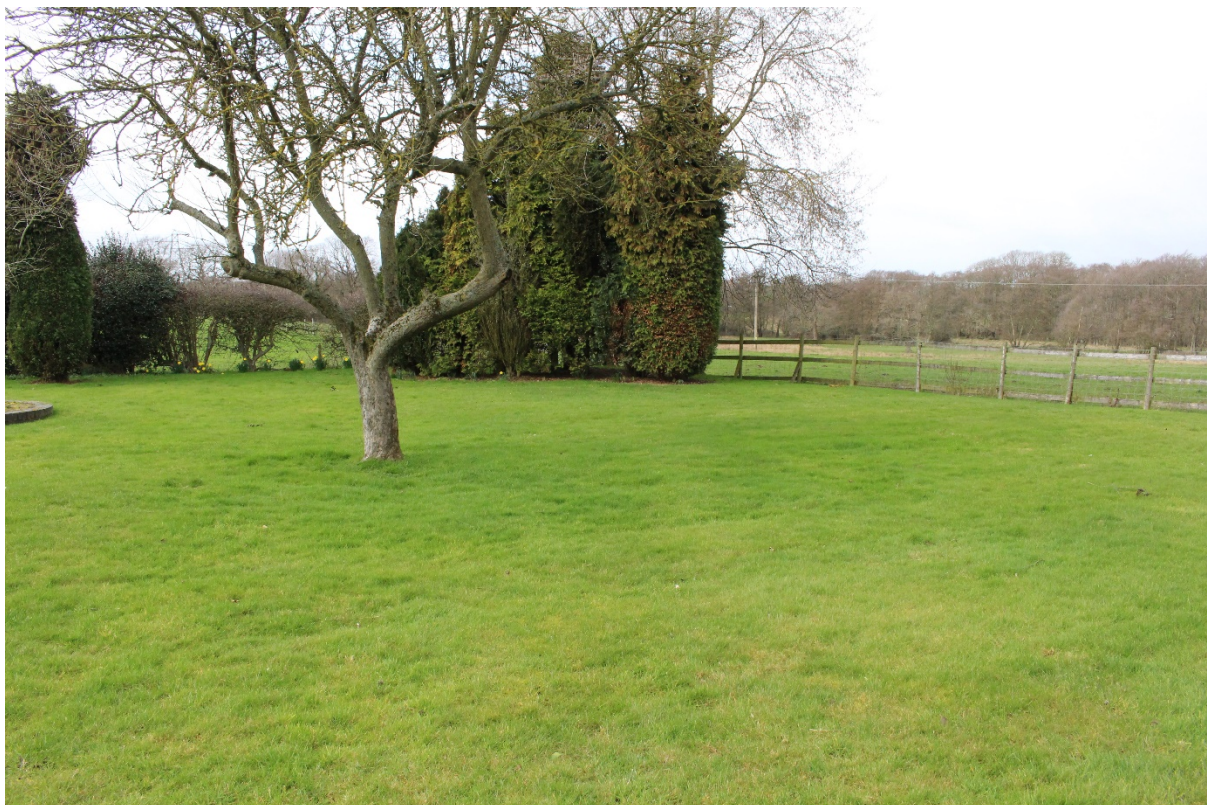
Image EDP 3 View of area for to the north of the pond, facing north-west, illustrating the lack of above-ground features suggestive of moat earthworks.

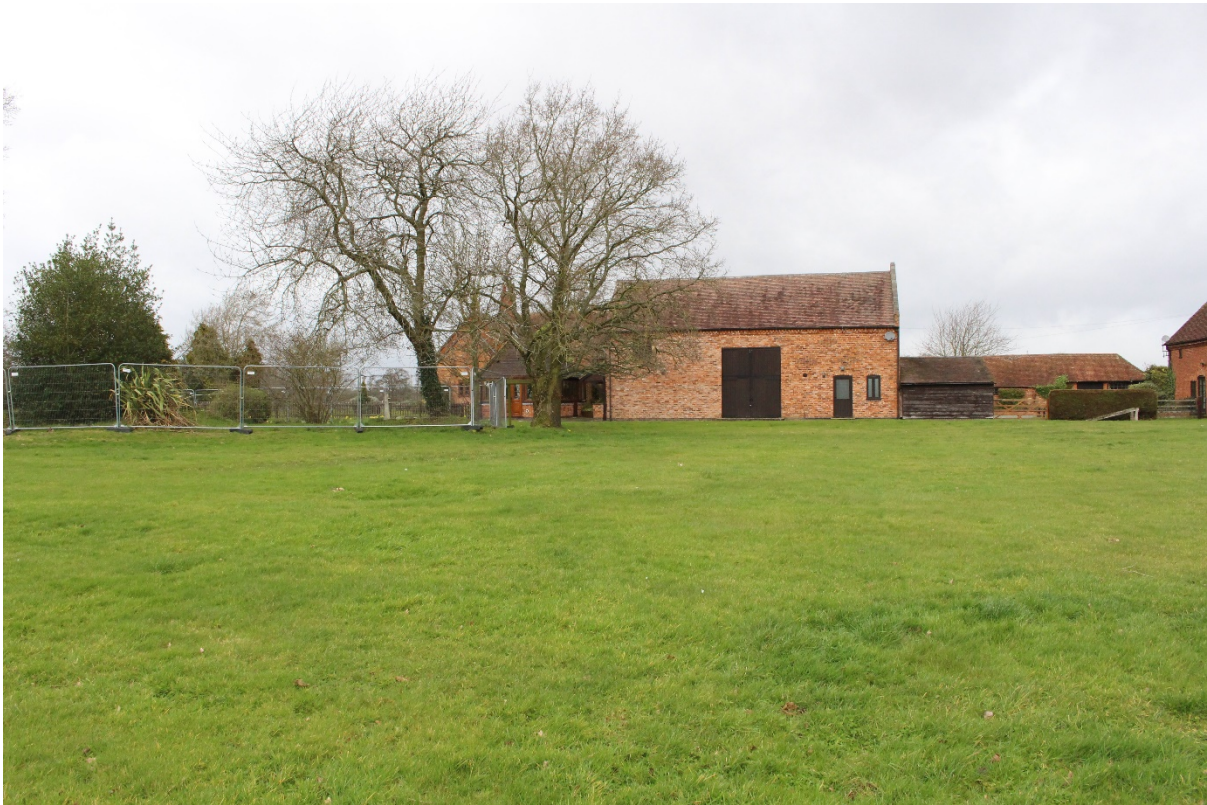
Image EDP 4 View of the pond and southern elevation of the barn, facing north, illustrating the lack of above-ground features suggestive of moat earthworks. One of the proposed modular buildings will be located on the right of this picture. There is also no evidence for the former 20th century barns here, suggesting a substantial amount of later landscaping to remove such features.

- 5.10 The proposed construction of the modular building within this part of the application site (**Appendix EDP 1**), which is currently occupied by landscaped gardens (**Image EDP 4**) is anticipated to require some strip foundations and minimal ground reduction work to existing levels. As such, it is considered that this development would be unlikely to result in any extensive adverse impact on significant archaeological remains. Any remains of the potential moated site that survive in this location are likely to be overlain by significant deposits of later material associated with infill and levelling deposits and construction activities recorded in this area since the post-medieval period.

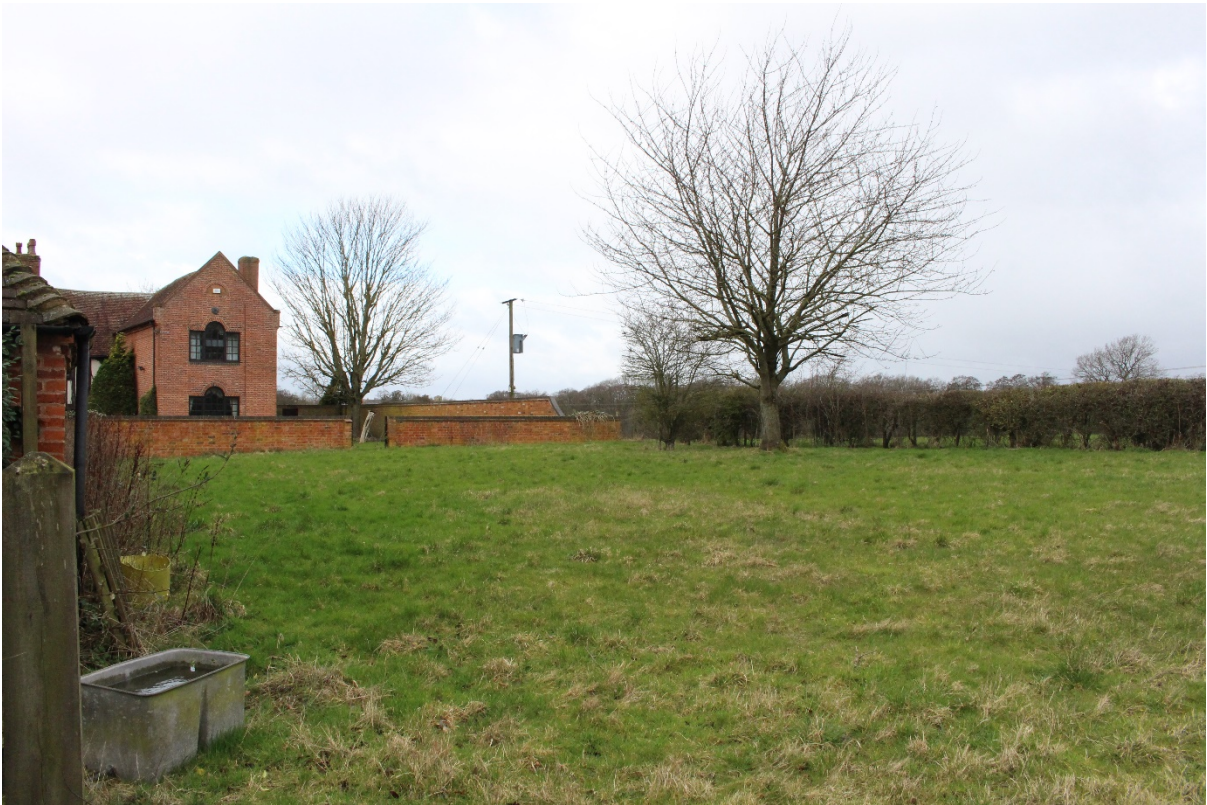
Image EDP 5 View of the area of the second modular building, facing north-west, illustrating the lack of above-ground features suggestive of earlier earthworks.

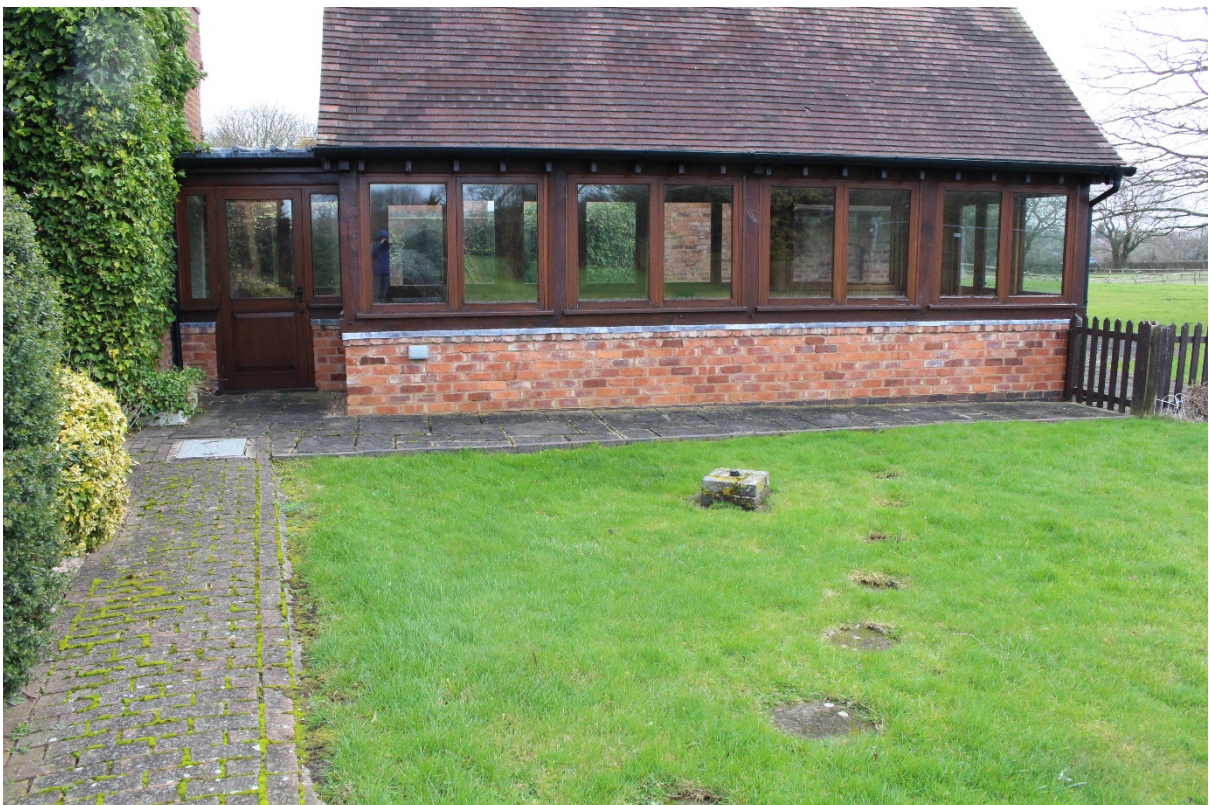
- 4.72 There was also no evidence of the building foundations to the south of the house as mentioned in the HER (**Image EDP 6**). In the eastern area of the application site, where the proposed parking area is located, there were no earthwork features identified (**Image EDP 7**).

Image EDP 6 View of the area to the south of the main house where the HER suggested foundations of a former building was present. No evidenced of these foundations were observed during the site visit.

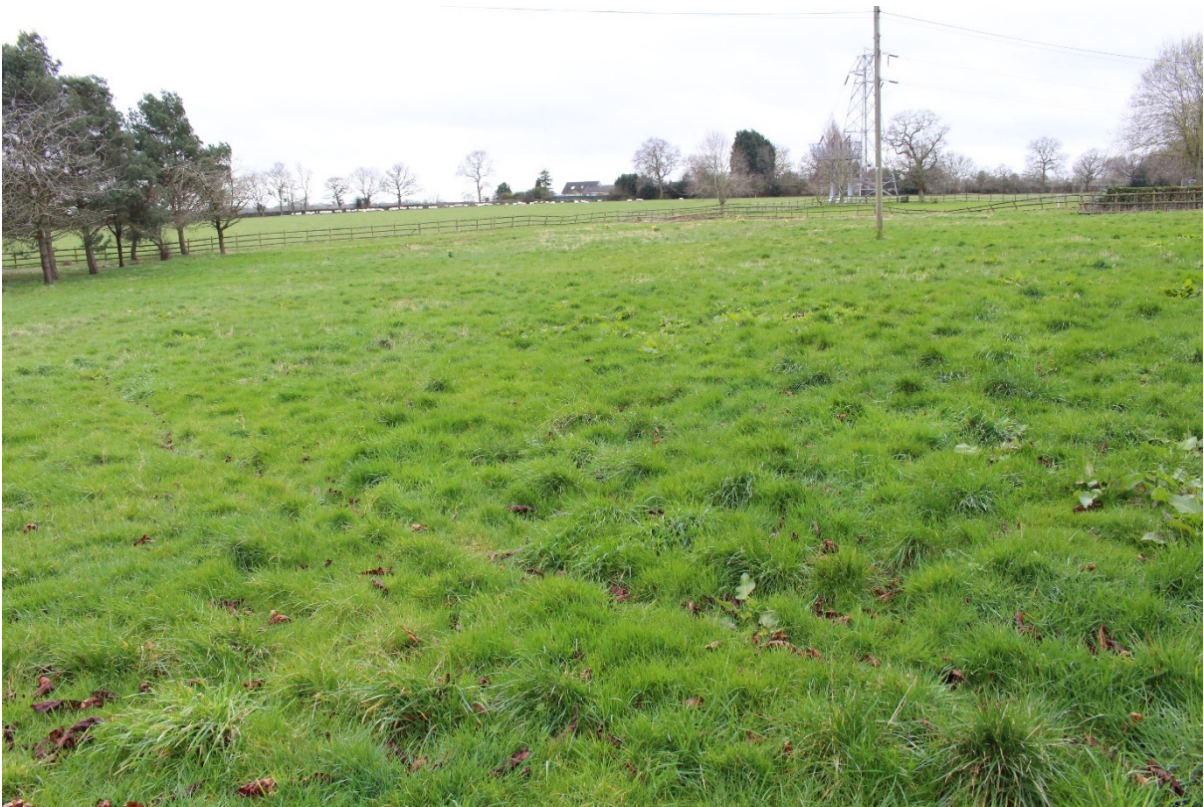
Image EDP 7 View of the south-eastern area of the application site where the proposed car parking area will be located, facing south-west, illustrating the lack of above-ground features.

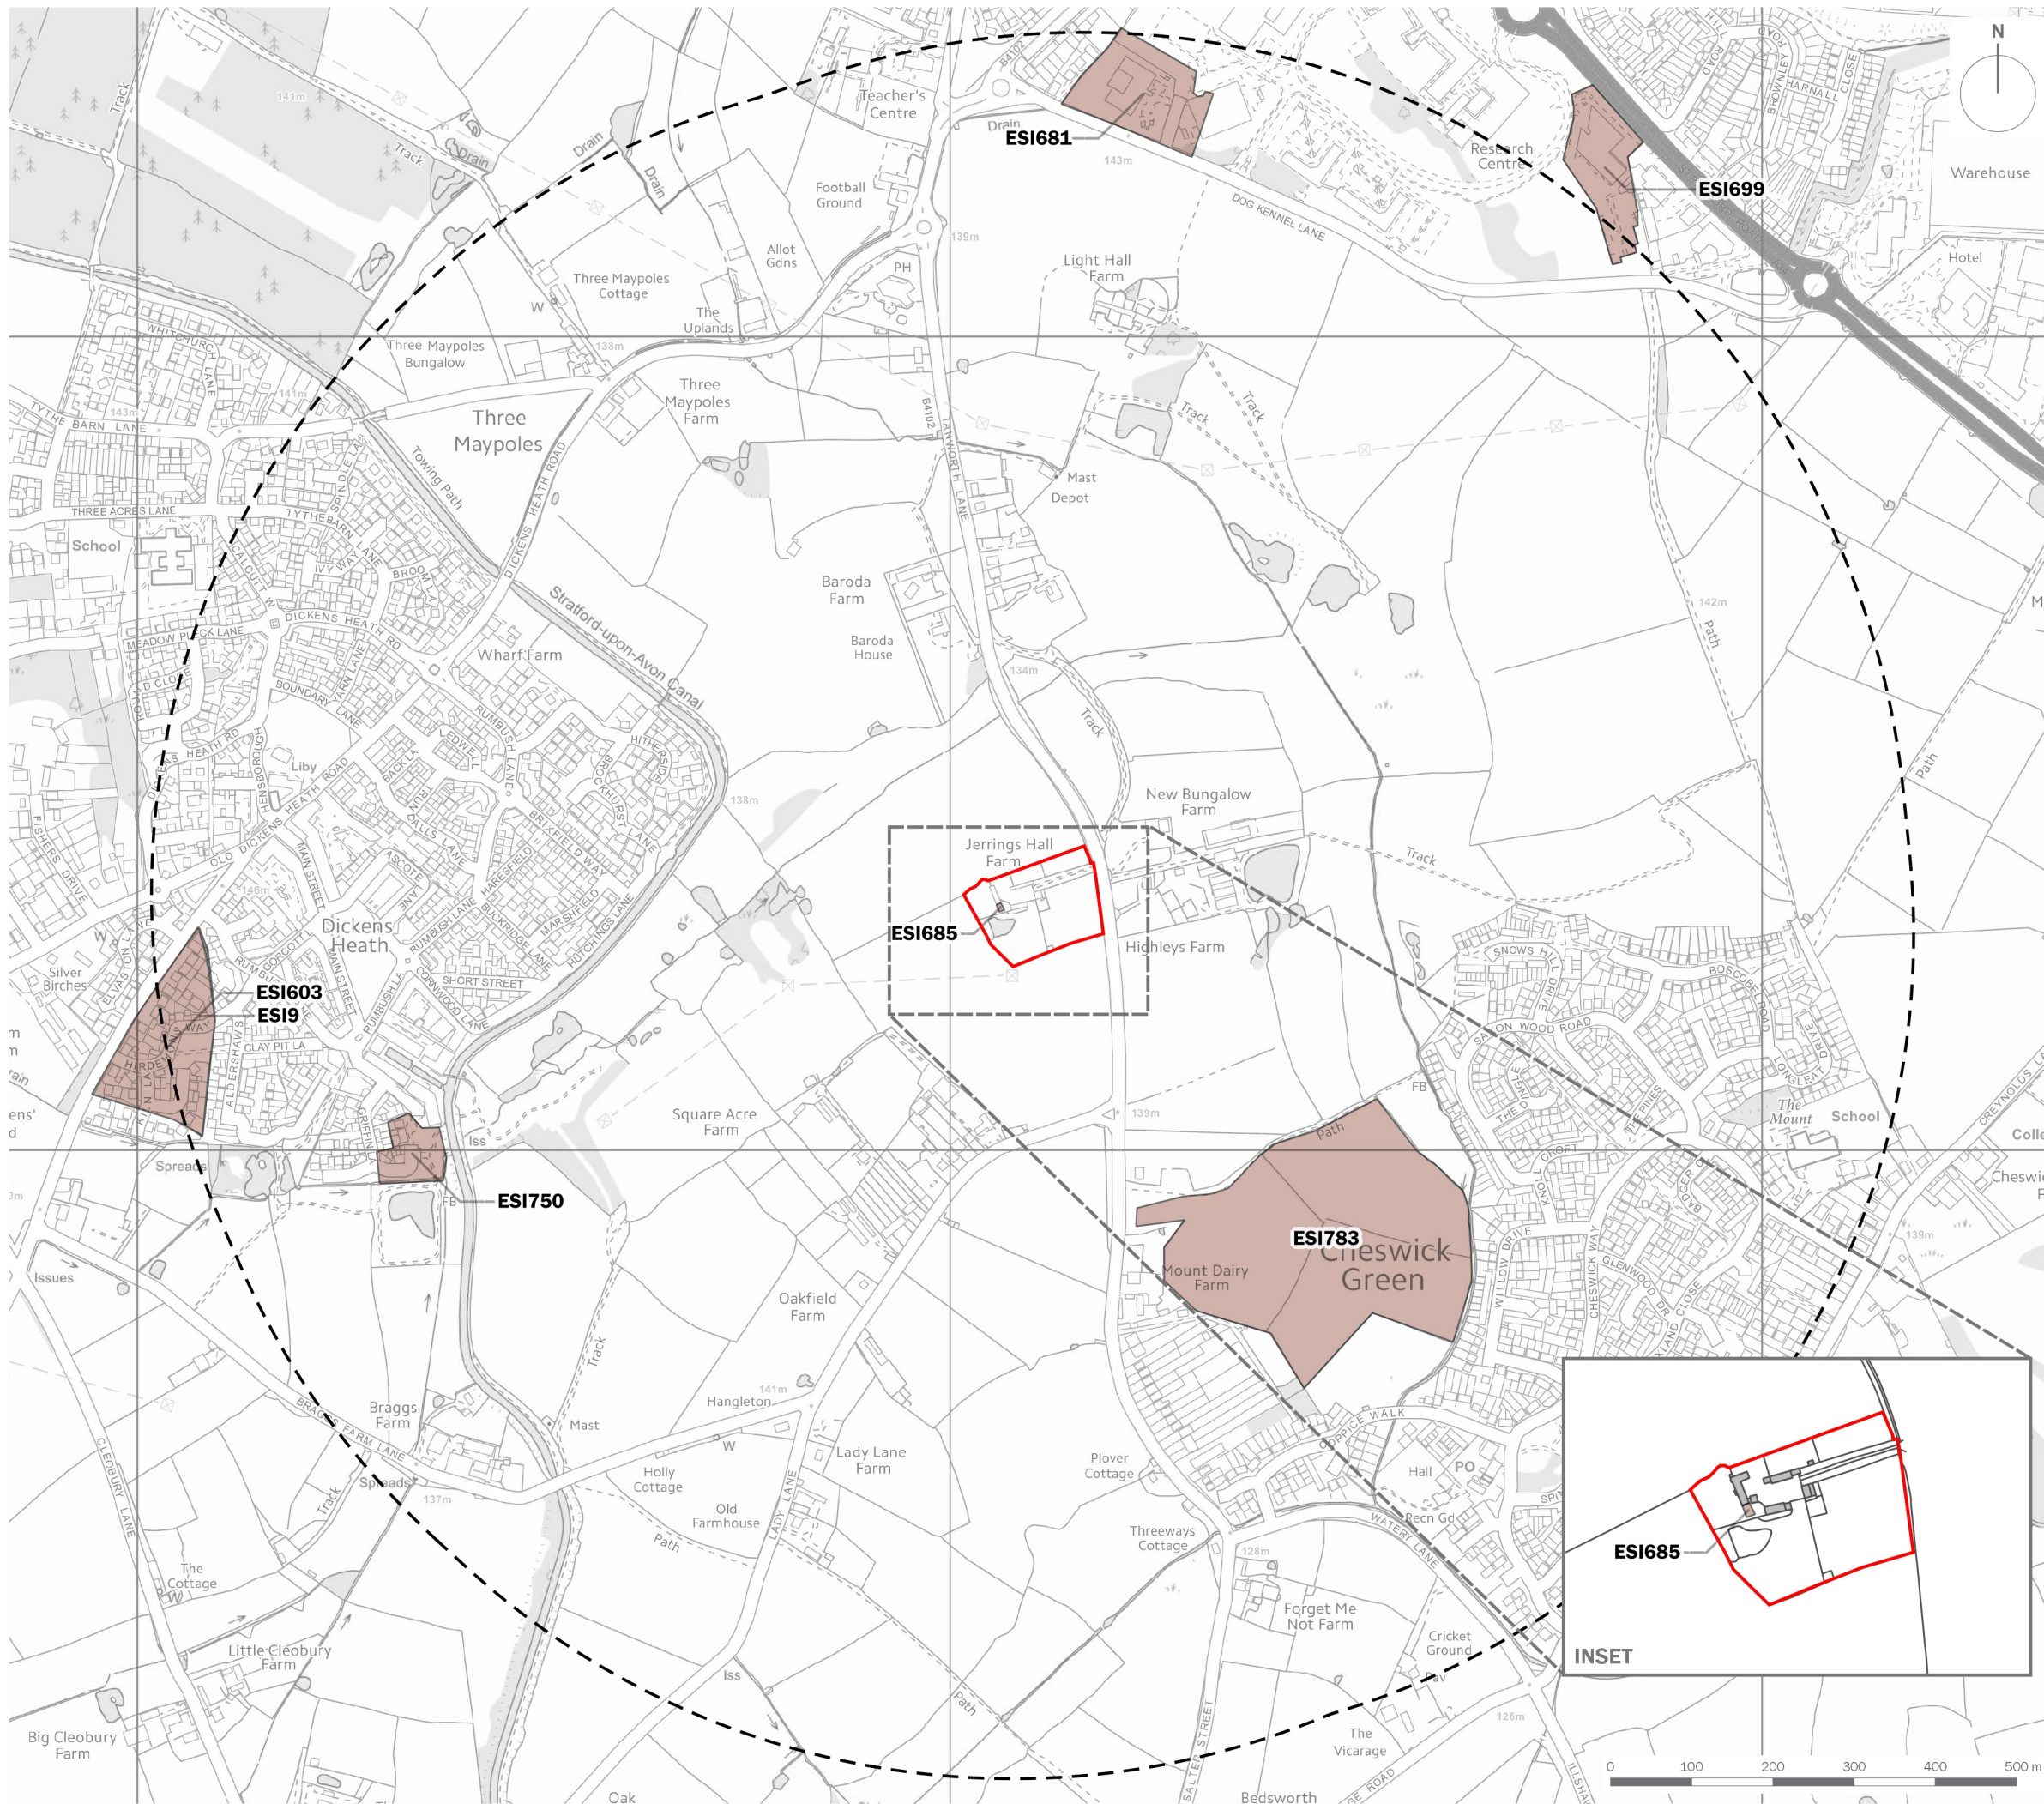
client
The Island Project
 project title
Jerrings Hall Farm
 drawing title
Plan EDP 3: Previous Archaeological Works
 date **19 MAY 2020** drawn by **AG**
 drawing number **edp5137_d007a** checked **LB**
 scale **1:8,000 @ A3** QA **JTF**

- 4.42 The HER records a watching brief (**Plan EDP 3 - ESI685**) which was undertaken within the application site in 2006 (Rann, 2006). This entailed monitoring the excavation of foundation trenches for a garden room to the south of the main house. The works were required as part of a planning condition, as the proposed site was thought to lie within the bounds of the probable medieval moat.

- 4.43 The 0.58m wide foundation trenches were excavated to a depth of 0.6m. The natural ground was located at a depth of 0.47m in the northern end and at 0.25m on the south end. In the north-western part of the application site a layer of black sandy loam was found overlying the natural. This layer contained medium sized cobbles and brick fragments, along with several sherds of 19th century pottery. This was interpreted as rubble layer likely deposited to raise the ground level as the water table was high in this area.
