Near miss at Forestry user worked crossing, Norfolk, 18 September 2021

Summary of the incident

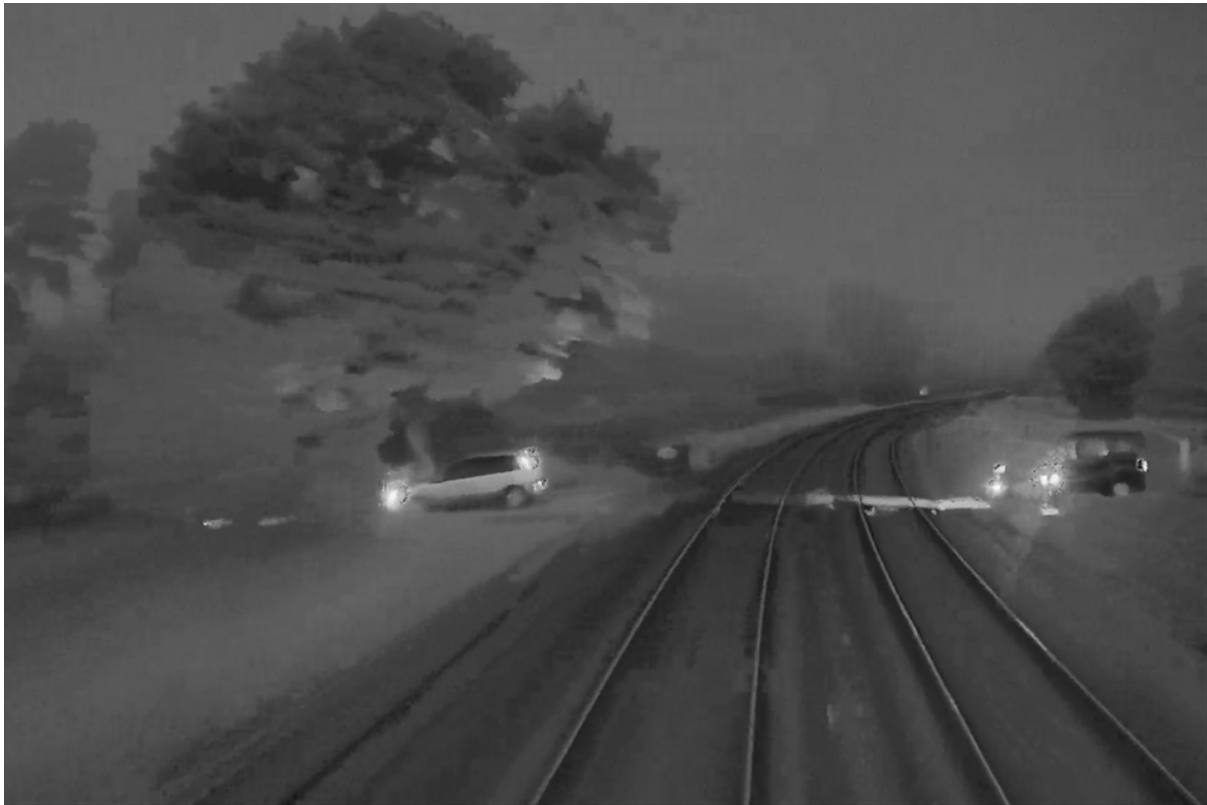
At around 06:05 hrs, a near miss occurred at Forestry user worked level crossing located between Thetford and Brandon. Train 1K55, the 05:27 hrs Greater Anglia service from Norwich to Stansted Airport, travelling on the up main line, came close to striking two cars. One of these cars had already crossed the tracks when the train entered the crossing. However, because the driver had not opened the gate on the far side of the tracks before crossing, this car was unable to move away, and remained within the railway boundary as the train passed.

The second car involved was inside the railway boundary on the other side of the crossing and was waiting to cross when the train passed. Although both cars were within the railway boundary, they were clear of the line itself, and the train passed between them without causing any damage or injury.

Still image from train 1K55's forward-facing CCTV, showing the location of the cars (crossing from right to left) at the time of the near miss (image courtesy of Abellio Greater Anglia)

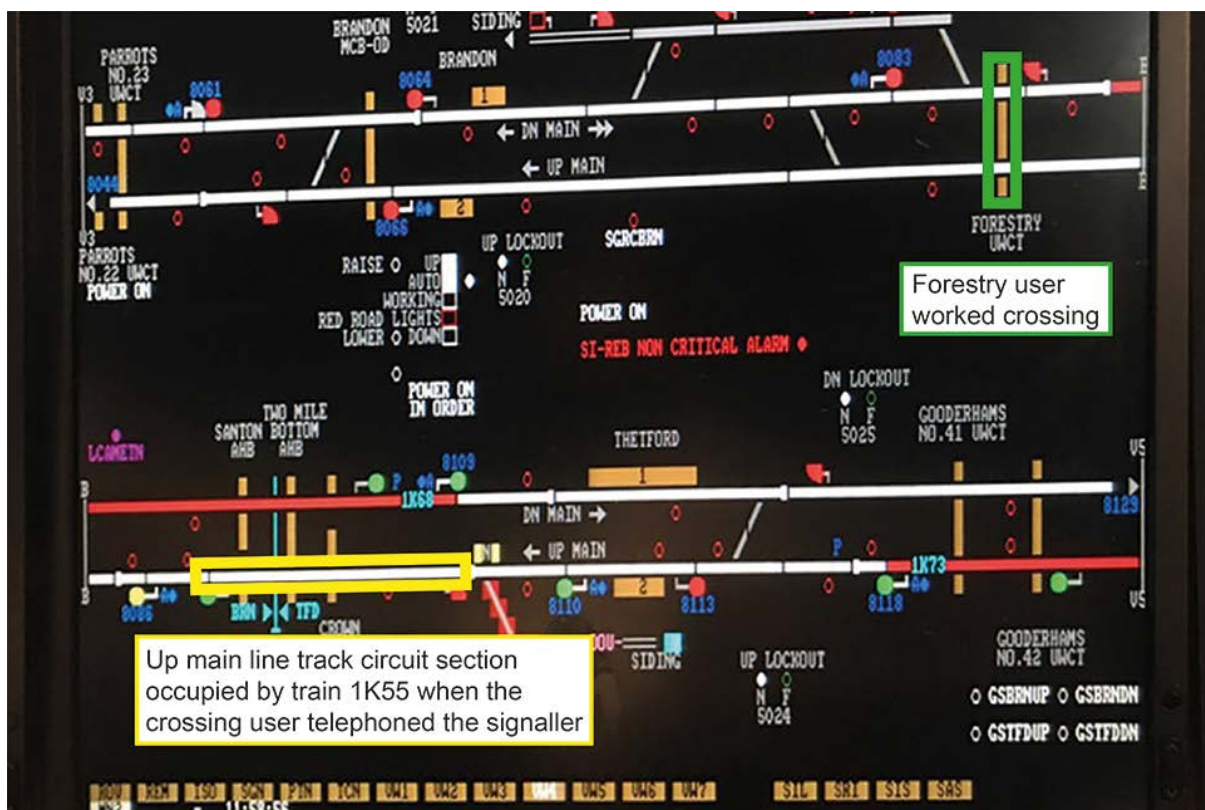
The Thetford workstation is a computer-based signalling display comprising five screens, which together present a schematic layout of the railway lines from Wymondham to Shippea Hill. Each screen represents the railway lines in white, divided into sections according to the track circuits that form part of the signalling system. Because the display is schematic, the lengths of the sections on the screens are not representative of their actual length in the real world. When a train occupies a given section, that section changes from white to red and includes a label showing the train's reporting number.

When the crossing user made the request from the crossing, train 1K55 had passed Thetford station and was occupying a track circuit section between the station and Forestry user worked crossing. RAIB calculated that this section is about 5.64 miles (9.08 km) long, meaning that a train travelling at the maximum permitted linespeed of 90 mph (145 km/h) would take around 3 minutes and 46 seconds to traverse its length. On leaving this section, trains approaching the crossing pass into two shorter track circuit sections, before occupying the section which includes Forestry user worked crossing. When he checked the display and gave permission for the users to cross, the signaller believed that train 1K55 had only recently departed from Thetford station and, given the length of that track circuit section, that there would be enough time for the users to cross before the train arrived at the crossing.

The Thetford workstation screen. Note that this image does not represent the situation at the time of the incident (image courtesy of Network Rail)

However, RAIB's analysis concluded that at the time the signaller gave permission for the users to cross, train 1K55 was actually nearing the far end of this track circuit, and was only around 44 seconds from Forestry user worked crossing. In fact, by the time the signaller had recorded the crossing request in the level crossing occurrence book, the train had already moved past Forestry user worked crossing and was occupying the track circuit section which includes Brandon station.

Network Rail also carried out a number of other actions to address the recommendations arising from the Hockham Road investigation, some of which have relevance to the incident at Forestry user worked crossing. Two additional screens were commissioned on the Thetford workstation (bringing the total to the five that were in place at the time of the incident), providing more detail on the displays, while the labelling of crossings on some screen views was made clearer. In addition, Network Rail reviewed the rules surrounding signallers' granting permission to users at user worked crossings, and rebriefed the rules to all staff in Cambridge signal box.
