# **High Speed Rail (Crewe to Manchester)**

BID HE-004-0MA06

MA06: Hulseheath to Manchester Airport  
Historic environment field survey report

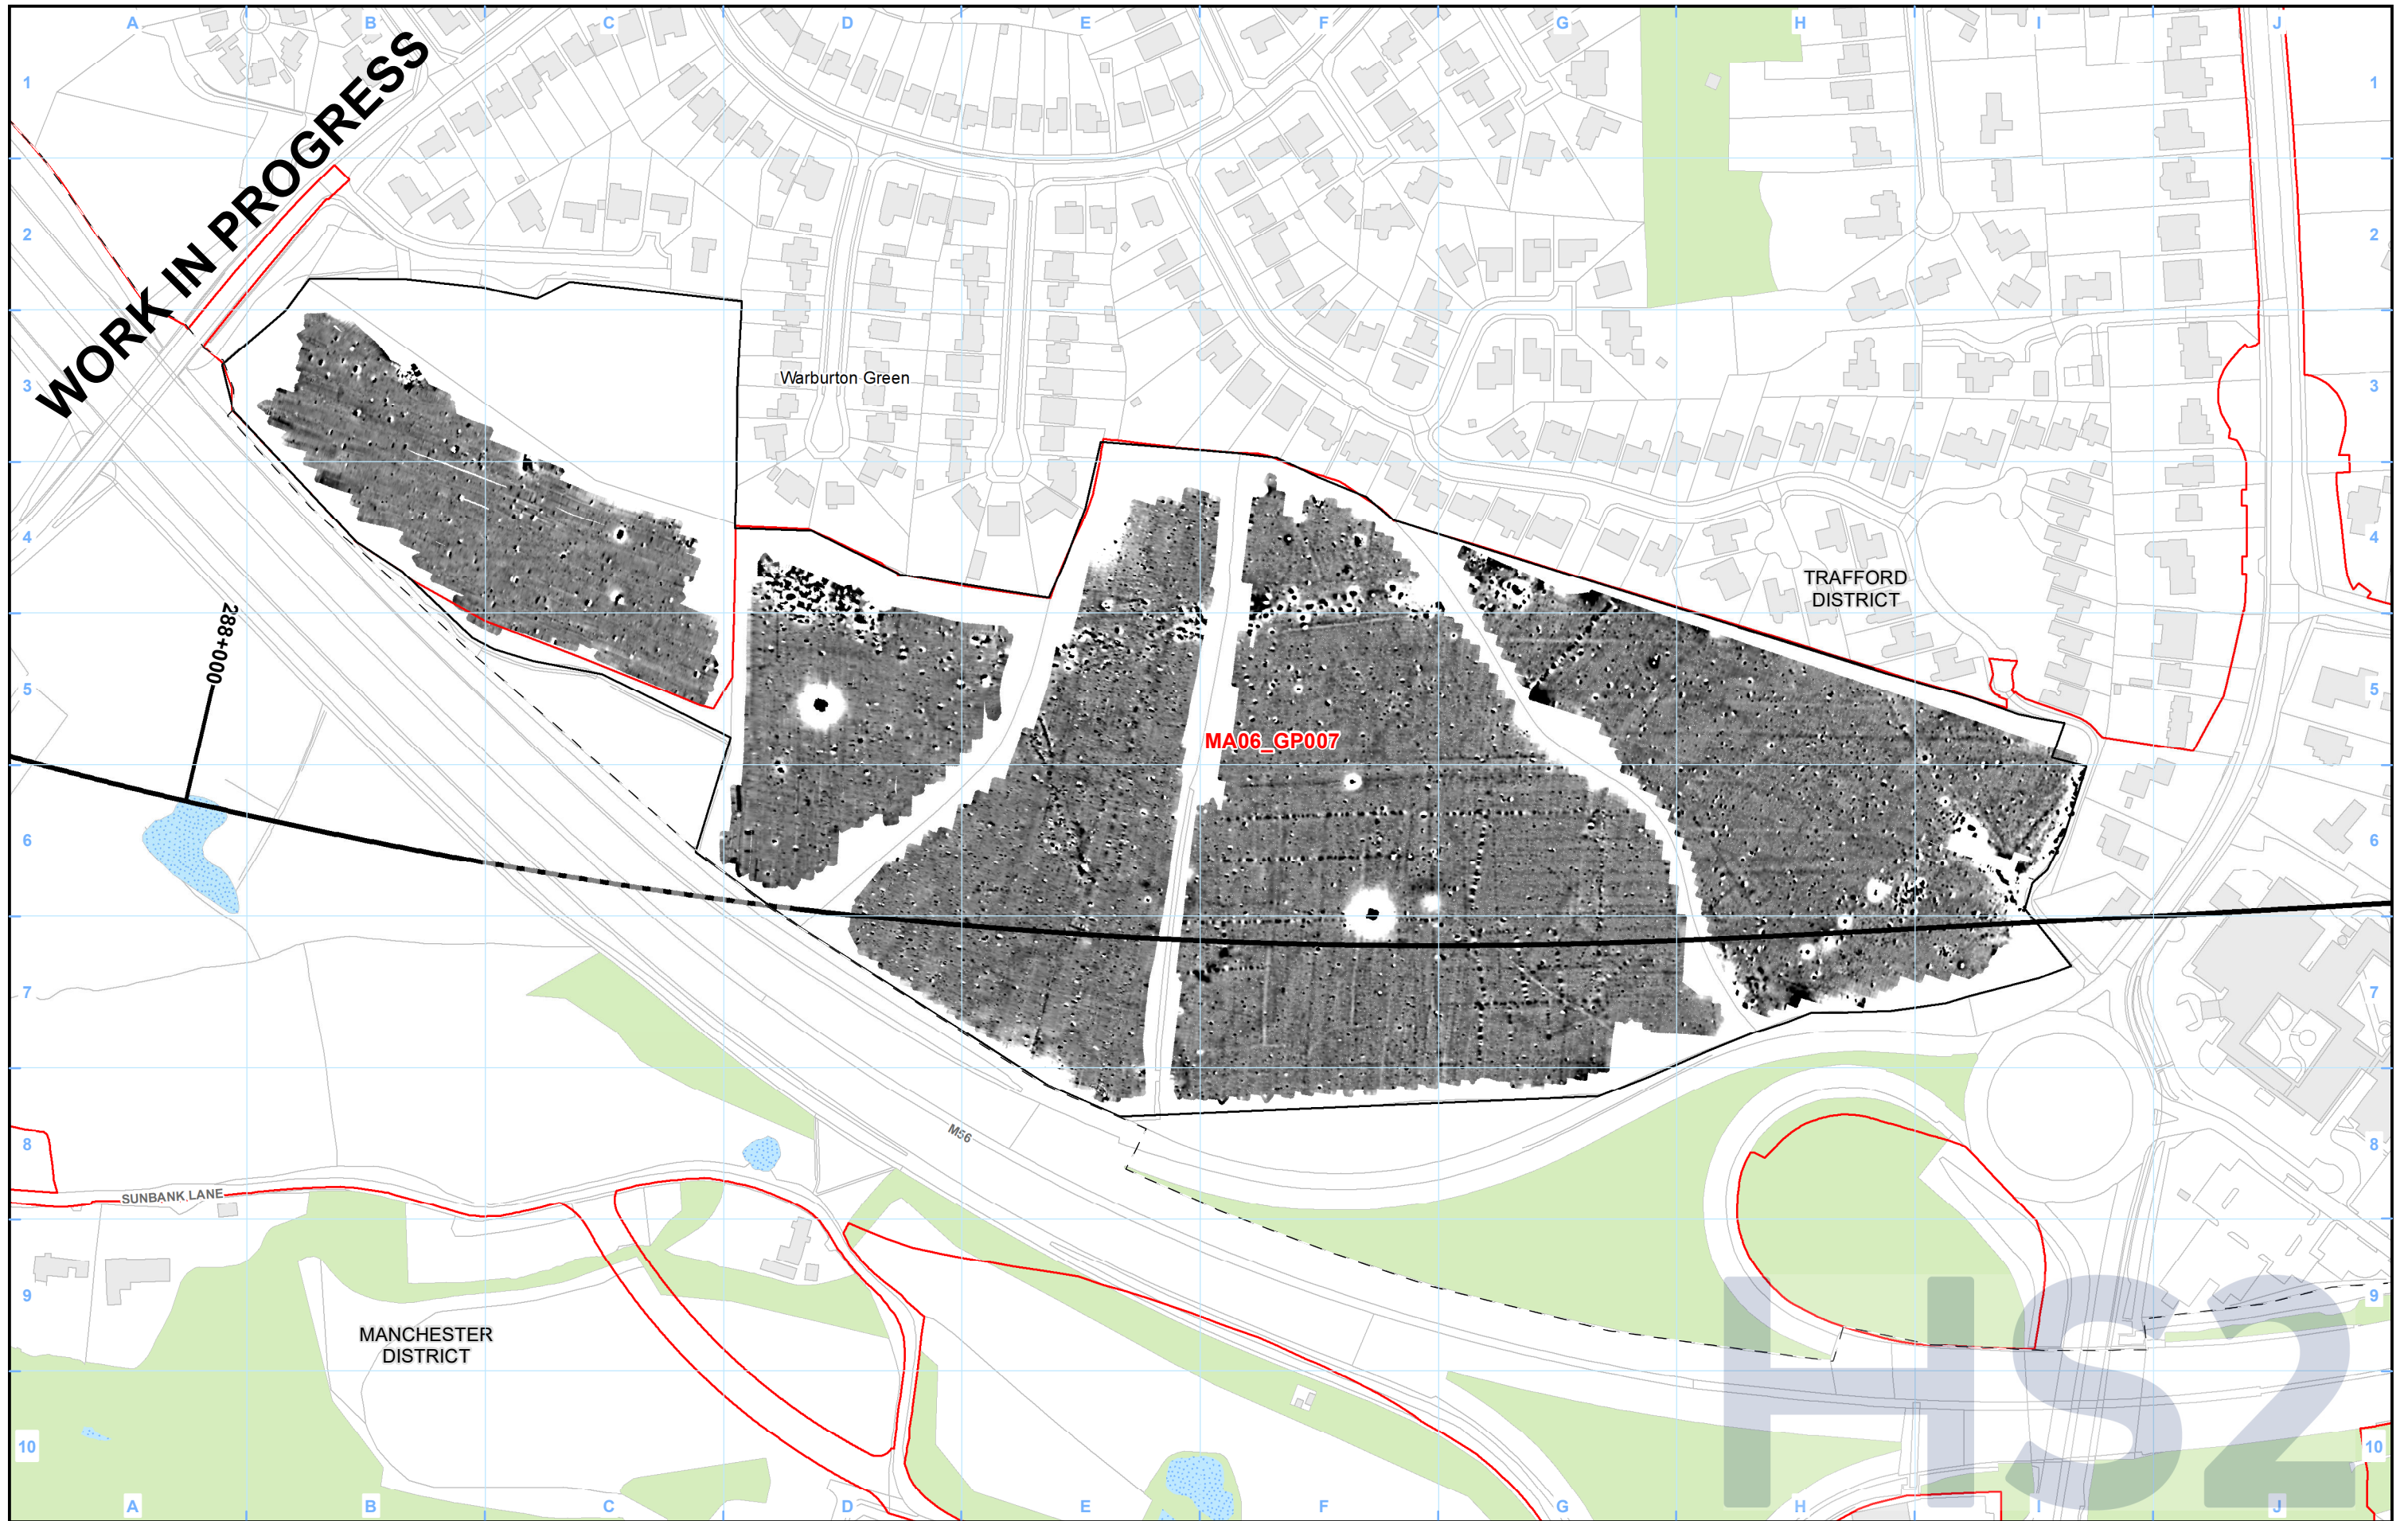
northern end of the field (see Figures 6 and 7, MA06\_GP007.001; MA06\_0331), and two others (see Figures 6 and 7, MA06\_GP007.002; MA06\_0331), in a T-shaped configuration, close to its southern boundary.

- 3.3.8 A zone of intense magnetic noise (see Figures 6 and 7, MA06\_GP007.004) at the edge of the second field from the south coincides with a cluster of former ponds depicted on historic Ordnance Survey maps. A magnetic response of this type indicates an abundance of ferrous debris within the backfill of the ponds.
- 3.3.9 A small irregular positive anomaly (see Figures 6 and 7, MA06\_GP007.005) near the middle of the central field probably represents a pond that the Hale Tithe Map<sup>12</sup> shows to have lain in this location.
