Air Quality and Dust Monitoring Monthly Report - October 2021 **Buckinghamshire** Council

Air Quality and Dust Monitoring Summary Report, October 2021 Buckinghamshire Council

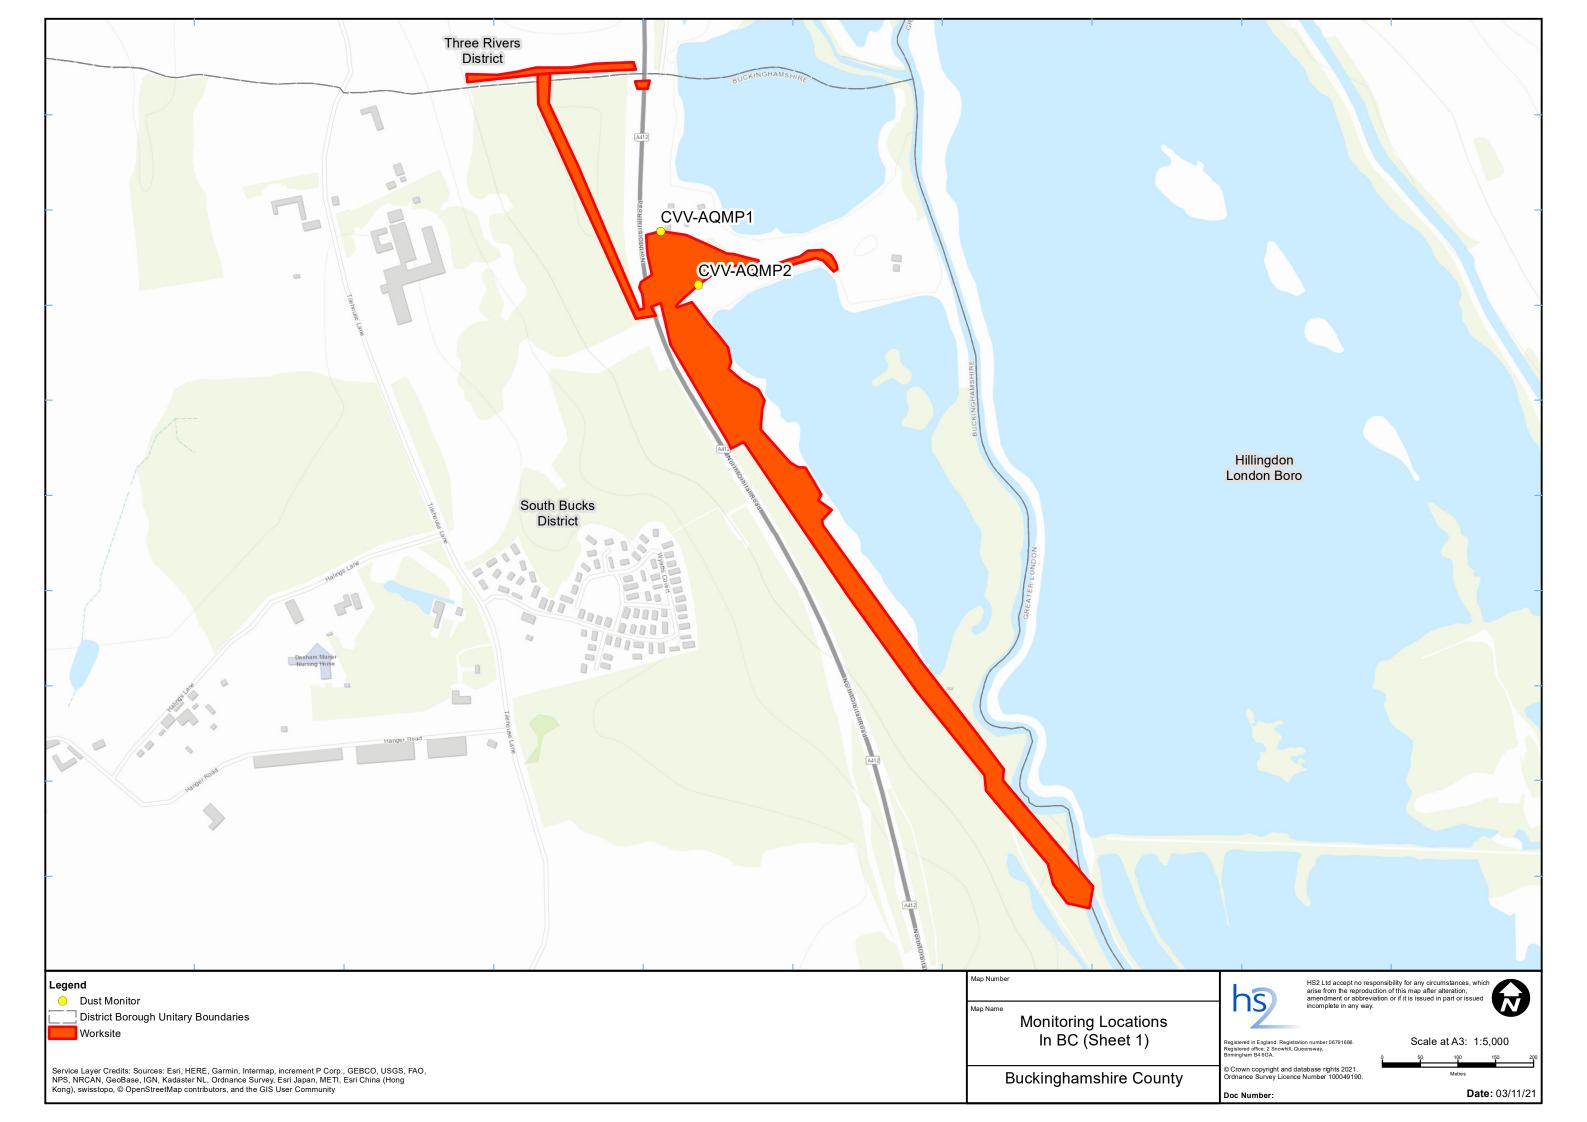
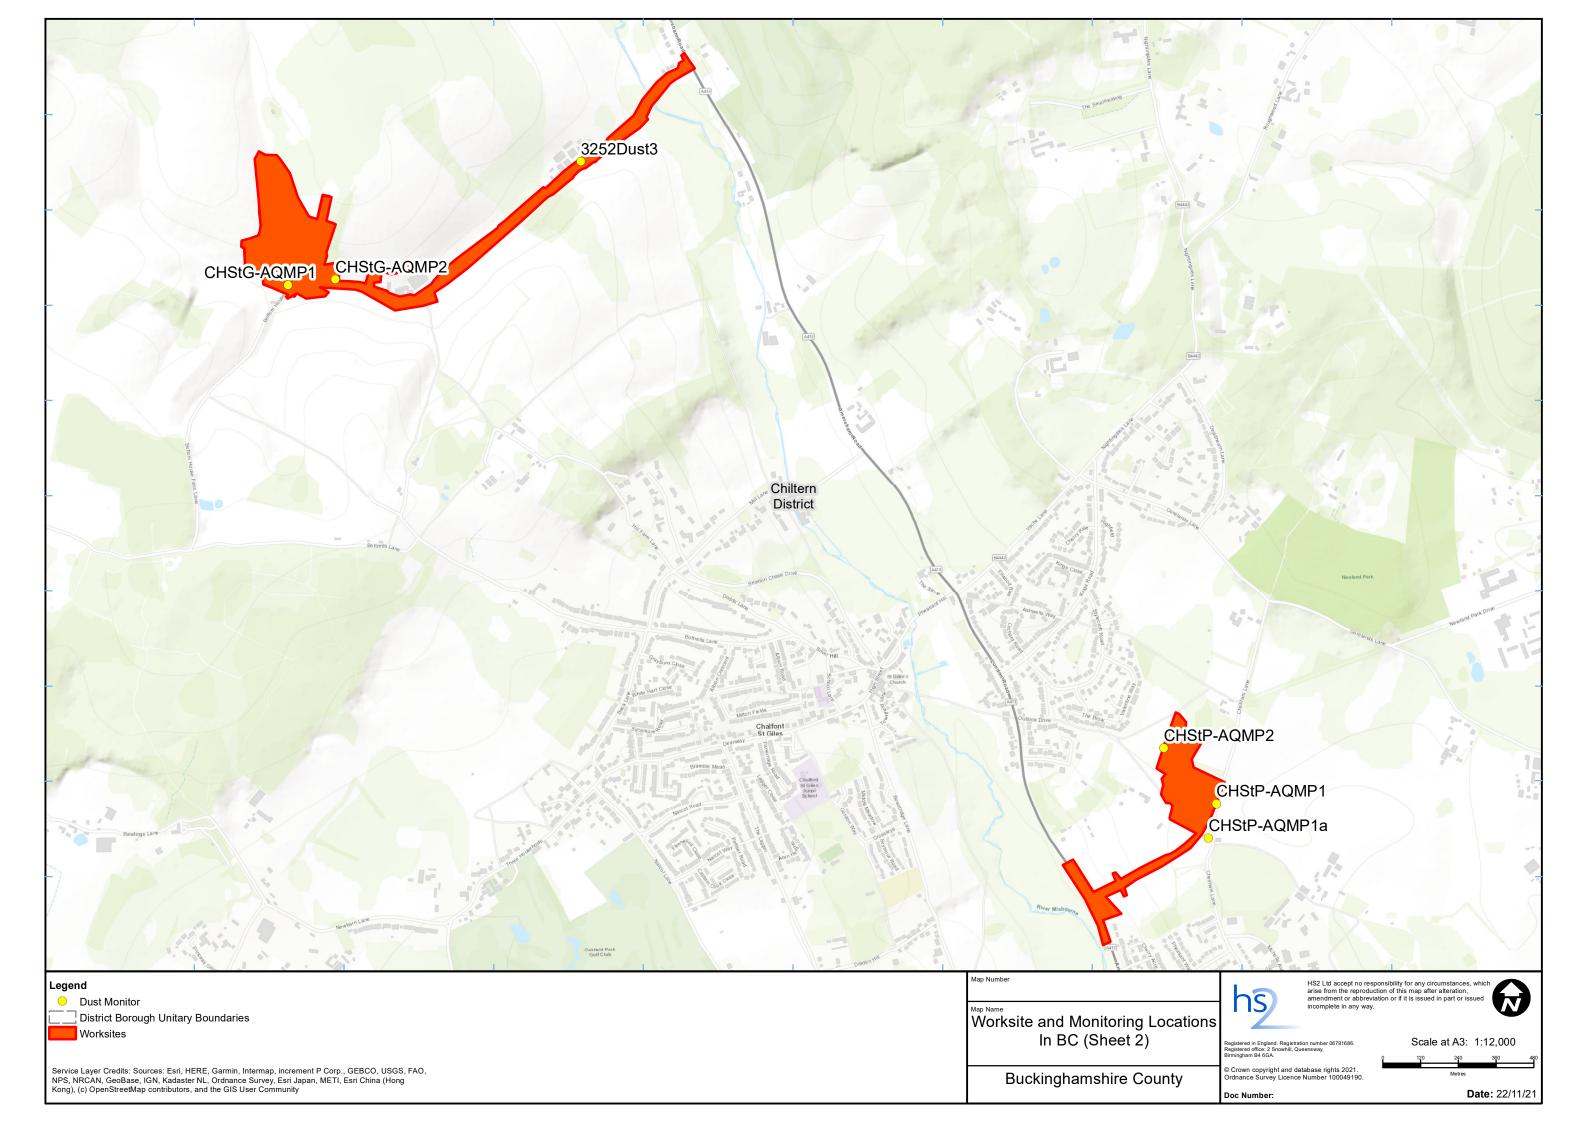
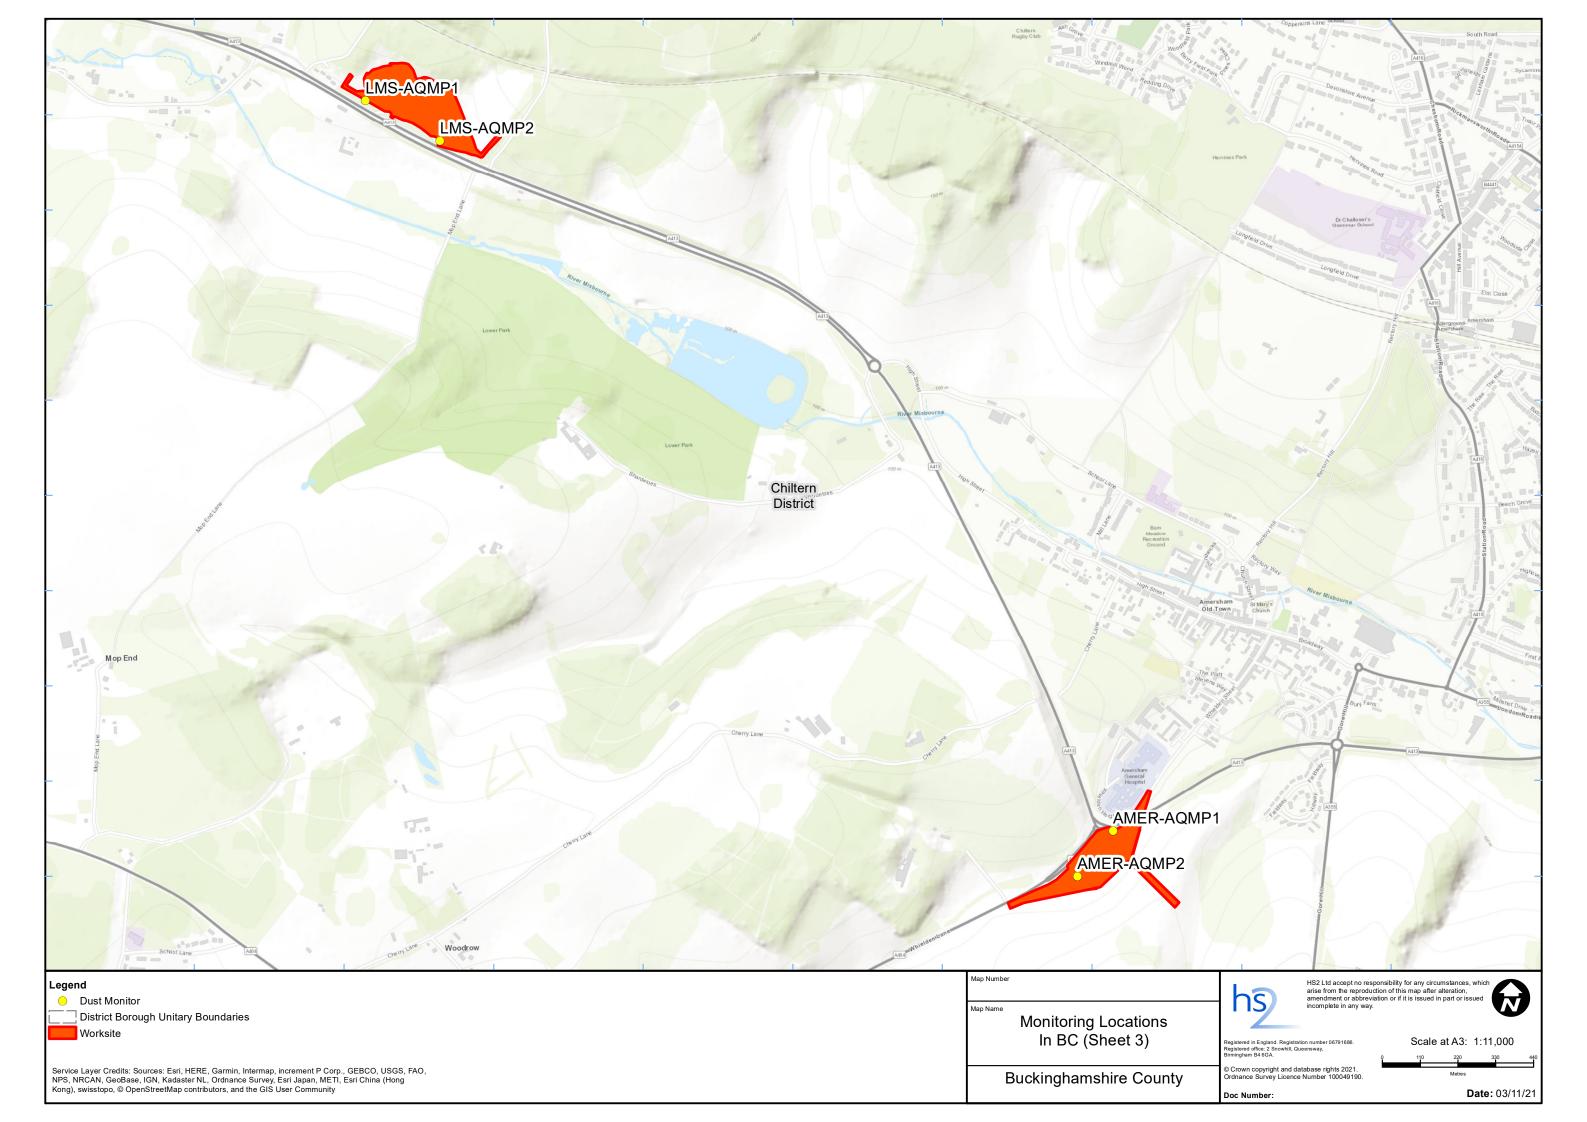
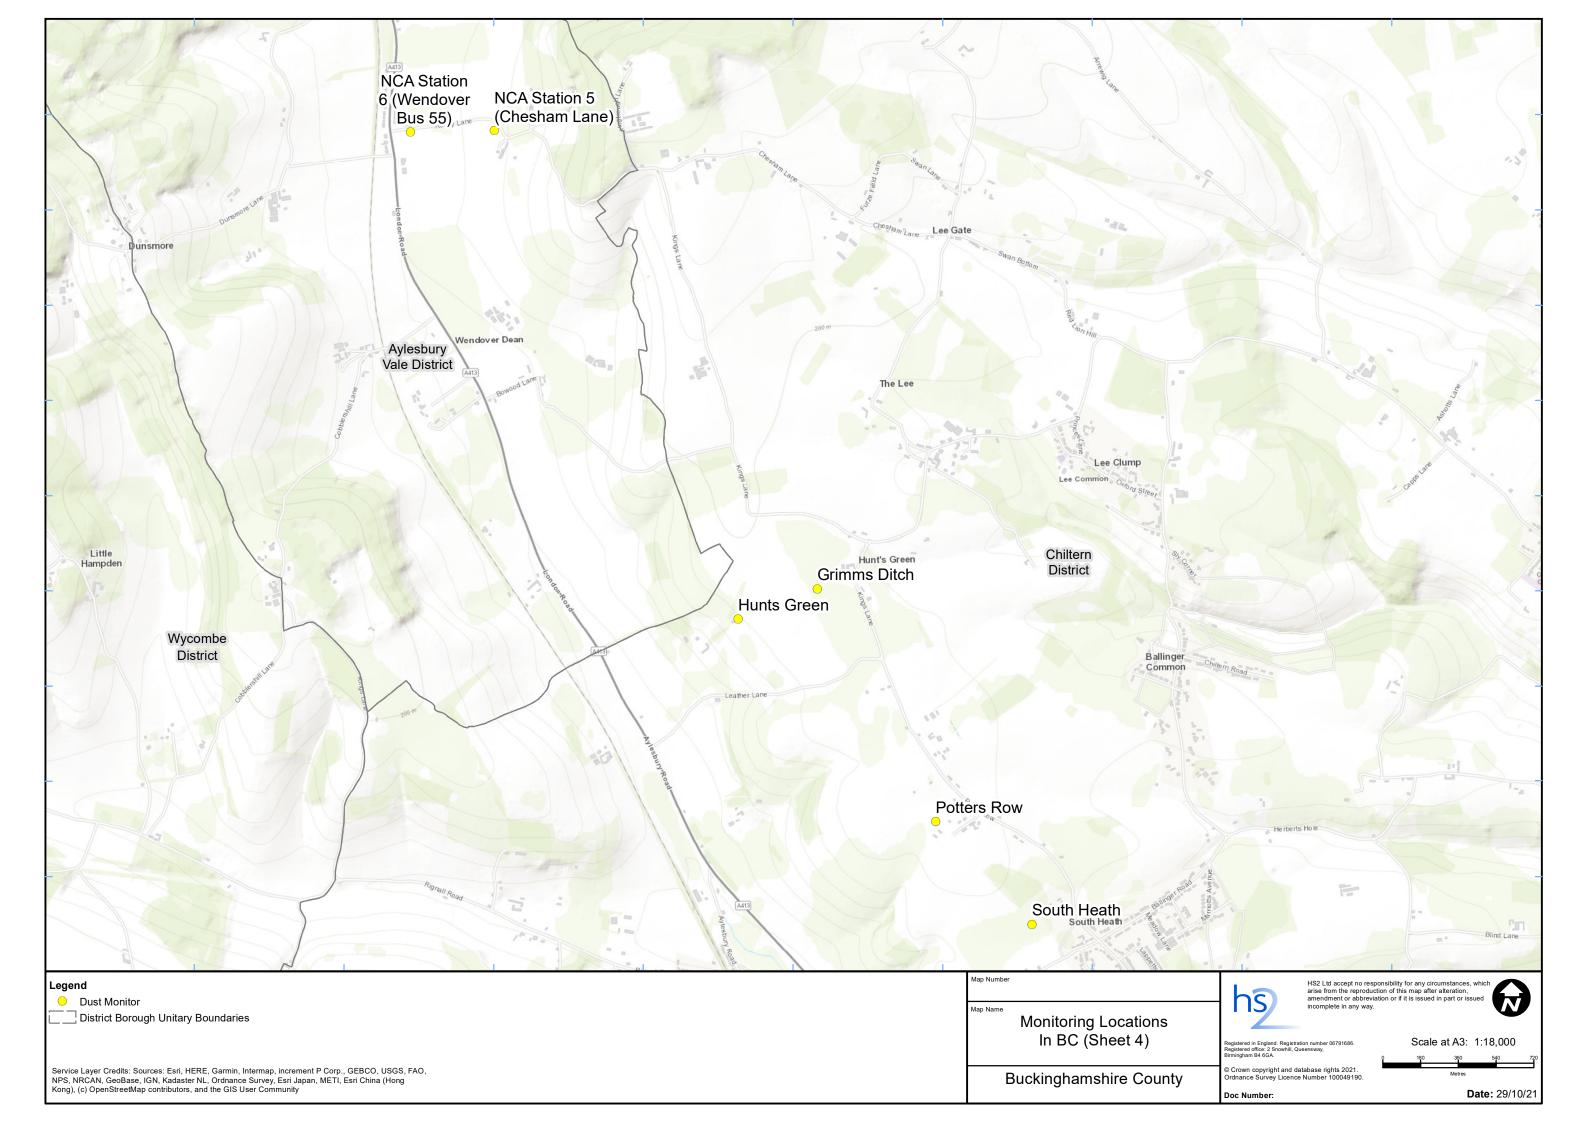
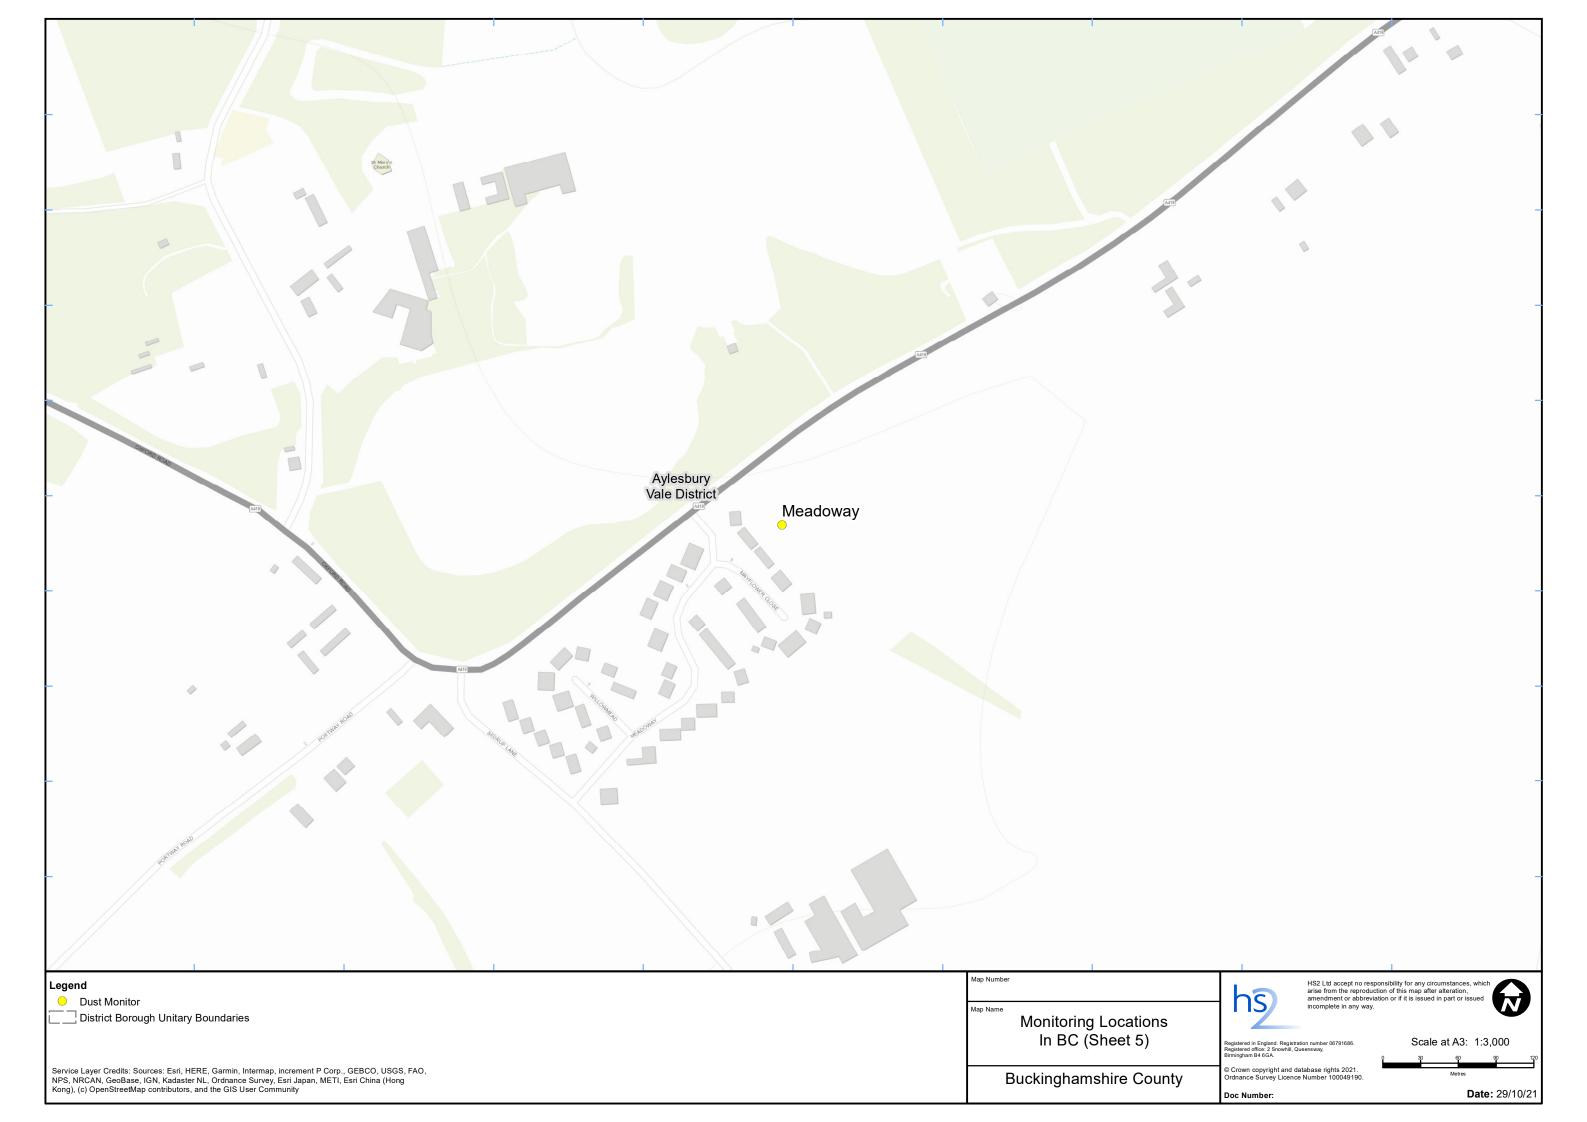
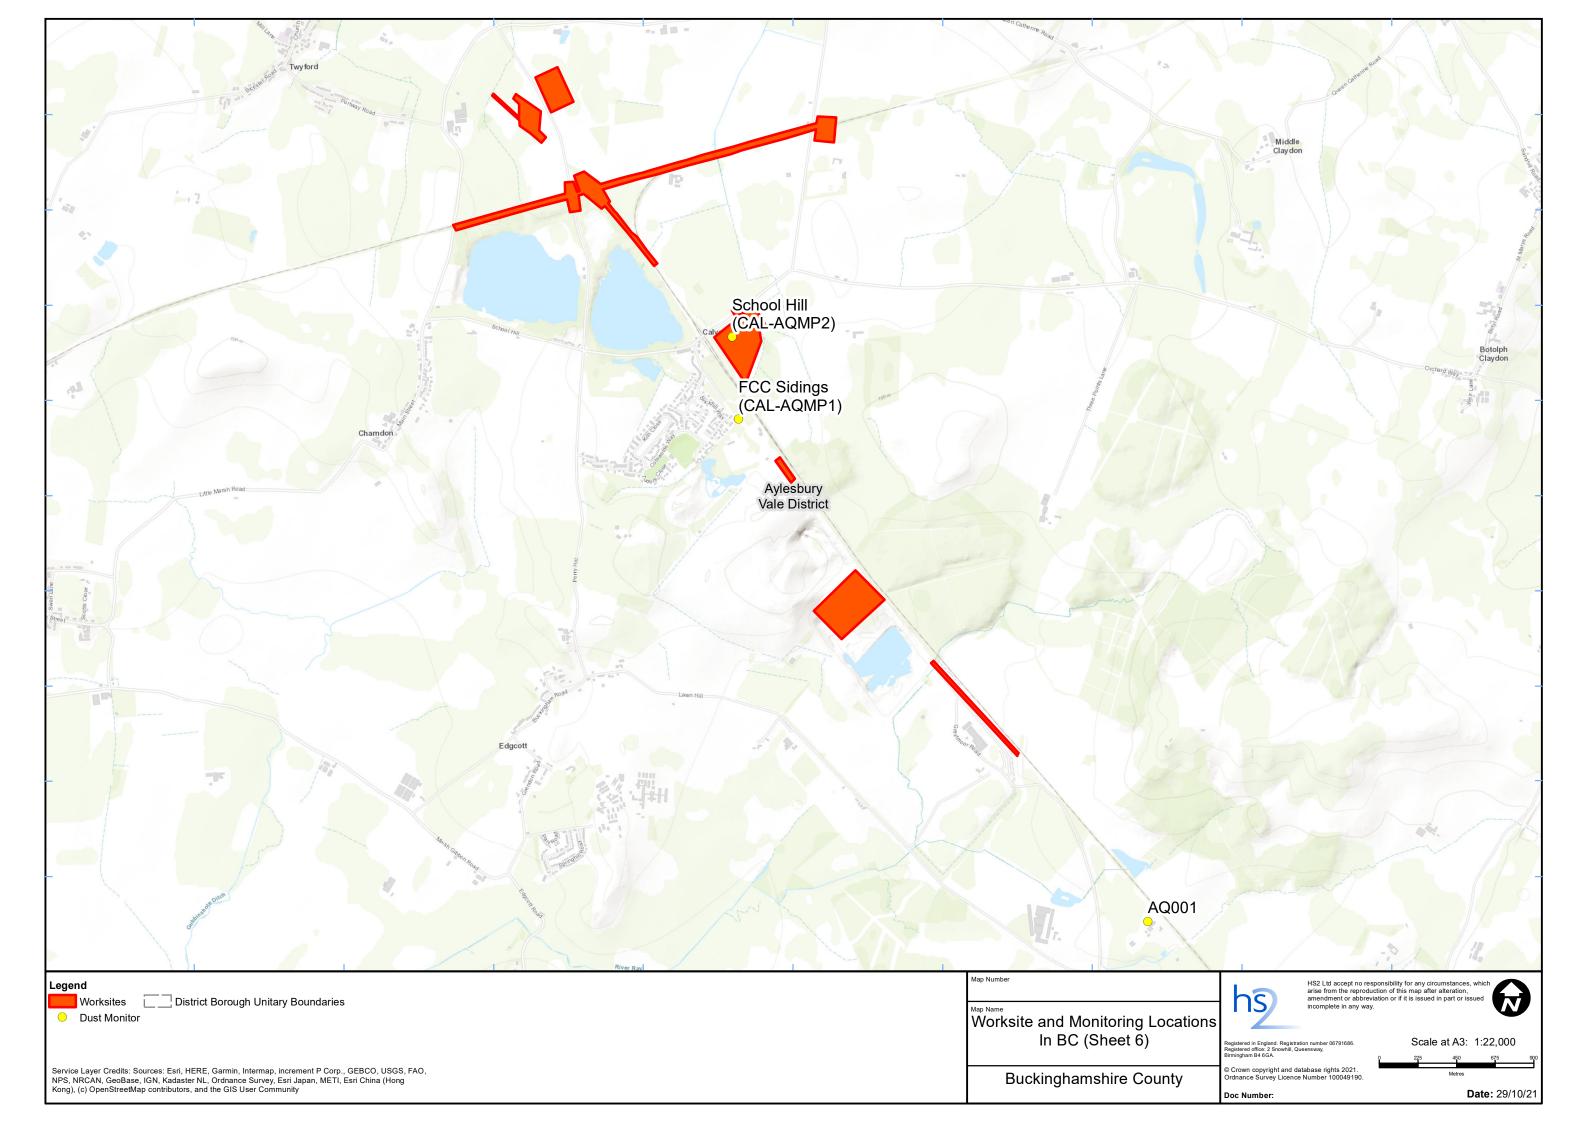
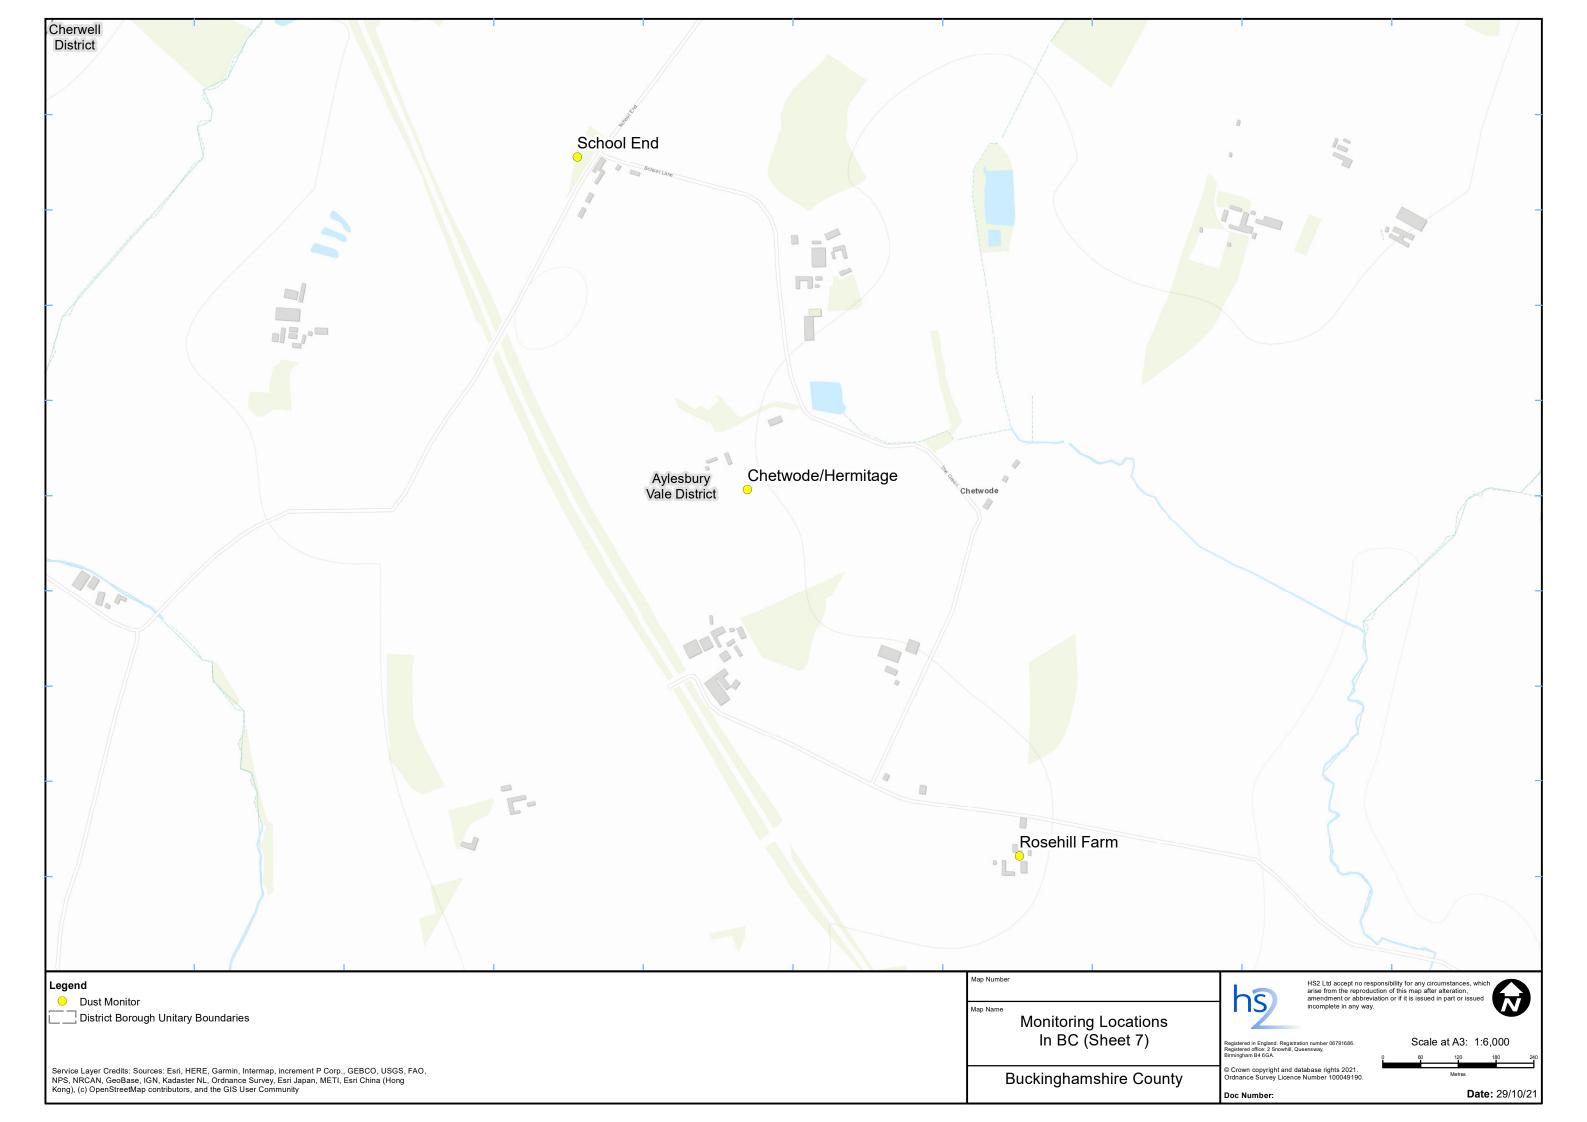
Figure 1 to Figure 7: Worksites and monitoring locations within the BC

- 1.1.2 Figure 1 to Figure 7 in Appendix A indicate the current worksites together with the dust monitoring locations.
- 1.1.3 This summary should be read in conjunction with the overview monitoring report available from www.gov.uk/government/collections/monitoring-the-environmental-effects-of-hs2, which highlights the applicable standards and guidance, as well as the air quality and dust monitoring methodologies to be implemented by nominated undertakers throughout construction.

- 1.1.4 The current phase of works at the commenced in January 2020. The current worksites, as presented in Appendix A, Figure 1 to Figure 7, include:

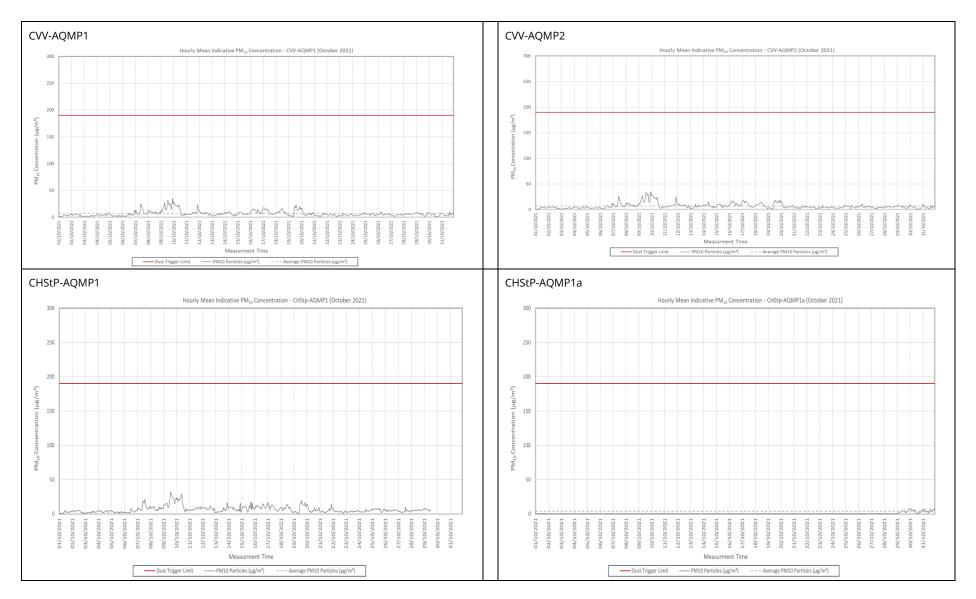
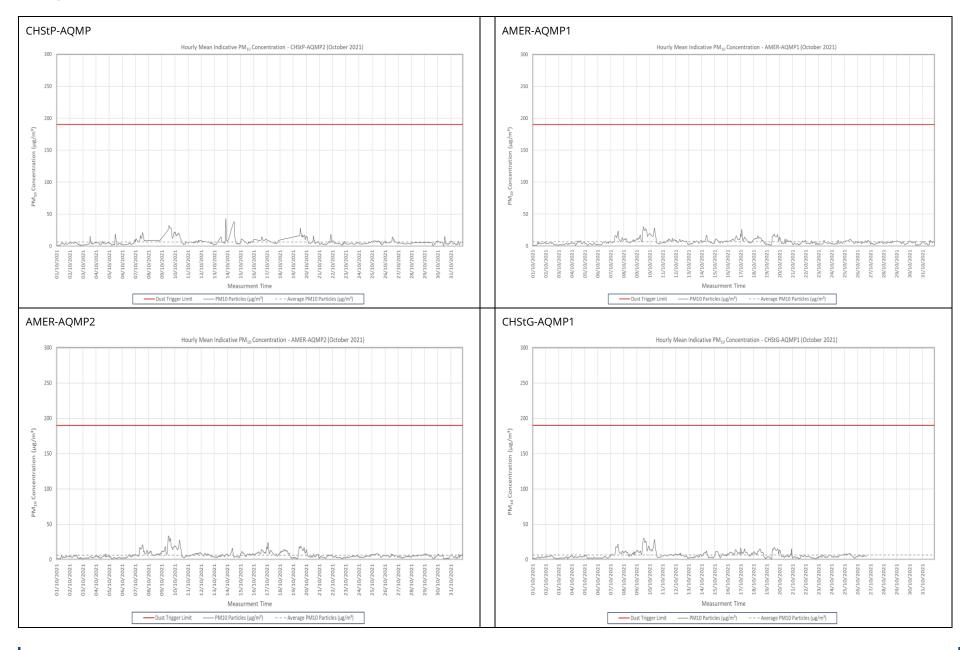
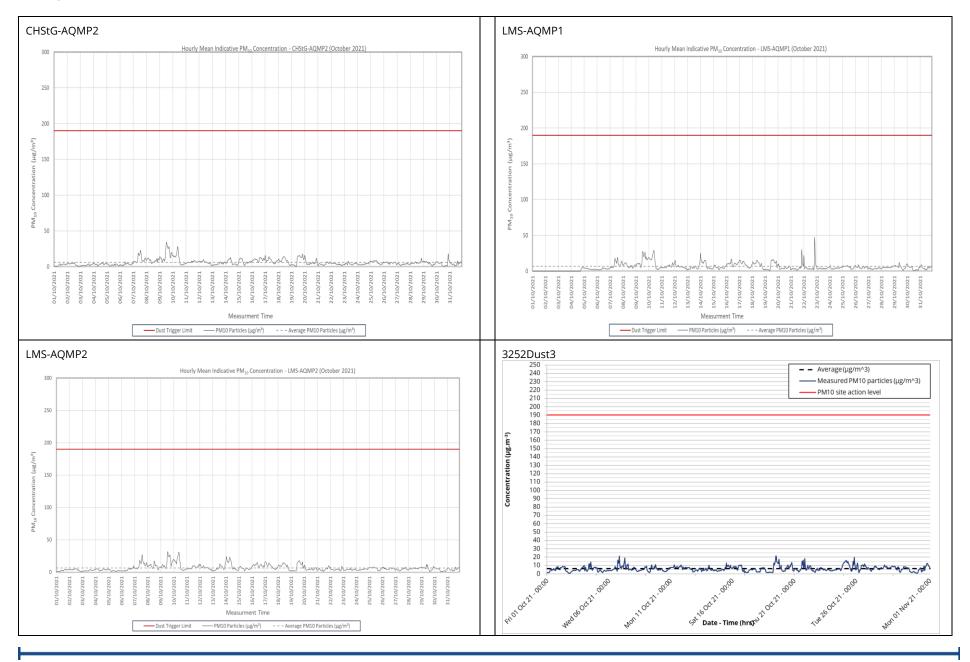
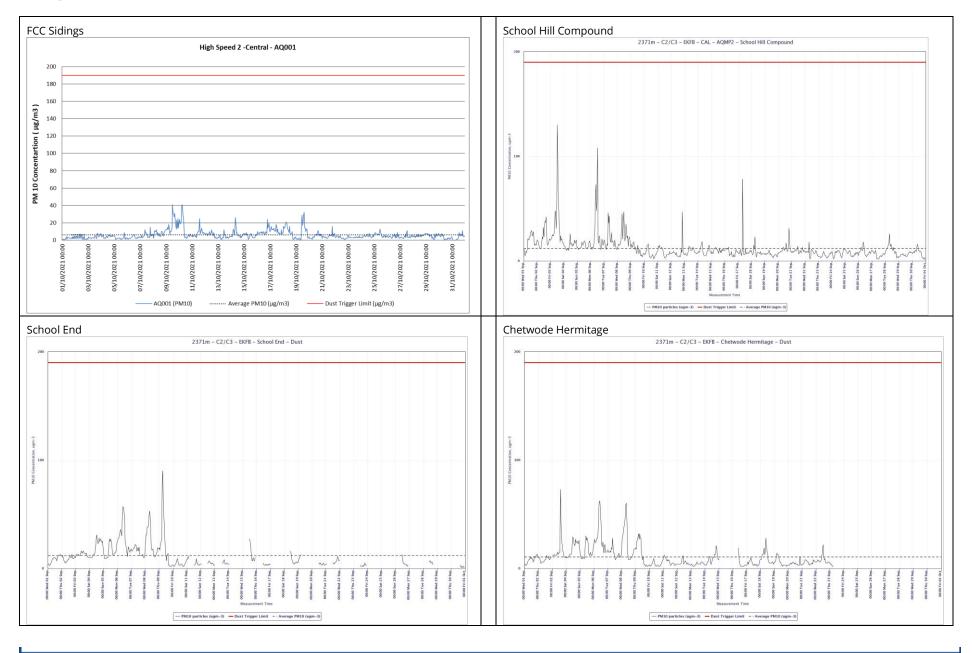
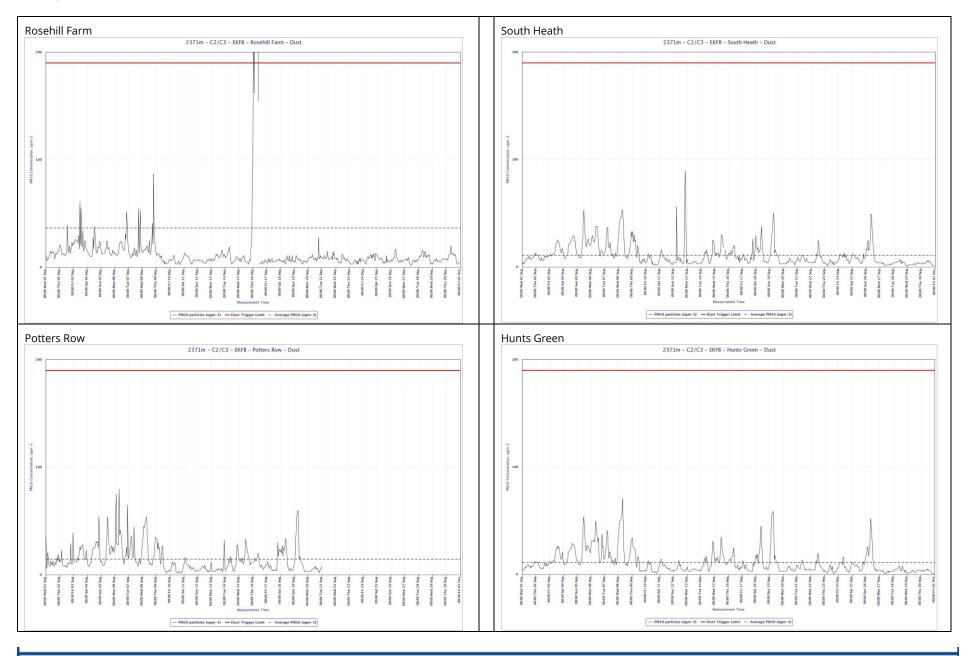
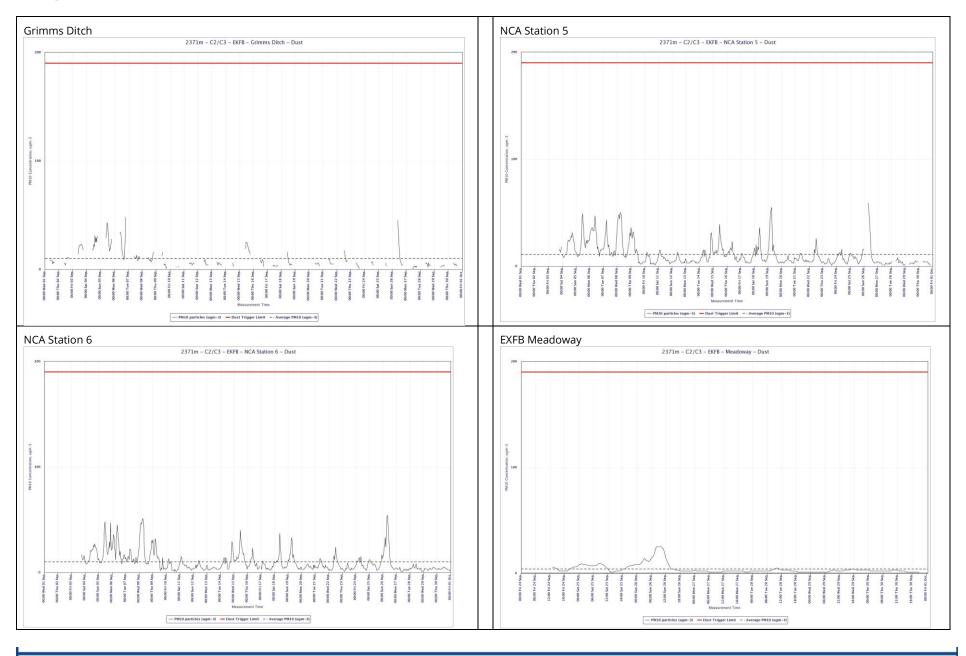
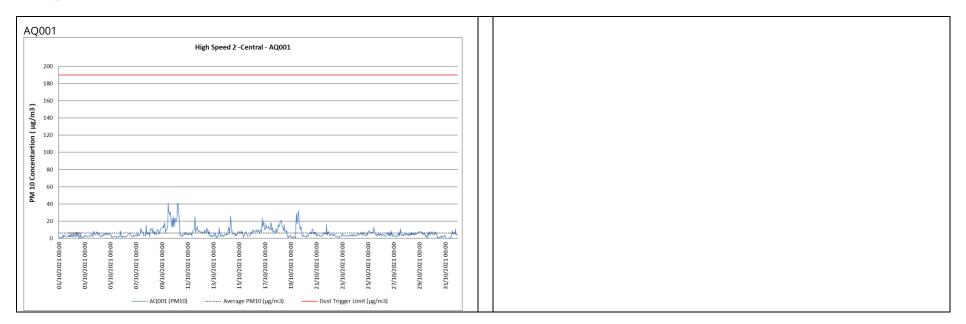
Figure 8: Continuous dust 1-hour mean indicative PM₁₀ concentrations for all dust monitors

- 1.1.5 Twenty six (26) dust monitors are installed around the worksites where works are underway. These sites returned a medium dust risk rating.
- 1.1.6 Dust monitoring locations and results are presented in Appendix B, Table 1, together with line charts of monthly data from each dust monitor, in Figure 8. All continuous dust monitoring is undertaken using indicative monitors. Despite being Environment Agency (MCERTS) certified, indicative monitors carry a higher level of uncertainty than reference monitors, and therefore cannot be strictly compared with Air Quality Standards for human health and the environment. The purpose of the monitoring undertaken is to ensure the effectiveness of the on-site mitigation.

- 1.1.7 The trigger level for PM_{10} concentrations of 190 μ g/m³, measured as a 1-hour mean, in accordance with the updated guidance document 'Guidance on Monitoring in the Vicinity of Demolition and Construction Sites (October 2018)' has been applied.

- 1.1.8 Dust trigger alerts were recorded during the monitoring period (October 2021) and are reported in Appendix B Table 2, it was noted that the trigger alerts were not associated with the site activities.

- 1.1.9 Data capture was below 90% for multiple monitors in October 2021 due to data transfer issues, power faults and SIM card replacements.
- 1.1.10 There were no (0) complaints were received during this reporting period.

Monitoring Site ID	Period exceeding trigger level	Investigation	Outcomes / Resolution / Remedial measures implemented
Rosehill Farm – Dust	16/09/2021 (x7 alerts) 01:01 – 02:00; 226.6 µg/m³ 03:01 – 04:00; 915.9 µg/m³ 04:01 – 05:00; 224.9 µg/m³ 05:01 – 06:00; 377.9 µg/m³ 06:01 – 07:00; 3,715.0 µg/m³ 07:01 – 08:00; 6,527.9 µg/m³ 08:01 – 09:00; 6,453.5 µg/m³	Upon investigation, the alerts occurred during the night into the early morning, up to gam. No works have been undertaken during this period. Furthermore, due to gas issues, the monitor was temporarily down, as such these are considered false alerts.	The Hydrogen power supplier has been out the same today and changed the empty gas cylinders. The monitored concentrations have returned to normal.
