## **Construction noise and vibration Monthly Report – October 2021**

### **Buckinghamshire**

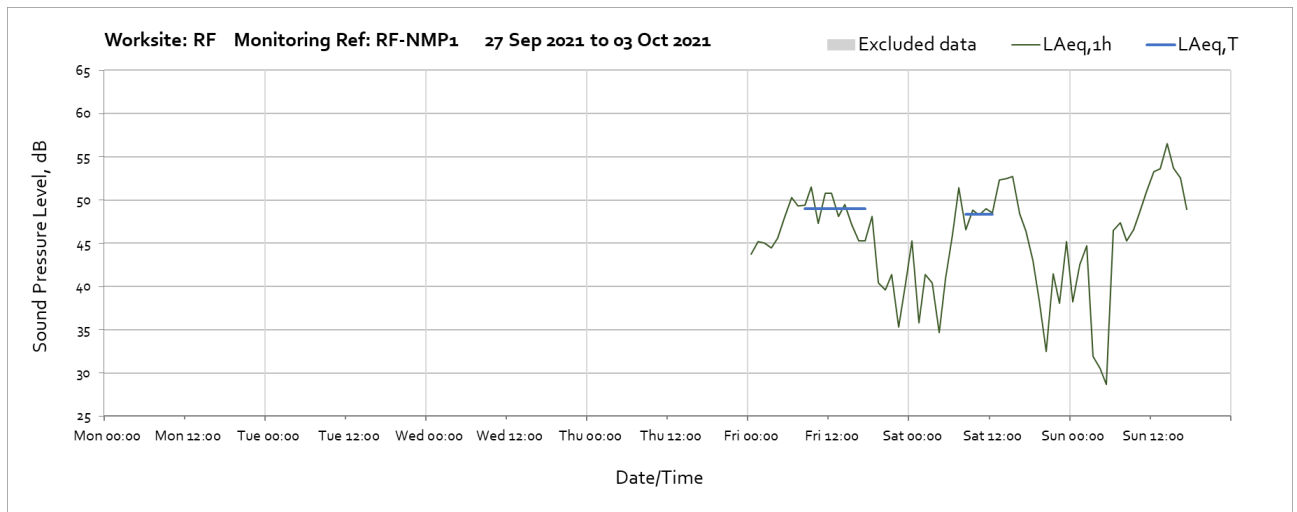
## Worksite: RF – Monitoring Ref: RF-NMP1

Note: Missing data between 18:00 on Sunday 3<sup>rd</sup> October and 11:00 on Tuesday 12<sup>th</sup> October was due to loss of continuous site power from the hydrogen generator.

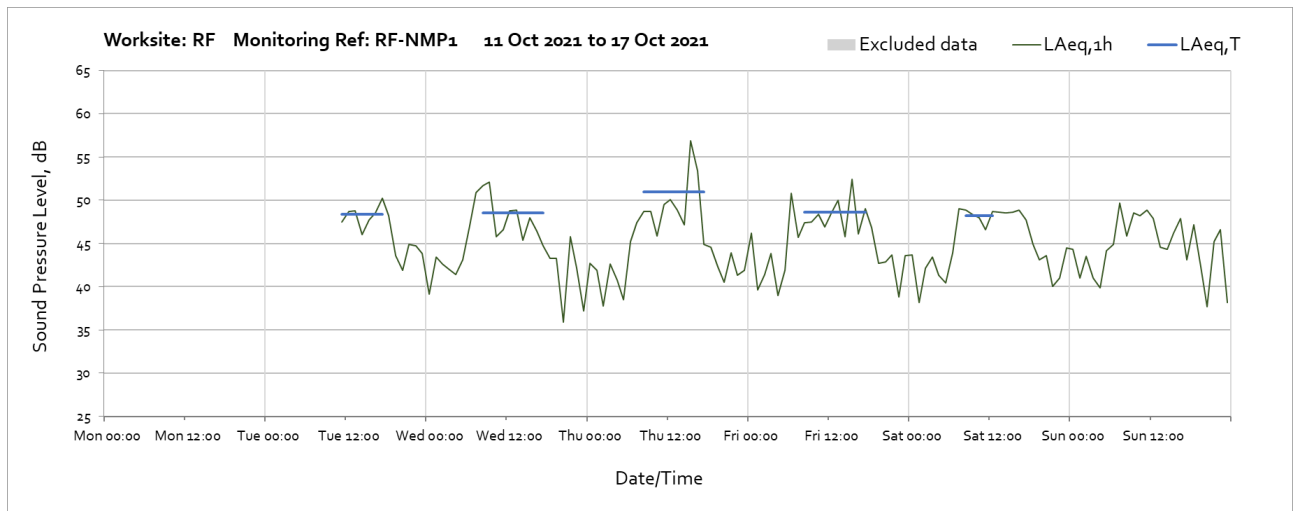
Note: Missing data between 18:00 on Sunday 3<sup>rd</sup> October and 11:00 on Tuesday 12<sup>th</sup> October was due to loss of continuous site power from the hydrogen generator.

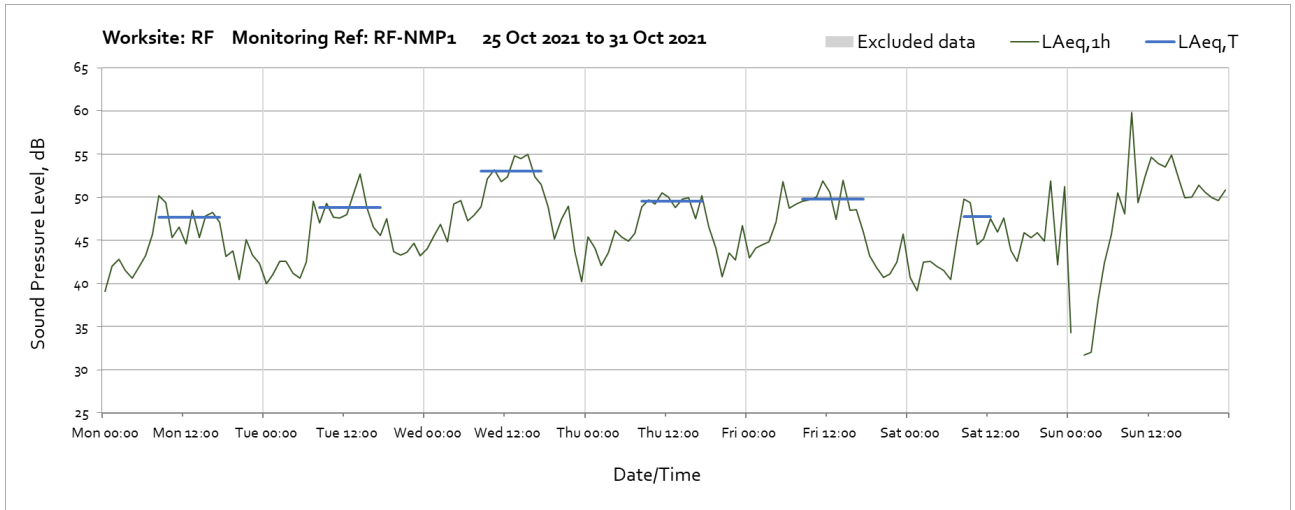
Note: Missing data between 01:00 and 02:00 on Sunday 31<sup>st</sup> October was due to a daylight saving adjustment.

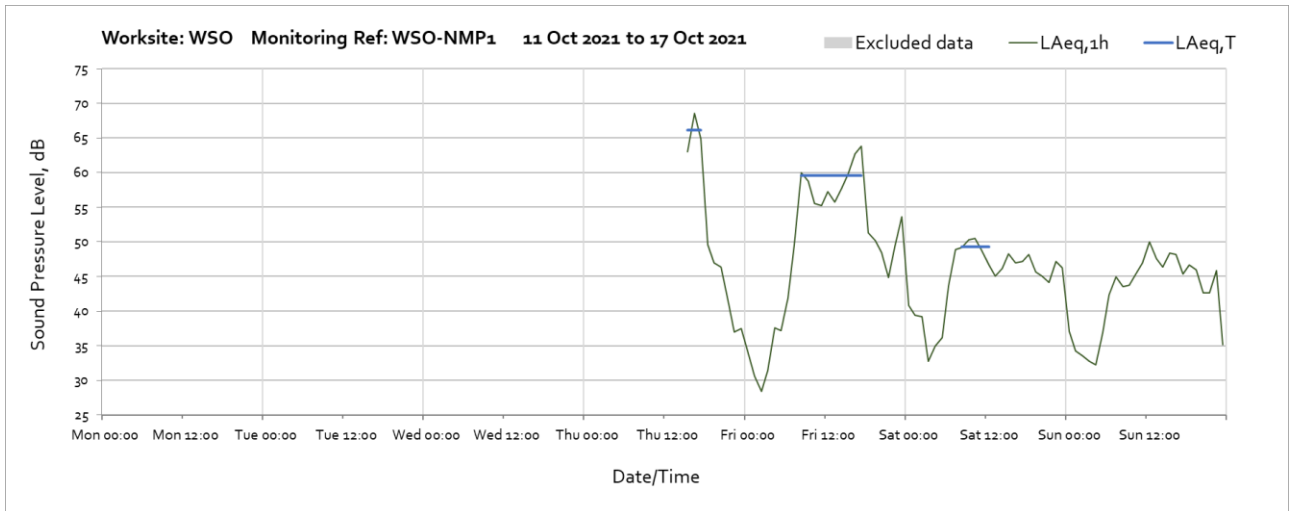
**Worksite: WSO – Monitoring Ref: WSO-NMP1**

Note: Noise Monitor was installed on 14<sup>th</sup> October 2021.

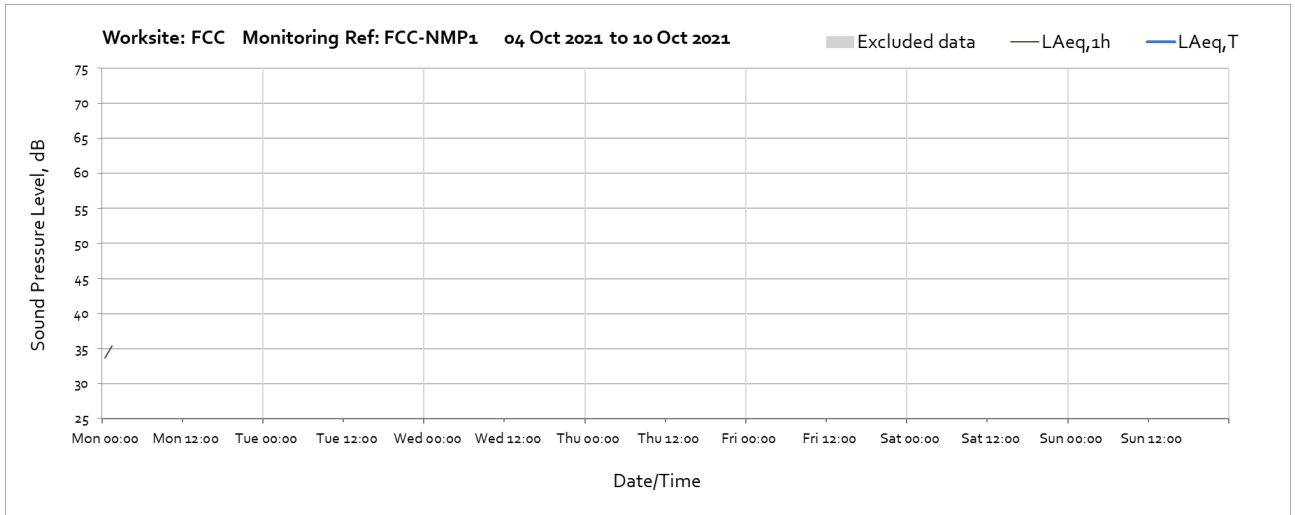
Note: Missing data between 01:00 on Monday 4<sup>th</sup> October and 14:00 on Wednesday 13<sup>th</sup> of October was due to poor solar coverage and backup battery being out of power.

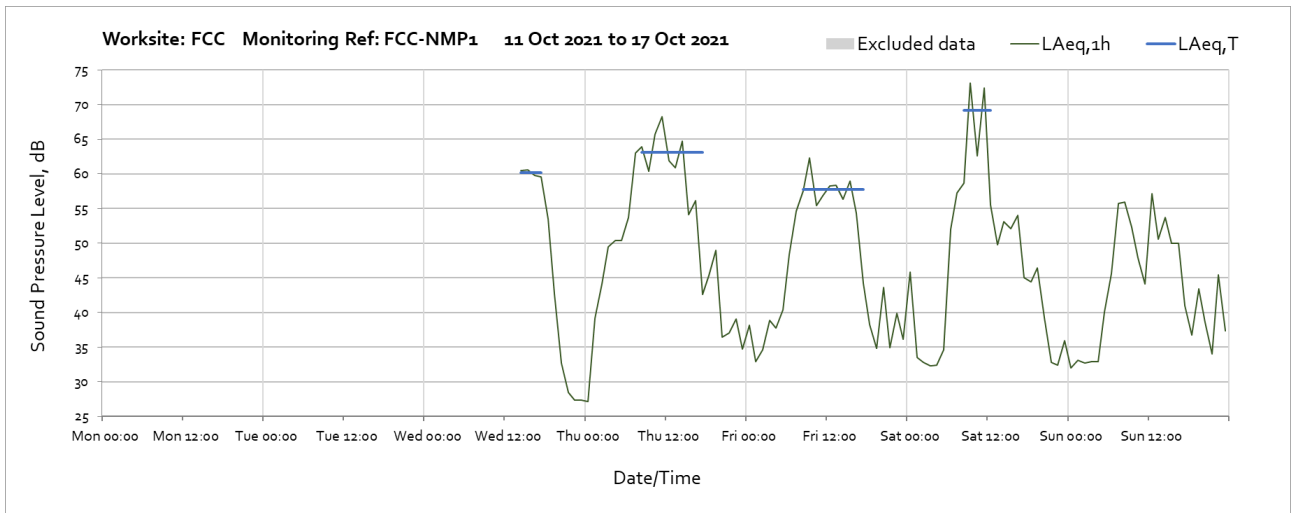
Note: Missing data between 01:00 on Monday 4<sup>th</sup> October and 14:00 on Wednesday 13<sup>th</sup> of October was due to poor solar coverage and backup battery being out of power.

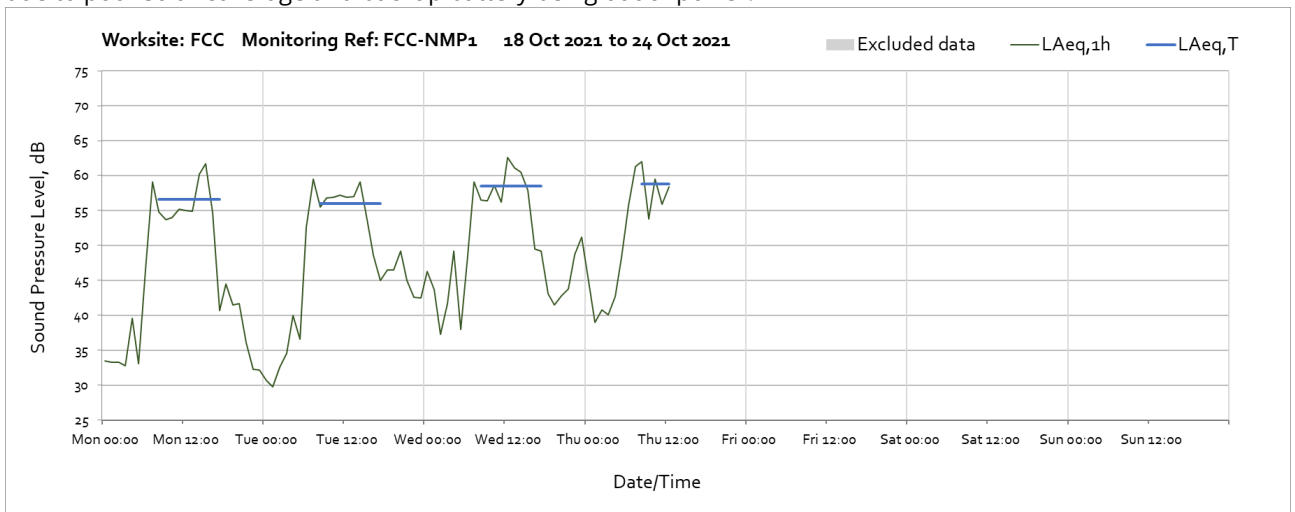
Note: Missing data between 13:00 on Thursday 21<sup>st</sup> October and the end of the month was due to poor solar coverage and backup battery being out of power.

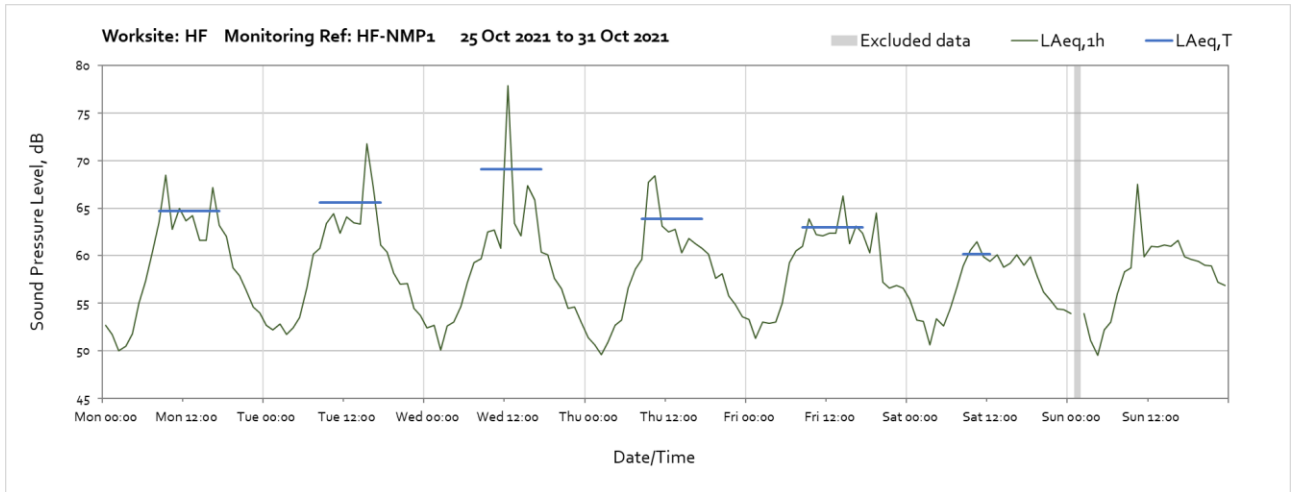
Note: Missing data between 01:00 and 02:00 on Sunday 31<sup>st</sup> October was due to change to daylight saving.

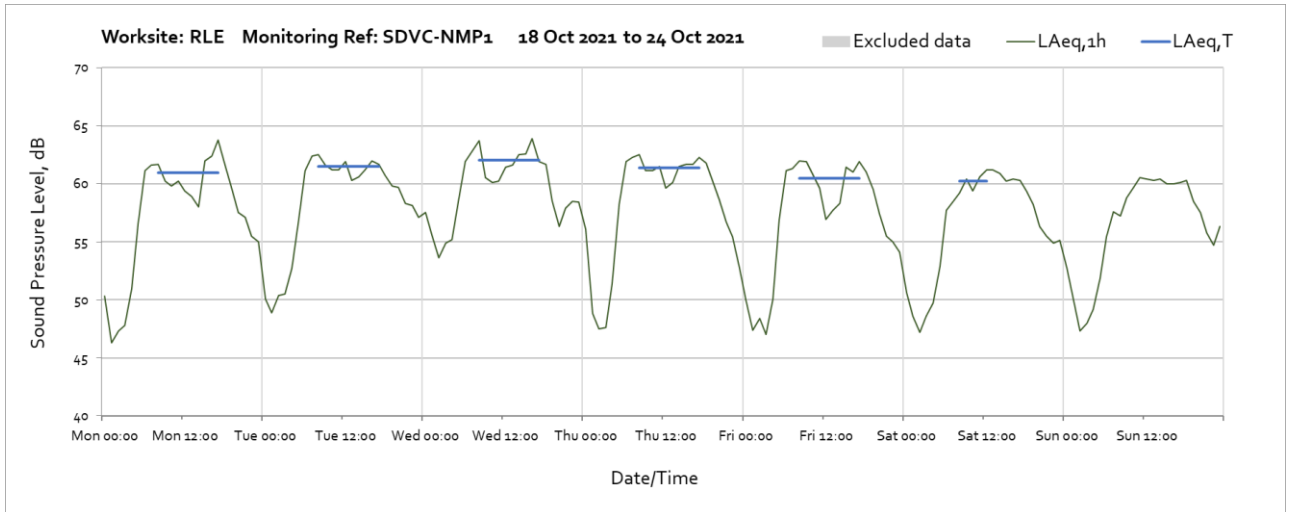
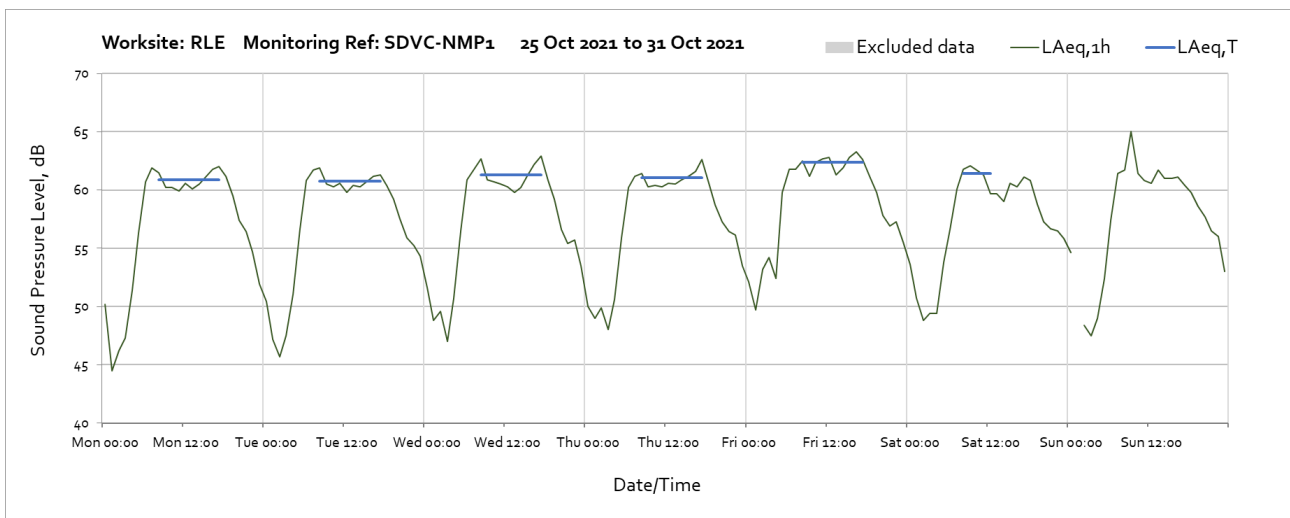
Note: Missing data between 01:00 and 02:00 on Sunday 31<sup>st</sup> October was due to a daylight saving adjustment.

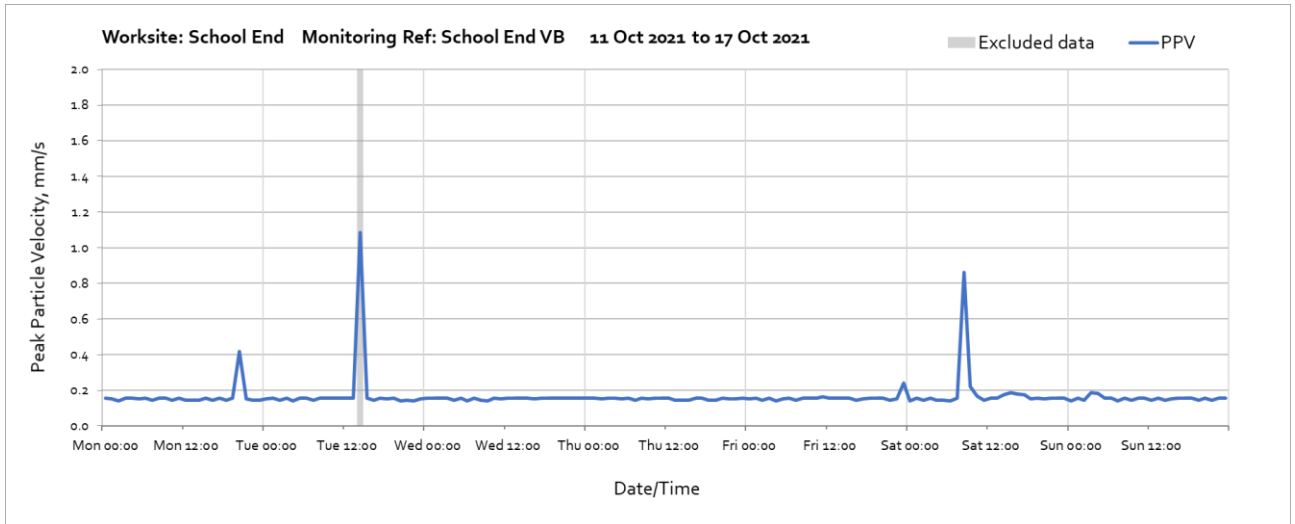
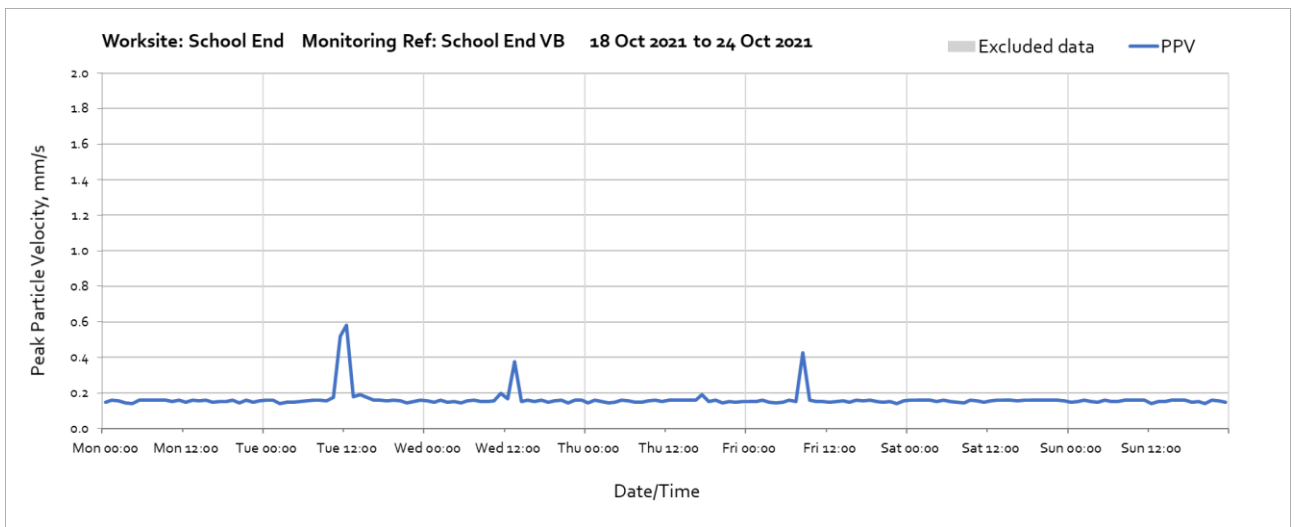
## Worksite: SE – Monitoring Ref: SE-Vib 1

Note: High levels of vibration measured through out the week were due to local disturbance of the monitor and are not representative of HS2 construction vibration levels at the nearest receptors.

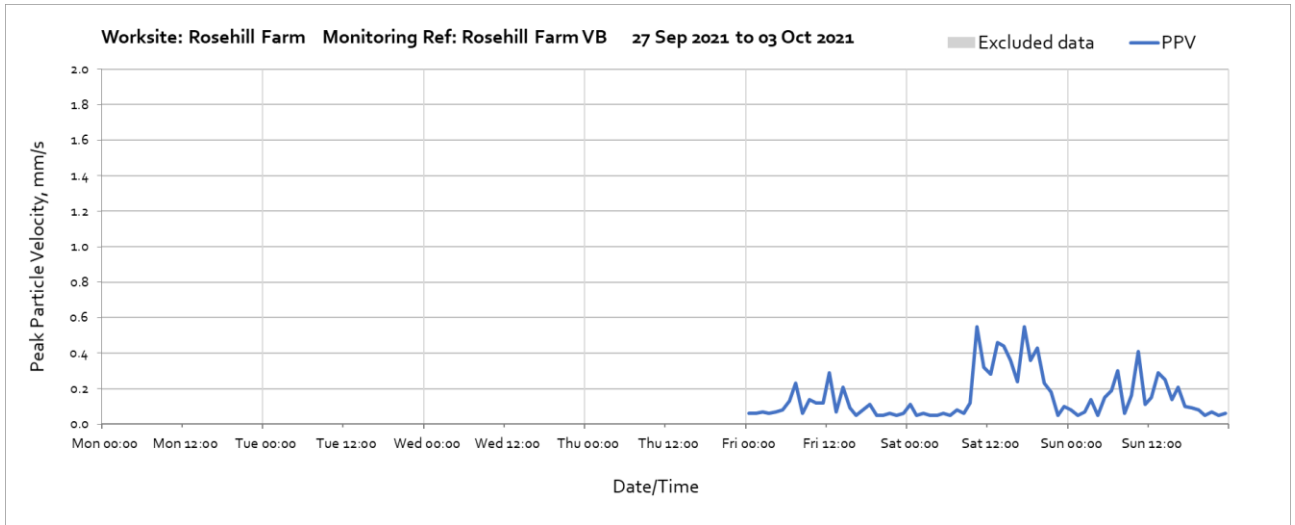
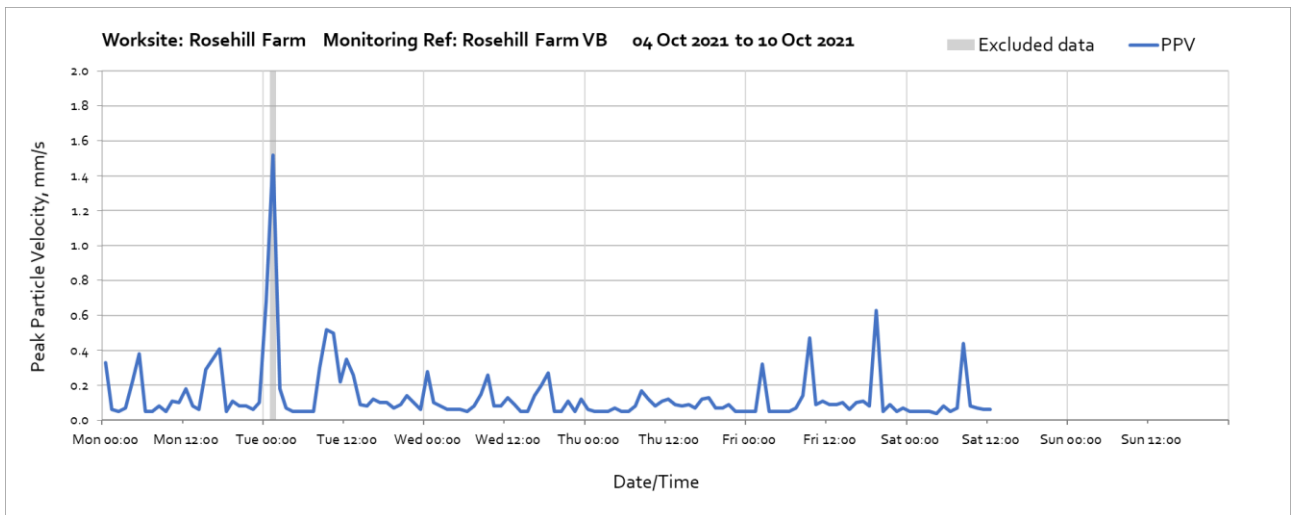
## Worksite: RF – Monitoring Ref: RF-Vib 1

Note: High levels of vibration measured at 01:00 on Tuesday 5<sup>th</sup> of October was due to local disturbance of the monitor and are not representative of HS2 construction vibration levels at the nearest receptors. Missing data between 13:00 on Tuesday 9<sup>th</sup> of October and 17:00 on Thursday 14<sup>th</sup> of October were due to loss of power to the monitor.

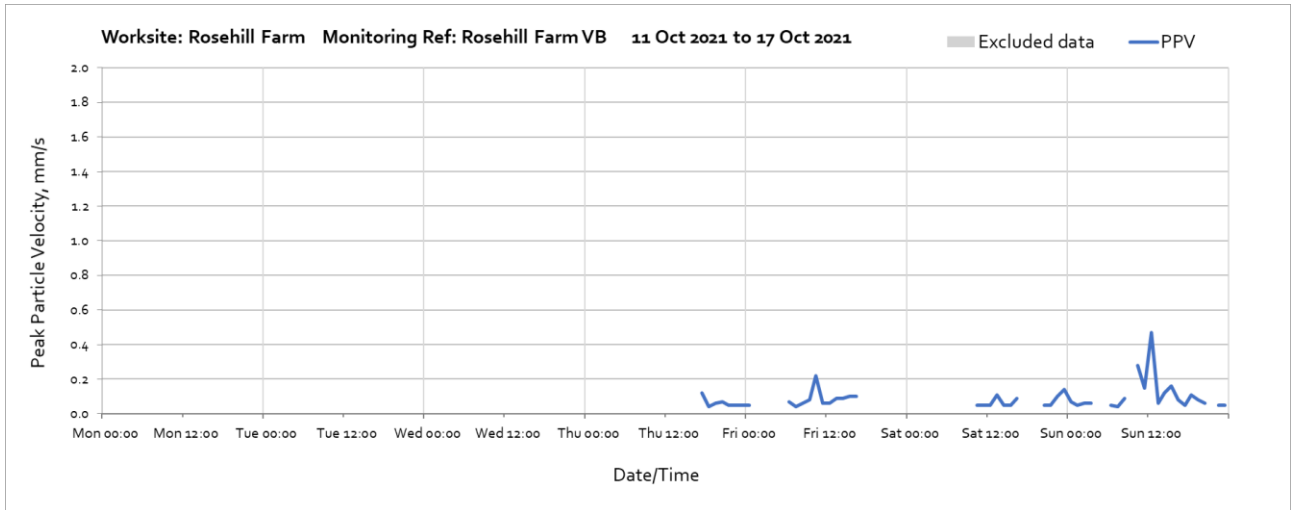
Note: Missing data between 13:00 on Tuesday 9<sup>th</sup> of October and 17:00 on Thursday 14<sup>th</sup> of October were due to loss of power to the monitor. Other intermittent loss of data through out the week were due to poor signal at monitoring location.

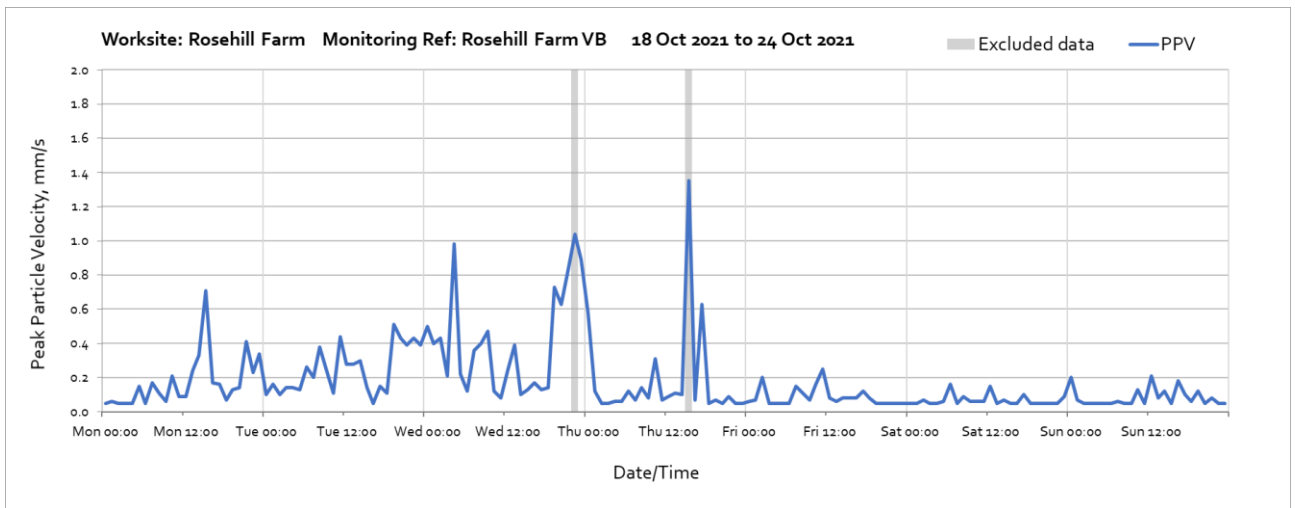
Note: High levels of vibration measured throughout the week were due to local disturbance of the monitor and are not representative of HS2 construction vibration levels at the nearest receptors.

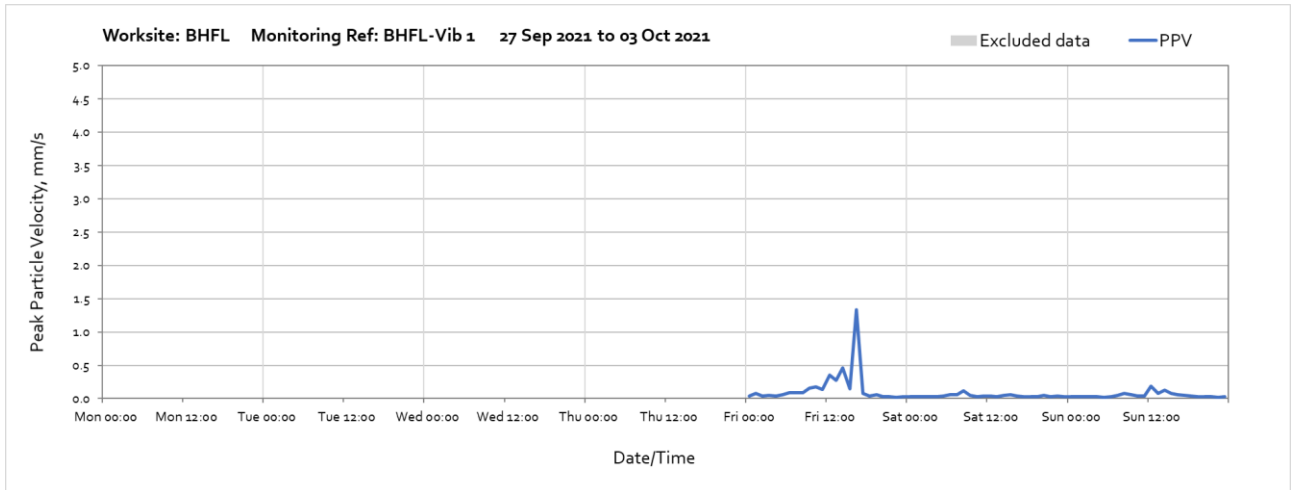
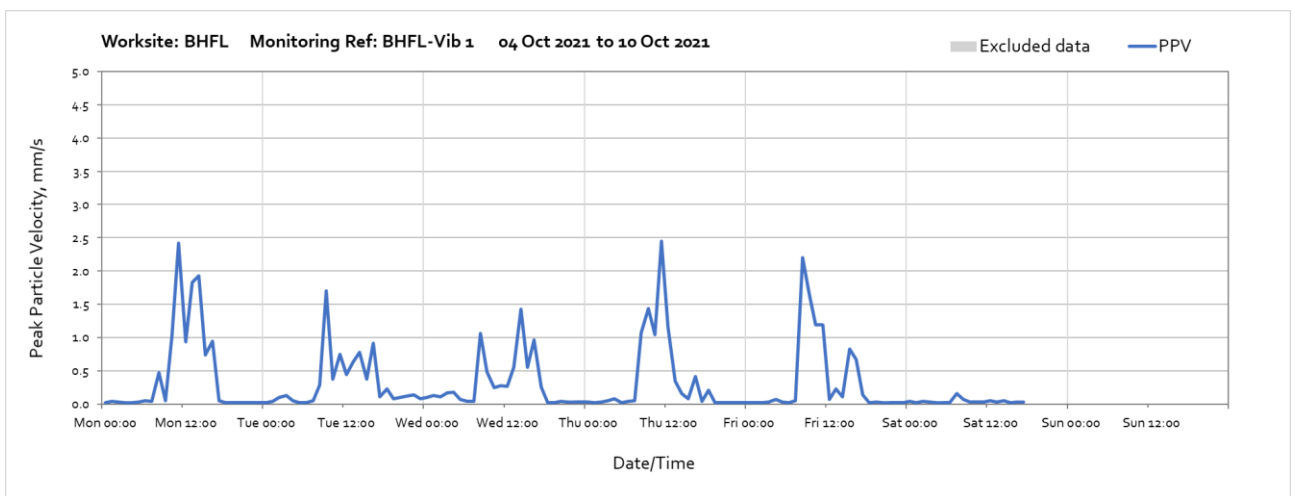
## Worksite: BHFL – Monitoring Ref: BHFL-Vib 1

Note: Missing data between 18:00 on Saturday 9<sup>th</sup> and 07:00 on Monday 11<sup>th</sup> October was due to equipment synchronize error. High levels of vibration measured throughout the week were due to HS2 related road widening works.

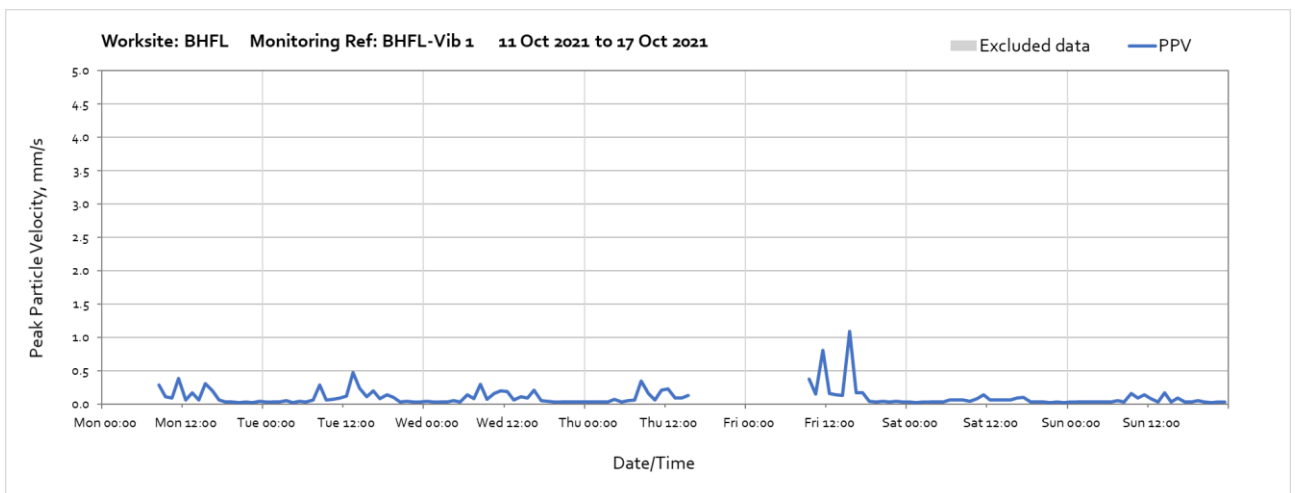
Note: Missing data between 16:00 on Thursday 14<sup>th</sup> and 09:00 on Friday 15<sup>th</sup> October was due to equipment synchronize error.

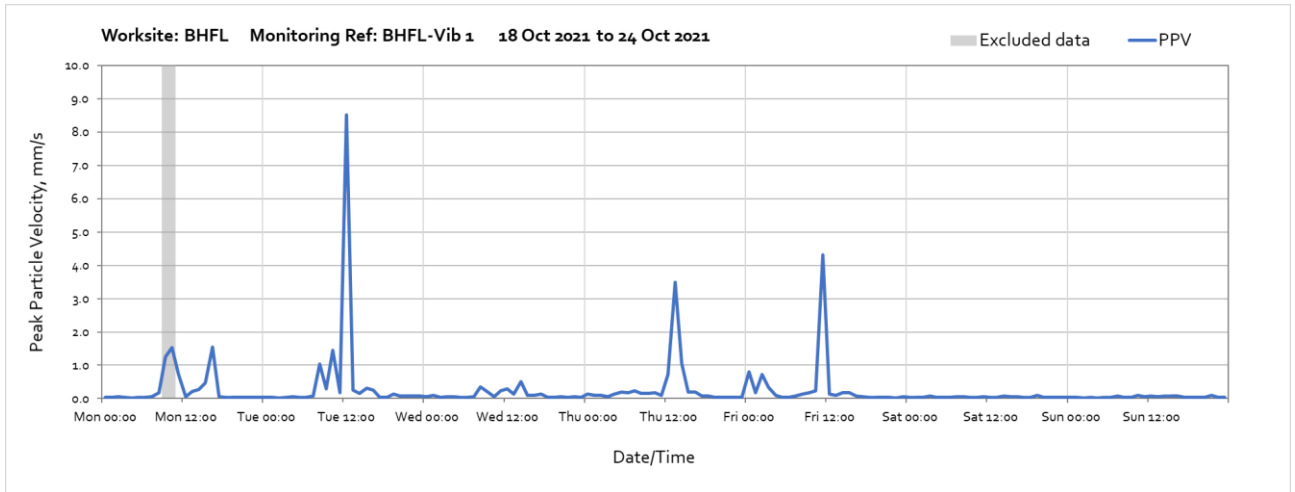
Note: High levels of vibration measured throughout the week were due to HS2 related road widening works.
