Construction noise and vibration Monthly Report –October 2021

Warwick District Council

Non-Technical Summary

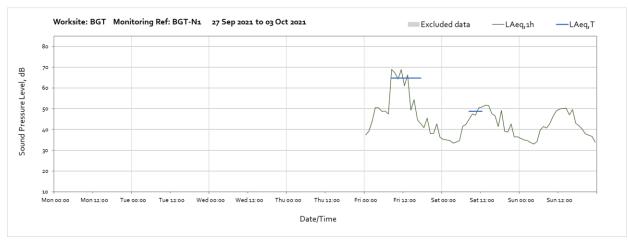
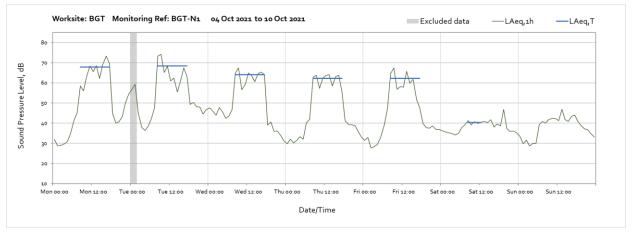
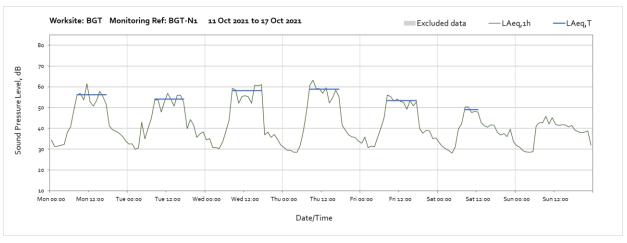
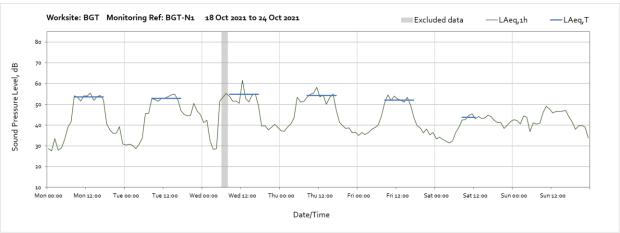
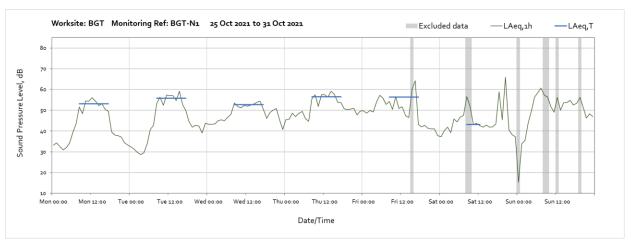
Worksite: BGT - Monitoring Ref: BGT-N1

The following graphs show the hourly measured ambient noise level $L_{Aeq,1h}$ and, where relevant, the averaged noise level $L_{Aeq,T}$ values, where the time period T is as specified in Table 1 of HS2 Information Paper E23. Periods with adversely weather affected noise levels are greyed out and have been excluded from the calculation of the $L_{Aeq,T}$ values in Table 3 of the main report.

Note: Unusually low data between 00:00 and 01:00 on Sunday 31st October was due to sound level meter daylight saving time adjustment.

| Worksite Reference | Measurement Reference | Site Address | Free-field or ress Façade Measurement | | Weekly Average L _{Aeq,T} (highest day L _{Aeq,T}) | | | | Saturday Average L _{Aeq,T} (highest day L _{Aeq,T}) | | | | Sunday / Public Holiday Average L _{Aeq,T} (highest day L _{Aeq,T}) | | |
|---|--|---|---|---|--|---|---|---|--|---|---|---|---|---|---|
| BGT | BGT-N1 | 301 Cromwell Lane, Burton Green, Warwick, Warwickshire | Free-field | 46.1 (52.8) | 57.7 (68.4) | 42.1 (50.8) | 41.1 (51.1) | 40.0 (57.2) | 42.1 (47.5) | 45.0 (49.0) | 44.3 (51.7) | 45.6 (65.9) | 39.9 (58.5) | 46.0 (60.8) | 37.6 (48.3) |

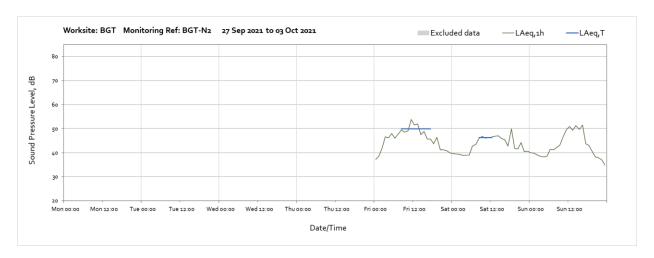
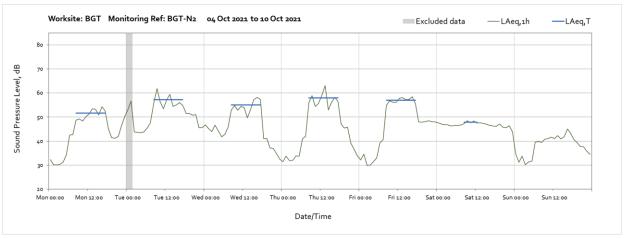
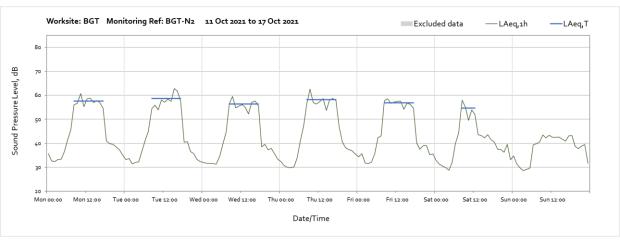
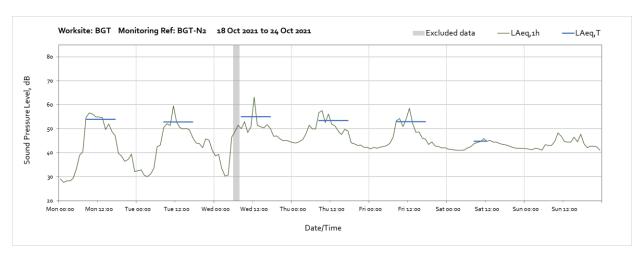
Worksite: BGT - Monitoring Ref: BGT-N2

Note: Unusually low data between 00:00 and 01:00 on Sunday 31st October was due to sound level meter daylight saving time adjustment.

| Worksite Reference | Measurement Reference | Site Address | Free-field or ress Façade Measurement | | Weekly Average L _{Aeq,T} (highest day L _{Aeq,T}) | | | | Saturday Average L _{Aeq,T} (highest day L _{Aeq,T}) | | | | Sunday / Public Holiday Average L _{Aeq,T} (highest day L _{Aeq,T}) | | |
|---|--|---|---|---|--|---|---|---|--|---|---|---|---|---|---|
| BGT-N2 | Broadwell Woods Caravan Park, Red Lane, Burton Green, Warwick, Warwickshire | Free-field | 44.6 (49.9) | 55.6 (64.9) | 43.8 (51.5) | 42.4 (51.5) | 40.2 (51.5) | 44.5 (46.7) | 48.1 (54.6) | 45.9 (47.6) | 45.8 (60.0) | 40.3 (46.8) | 45.3 (53.6) | 39.0 (47.4) | |

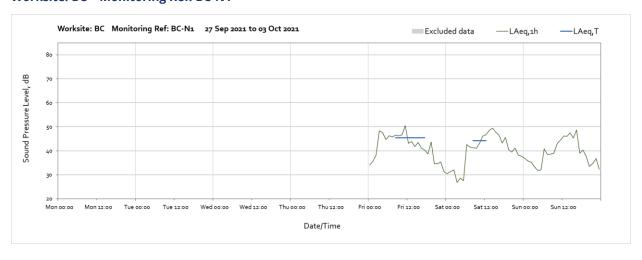
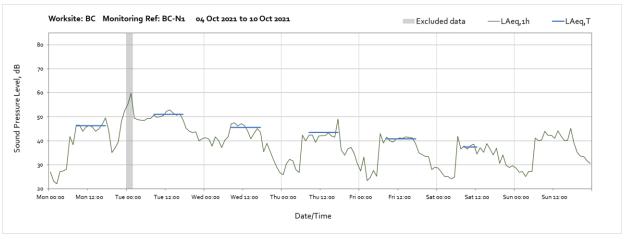
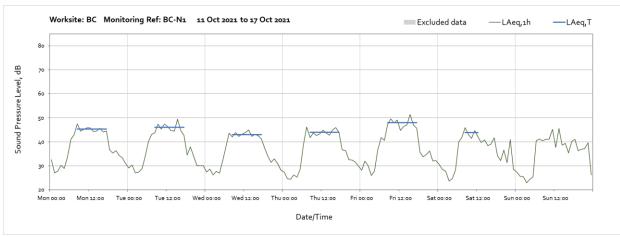
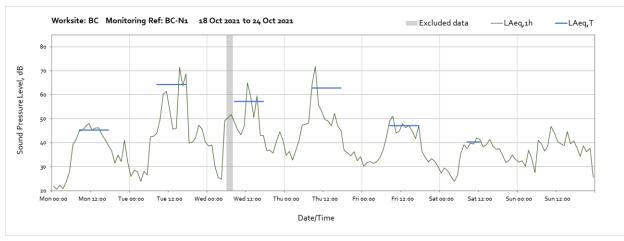
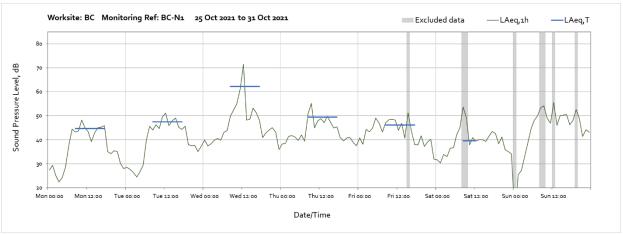
Worksite: BC - Monitoring Ref: BC-N1

Note: Unusually low data between 00:00 and 01:00 on Sunday 31st October was due to sound level meter daylight saving time adjustment.

| Worksite Reference | Measurement Reference | Site Address | Free-field or ress Façade Measurement | | Weekly Average L _{Aeq,T} (highest day L _{Aeq,T}) | | | | Saturday Average L _{Aeq,T} (highest day L _{Aeq,T}) | | | | Sunday / Public Holiday Average L _{Aeq,T} (highest day L _{Aeq,T}) | | |
|---|--|---|---|---|--|---|---|---|--|---|---|---|---|---|---|
| ВС | BC-N1 | Thistle Estate, Red Lane, Burton Green, Warwick, Warwickshire | Free-field | 43.1 (49.3) | 48.8 (64.2) | 38.2 (45.7) | 37.2 (47.4) | 37.0 (52.6) | 40.8 (45.1) | 41.0 (44.3) | 40.7 (48.6) | 39.5 (49.5) | 36.2 (48.1) | 43.1 (50.6) | 35.5 (44.2) |

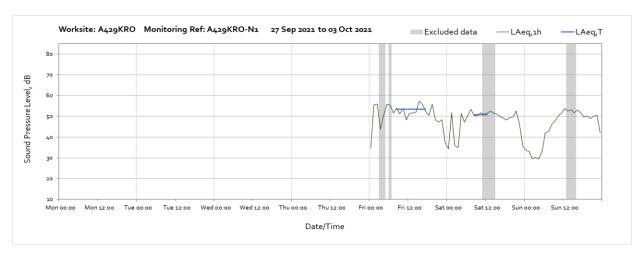
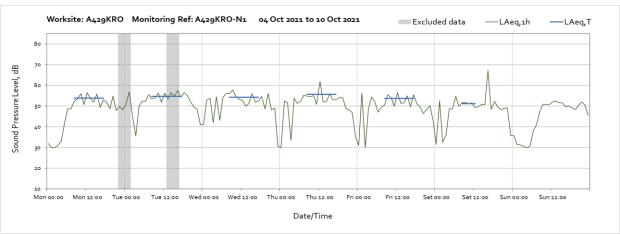
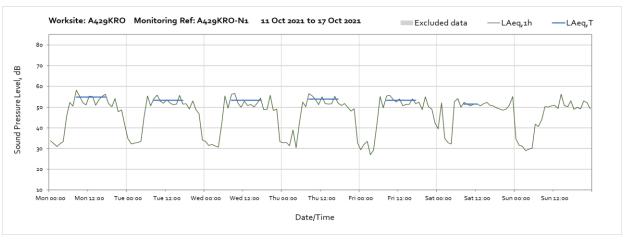
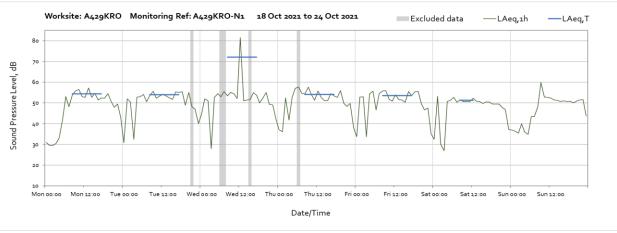
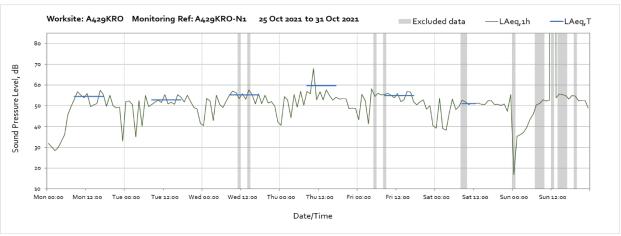
Worksite: A429KRO - Monitoring Ref: A429KRO-N1

Note: High noise level between 12:00 and 13:00 Sunday 31st October was due to a software issue. Unusually low data between 00:00 and 01:00 on Sunday 31st October was due to sound level meter daylight saving time adjustment.

| Worksite Reference | Measurement Reference | Site Address | Free-field or ress Façade Measurement | | Weekly Average L _{Aeq,T} (highest day L _{Aeq,T}) | | | | Saturday Average L _{Aeq,T} (highest day L _{Aeq,T}) | | | | Sunday / Public Holiday Average L _{Aeq,T} (highest day L _{Aeq,T}) | | |
|---|--|---|---|---|--|---|---|---|--|---|---|---|---|---|---|
| A429KRO | A429KRO-N1 | Millburn Grange, Coventry Road, Kenilworth | Free-field | 51.5 (55.9) | 55.2 (72.0) | 52.2 (56.5) | 51.9 (56.1) | 49.8 (58.2) | 50.6 (53.4) | 51.1 (51.5) | 50.7 (51.3) | 52.0 (67.2) | 43.1 (55.4) | 51.5 (59.9) | 46.4 (53.1) |

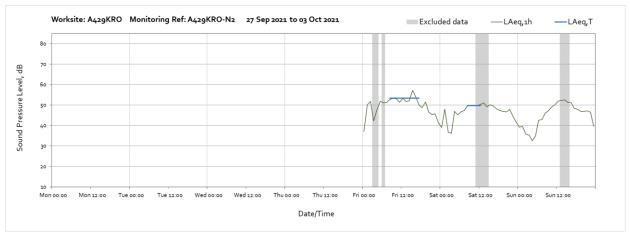
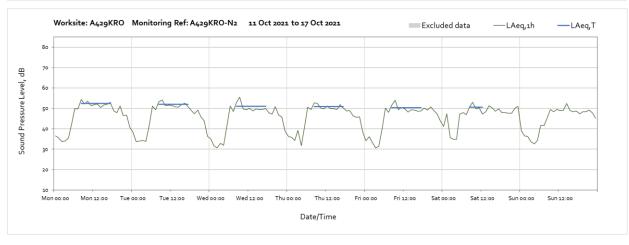
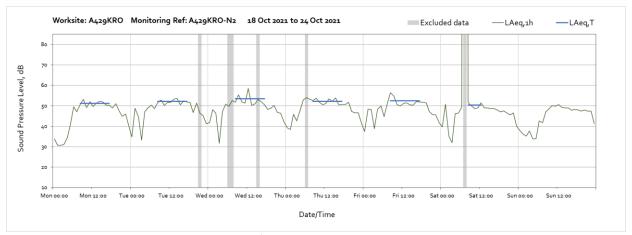
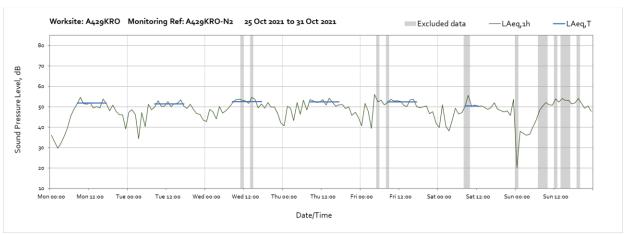
Worksite: A429KRO - Monitoring Ref: A429KRO-N2

Note: High noise level at 07:00 on Sunday 23rd October was due to a software issue.

Note: Unusually low data between 00:00 and 01:00 on Sunday 31st October was due to sound level meter daylight saving time adjustment.

| Worksite Reference | Measurement Reference | Site Address | Free-field or ress Façade Measurement | | Weekly Average L _{Aeq,T} (highest day L _{Aeq,T}) | | | | Saturday Average L _{Aeq,T} (highest day L _{Aeq,T}) | | | | Sunday / Public Holiday Average L _{Aeq,T} (highest day L _{Aeq,T}) | | |
|---|--|---|---|---|--|---|---|---|--|---|---|---|---|---|---|
| | A429KRO-N2 | Brookview, Milburn Grange, Coventry Road, Kenilworth | Free-field | 49.8 (53.1) | 52.1 (53.8) | 49.4 (52.0) | 48.7 (52.1) | 46.1 (56.0) | 46.9 (47.4) | 49.6 (50.5) | 48.5 (50.4) | 48.3 (52.0) | 42.3 (53.6) | 49.1 (52.4) | 43.8 (50.4) |

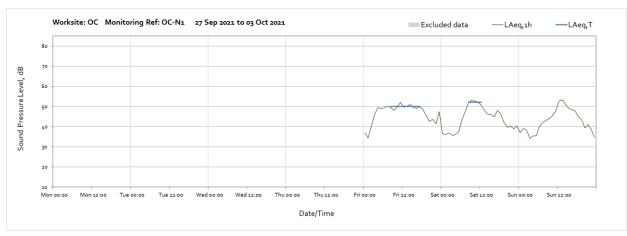
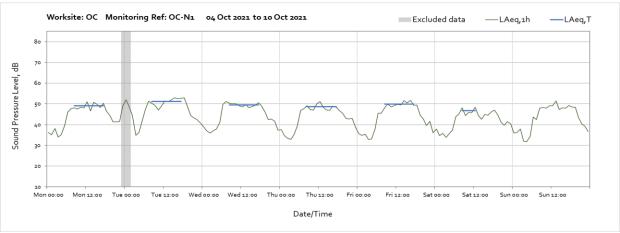
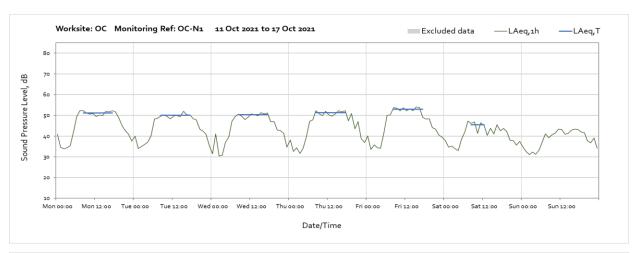
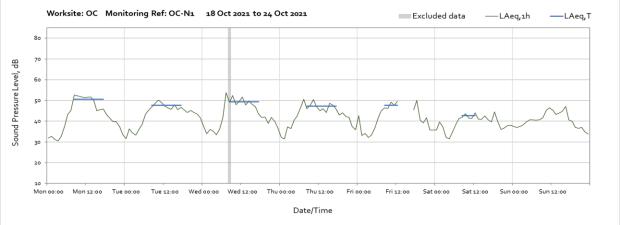
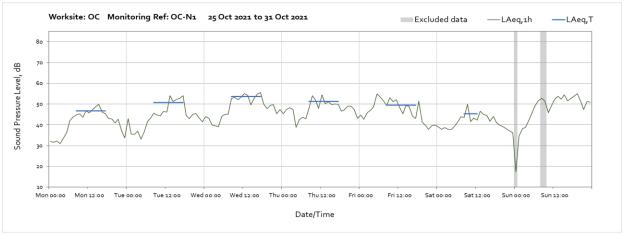
Worksite: OC - Monitoring Ref: OC-N1

Note: Missing data between 13:00 and 17:00 Friday 22nd October was due to system error during field calibration.

Note: Unusually low data between 00:00 and 01:00 on Sunday 31st October was due to sound level meter daylight saving time adjustment.

| Worksite Reference | Measurement Reference | Site Address | Free-field or Façade Measurement | Weekly Average L _{Aeq,T} (highest day L _{Aeq,T}) | | | | Saturday Average L _{Aeq,T} (highest day L _{Aeq,T}) | | | | Sunday / Public Holiday Average L _{Aeq,T} (highest day L _{Aeq,T}) | | | |
|---|---|---|--|--|---|---|---|--|---|---|---|---|---|---|---|
| ОС | OC-N1 | Welsh Road, Offchurch, Leamington | Free-field | 48.0 (53.7) | 49.9 (53.6) | 47.4 (52.9) | 44.2 (50.9) | 41.0 (54.9) | 45.0 (47.5) | 46.5 (52.2) | 44.1 (48.0) | 43.0 (48.1) | 38.7 (49.3) | 46.7 (54.9) | 41.0 (51.2) |
