Area South

2021 Overview

Area South - EWC 2021 Overview

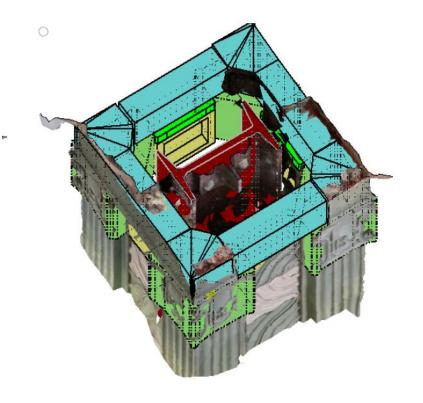
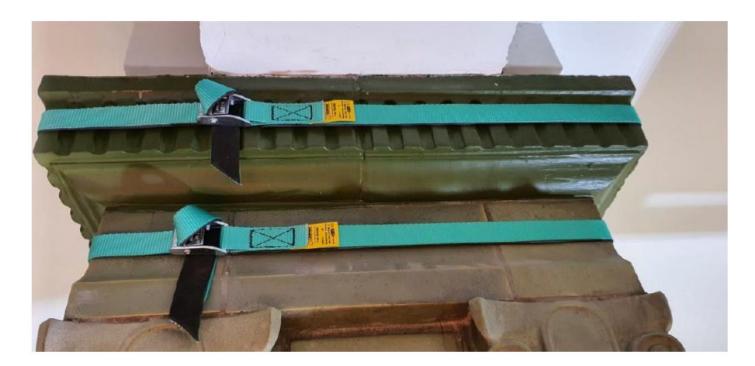
Royal College of General Practitioners

- Protection of the building during construction works.
 - Monitoring building movement.
 - Installing protection measures.

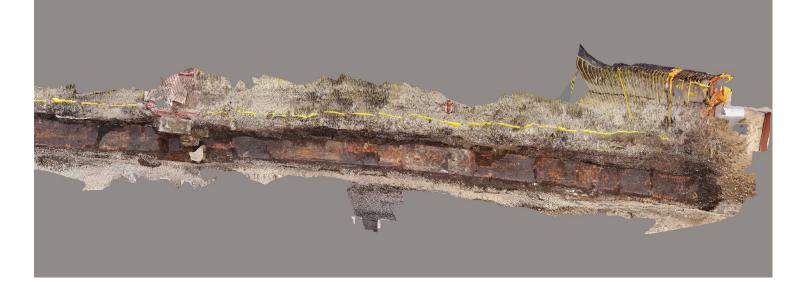
Approximately 100m long

1200mm in depth

9 courses of brick with Portland cement mortar

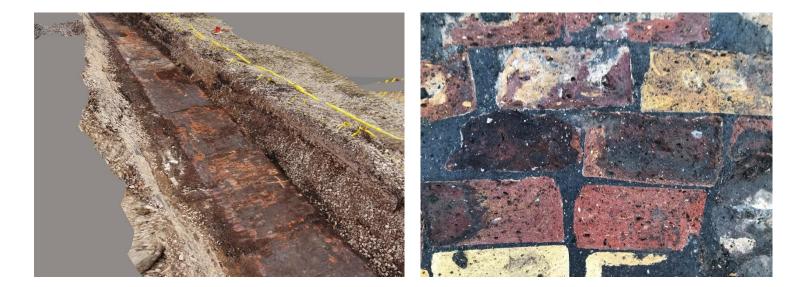
Composition of brickwork variable

Base of Portland Cement with substantial quantities of pebbles and gravels
