Tecalemit Scissor Lift SF/9094 or 5 and SF9064 or 5 (Manufactured 2014 – 2018)

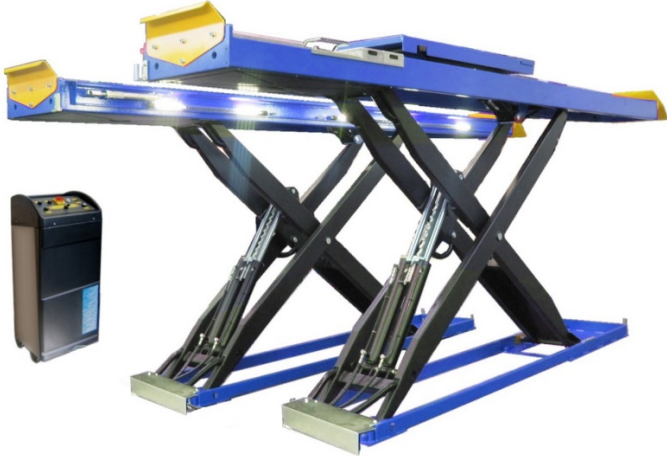
<p>The image shows a blue and yellow scissor lift. It has a platform at the top with yellow safety railings. The lift is supported by four hydraulic scissor arms. To the left of the lift is a black control panel with a yellow emergency stop button and a blue start button.</p>
Alert Number	2112-0572
Product Type	Machinery – Scissor Lift
Product Identifiers	4.5t Service and MOT Class IV Scissor Lift – SF/9094/EV & SF/9095/EV and 5.0t Service and MOT Class VII Scissor Lift SF/9064/EV& SF/9065/EV manufactured 2014 – 2018.
Product Description	Hydraulic scissor lift for lifting vehicles. Capacity 4.5 and 5.0 tonnes.
Country of Origin	Italy
Counterfeit	No
Risk Level	Serious Risk
Risk Type	Injury
Risk Description	<p>The manufacturer has identified a potential weakness in a weld on the scissor lifts. They have provided a kit which should be fitted to the scissor lift. The manufacturer has issued instructions to avoid using the lift with a load exceeding 3.5 tonnes until the kit has been fitted. A product of identical design is now known to have failed with a loading of less than 3.5 tonnes. This product does not comply with the Supply of Machinery (Safety) Regulations 2008.</p>

Corrective measures	All affected scissor lifts have had the manufacturer’s kit fitted or arrangements are in place to have this work done. End users are advised to stop using the scissor lift until the kit has been fitted.
Online Marketplace	N/A
Notifier	HSE
