## **Construction noise and vibration Monthly Report – November 2021**

**Warwick District Council**

# Non-Technical Summary

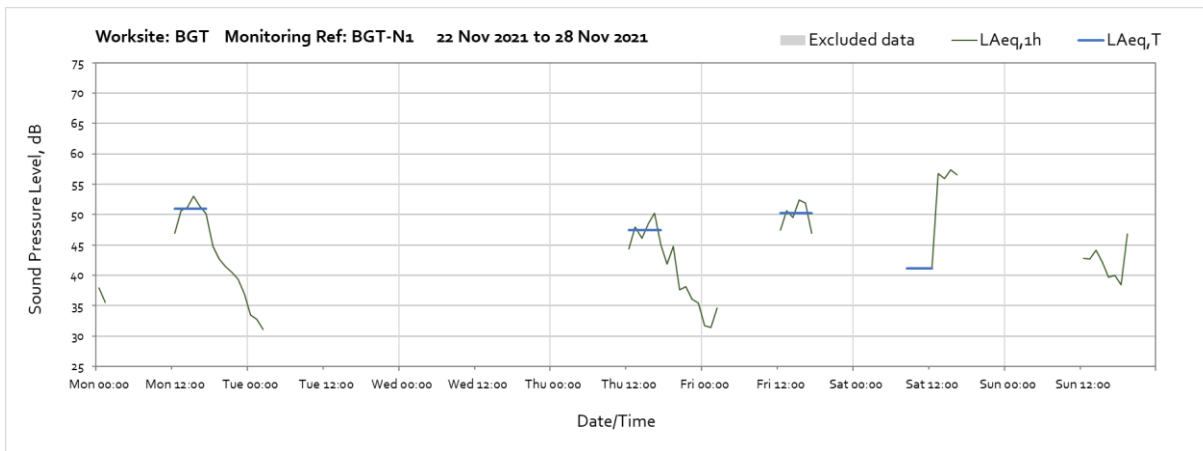
Note: Missing data throughout the week were due to loss of solar power to the equipment.

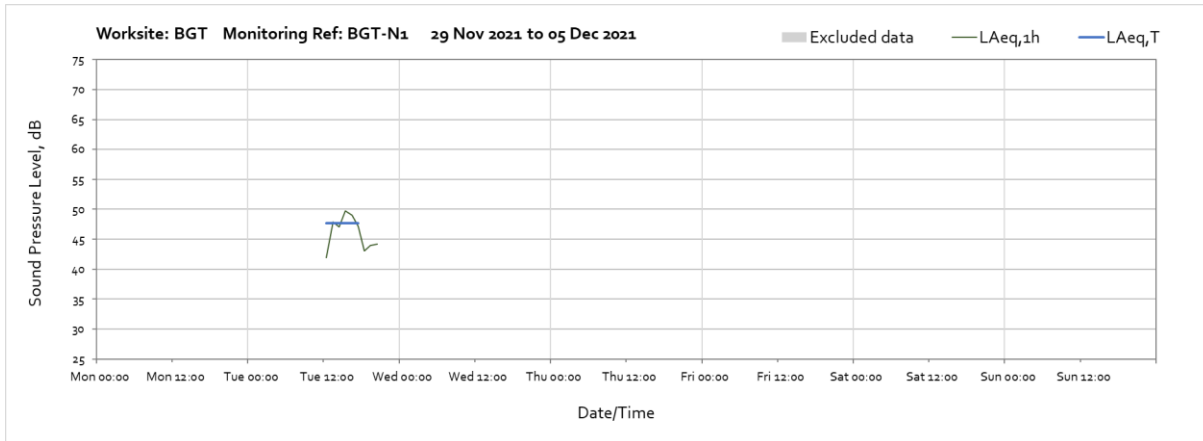
Note: Missing data throughout the week were due to loss of solar power to the equipment. To ensure there is no loss of power again batteries have been installed and are replaced frequently.

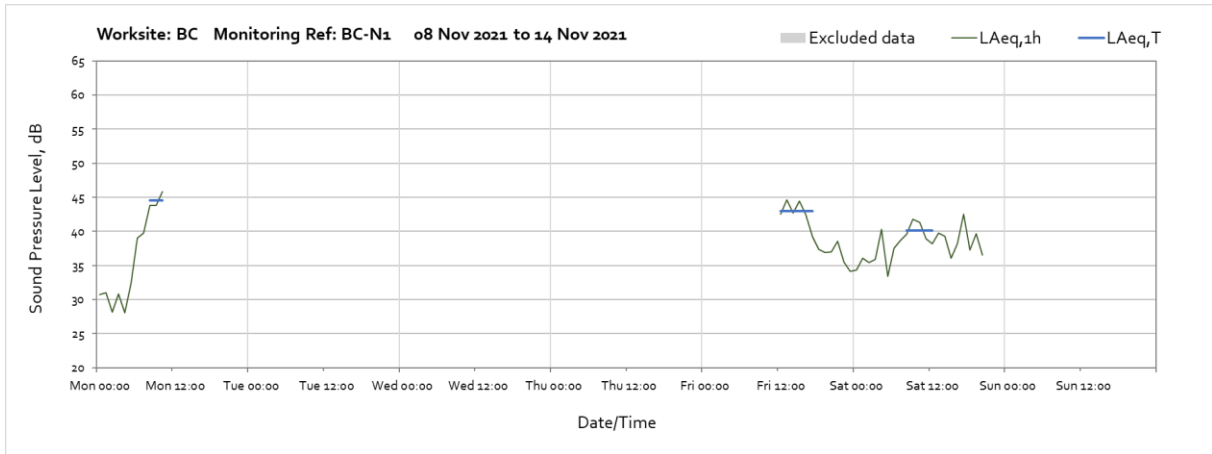
**Worksite: BC - Monitoring Ref: BC-N1**

Note: Missing data throughout the week were due to loss of solar power to the equipment. To ensure there is no loss of power again batteries have been installed and are replaced frequently and solar maintenance is being conducted.

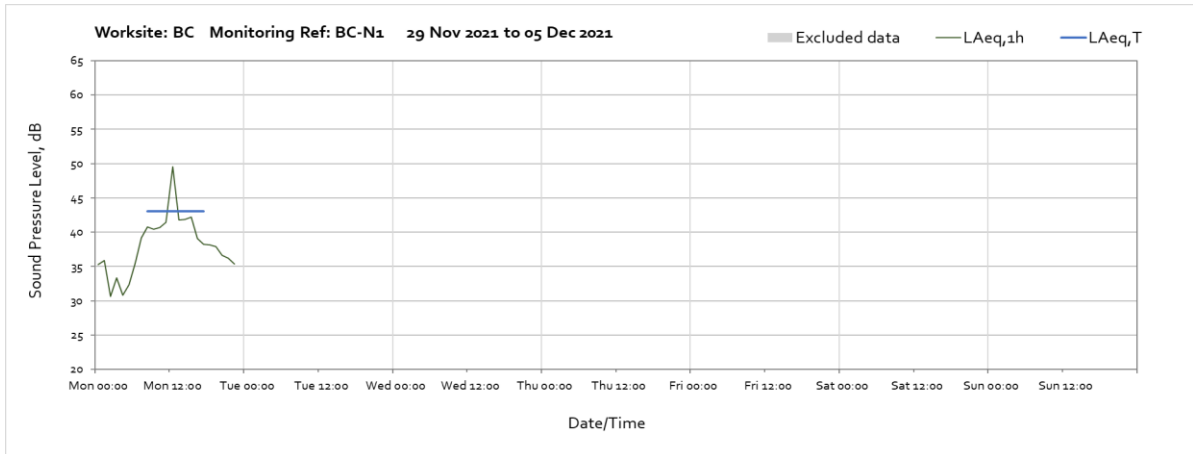
Note: Missing data between 23:00 on Monday 29<sup>th</sup> of November and the end of the month was due to loss of solar power to the equipment.

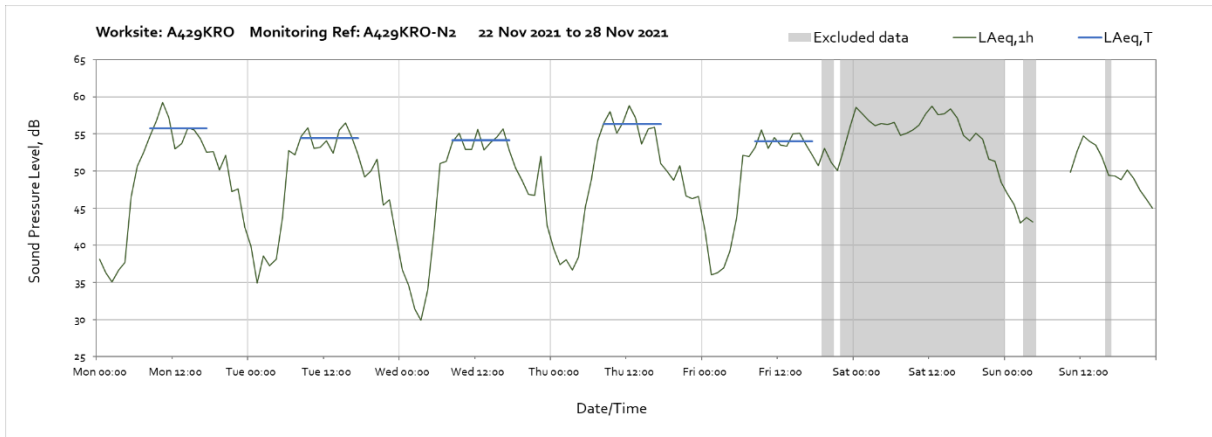
**Worksite: A429KRO – Monitoring Ref: A429KRO-N2**

Note: Missing data between 05:00 and 10:00 on Sunday 28<sup>th</sup> of November was due to loss of solar power to the equipment.

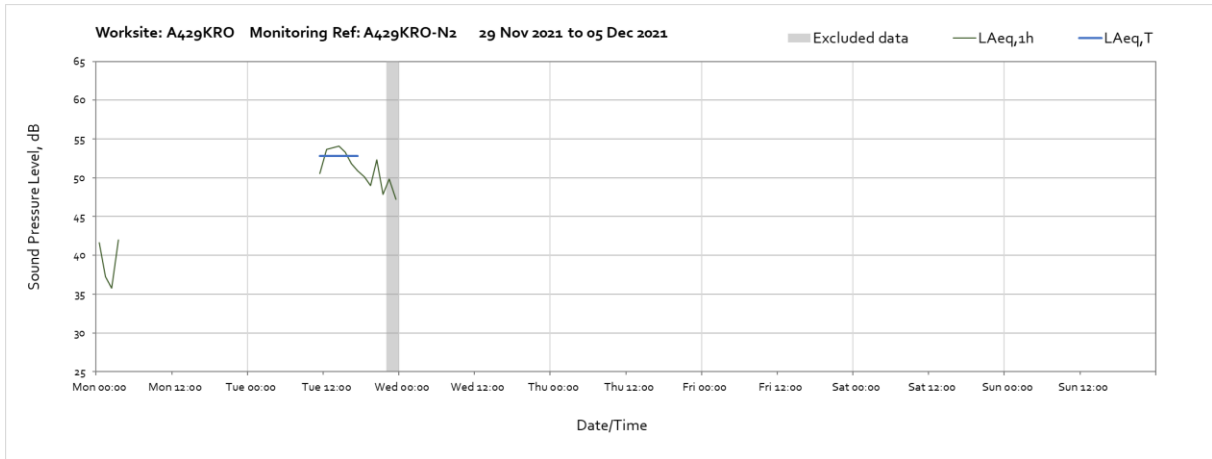
Note: Missing data between 04:00 on Monday 29<sup>th</sup> of November and 11:00 on Tuesday 30<sup>th</sup> of November was due to loss of solar power to the equipment.

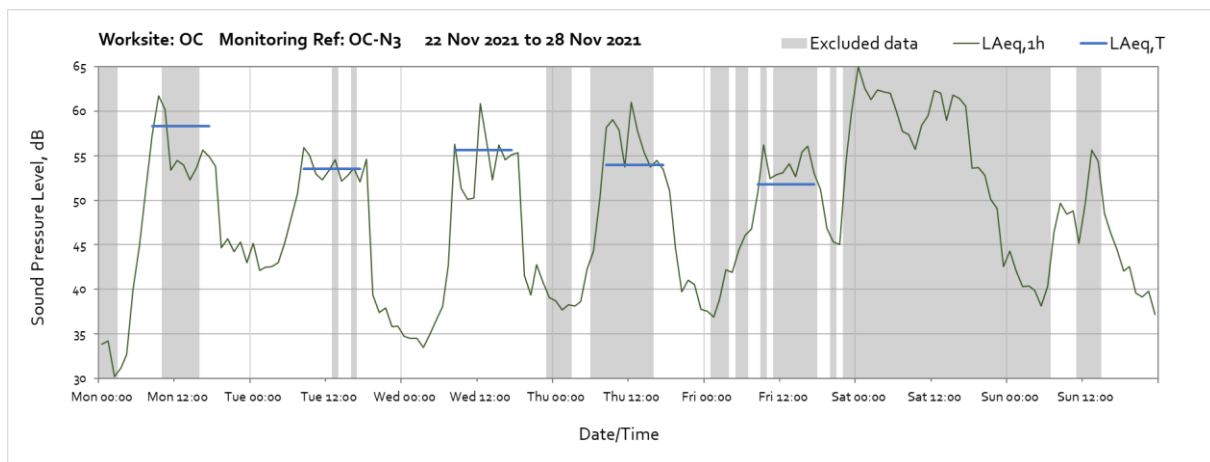
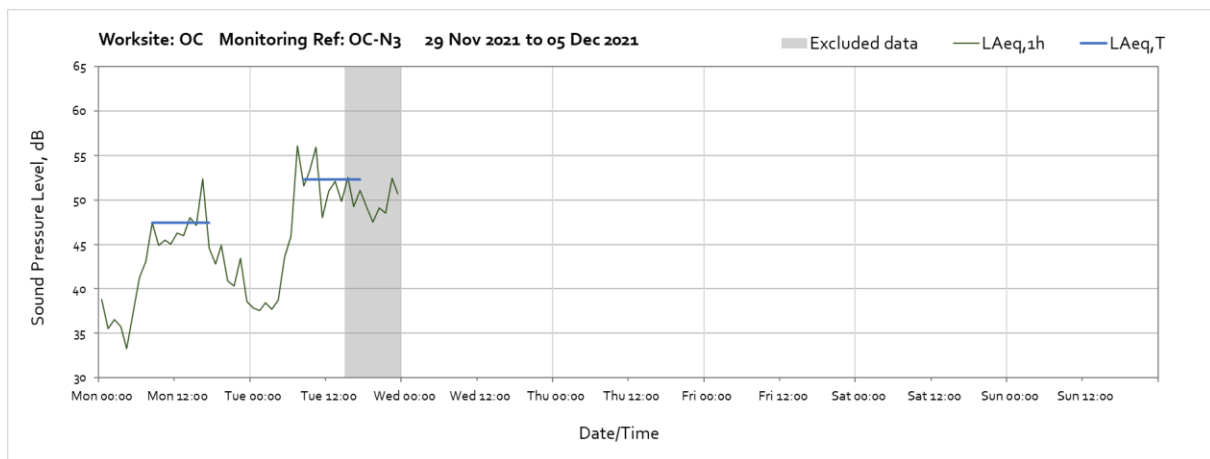
## Worksite: OC – Monitoring Ref: OC-N3

Note: The noise monitor was installed on 18<sup>th</sup> of November 2021.
