Construction noise and vibration Monthly Report – December 2021

Buckinghamshire

This Noise and Vibration Monitoring Report fulfils HS2 Limited's commitment detailed in the Environmental Minimum Requirements (EMRs), Annex 1, Code of Construction Practice, to present the results of noise monitoring carried out within Buckinghamshire (BS) during the month of December 2021.

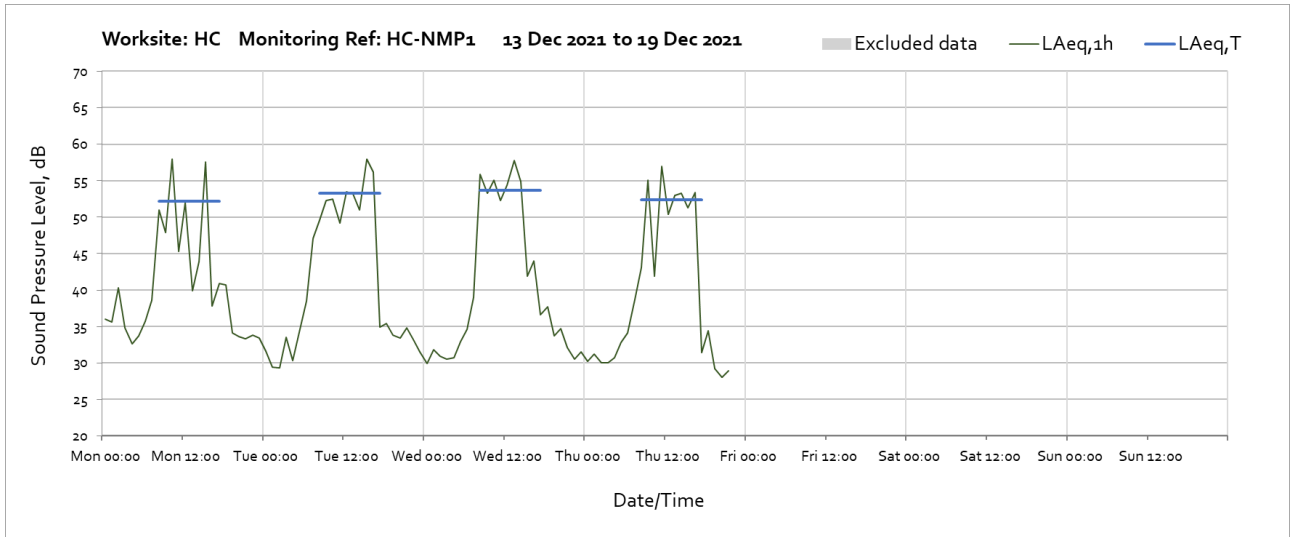
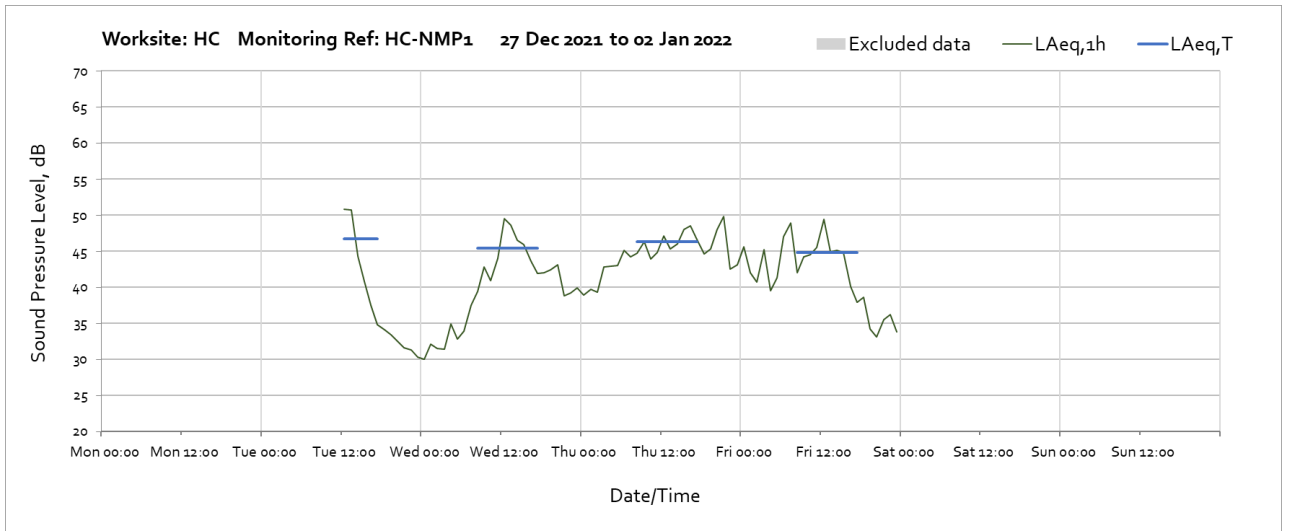
Worksite: HC - Monitoring Ref: HC-NMP1

Note: Missing data between 22:00 on the 16th December and 12:00 on the 28th December was due to loss of power to the monitoring station from lack of sufficient solar energy to keep the battery charged. Installation of wind turbine to provide additional energy is currently being pursued.

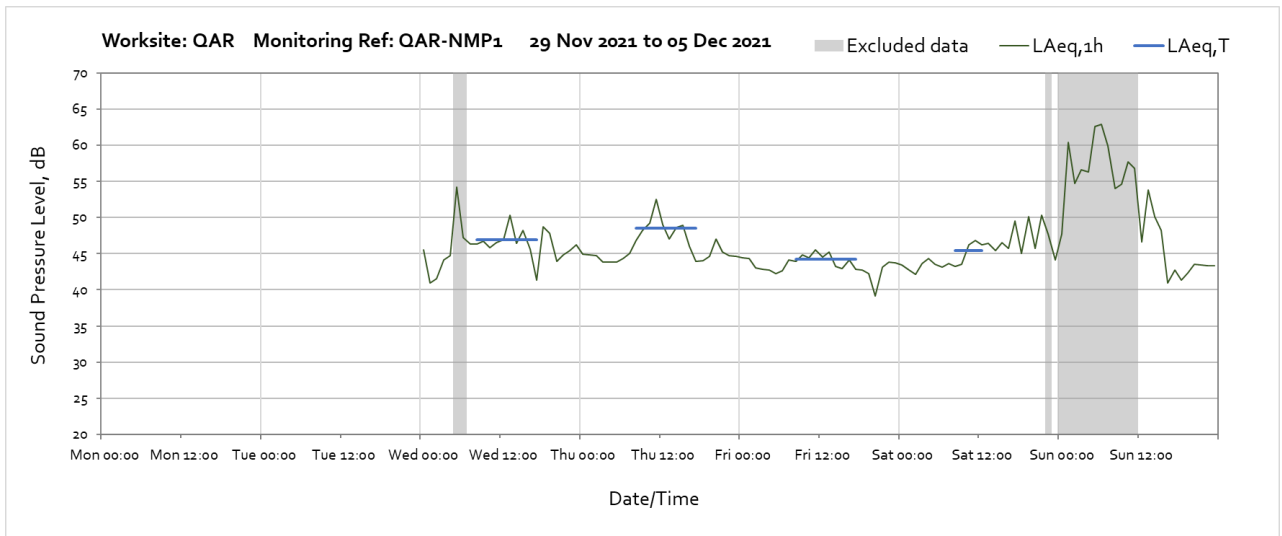
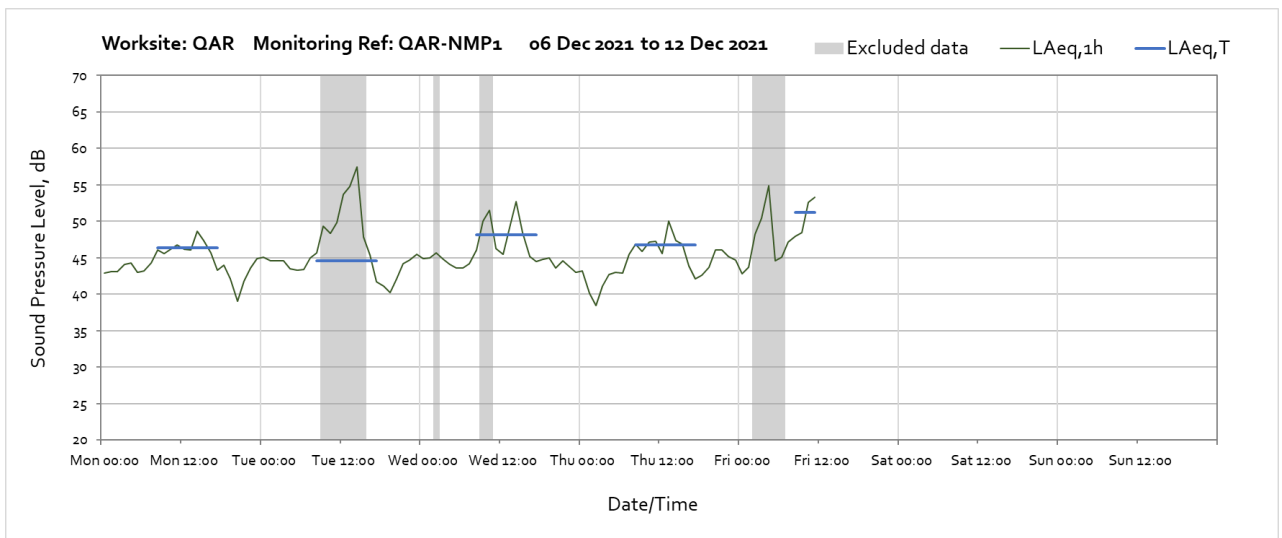
Worksite: QAR – Monitoring Ref: QAR-NMP1

Note: Missing data from 12:00 on the 12th December was due to the monitor being removed.

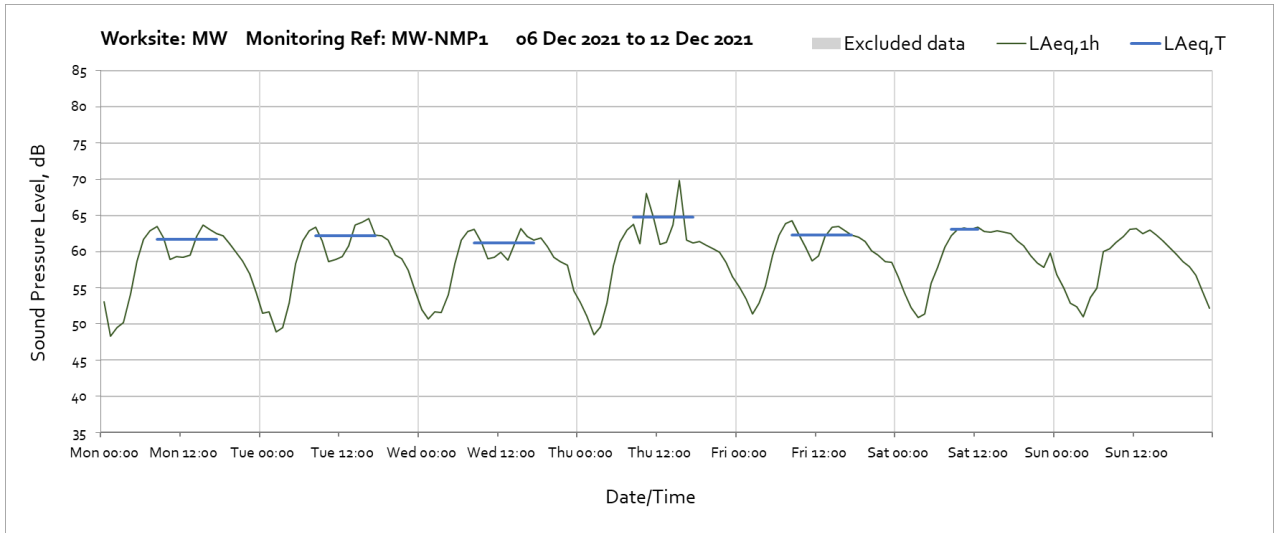
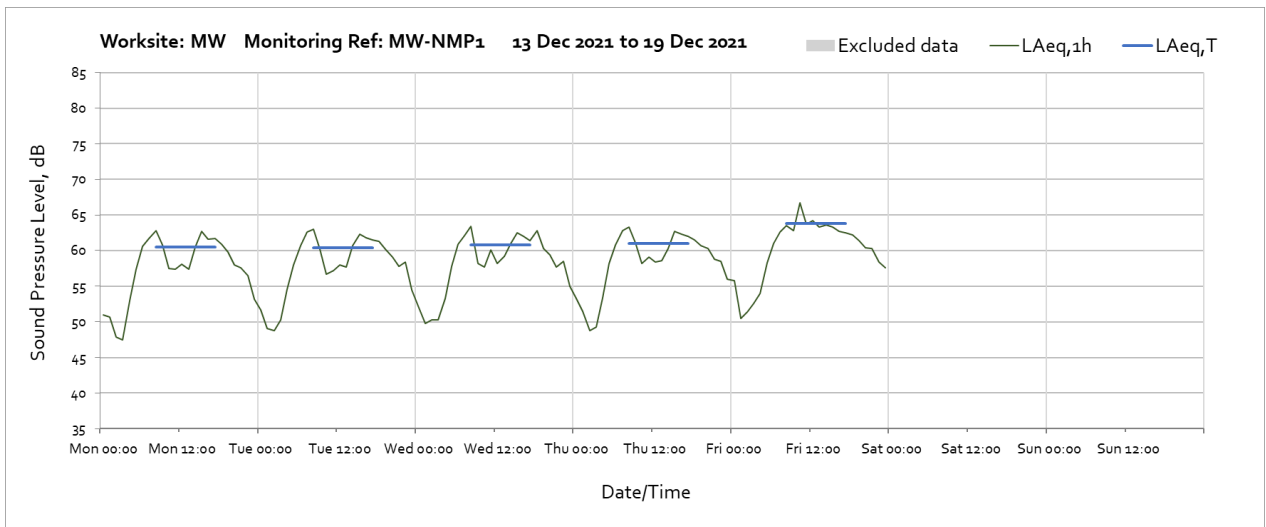
Worksite: MW – Monitoring Ref: MW-NMP1

Note: Missing data from 00:00 on the 18th December till the end of December was due to technical issues from the charging controller. The battery and charge controller have now been replaced.

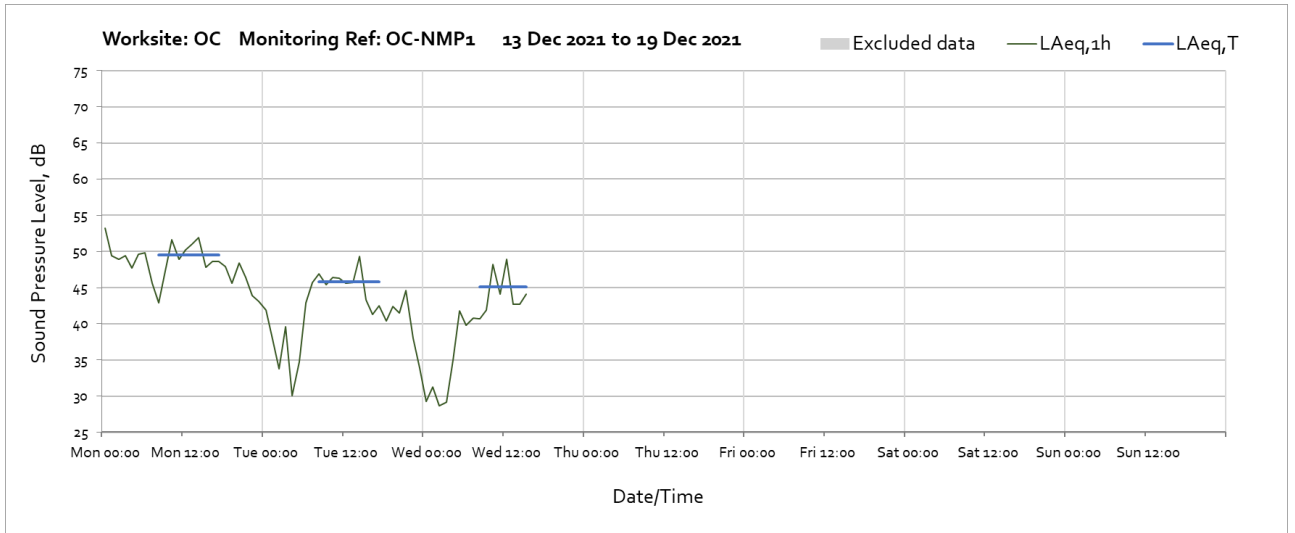
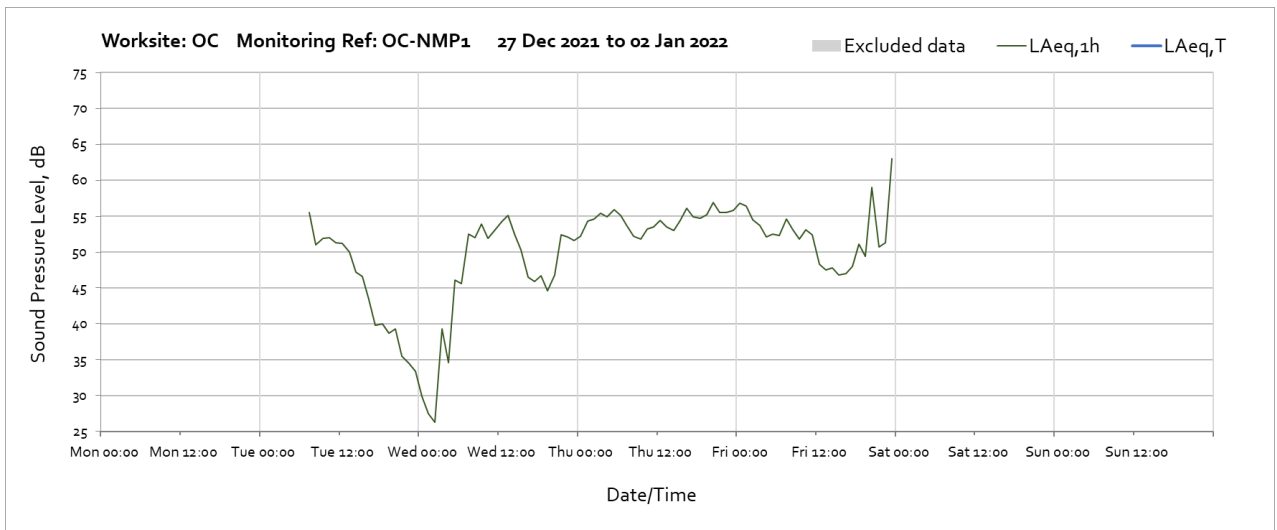
Worksite: OC – Monitoring Ref: OC-NMP1

Note: Missing data between 16:00 on the 15th December and 07:00 on the 28th December was due to loss of power to the monitor. Inspection is taking place to ensure this does not happen again.

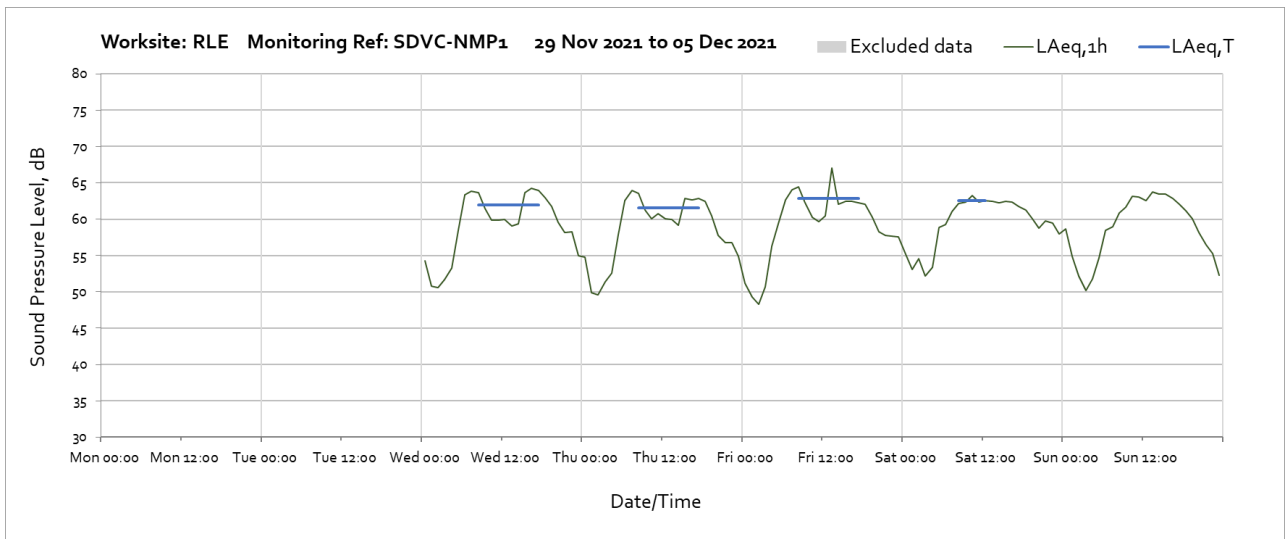
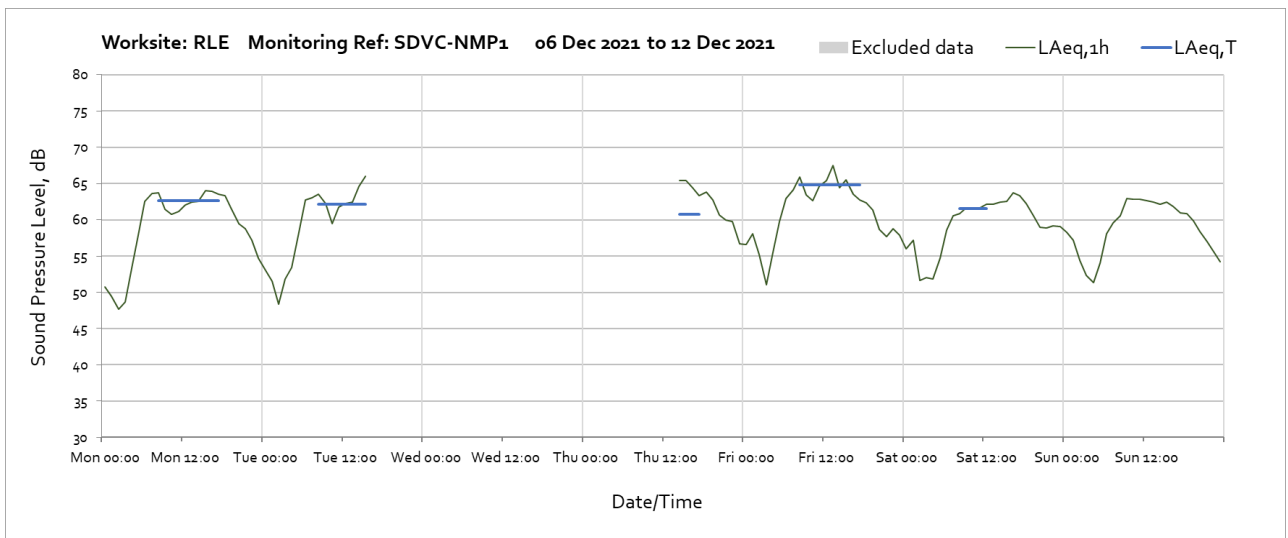
Worksite: RLE – Monitoring Ref: SDVC-NMP1

Note: Missing data between 16:00 on the 7th December and 14:00 on the 9th December was due to loss of solar power because of lack of sunlight and no wind turbine power source. Wind turbine power source will be installed soon to prevent issue occurring again.

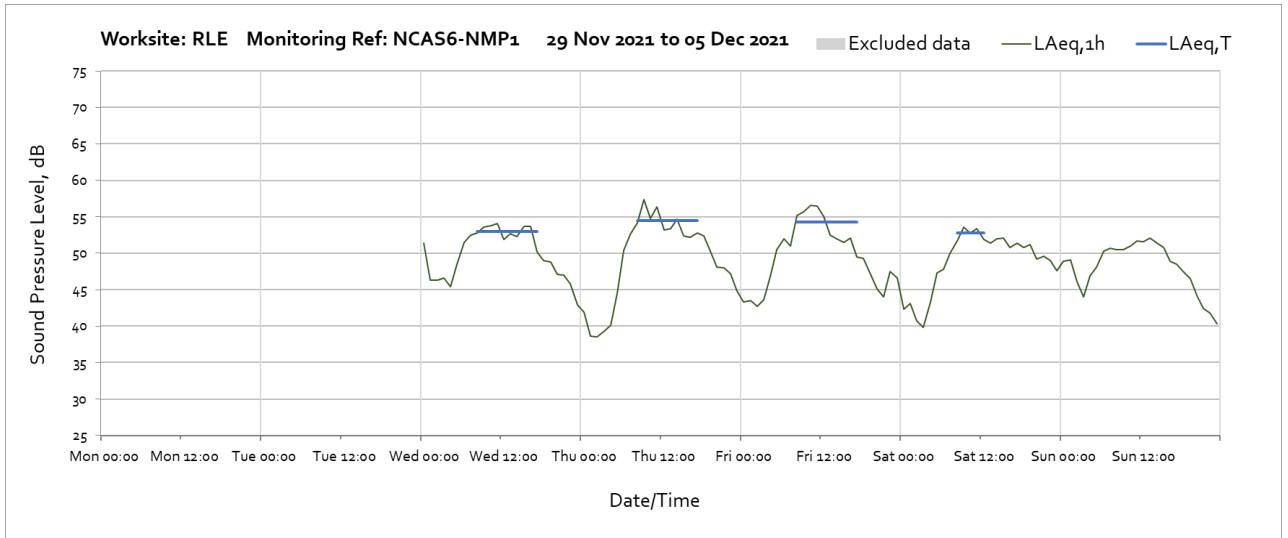
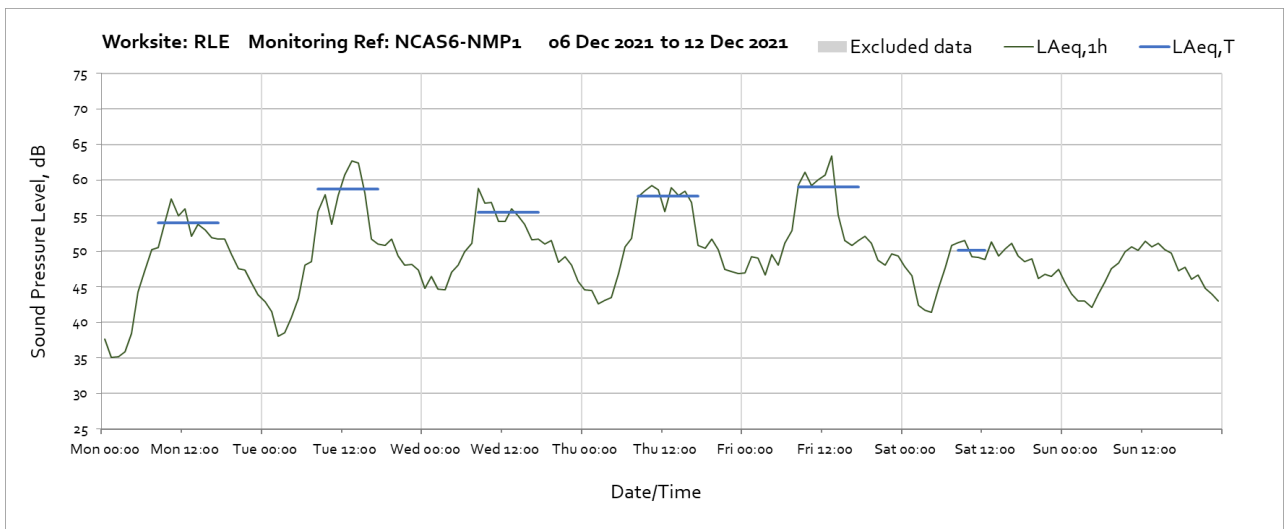
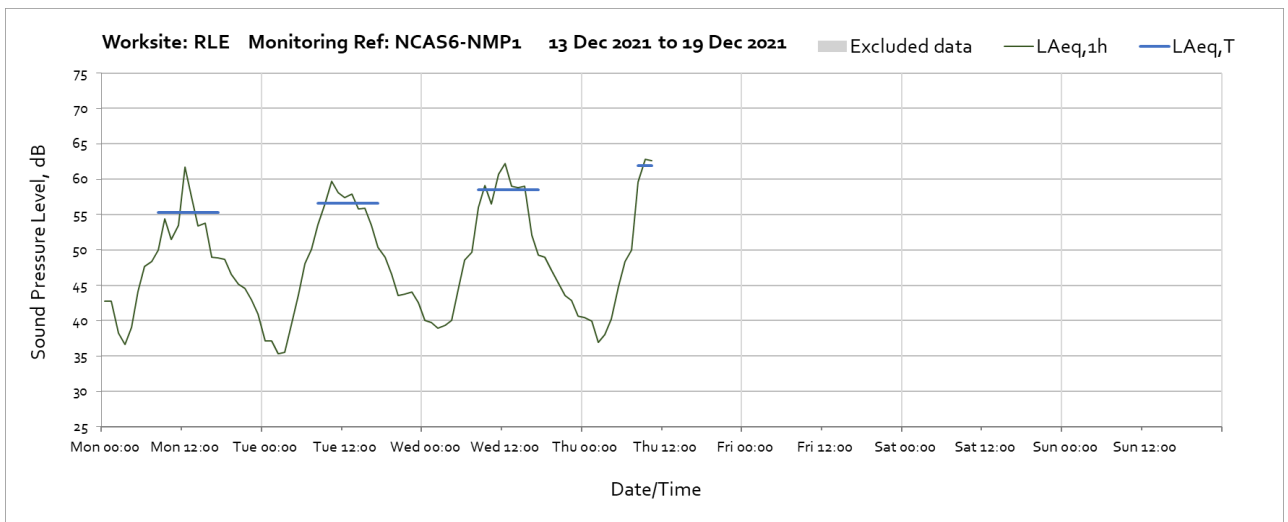
Worksite: RLE - Monitoring Ref: NCAS6-NMP1

Note: Missing data from 11:00 on the 16th December till the end of December was due to loss of solar power because of lack of sunlight and no wind turbine power source. Wind turbine power source will be installed soon to prevent issue occurring again.

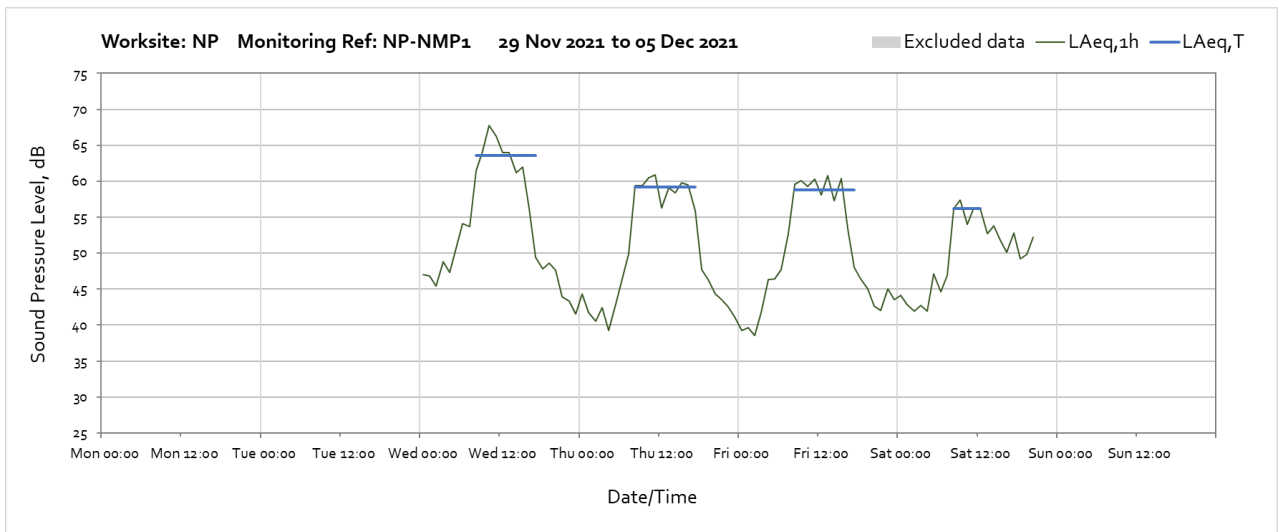
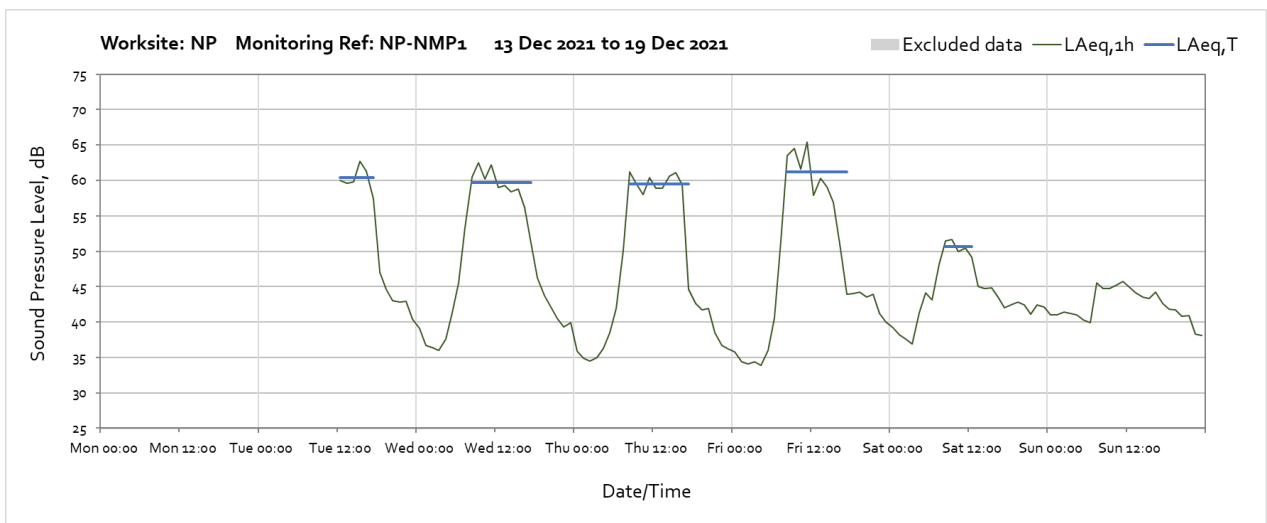
Worksite: NP – Monitoring Ref: NP-NMP1

Note: Missing data from 21:00 on the 4th December until 12:00 on the 14th December was due to loss of power from external batteries. The monitor will have mains power to prevent loss of data in the future.

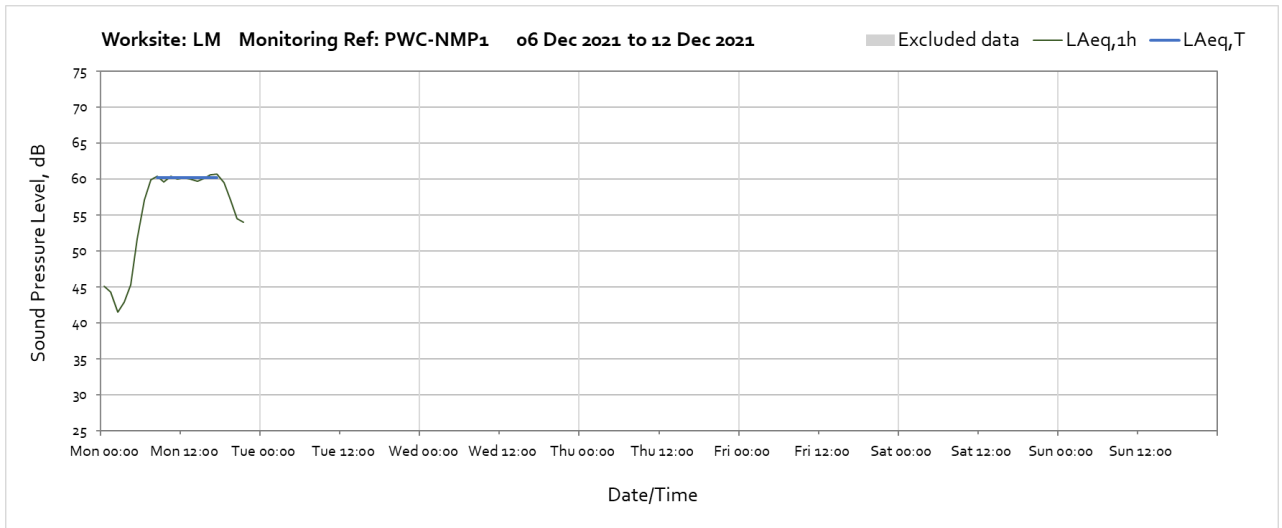
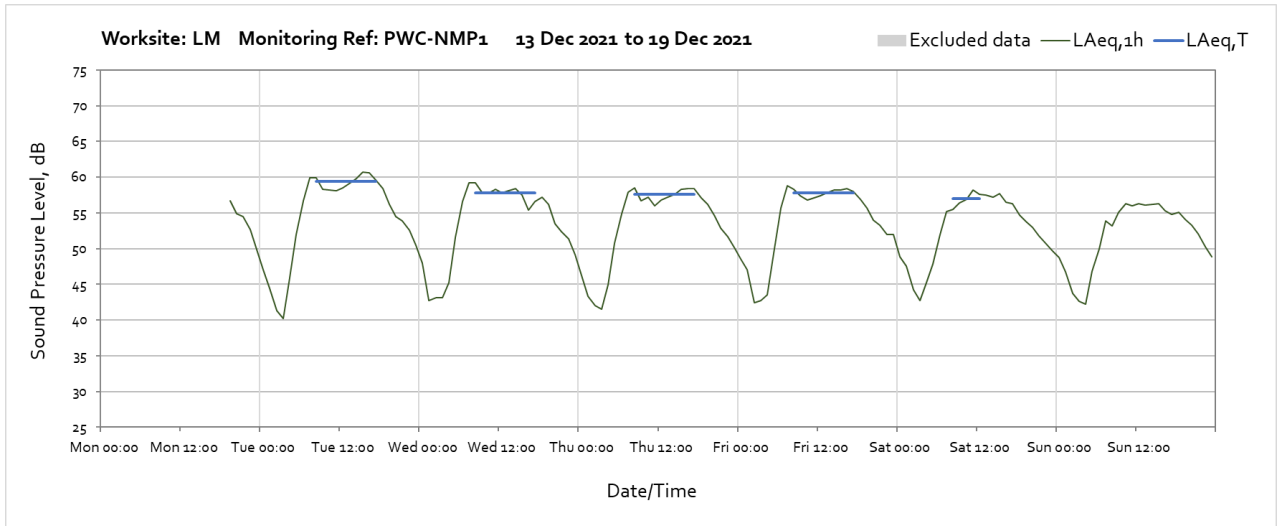
Worksite: LM – Monitoring Ref: PWC-NMP1

Note: Missing data from 22:00 on the 6th December till 19:00 on the 13th December was due to loss of power from external batteries. The monitor is expected to have mains power going forward.

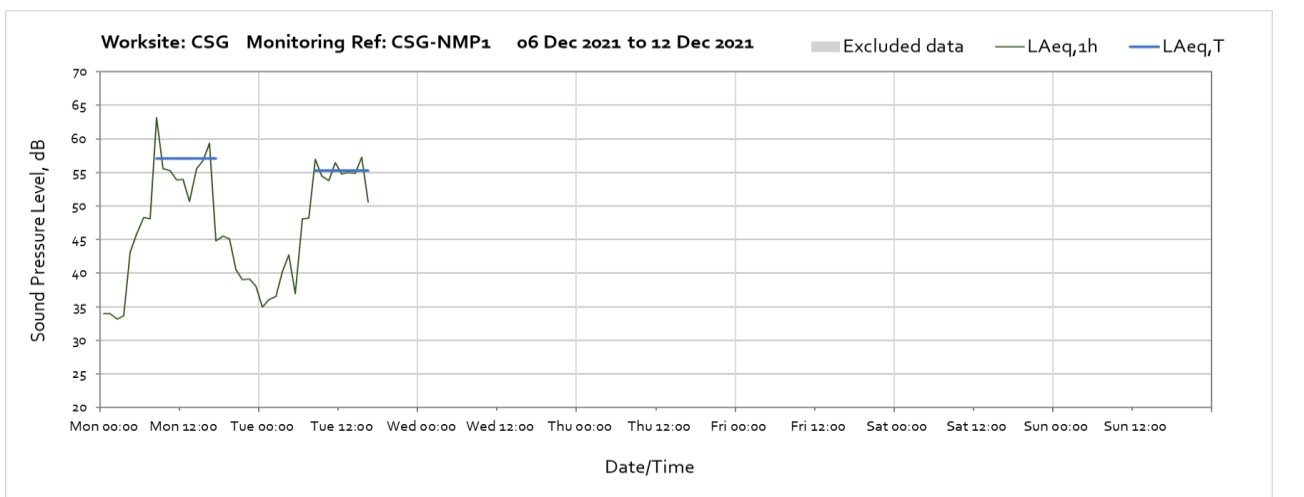
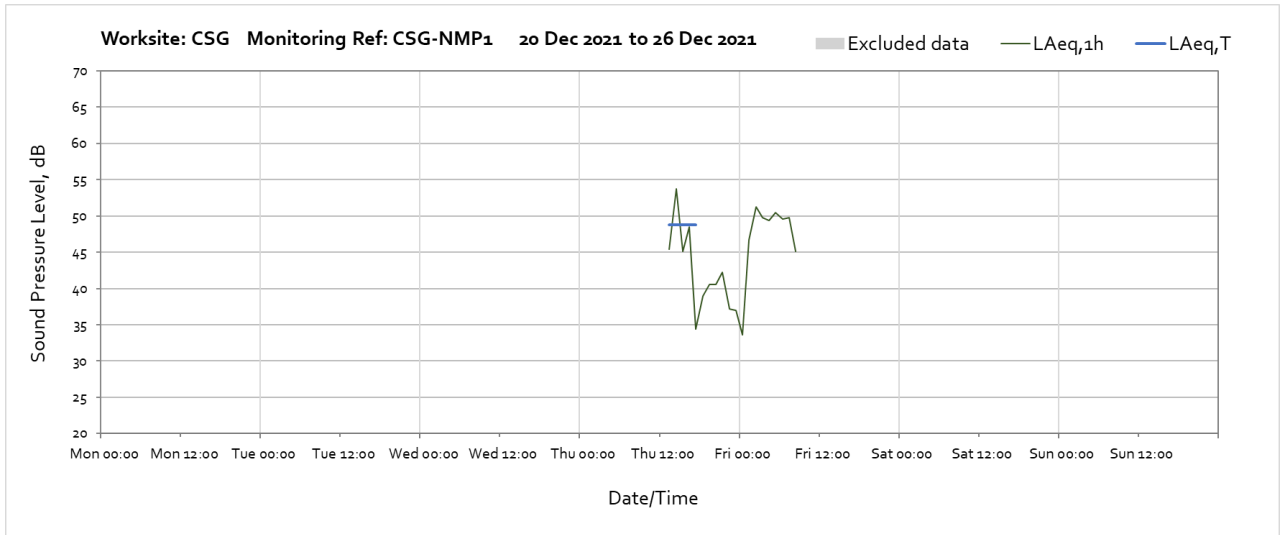
Worksite: CSG – Monitoring Ref: CSG-NMP1

Note: Missing data between 17:00 on the 7th December until 13:00 on the 23rd December was due to a fault with the power supply to this monitor. The power supply fault has been rectified to help prevent loss of data in the future.

Note: Missing data between 17:00 on the 7th December until 13:00 on the 23rd December and between 09:00 on the 24th December until the end of December was due to a fault with the power supply to this monitor. The power supply fault has been rectified to help prevent loss of data in the future.

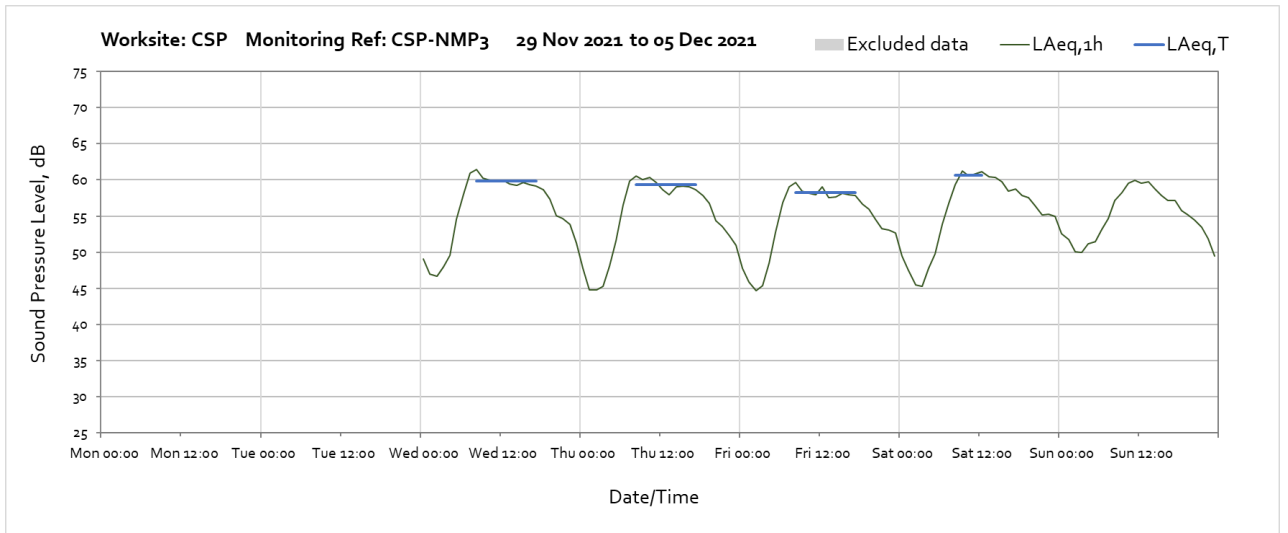
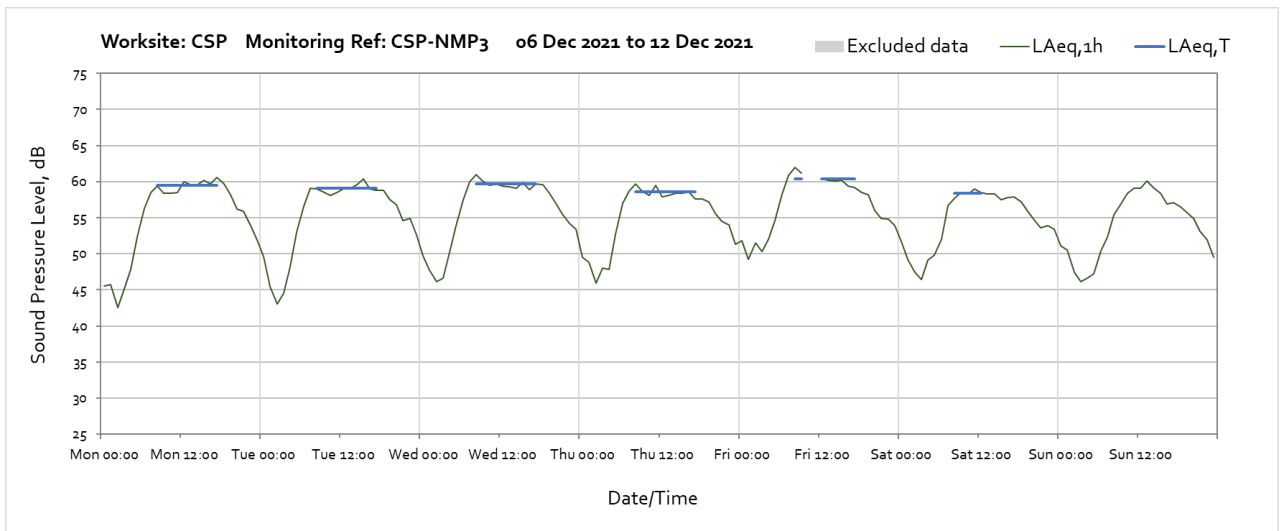
Worksite: CSP - Monitoring Ref: CSP-NMP3

Note: Missing data between 10:00 and 12:00 on the 10th December was due to monitor maintenance.

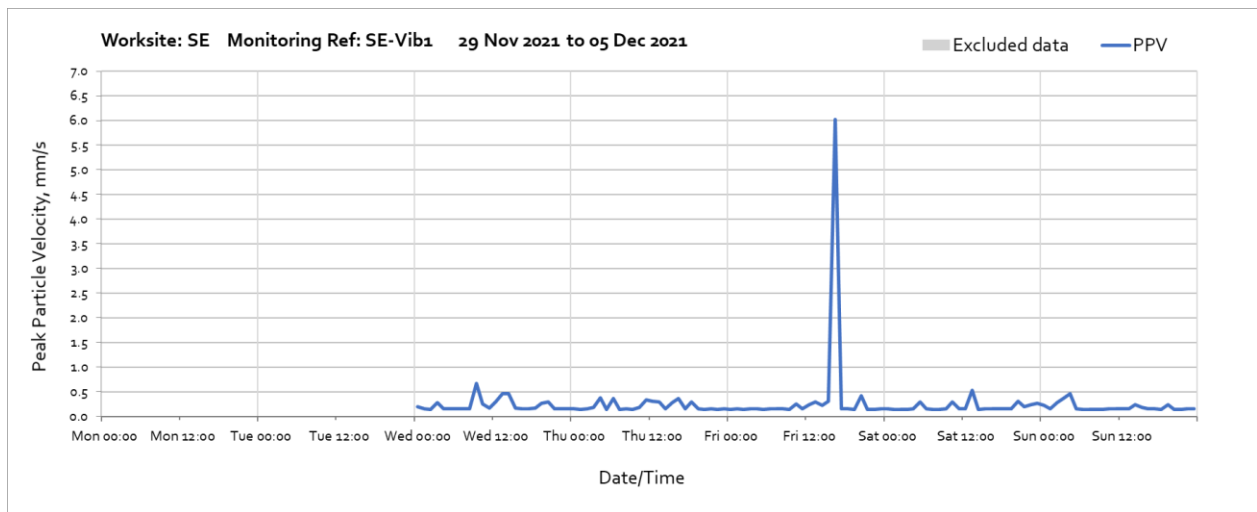
Worksite: SE – Monitoring Ref: SE-Vib 1

The following graphs show the hourly measured peak particle velocity PPV recorded during the monitoring period. The graphs show the highest PPV of the three orthogonal axes x, y and z. Where high values of PPV were caused by local interference with the vibration monitor, which are not representative of HS2 construction works, these values have been greyed out in the following charts and have been excluded to calculate values in Table 4 of the main report.

Note: High levels of vibration measured between 16:00 and 17:00 on Friday 3rd December were due to deliveries to the work site. The receptor is located further from the monitoring location therefore vibration levels are expect to be lower.
