Construction noise and vibration Monthly Report – November 2021

Buckinghamshire

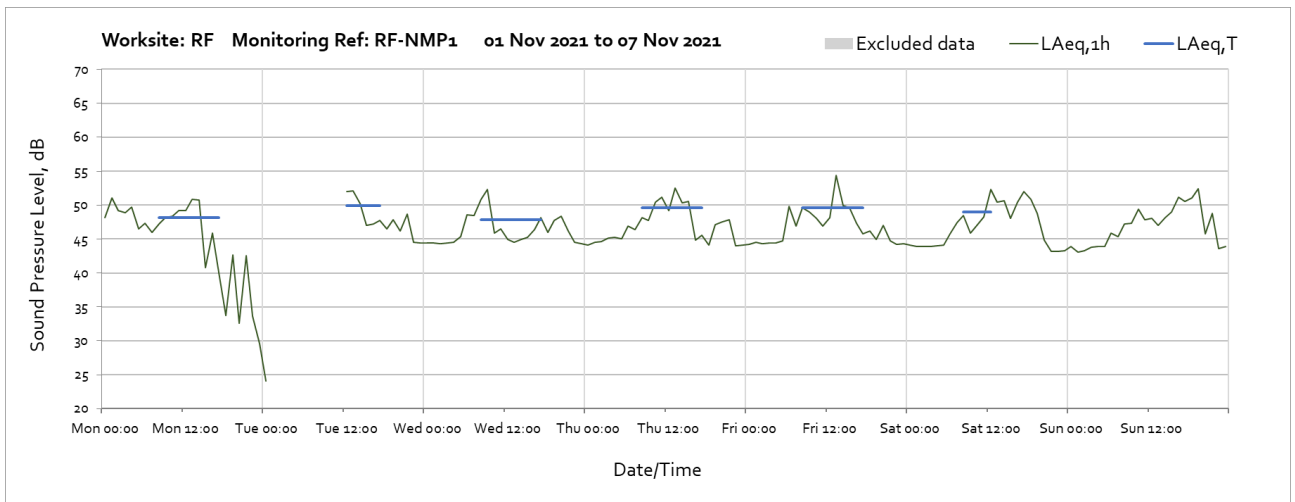
Worksite: RF – Monitoring Ref: RF-NMP1

Note: Missing data between 01:00 and 12:00 on Tuesday 2nd was due to loss of continuous site power from the hydrogen generator.
