HS2

March 2022

Construction Noise and Vibration Monthly Report – January 2022

Buckinghamshire

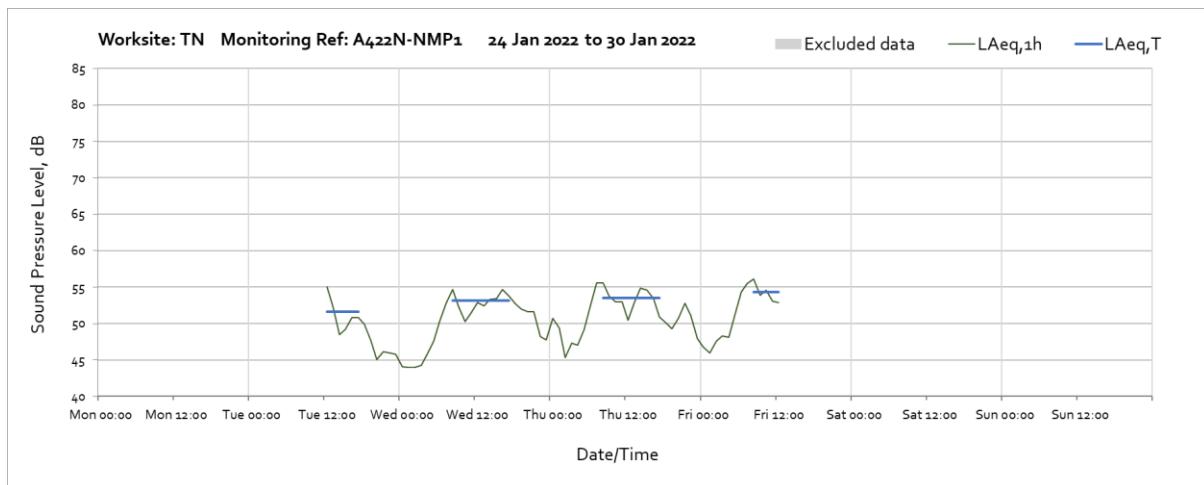
Worksite: TN – Monitoring Ref: A422N-NMP1

Note: The noise monitor was installed on 25th January 2022. Missing data from 13:00 on the 28th of January till the end of the month was due to loss of power to the monitor.

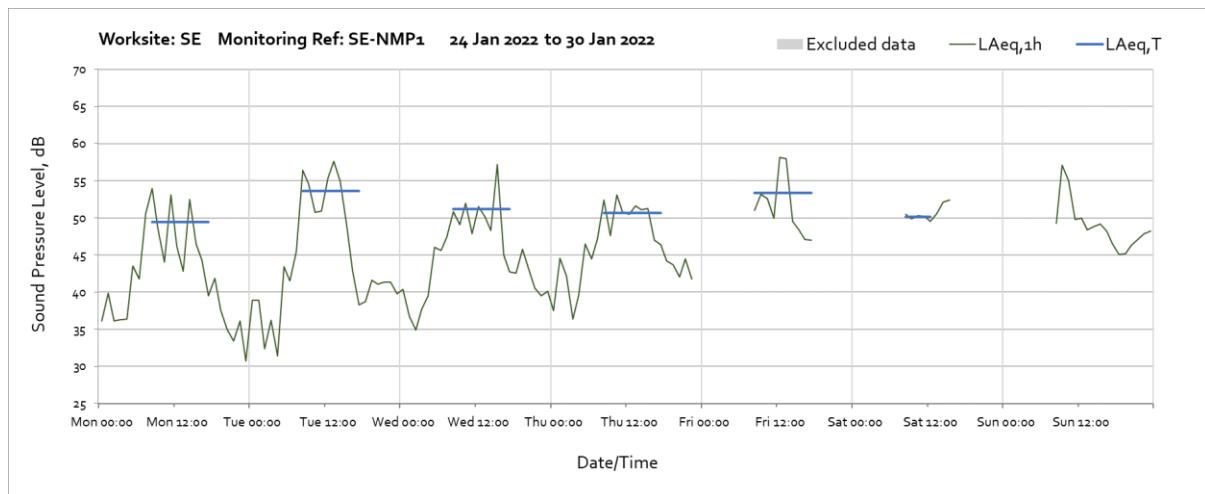
Note: Missing data throughout the week was due to loss of power to the equipment.

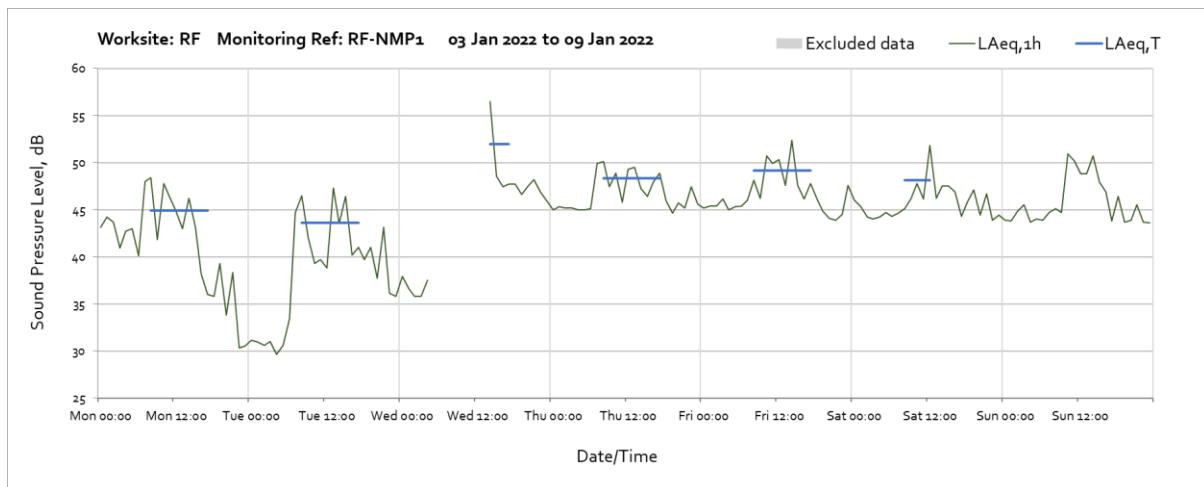
Note: Missing data from 05:00 to 14:00 on 5th January was due to loss of power to the equipment.

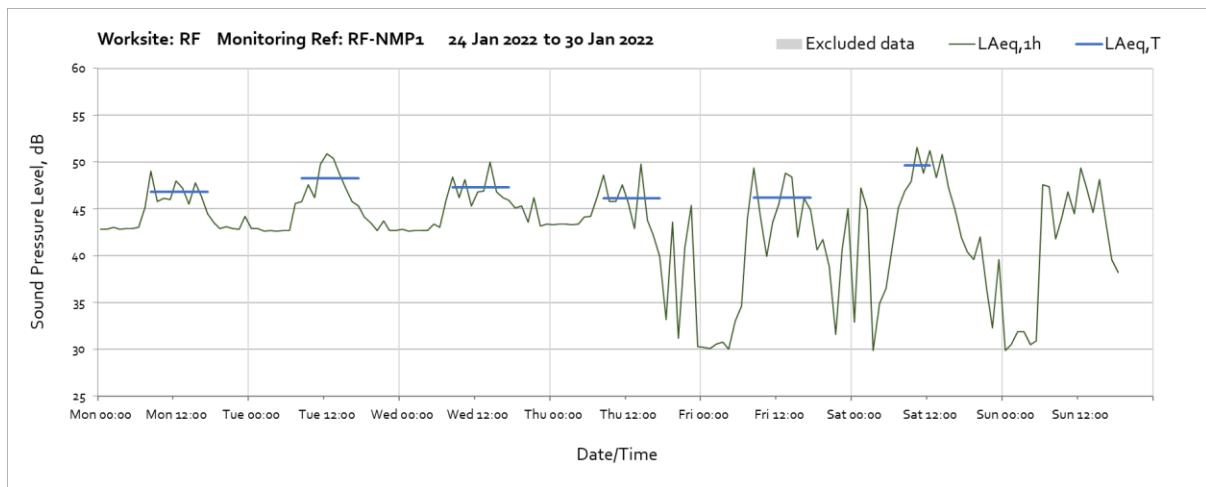
Note: Missing data from 19:00 on 30th January till the end of the month was due to loss of power to the equipment.

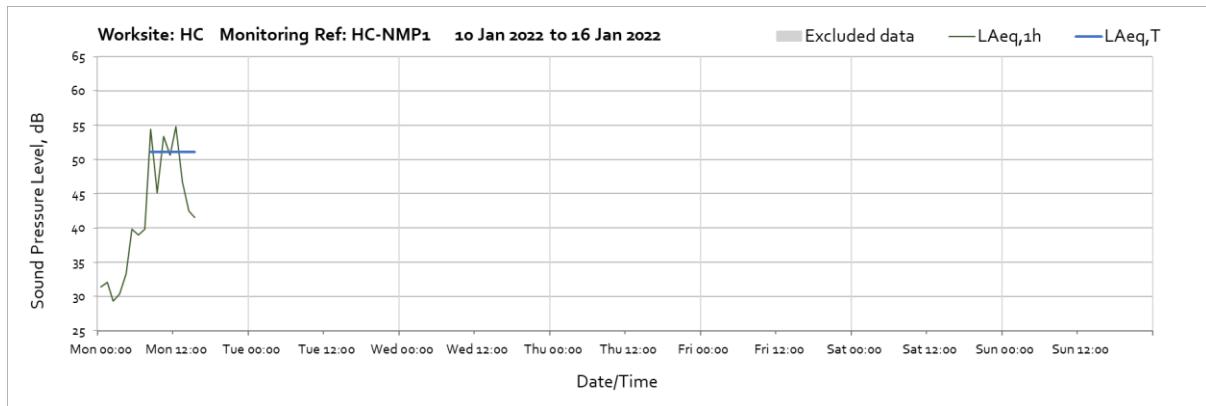
Note: Missing data from 16:00 on the 10th of January till the end of the week was due to loss of power to the monitor.

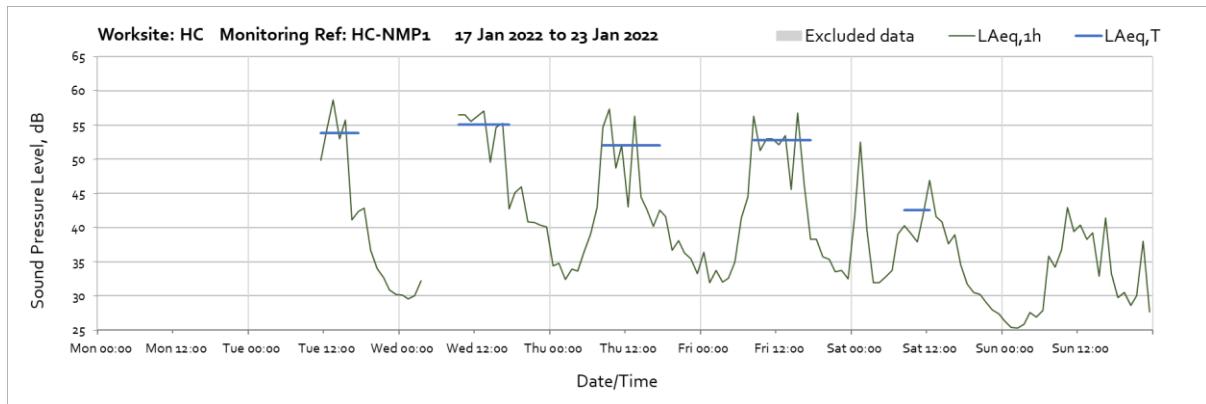
Note: Missing data throughout the week was due to loss of power to the equipment.

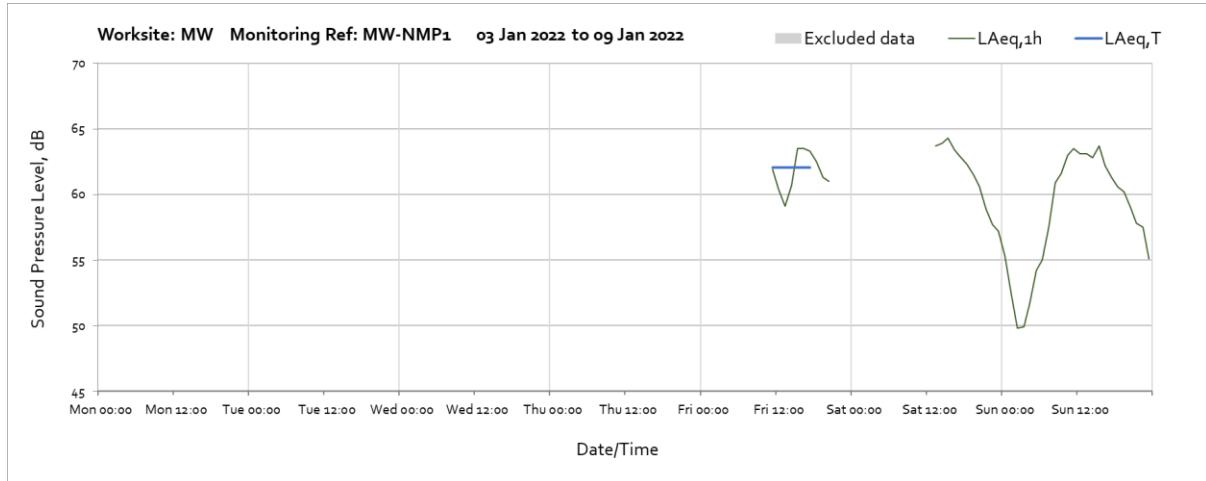
Worksite: MW&GH – Monitoring Ref: MW-NMP1

Note: Missing data between 21:00 on 7th January and 13:00 on 8th January was due to technical issues from the charging controller.

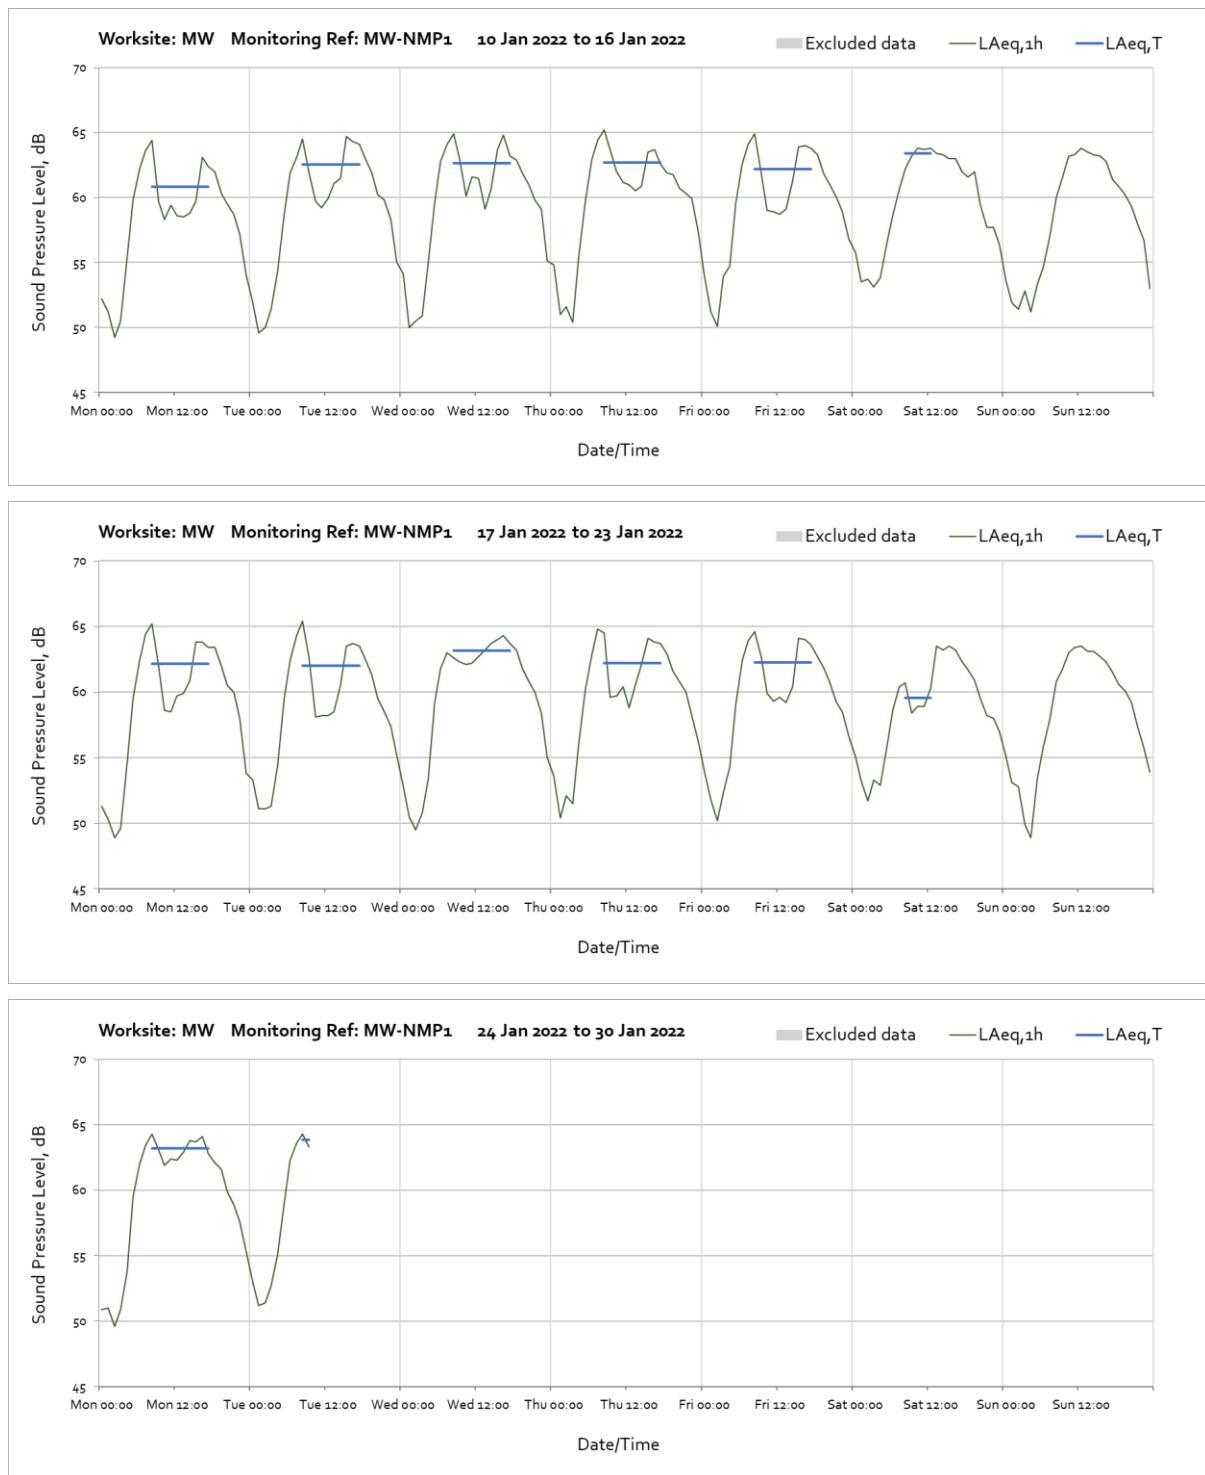
Note: Missing data from 10:00 on 25th January till the end of the month was due loss of power to the noise monitor.

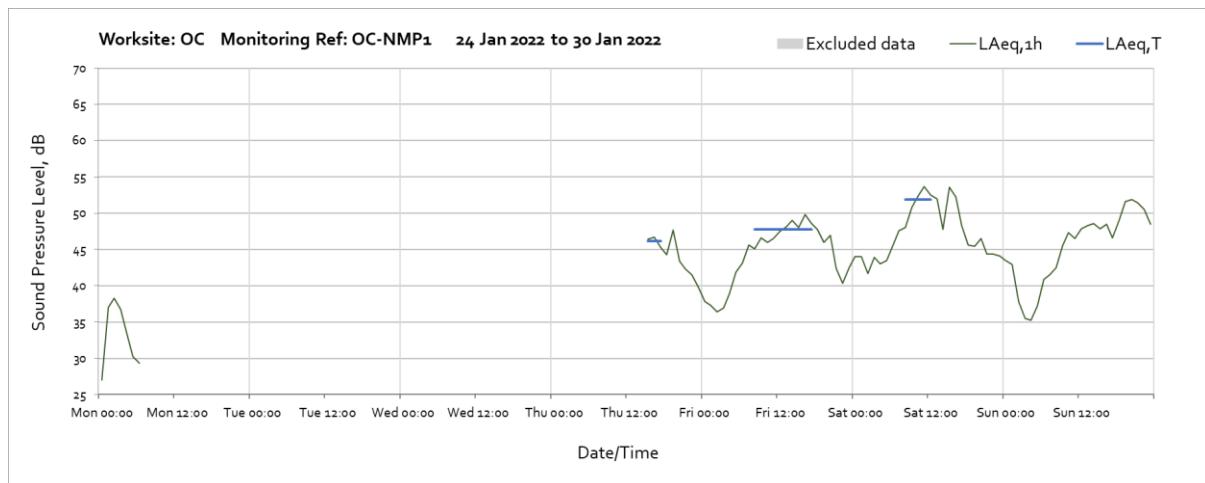
Note: Missing data from 07:00 on 24th January and 15:00 on 27th January month was due loss of power to the noise monitor.

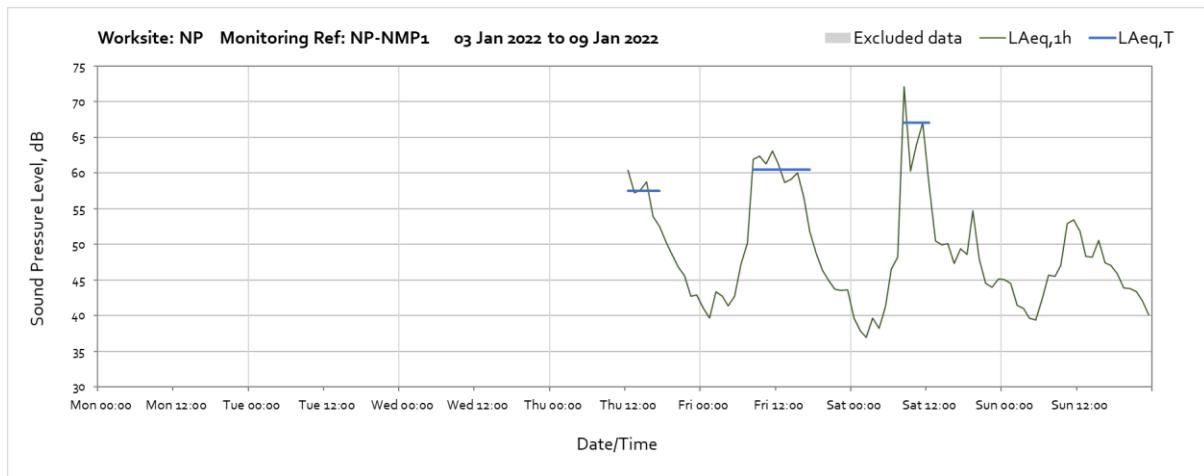
Worksite: NP – Monitoring Ref: NP-NMP1

Note: Missing data until 6th of January was due to loss of power to the noise monitor.

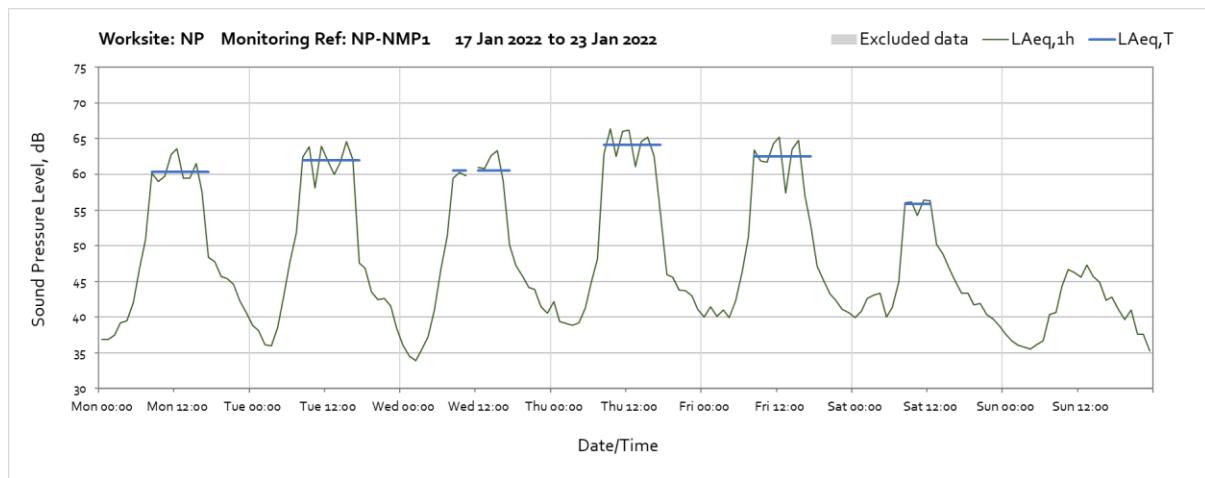
Note: Missing data between 11:00 and 12:00 on 19th January was due to monitor being paused for field calibration.

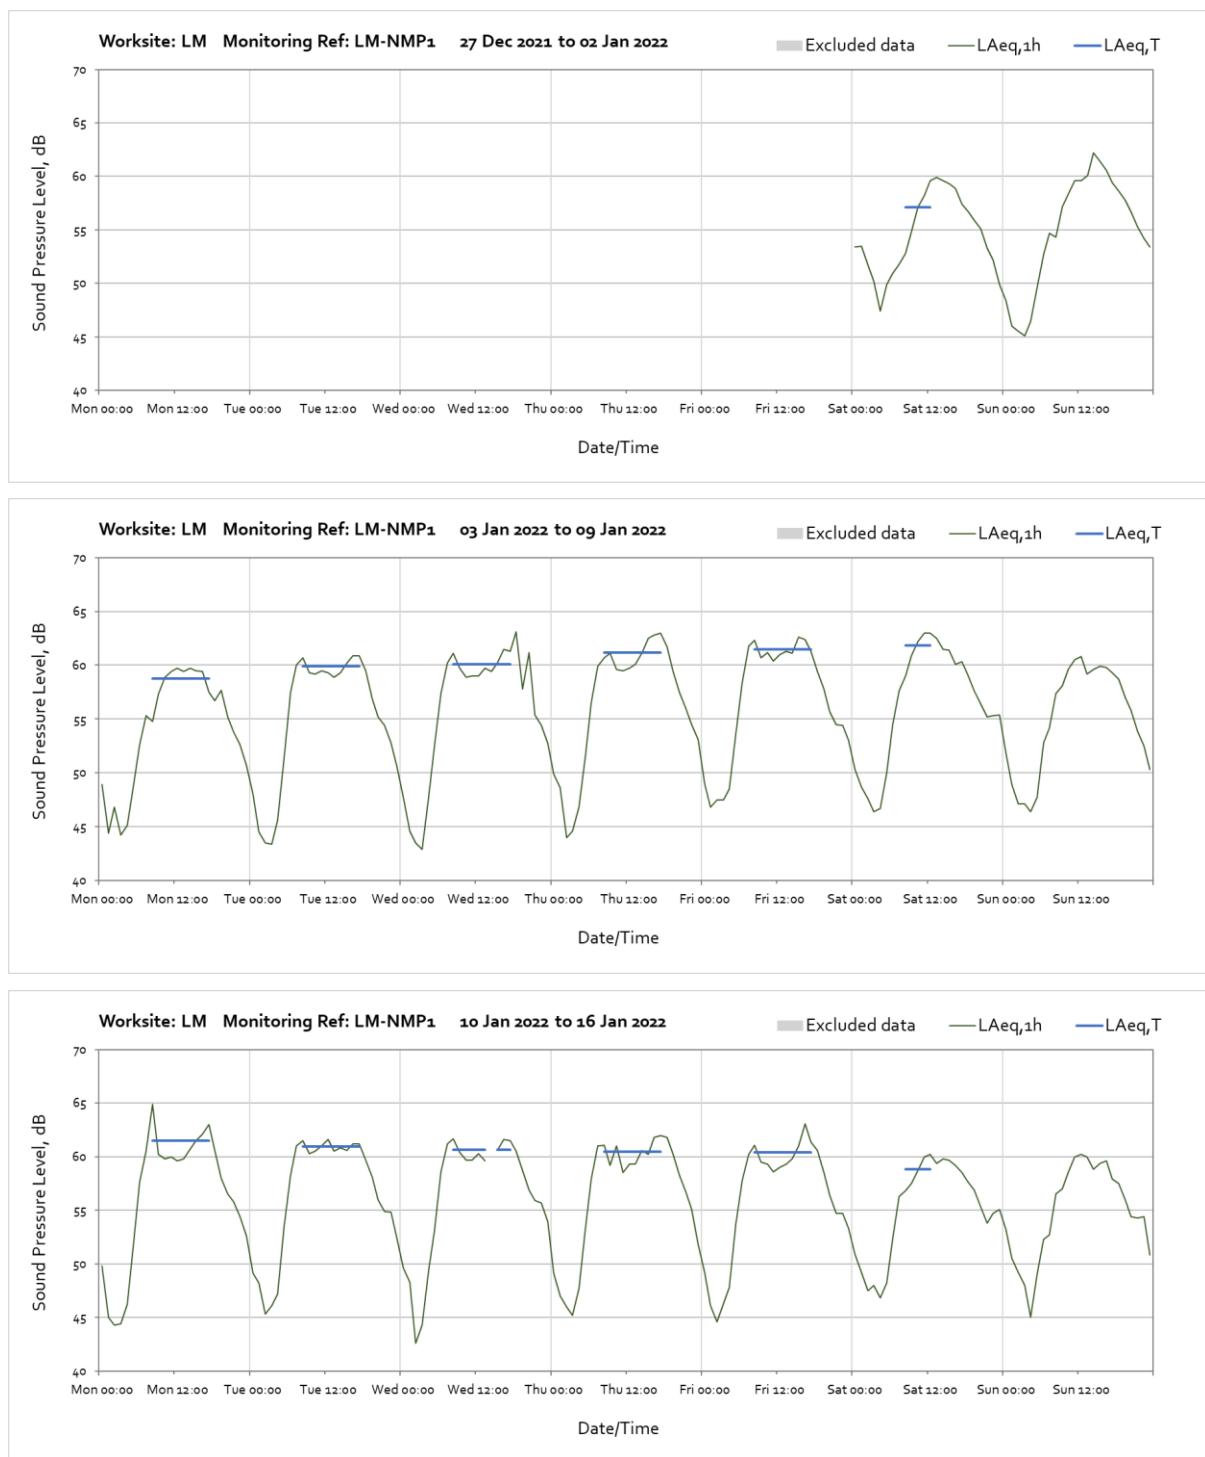
Worksite: LM – Monitoring Ref: LM-NMP1

Note: Missing data between 14:00 and 15:00 on 12th January was due to monitor being paused for field calibration.

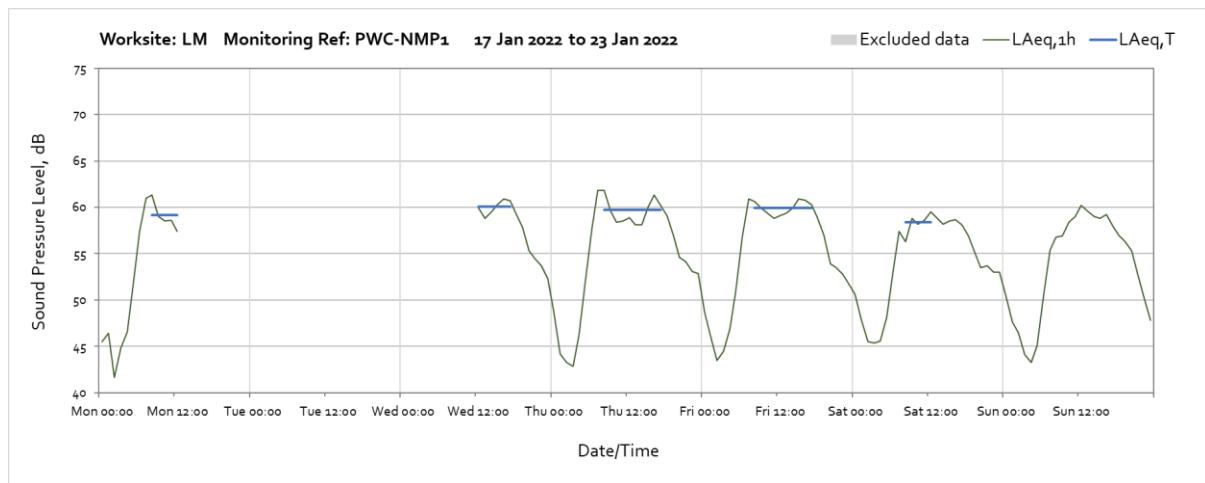
Note: Missing data between 13:00 on 17th January and 12:00 on 19th January was due to loss of power to the equipment.

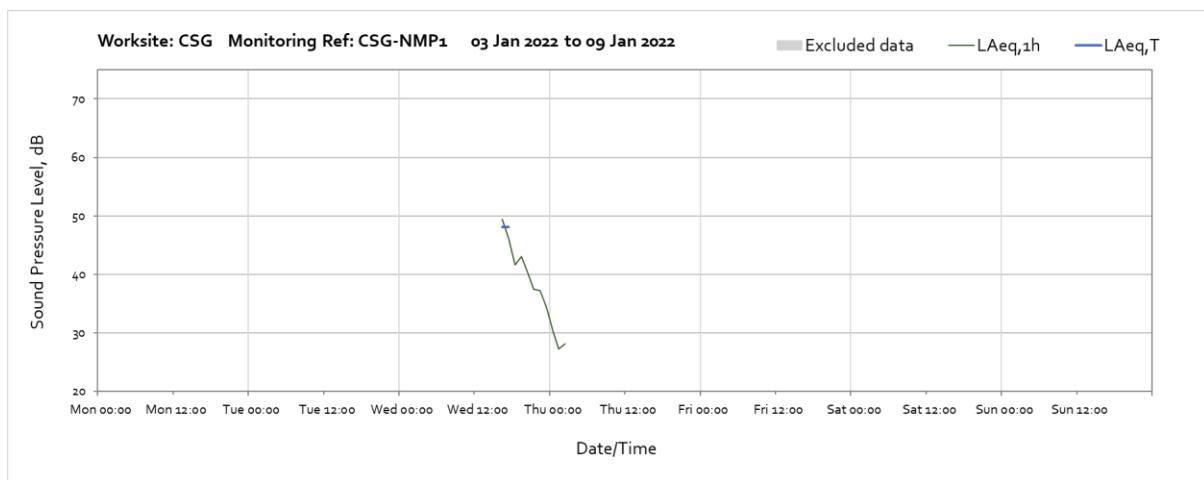
Worksite: CSG – Monitoring Ref: CSG-NMP1

Note: Missing data throughout the week was due to loss of power to the equipment.

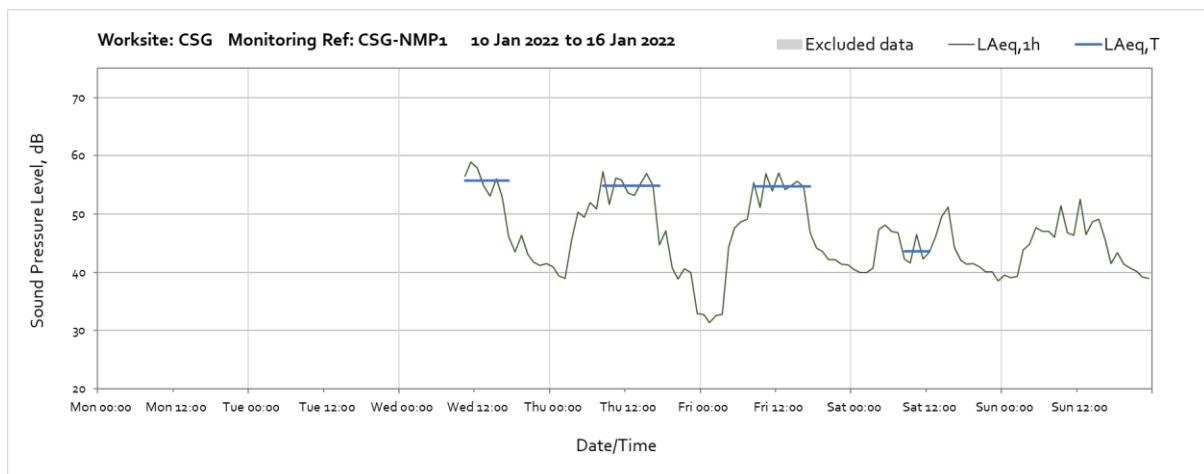
Note: Missing data between 00:00 on 10th January and 10:00 on 12th January was due to loss of power to the equipment.

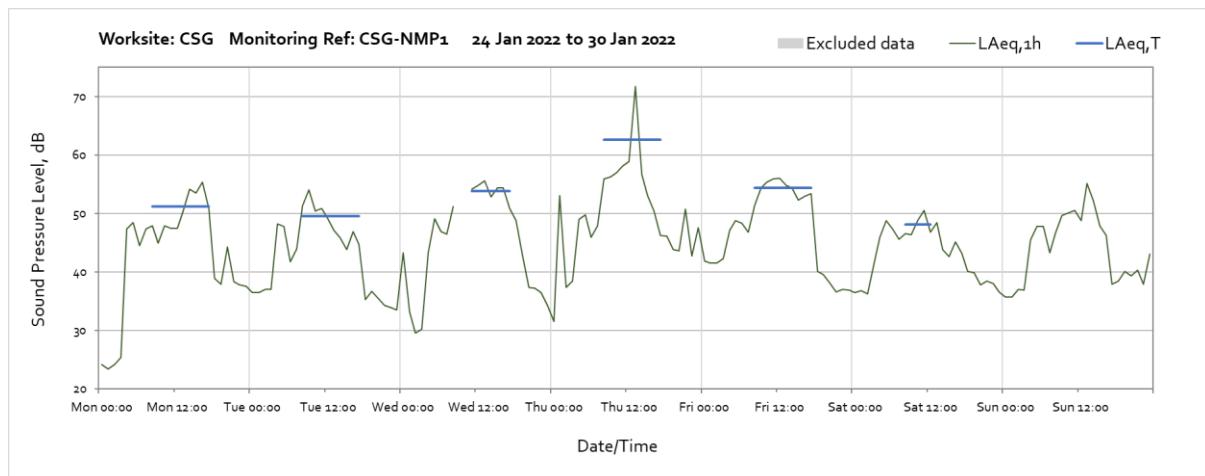
Note: Missing data from 09:00 to 10:00 on 26th January was due to loss of connection to the monitor.

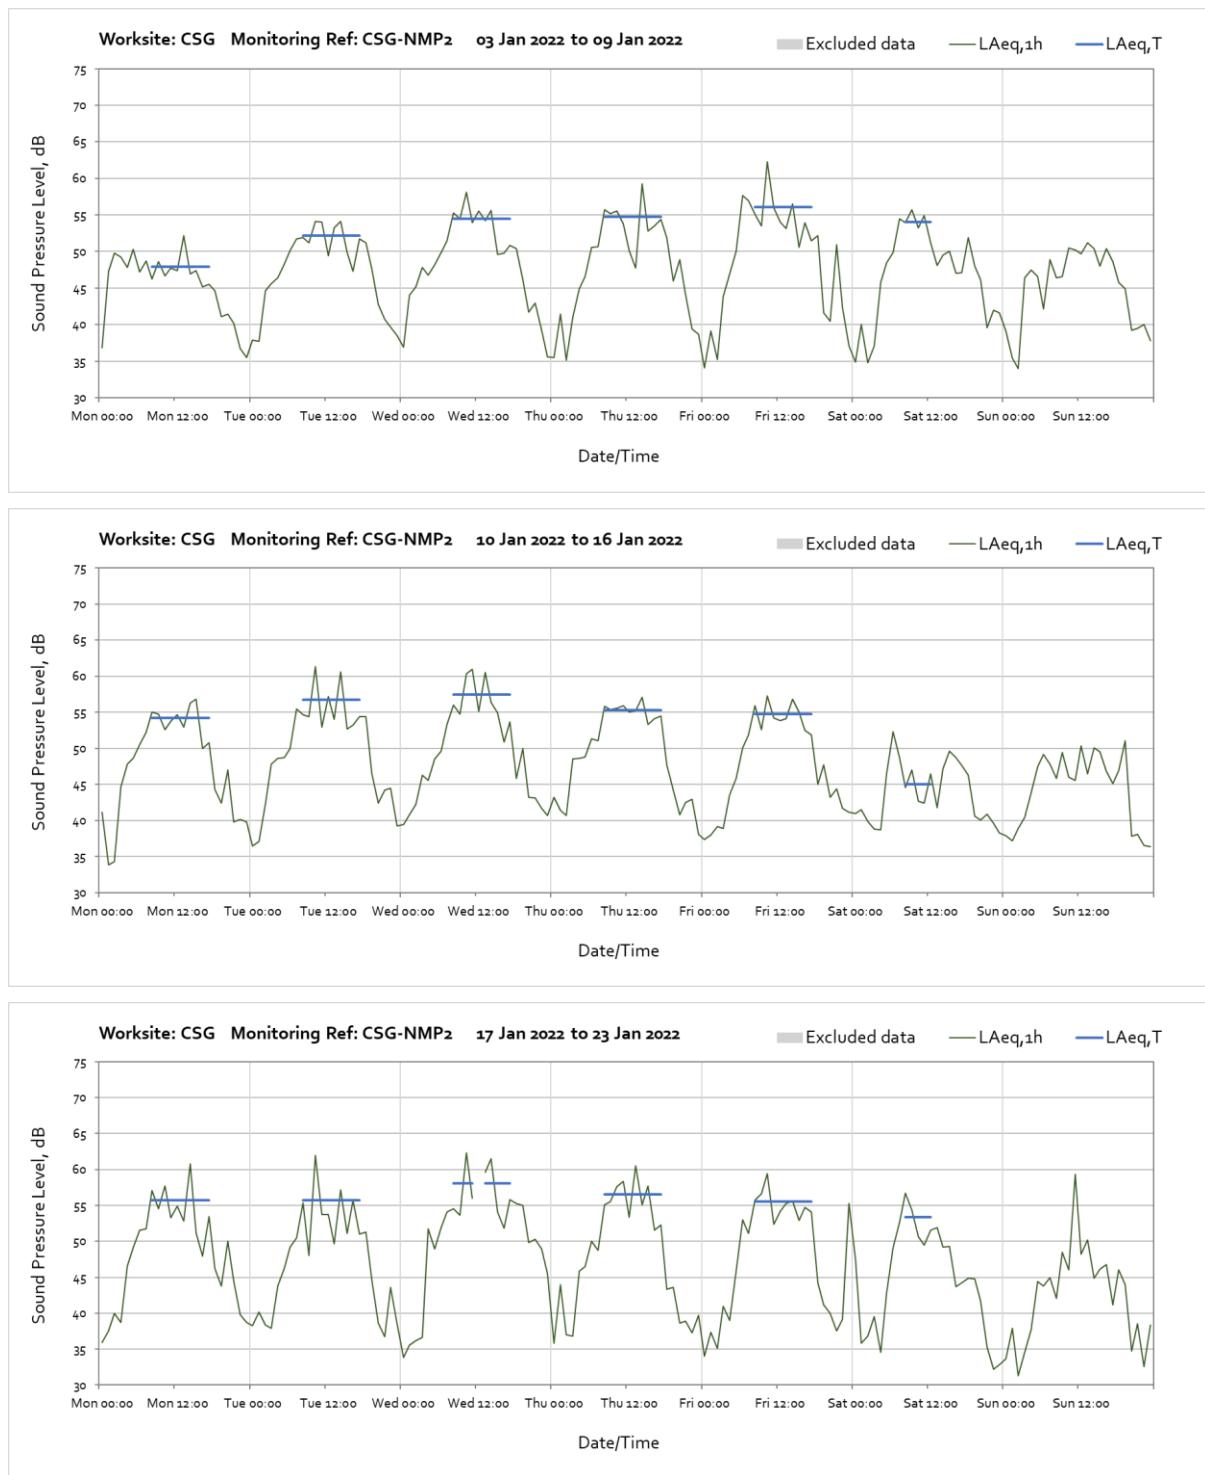
Note: Missing data at 12.00 on 19th January was due to monitor being paused for field calibration.

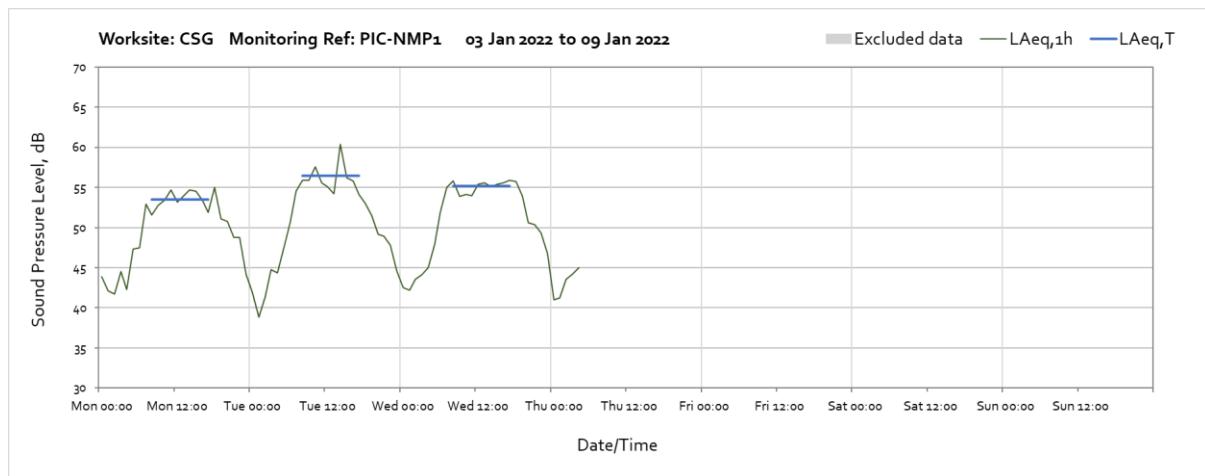
Note: Missing data between 05:00 on 6th January till the end of the month was due to loss of power to the monitor.

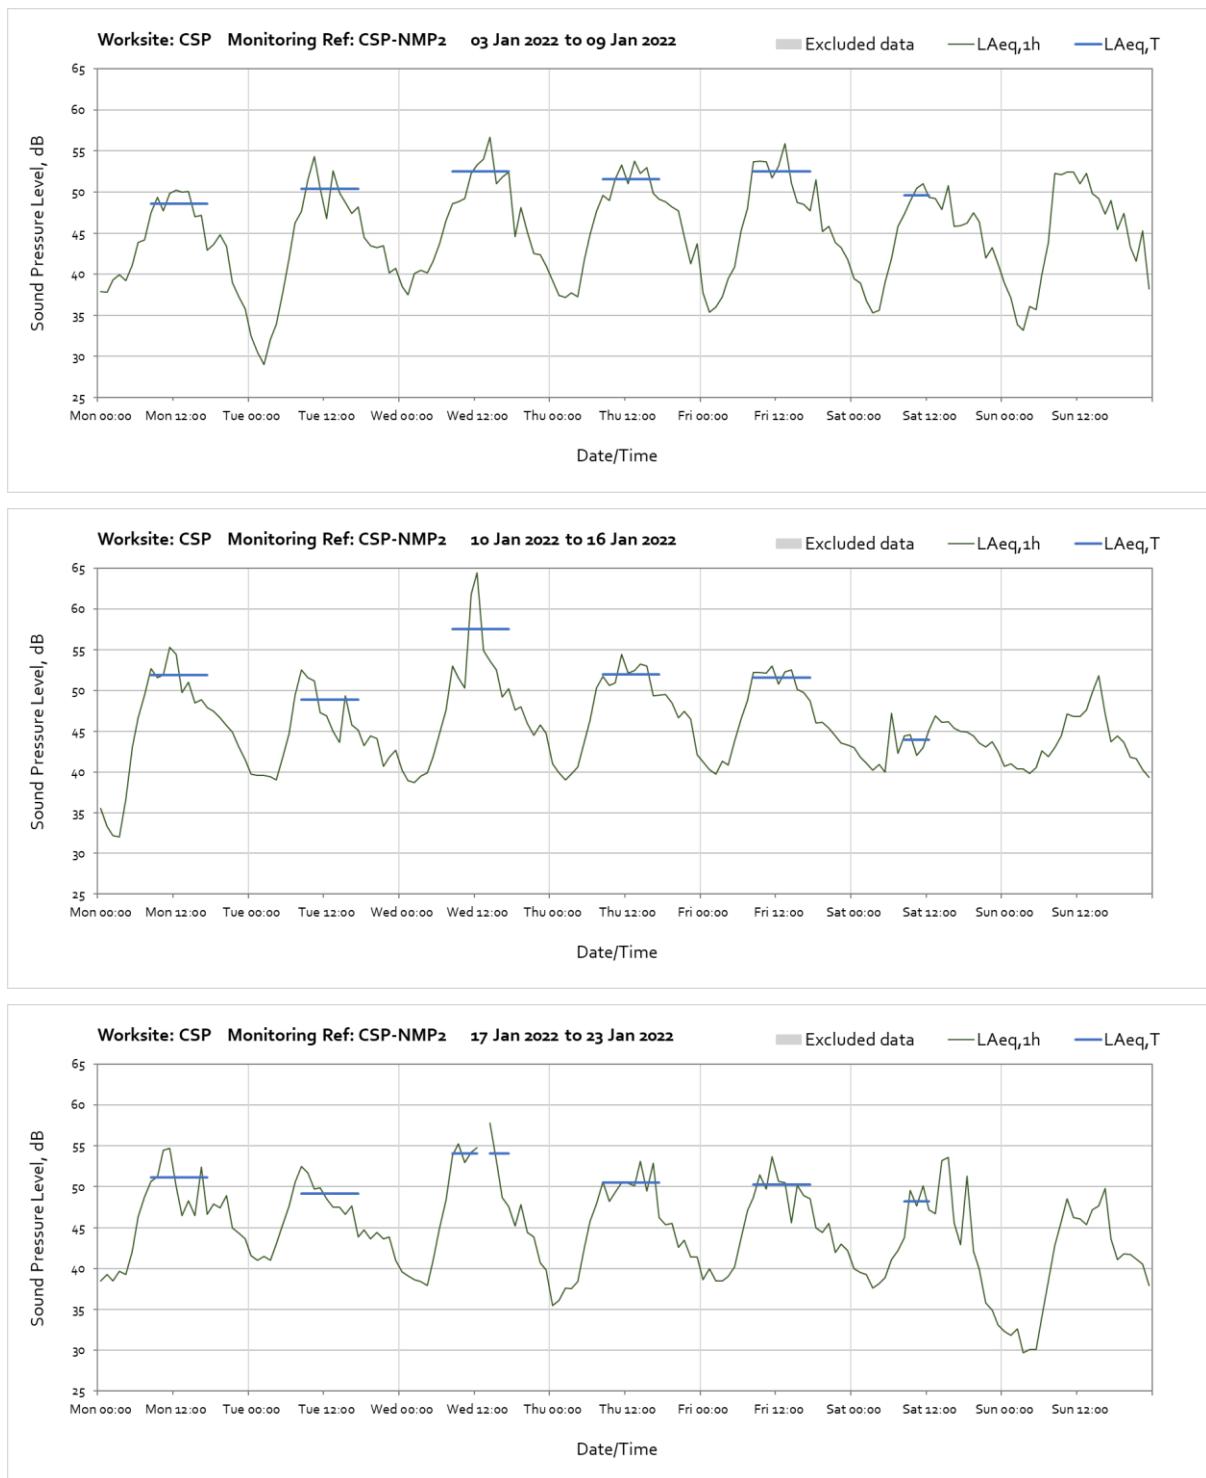
Note: Missing data at 13.00 on 19th January was due to monitor being paused for field calibration.

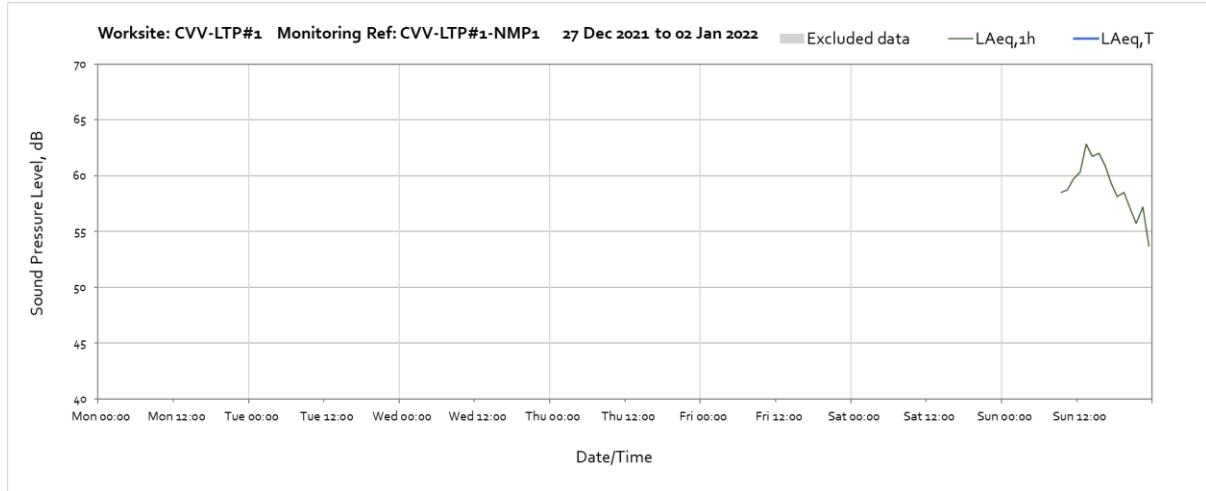
Worksite: CVV-LPT#1 – Monitoring Ref: CVV-LPT#1-NMP1

Note: Missing data throughout the week was due to loss of power to the equipment.

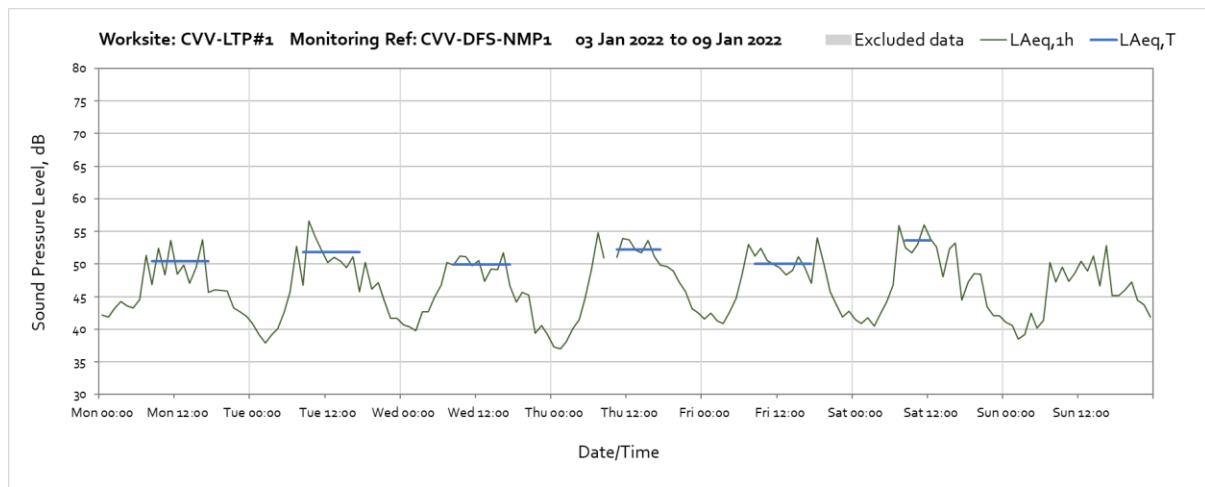
Note: Missing data at 09.00 on 6th January was due to monitor being paused for field calibration.

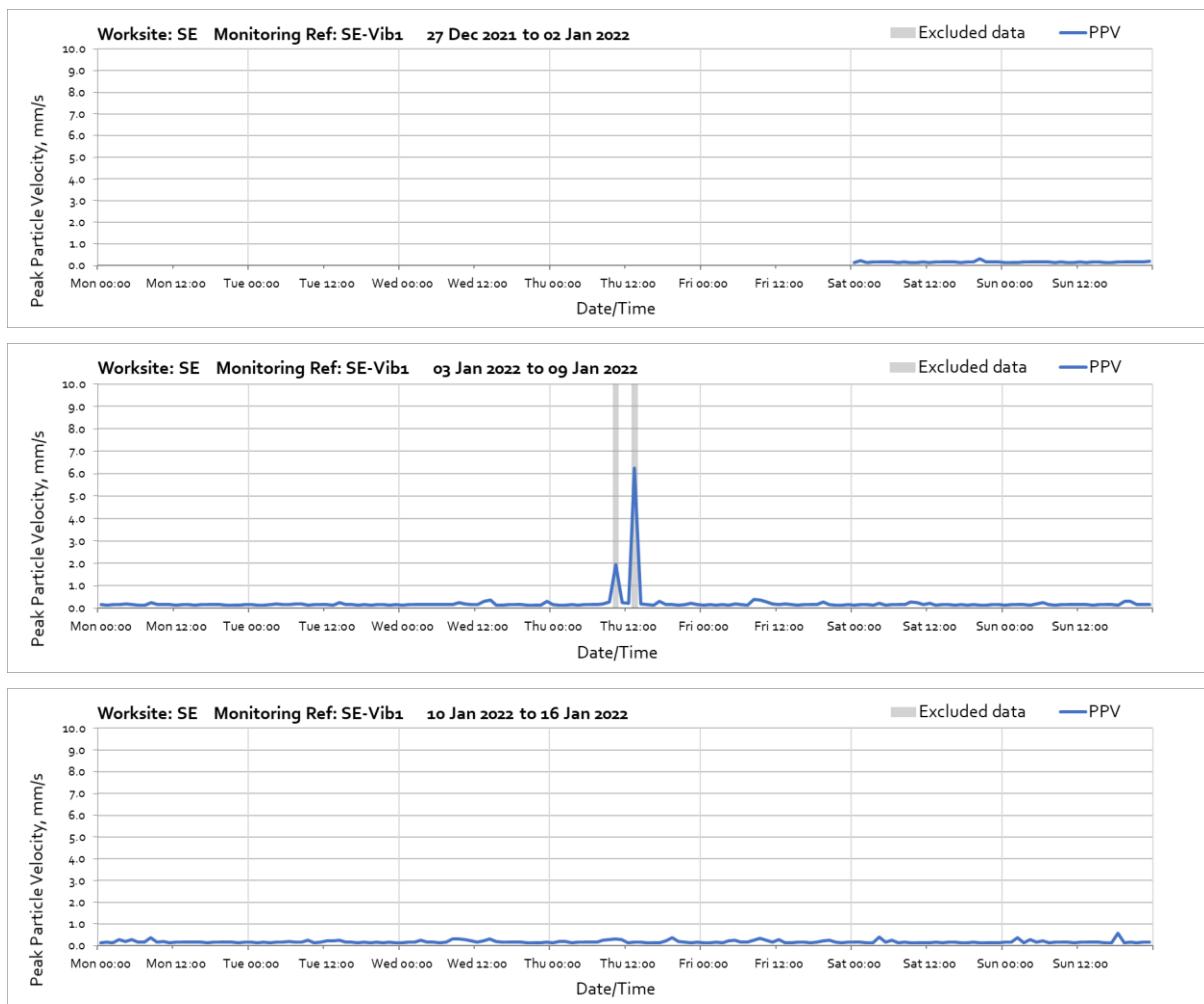
Worksite: SE – Monitoring Ref: SE-Vib 1

The following graphs show the hourly measured peak particle velocity PPV recorded during the monitoring period. The graphs show the highest PPV of the three orthogonal axes x, y and z. Where high values of PPV were caused by local interference with the vibration monitor, which are not representative of HS2 construction works, these values have been greyed out in the following charts and have been excluded to calculate values in Table 4 of the main report.
