Construction Noise and Vibration Monthly Report – January 2022

London Borough of Camden

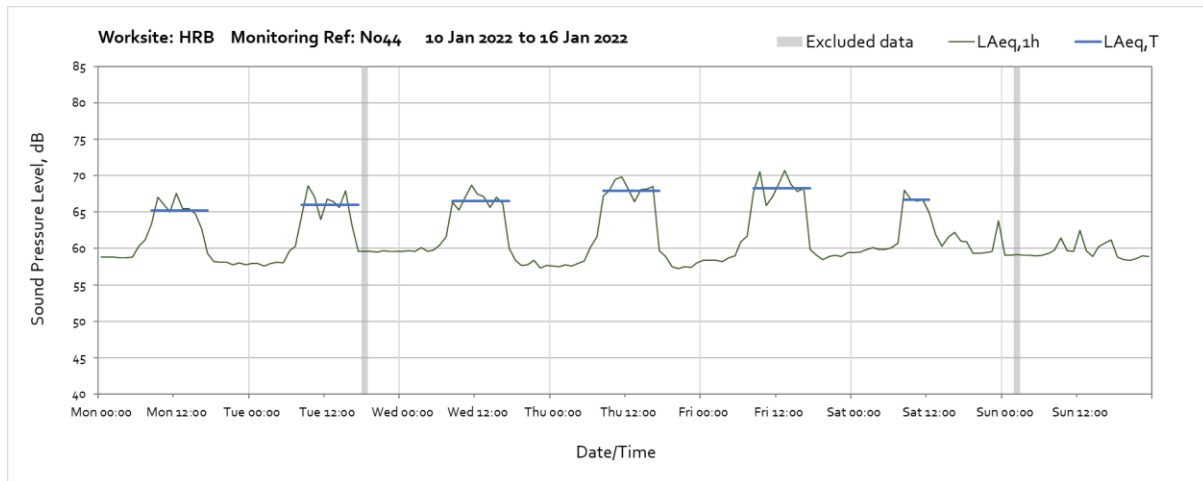
Worksite: HRB – Monitoring Ref: N044

Note: Continuous noise levels measured throughout the week were caused by an operational generator near to the monitor. The nearest receptor is located further from the generator and will therefore experience lower noise levels.
