## **Construction Noise and Vibration Monthly Report – January 2022**

### **Solihull Metropolitan District**

This Noise and Vibration Monitoring Report fulfils HS2 Limited's commitment detailed in the Environmental Minimum Requirements (EMRs), Annex 1, Code of Construction Practice, to present the results of noise and vibration monitoring carried out within the Solihull Metropolitan District (SMD) during the month of January 2022.

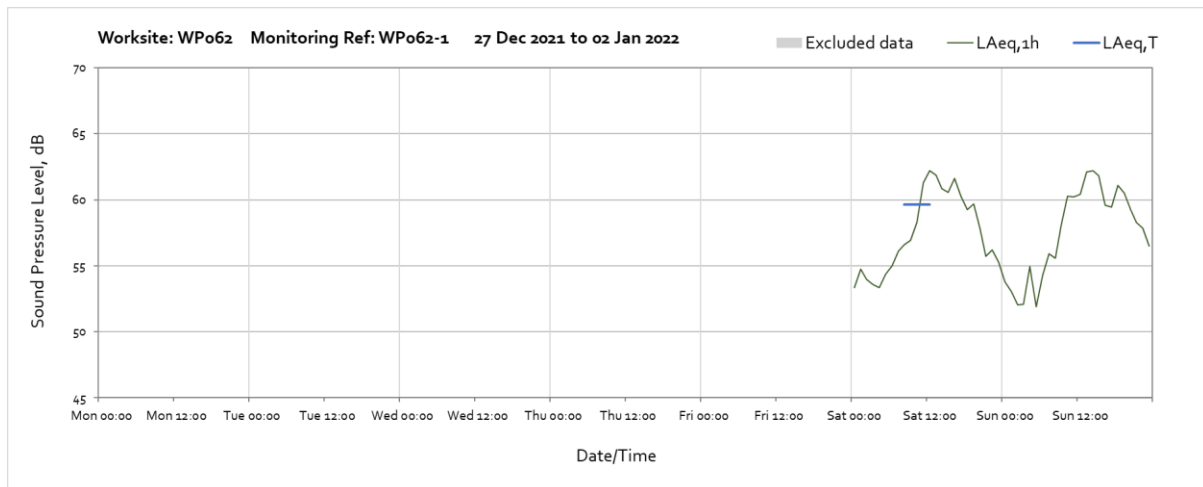
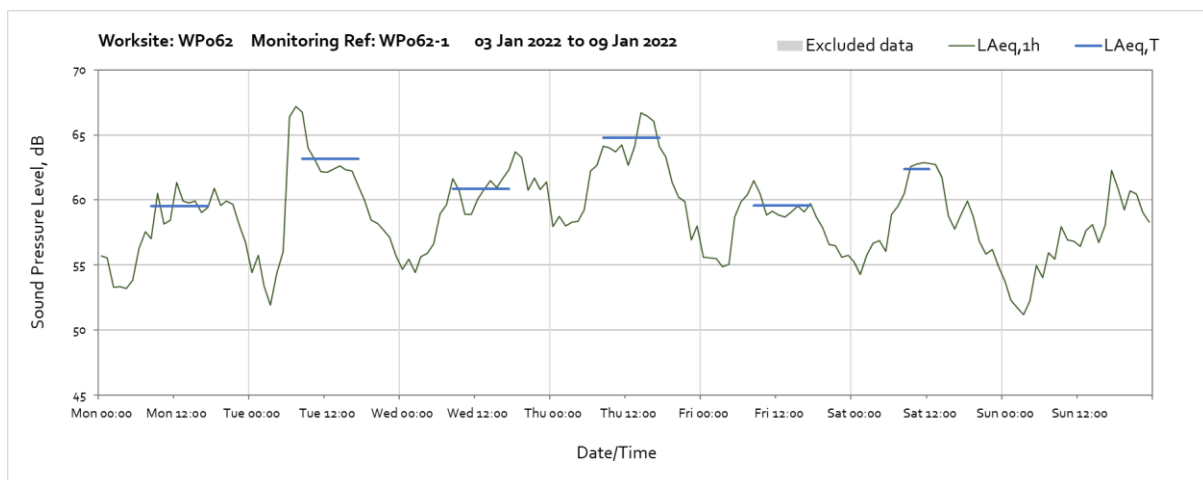
### Worksite: WP062 – Monitoring Ref: WP062-1

The following graphs show the hourly measured ambient noise level  $L_{Aeq,1h}$  and, where relevant, the averaged noise level  $L_{Aeq,T}$  values, where the time period T is as specified in Table 1 of HS2 Information Paper E23. Periods with adversely weather affected noise levels are greyed out and have been excluded from the calculation of the  $L_{Aeq,T}$  values in Table 3 of the main report.

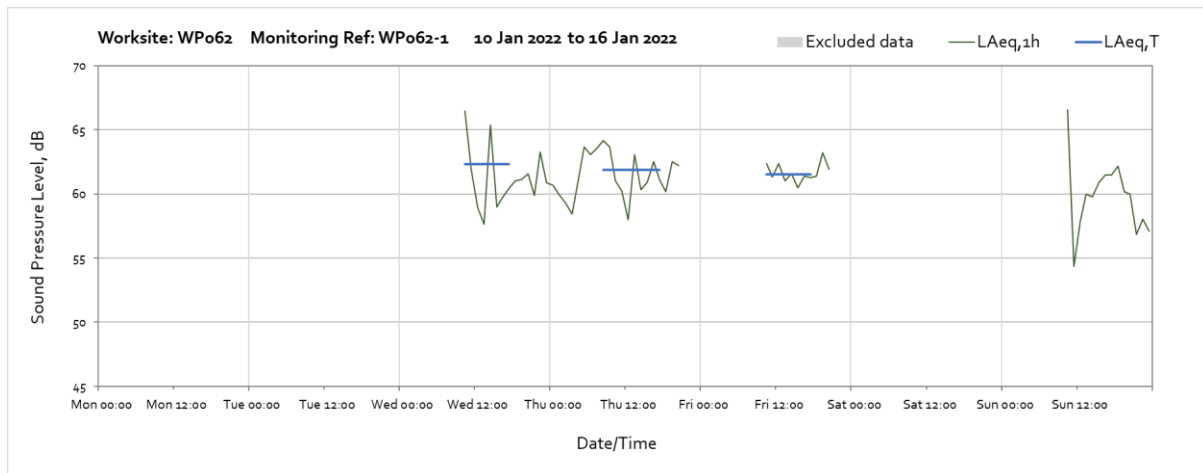
Note: Missing data during the week were due to loss of power to the monitor caused by insufficient sunlight to charge ancillary batteries.

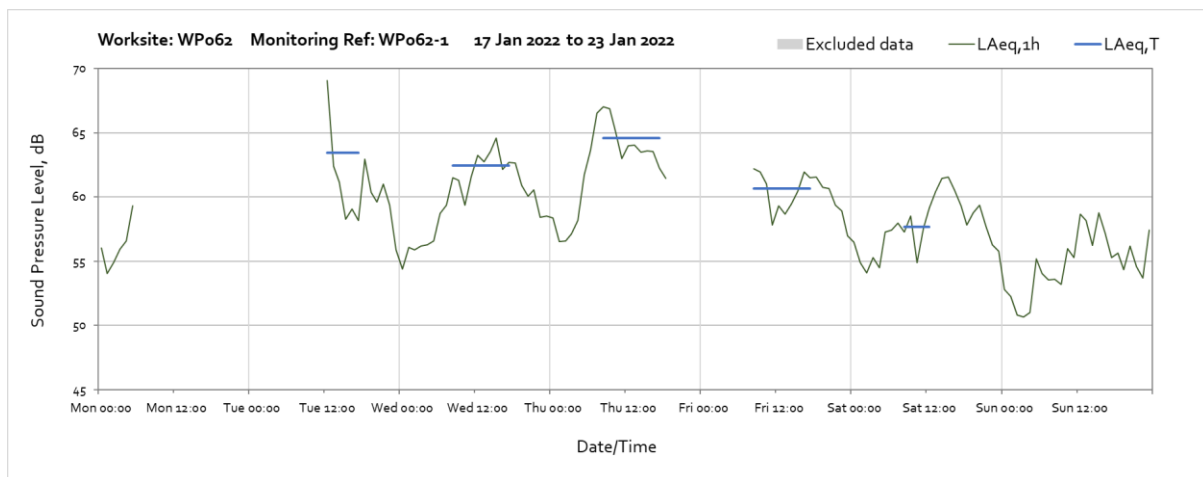
Note: Missing data during the week were due to loss of power to the monitor caused by insufficient sunlight to charge ancillary batteries.

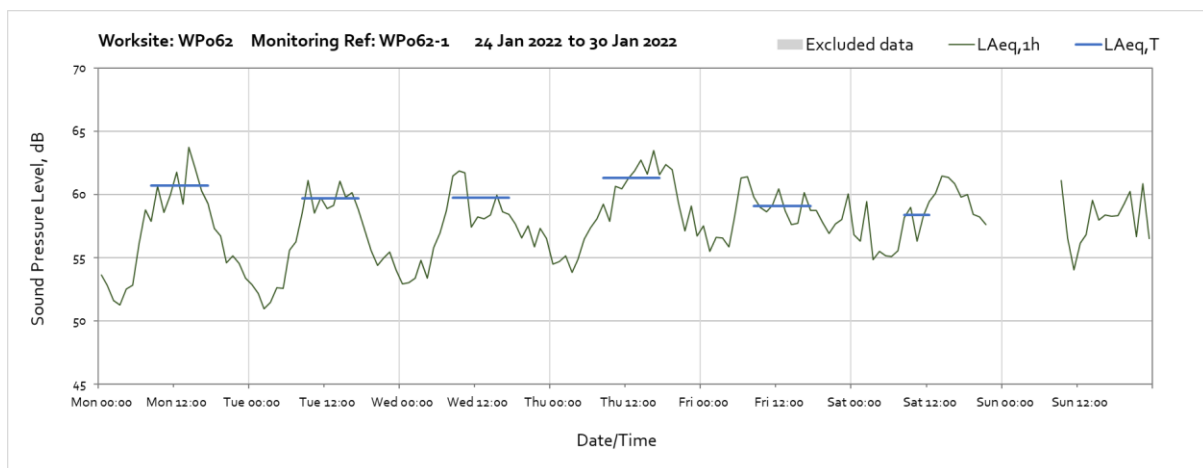
Note: Missing data between 22:00 on Saturday 29<sup>th</sup> January and 09:00 on Sunday 30<sup>th</sup> January were due to loss of power to the monitor caused by insufficient sunlight to charge ancillary batteries.

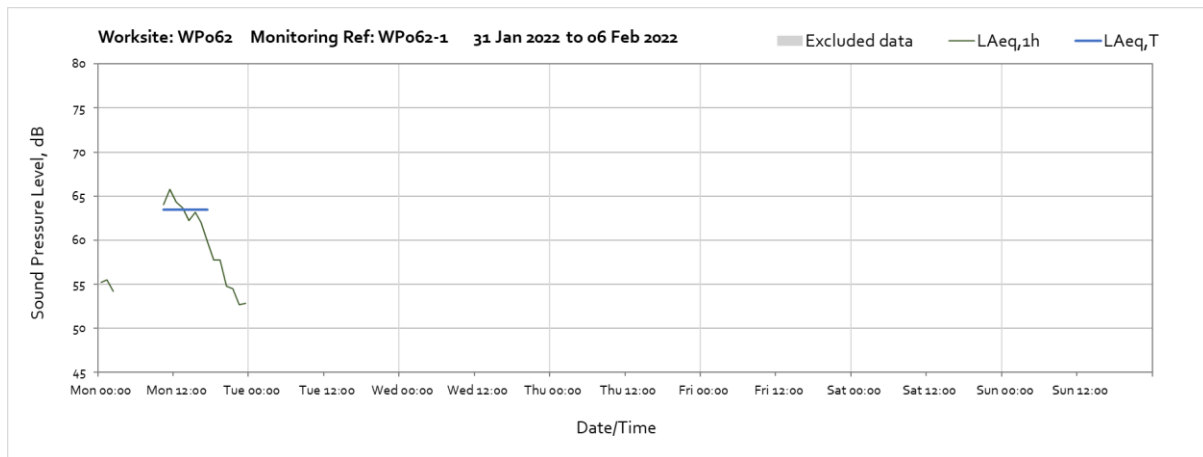
Note: Missing data between 03:00 and 10:00 on Monday 31<sup>st</sup> January were due to loss of power to the monitor caused by insufficient sunlight to charge ancillary batteries.

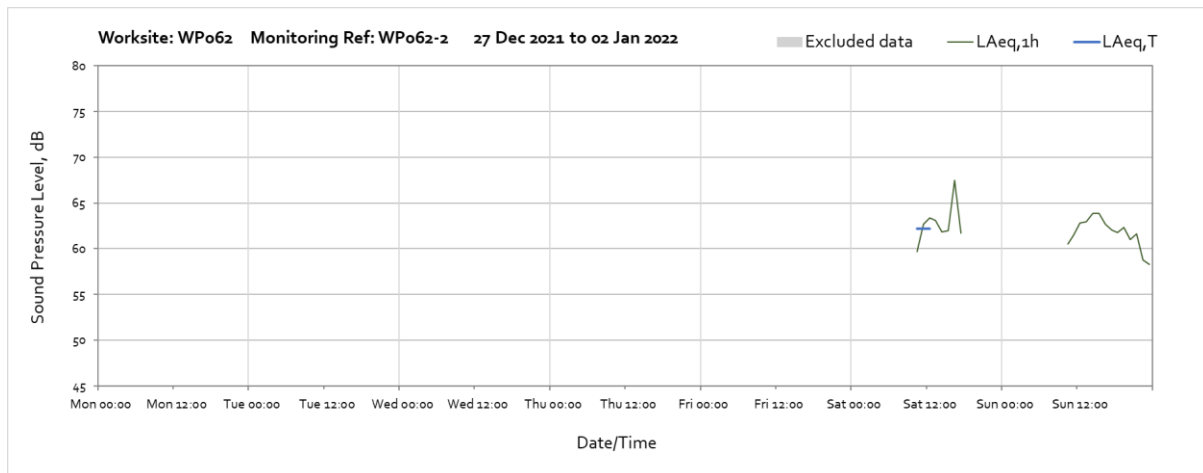
### Worksite: WPO62 – Monitoring Ref: WPO62-2

Note: Missing data during the week were due to loss of power to the monitor caused by insufficient sunlight to charge ancillary batteries.

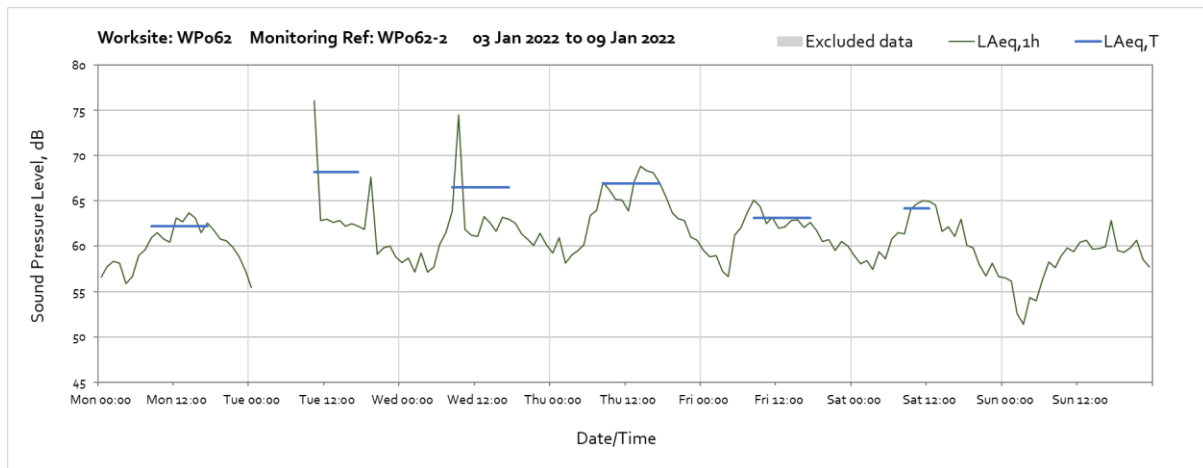
Note: Missing data between 01:00 and 10:00 on Tuesday 4<sup>th</sup> January were due to loss of power to the monitor caused by insufficient sunlight to charge ancillary batteries.

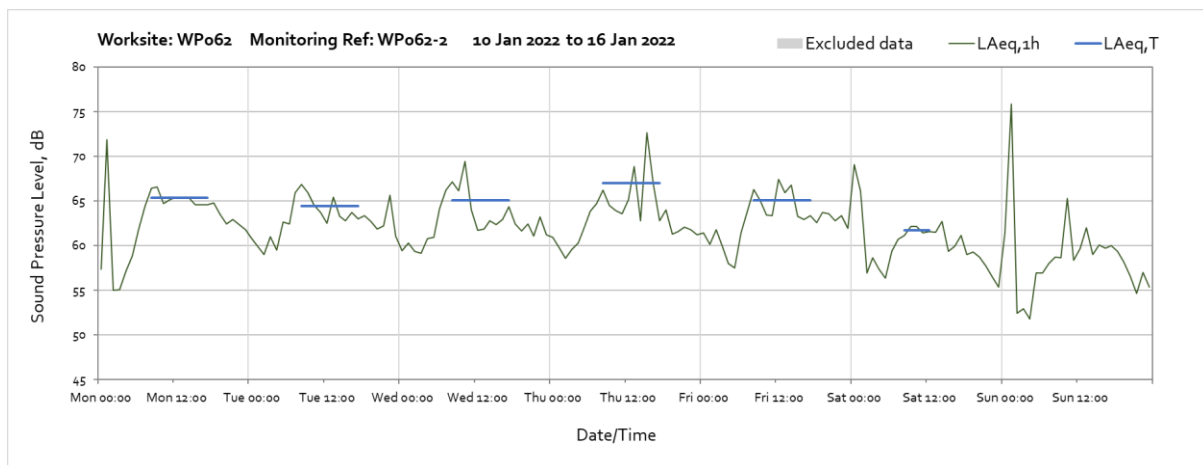
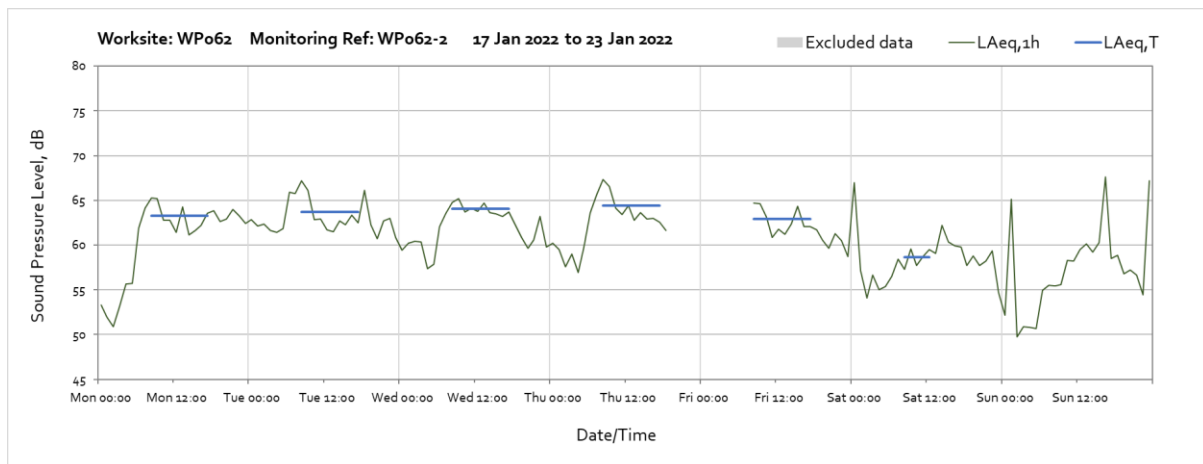
Note: Missing data between 19:00 on Thursday 20<sup>th</sup> January and 08:00 on Friday 21<sup>st</sup> January were due to loss of power to the monitor caused by insufficient sunlight to charge ancillary batteries.

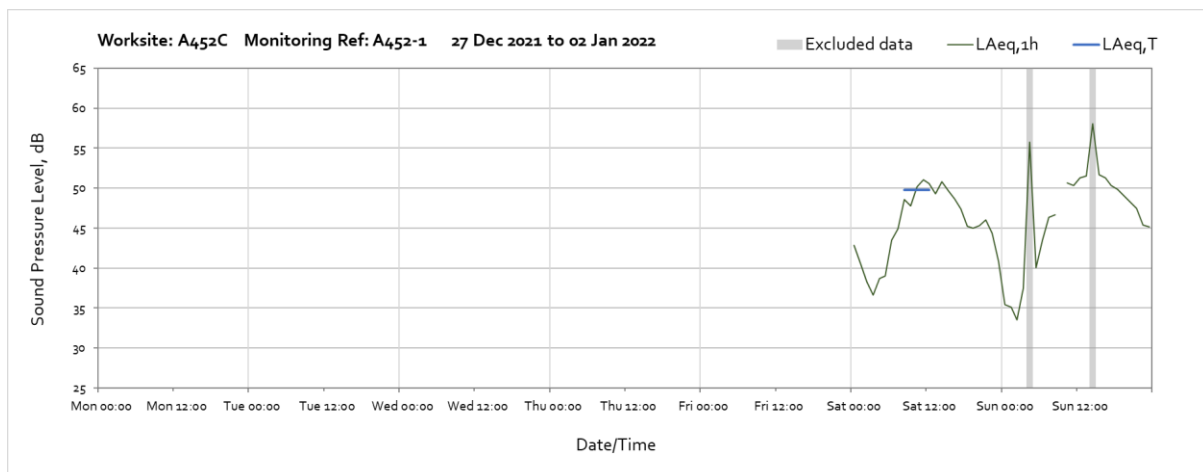
## Worksite: A452 Compound – Monitoring Ref: A452-1

Note: Missing data between 09:00 and 10:00 on Sunday 2<sup>nd</sup> January were due to loss of power to the monitor caused by insufficient sunlight to charge ancillary batteries.

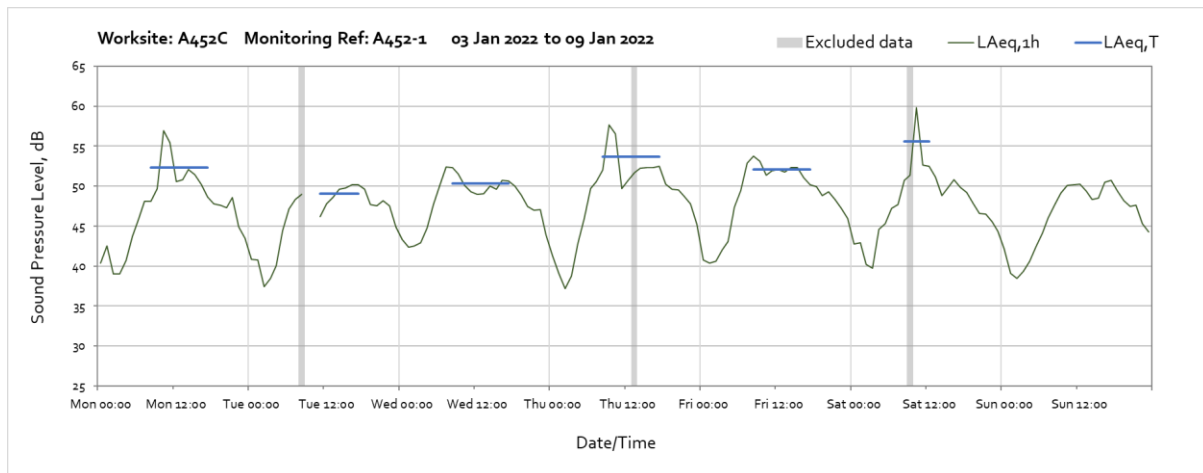
Note: Missing data between 09:00 and 11:00 on Tuesday 4<sup>th</sup> January were due to loss of power to the monitor caused by insufficient sunlight to charge ancillary batteries.

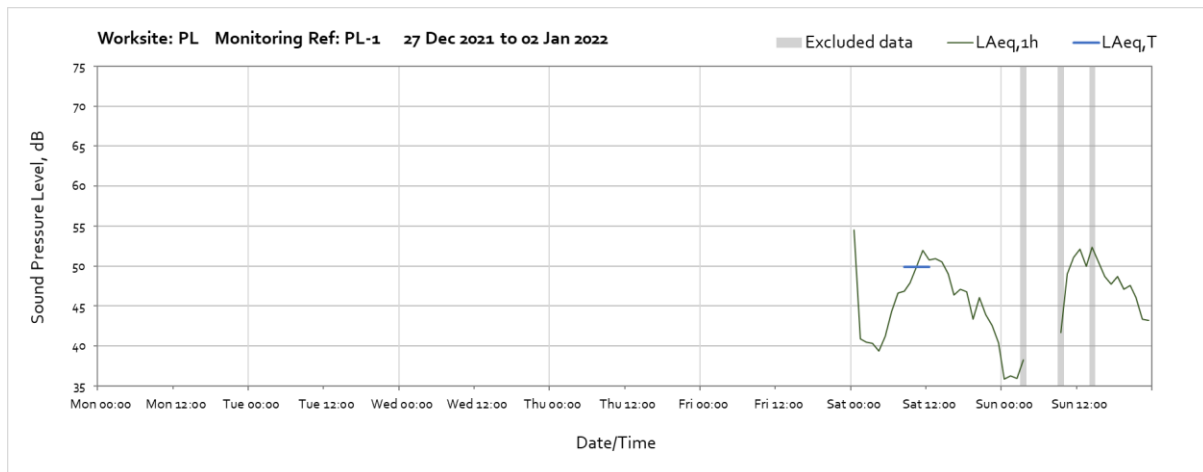
## Worksite: PL – Monitoring Ref: PL-1

Note: Missing data between 04:00 and 09:00 on Sunday 2<sup>nd</sup> January were due to loss of power to the monitor caused by insufficient sunlight to charge ancillary batteries.

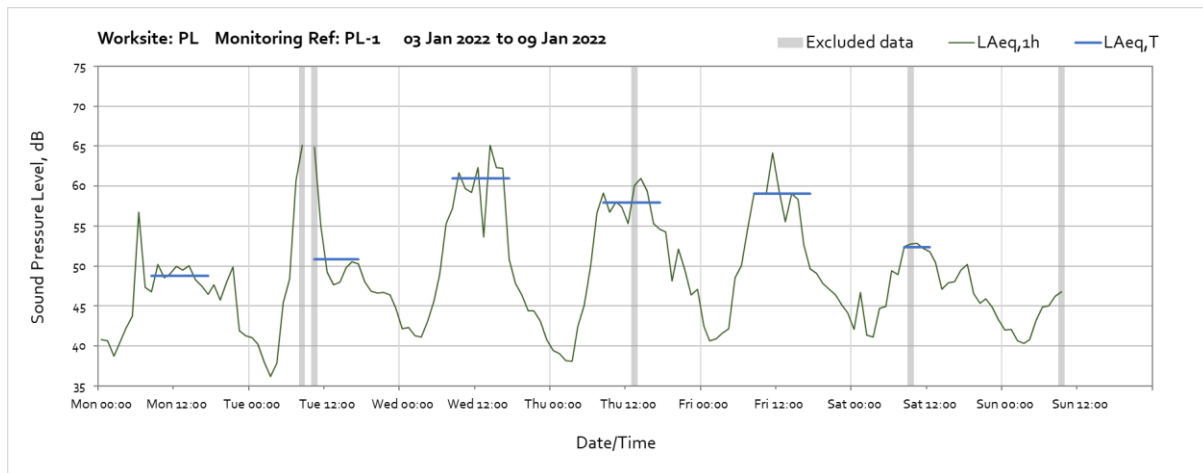
Note: Missing data between 09:00 and 10:00 on Tuesday 4<sup>th</sup> January and between 09:00 on Sunday 9<sup>th</sup> January and 15:00 on Tuesday 25<sup>th</sup> January were due to loss of power to the monitor caused by insufficient sunlight to charge ancillary batteries.

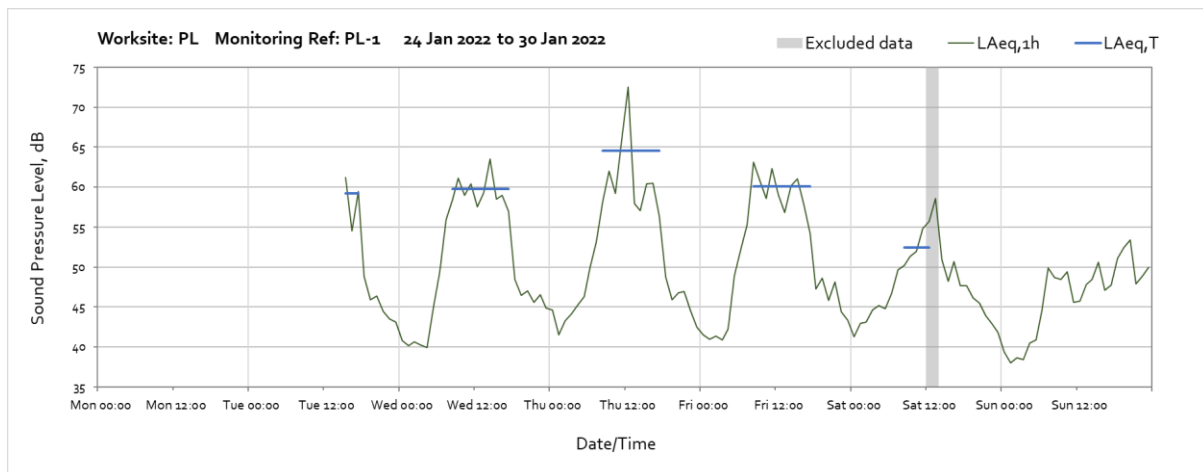
Note: Missing data between 09:00 on Sunday 9<sup>th</sup> January and 15:00 on Tuesday 25<sup>th</sup> January were due to loss of power to the monitor caused by insufficient sunlight to charge ancillary batteries.

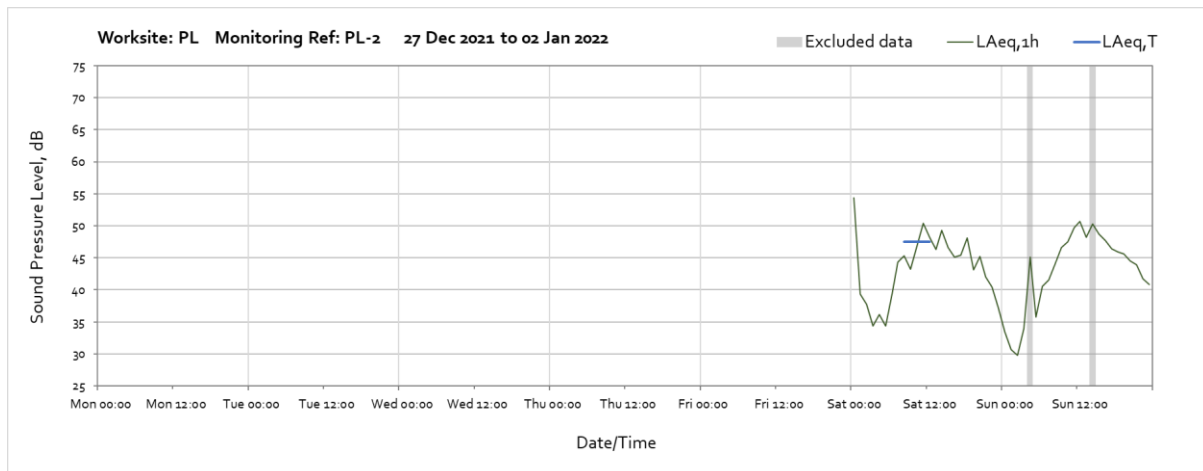
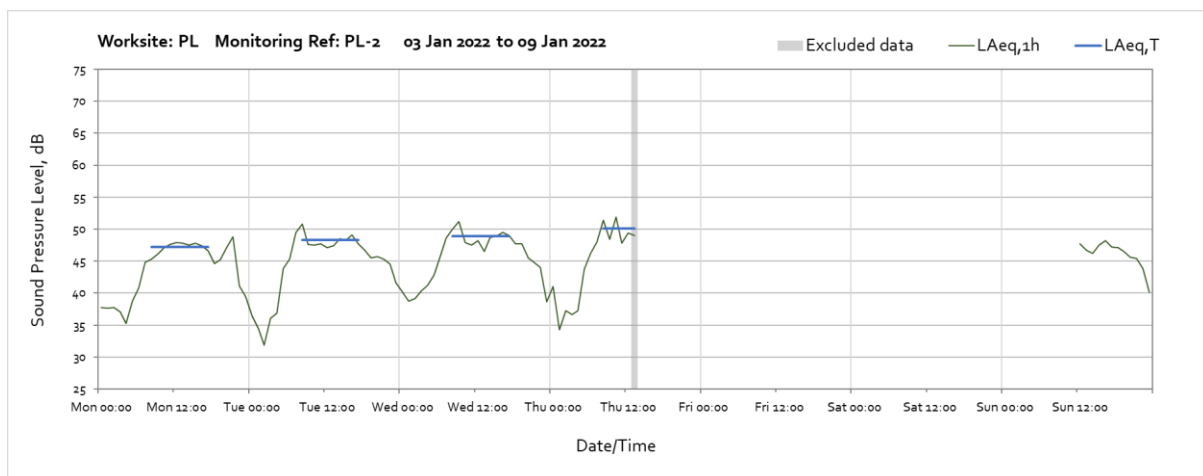
## Worksite: PL – Monitoring Ref: PL-2

Note: Missing data between 14:00 on Thursday 6<sup>th</sup> January and 12:00 on Sunday 9<sup>th</sup> January were due to loss of power to the monitor caused by insufficient sunlight to charge ancillary batteries.

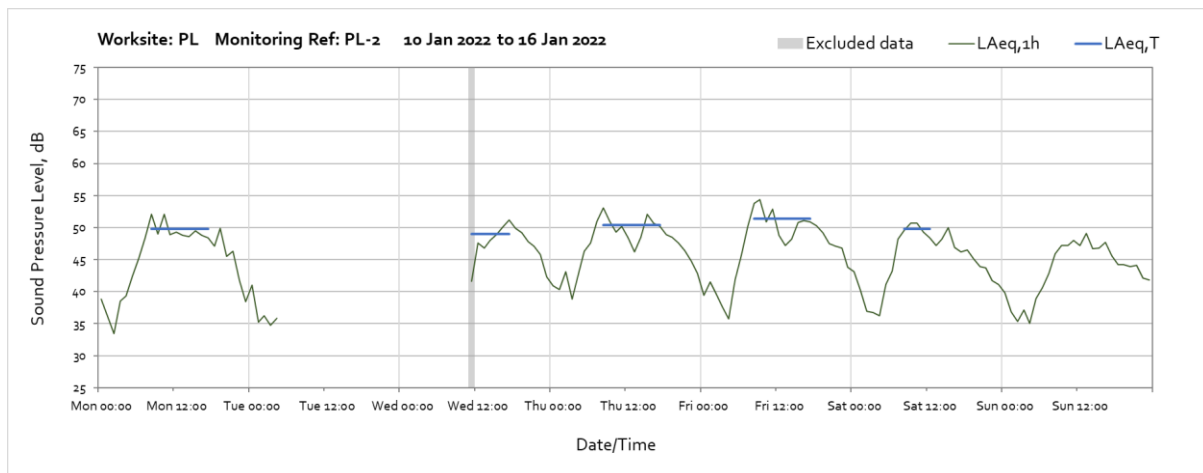
Note: Missing data between 05:00 on Tuesday 11<sup>th</sup> January and 11:00 on Wednesday 12<sup>th</sup> January were due to loss of power to the monitor caused by insufficient sunlight to charge ancillary batteries.

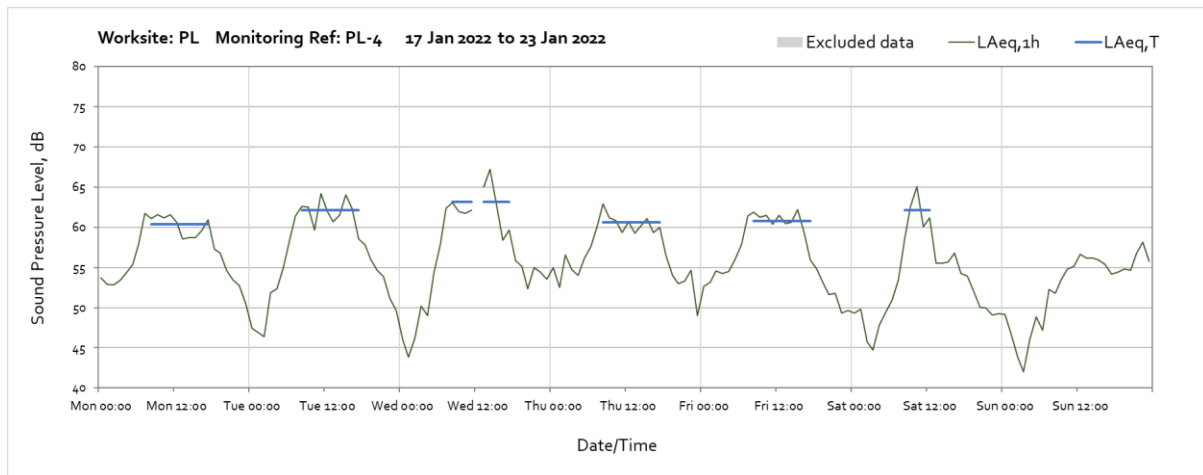
Note: Missing data at 12:00 on Wednesday 19<sup>th</sup> January were due to monitoring equipment updating and synchronizing.

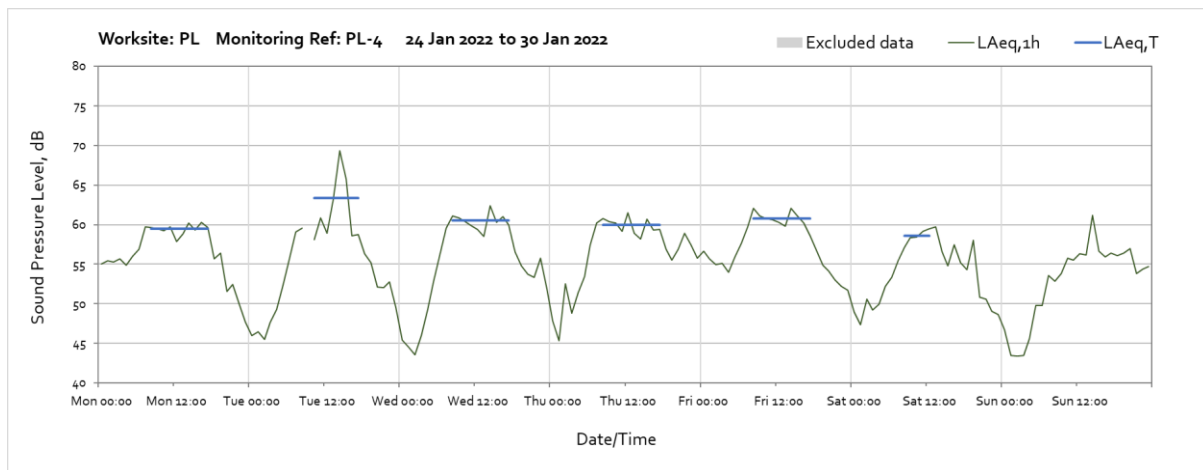
Note: Missing data at 09:00 on Tuesday 25<sup>th</sup> January were due to monitoring equipment updating and synchronizing.

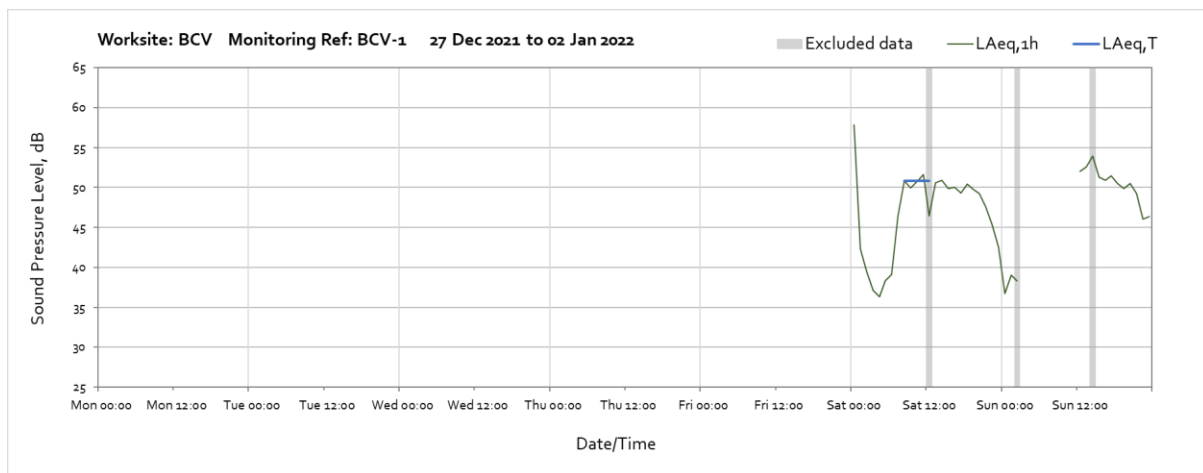
## Worksite: BCV – Monitoring Ref: BCV-1

Note: Missing data between 03:00 and 12:00 on Sunday 2<sup>nd</sup> January were due to loss of power to the monitor caused by insufficient sunlight to charge ancillary batteries.

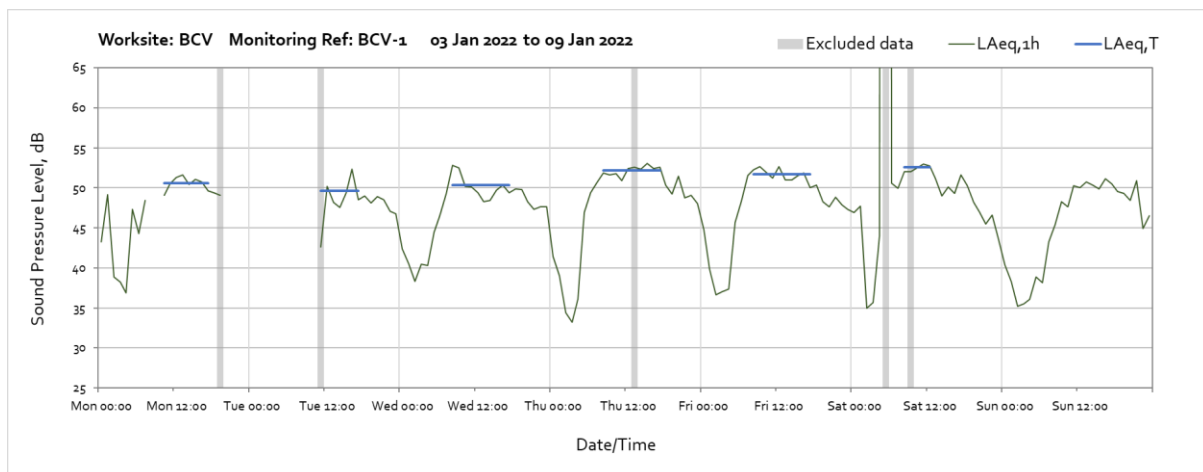
Note: Missing data throughout the week were due to loss of power to the monitor caused by insufficient sunlight to charge ancillary batteries. High noise levels between 05:00 and 06:00 on Saturday 9<sup>th</sup> January was due to failure of connection between meter and server.

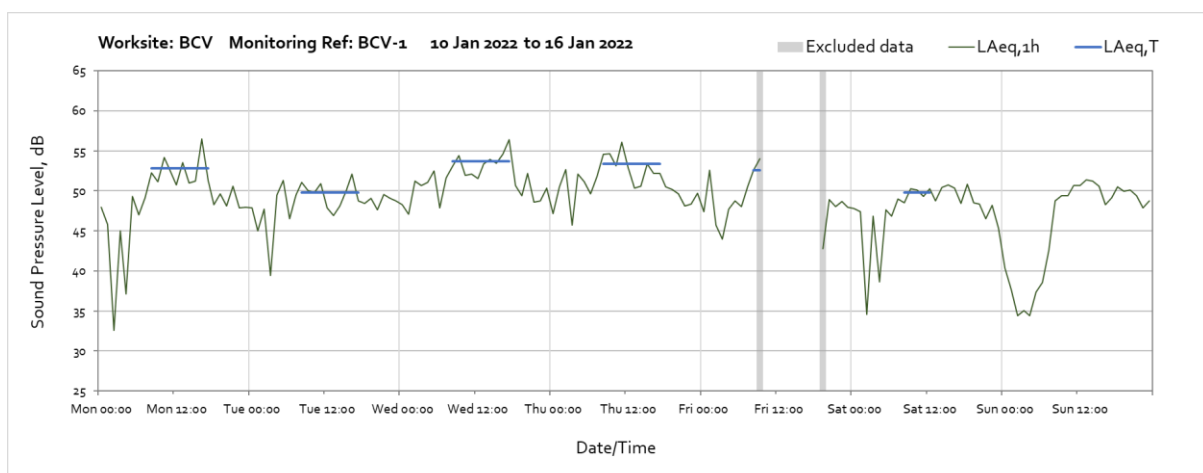
Note: Missing data between 10:00 and 19:00 on Friday 14<sup>th</sup> January were due to loss of power to the monitor caused by insufficient sunlight to charge ancillary batteries.

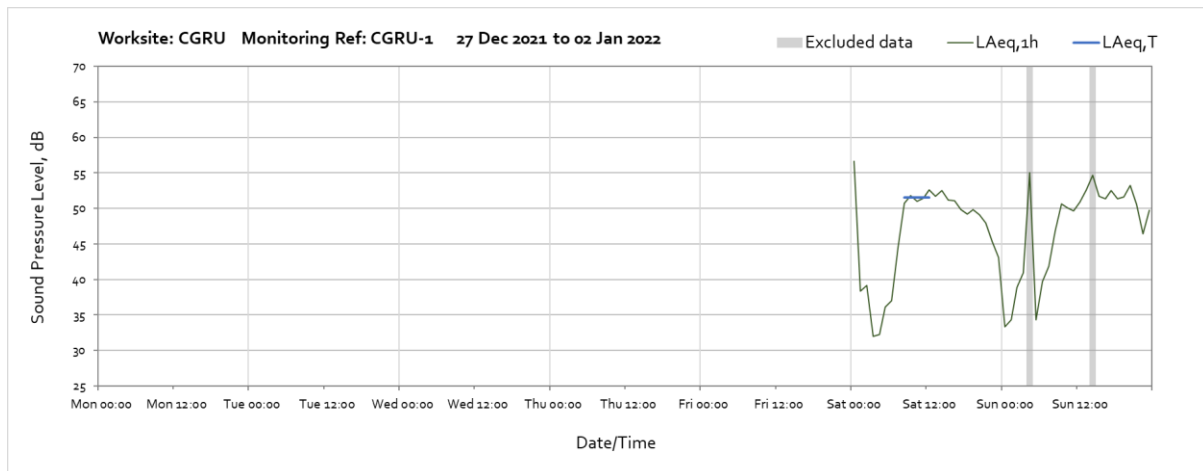
## Worksite: CGRU- Monitoring Ref: CGRU-1

Note: Missing data throughout the week were due to loss of power to the monitor caused by insufficient solar energy to charge ancillary batteries.

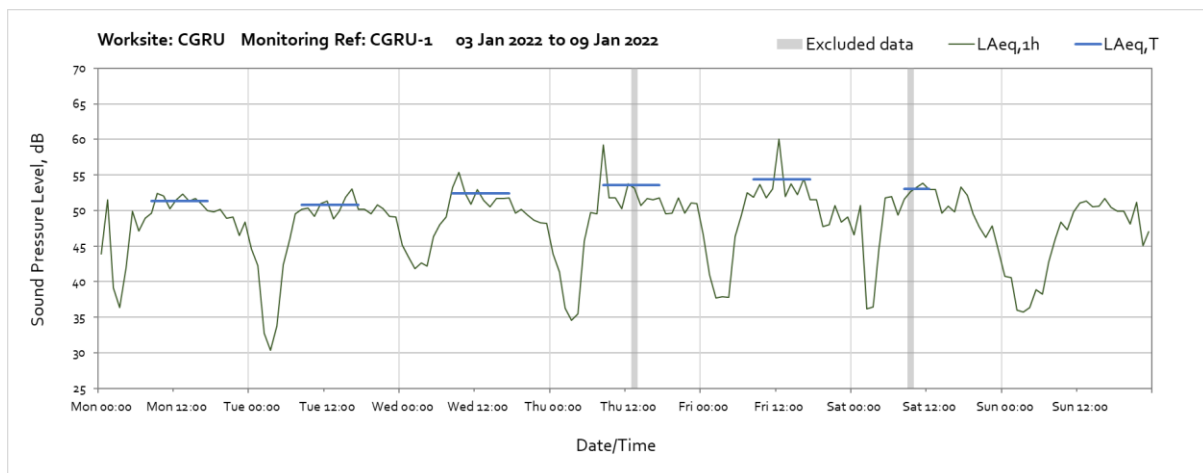
Note: Missing data throughout the week were due to loss of power to the monitor caused by insufficient solar energy to charge ancillary batteries.

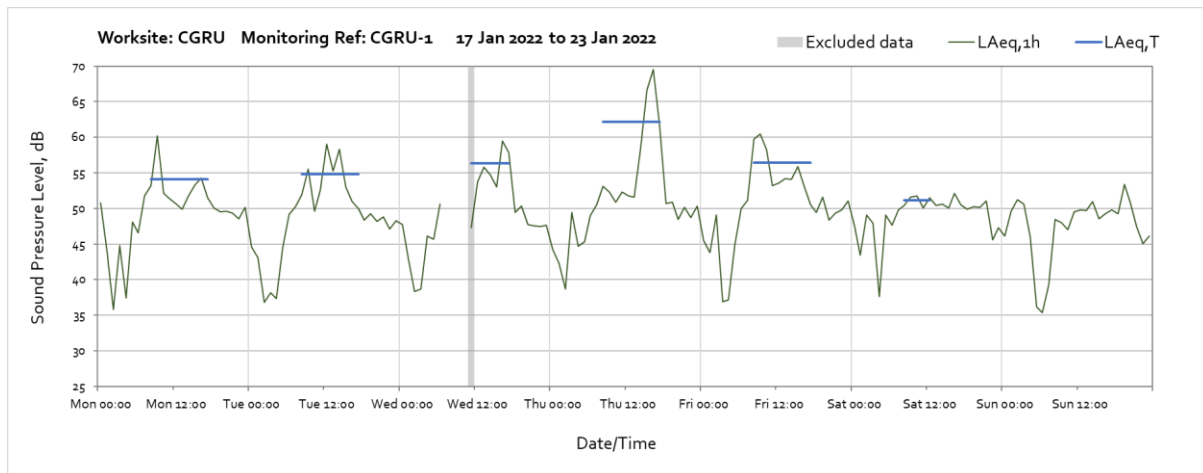
Note: Missing data between 07:00 and 11:00 on Wednesday 19<sup>th</sup> January were due to loss of power to the monitor caused by insufficient sunlight to charge ancillary batteries.

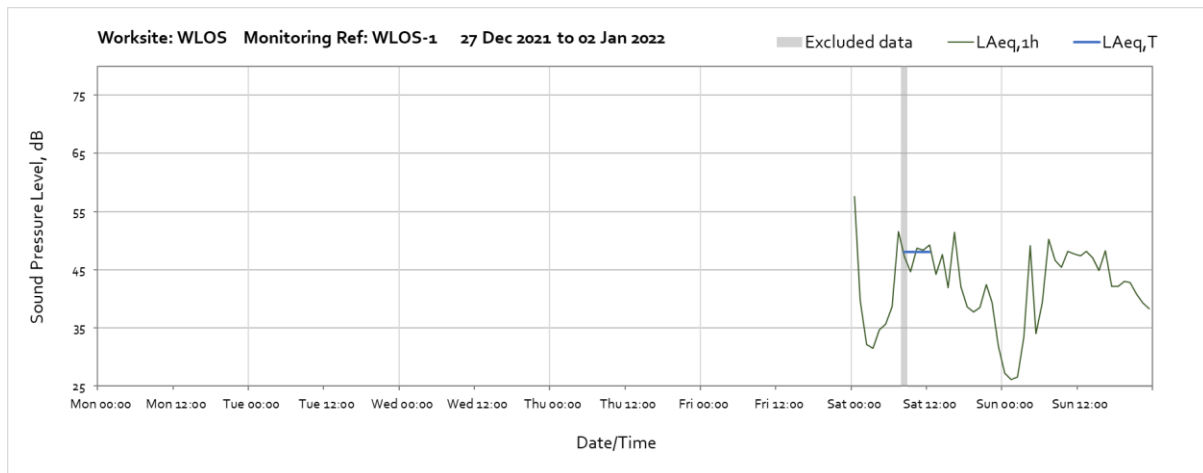
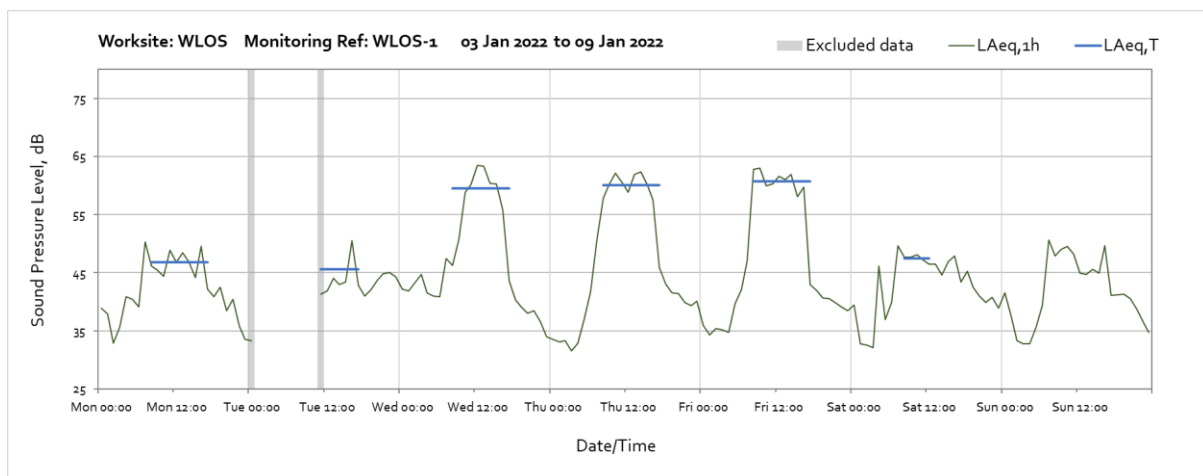
## Worksite: WLOS – Monitoring Ref: WLOS-1

Note: Missing data between 01:00 and 11:00 on Tuesday 4<sup>th</sup> January were due to loss of power to the monitor caused by insufficient sunlight to charge ancillary batteries.

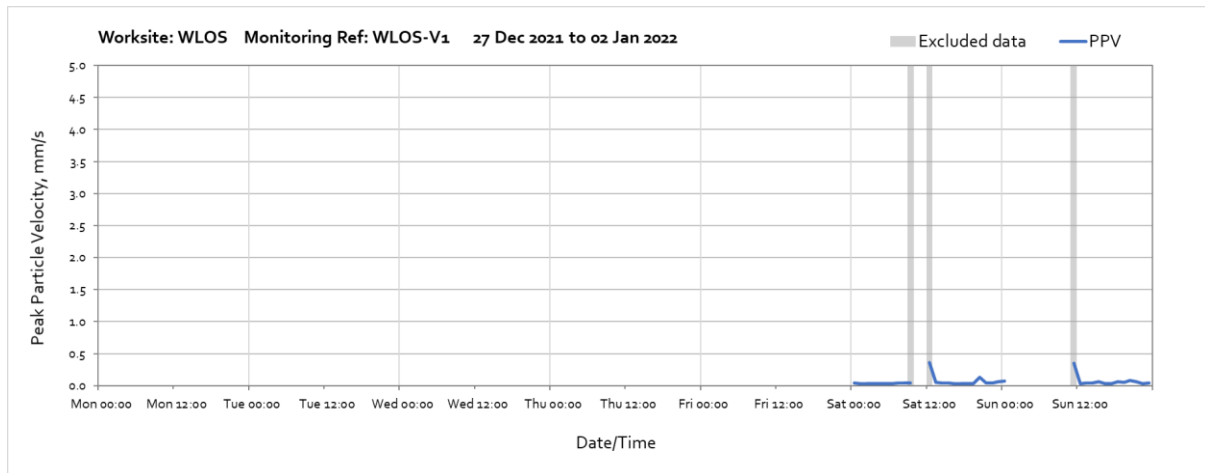
### Worksite: WLOS – Monitoring Ref: WLOS-V1

The following graphs show the hourly measured peak particle velocity PPV recorded during the monitoring period. The graphs show the highest PPV of the three orthogonal axes x, y and z. Where high values of PPV were caused by local interference with the vibration monitor, which are not representative of HS2 construction works, these values have been greyed out in the following charts and have been excluded to calculate values in Table 4 of the main report.

Note: Missing data during the week were due to loss of power to the monitor caused by insufficient sunlight to charge ancillary batteries.

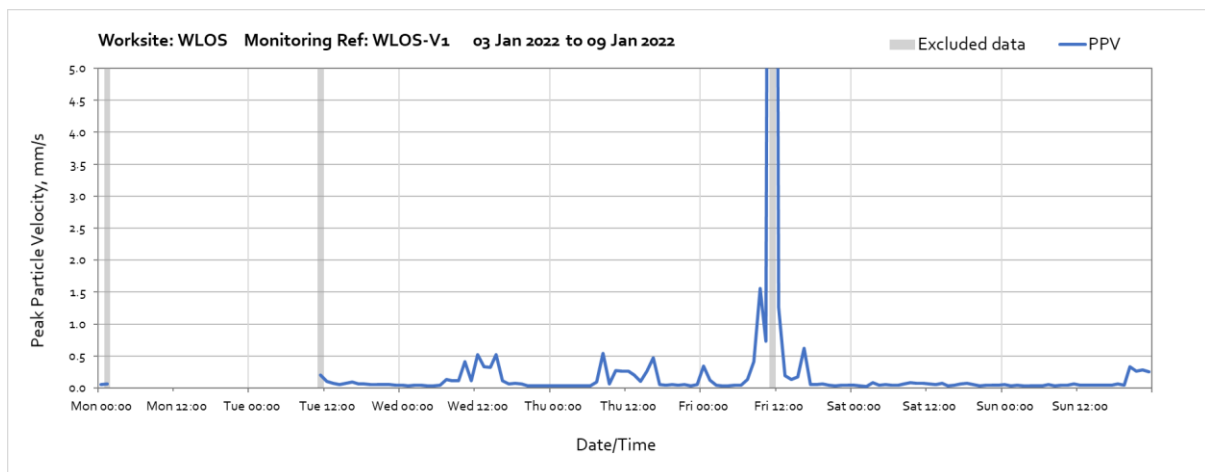
Note: Missing data during the week were due to loss of power to the monitor caused by insufficient sunlight to charge ancillary batteries. High vibration measured on 11:00 Friday 7<sup>th</sup> January was due to local disturbance and is not related to HS2 works.

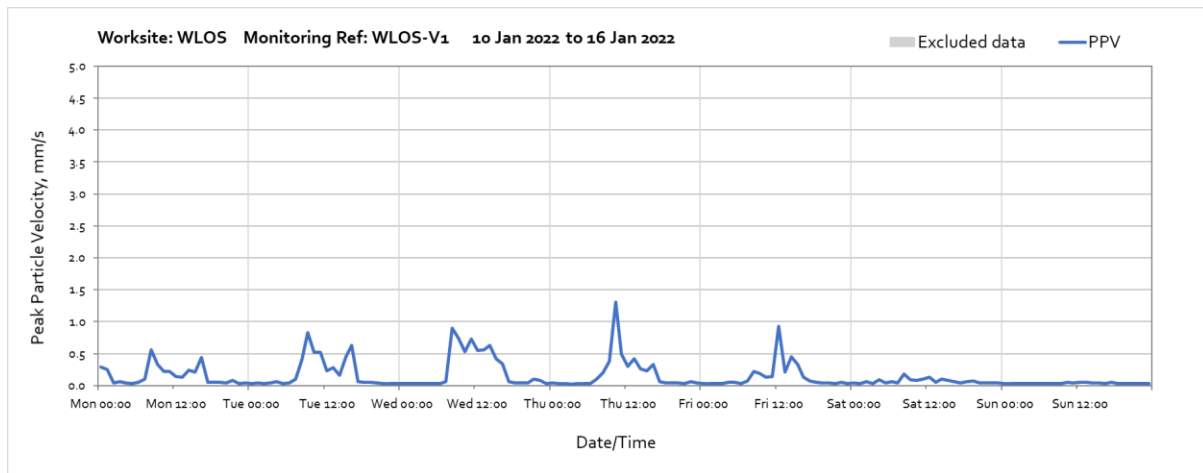
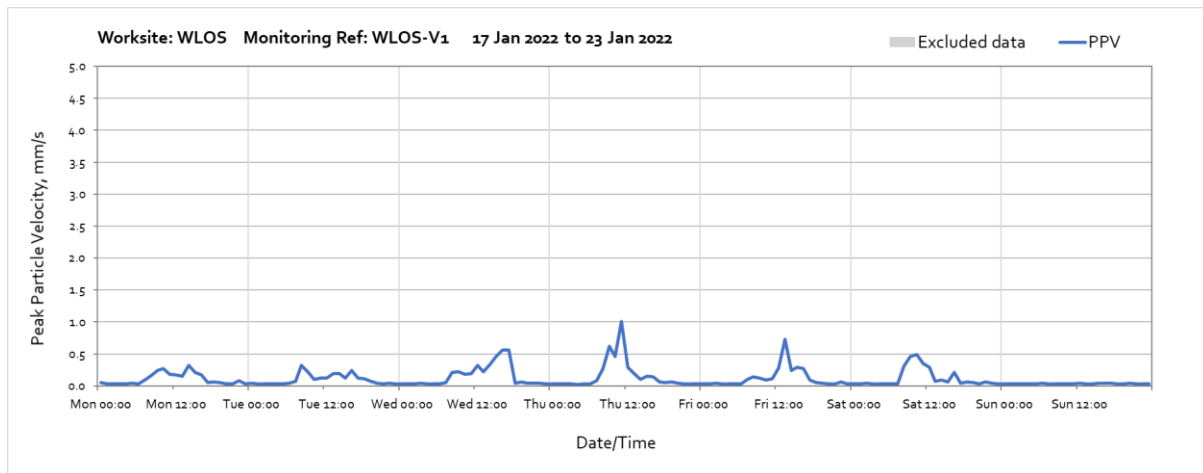
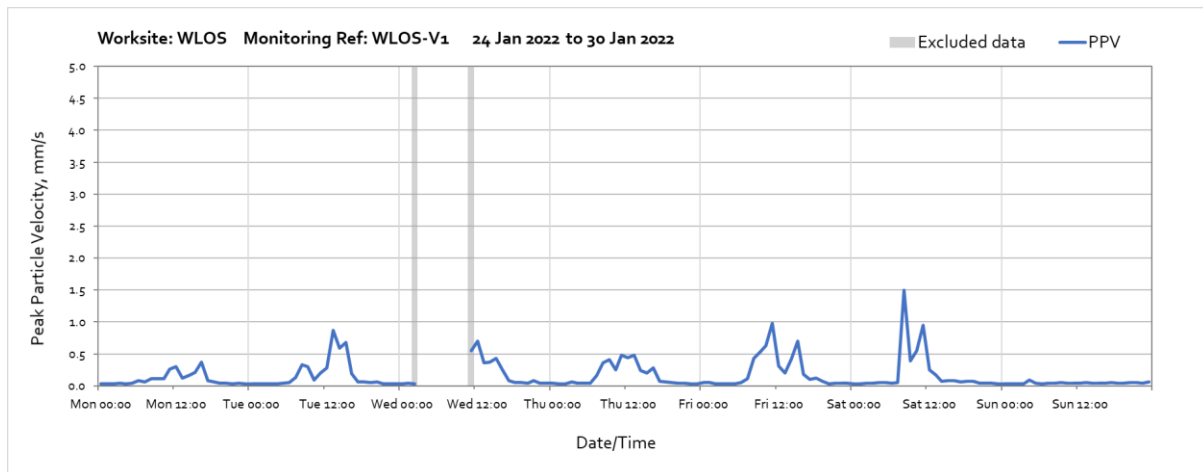
Note: Missing data during the week were due to loss of power to the monitor caused by insufficient sunlight to charge ancillary batteries.
