## **Construction Noise and Vibration Monthly Report – January 2022**

### **Solihull Metropolitan District**

This Noise and Vibration Monitoring Report fulfils HS2 Limited's commitment detailed in the Environmental Minimum Requirements (EMRs), Annex 1, Code of Construction Practice, to present the results of noise and vibration monitoring carried out within the Solihull Metropolitan District (SMD) during the month of January 2022.

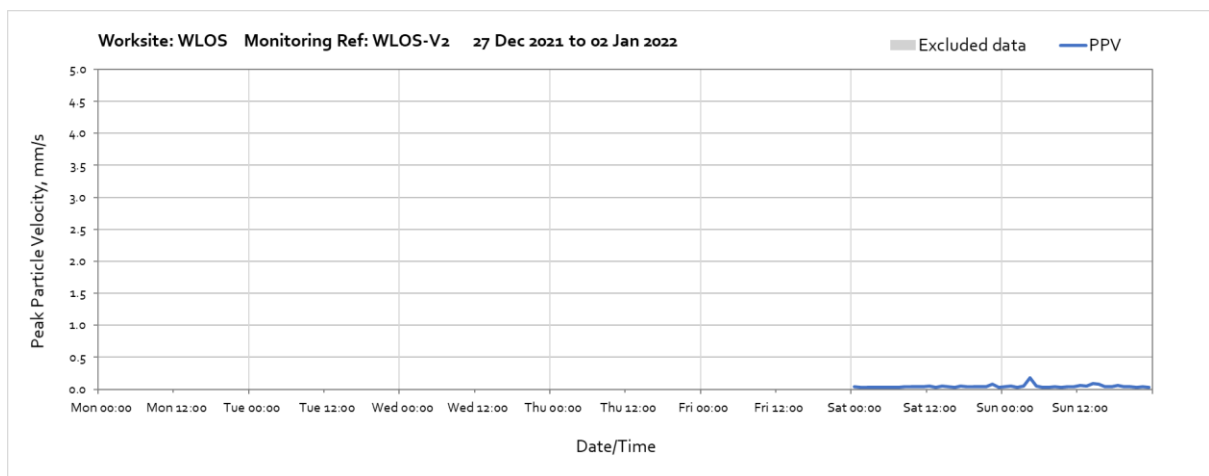
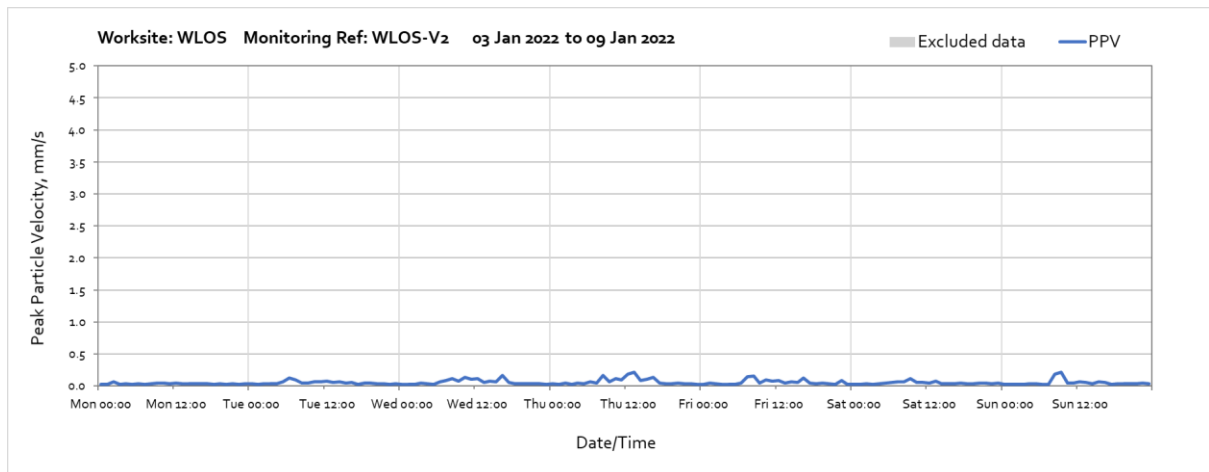
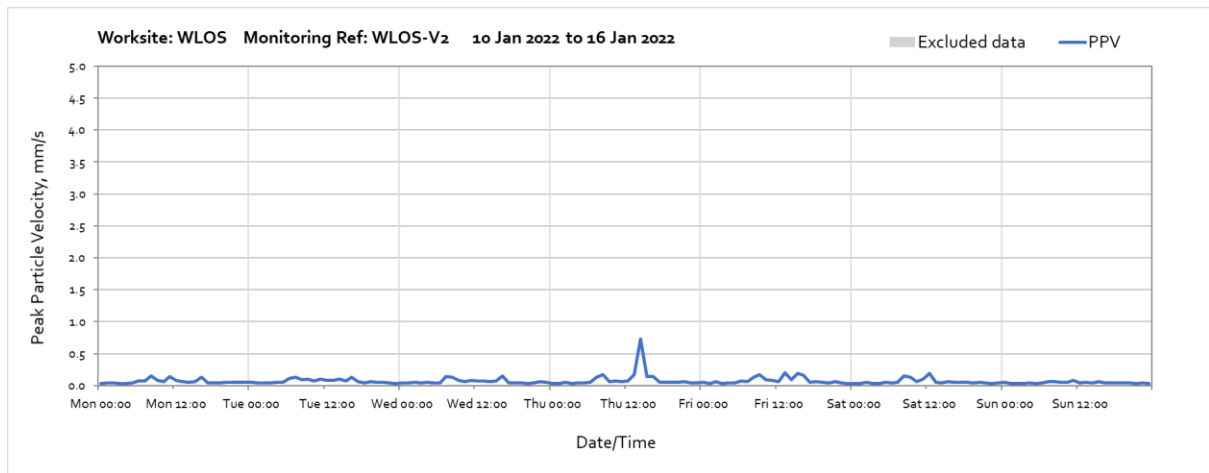
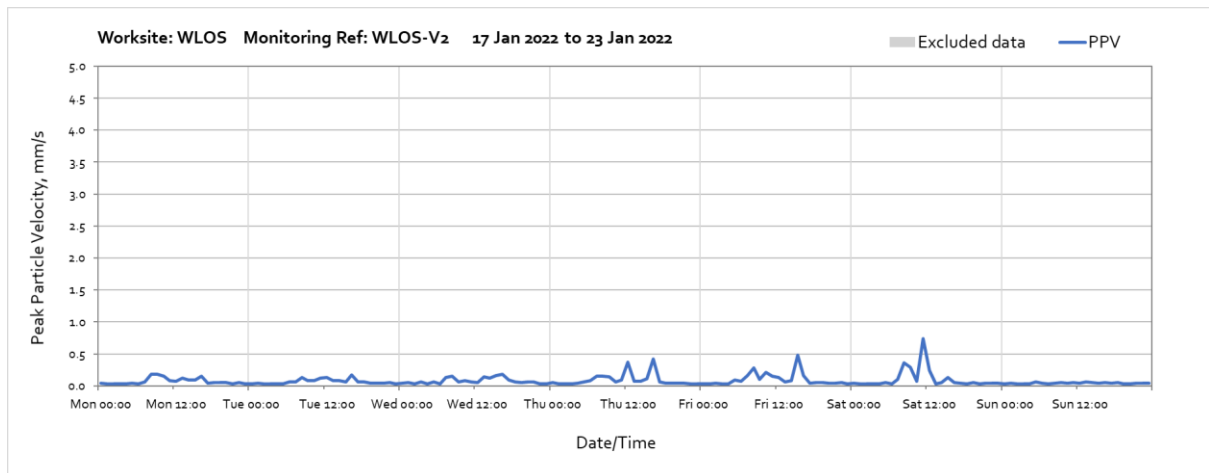
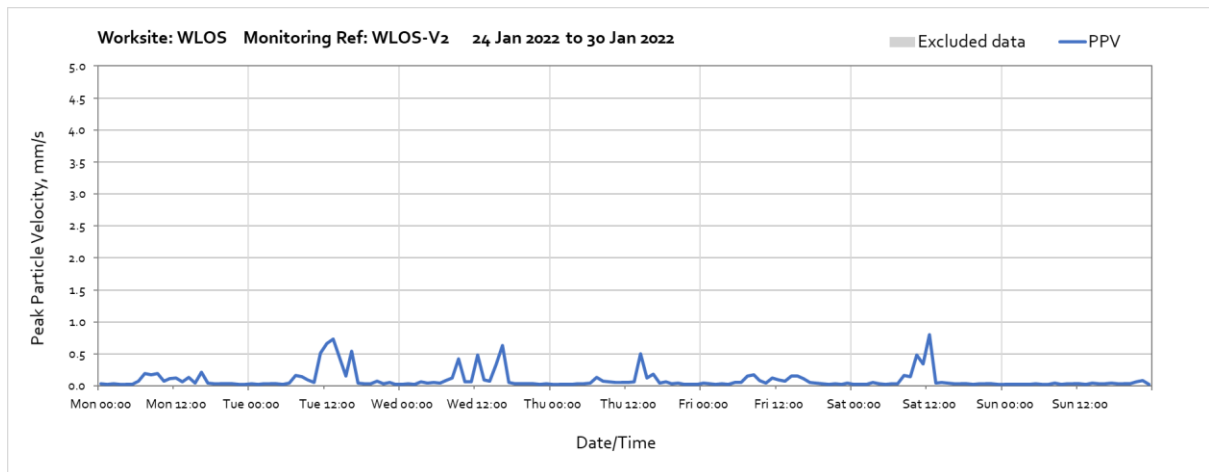
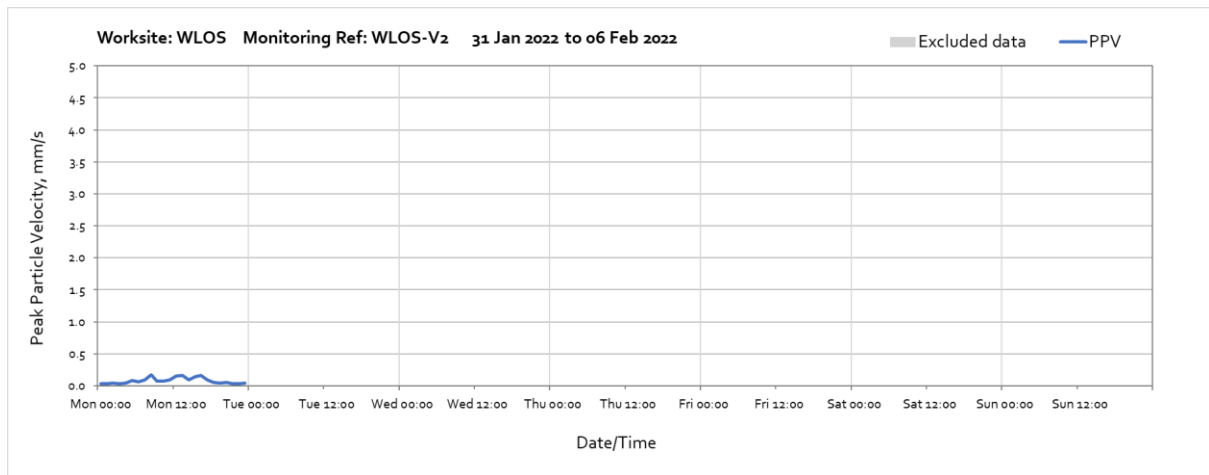
## Worksite: WLOS – Monitoring Ref: WLOS-V2

The following graphs show the hourly measured peak particle velocity PPV recorded during the monitoring period. The graphs show the highest PPV of the three orthogonal axes x, y and z. Where high values of PPV were caused by local interference with the vibration monitor, which are not representative of HS2 construction works, these values have been greyed out in the following charts and have been excluded to calculate values in Table 4 of the main report.
