Construction Noise and Vibration Monthly Report – January 2022

Warwick District Council

Non-Technical Summary

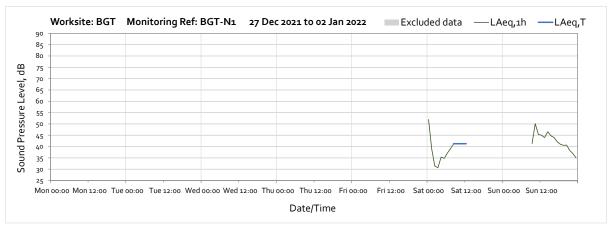
Worksite: BGT - Monitoring Ref: BGT-N1

Note: High noise levels measured at 00:00 on Saturday 1st January were due to New Year Night celebration. Note: Missing data between 09:00 on Saturday 1st January and 08:00 on Sunday 2nd January was due to battery falling below required voltage limit caused by prolonged insufficient sunlight

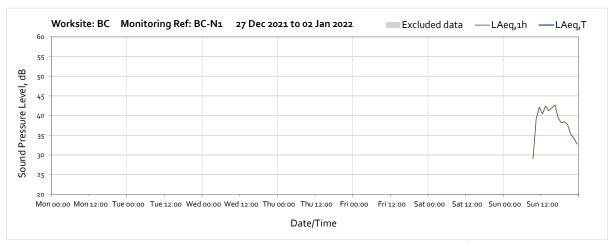
Worksite: BC - Monitoring Ref: BC-N1

Note: Missing data between 00:00 on Saturday 1st January and 08:00 on Sunday 2nd January was due to battery falling below required voltage limit caused by prolonged insufficient sunlight.

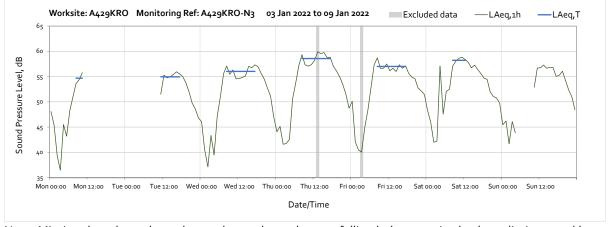
Note: Missing data throughout the week was due to battery falling below required voltage limit caused by prolonged insufficient sunlight.

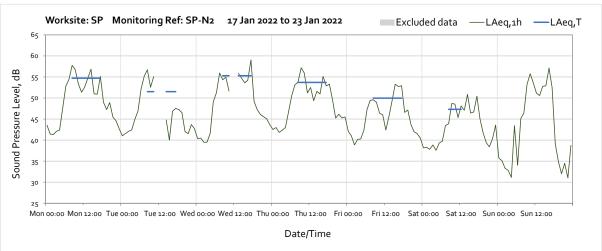
Note: Missing data throughout the week was due to battery falling below required voltage limit caused by prolonged insufficient sunlight.
