SERIOUS INCIDENT

Aircraft Type and Registration:	Reims Cessna F172N, G-BGIY	
No & Type of Engines:	1 Lycoming O-320-H2AD piston engine	
Year of Manufacture:	1979 (Serial no: 1824)	
Date & Time (UTC):	28 August 2021 at 1120 hrs	
Location:	Glasgow Airport	
Type of Flight:	Private	
Persons on Board:	Crew - 1	Passengers - 2
Injuries:	Crew - None	Passengers - None
Nature of Damage:	None	
Commander's Licence:	Private Pilot's Licence	
Commander's Age:	53 years	
Commander's Flying Experience:	564 hours (of which 451 were on type) Last 90 days - 26 hours Last 28 days - 8 hours	
Information Source:	Aircraft Accident Report Form submitted by the pilot and further AAIB enquiries

Synopsis

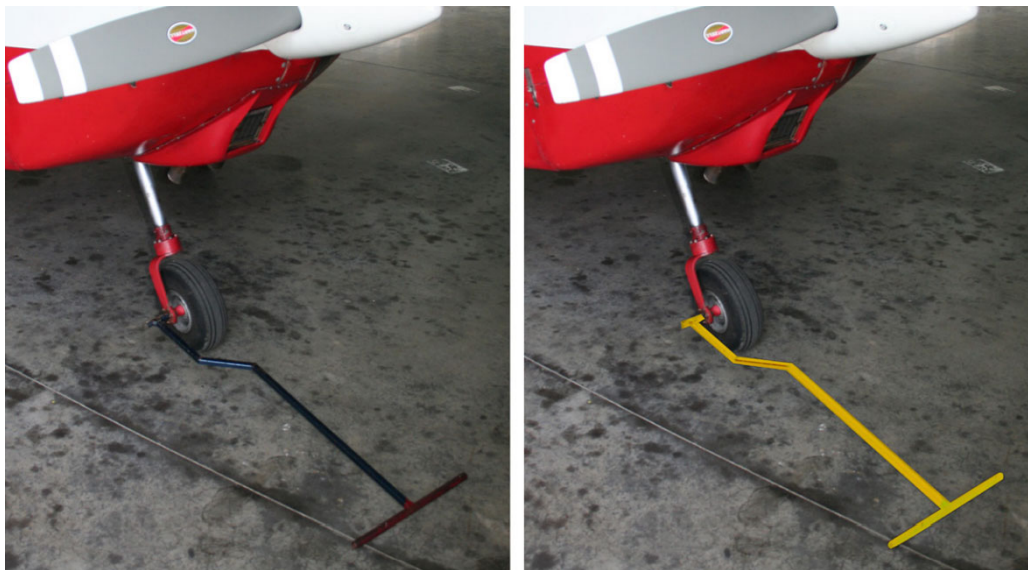
Figure 1

On 7 August 2019, a Cessna P210N departed from Southend Airport with a towbar attached². The AAIB investigation of that incident revealed the pilot had been distracted by a stressful event he had experienced earlier that day. As a result of that incident, the CAA took action to promote the importance of increasing the visibility of ground equipment in the General Aviation environment³ (Figure 1).

Excerpt from the CAA’s ‘Clued up’ article about Towbars

With distraction a factor, the conspicuity of the towbar may not have been significant to this incident. However, consistent with the CAA’s guidance following the incident involving G-CDMH, the operator took the precaution of attaching reflective tape to its towbars.
