**Chase New Homes**

# Former Friends School, Saffron Walden

Flood Risk Assessment and Surface Water Drainage Strategy

680119-R1(2)-FRA

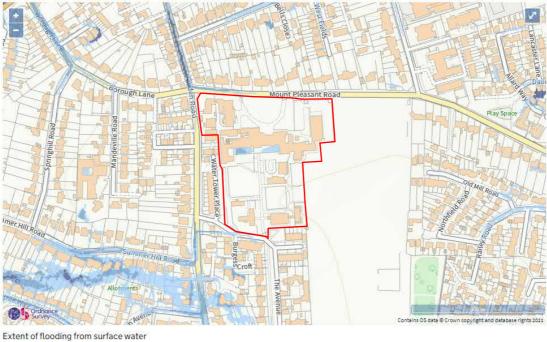
#### Figure 4.2: Environment Agency 'Flood risk from surface water' map

The EA's surface water flood map (**Figure 4.2**) shows that some localised 'low' to 'medium' risk surface water ponding is predicted to occur in the centre of the site corresponding to two localised lower areas to the rear of the main building. The remainder of the site is at a 'very low' risk of flooding from this source.

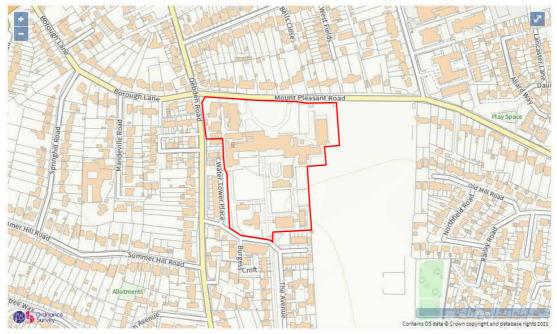
#### Figure 4.3: Environment Agency 'Flood risk from reservoirs' map

The EA reservoir flood map (reproduced as **Figure 4.3**) shows the largest area that might be flooded if a reservoir were to fail and release the water it holds. Since this is a prediction of a worst-case scenario, it is unlikely that any actual flood would be this large. According to the EA Reservoir flood maps the site is not at risk of flooding from reservoirs.

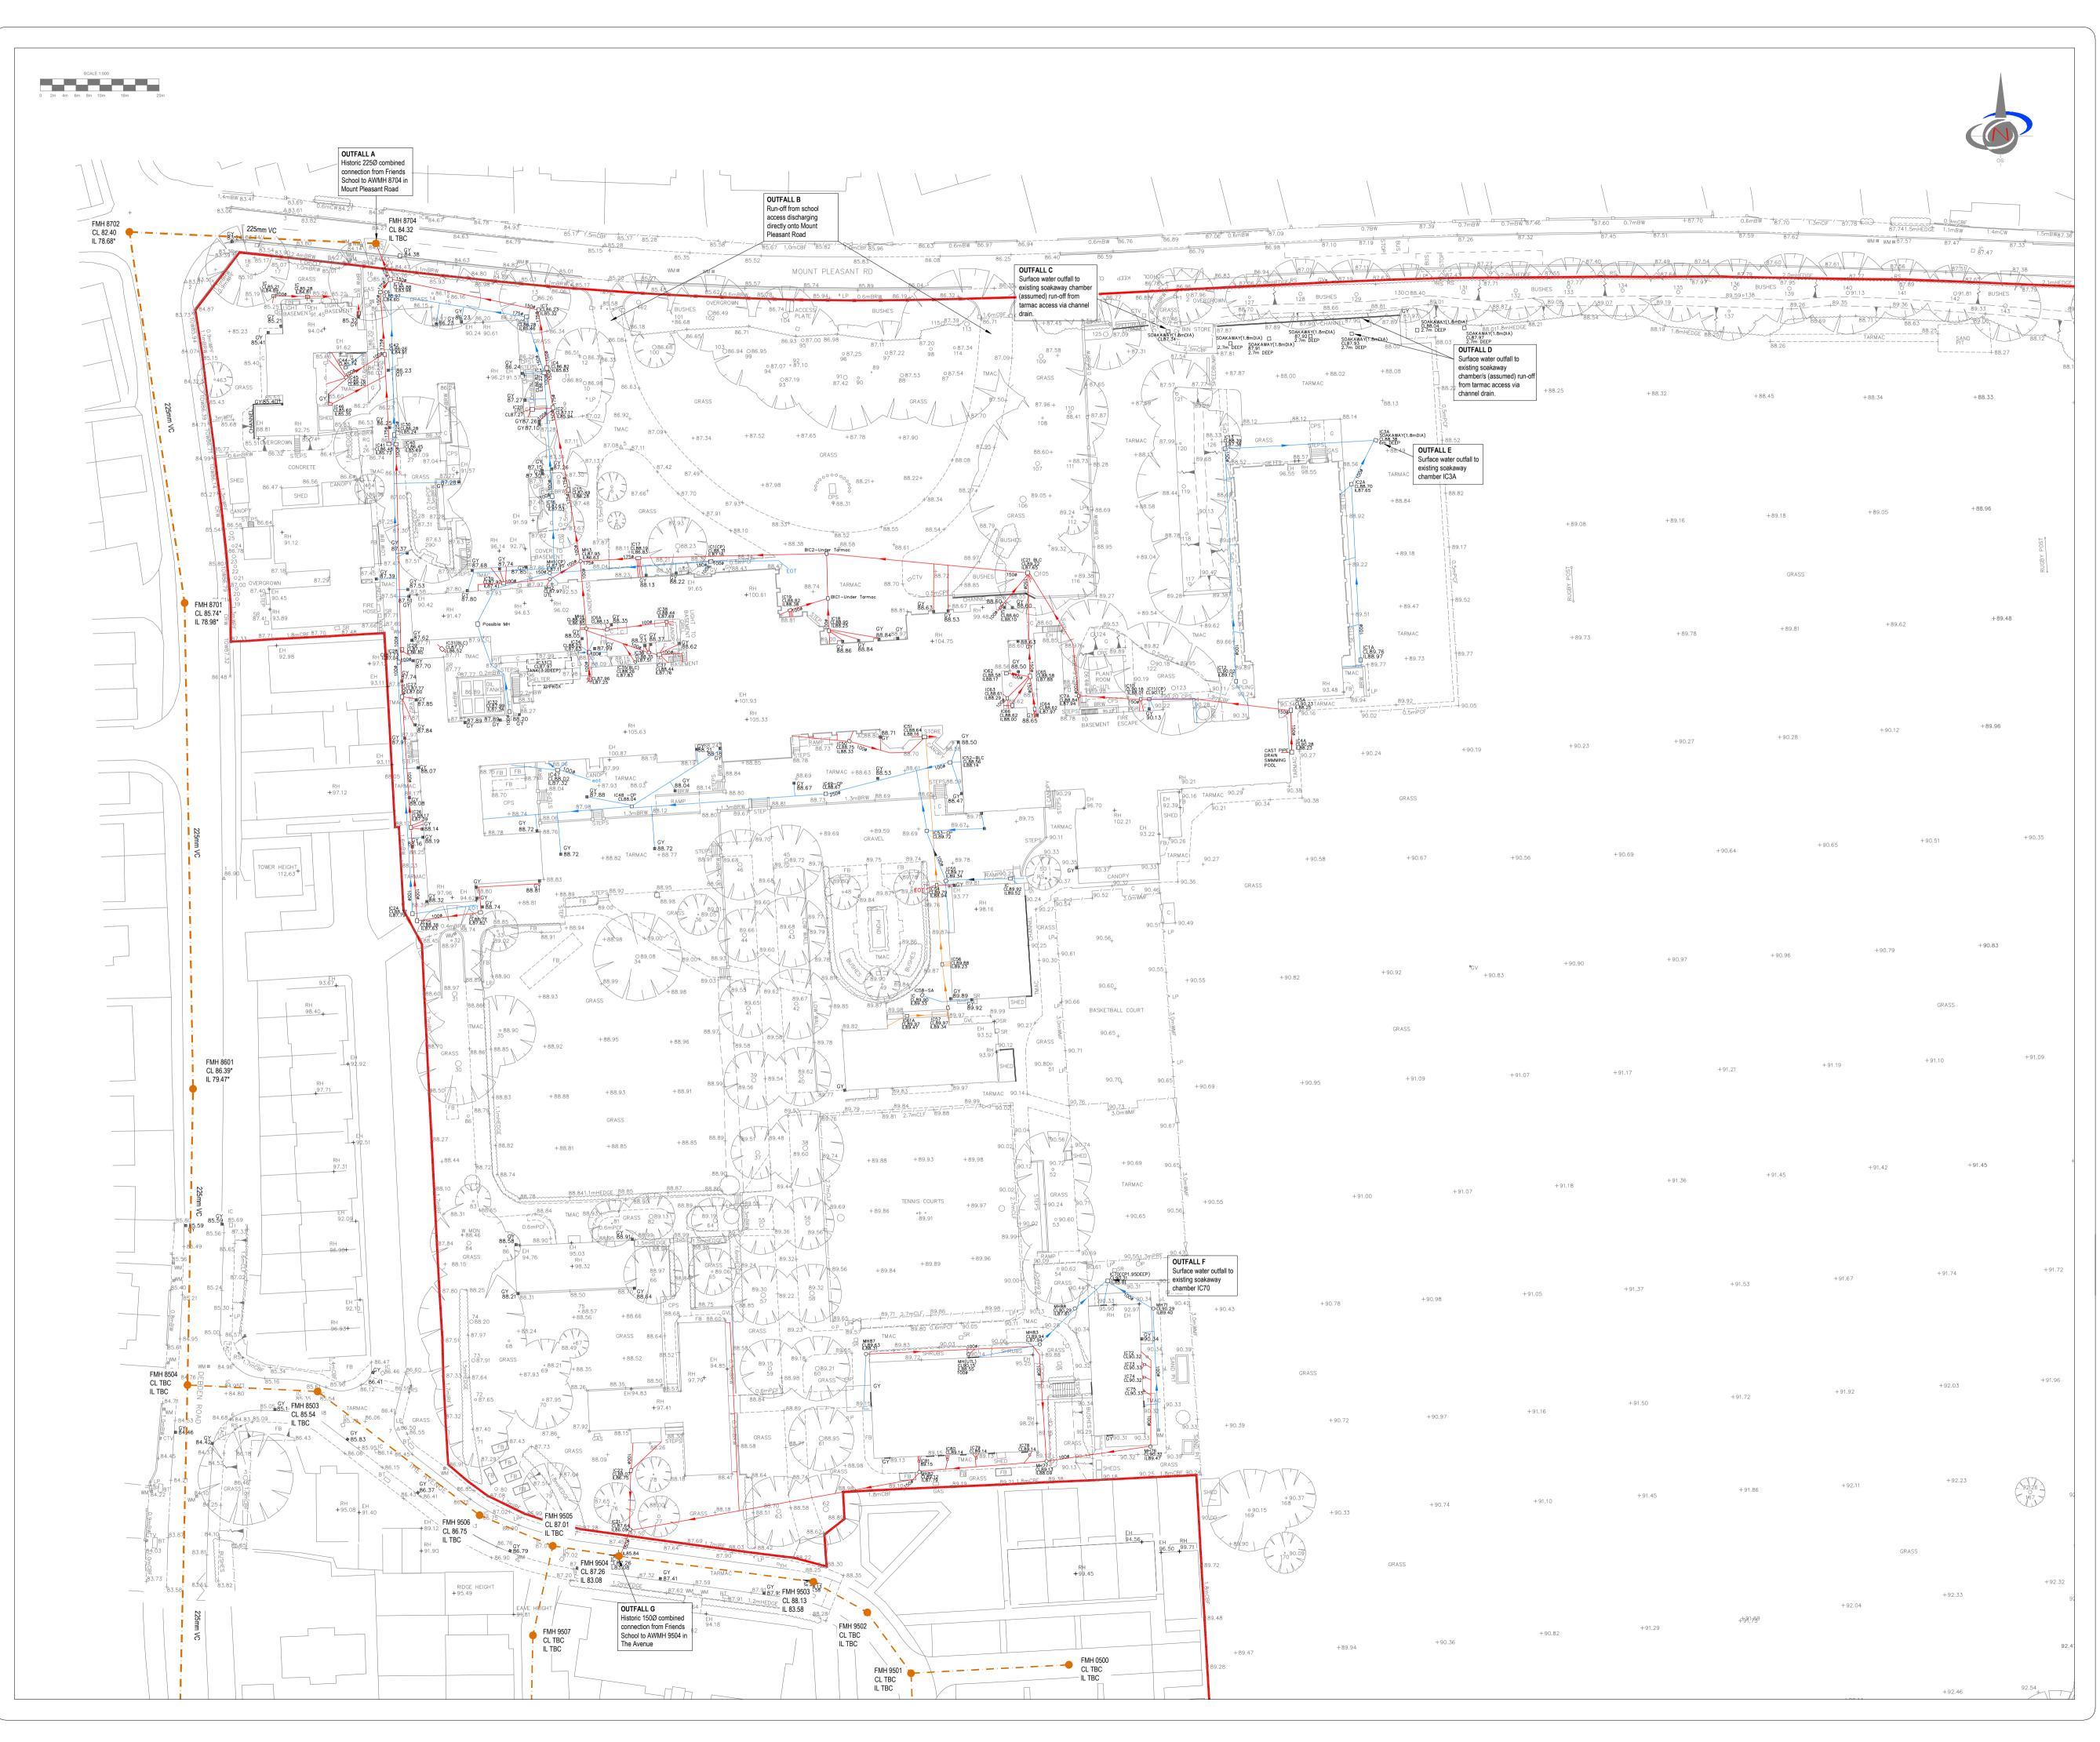
### APPENDIX D EXISTING PRIVATE DRAINAGE SURVEY

• The CCTV survey identified 0 Grade 5 defects within the existing private drainage network, a Grade 5 defect being serious and indicating urgent repair. Grade 3-4 defects are less serious and less urgent concerning repair; 57 defects of this grade were noted. Finally, 192 Grade 1-2 defects were identified, a Grade 1-2 defect being relatively minor and could be monitored and/or repaired if thought necessary.

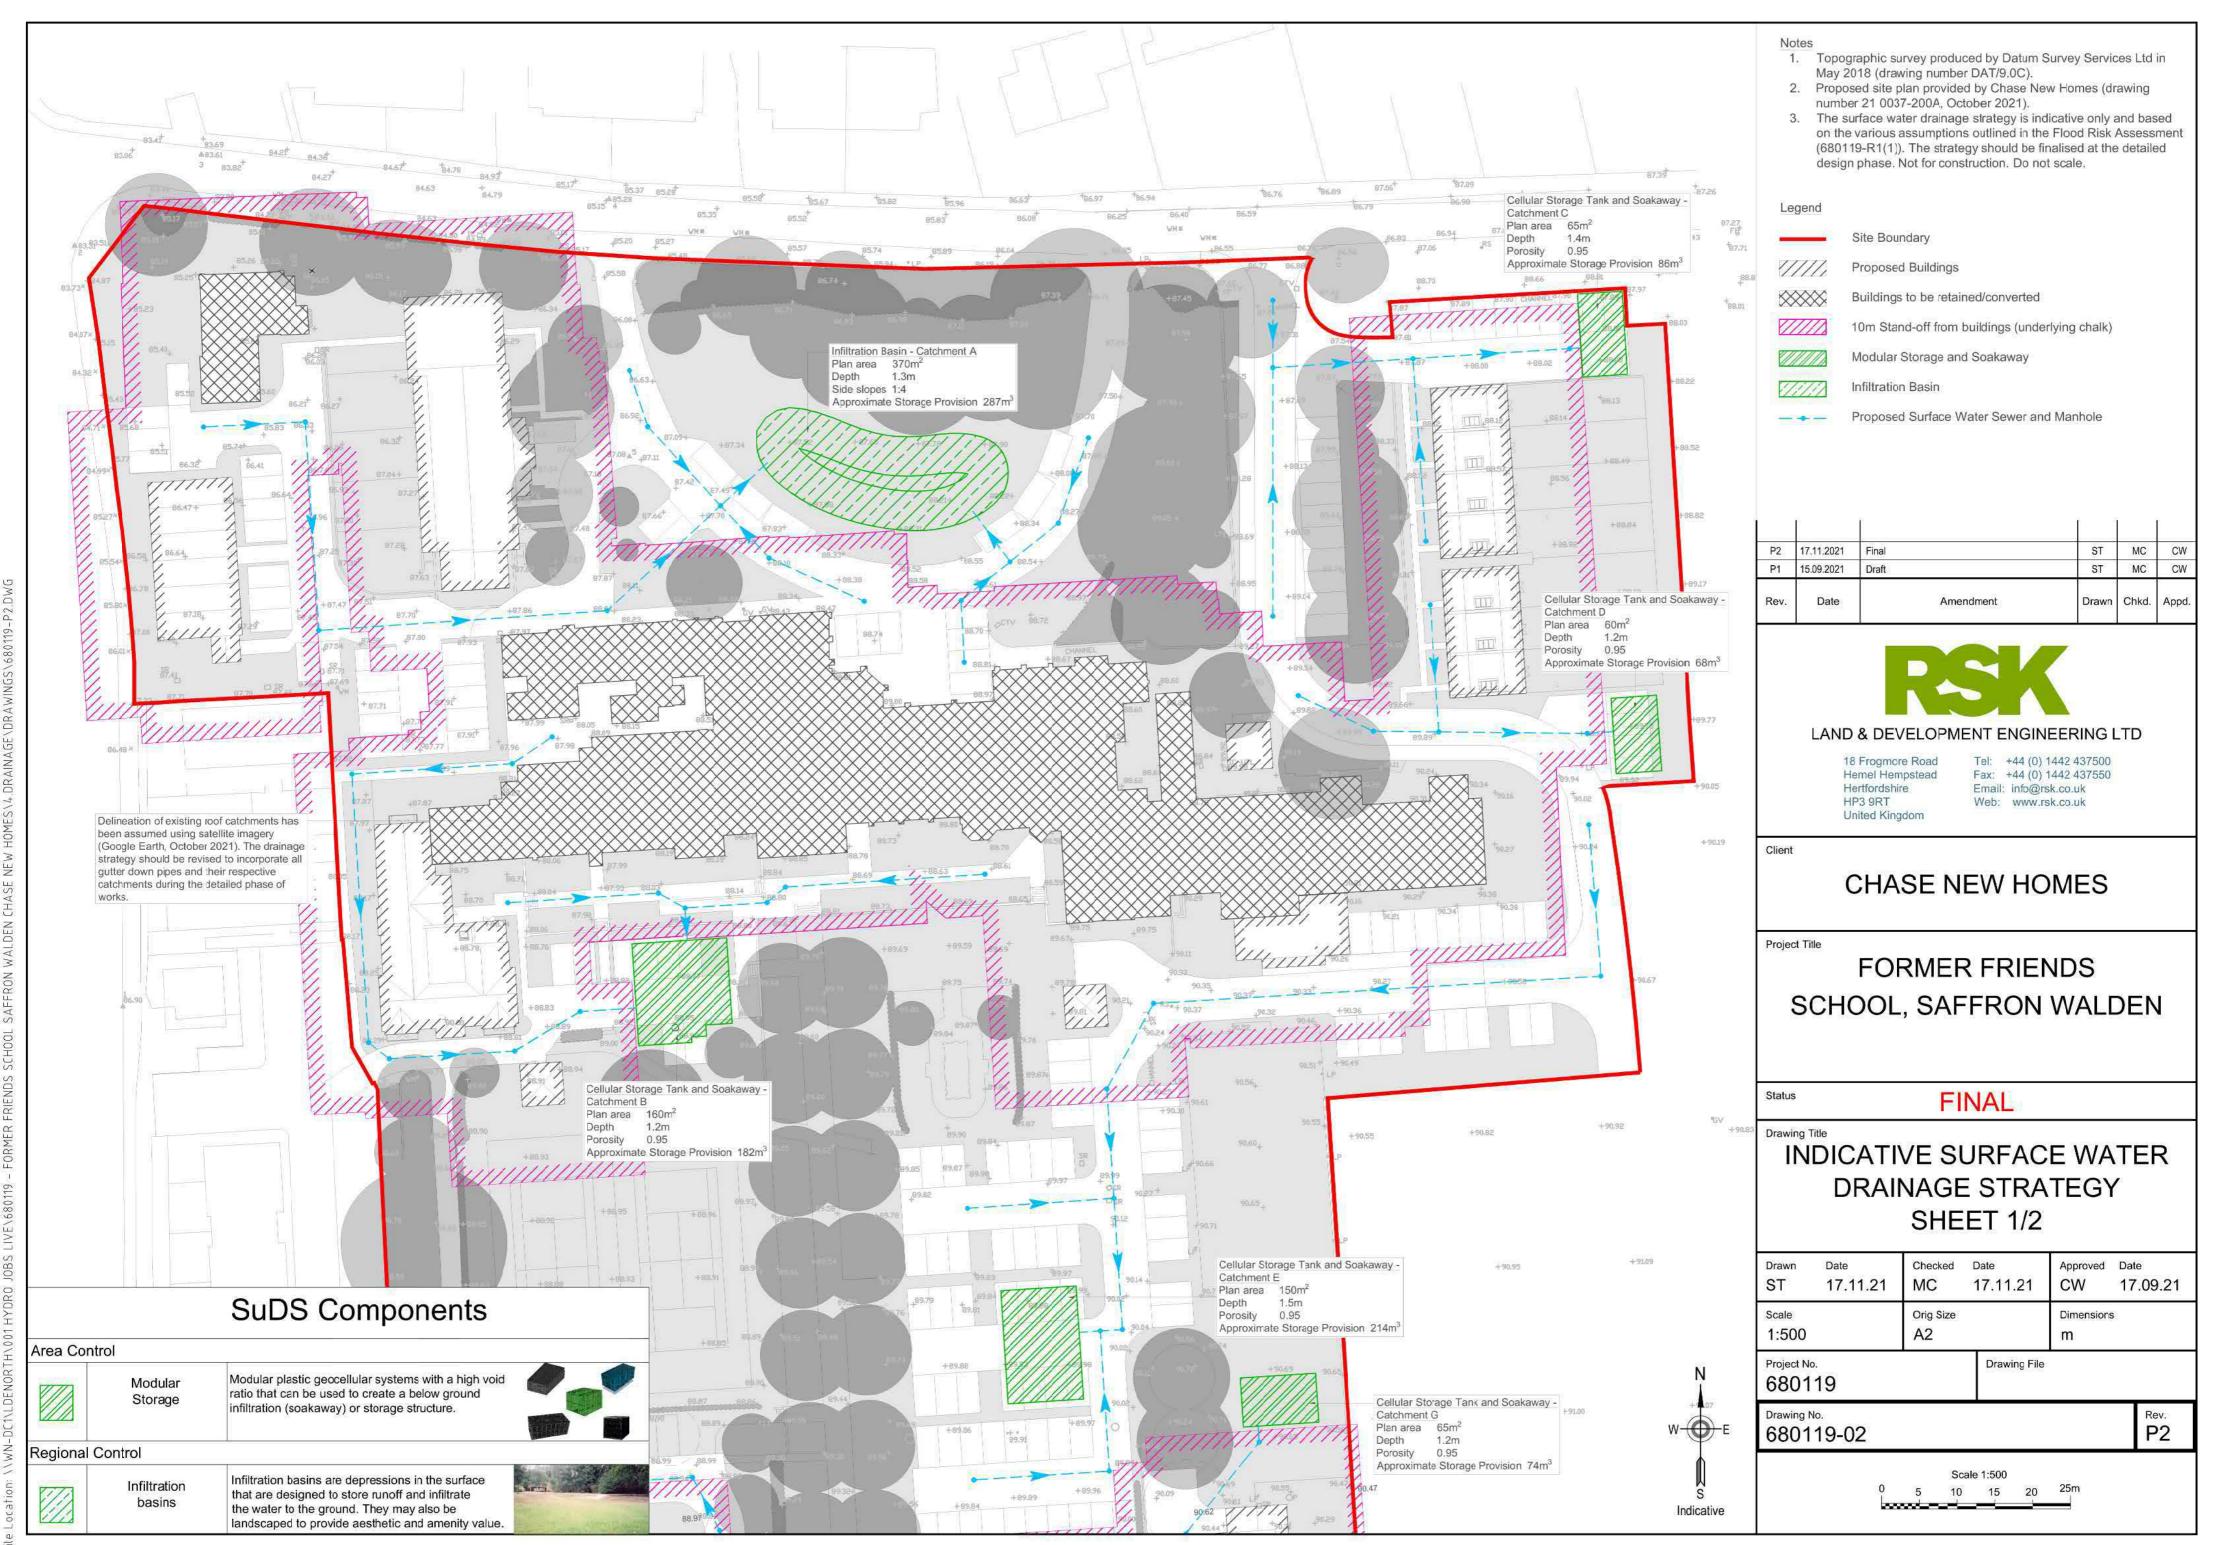
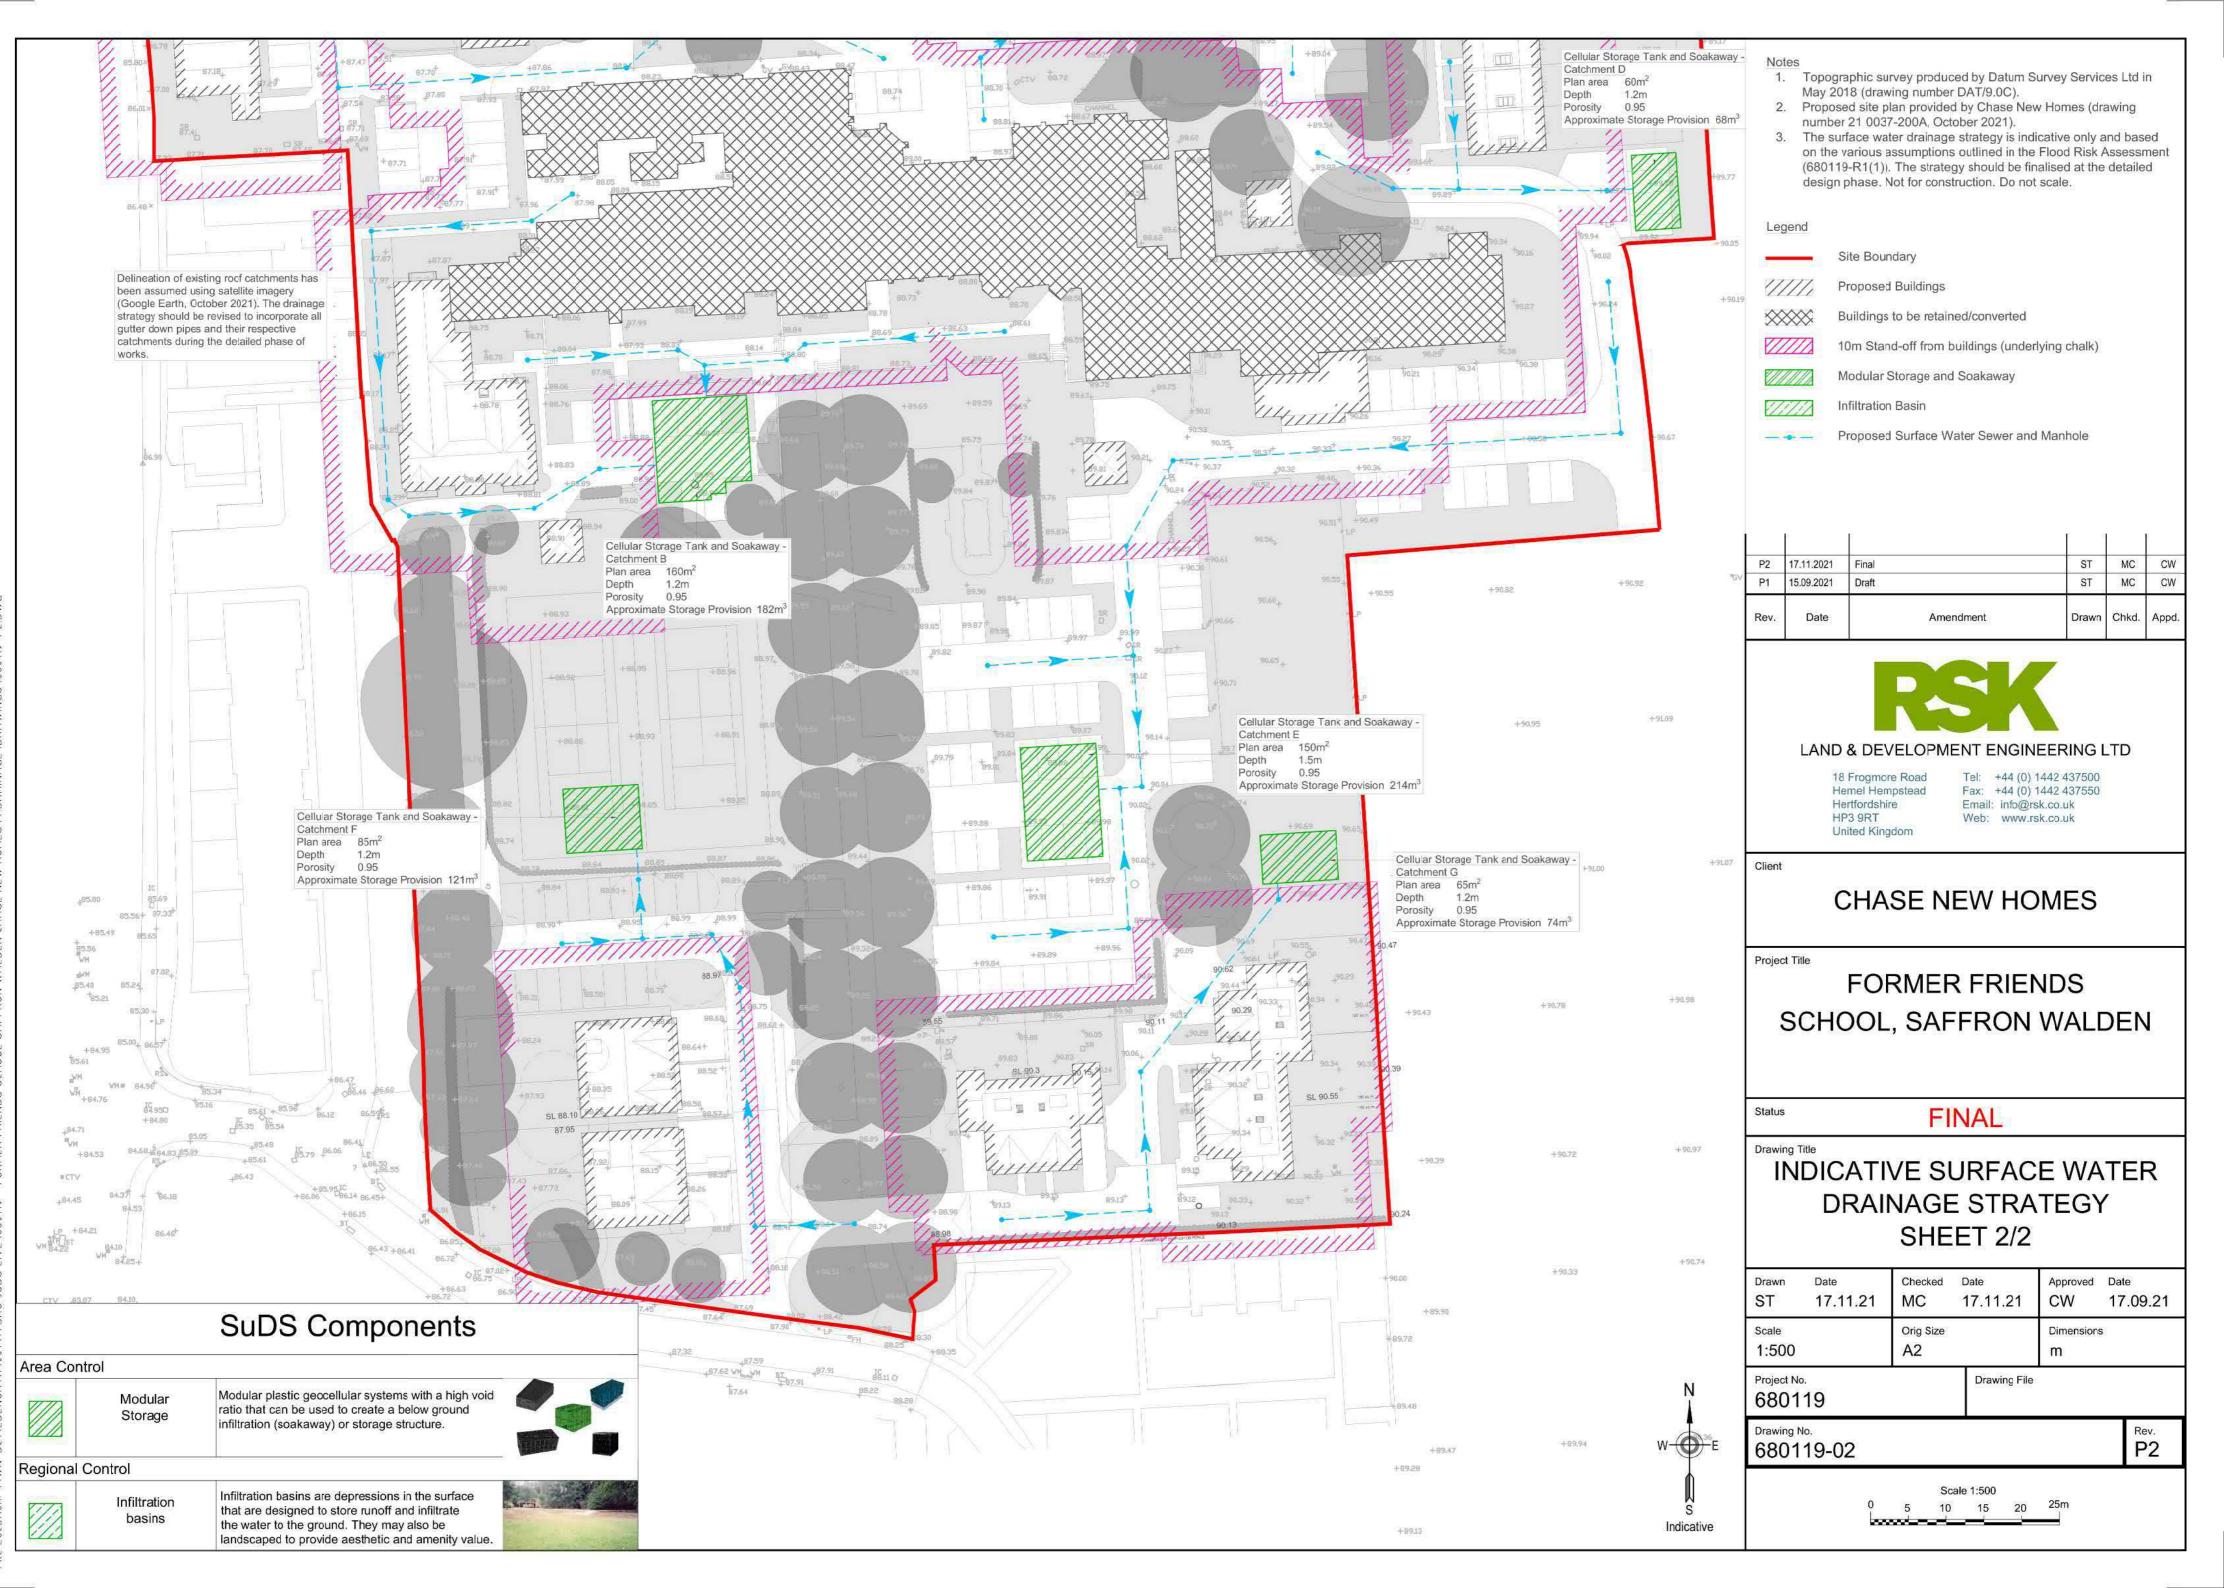
### APPENDIX J INDICATIVE SURFACE WATER DRAINAGE STRATEGY

The proposed SuDS for the site include a combination of geo-cellular soakaways and an infiltration basin which have been located depending on the position of the proposed and retained buildings. The SuDS have been designed to encourage surface water infiltration into the ground and reduce the amount that is required to store. The site has been split into 7 catchments, as detailed in **Appendix I**, and the proposed drainage layout drawing is shown in **Appendix J**. In principle, the strategy contains the following features and criteria:

- Modular storage tanks have been located mainly beneath shared surfaces (public open space, sports courts and courtyards) to provide additional attenuation and comprise the sole soakage features in Catchments B, C, D, E, F and G. In most locations modular storage has been indicated as 1.2m deep, with the tank in Catchment C indicated as 1.4m deep and Catchment E 1.5m deep. However, as mentioned previously, all soakaways will need to be designed taking into consideration groundwater levels, any potential contamination and the site-specific infiltration rates at the detailed design stage.

- An **infiltration basin** has been located to the north of the existing school building within the area of open space. This basin receives runoff from Catchment A and facilitates its infiltration whilst also providing biodiversity and water quality benefits.
