## **Construction Noise and Vibration Monthly Report – February 2022**

### **Buckinghamshire**

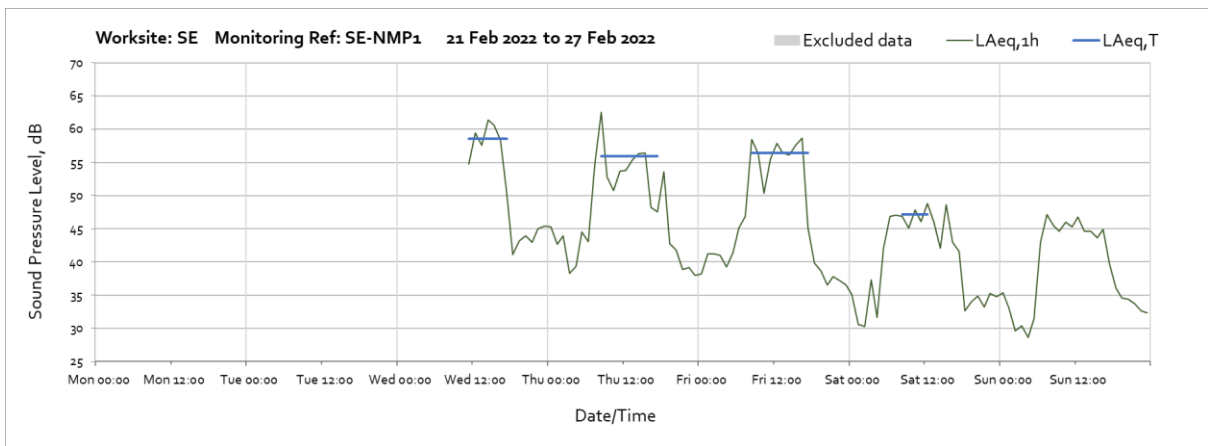
Note: Missing data between 22:00 on 20<sup>th</sup> February and 11:00 on 23<sup>rd</sup> February was due to loss of power to the equipment.
