## **Construction Noise and Vibration Monthly Report – February 2022**

**London Borough of Camden**

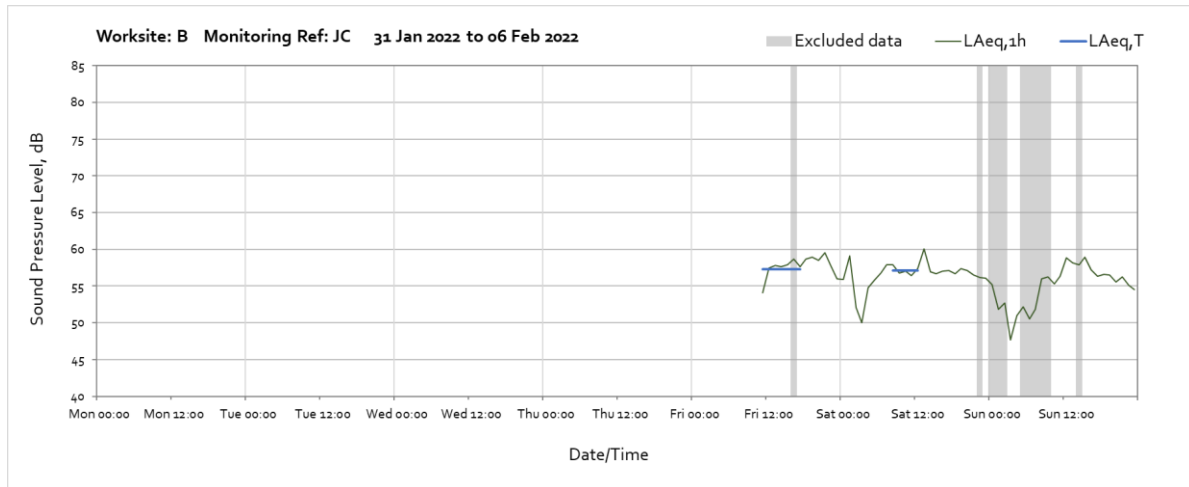
### Worksite: B – Monitoring Ref: JC

Note: Missing data from the start of the month until 11:00 on Friday 4<sup>th</sup> February was due to loss of power to the monitoring station caused by a damaged power supply unit. The power supply unit has been repaired with view of minimising loss of data in the future.

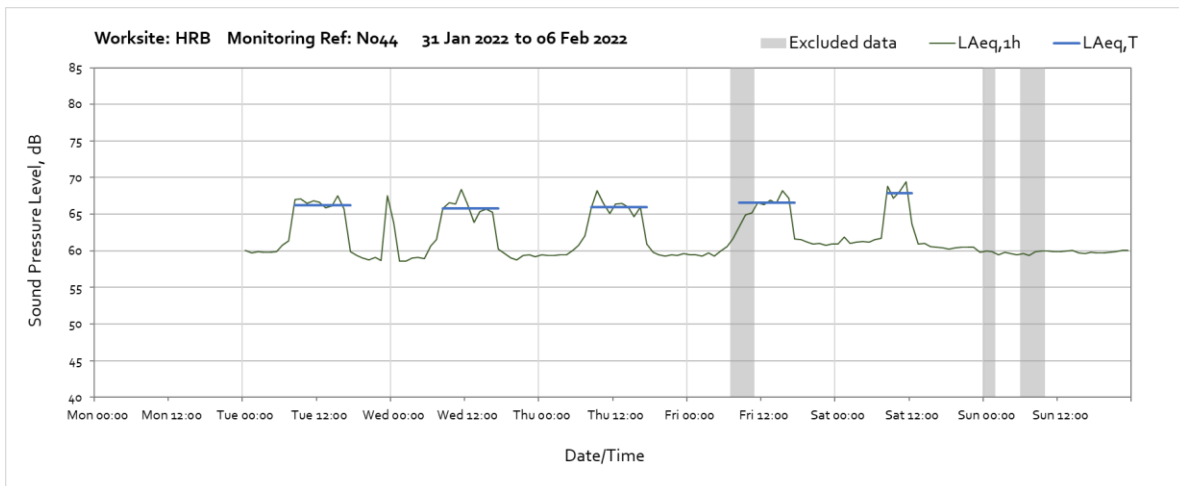
**Worksite: HRB – Monitoring Ref: N044**

Note: Continuous noise levels measured throughout the week were caused by an operational generator near to the monitor. The nearest receptor is located further from the generator and will therefore experience lower noise levels.

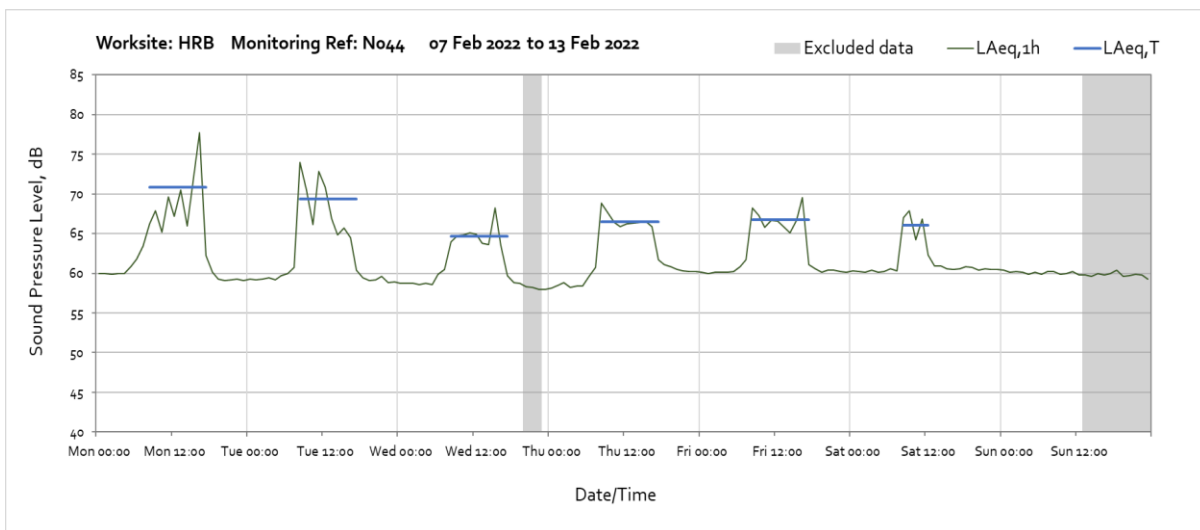
Note: Continuous noise levels measured throughout the week were caused by an operational generator

near to the monitor. The nearest receptor is located further from the generator and will therefore experience lower noise levels.

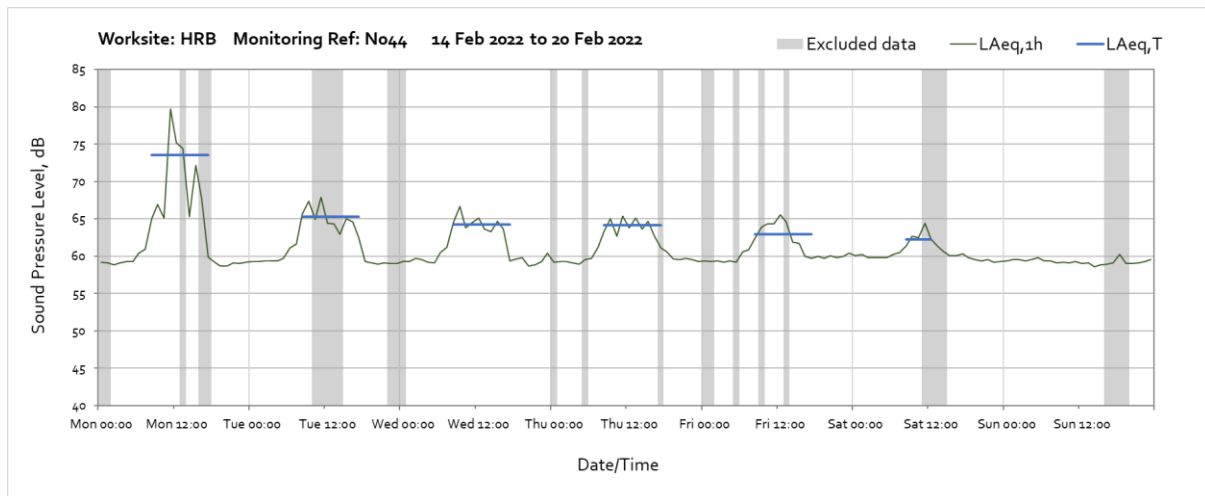
Note: Continuous noise levels measured throughout the week were caused by an operational generator near to the monitor. The nearest receptor is located further from the generator and will therefore experience lower noise levels.

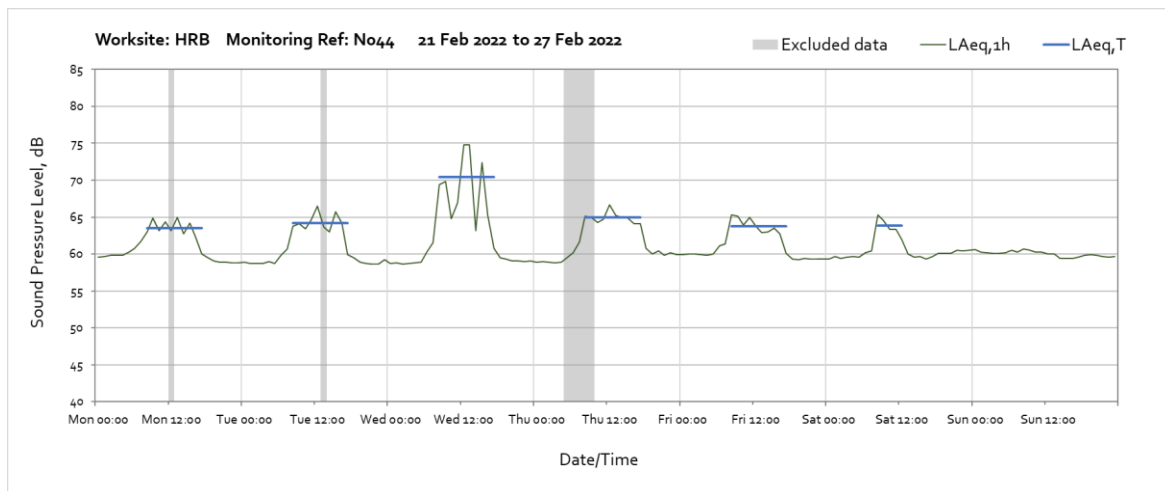
Note: Continuous noise levels measured throughout the week were caused by an operational generator near to the monitor. The nearest receptor is located further from the generator and will therefore experience lower noise levels.

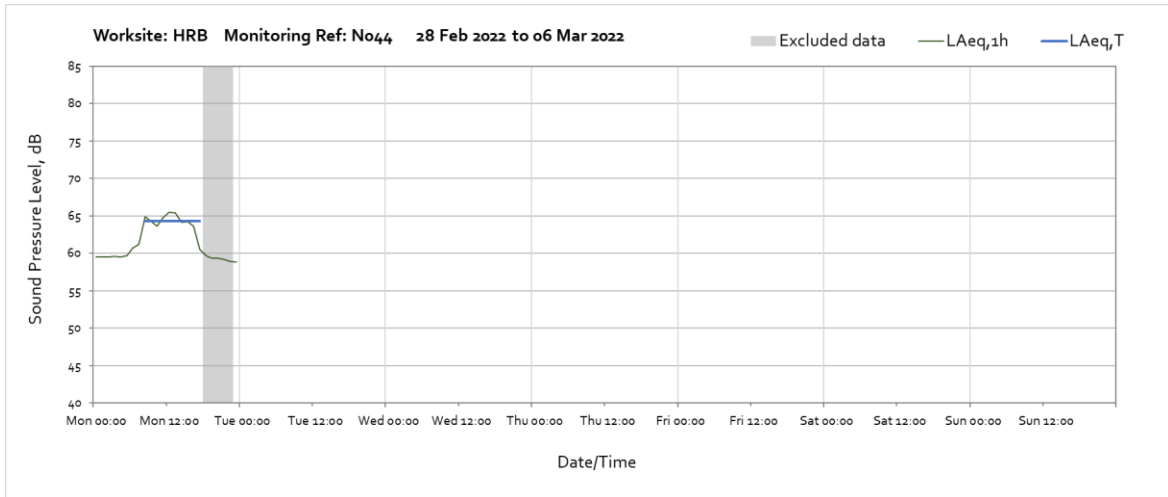
Note: Continuous noise levels measured throughout the week were caused by an operational generator near to the monitor. The nearest receptor is located further from the generator and will therefore experience lower noise levels.

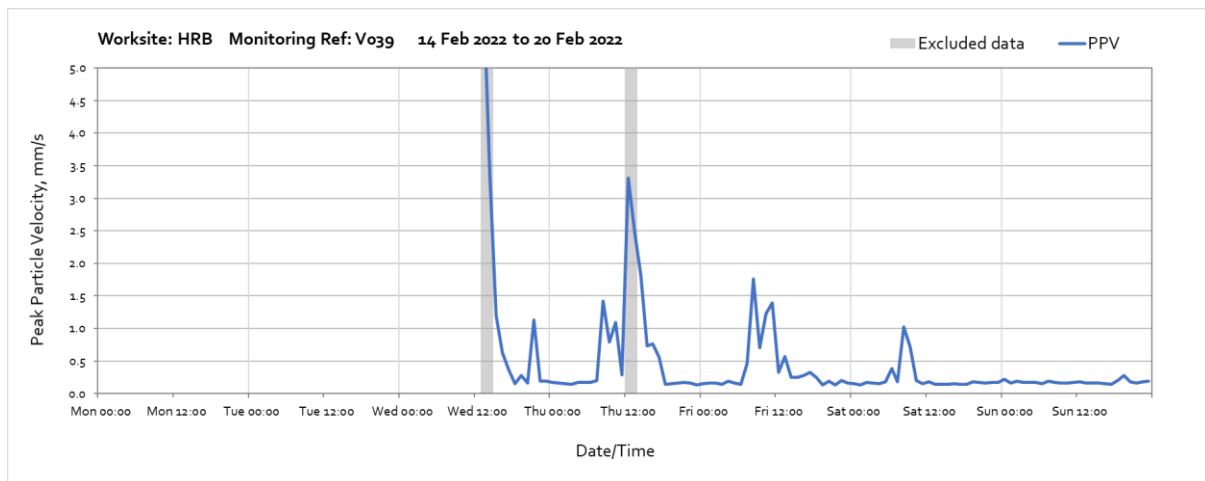
### Worksite: HRB – Monitoring Ref: V039

Note: Missing data from the start of the month until 13:00 on Wednesday 16<sup>th</sup> February was due to the removal of the monitor from site to allow modifications to the site hoarding.

High vibration levels measured from 13:00 until 14:00 on Wednesday 16<sup>th</sup> February were due to local disturbance of the monitor and are not representative of HS2 vibration levels at the receptor.

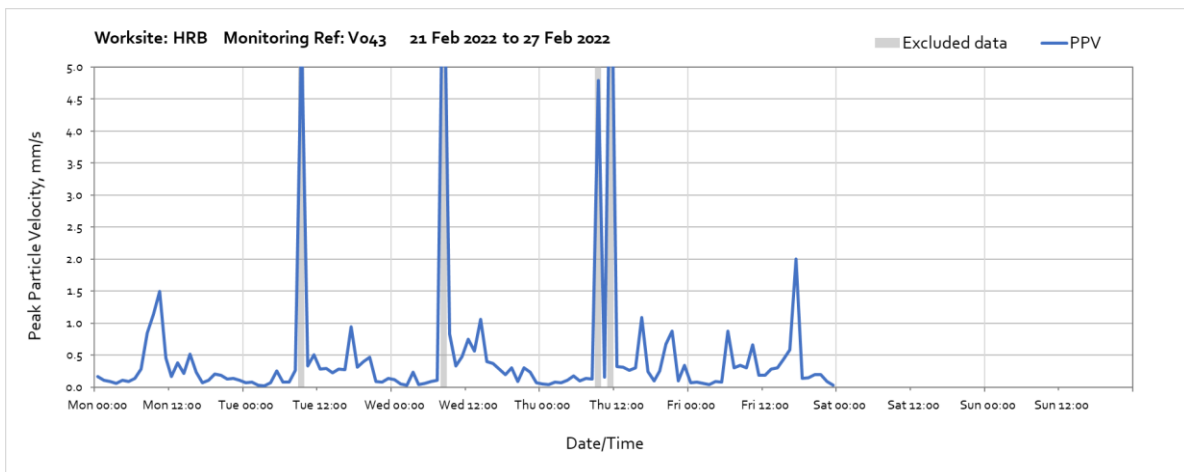
Note: High vibration levels measured throughout the week were due to local interference of the monitor and are not representative of HS2 vibration levels at the receptor. Missing data from 00:00 on Saturday 26<sup>th</sup> February until the end of the month was due to depletion of the monitoring station internal battery.

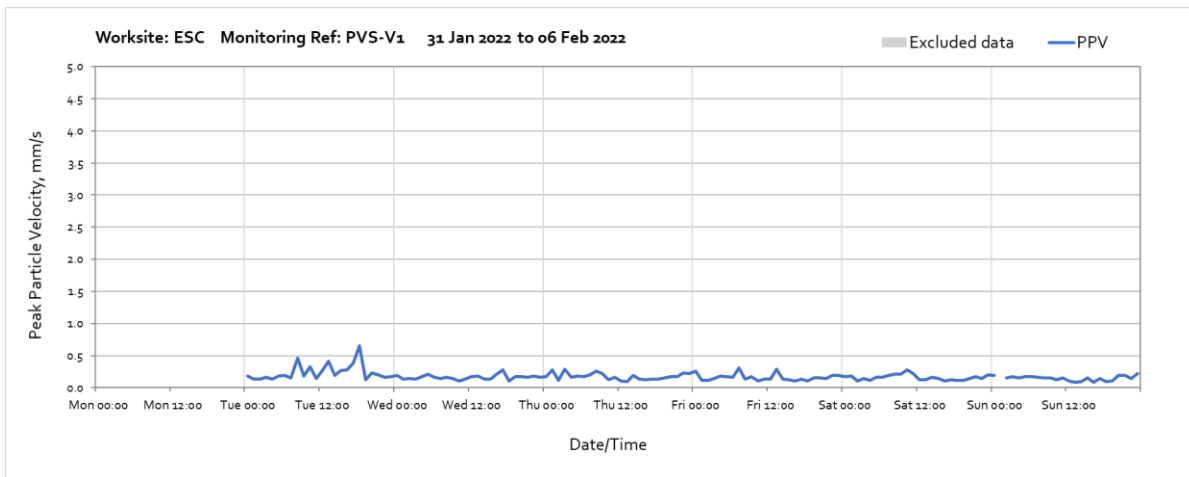
**Worksite: ESC - Monitoring Ref: PVS-V1**

Note: Missing data from 01:00 until 02:00 on Sunday 6<sup>th</sup> February was due to to a monitoring station error.

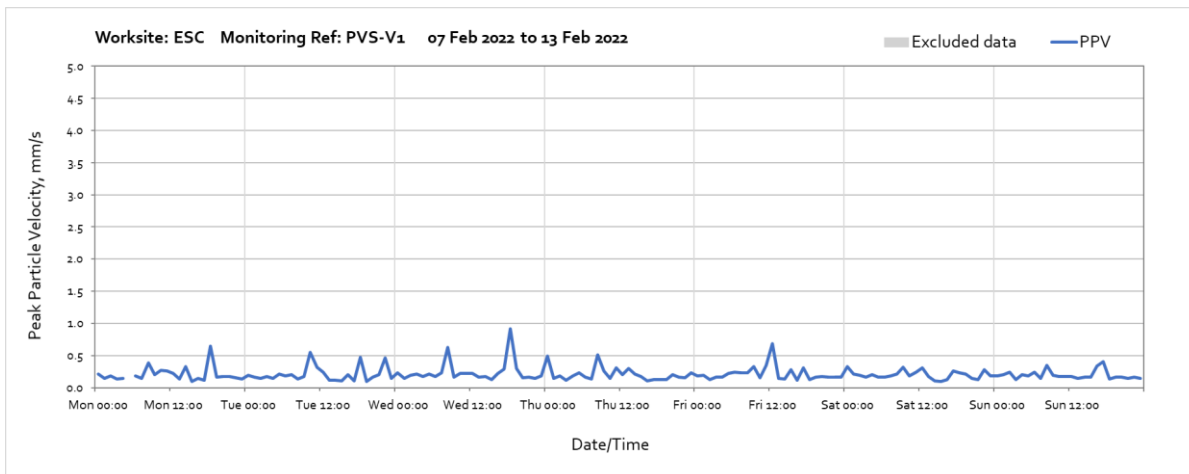
Note: Missing data from 05:00 until 06:00 on Monday 7<sup>th</sup> February was due to a monitoring station error.

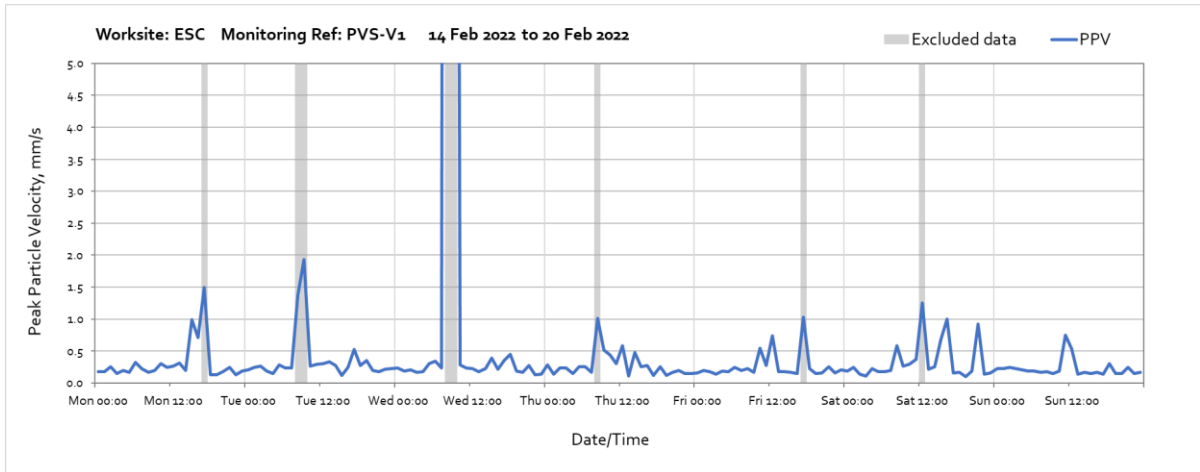
Note: High vibraton levels measured throughout the week were due to local interference of the monitor and are not representative of HS2 vibration levels at the receptor.
