Construction Noise and Vibration Monthly Report – March 2022

Buckinghamshire

This Noise and Vibration Monitoring Report fulfils HS2 Limited's commitment detailed in the Environmental Minimum Requirements (EMRs), Annex 1, Code of Construction Practice, to present the results of noise monitoring carried out within Buckinghamshire (BS) during the month of March 2022.

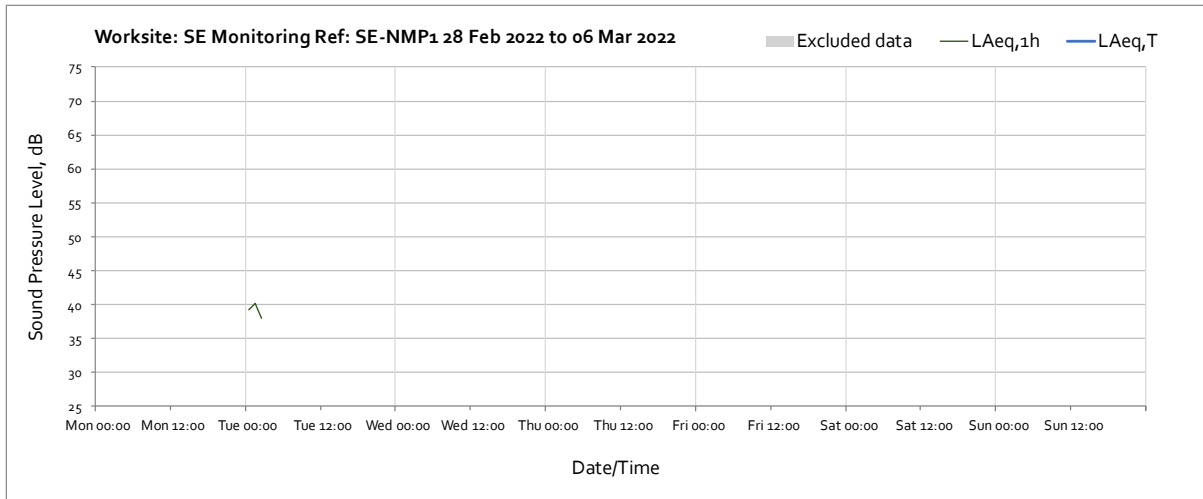
Worksite: SE – Monitoring Ref: SE-NMP1

Note: Missing date between 03:00 on Tuesday 1st March and 15:00 on Monday 7th March were due to prolonged loss of remote connection triggering a software error that temporarily prevented data capture, which has now been resolved.
