## **Construction Noise and Vibration Monthly Report – March 2022**

**London Borough of Camden**

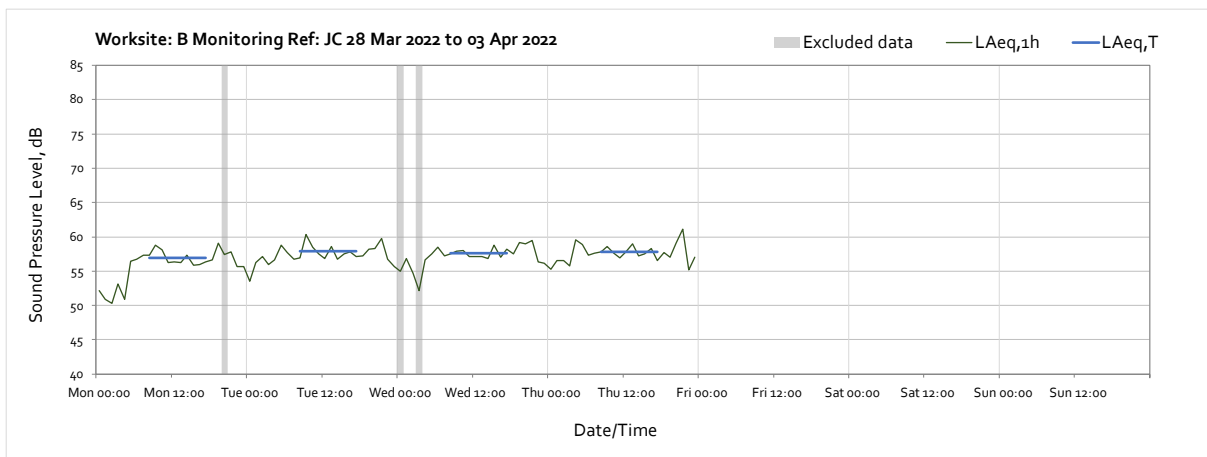
Note: Missing data at 01:00 on Sunday 27th March 2021 was due to the clocks going forward at the start of British Summer Time.

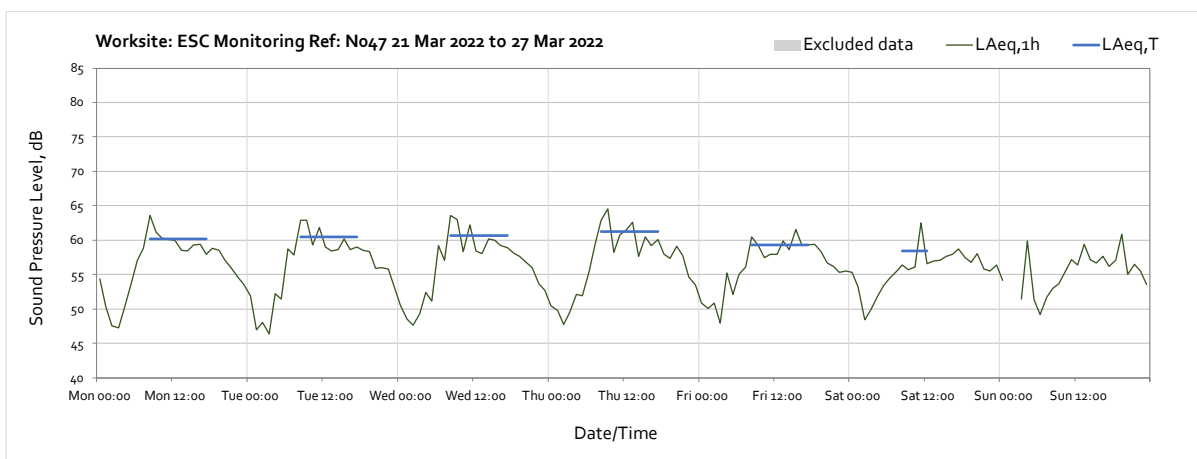
Note: Missing data at 01:00 on Sunday 27th March 2021 was due to the clocks going forward at the start of British Summer Time.

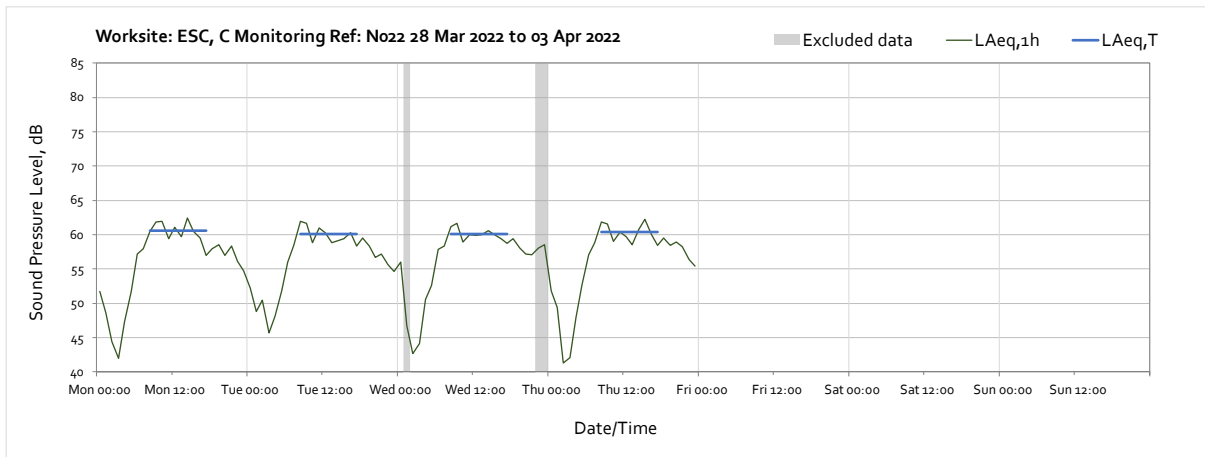
Note: Missing data at 01:00 on Sunday 27th March 2021 was due to the clocks going forward at the start of British Summer Time.

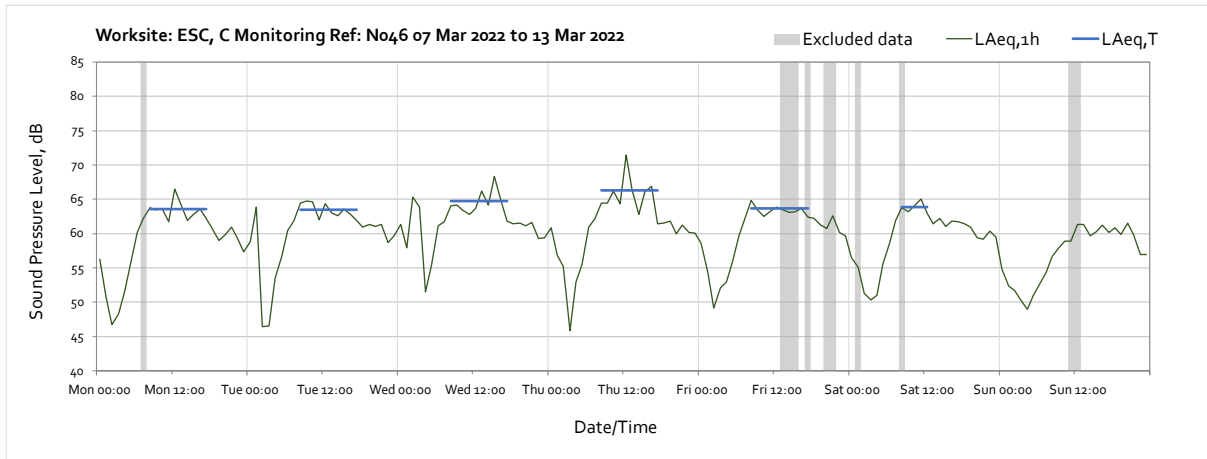
### Worksite: ESC, C – Monitoring Ref: N046

Note: Missing data at 01:00 on Sunday 27th March 2021 was due to the clocks going forward at the start of British Summer Time.

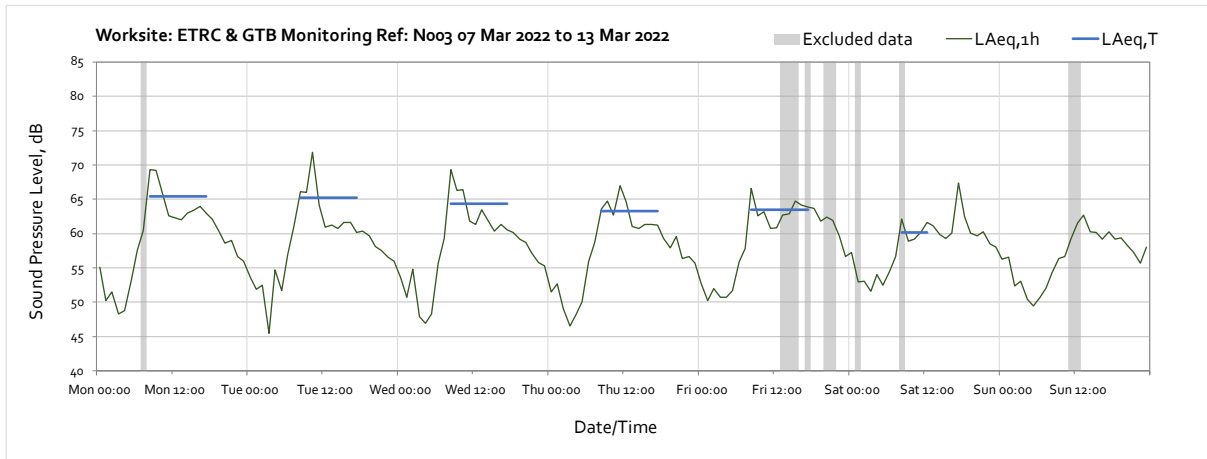
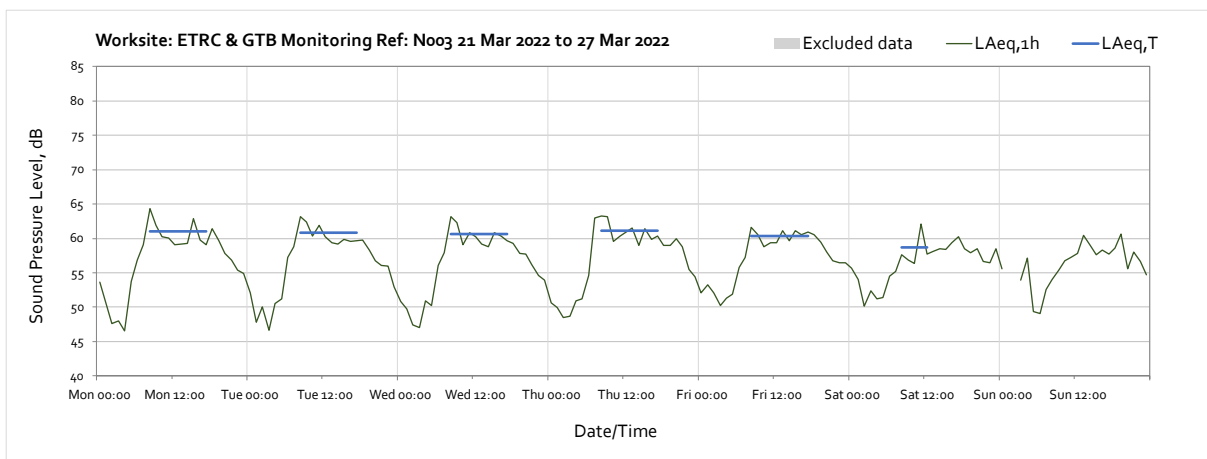
### Worksite: ETRC & GTB - Monitoring Ref: N003

Note: Missing data at 01:00 on Sunday 27th March 2021 was due to the clocks going forward at the start of British Summer Time.

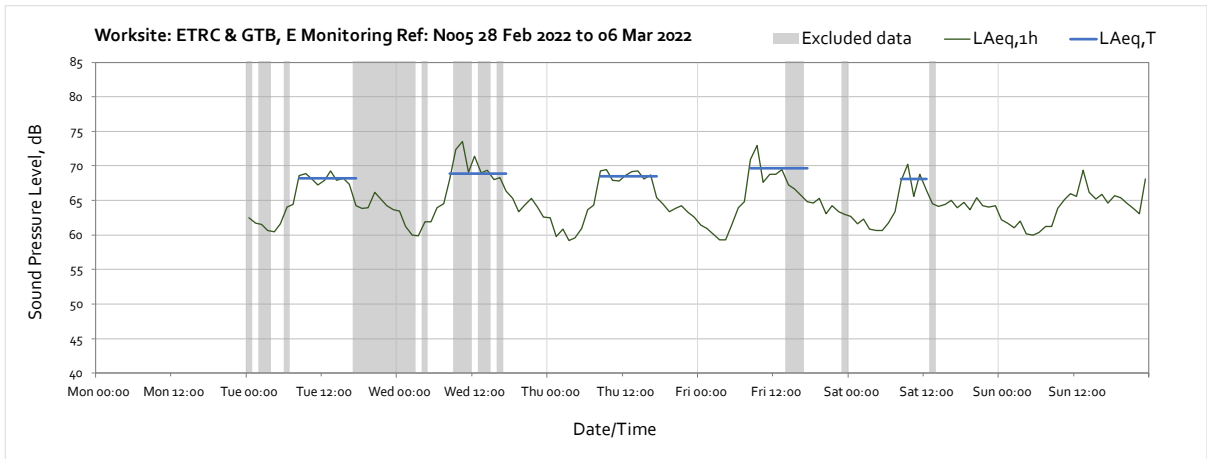
**Worksite: ETRC & GTB, E - Monitoring Ref: N005**

Note: Missing data at 01:00 on Sunday 27th March 2022 was due to the clocks going forward at the start of British Summer Time.

Note: Missing data at 11:00 on Sunday 27th March 2022 was due to a continuous loss of power.

Note: Missing data at 11:00 on Sunday 27th March 2022 to 09:00 on Monday -28<sup>th</sup> March 2022 was due to a continuous loss of power.

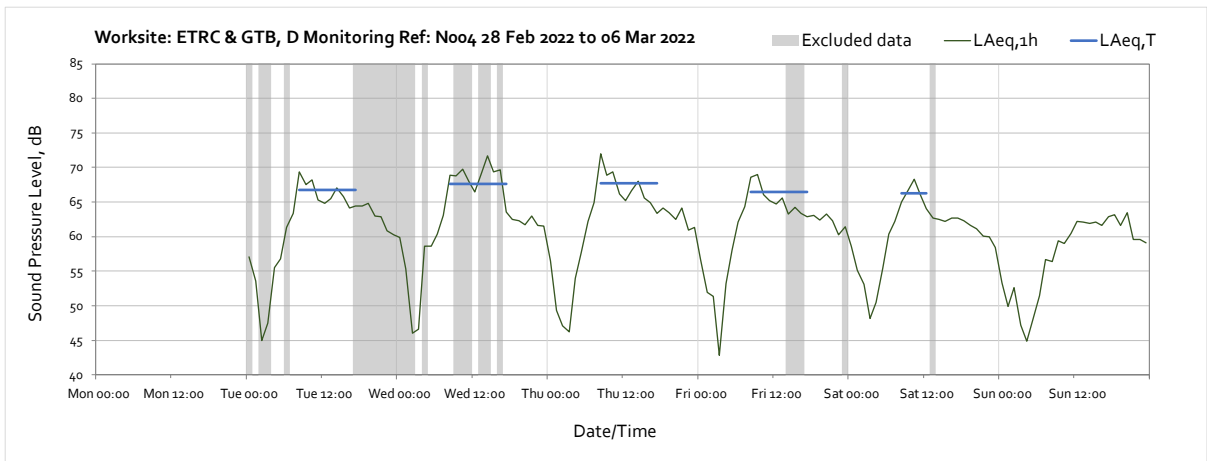
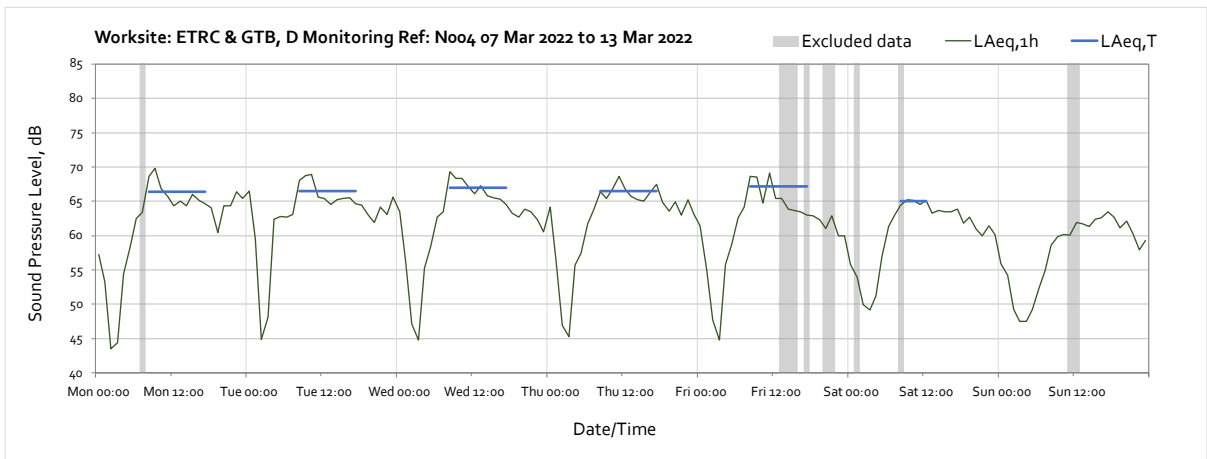
**Worksite: ETRC & GTB, D – Monitoring Ref: N004**

Note: Missing data at 01:00 on Sunday 27th March 2021 was due to the clocks going forward at the start of British Summer Time.

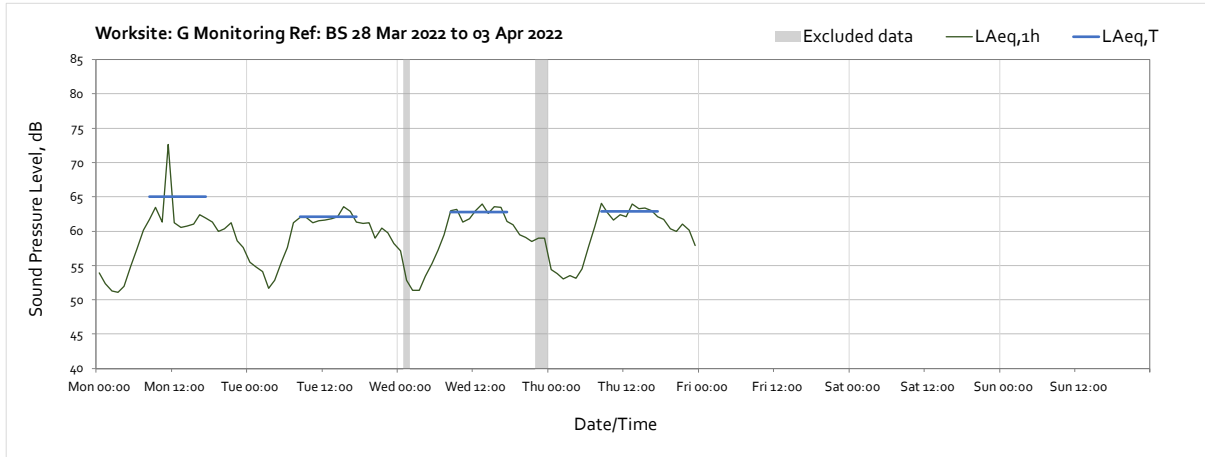
Note: Missing data at 01:00 on Sunday 27th March 2021 was due to the clocks going forward at the start of British Summer Time.

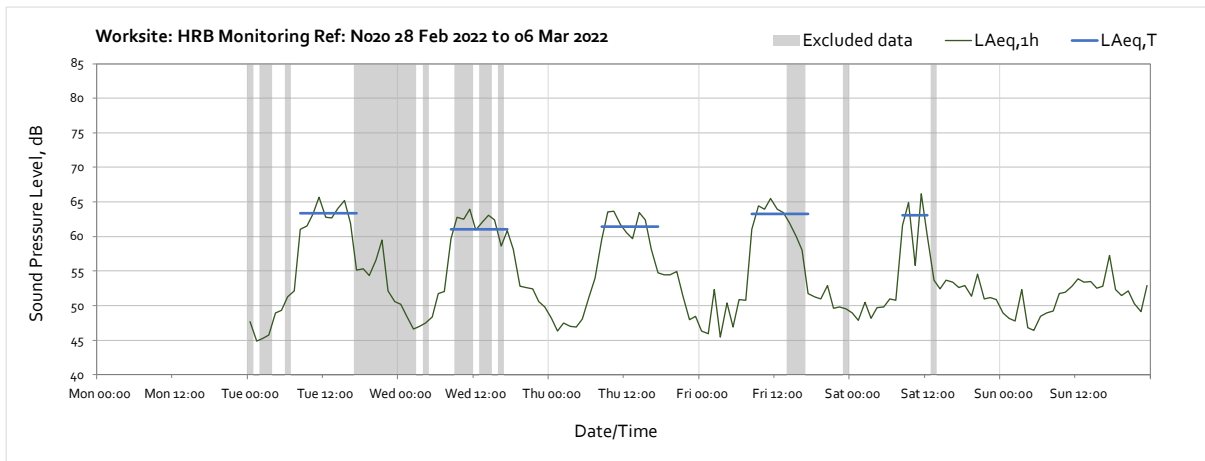
**Worksite: HRB – Monitoring Ref: N020**

Note: Missing data at 01:00 on Sunday 27th March 2021 was due to the clocks going forward at the start of British Summer Time.

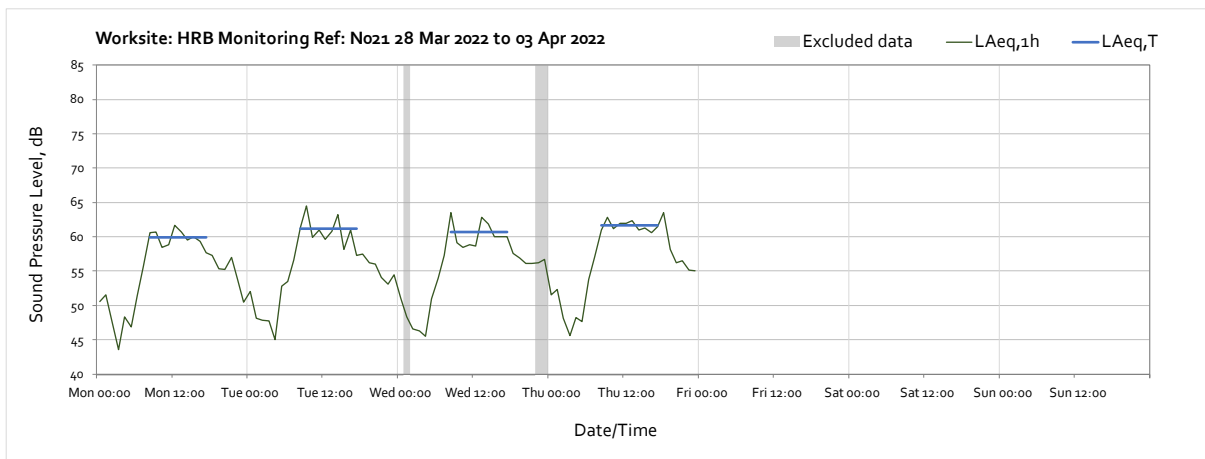
Note: Missing data at 01:00 on Sunday 27th March 2021 was due to the clocks going forward at the start of British Summer Time.

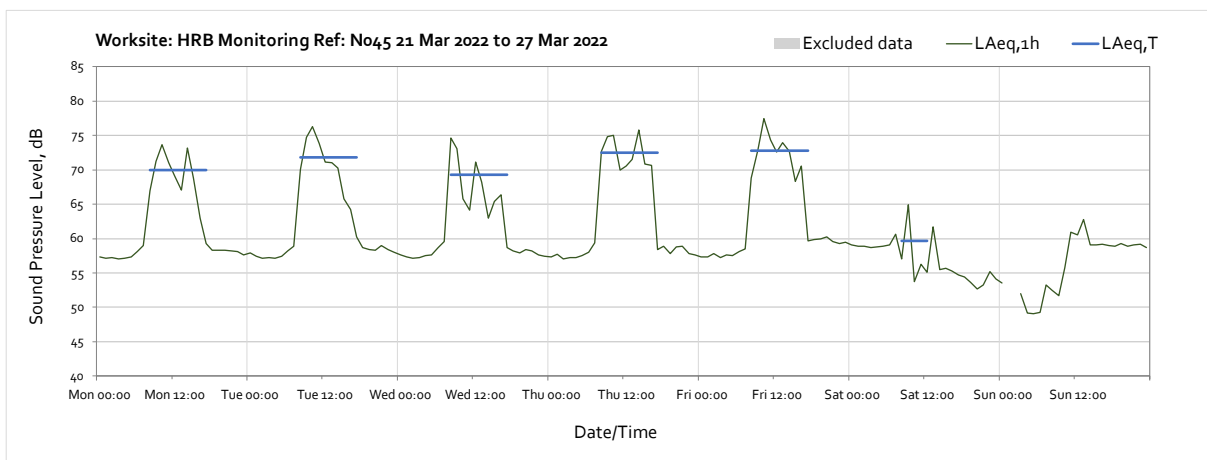
**Worksite: HRB – Monitoring Ref: N045**

Note: Missing data at 01:00 on Sunday 27th March 2021 was due to the clocks going forward at the start of British Summer Time.

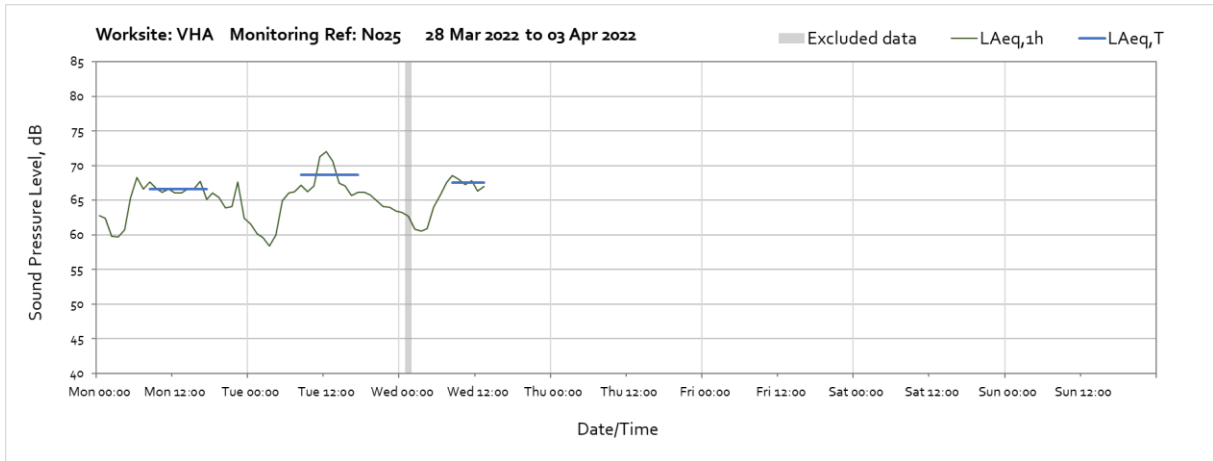
Note: Missing data at 01:00 on Sunday 27th March 2021 was due to the clocks going forward at the start of British Summer Time.

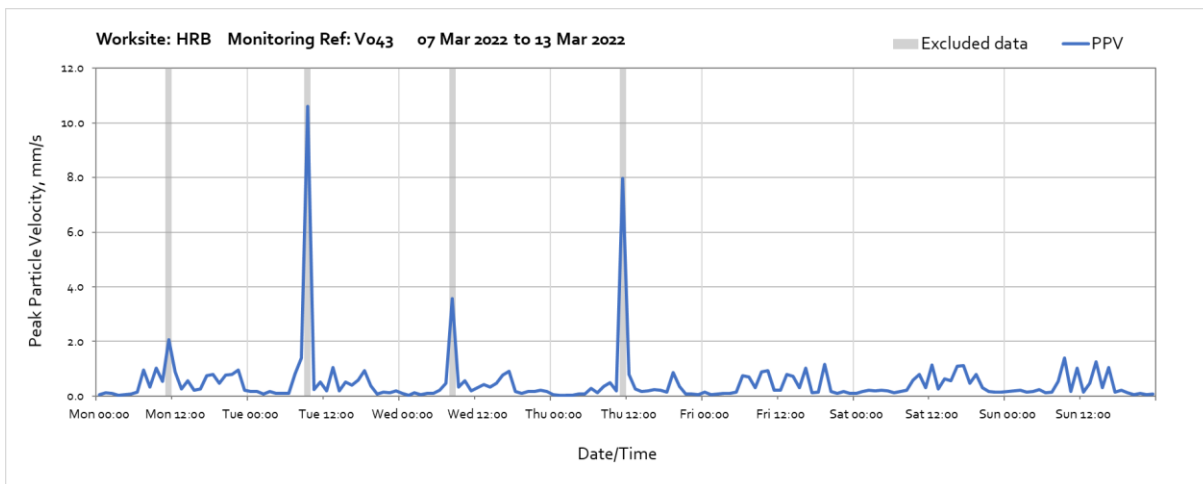
Note: Missing data from the start of the month until 11:00 on Tuesday 1<sup>st</sup> March was due to depletion of the monitoring station batteries. High vibration levels measured throughout the week were due to local disturbance of the monitor and are not representative of HS2 vibration levels at the receptor.

Note: High vibration levels measured throughout the week were due to local disturbance of the monitor and are not representative of HS2 vibration levels at the receptor.

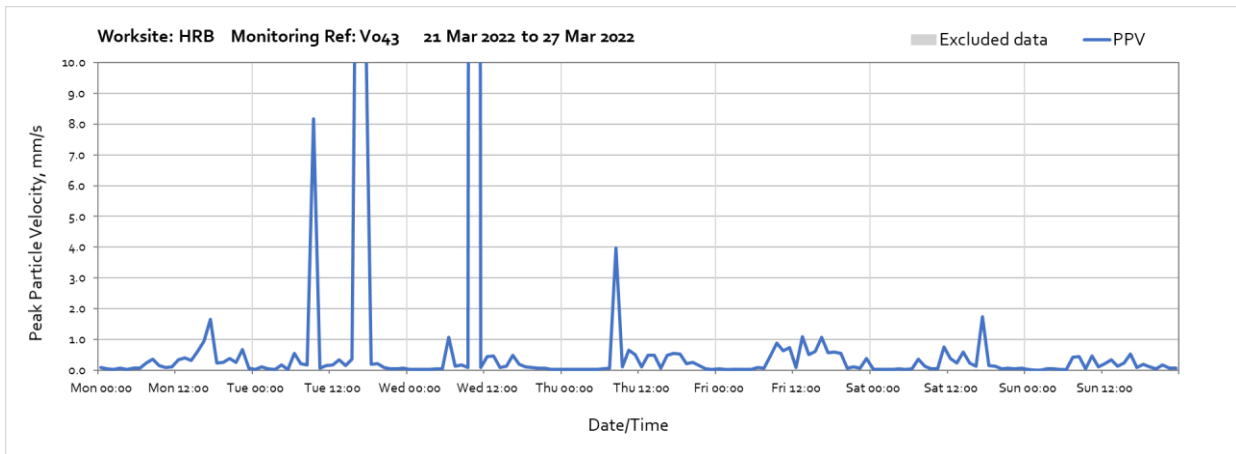
Note: High vibration levels measured throughout the week were due to local disturbance of the monitor and are not representative of HS2 vibration levels at the receptor.

Note: Missing data at 01:00 on Sunday 27th March 2021 was due to the clocks going forward at the start of British Summer Time.

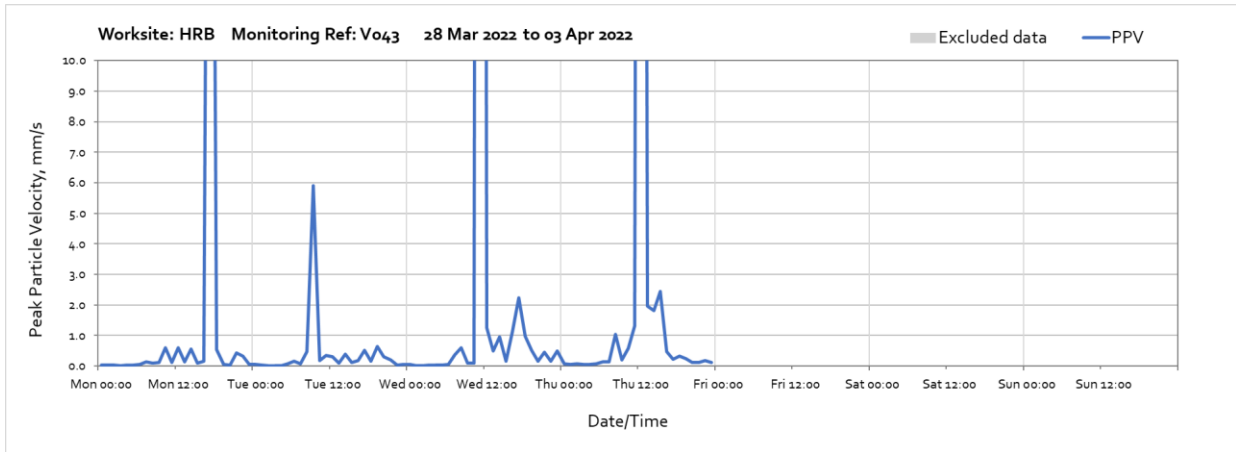
Note: High vibration levels measured throughout the week were due to local disturbance of the monitor and are not representative of HS2 vibration levels at the receptor.

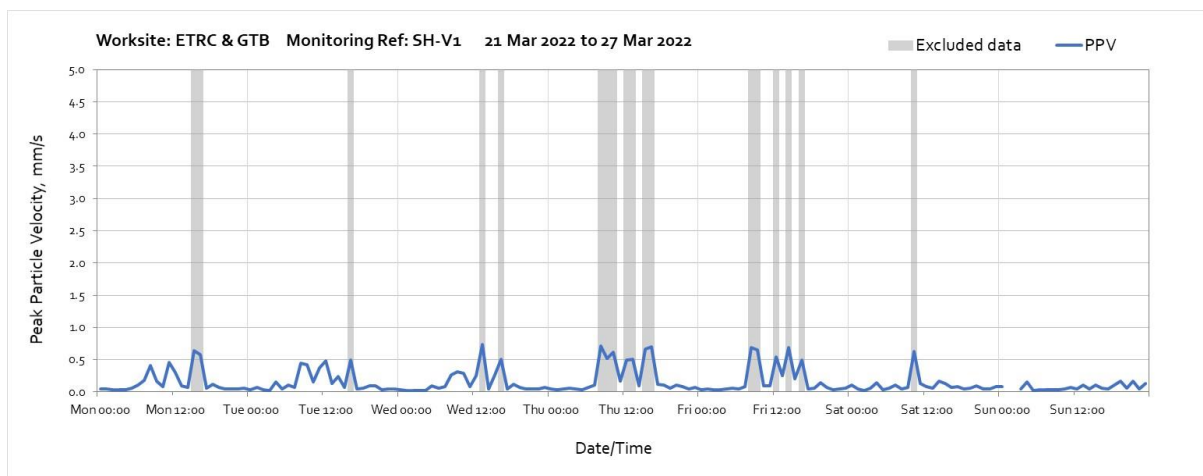
Note: High vibration levels measured throughout the week were due to local disturbance of the monitor and are not representative of HS2 vibration levels at the receptor.

Note: Missing data at 01:00 on Sunday 27th March 2021 was due to the clocks going forward at the start of British Summer Time.

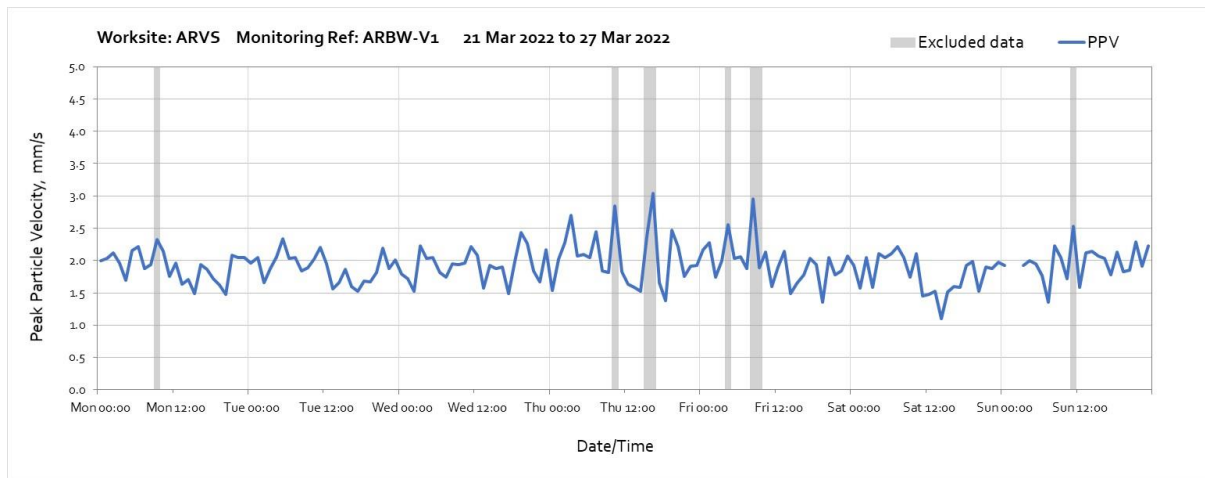
Note: High vibration levels measured throughout the week were due to local disturbance of the monitor and are not representative of HS2 vibration levels at the receptor.

Note: Missing data at 01:00 on Sunday 27th March 2021 was due to the clocks going forward at the start of British Summer Time.
