ACCIDENT

Aircraft Type and Registration:	Vickers Slingsby T65A Vega, G-EECK
No & Type of Engines:	N/A
Year of Manufacture:	1979 (Serial no: 1917)
Date & Time (UTC):	13 October 2021 at 1216 hrs
Location:	Near Portmoak Airfield, Scotlandwell, Kinross
Type of Flight:	Private
Persons on Board:	Crew - 1 Passengers - None
Injuries:	Crew - 1 (Serious) Passengers - N/A
Nature of Damage:	Damaged beyond economical repair
Commander's Licence:	Other
Commander's Age:	70 years
Commander's Flying Experience:	212 hours (of which 64 were on type) Last 90 days - 5 hours Last 28 days - 3 hours
Information Source:	Aircraft Accident Report Form submitted by the pilot and further enquiries by the AAIB

The pilot lost control of the glider and struck the ground after the canopy became insecure soon after takeoff.

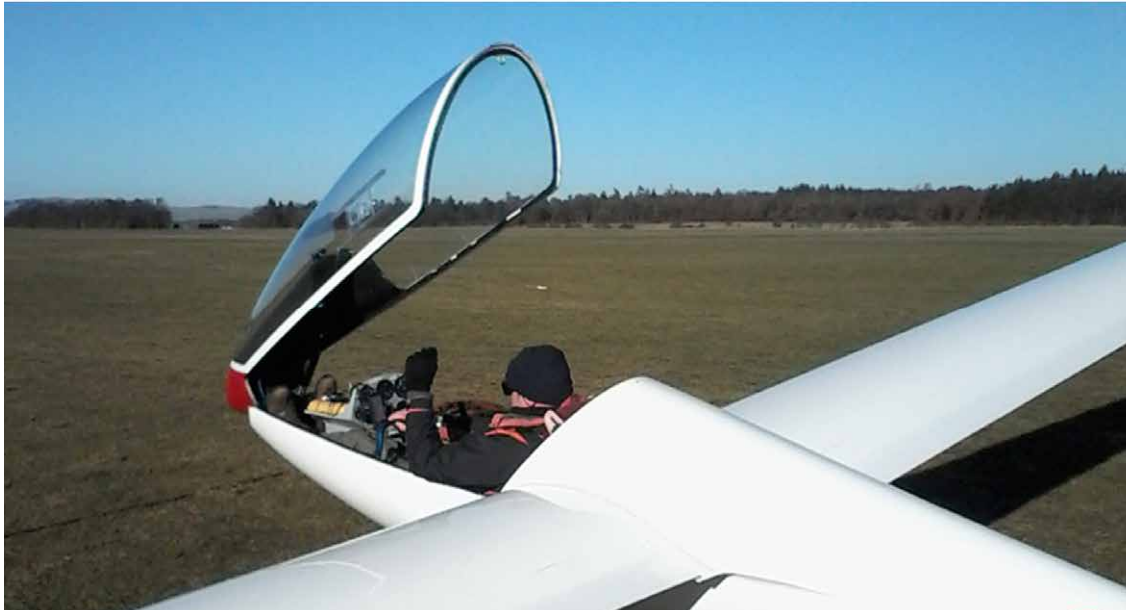
Figure 1

The canopy on the Slingsby T65A Vega has an opening hinge on the nose of the glider and opens vertically at the rear (Figure 1).

Slingsby T65A Vega glider showing canopy open and side window

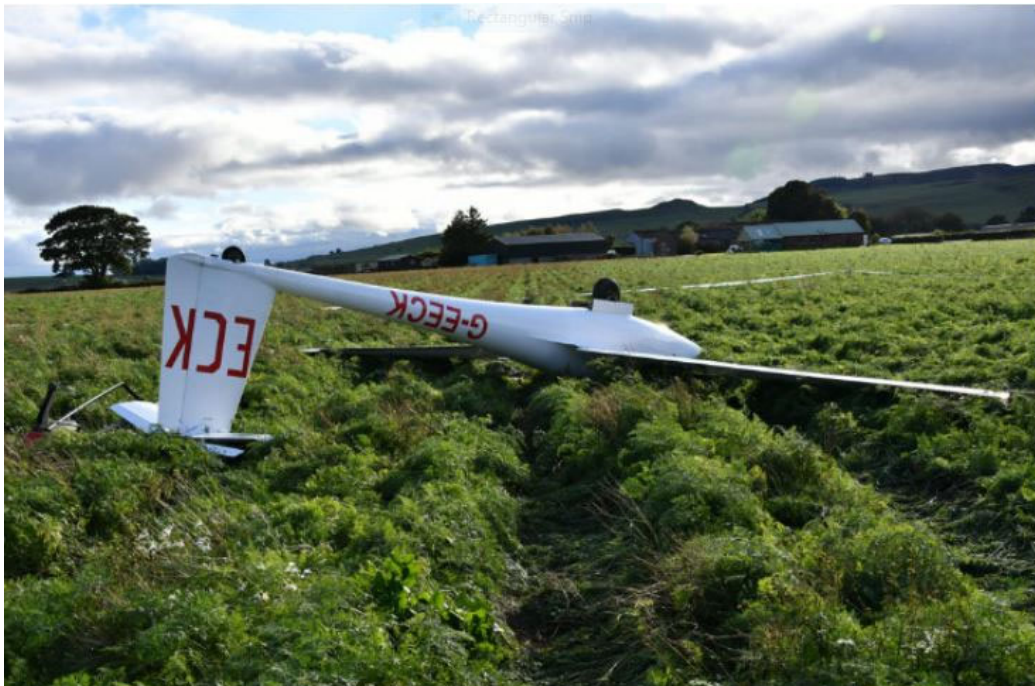
struck the ground at an attitude of about 20° to 30° nose down, cartwheeled and came to rest inverted in a field of vegetables in the undershoot of Runway 28 (Figure 2). This left the pilot trapped upside down in the cockpit supported by his harness.

Figure 2
G-EECK after the accident

The glider became airborne with its canopy not closed and locked. This led him to secure it with one hand while trying to fly the glider and configure it for landing with the other. This meant he released the control column during the approach and lost control.

The glider's canopy was not secured during the pre-flight preparation because the pilot and his assistant became distracted. This led to the canopy becoming unsecure soon after takeoff.
