May 2022

HS2

Air Quality and Dust Monitoring Monthly Report - May 2022 **Buckinghamshire** Council

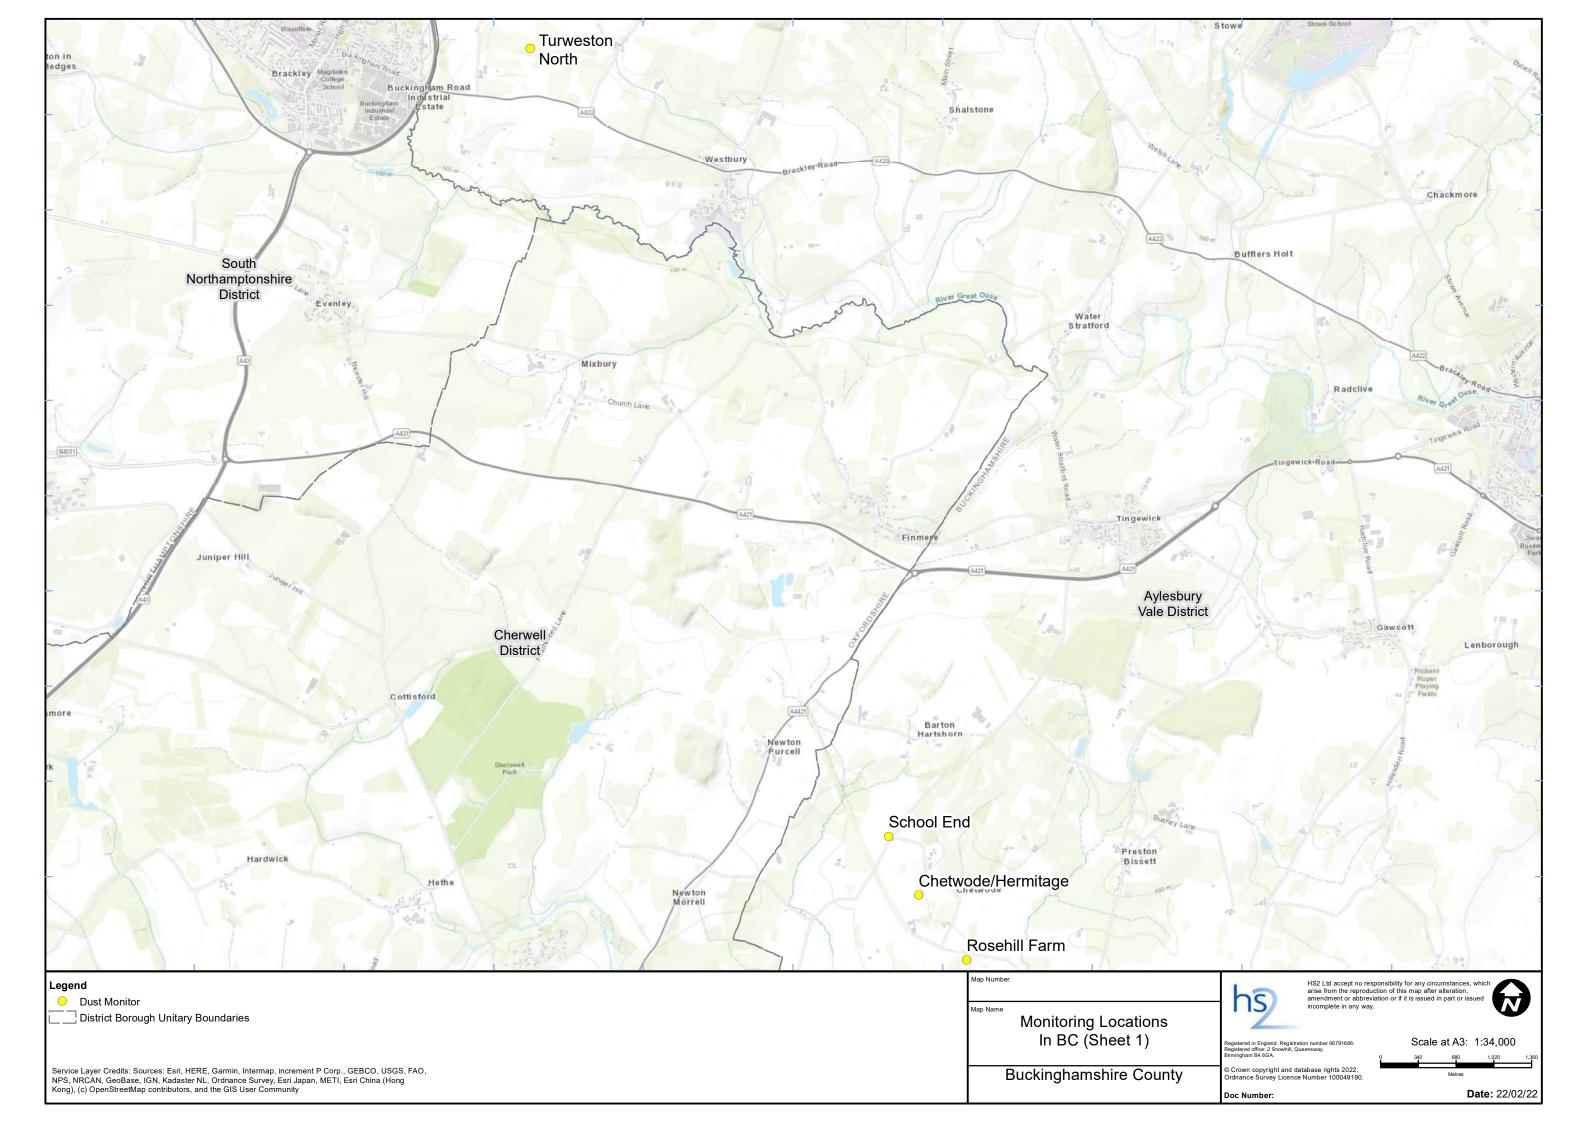
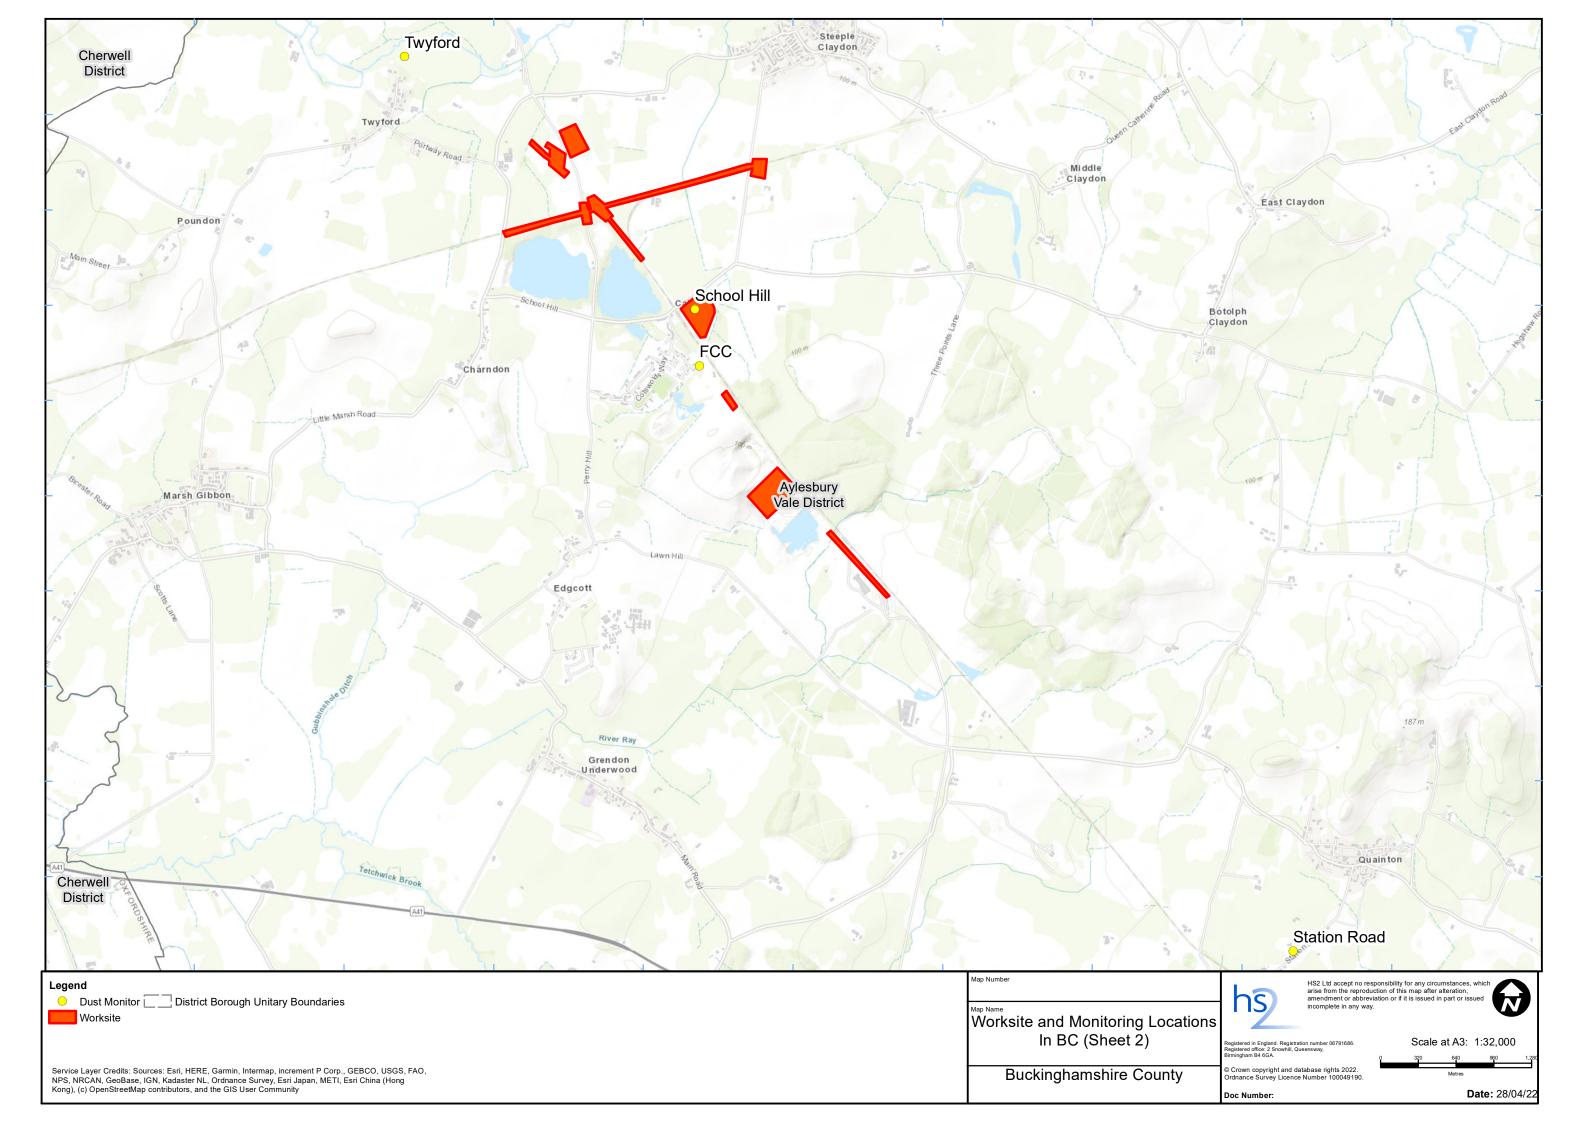
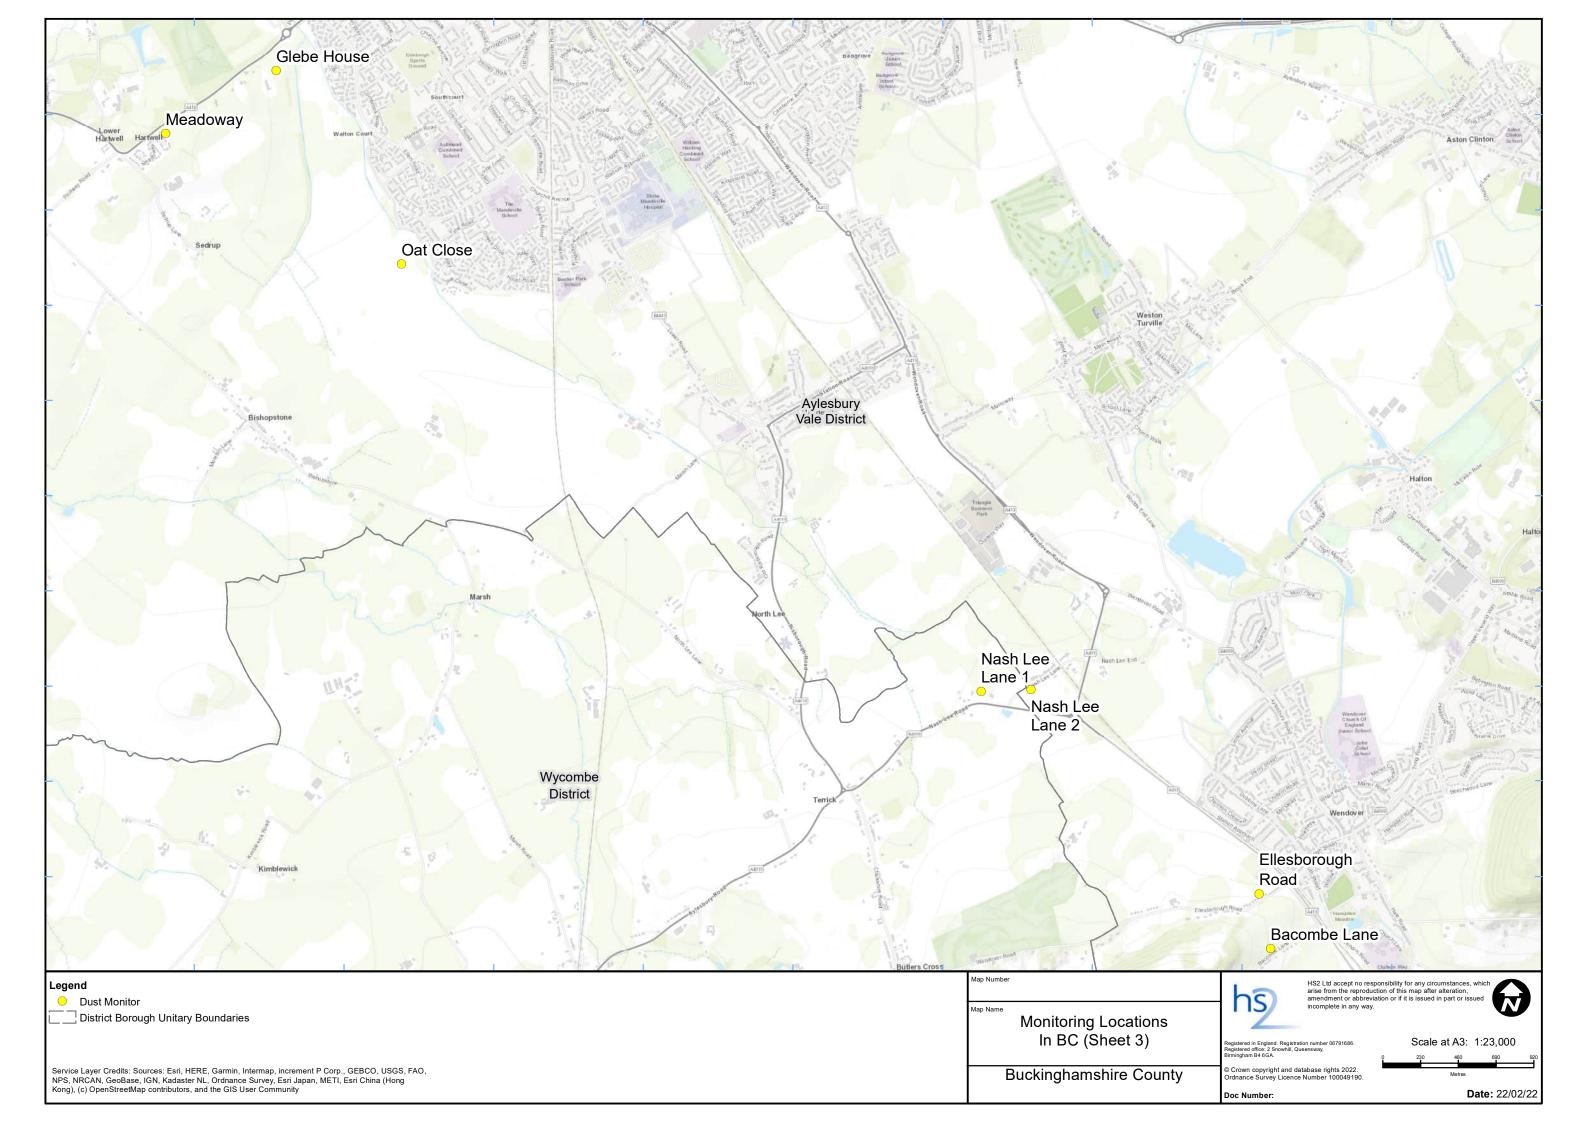
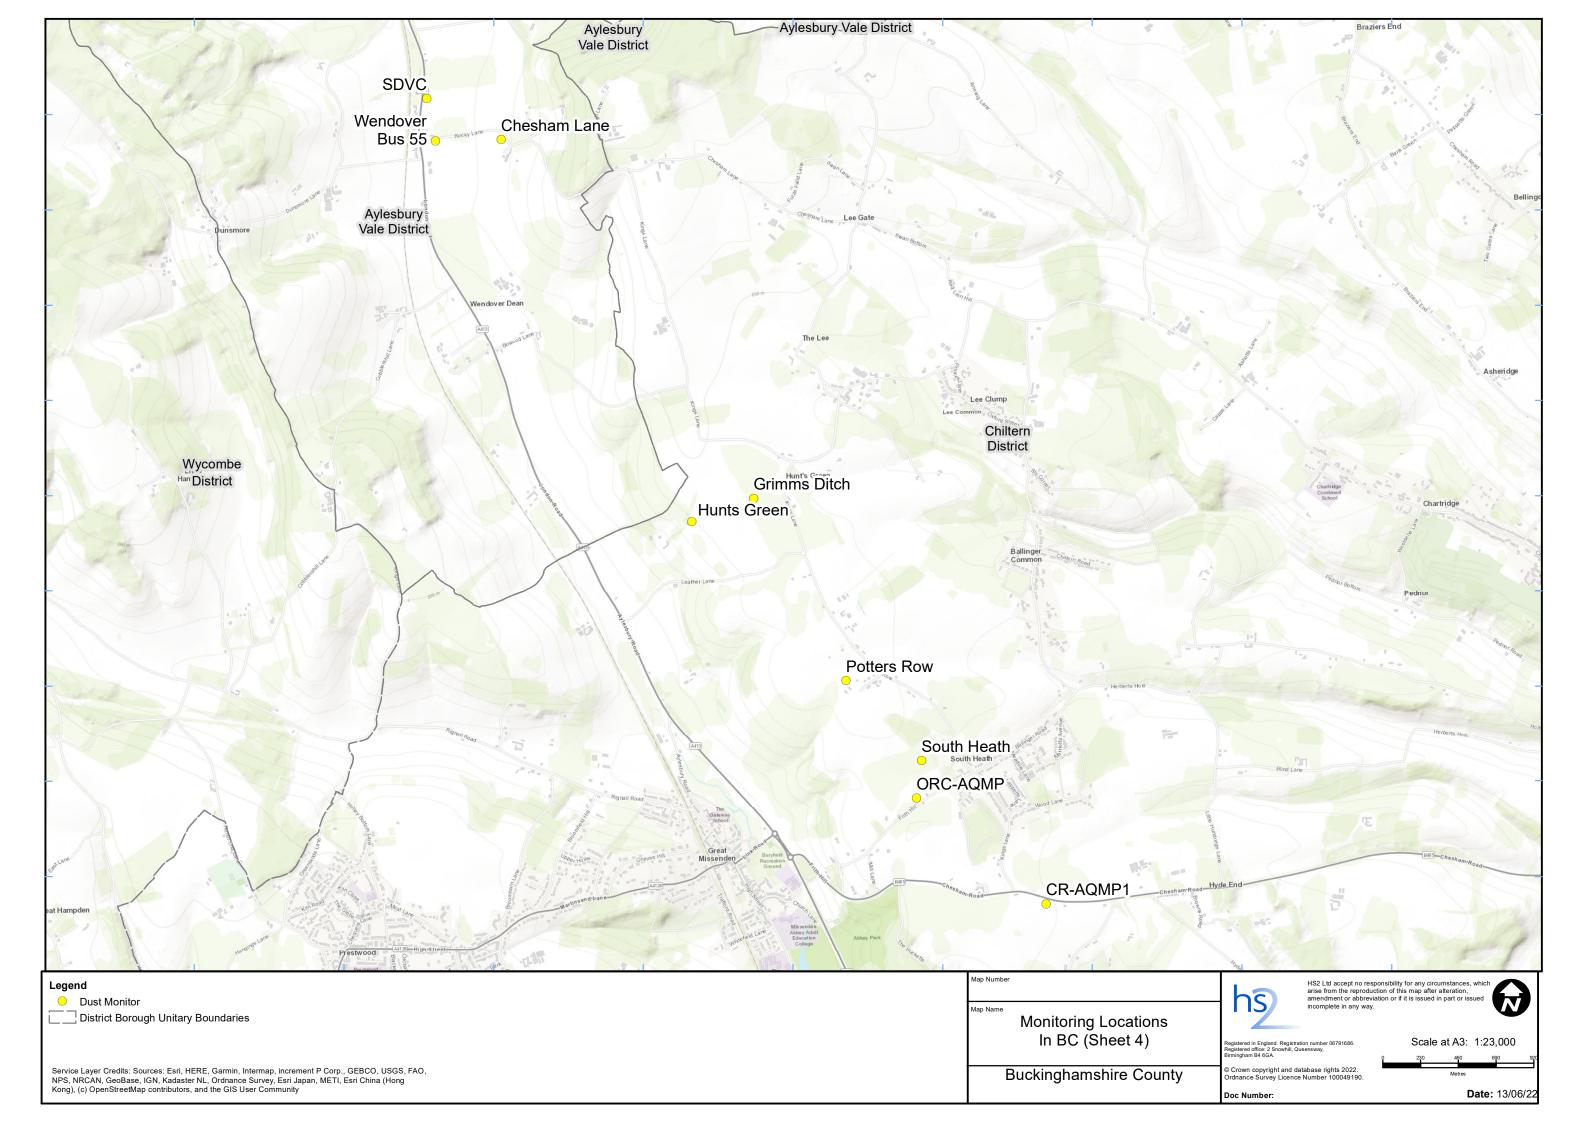
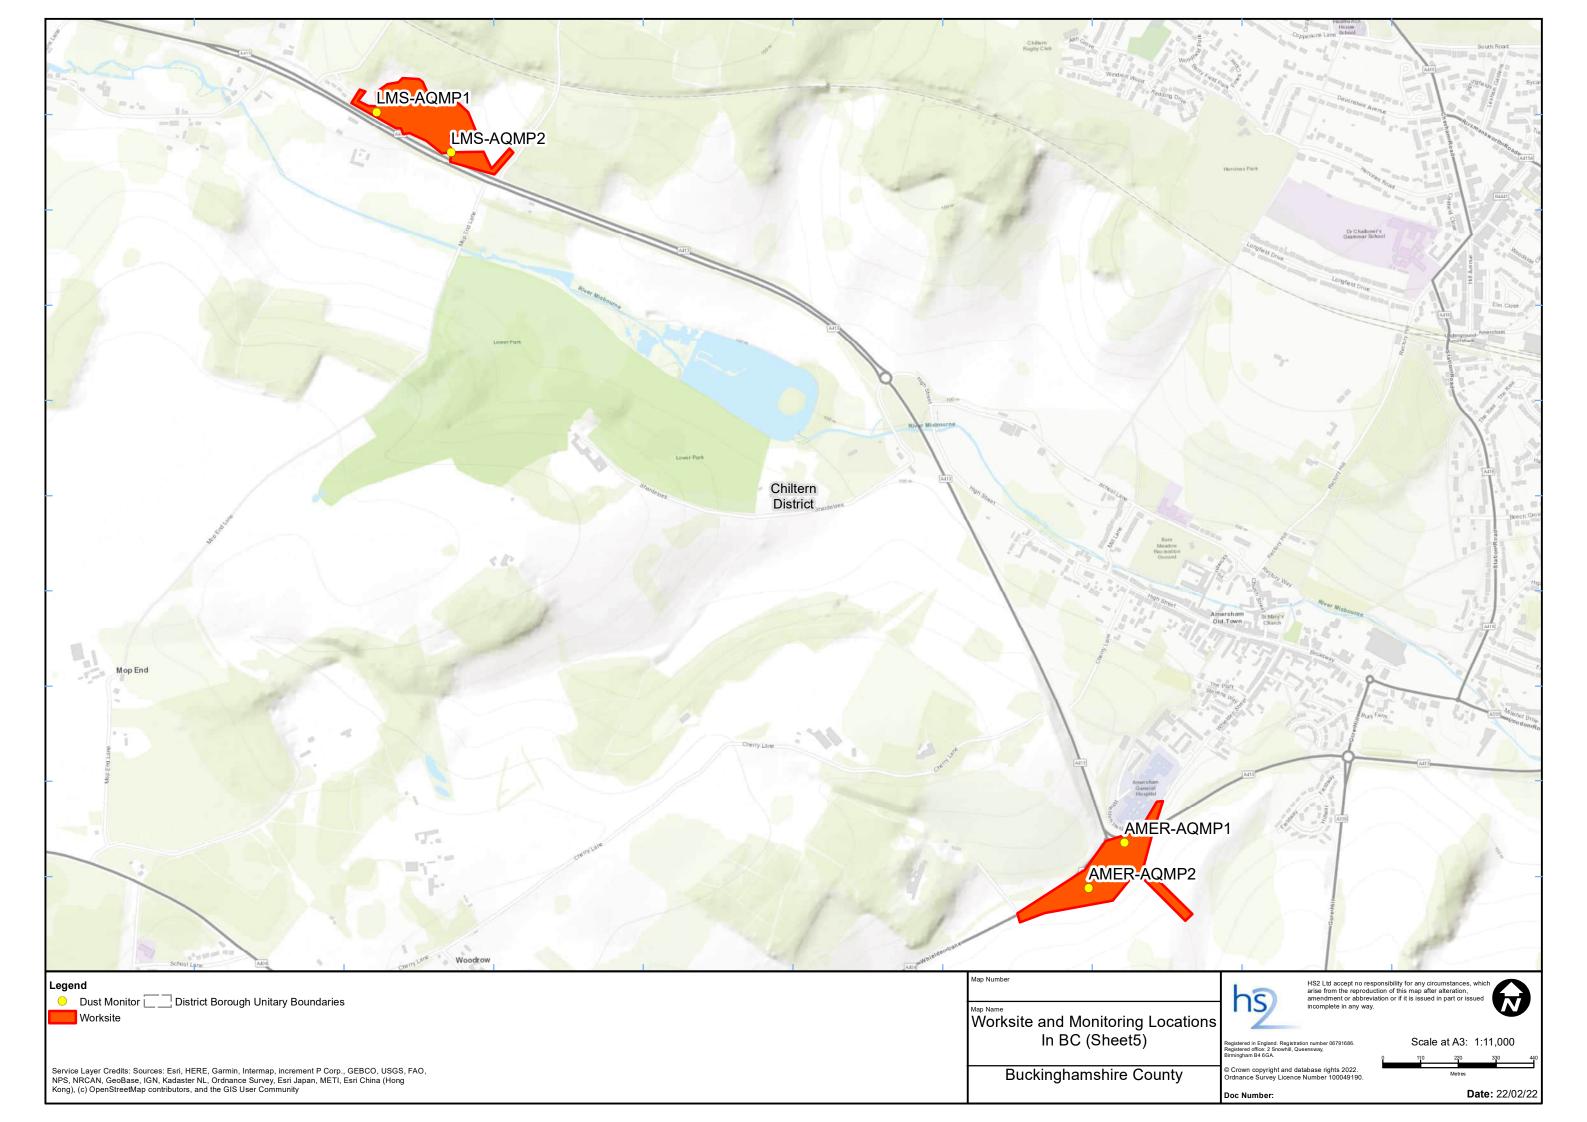
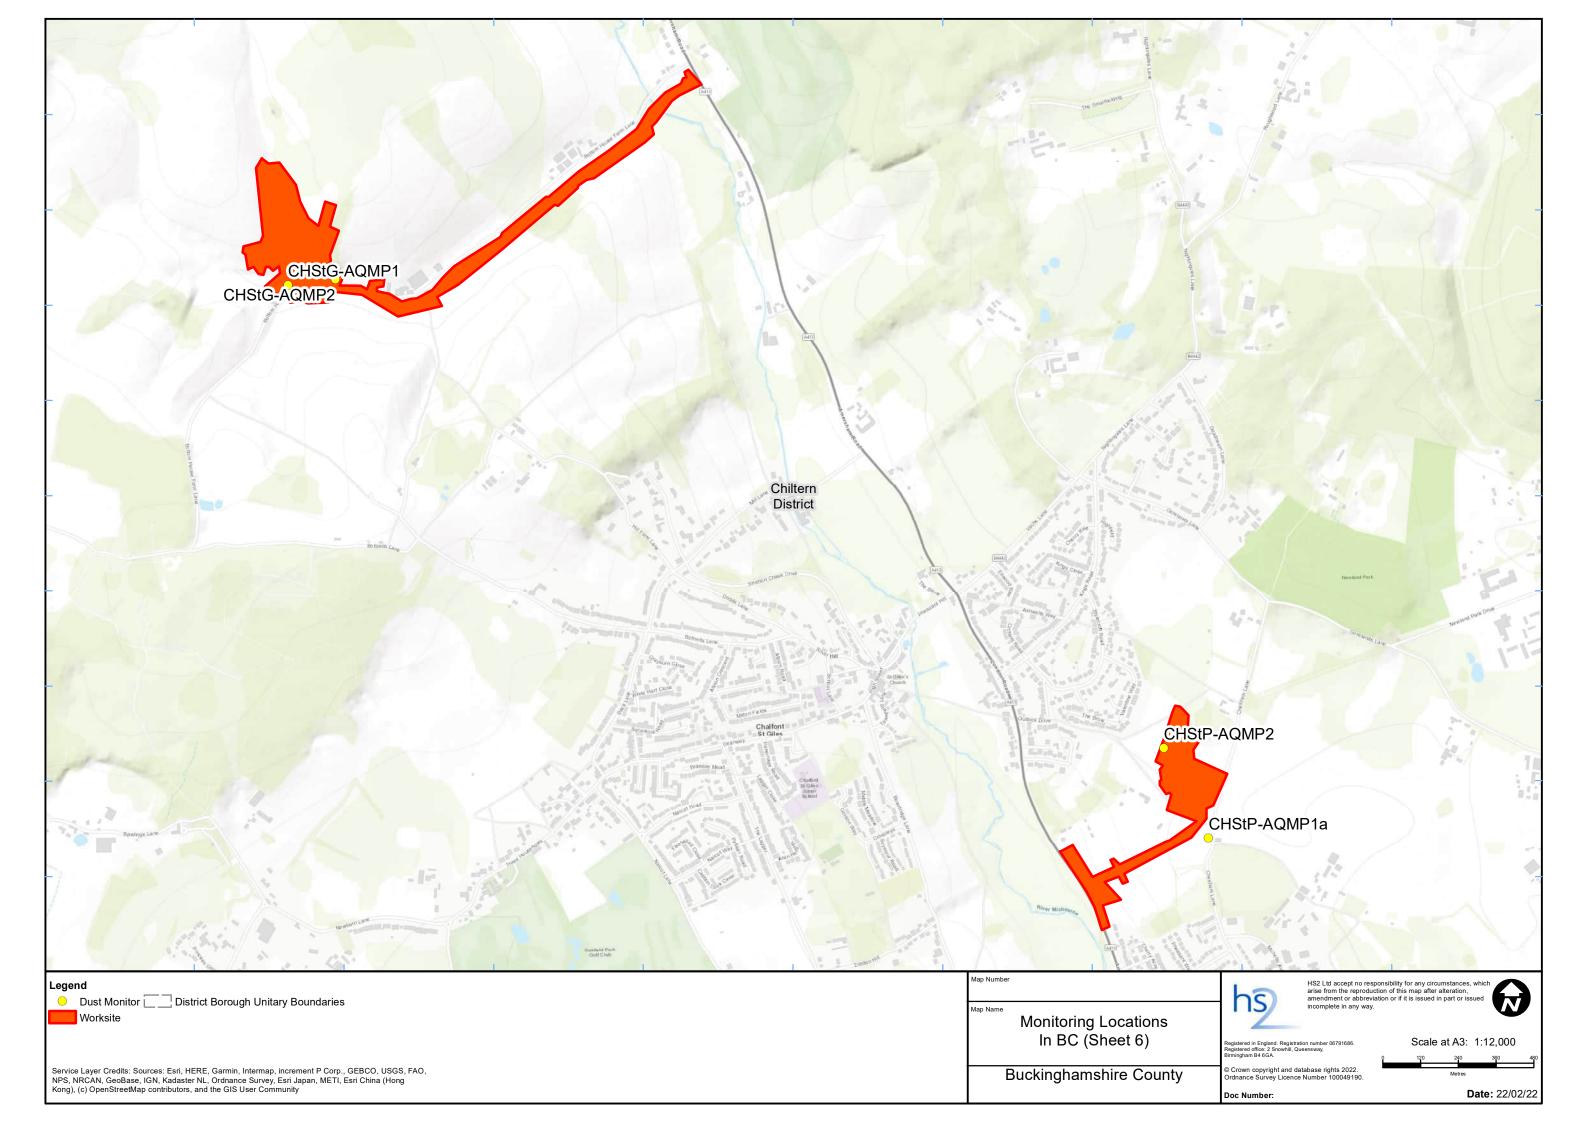
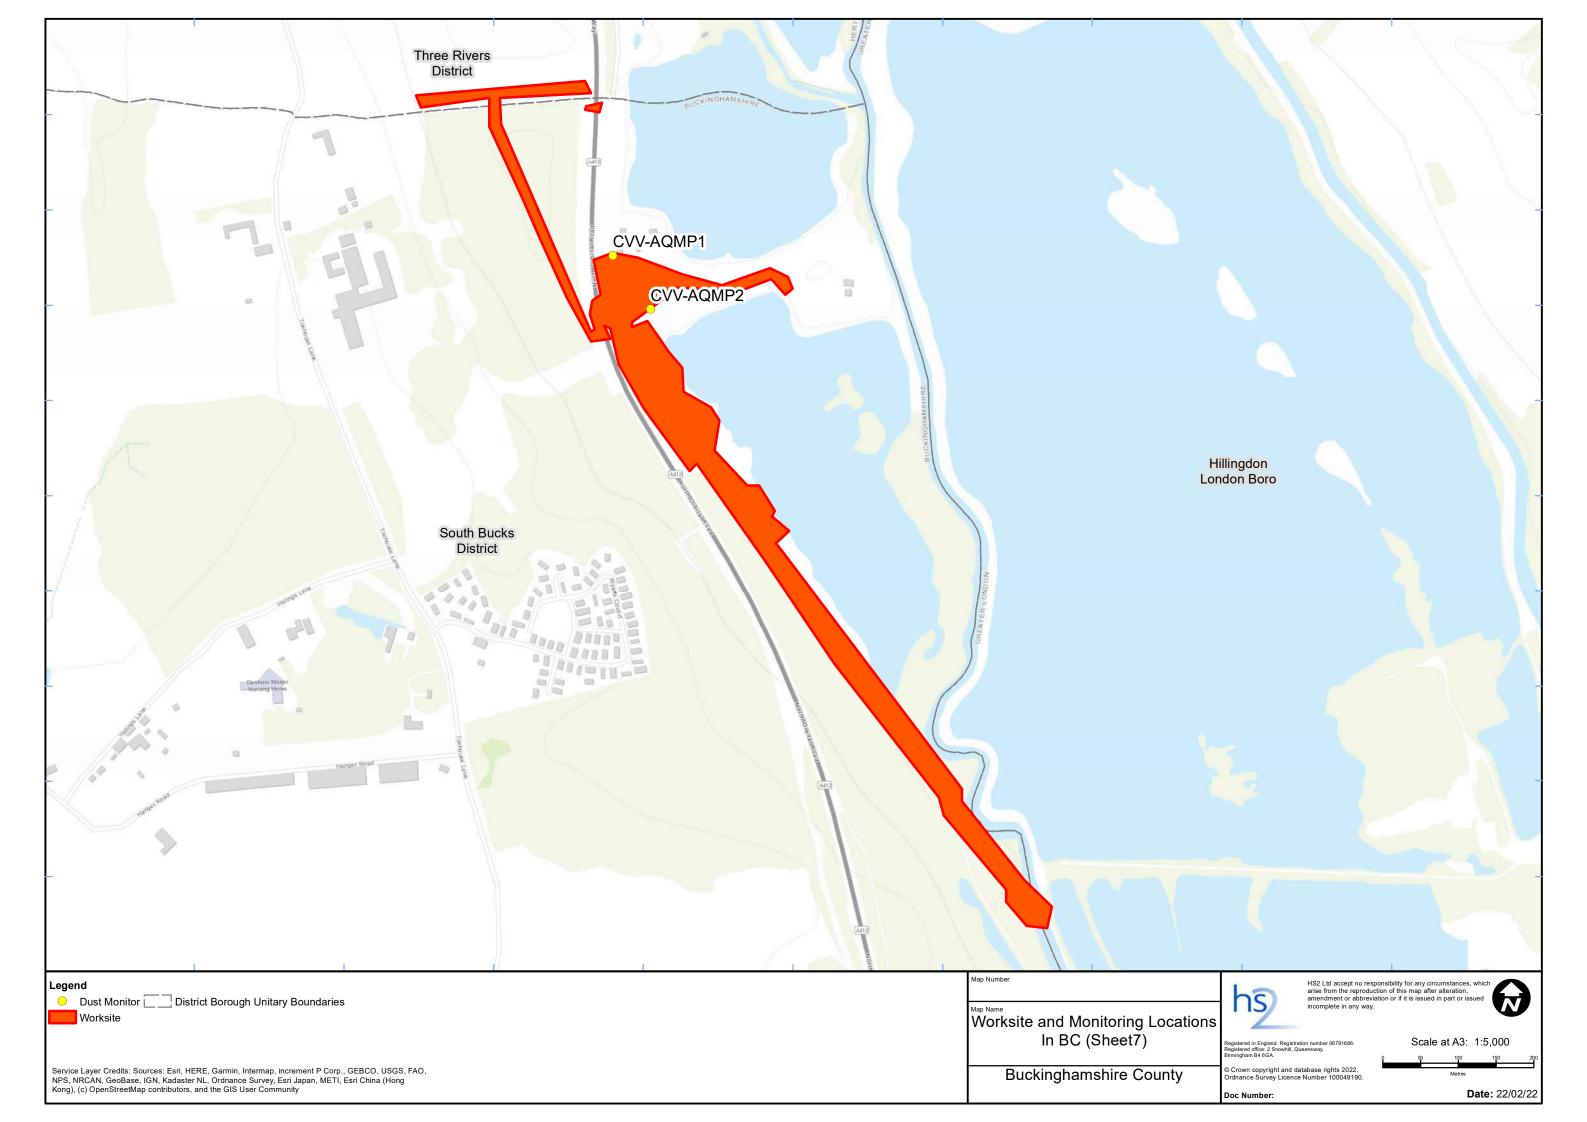
Figure 1 -7: Worksite and monitoring locations within the BC

- 1.1.2 Figures 1-7 in Appendix A present the current worksites together with the dust monitoring locations for May 2022.
- 1.1.3 This summary should be read in conjunction with the overview monitoring report available from www.gov.uk/government/collections/monitoring-the-environmental-effects-of-hs2, which highlights the applicable standards and guidance, as well as the air quality and dust monitoring methodologies to be implemented by nominated undertakers throughout construction.

- 1.1.4 The current worksites, as presented in Appendix A, Figures 1-7, include:

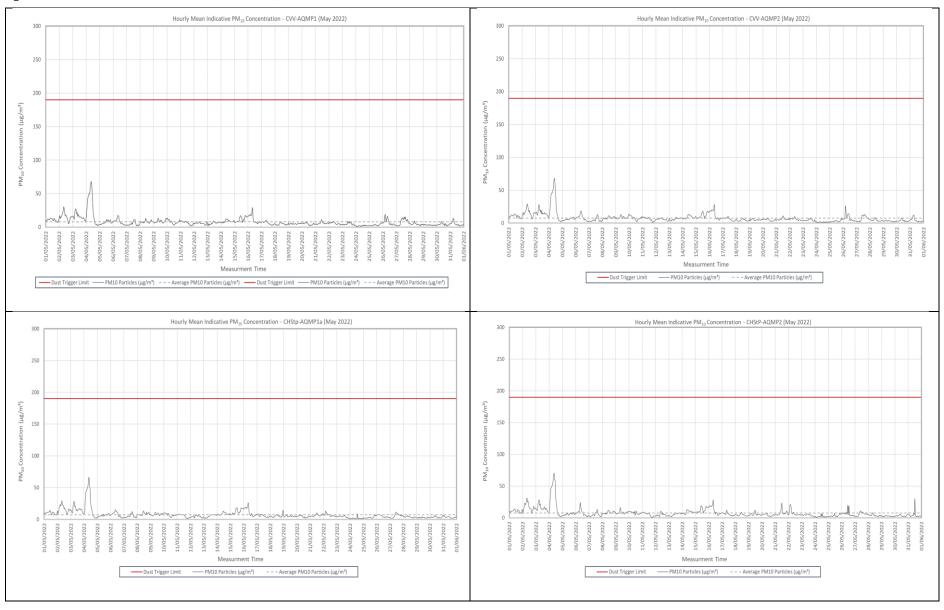
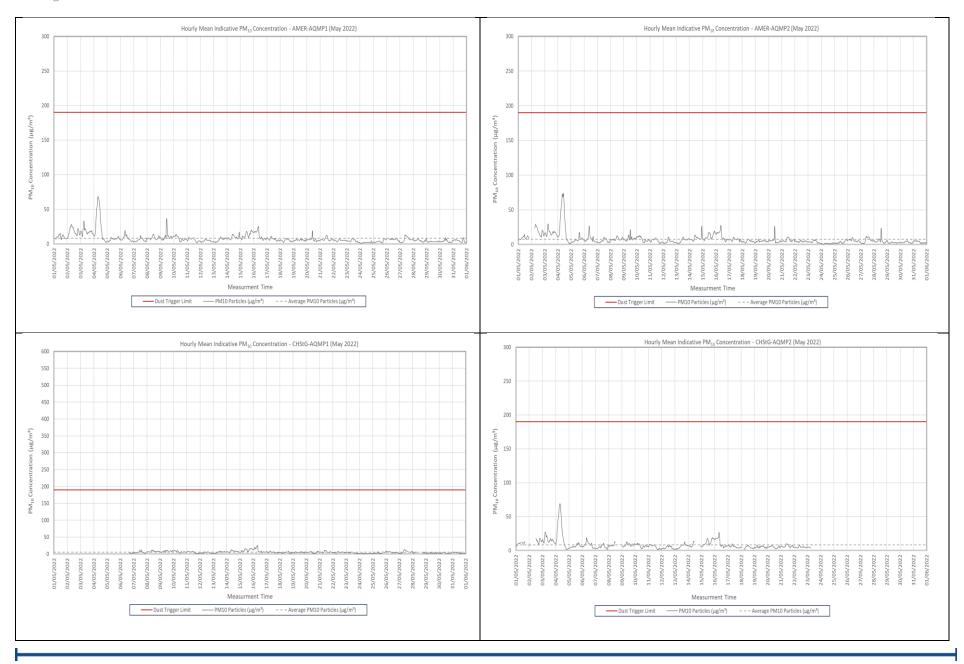
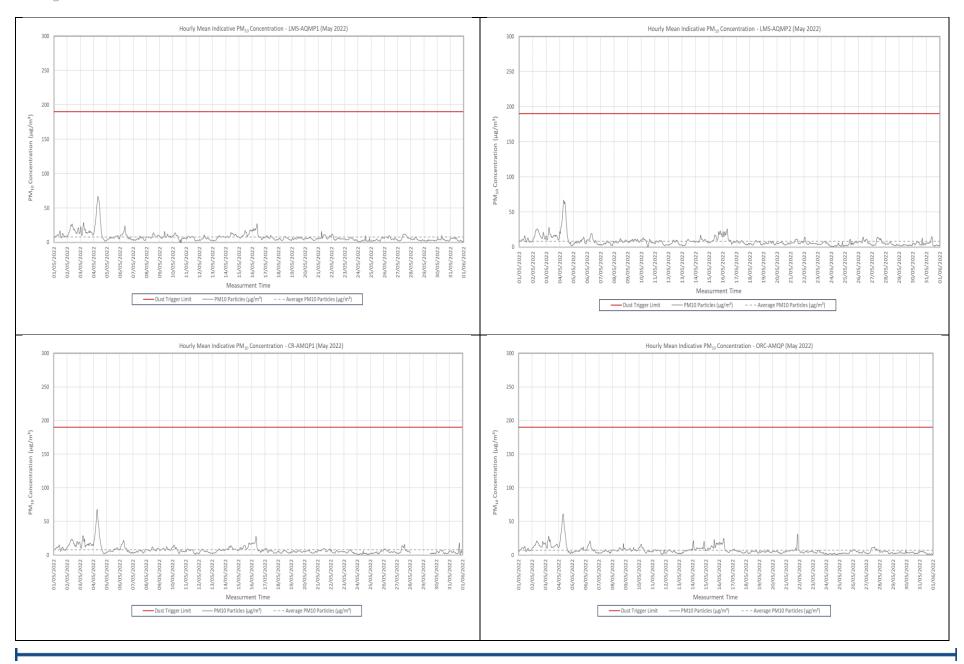
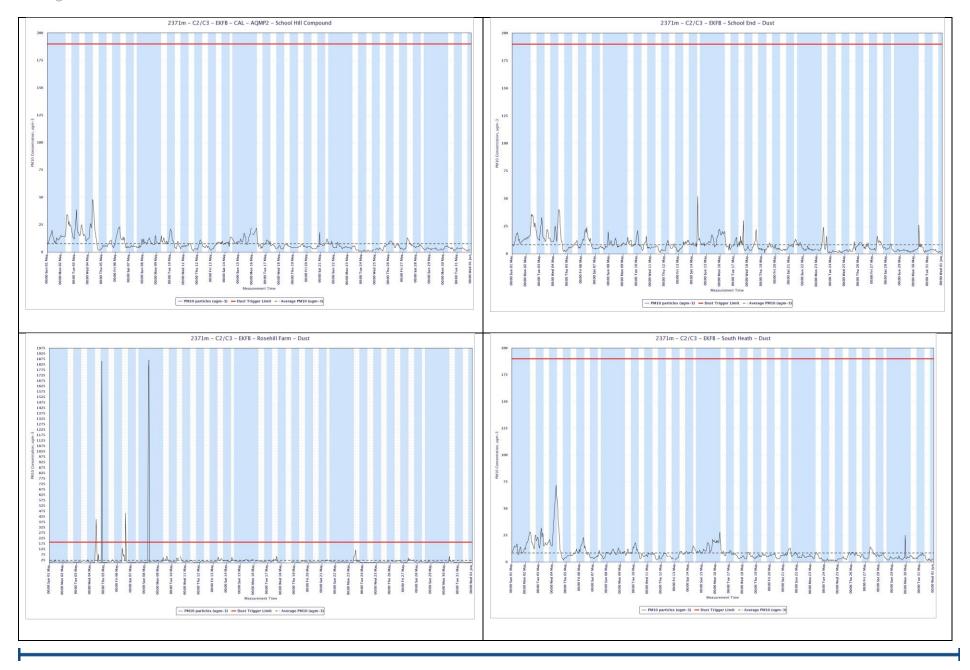
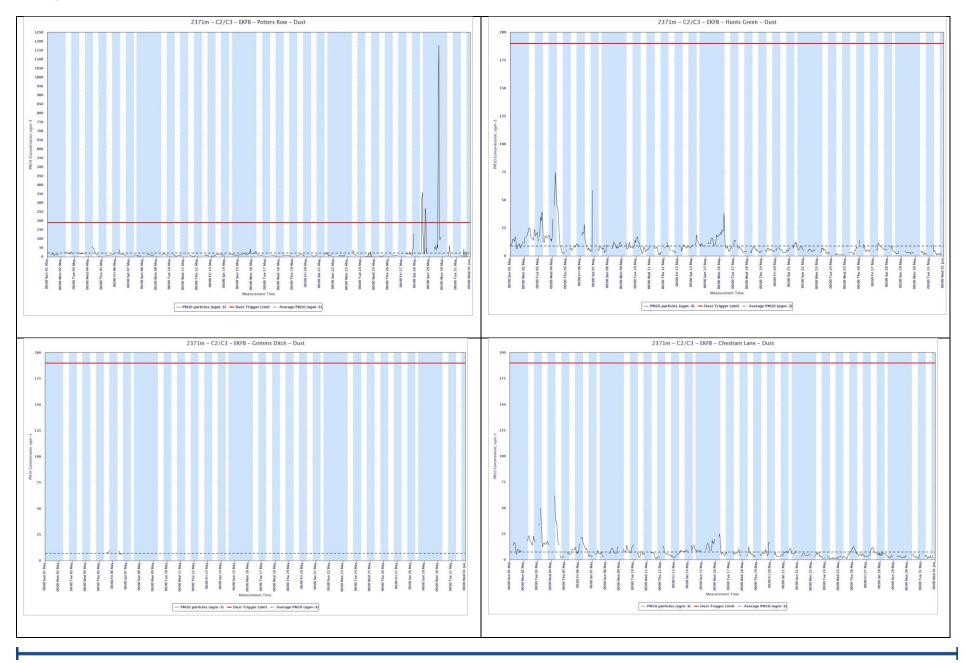
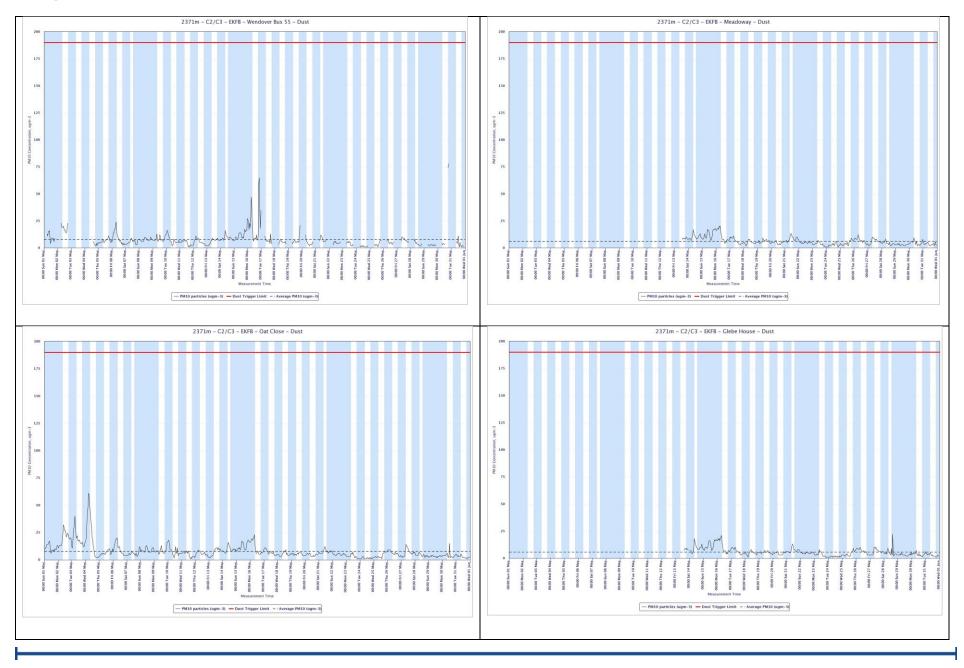
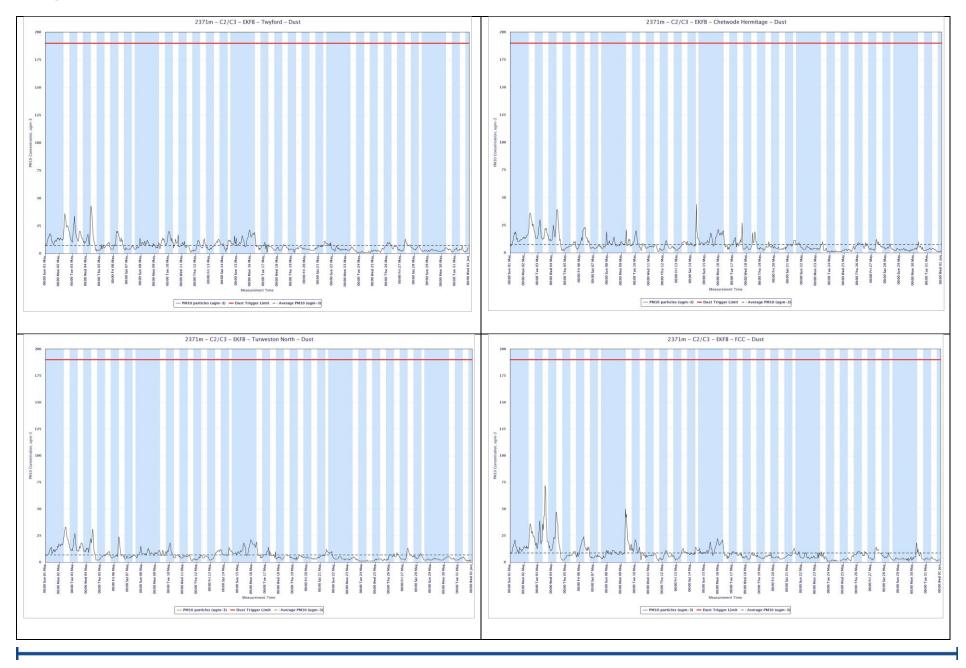
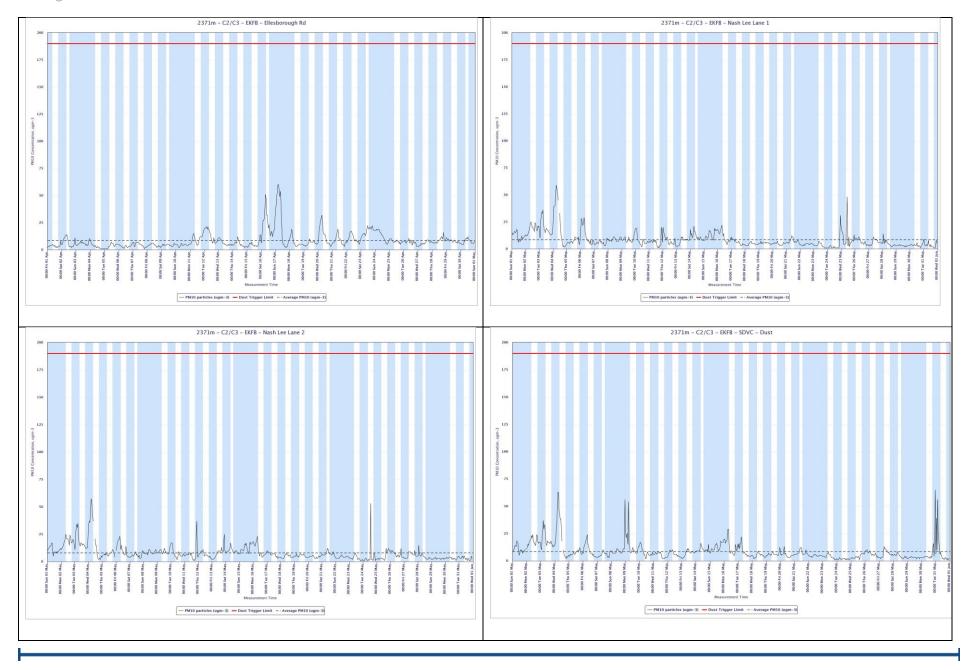
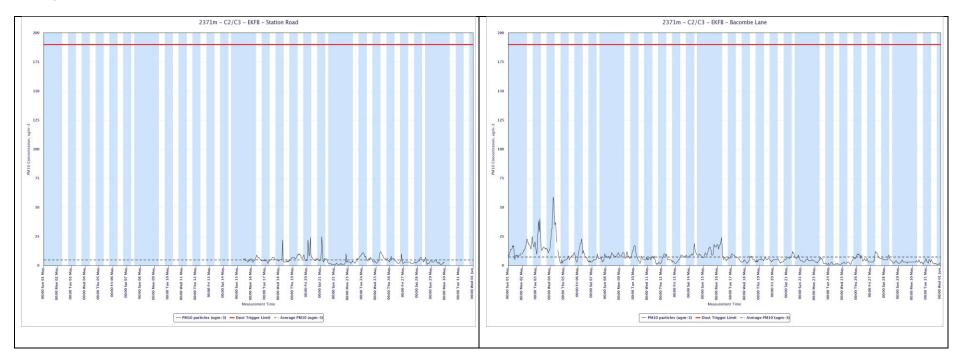
Figure 8: Continuous dust 1-hour mean indicative PM₁₀ concentration for all monitors

- 1.1.6 Dust monitoring locations and results for May 2022 are presented in Appendix B, Table 2, together with line charts of monthly data from each dust monitor presented in Figure 8. All continuous dust monitoring is undertaken using indicative monitors. Despite being Environment Agency (MCERTS) certified, indicative monitors carry a higher level of uncertainty than reference monitors, and therefore cannot be strictly compared with Air Quality Standards for human health and the environment. The purpose of the monitoring undertaken is to ensure the effectiveness of the on-site mitigation.

- 1.1.7 The trigger level for PM_{10} concentrations of 190 μ g/m³, measured as a 1-hour mean, in accordance with the updated guidance document 'Guidance on Monitoring in the Vicinity of Demolition and Construction Sites (October 2018)' has been applied.

Monitoring Site ID	Period of trigger alert &	Investigation	Outcomes / Resolution / Remedial measures implemented		
	Concentration recorded				
Rosehill Farm – Dust	04/05/22 9:01 – 10:00; 401.7 μg/m ³ 19:01 - 20:00; 1856.1 μg/m ³ 08/05/22 05:01 - 06:00; 1720.5 μg/m ³ 06:01 - 07:00; 1867.4 μg/m ³	No works were undertaken in close vicinity of Rosehill properties or on a Sunday.	N/A		
	06/05/22 13:01 - 14:00; 456.7 μg/m ³	No Demolition activities were undertaken this day. Activities finished at 12:00PM.	N/A		
	28/05/22 11:01 - 12:00; 360 µg/m ³	Monitor was located circa 90m away from the works. There is a farm on the other side of the monitor, some works could have been happening there, but there is no evidence of it. The works carried out at the dates and times of the trigger alerts were hauling and road sweeping with a limitation of hauling until 13:00h on Saturday, and bowsers were in place during the shift. It was found that monitors were not set up to send alarms on real time of exceedances to the environmental team.	Monitors have been configured in order to send the trigger alarms notifications to the environmental team and earthworks team on real time. Dust suppression measures were in place. Incident will be raised to HS2 and LA will be notified.

Potters Row – Dust	28/05/22 10:01 - 11:00; 321 μg/m ³	Monitor was located circa 90m away from the works. There is a farm on the other side of the monitor, some works could have been happening there, but there is no evidence of it. The works carried out at the dates and times of the trigger alerts were hauling and road sweeping with a limitation of hauling until 13:00h on Saturday, and bowsers were in place during the shift. It was found that monitors were not set up to send alarms of exceedances to the environmental team.	Monitors have been configured in order to send the trigger alarms notifications to the environmental team and earthworks team on real time. Dust suppression measures were in place. Incident will be raised to HS2 and LA will be notified.		
	28/05/22 16:01 - 17:00; 270 μg/m³	No works undertaken after 17:00h on Saturday.	N/A		
	28/05/22 17:01 - 18:00; 249 µg/m³	No works undertaken after 17:00h on Saturday	N/A
