Construction Noise and Vibration Monthly Report – April 2022

Buckinghamshire

This Noise and Vibration Monitoring Report fulfils HS2 Limited's commitment detailed in the Environmental Minimum Requirements (EMRs), Annex 1, Code of Construction Practice, to present the results of noise monitoring carried out within Buckinghamshire (BS) during the month of April 2022.

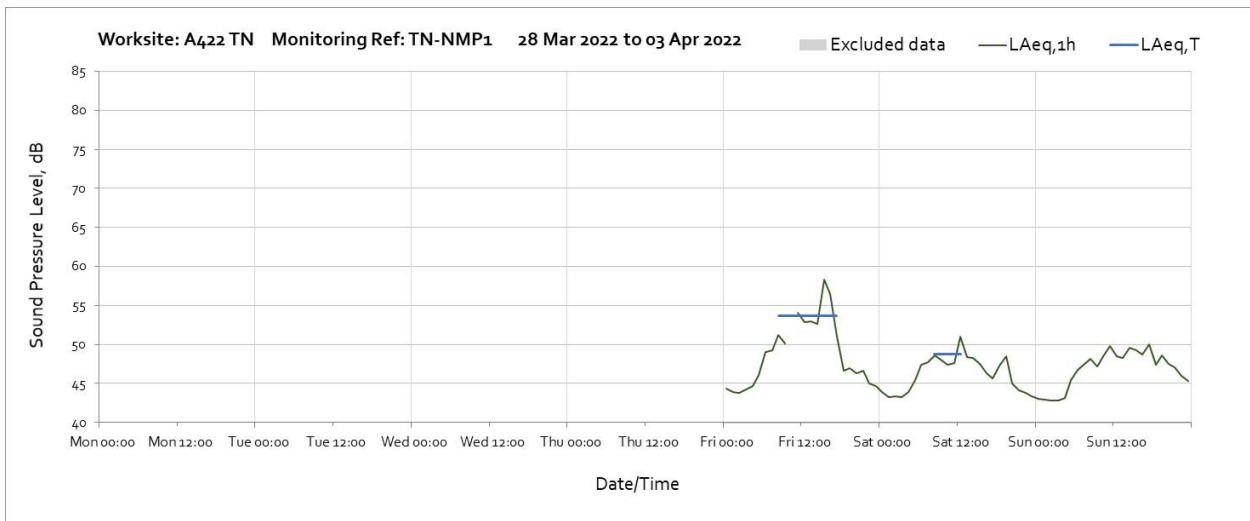
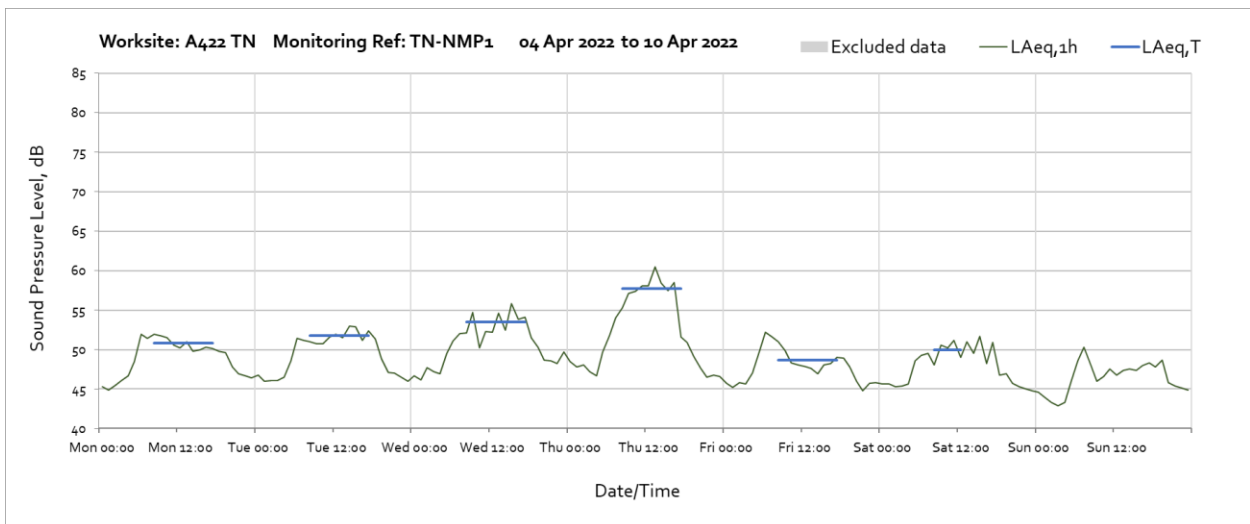
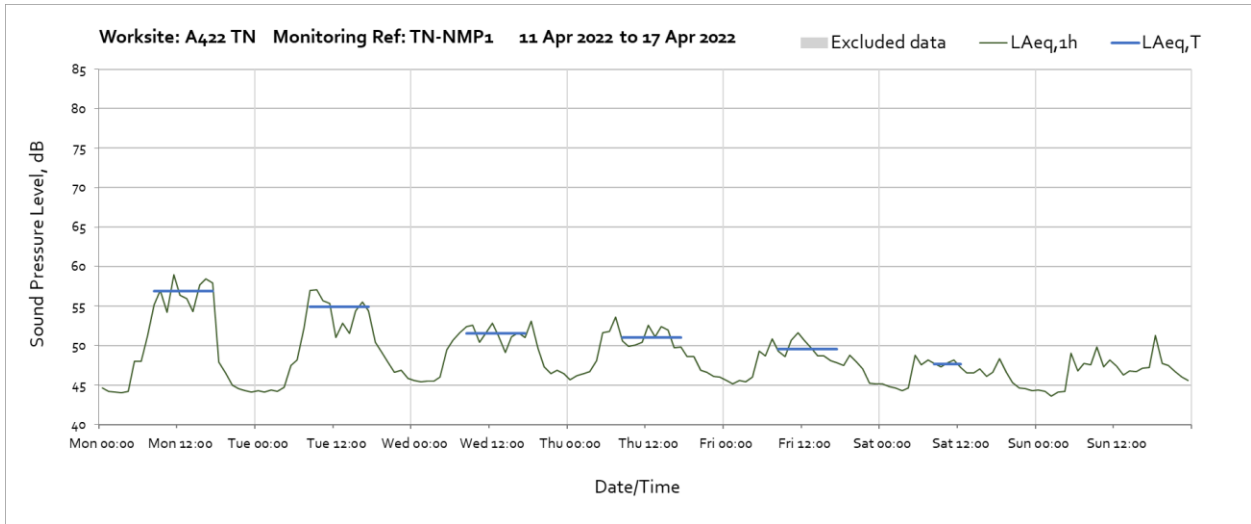
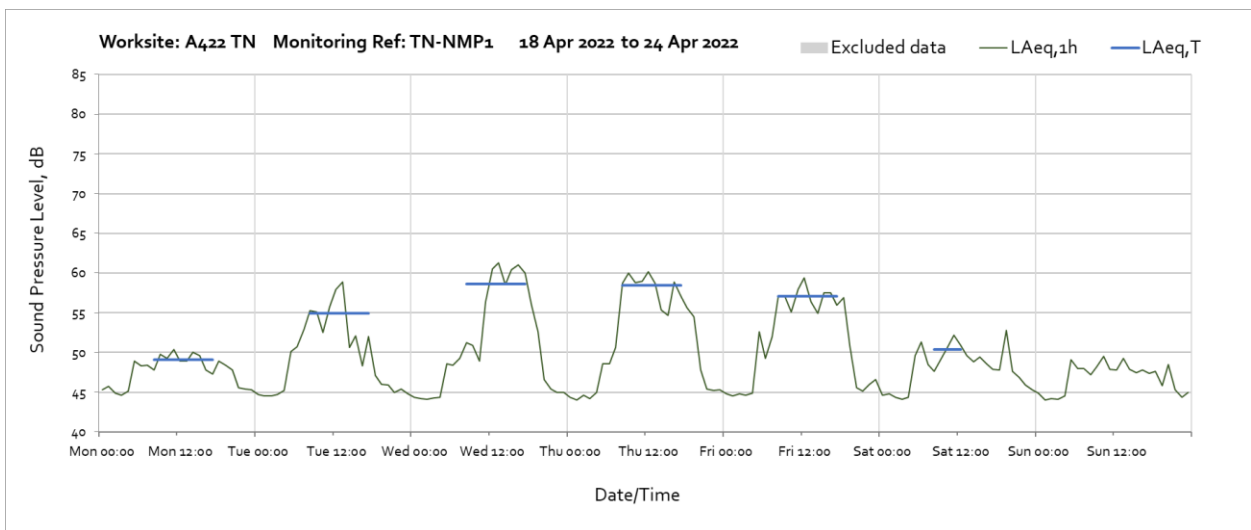
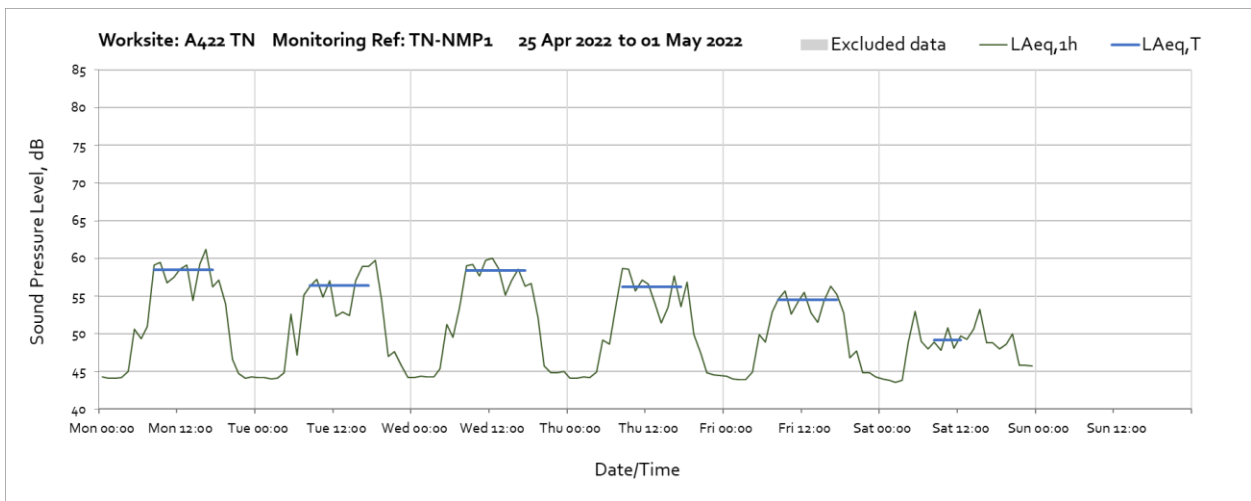
Worksite: A422 TN – Monitoring Ref: TN-NMP1

Note: Missing data at 10:00 on Friday 1st April was due to loss of continuous site power.

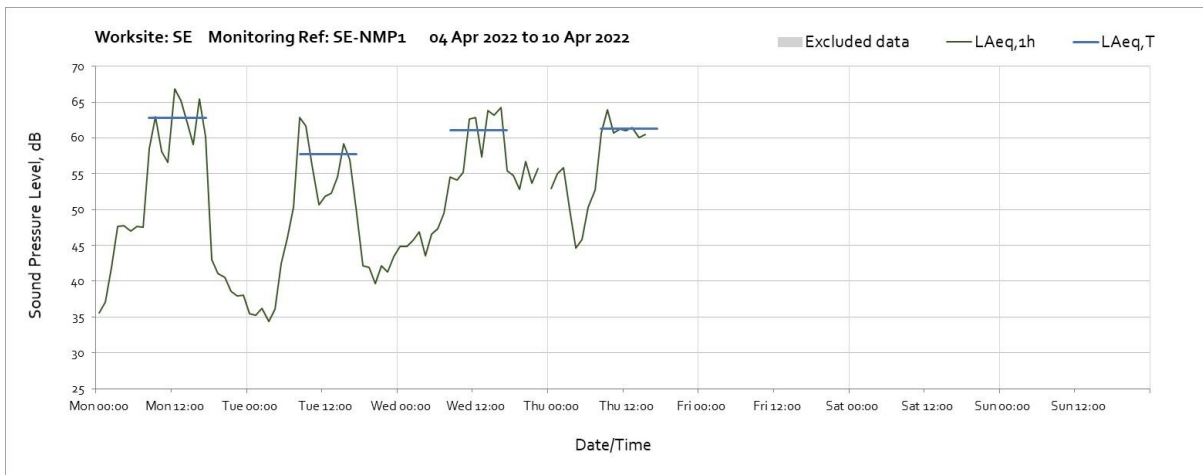
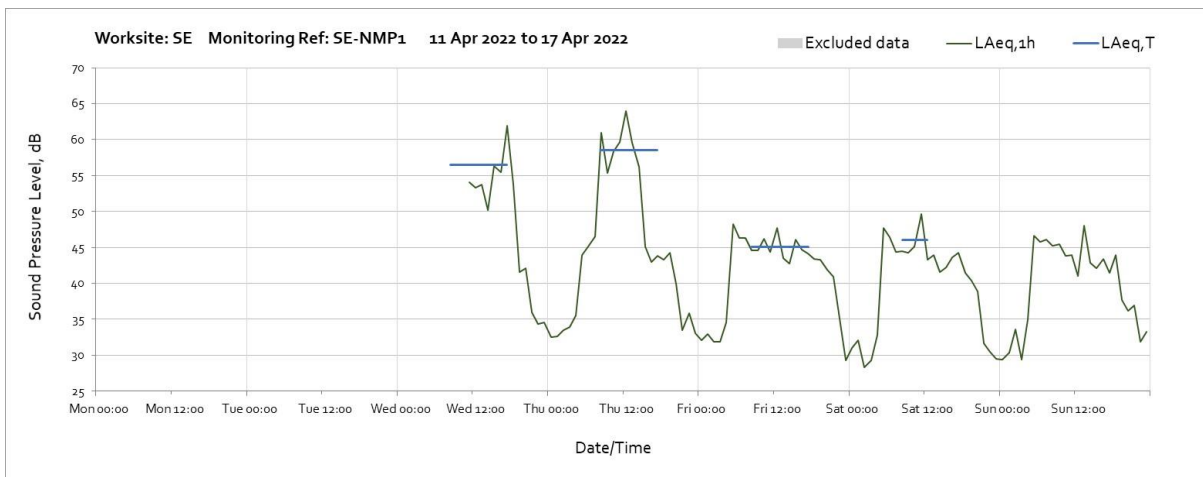
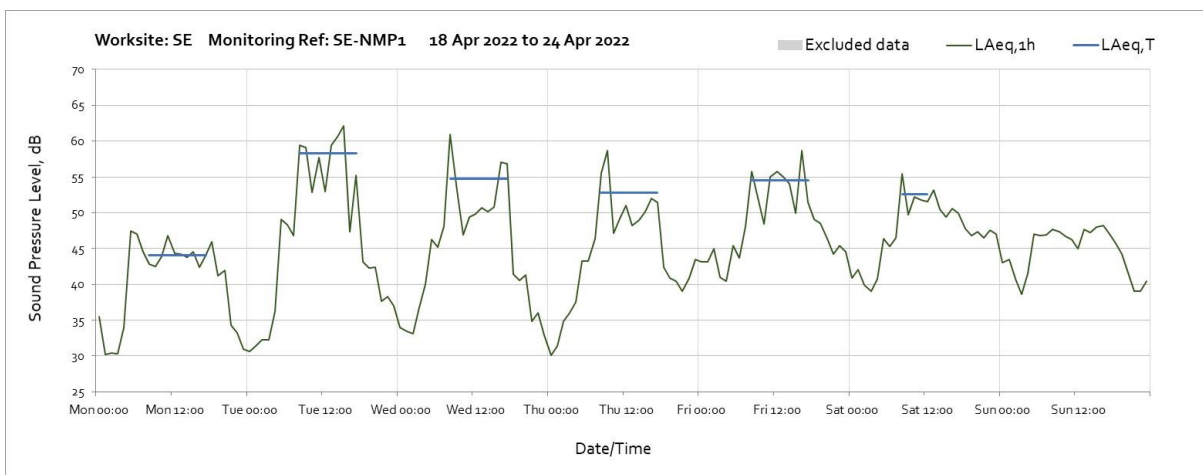
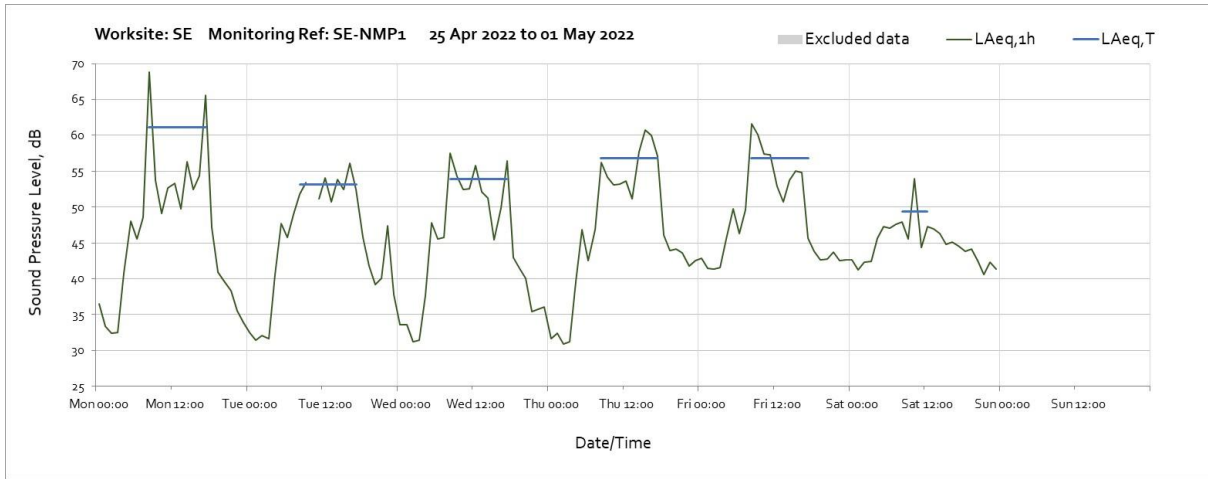
Worksite: SE – Monitoring Ref: SE-NMP1

Note: Missing data at 23:00 on Wednesday 6th April and between 16:00 on Thursday 7th April and 13:00 on Wednesday 13th April was due to loss of continuous site power.

Note: Missing data between 16:00 on Thursday 7th April and 13:00 on Wednesday 13th was due to loss of continuous site power.

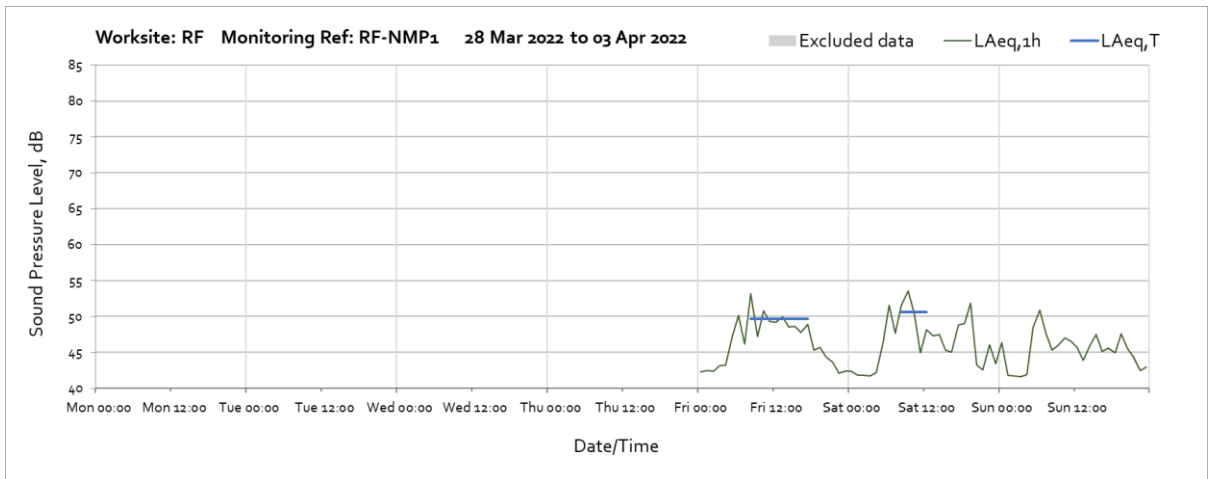
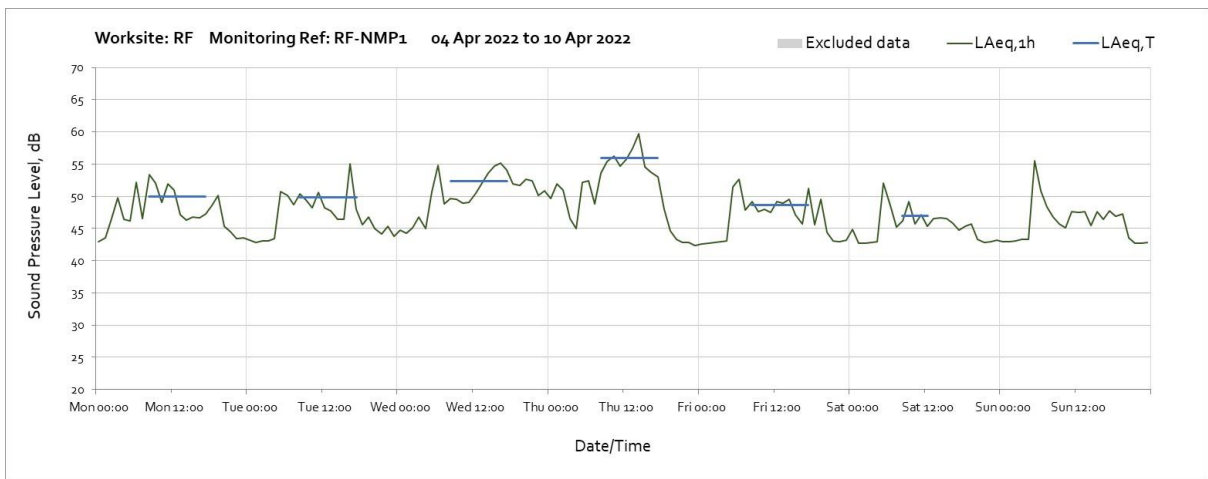
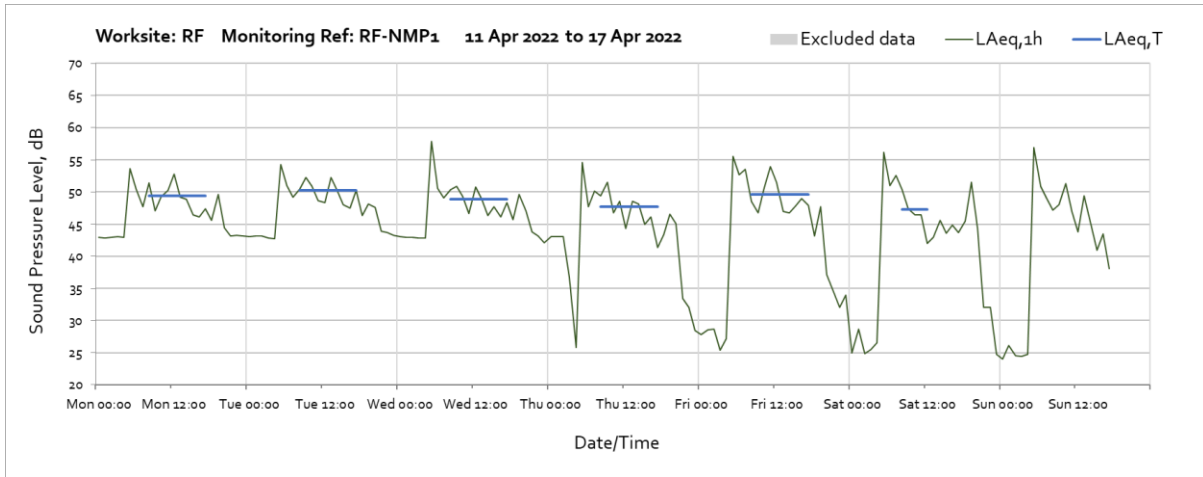
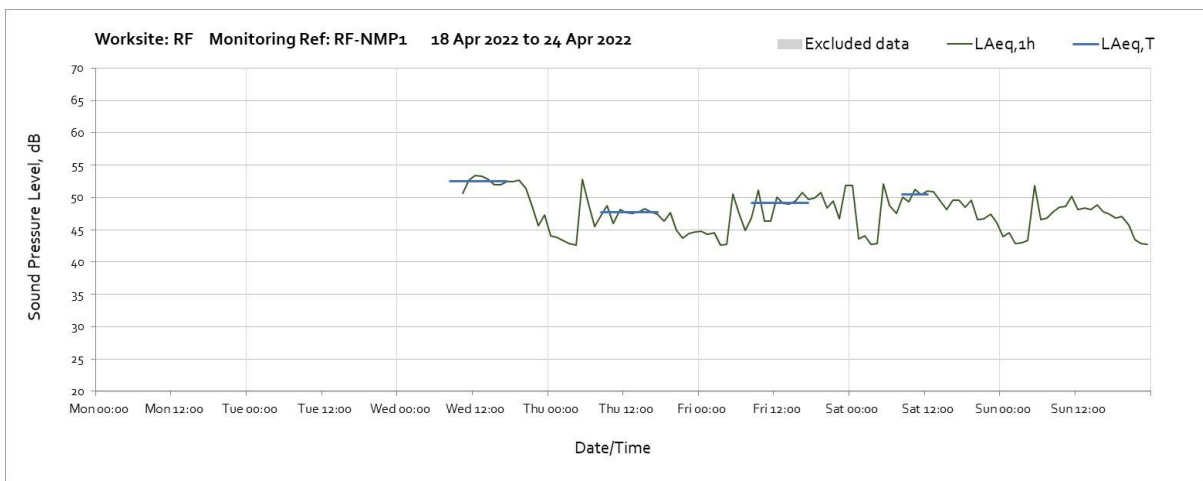
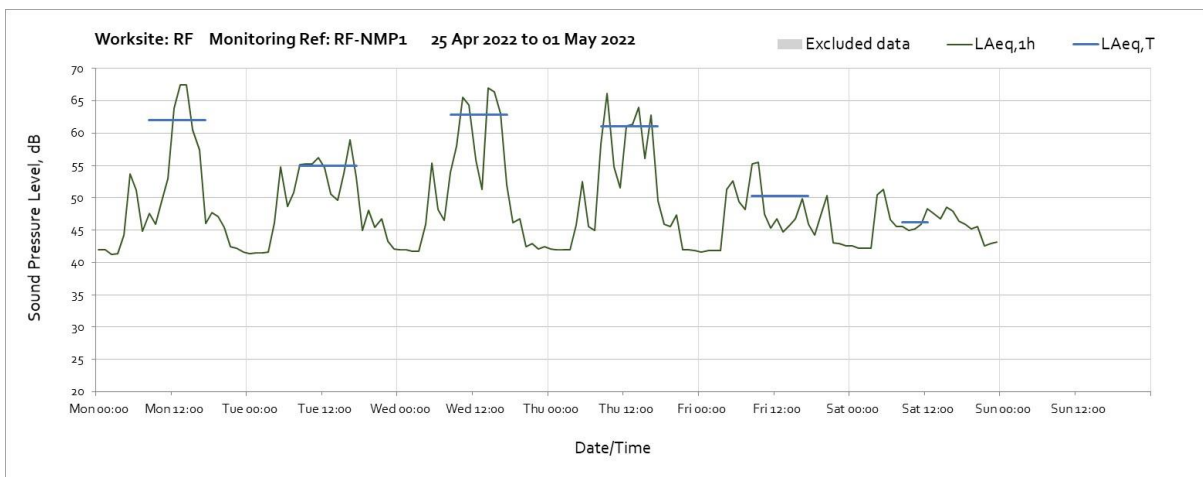
Worksite: RF – Monitoring Ref: RF-NMP1

Note: Missing data between 18:00 on Sunday 17th April and 10:00 on Wednesday 20th April was due to loss of continuous site power. Power supply equipment has now been replaced.

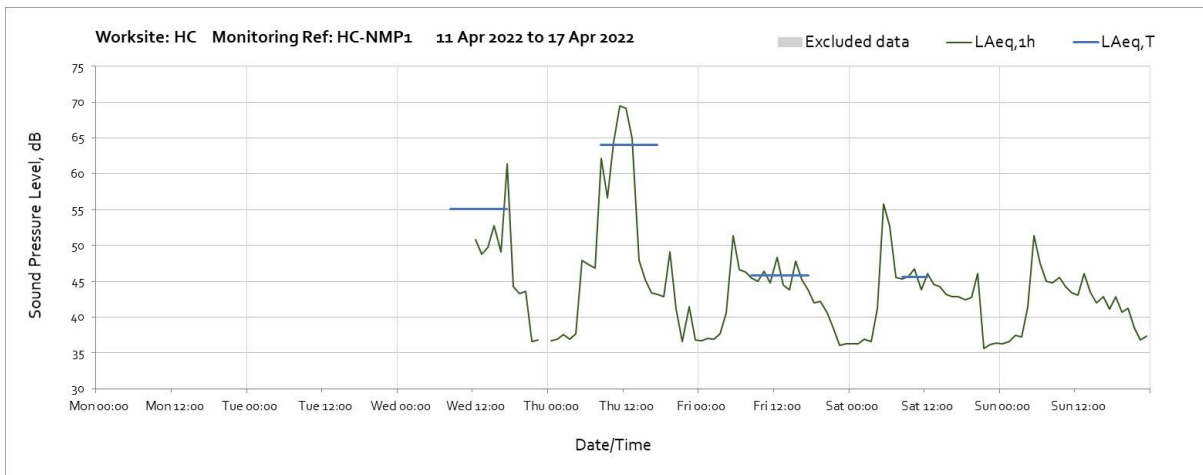
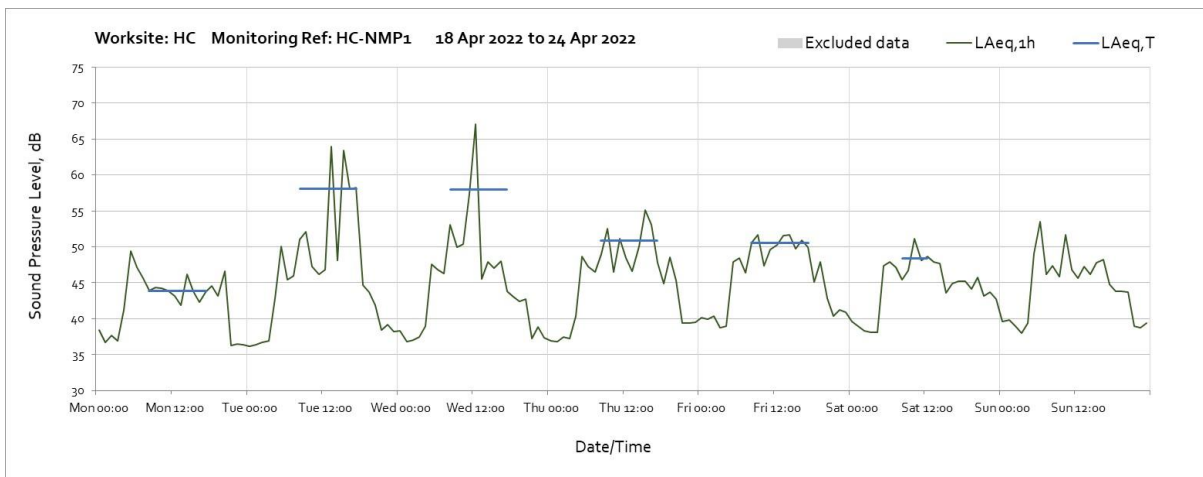
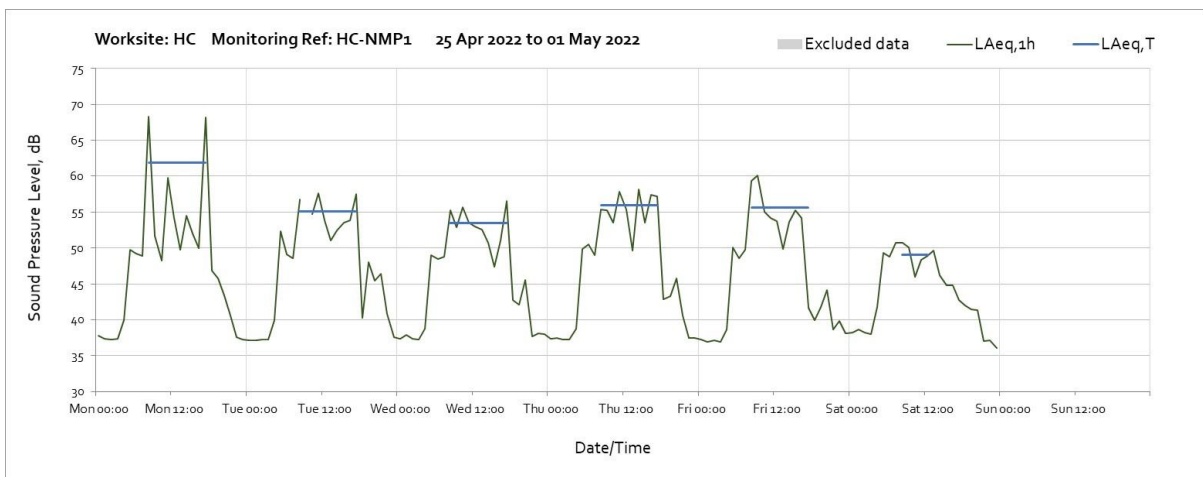
Worksite: HC – Monitoring Ref: HC-NMP1

Note: Missing data from the beginning of the month to 11:00 on Wednesday 13th April and at 23:00 on Wednesday 13th April was due to loss of continuous site power.

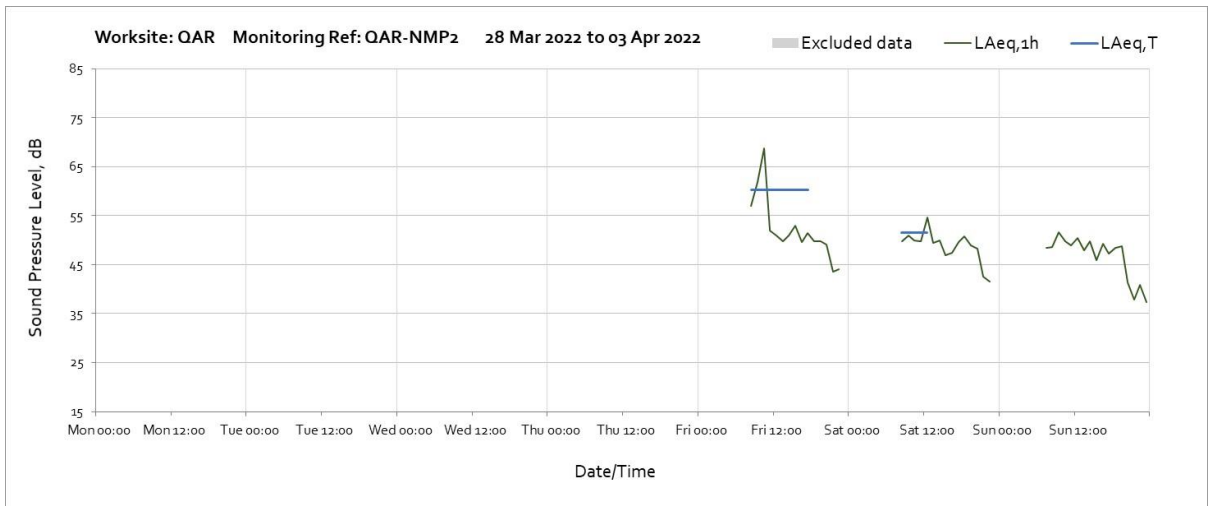
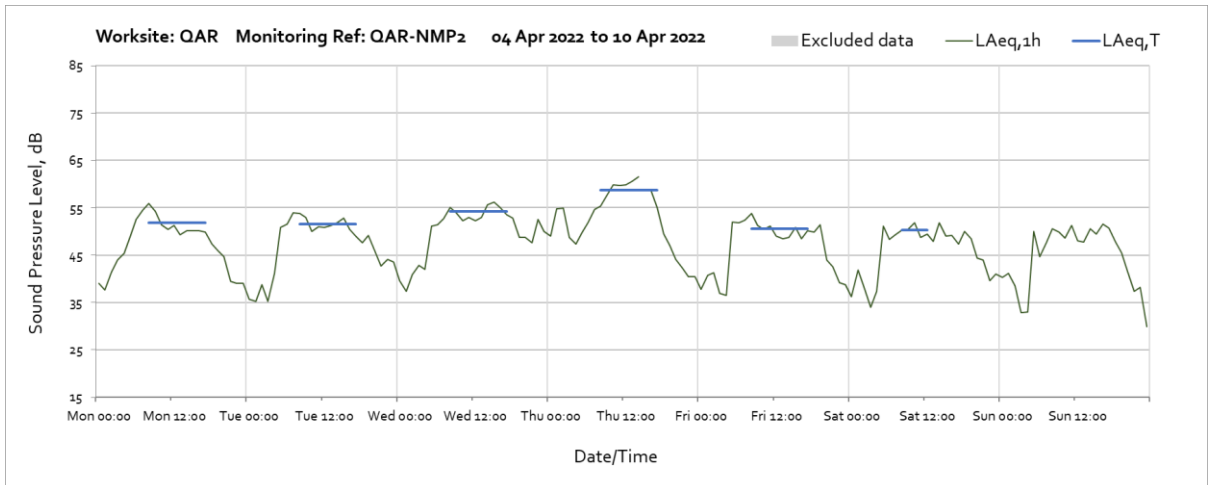
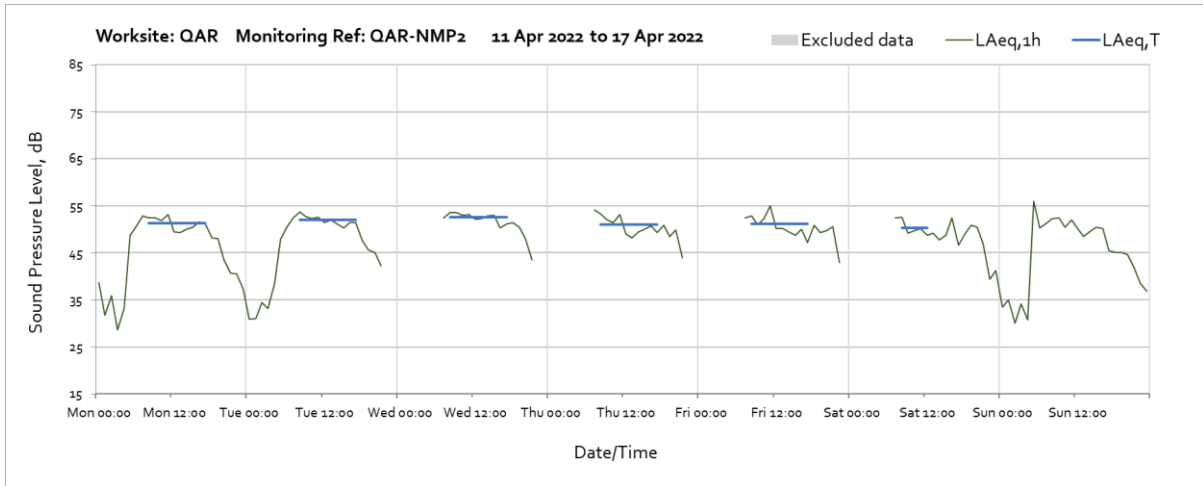
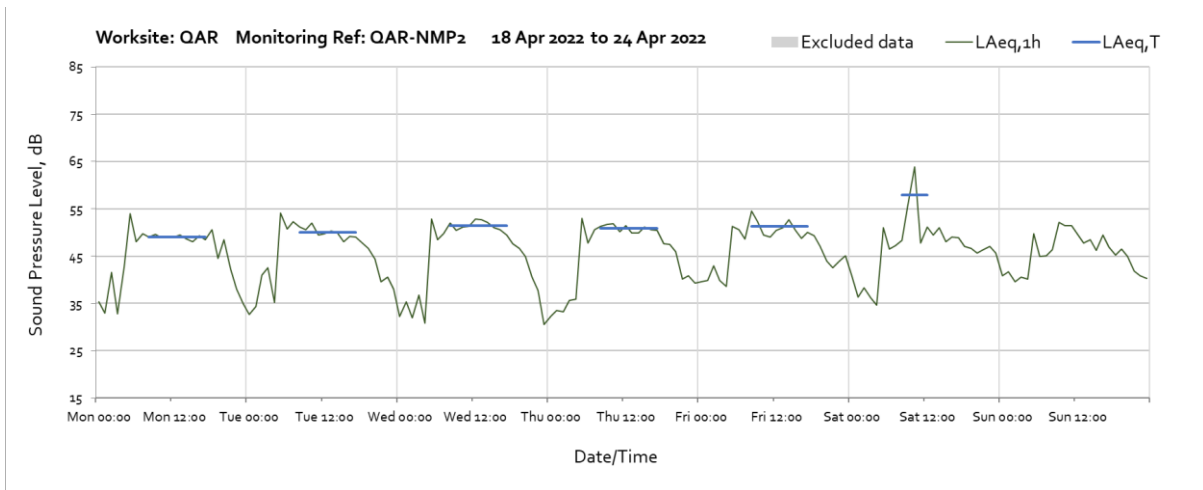
Worksite: QAR – Monitoring Ref: QAR-NMP2

Note: Missing data across the week was due to loss of power at the monitoring station.

Note: Missing data at 15:00 on Thursday 7th April was due to loss of power at the monitoring station.

Note: Field calibration on Thursday 28th April revealed a problem with the equipment and data for the remaining period was excluded. The equipment has been sent for repair and a temporary equipment has installed on the 5th of May.

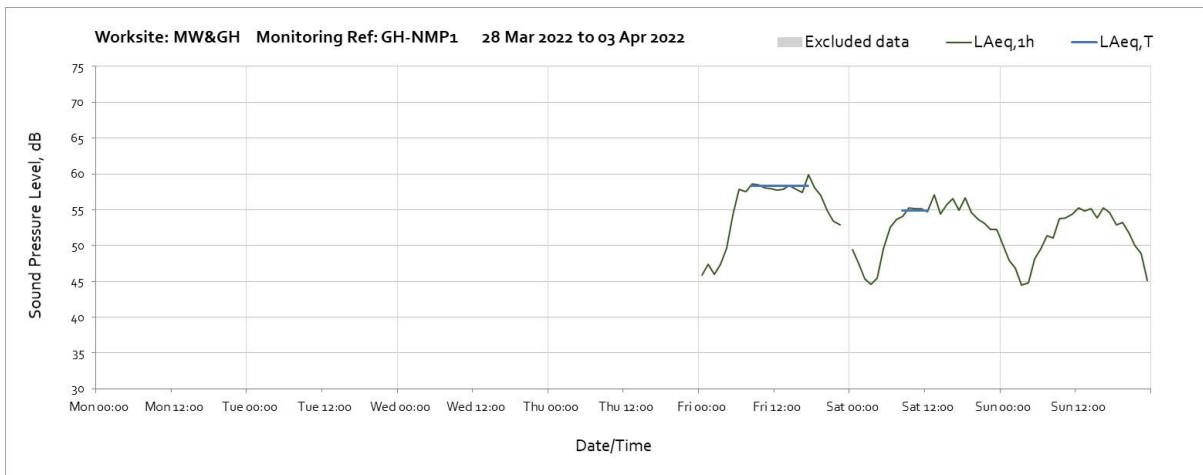
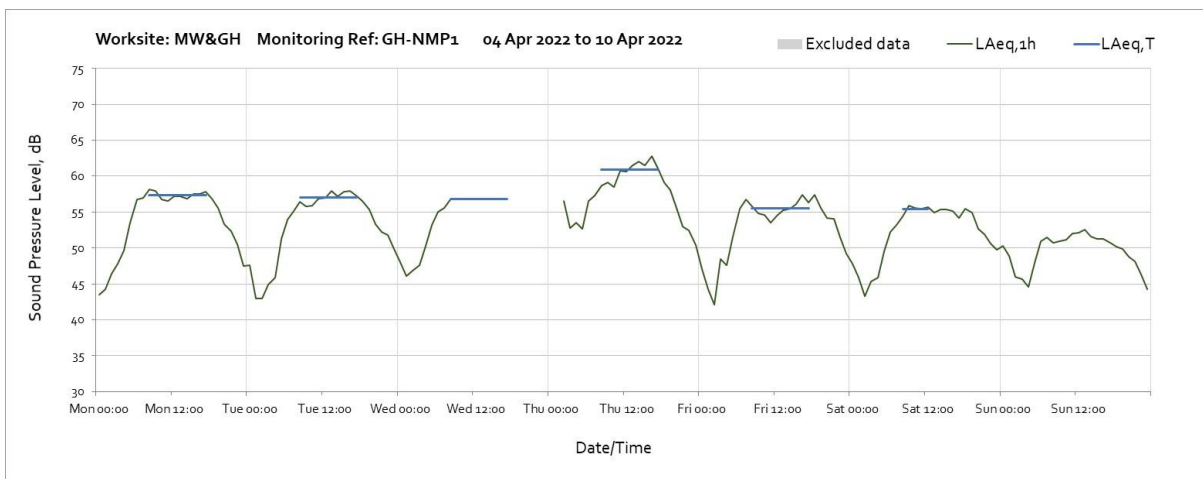
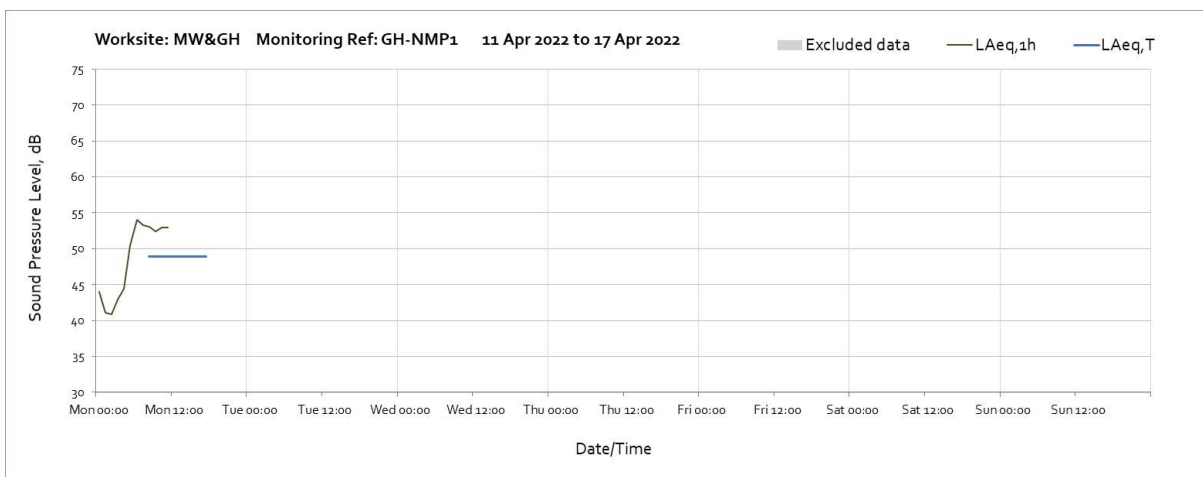
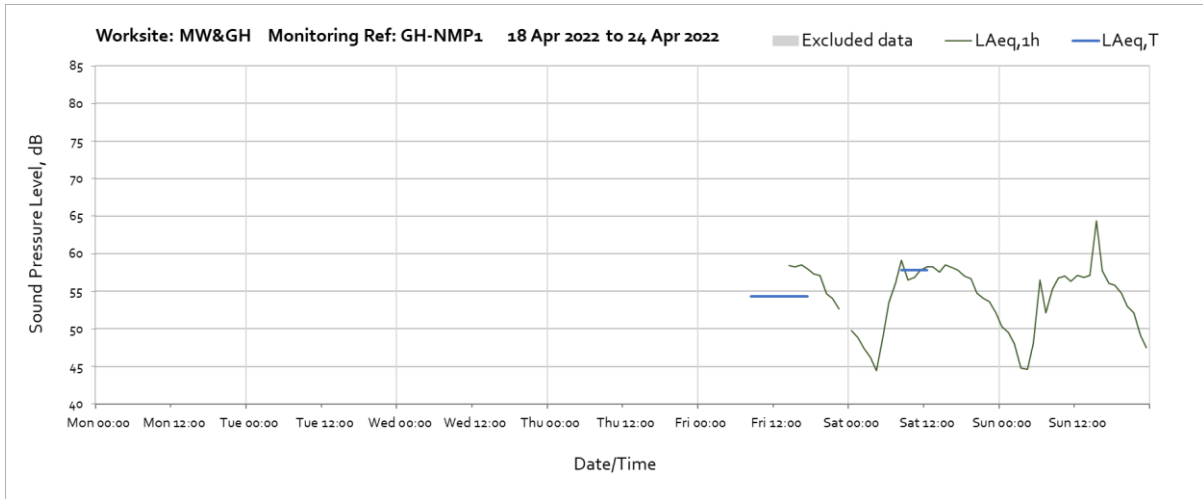
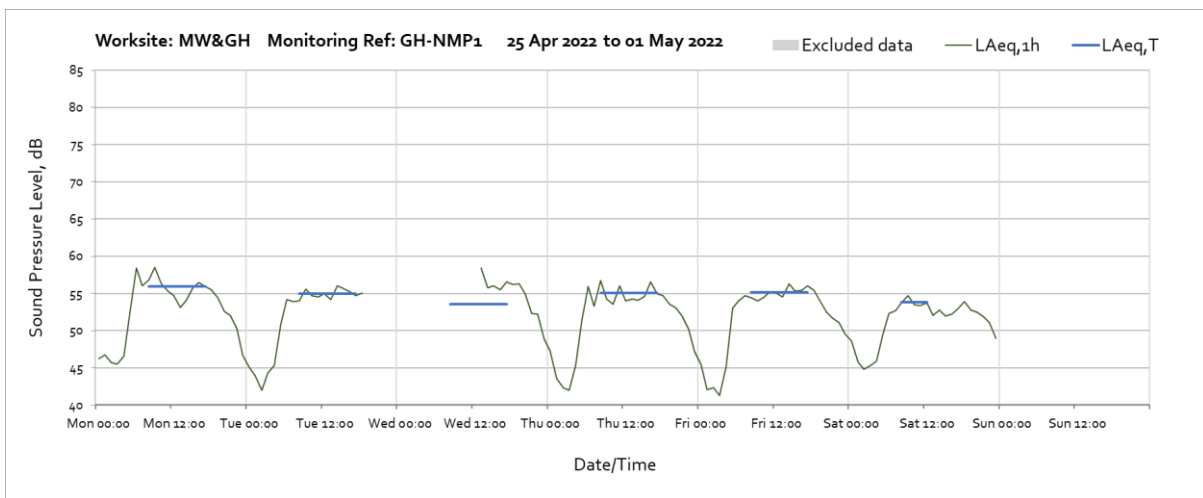
Worksite: MW&GH – Monitoring Ref: GH-NMP1

Note: Missing data at 23:00 on Friday 1st April was due to loss of power at the monitoring station.

Note: Missing data between 09:00 on Wednesday 6th April and 02:00 on Thursday 7th April was due to loss of power at the monitoring station.

Note: Missing data across the week was due to loss of power at the monitoring station.

Note: Missing data between 19:00 on Tuesday 26th April and 13:00 on Wednesday 27th was due to loss of power at the monitoring station.

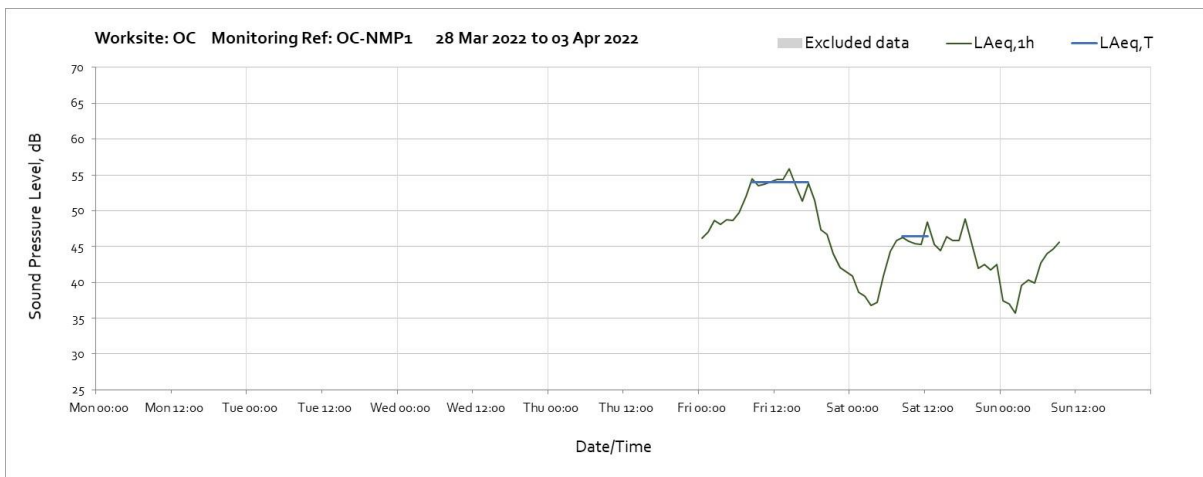
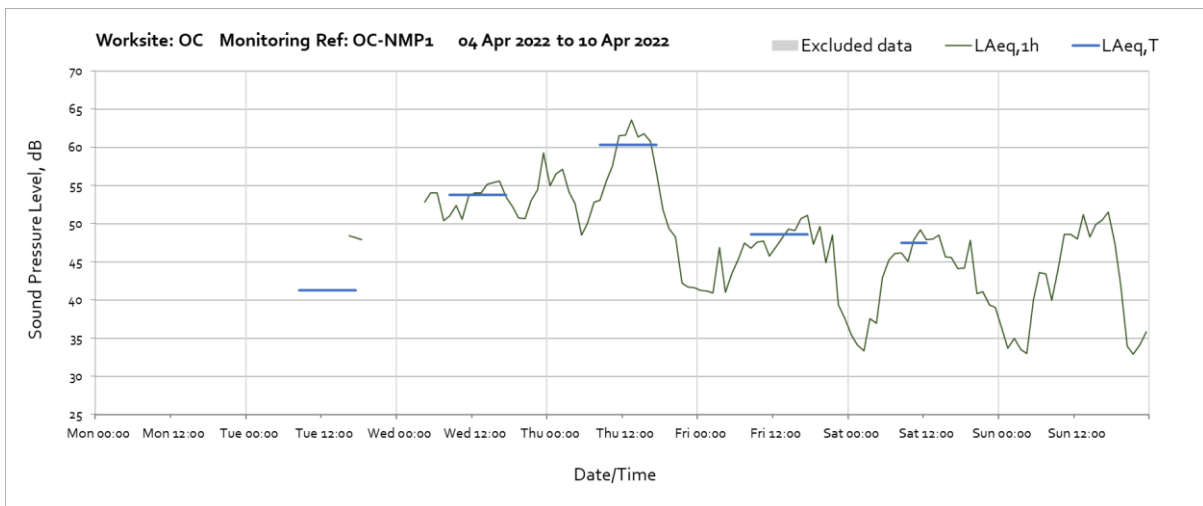
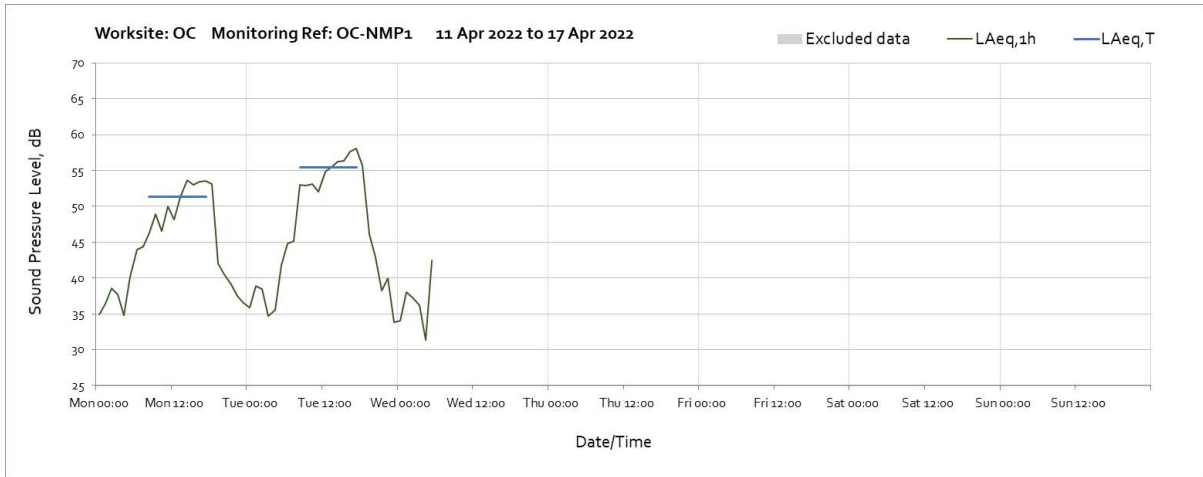
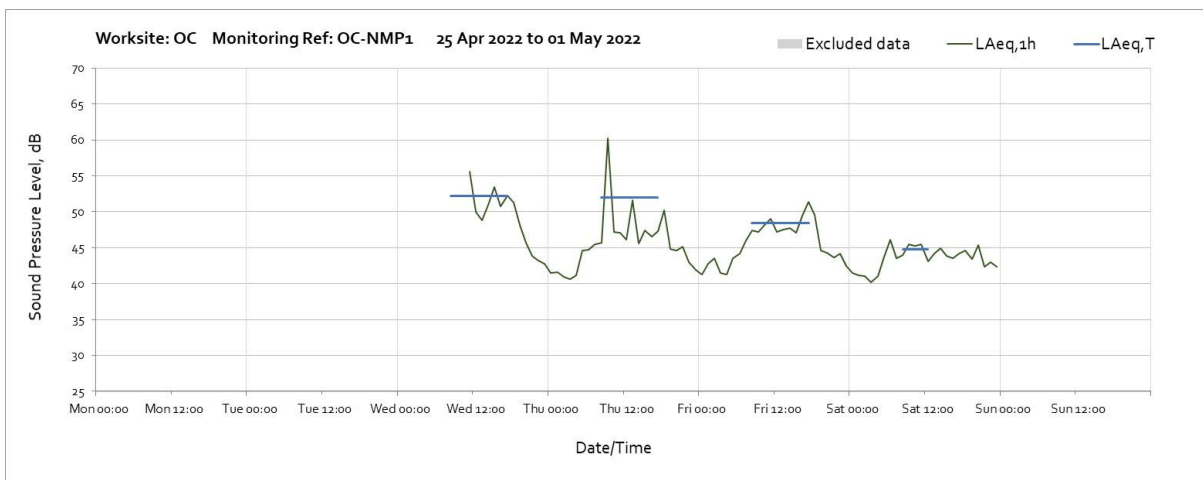
Worksite: OC - Monitoring Ref: OC-NMP1

Note: Missing data across the week was due to loss of power at the monitoring station.

Note: Missing data between 06:00 on Wednesday 13th April and 11:00 on Wednesday 27th April was due to loss of power at the monitoring station.

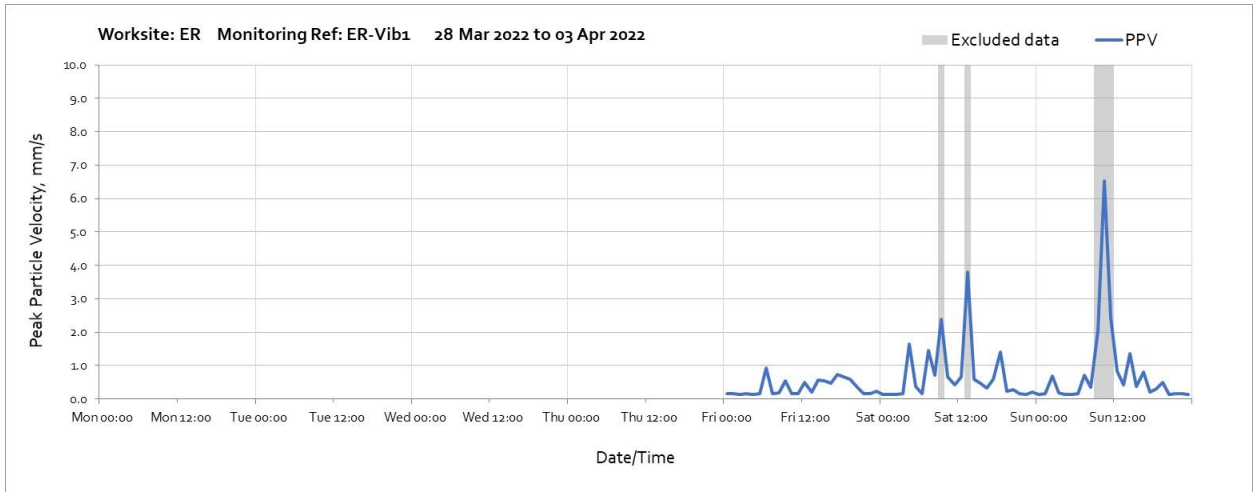
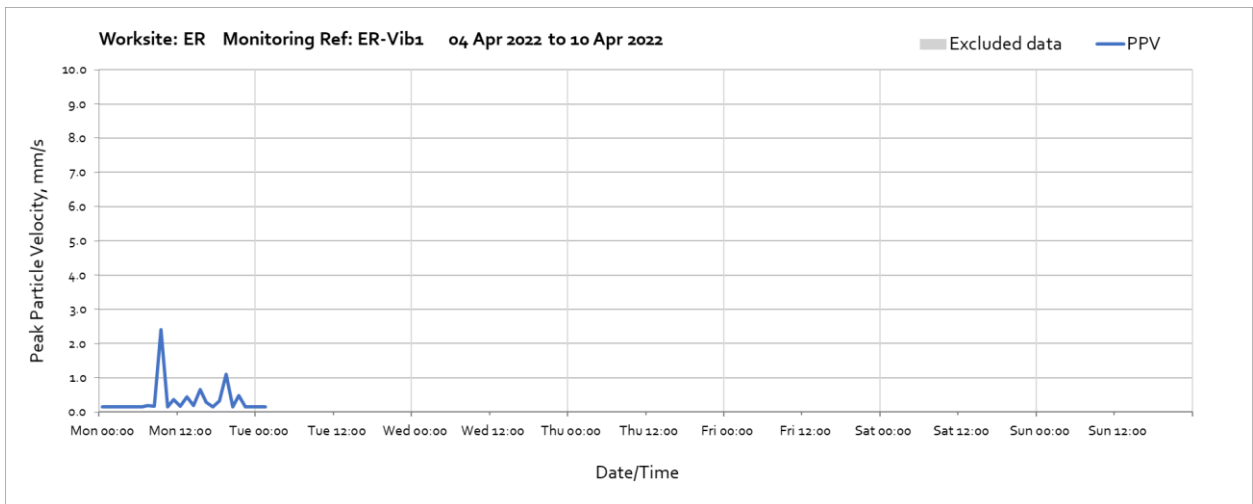
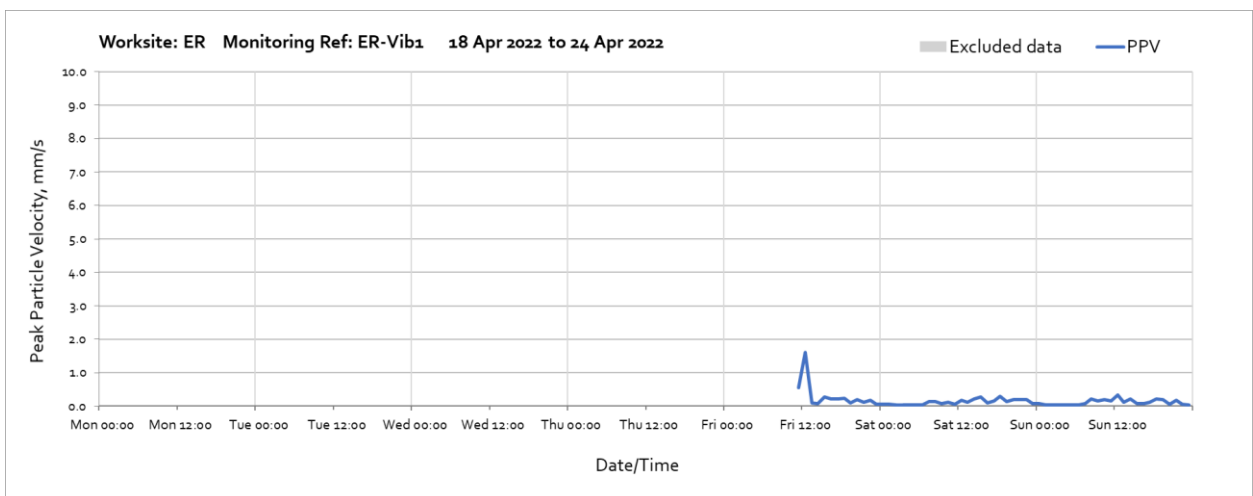
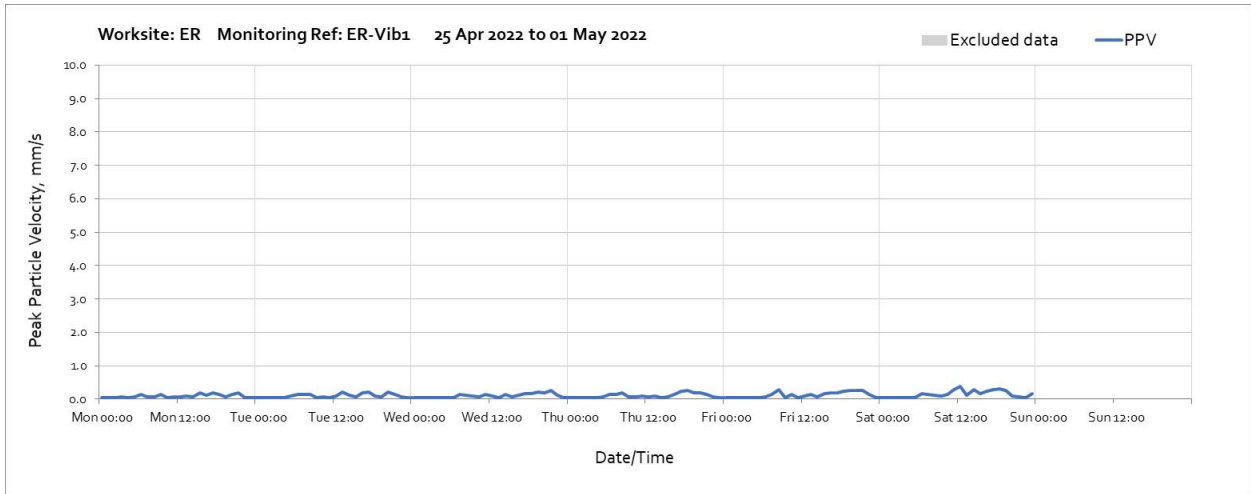
Worksite: ER – Monitoring Ref: ER-Vib 1

Note: Missing data from 02:00 on Tuesday 5th April to 11:00 on Friday 22nd April was due to internal fault of the monitoring equipment. A temporary monitor was installed on Friday 22nd April.
