Construction Noise and Vibration Monthly Report – April 2022

London Borough of Camden

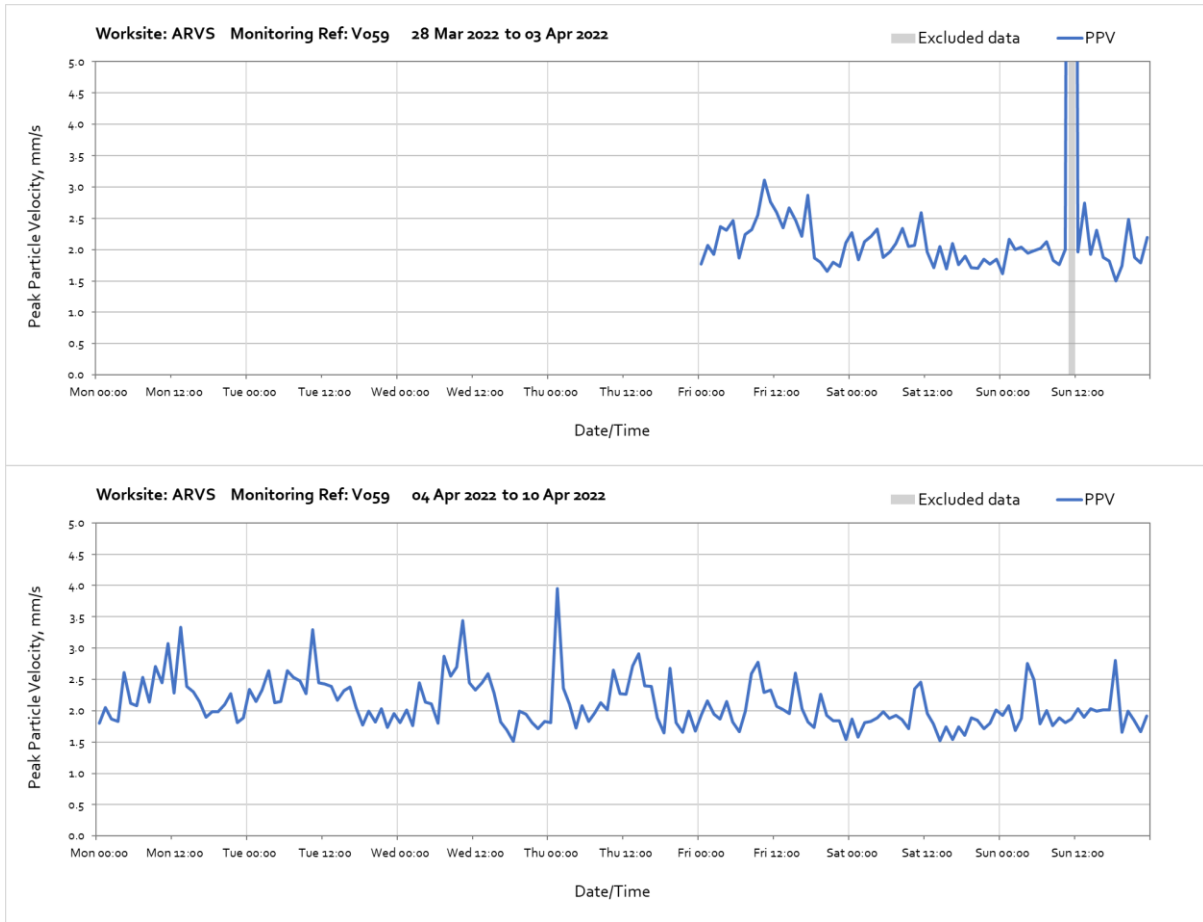
Worksite: ARVS – Monitoring Ref: V059

The following graphs show the hourly measured peak particle velocity PPV recorded during the monitoring period. The graphs show the resultant PPV due to vibration components on three orthogonal axes x, y and z. Where resultant PPV data is not available (monitors V039 and V043), the highest vibration component in either of the three axes is presented for each 1 hr measurement period respectively. Where high values of PPV were caused by local interference with the vibration monitor, which are not representative of HS2 construction works, these values have been greyed out in the following charts and have been excluded to calculate values in Table 4 of the main report.
